Cannonsville Dam Public Outreach Meetings

Deputy Commissioner Paul V. Rush, P.E.
Bureau of Water Supply

Deposit, NY
July 23, 2015

Cannonsville Dam

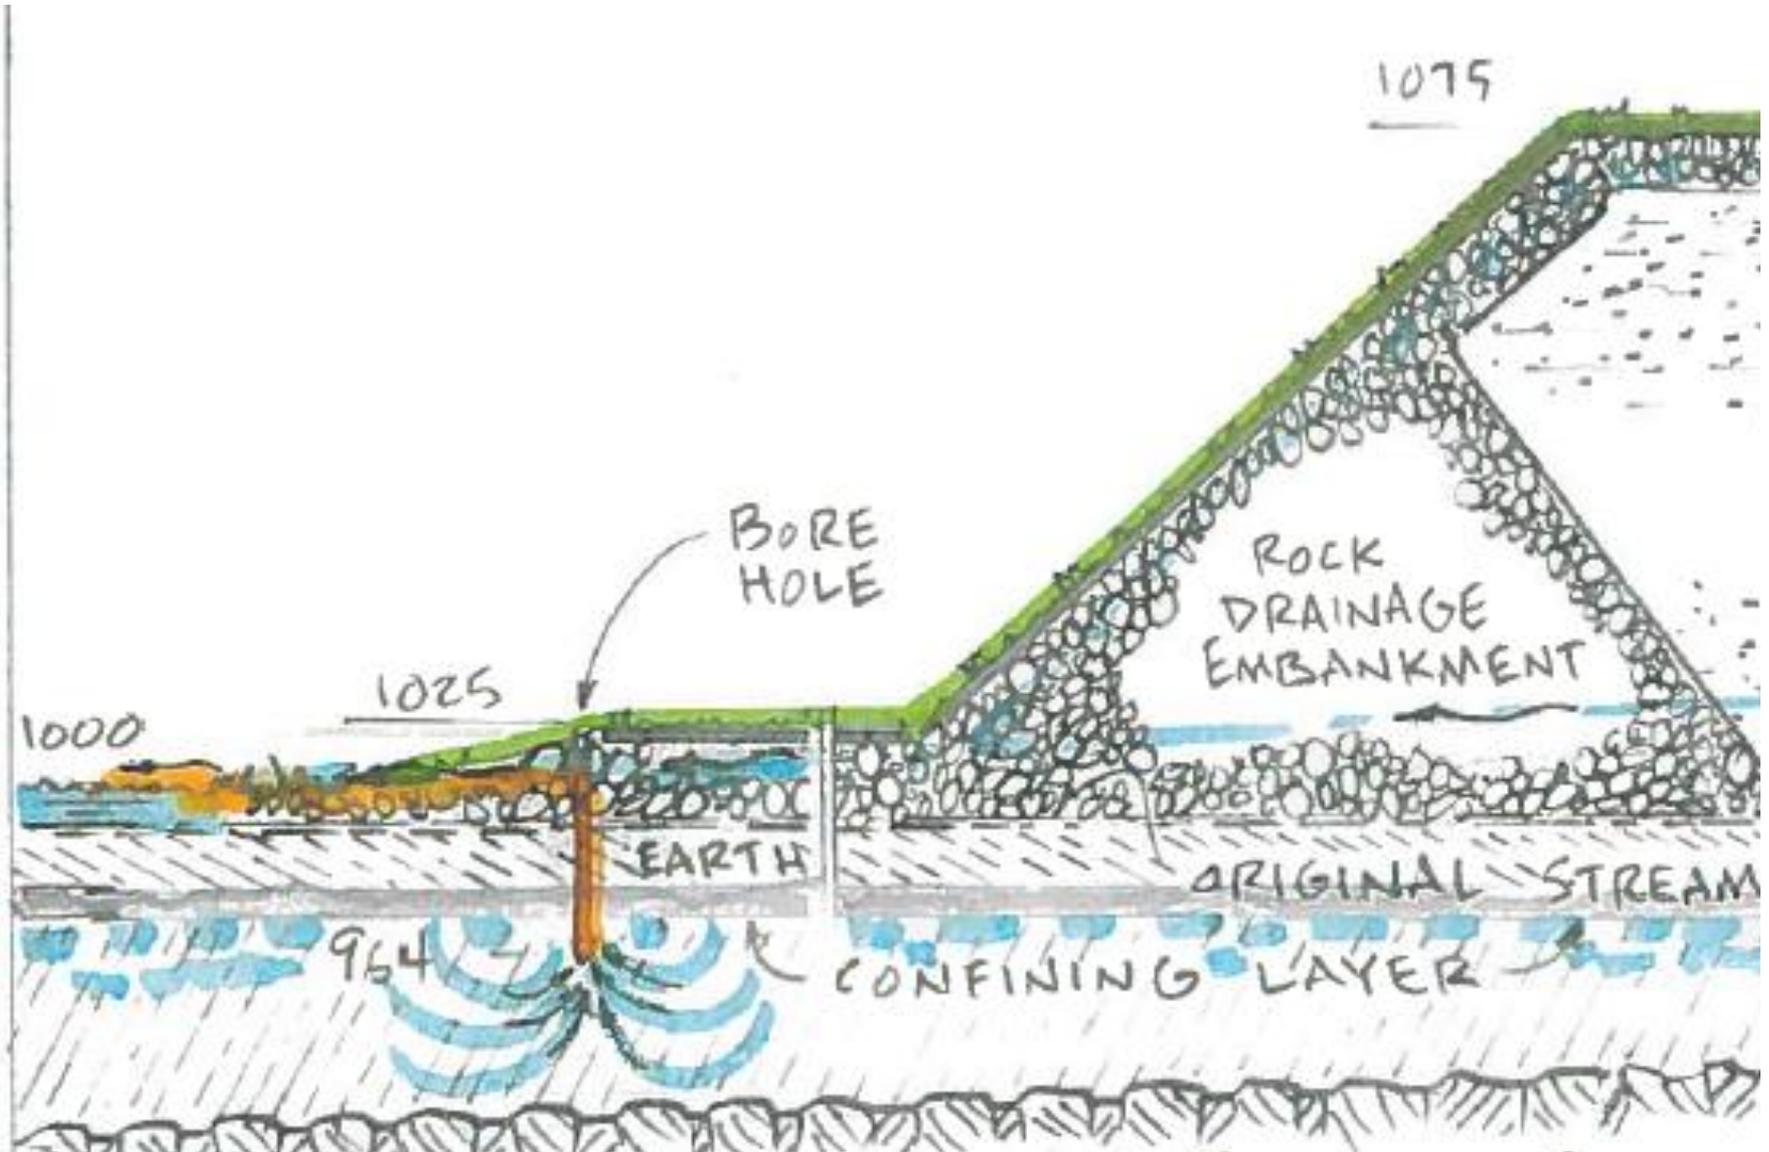
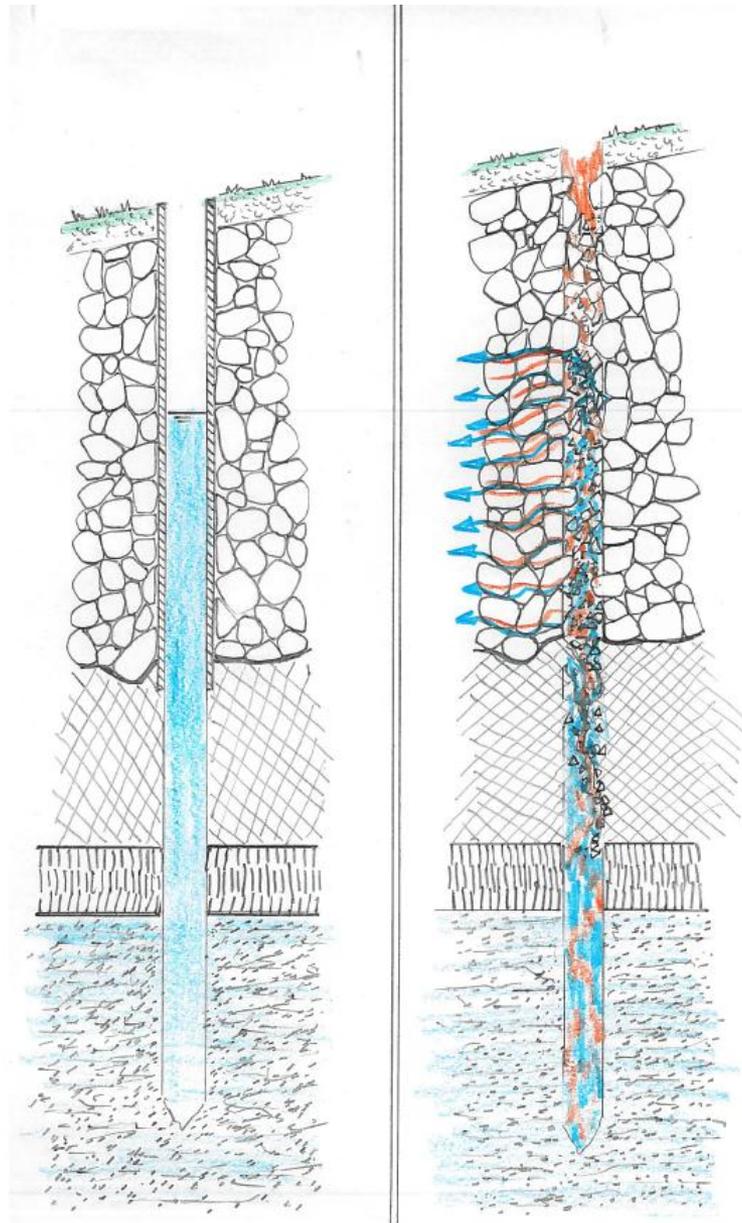
What happened

1. Hole bored through confining layer into artesian aquifer

2. Casing pulled, hole filled with Bentonite grout mixture.
3. Hole partially collapses - artesian water carries bore hole material and Bentonite, through rock embankment to river
