**New York City Department of Transportation  
Office of School Safety Engineering**

**School Safety Engineering Project**

**FINAL REPORT: P.S. 279 (Captain Manuel Rivera Jr. School), Bronx**

**August 9, 2006**

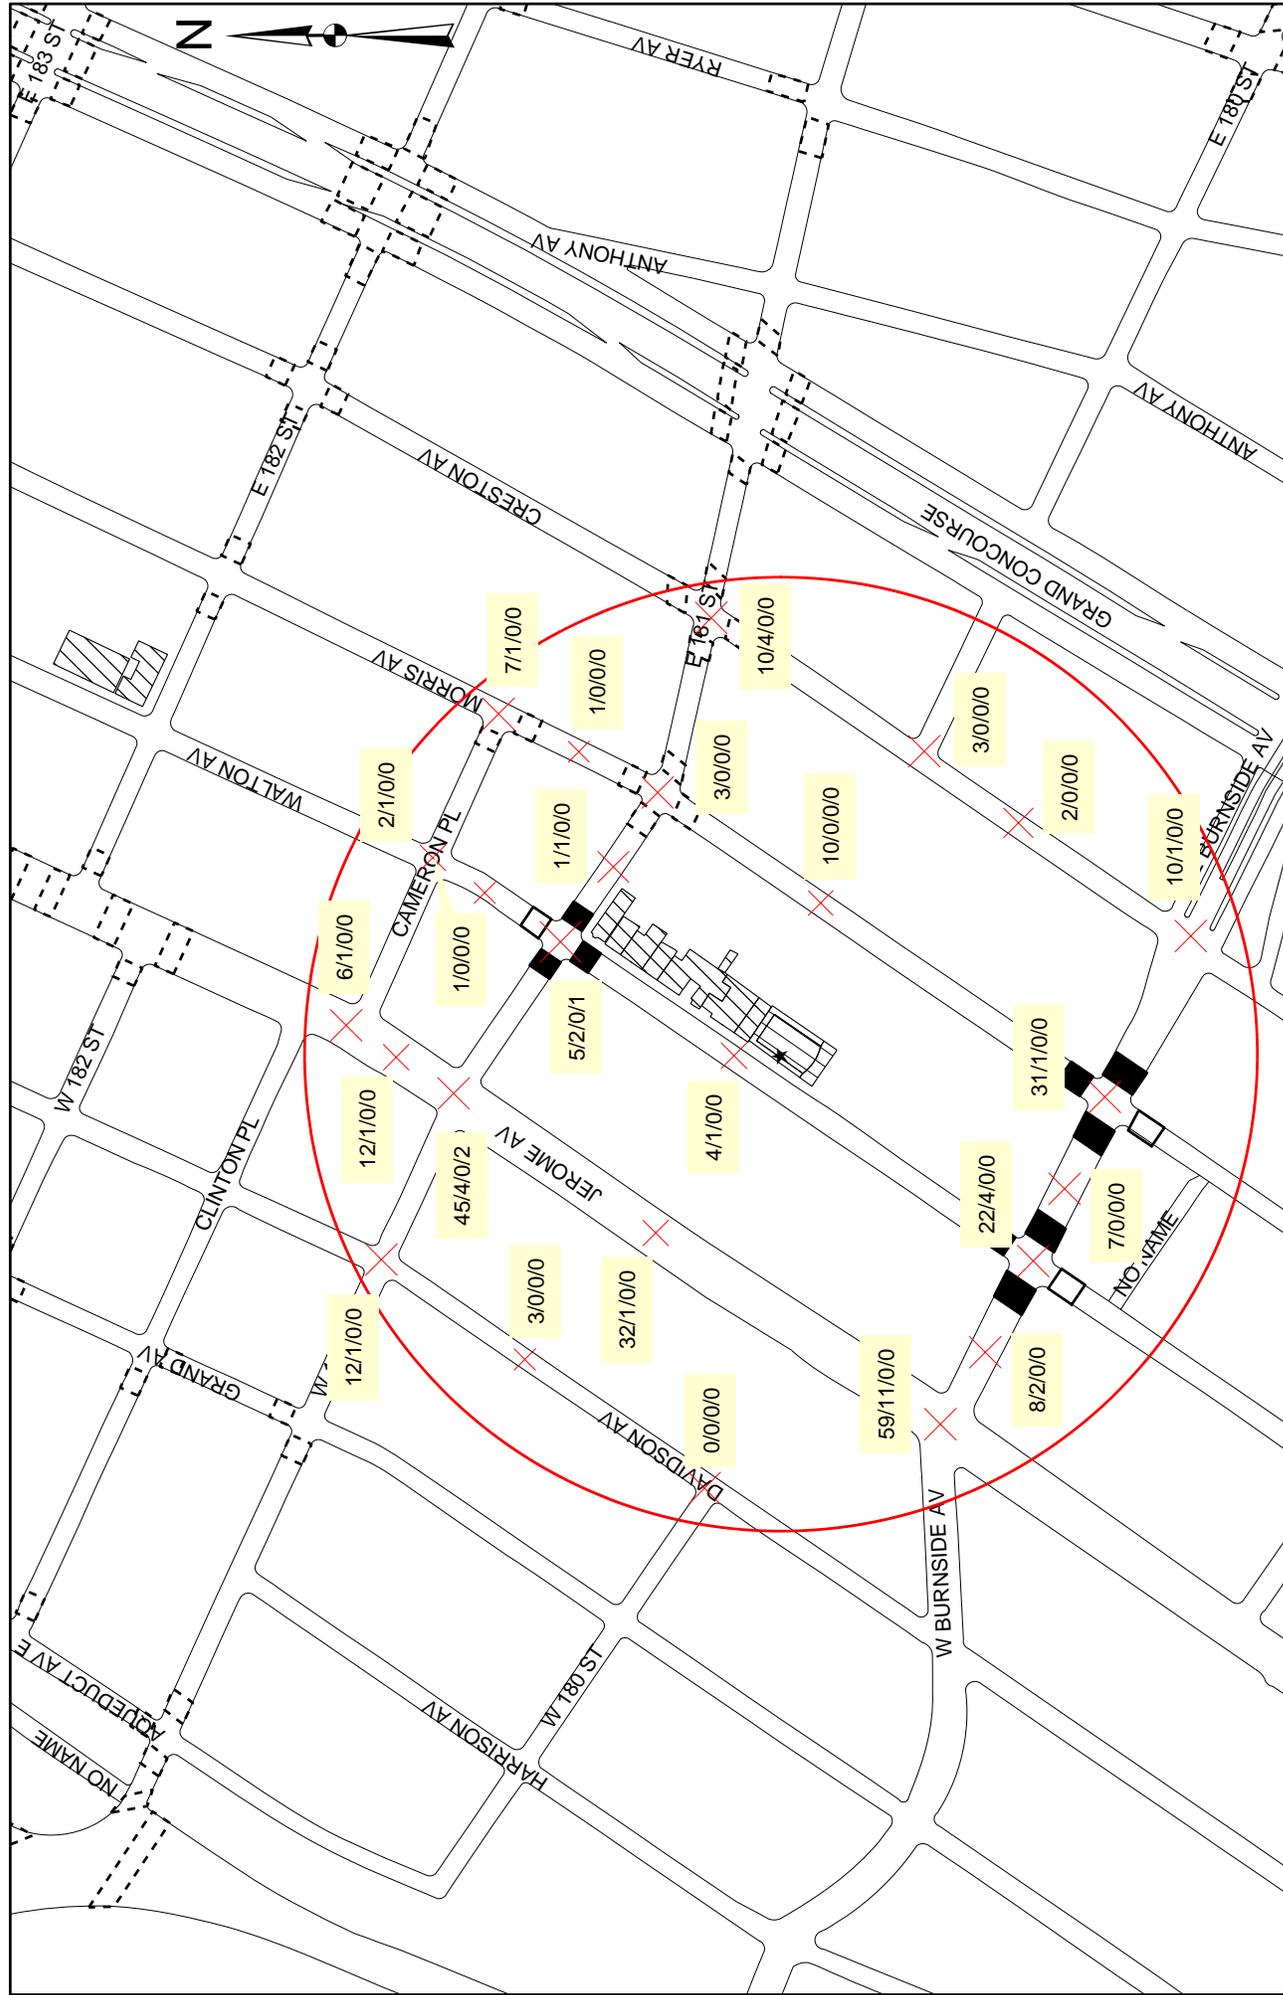
**EXHIBIT 6**

Exhibit 6 and Table 2 show a summary of accidents, as obtained from the New York State Department of Motor Vehicles (DMV), in the vicinity of P.S. 279 for a three-year period from January 1, 1998 through December 31, 2000. The DMV data provides some detail relating to the circumstances and cause of an accident. Table 3 is a summary of more recent accident data obtained from the NYC Police Department (NYPD). Though current through 2004, the NYPD data does not provide the same level of detail as the DMV data.

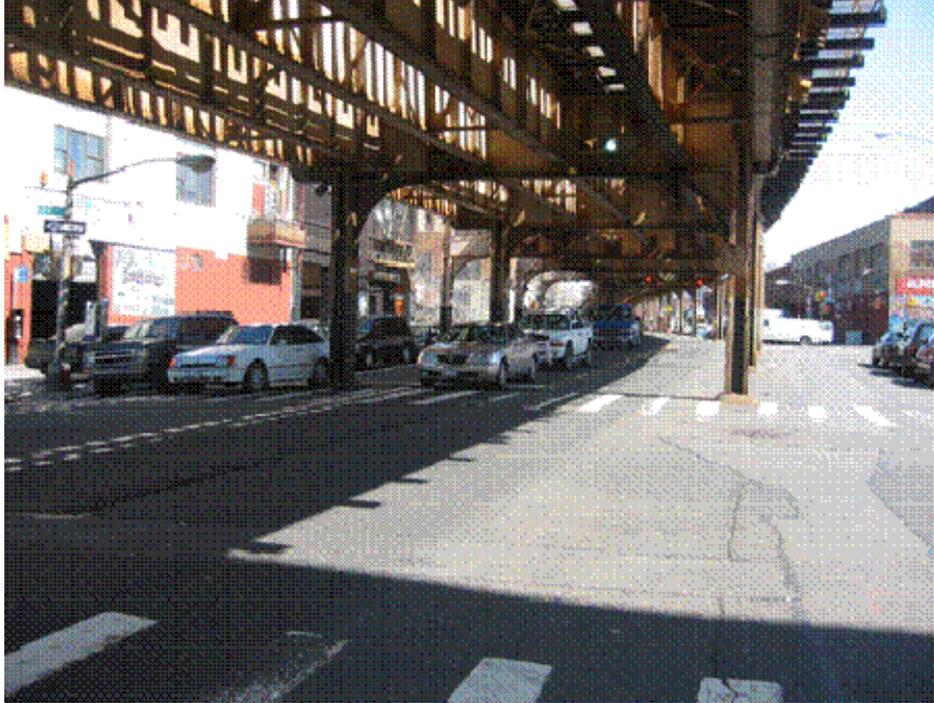
The principal of P.S. 279 considers the Jerome Avenue and East 181<sup>st</sup> Street intersection hazardous for his students to negotiate crossing Jerome Avenue, due to the width of the roadway, speeding vehicles, and double-parked vehicles. The principal has requested a school crossing guard for this location.

The northbound vehicles on Jerome Avenue between East 181<sup>st</sup> Street and East Burnside Avenue were found to be traveling with an 85<sup>th</sup> percentile speed of 31 mph. The southbound vehicles on Jerome Avenue between East 181<sup>st</sup> Street and East Burnside Avenue were found to be traveling with an 85<sup>th</sup> percentile speed of 30 mph.

*Figure 10: Looking north along Jerome Avenue at East 181<sup>st</sup> Street*

- Replace the high visibility crosswalks located across the north and south legs of Jerome Avenue with school crosswalks and provide associated advance warning signs.
- Assign a crossing guard to the intersection of Jerome Avenue and East 181<sup>st</sup> Street.

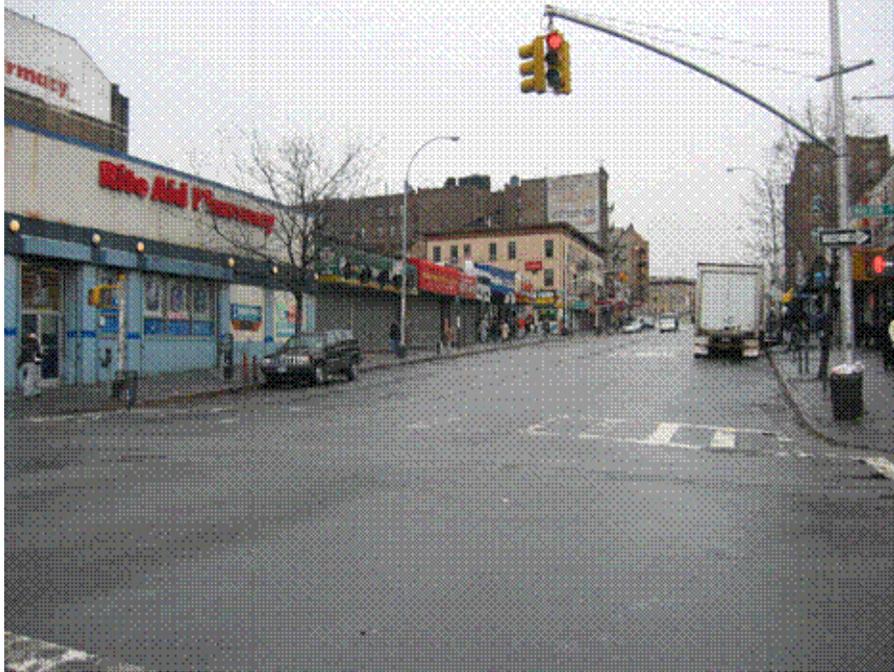
*Figure 14: Looking east along East Burnside Avenue across Walton Avenue*

The roadways in the vicinity of P.S. 279 are generally in fair condition, except for an area at the intersection of Walton Avenue and East Burnside Avenue and an area in front of the school on Walton Avenue. In these areas, and especially on Walton Avenue, the roadway is in need of maintenance with cracks and holes in the pavement surface. This condition appears to be a result of previous utility work in the roadway (see Figures 14 and 15).
