**New York City Department of Transportation  
Office of School Safety Engineering**

**School Safety Engineering Project**

**FINAL REPORT: ST. LUKE, Bronx**

**June 9, 2006**

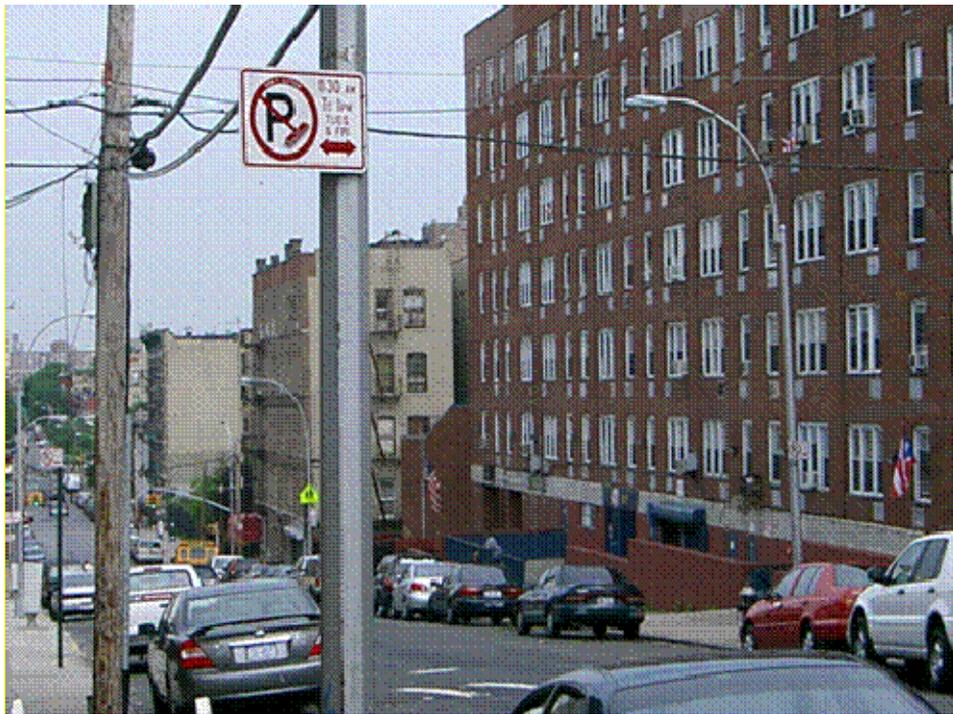
Parking regulations around the school block are shown in Exhibit 4, at the end of this section. East 138<sup>th</sup> Street is a “Snow Emergency Route” which prohibits vehicle standing on the street during an emergency condition. Typical parking regulation signs are shown in Figures 4 and 5.

*Figure 4: Typical parking regulations on East 139<sup>th</sup> Street in the vicinity of Saint Luke School*

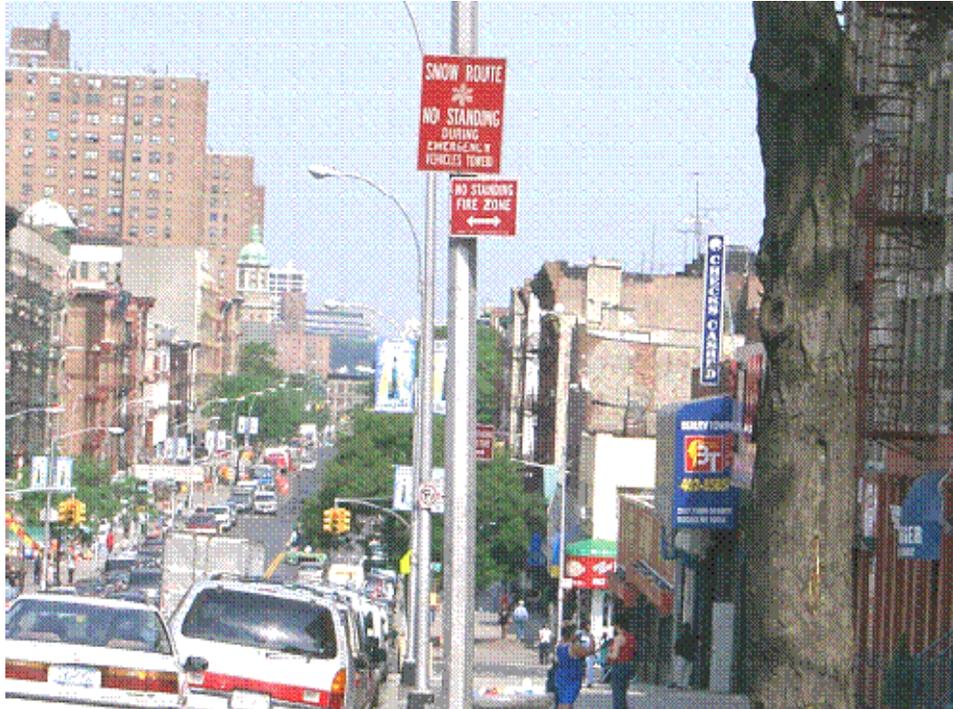
*Figure 5: Looking west along East 138<sup>th</sup> Street in the vicinity of Saint Luke School*

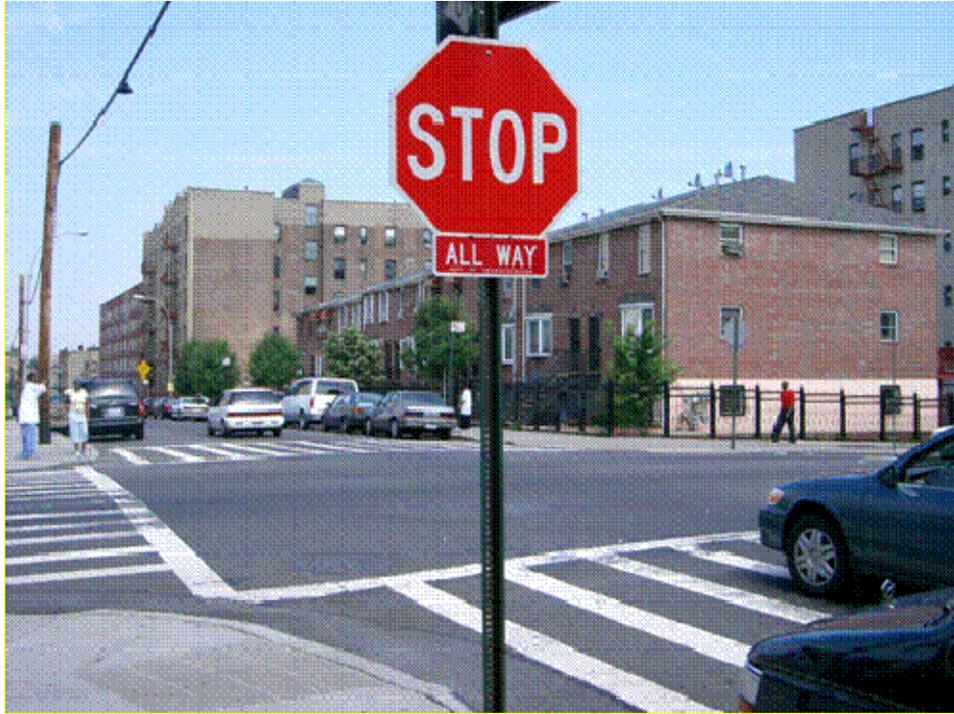
East 139<sup>th</sup> Street is one-way westbound street with one travel lane and parking on both sides of the roadway. Cypress Avenue is a two-way street with one traffic lane and a parking lane on each side of the roadway (see Figures 6 and 7).

This intersection has been the site of eleven (11) accidents between 1998 and 2000 with no pedestrian accidents (Table 2). The NYPD accident data (Table 3) shows seventeen (17) accidents including three pedestrian accidents, one (1) of which was school-related between 2001 and 2004. No further information is available about the school-related accident. There were no pedestrian fatalities during the same four-year period.

Figure 6: Looking northeast across intersection of East 139<sup>th</sup> Street & Cypress Avenue

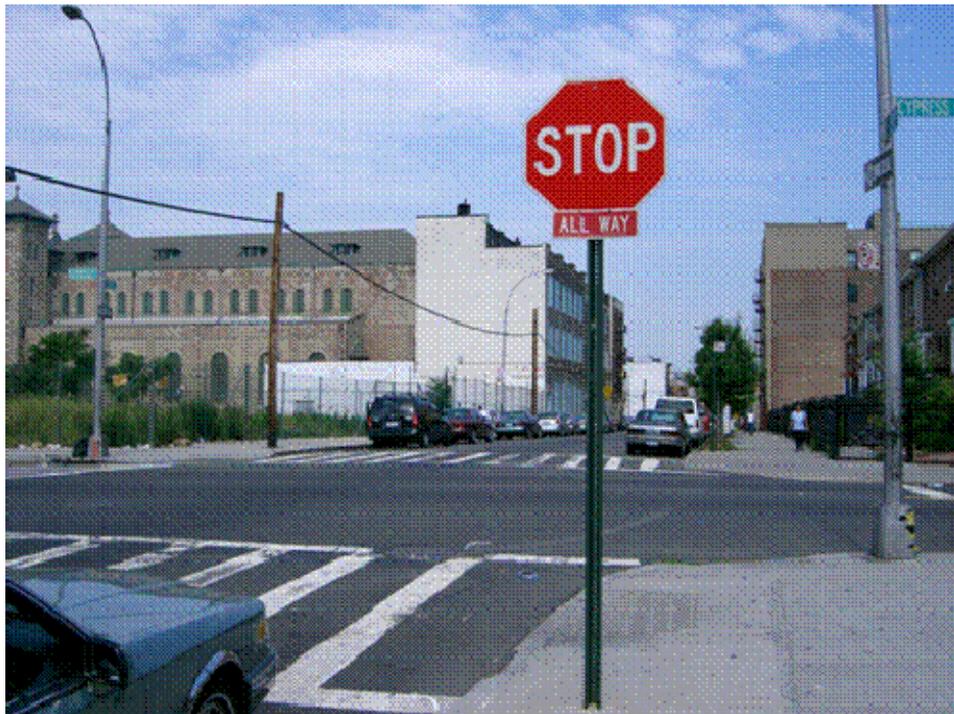
Figure 7: Looking west along East 139<sup>th</sup> Street across Cypress Avenue intersection (School is down on left)

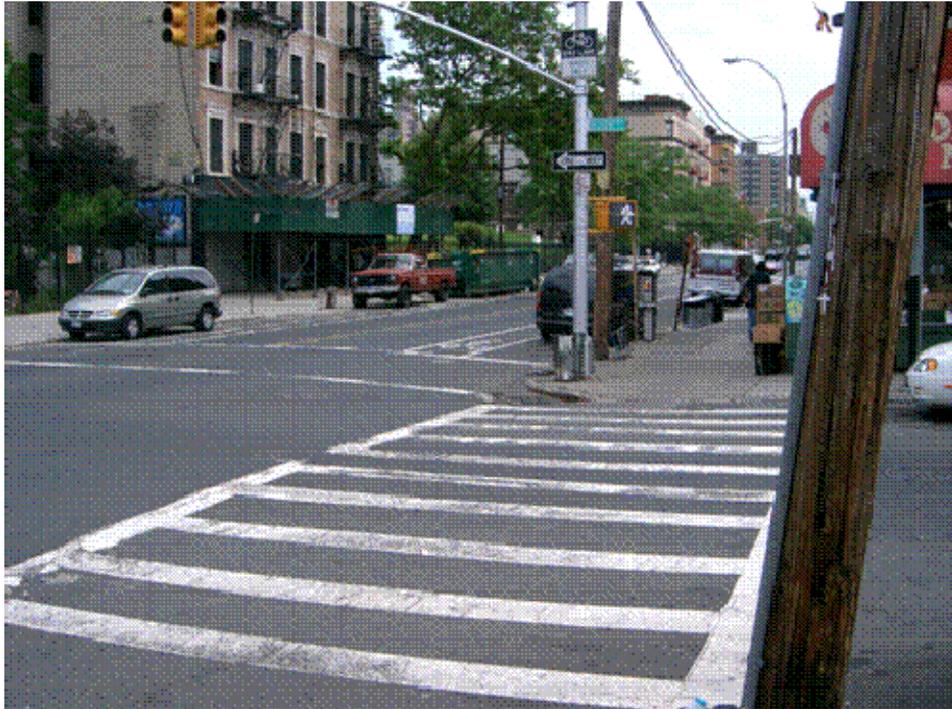
East 139<sup>th</sup> Street is a one-way westbound street with one travel lane and parking on both sides of the roadway. St. Ann's Avenue is a two-way street, with one travel lane, a bicycle lane, and parking on each side of the roadway. Both streets are generally residential in character, although there is some commercial activity located near the intersection (see Figures 8 and 9).

*Figure 8: Looking north across East 139<sup>th</sup> Street on east side of St. Ann's Avenue*

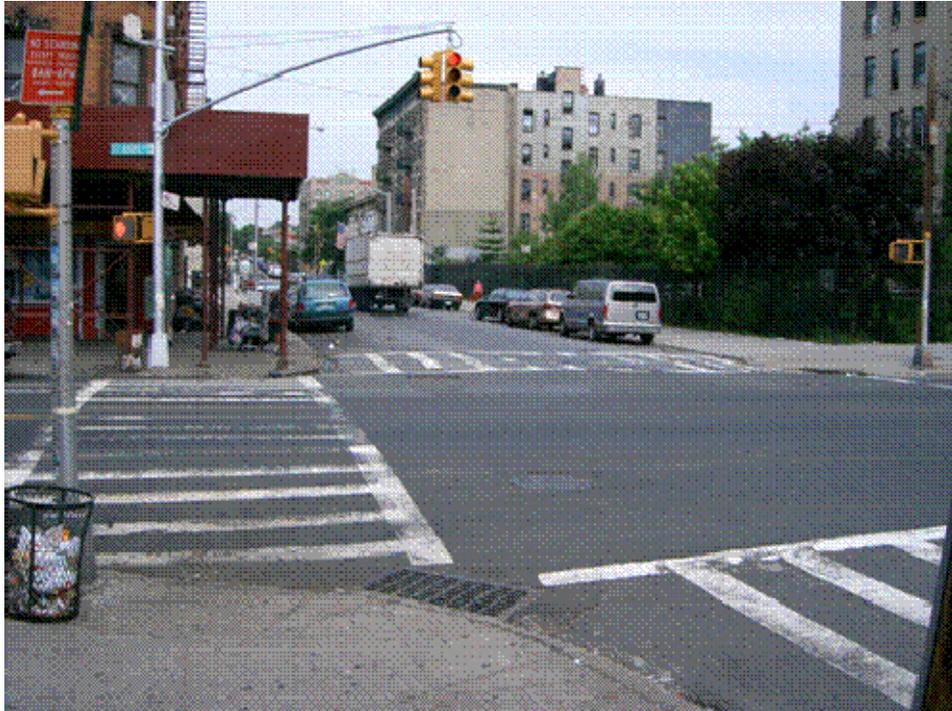
*Figure 9: Looking west across St. Ann's Avenue on south side of East 139<sup>th</sup> Street*

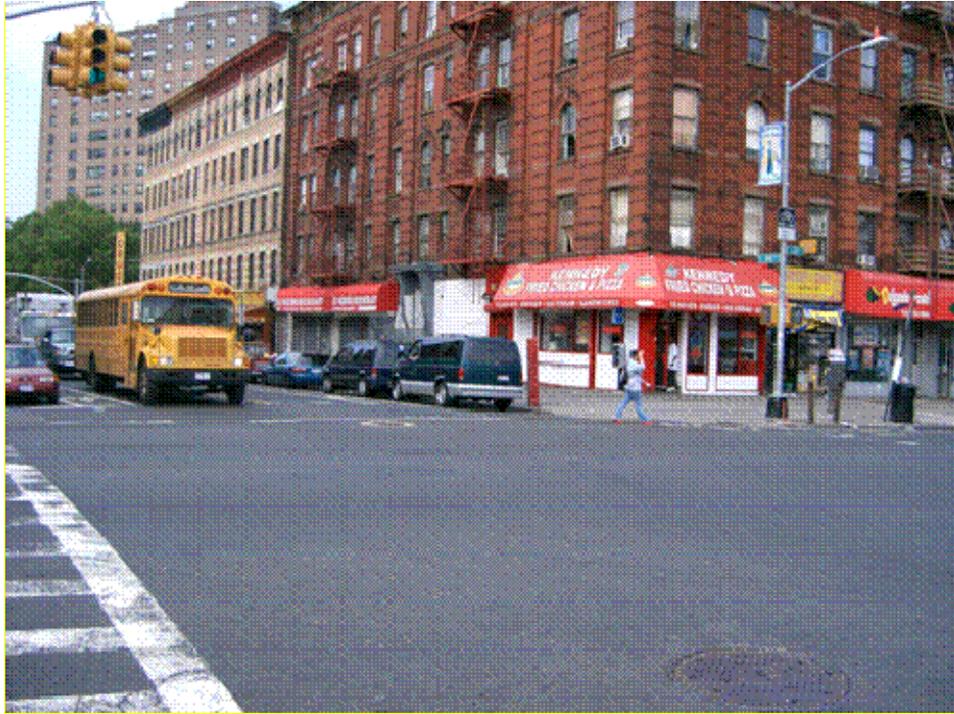
East 138<sup>th</sup> Street is a two-way street with one travel lane and a parking lane on each side of the roadway. East 138<sup>th</sup> Street is generally commercial in character with residential uses. East 138<sup>th</sup> Street is a designated "local" truck route and snow emergency route. St. Ann's Avenue is a two-way street, with one travel lane, a bicycle lane, and parking on each side of the roadway. It is generally residential in character with some commercial uses (see Figures 10 and 11).

Figure 10: Looking southwest across East 138<sup>th</sup> Street & St. Ann's Avenue intersection

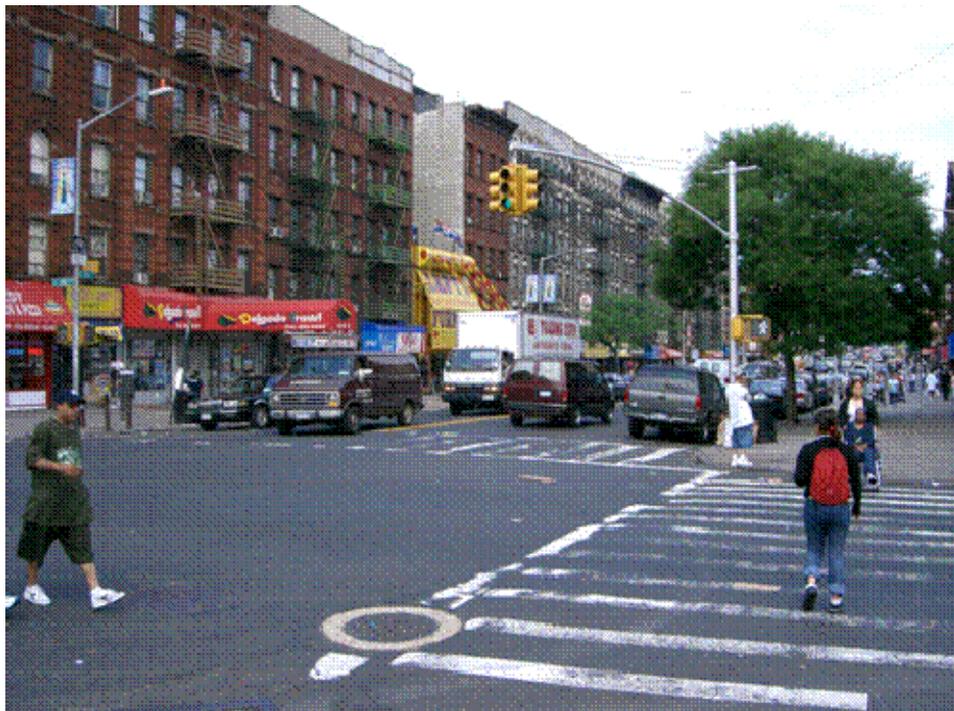
Figure 11: Looking west along East 138<sup>th</sup> Street across St. Ann's Avenue intersection

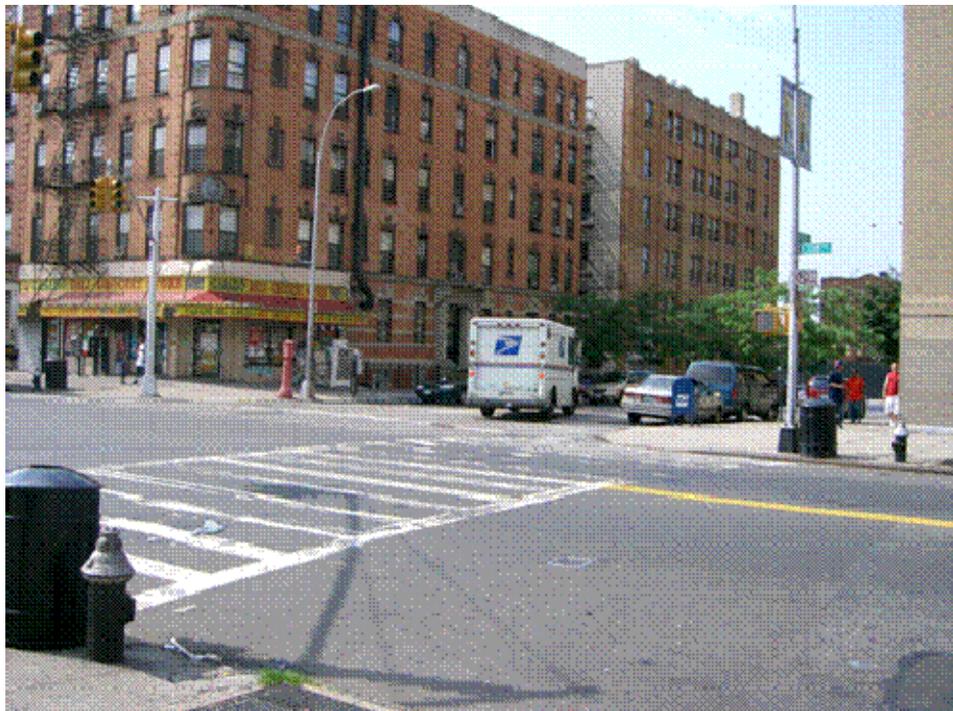
East 138<sup>th</sup> Street, a designated local truck route and snow emergency route, is a two-way street with one travel lane and a parking lane on each side of the roadway. East 138<sup>th</sup> Street is generally commercial in character with residential uses. Cypress Avenue is a two-way street with one travel lane and a parking lane on each side of the roadway. Cypress Avenue is generally residential in character with commercial uses (see Figures 12 and 13).

*Figure 12: Looking southeast across East 138<sup>th</sup> Street at Cypress Avenue intersection*

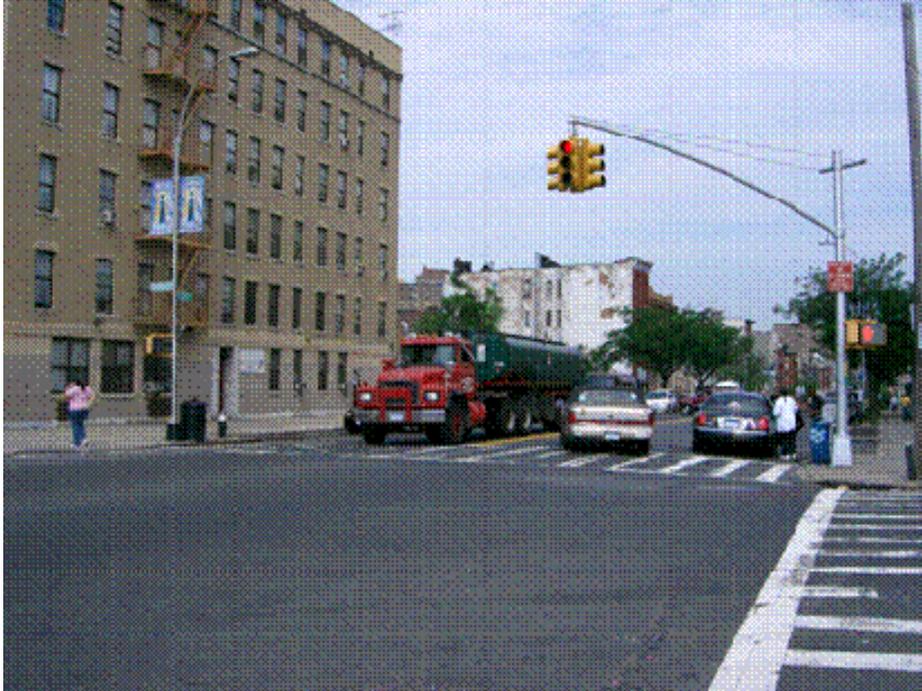
*Figure 13: Looking west across Cypress Avenue at East 138<sup>th</sup> Street intersection*

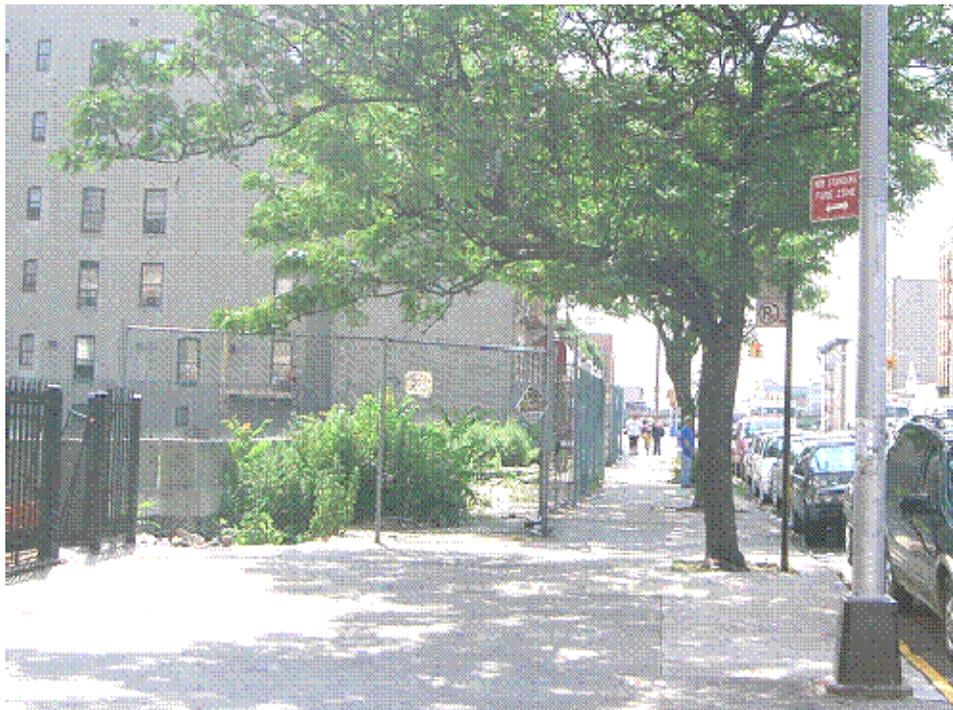
The roadways and sidewalks in the vicinity of Saint Luke School are generally fifteen to twenty feet wide and in fair condition except for one location. This location is on East 138<sup>th</sup> Street between the school and Cypress Avenue where a chain link fence is occupying a large portion of the sidewalk. The school officials report that this has been on going “construction site” for the last twelve years, with little or no activity. The chain link fence that has been there since previous activities at the site, has left an open foundation, or excavation in the ground. It is further reported that students will walk out into the street to enable someone in a wheelchair to negotiate this section of the sidewalk. They also report a teacher has hurt her wrist in a fall while negotiating this section of the sidewalk. The available sidewalk width is approximately five feet (see Figure 14).

*Figure 14: Looking east on East 138<sup>th</sup> Street at sidewalk occupied by chain link fence*

A chain link fence is occupying a large portion of the sidewalk on East 138<sup>th</sup> Street between the school and Cypress Avenue, immediately adjacent to and east of the school. The school officials reported that this has been an on going “construction site” for the last twelve years, with little to no activity. The chain link fence was apparently installed to protect pedestrians from the open foundation/excavation. It is further reported that students walk out into the street to enable someone in a wheelchair to negotiate this section of sidewalk. They also reported that a teacher had hurt her wrist in a fall while negotiating this section of sidewalk. The available sidewalk width between the chain link fence and the street trees has been reduced to approximately five feet in this area (see Figure 15). It may be possible to relocate the fence farther away from the street, thereby increasing the available width for pedestrian use.

The following is therefore recommended to:
