LENOX HILL HOSPITAL - CENTER FOR COMPREHENSIVE CARE

Landmarks Preservation Commission Submission

June 9, 2011

**SUBJECT: Façade and Roof Investigation:
Photo Report
Maritime Building
37th Avenue**

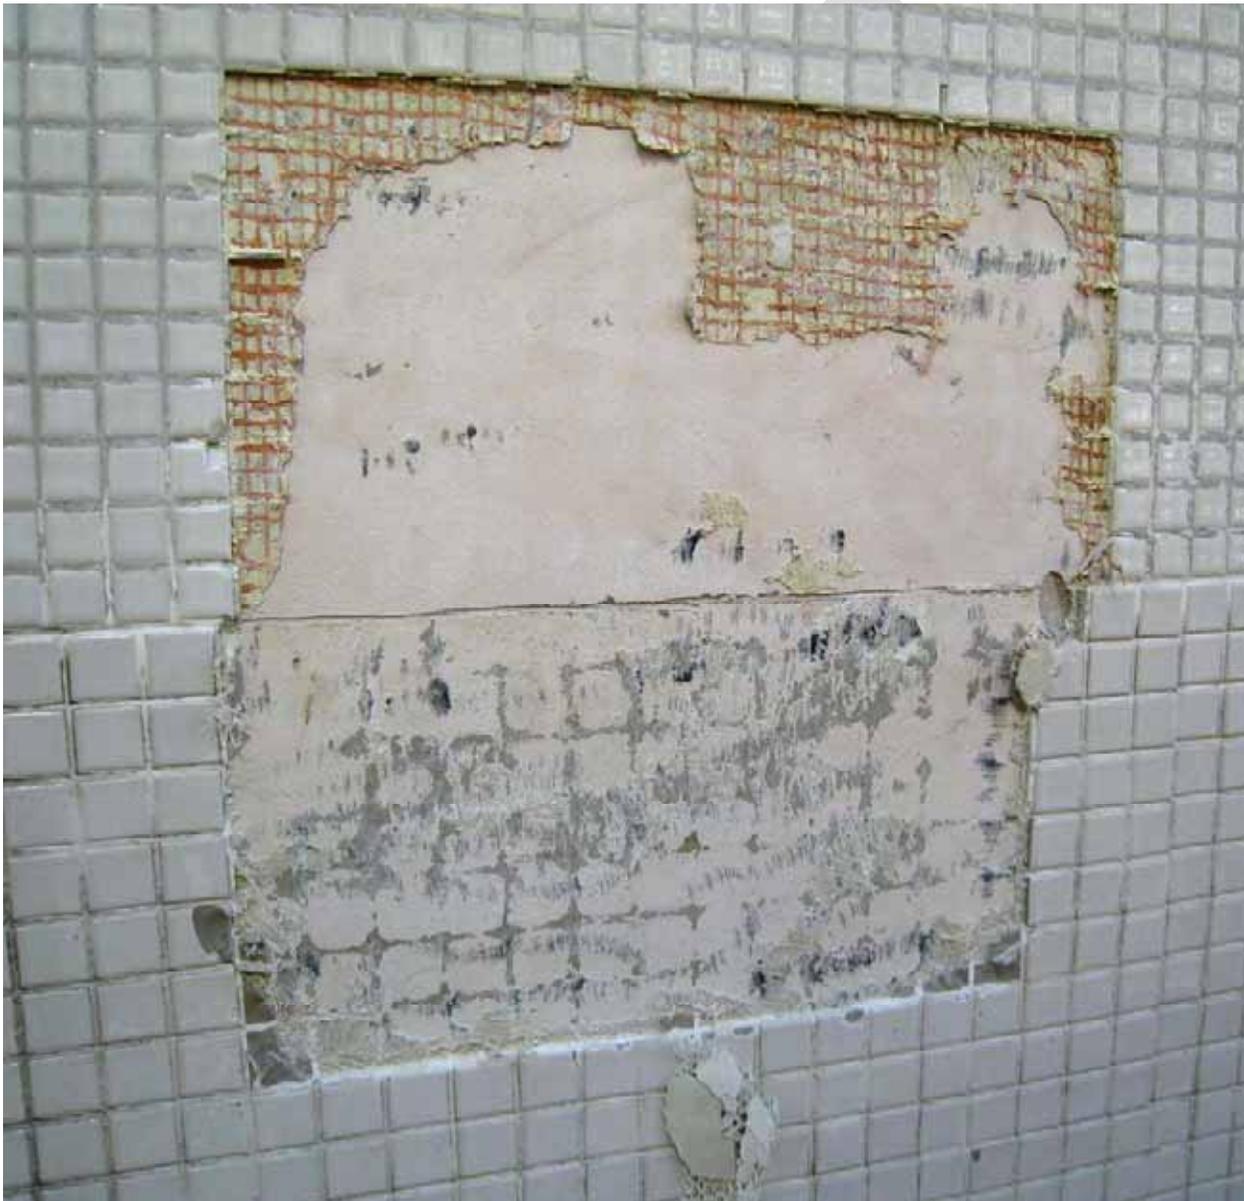
Freeze-thaw cycling and isolated concrete spalling has resulted in some damage and has necessitated areas of tile replacement, especially at the north elevation where shading inhibits evaporation. However, most of the tile is intact and in good condition. Limited probes have indicated that the 1964 tile, bonded in sheets with a fibrous-mesh backing was installed with a mortar-bed and can be cleanly removed; the underlying precast concrete appears in good condition with its original 1962 coating intact.

SAMPLE TILE REMOVAL SHOWING 1964 TILE WITH FIBER BACKING AND ADHESIVE MORTAR (ABOVE) AND LATER REPLACEMENT TILE (BELOW); THE ORIGINAL PAINT COATING OVER THE PRECAST CONCRETE SUBSTRATE IS INTACT.

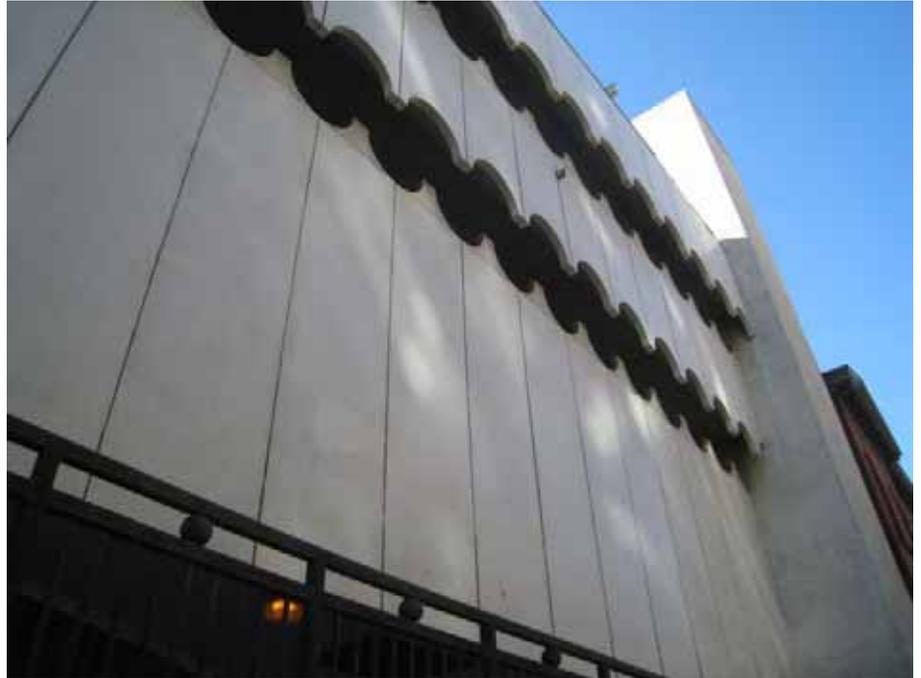
Photograph # 1:

Overview of North elevation at one of the up-close tile inspection locations

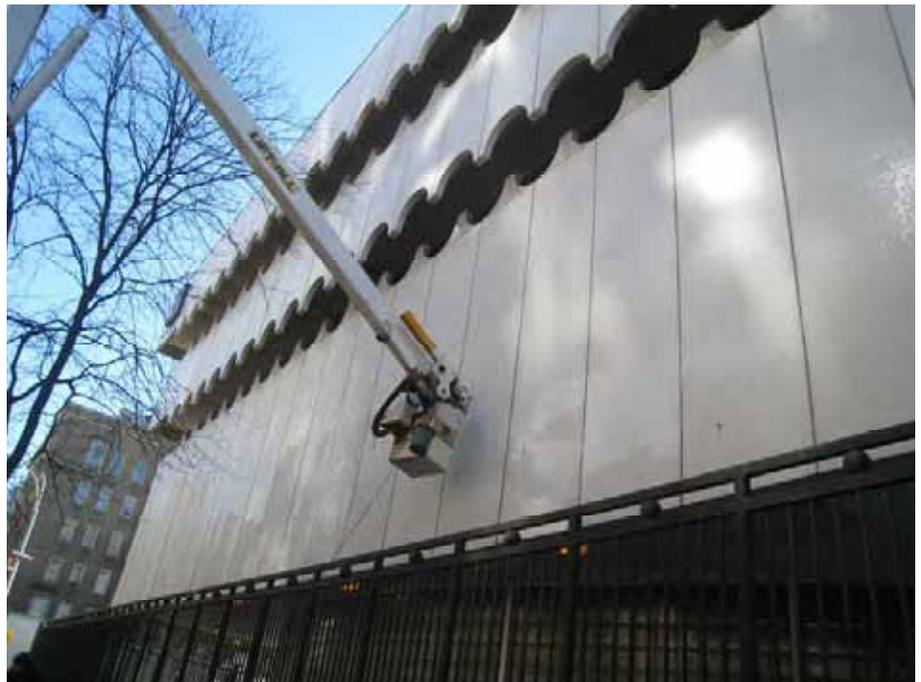
**Photograph # 2:**

Up-close investigation of the North Elevation.
Note: Large area of previously replaced tile. Replacement tiles are not the correct size.

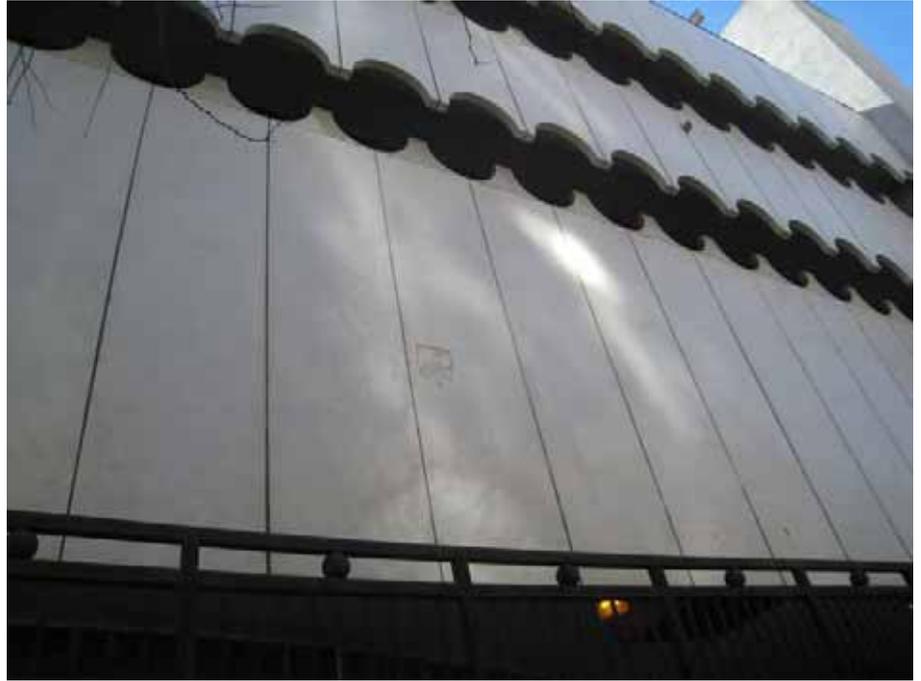
Photograph # 3:

North Elevation:

Tile removal performed to investigate the condition the of the pre-cast concrete panels.

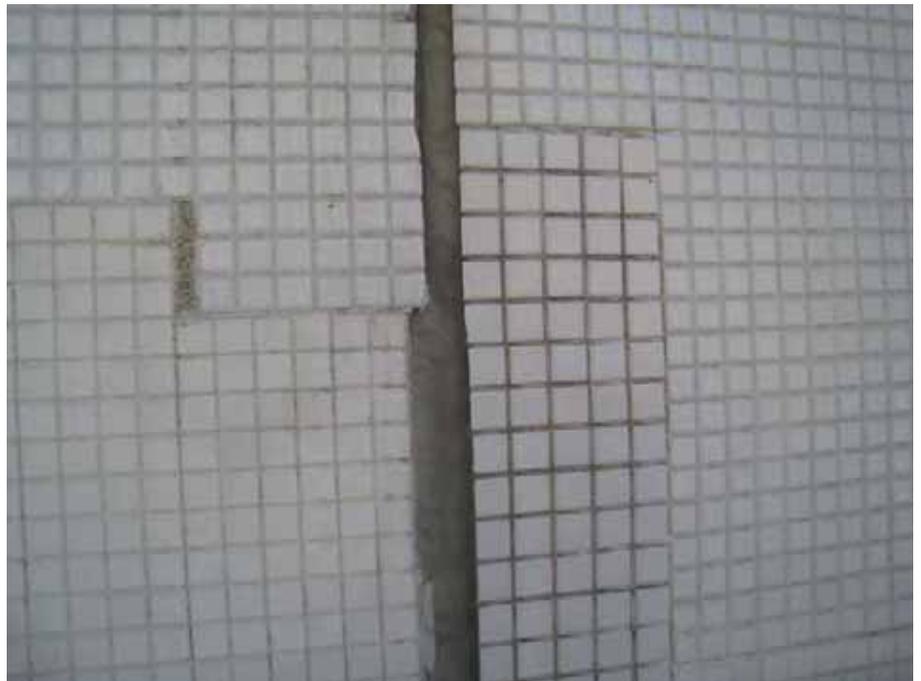
Photograph # 4:

North Elevation:

Close up photo of mismatched tiles noted at various locations.

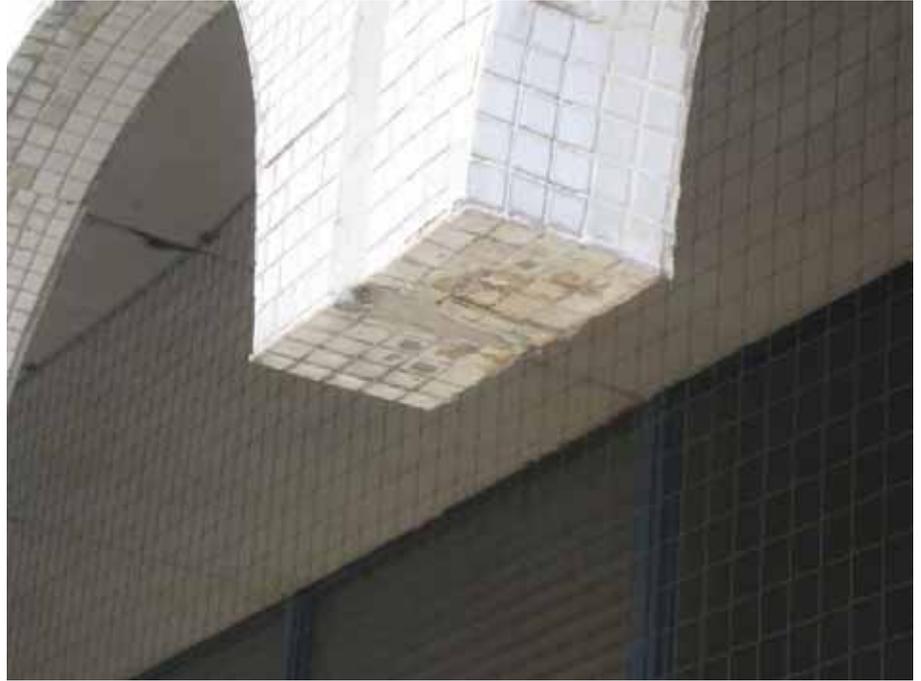
Photograph # 5:

East Elevation:

View of the underside of the pre-cast panel showing loose tiles.

- 1. **Façade Repair:** Remove all of the existing tiles, repair damaged concrete substrate with a trowel applied patching mortar such as Cathedral Stone Jahn M90 patching mortar. Apply roller applied or spray applied masonry coating to provide a uniform finish. This option will provide the most uniform and historically accurate appearance with the least amount of future maintenance

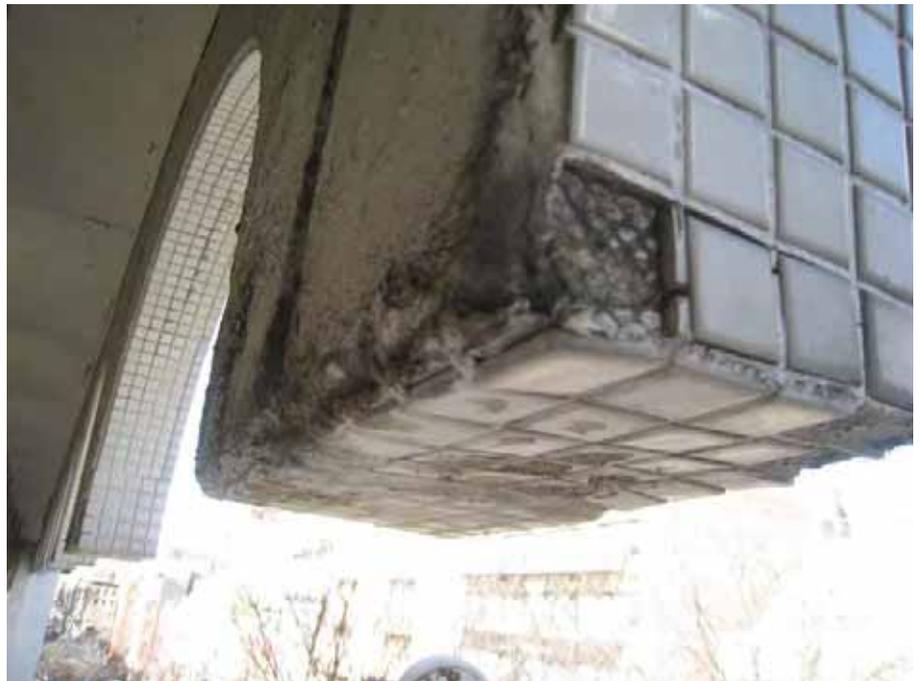
Photograph # 6:

East Elevation:

Close up view of the poor condition of the underside of the precast panels.
Note: loose and missing tiles and deteriorated grout joints

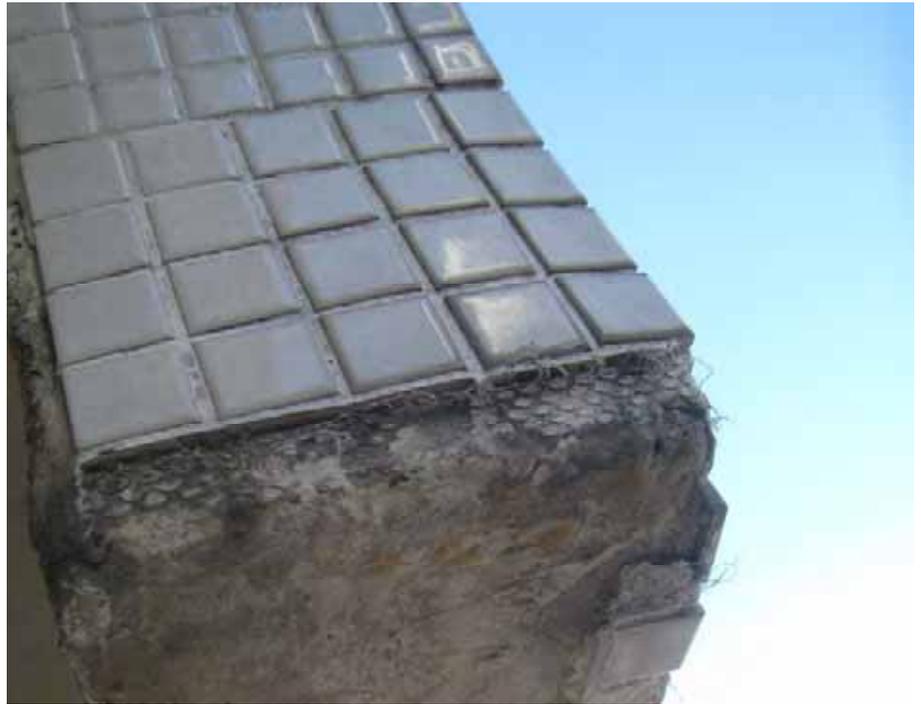
Photograph # 7:

East Elevation:

Similar to above.

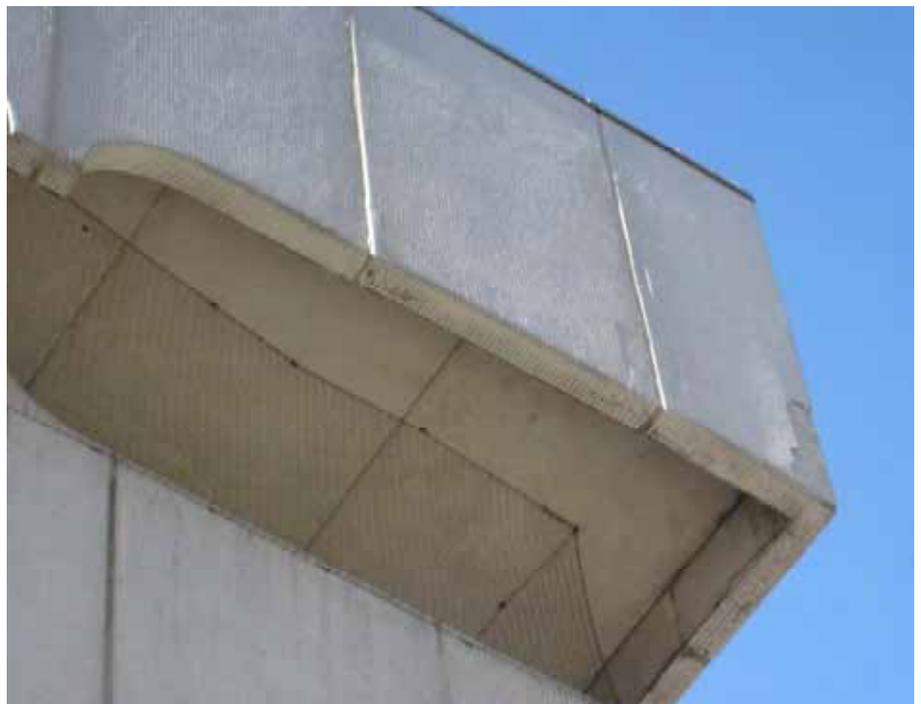
Photograph # 8:

East Elevation:

Areas of missing tiles noted on the North East corner.

Note: existing pigeon protection netting.

Excellent condition of the overhanging soffit noted at most locations

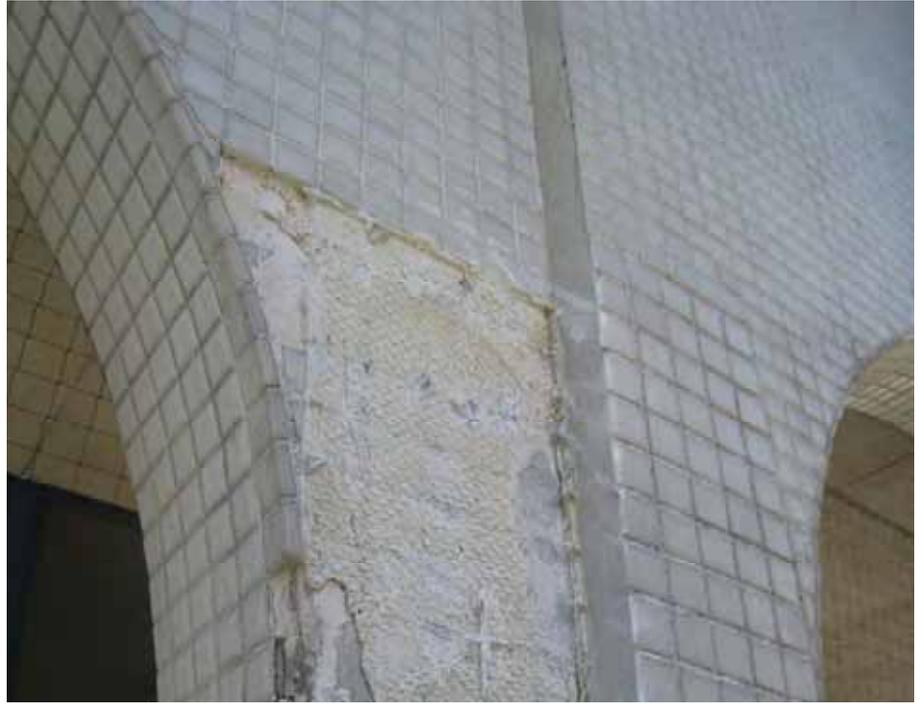
Photograph # 9:

East Elevation:

Loose tiles removed during the up-close investigation

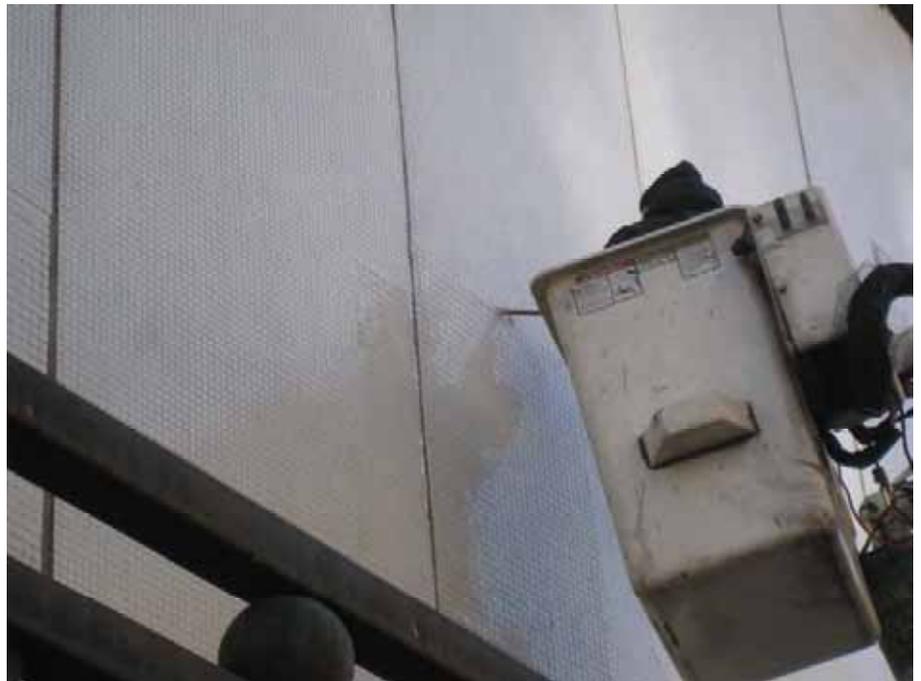
Photograph # 10:

East Elevation:

Tile Removal performed with a small electric chipping gun. Tile removal was achieved quickly and with no disruption to the existing pre-cast concrete panels.

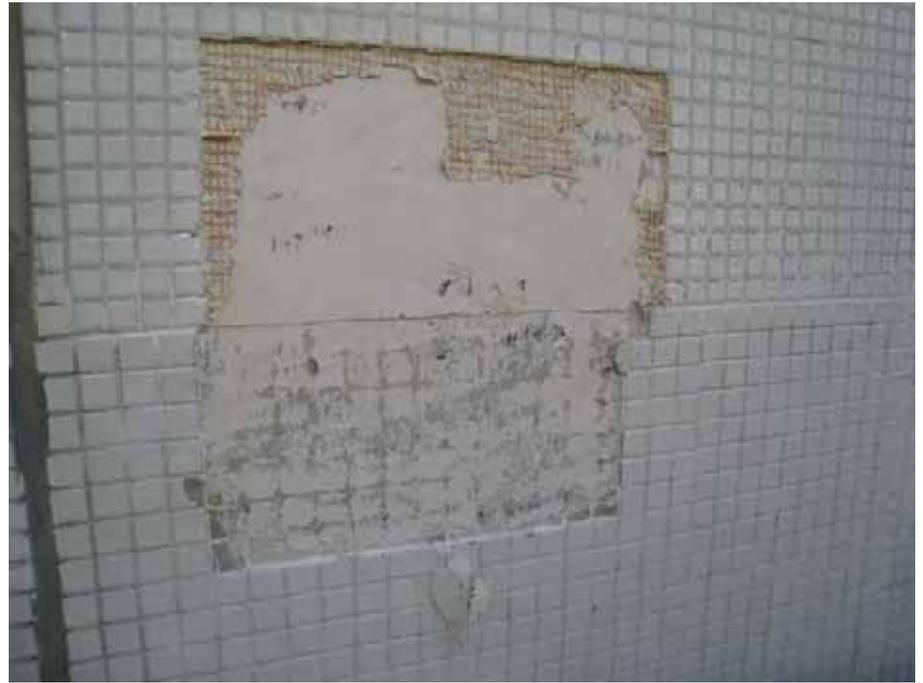
Photograph # 11:

Tile Probe:

Close up photo of pre-cast concrete substrate following the removal of the ceramic tile. The probe was performed at an area that had originally installed tile and latter replacement tiles.

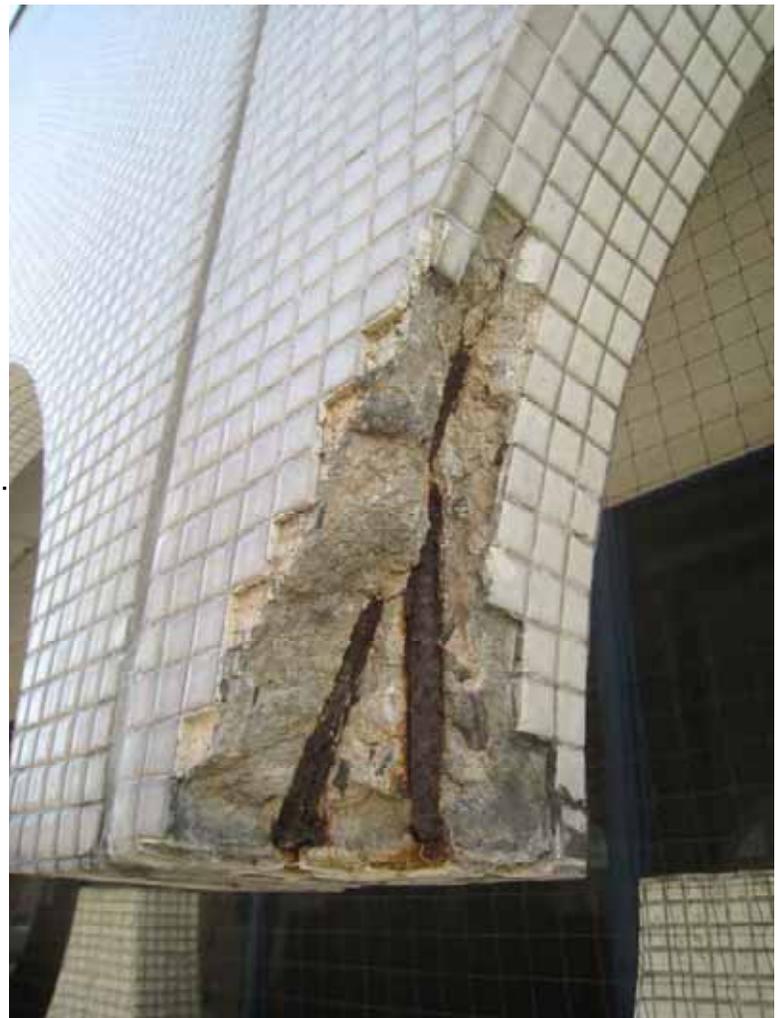
Photograph # 12:

Loose tile and concrete was removed at multiple locations at the narrow points of the semi circles throughout the façade. Concrete failure is directly related the corrosion of the embedded steel reinforcing.

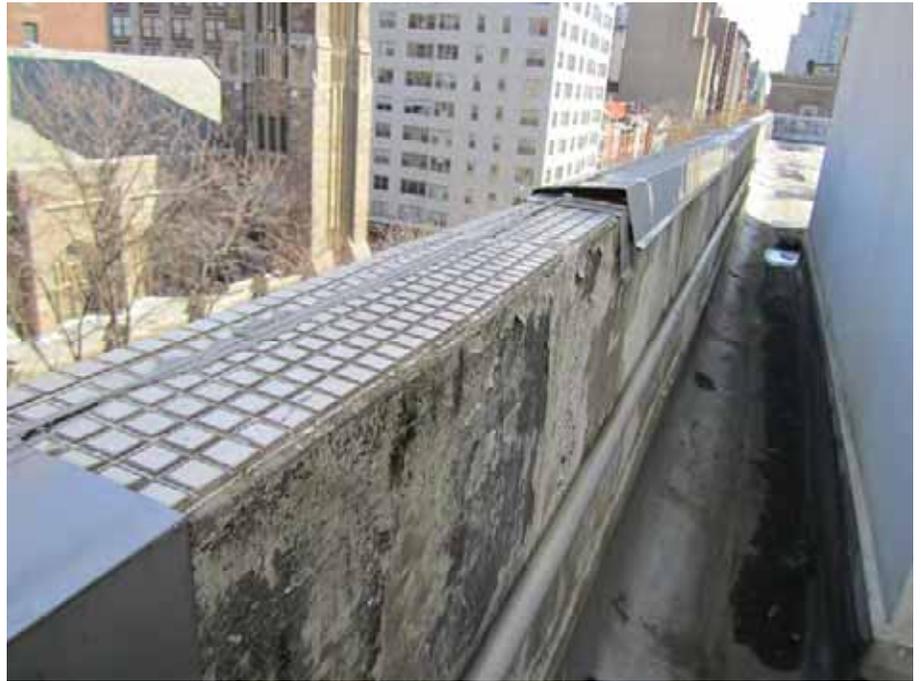
Photograph # 13:

North Elevation:

The parapets are capped with an aluminum coping at the main roof with the exception of the missing area noted here.

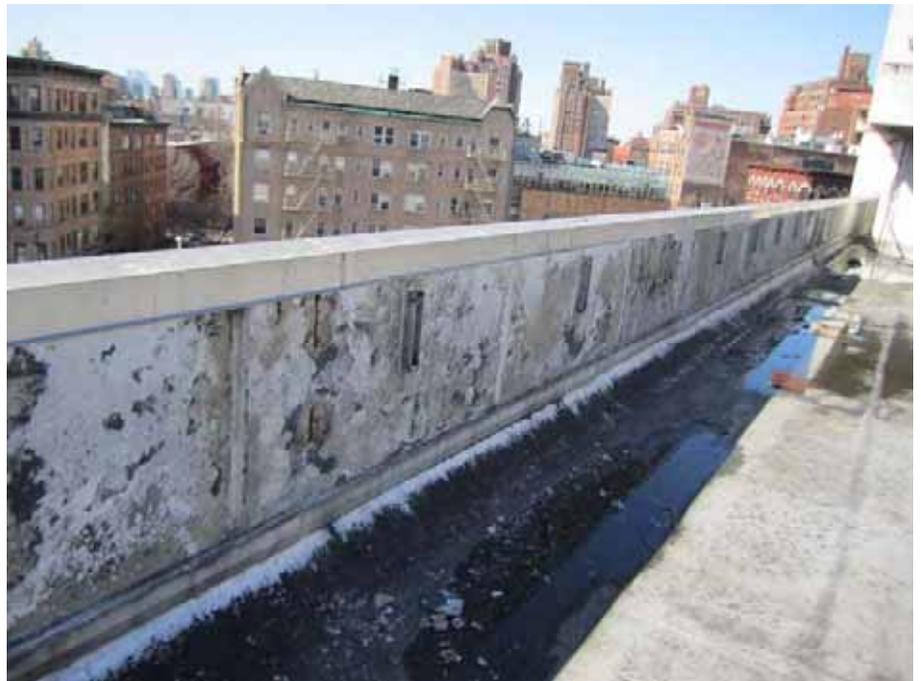
Photograph # 14:

South Elevation:

Very good condition of the inboard side of the main parapet walls with the exception of the failed coatings and isolated areas of minor concrete spalling

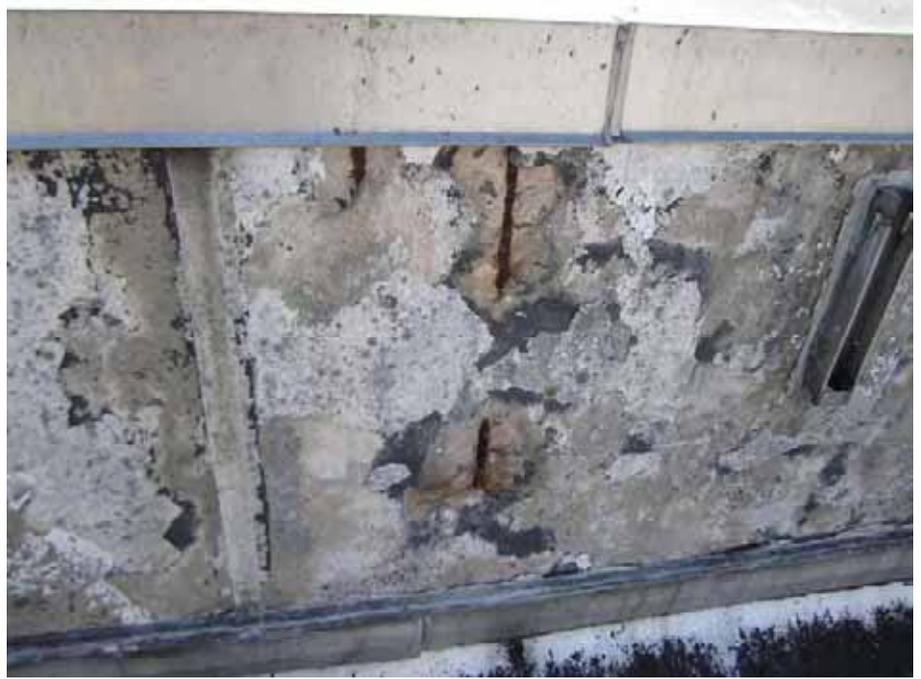
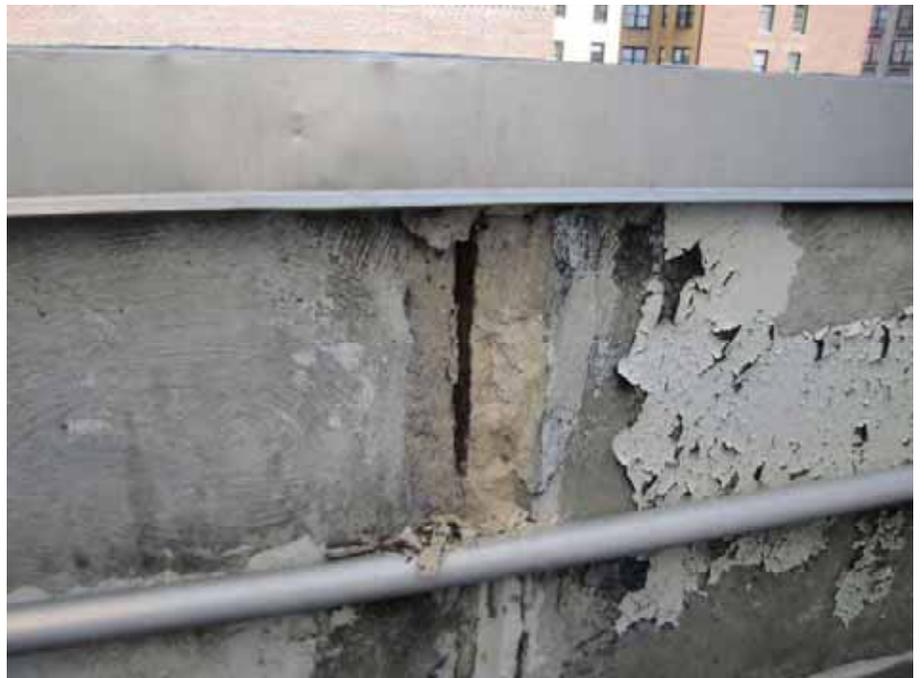
Photograph # 15 & 16:

Spalled Concrete related to the corrosion and expansion embedded rebar at 2 locations noted.

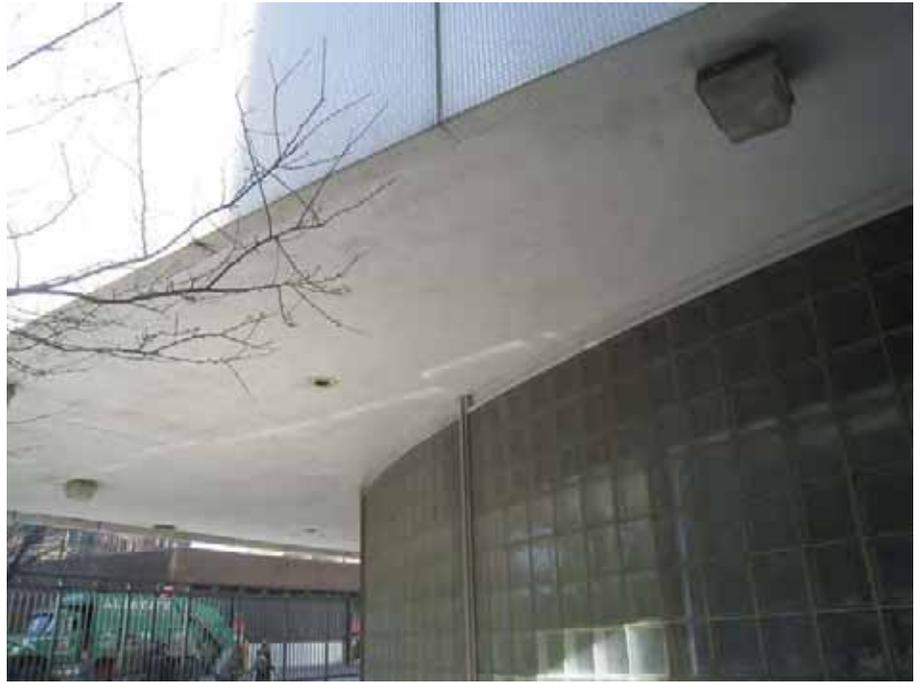
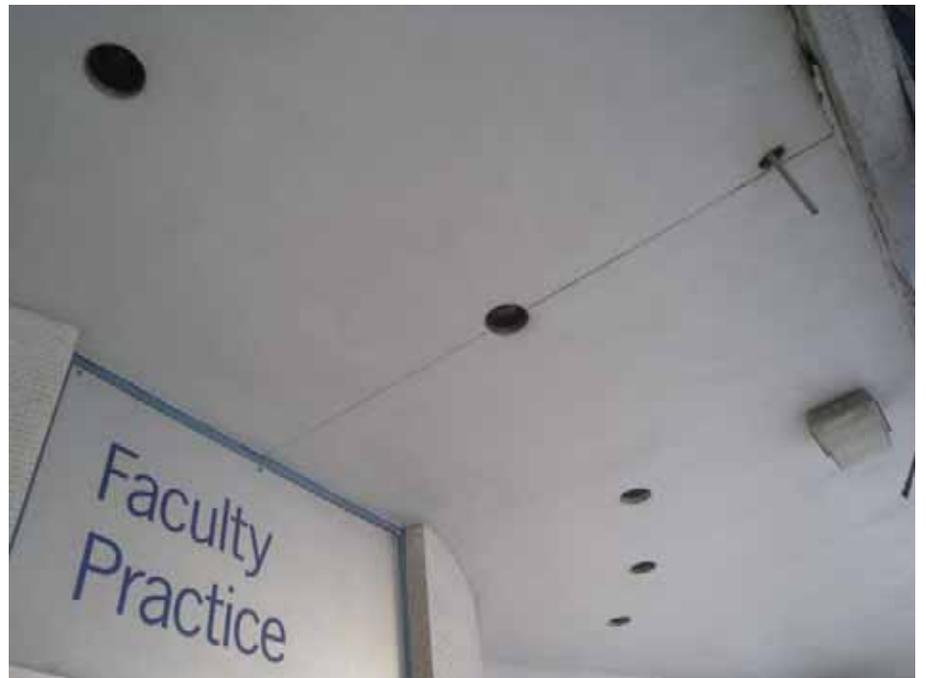
Photograph # 17 & 18:

Soffits:

The existing Soffit located at the base of the building are in good condition.

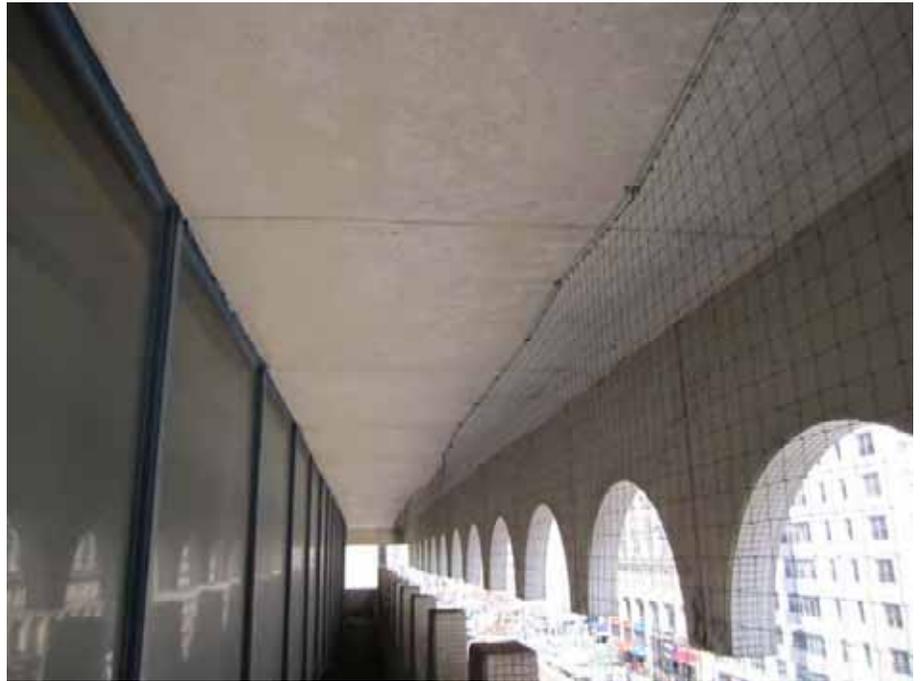
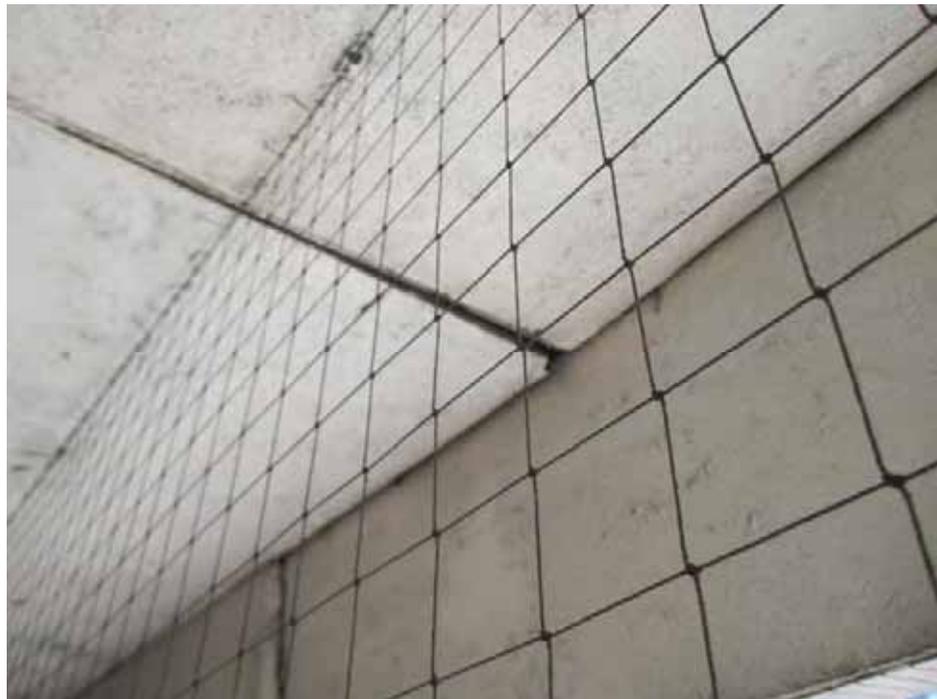
Photograph # 19 & 20 :

Soffits:

The existing soffits at the 4th & 5th floor balconies are in good condition with the exception of a few isolated penetrations made in the past to install conduit or plumbing for small air conditioner units

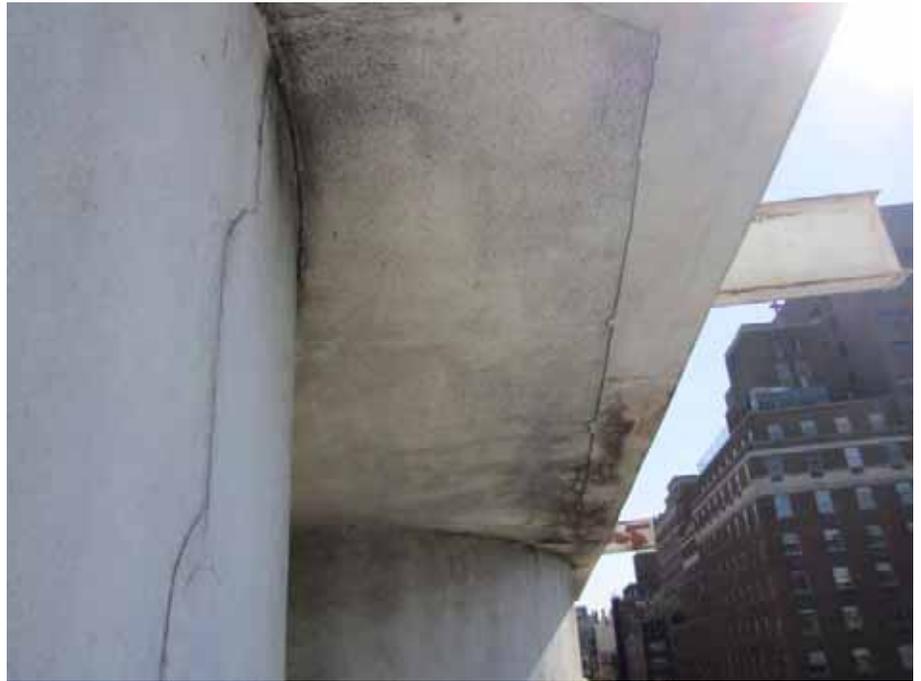
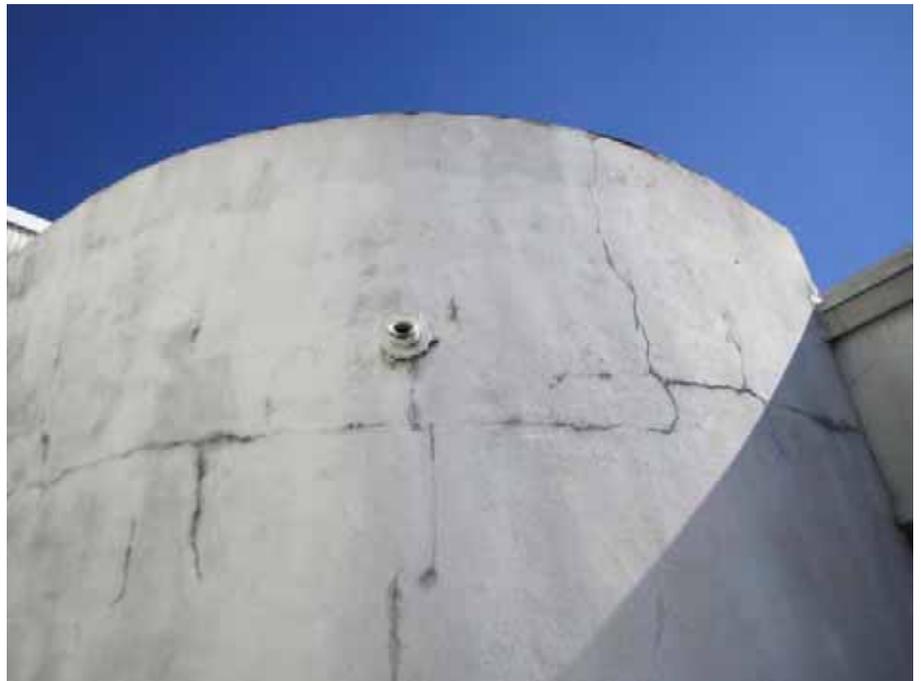
Photograph # 21 & 22:

Soffits:

Roof level soffits and stucco wall are cracked at some locations. Slightly more damage was noted at the roof level

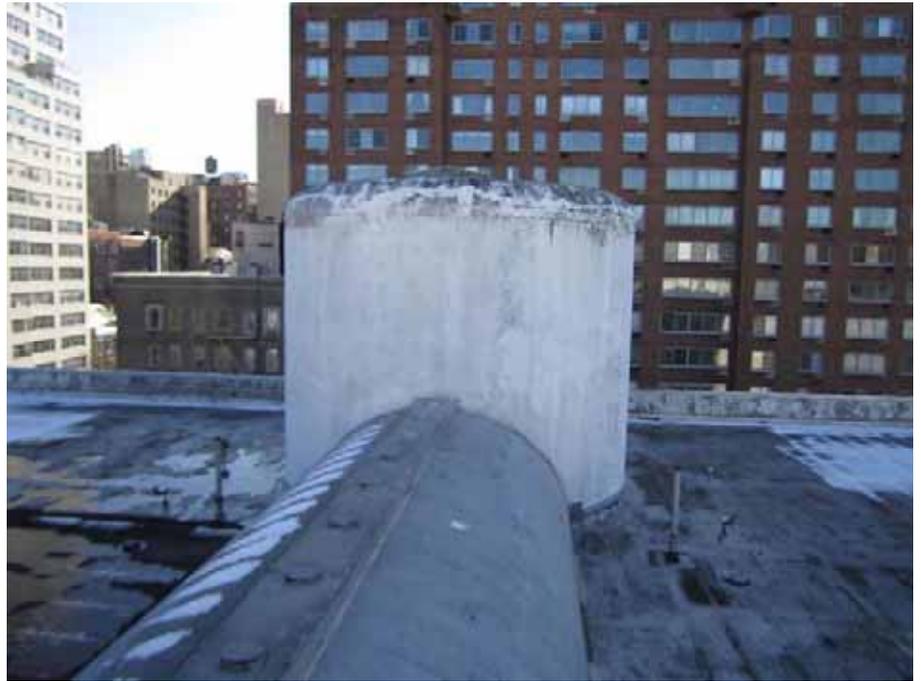
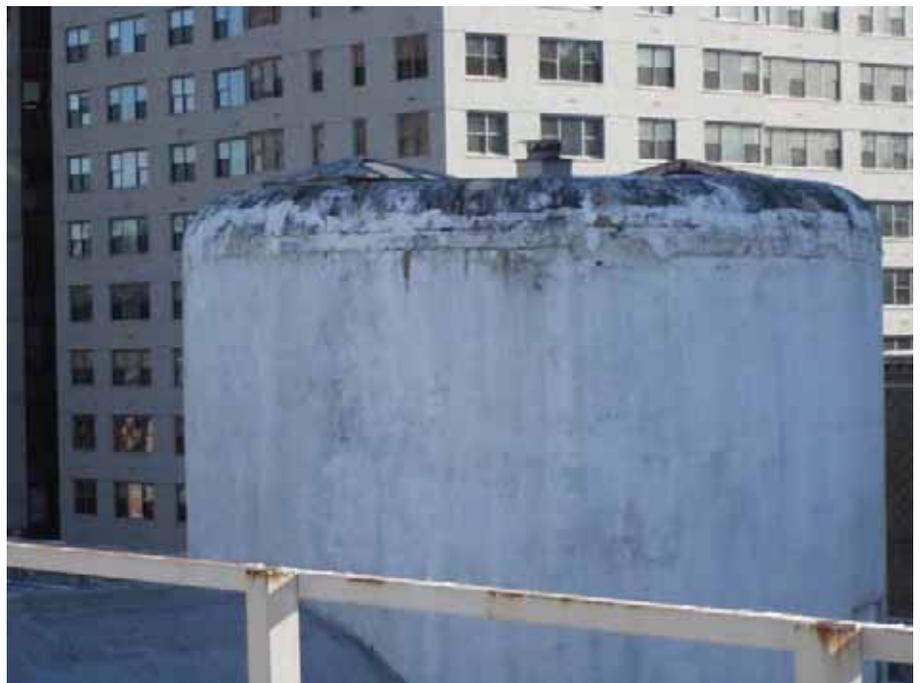
Photograph # 23 & 24:

Turret:

Overview of the turret
This concrete structure has significant deterioration at the top edge transition to the flat roof.

4. **Turret Waterproofing:** Remove all loose and spalling concrete from the structure. Patch as required to obtain a smooth consistent surface replicating the original profiles. Install a monolithic membrane such as Kemper BR. Patching more is to be Cathedral Stone Jahn M90

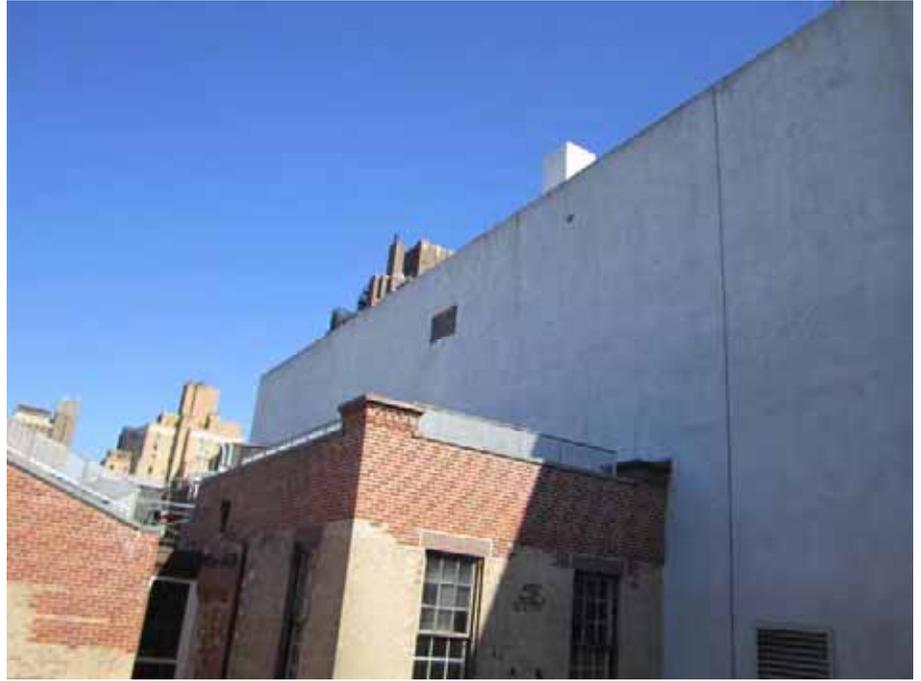
Photograph # 25 :

West Elevation:

Overview of the cast-in Place concrete building core. Predominately in very good condition with isolated areas of spalling and cracked concrete

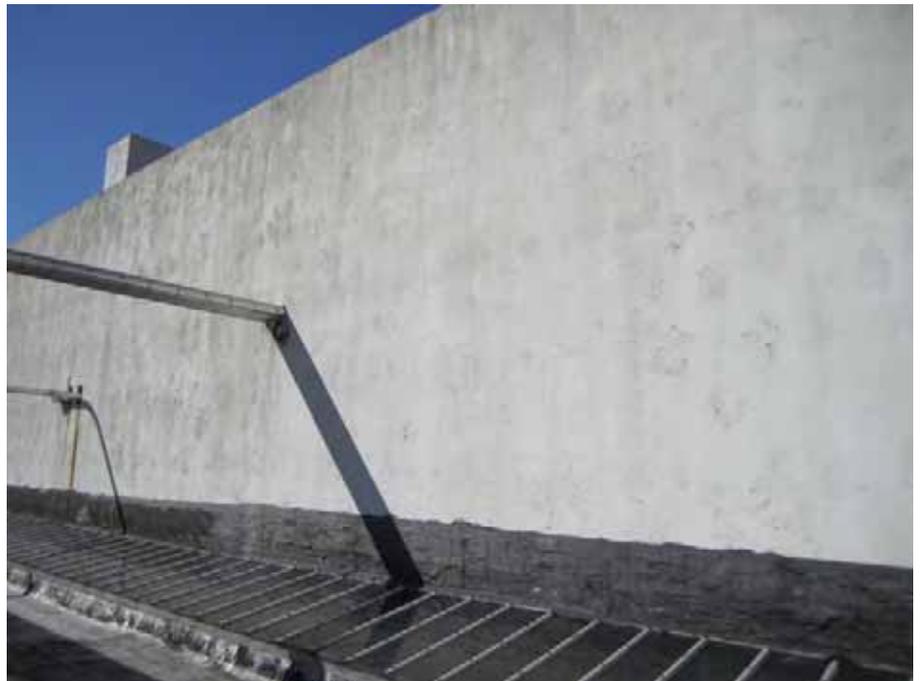
Photograph # 26:

East Elevation:

Overview of the Cast-on Place concrete building core in good condition.

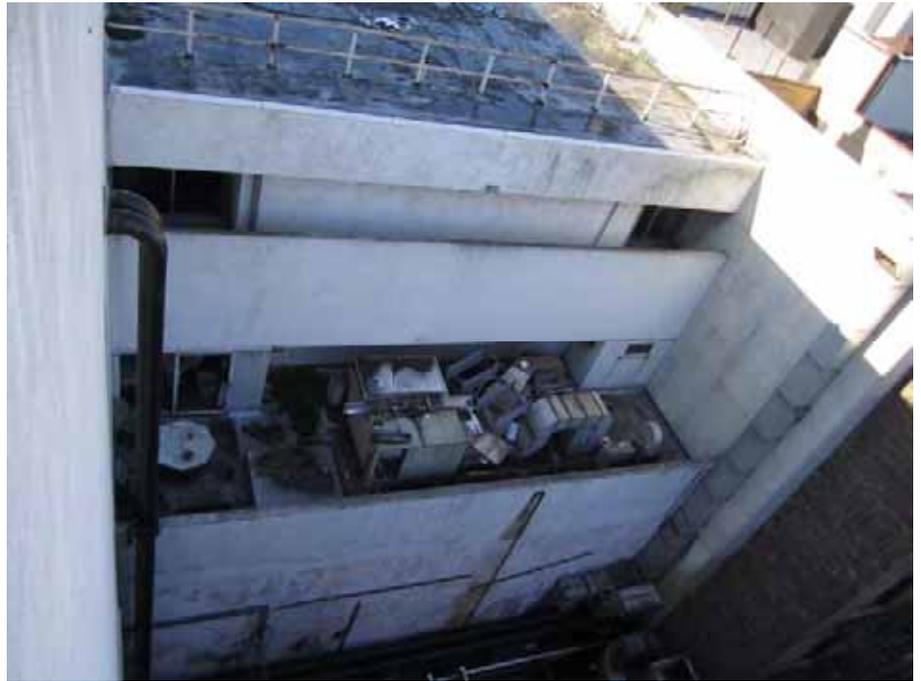
Photograph # 27:

West Elevation Annex:

Overview of the 3rd and 5th
Floor balconies and the stucco
facades on the North Elevation.

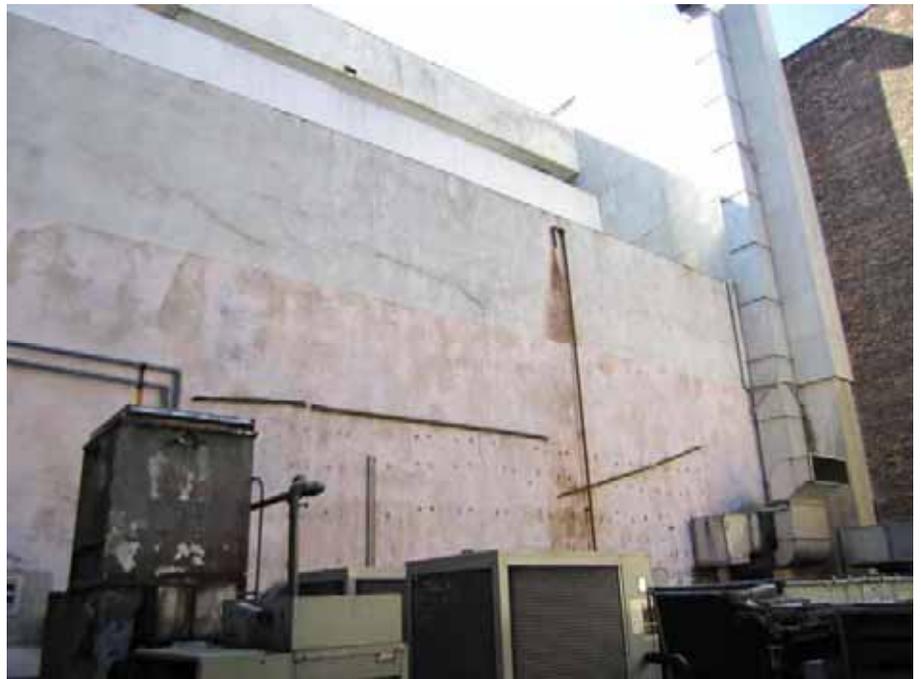
Photograph # 28:

West Elevation Annex :

Poor condition of the stucco at
the North Elevation at the 2nd
floor roof.

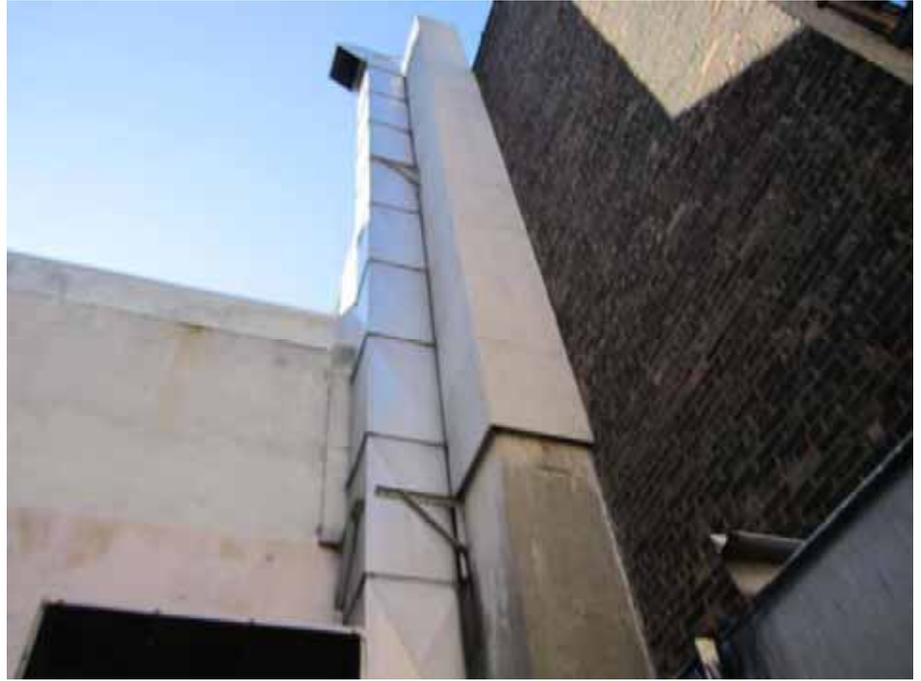
Photograph # 29:

West Elevation:

Marble cladding remains on a small section of the Western most walls at the north end.

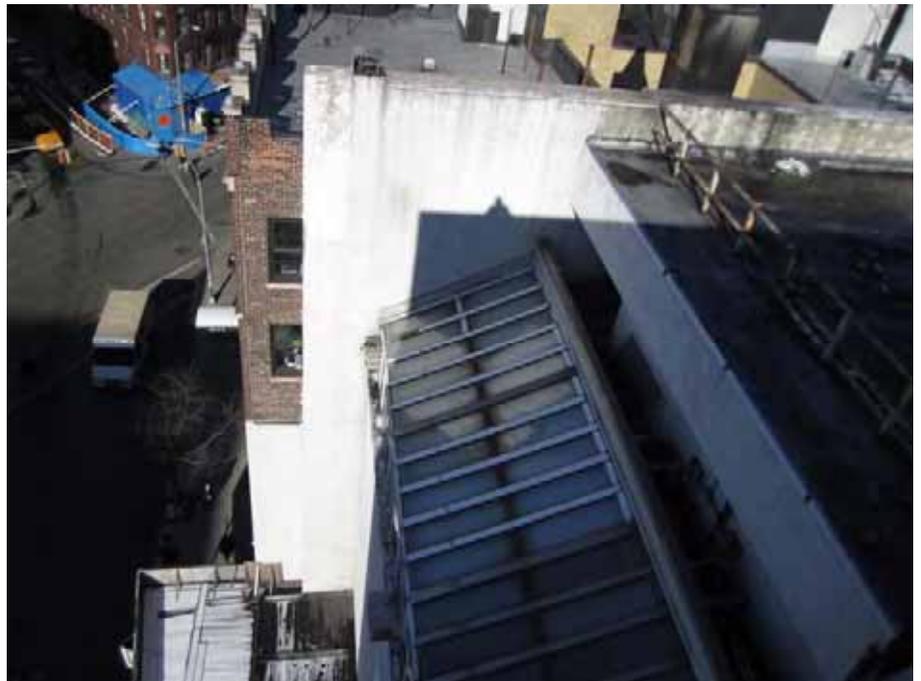
Photograph # 30:

West Elevation Annex:

Showing damaged Concrete at the top of the western most wall of the building and the south facing skylight at the 5th Floor.

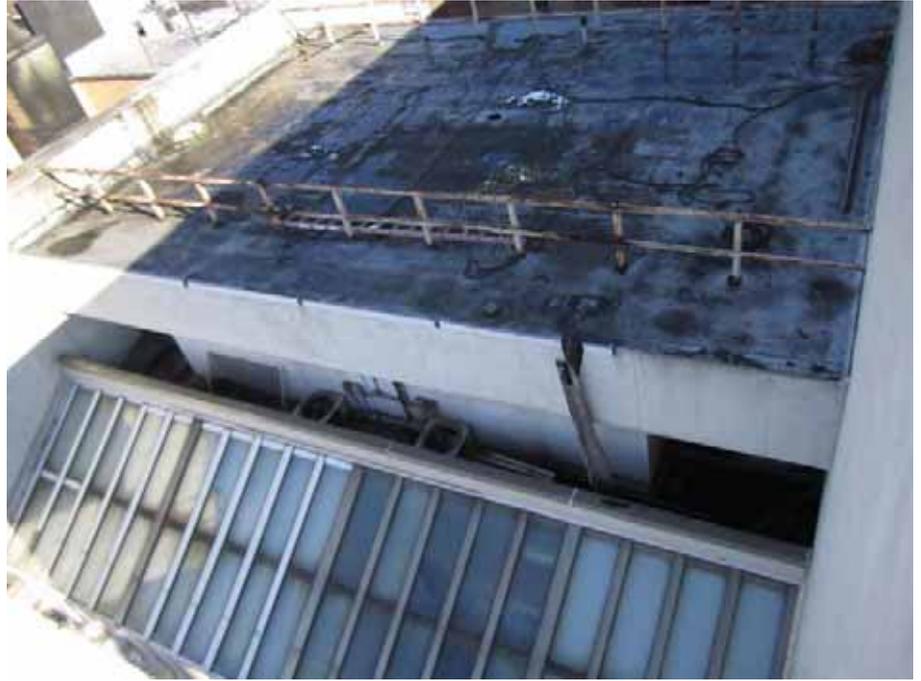
Photograph # 31:

West Elevation Annex Roofing:

5th Floor roof and railing and skylight.

Note: roof condition is typically poor throughout the building. Skylight is in serviceable condition
