LENOX HILL HOSPITAL - CENTER FOR COMPREHENSIVE CARE

Landmarks Preservation Commission Submission

June 9, 2011

**SUBJECT: Façade and Roof Investigation:
Photo Report
Maritime Building
37th Avenue**

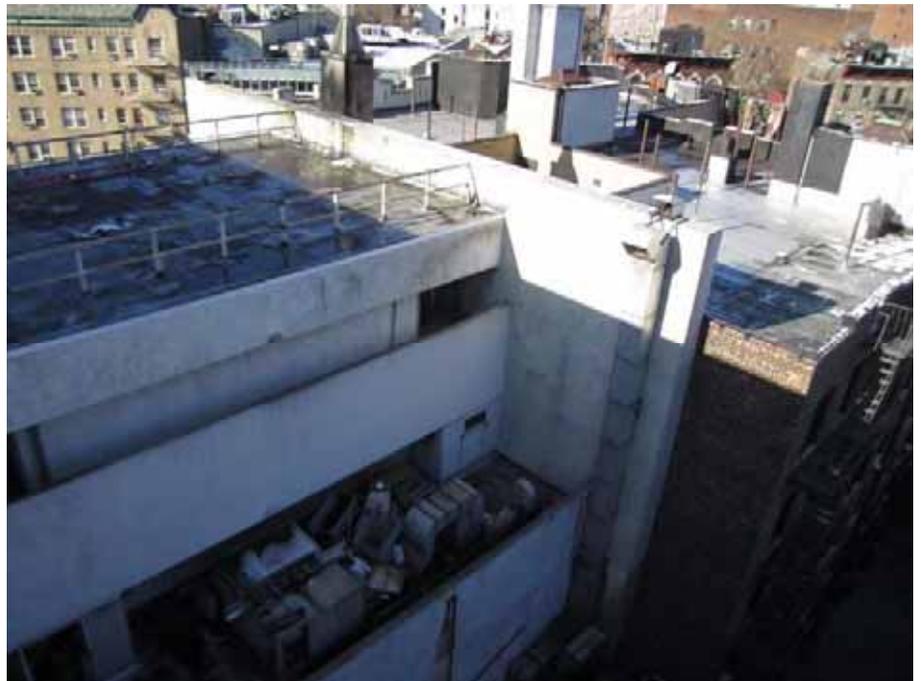
Photograph # 32:

West Elevation:

Setback roofs at the 3rd and 5th floor are in very poor condition

- 3. **Setback Roof replacement**
 - a. **6th Floor:** The existing roof is to be demolished, removing and disposing of all existing roofing material and insulation to expose the structural deck. A temporary roof is to be installed following demolition to keep a watertight system at all times. Installation of firestone Rubbergard Ecowhite EPDM fully adhered roof system with a 15 year NDL warranty.

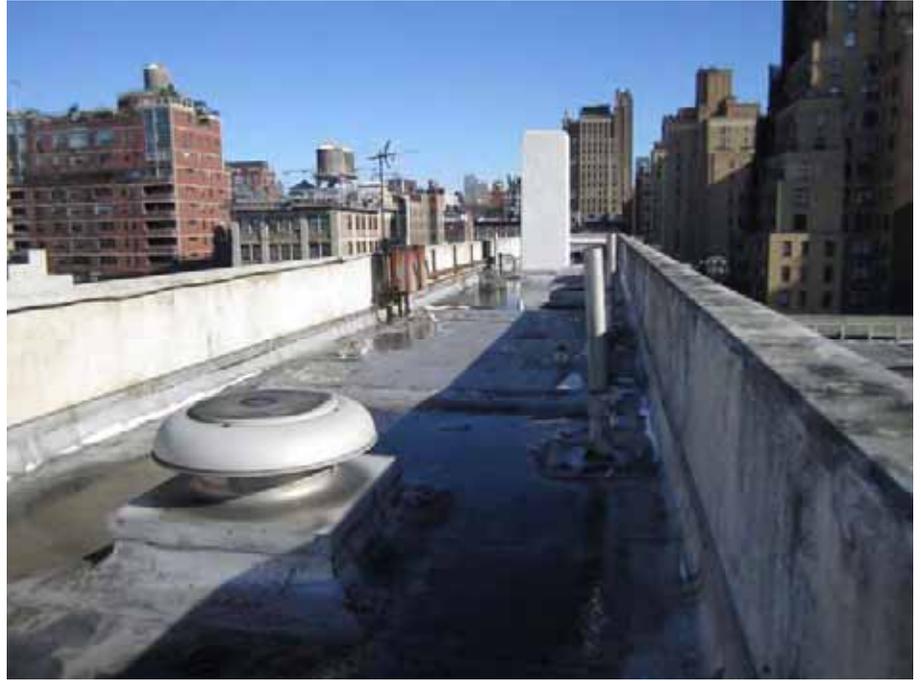
Photograph # 33:

Building Core Roof:

Typical of all the roofing systems, standing water, poor pitch to drain and overall deteriorated roofing systems that have exceeded their life expectancy.

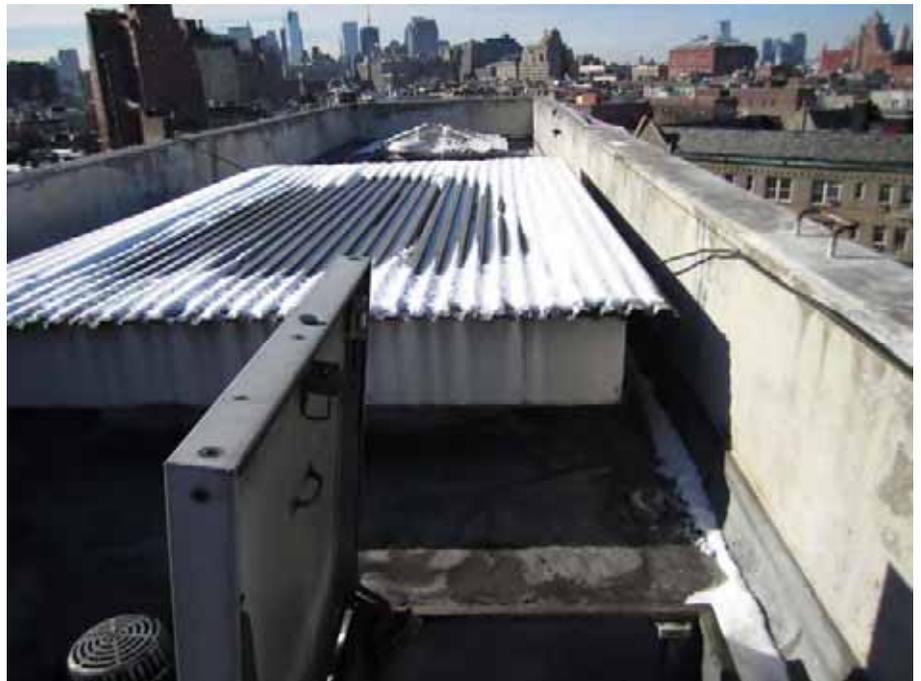
Photograph # 34:

Building Core Roof:

Similar to above

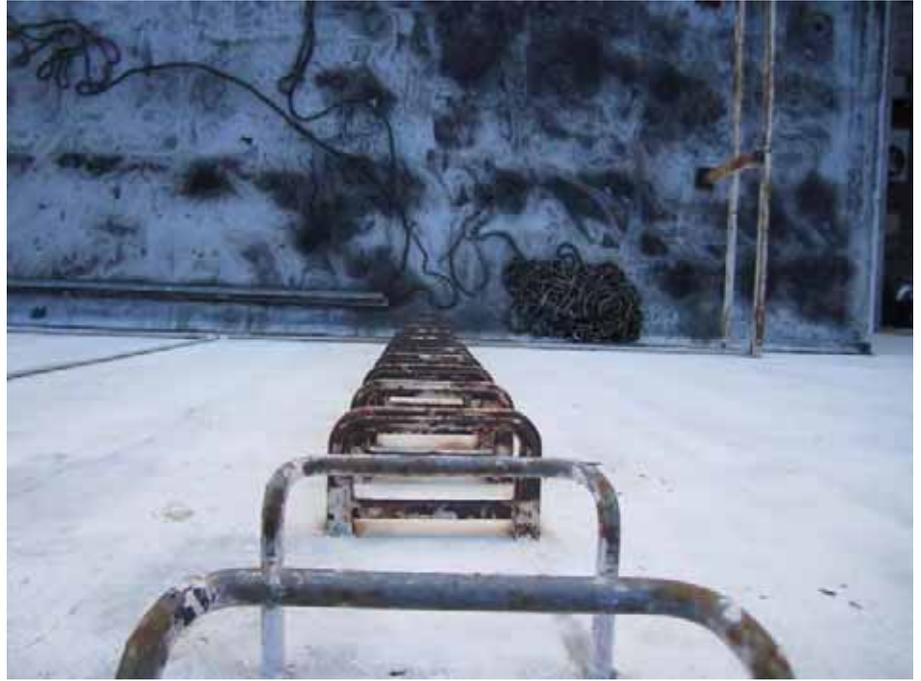
Photograph # 35:

West Elevation:

Embedded steel ladder from the top of the building core to the 5th floor roof of the annex.

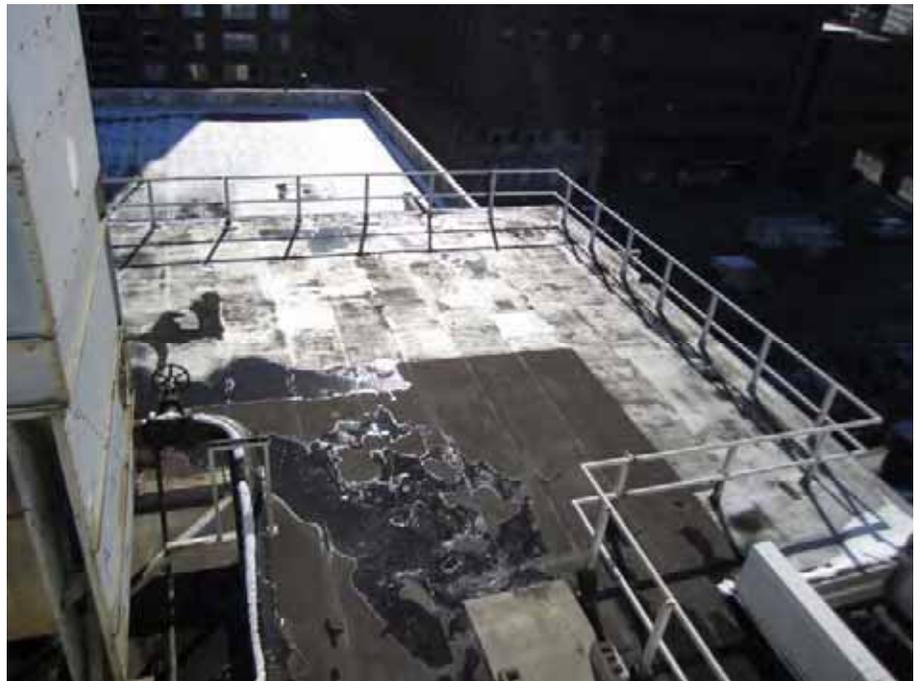
Photograph # 36:

South Elevation:

Typical overview of the main roof.

Note: numerous patches, standing water and deteriorated aluminum coating.

- 1. **5th Floor Main Roof Replacement:** The existing roof is to be demolished, removing and disposing of all existing roofing material and insulation to expose the structural deck. A temporary roof is to be installed following demolition to keep a watertight system at all times. Installation of firestone Rubbergard Ecowhite EPDM fully adhered roof system with a 15 year NDL warranty.

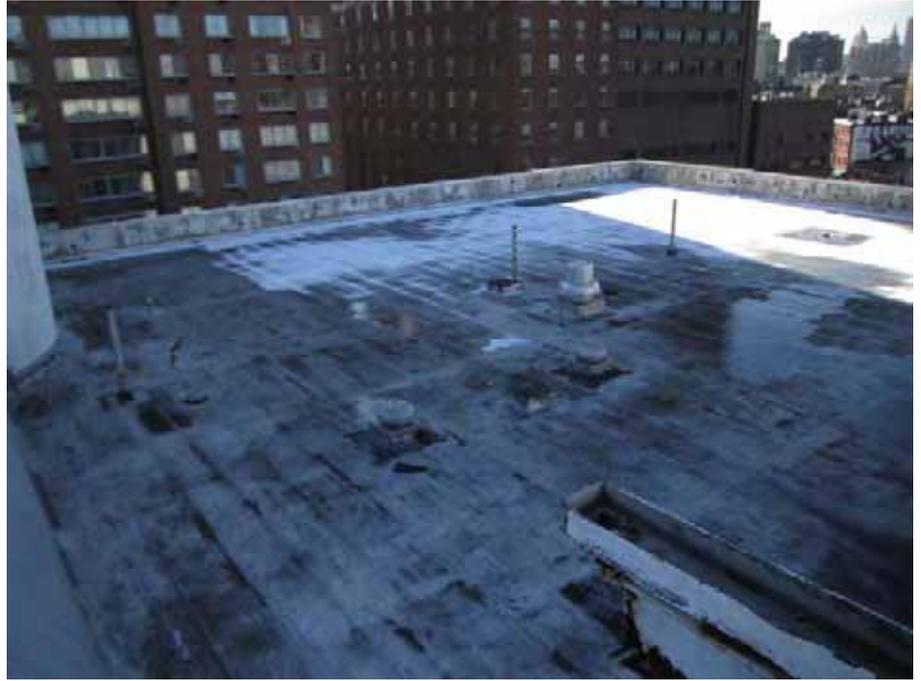
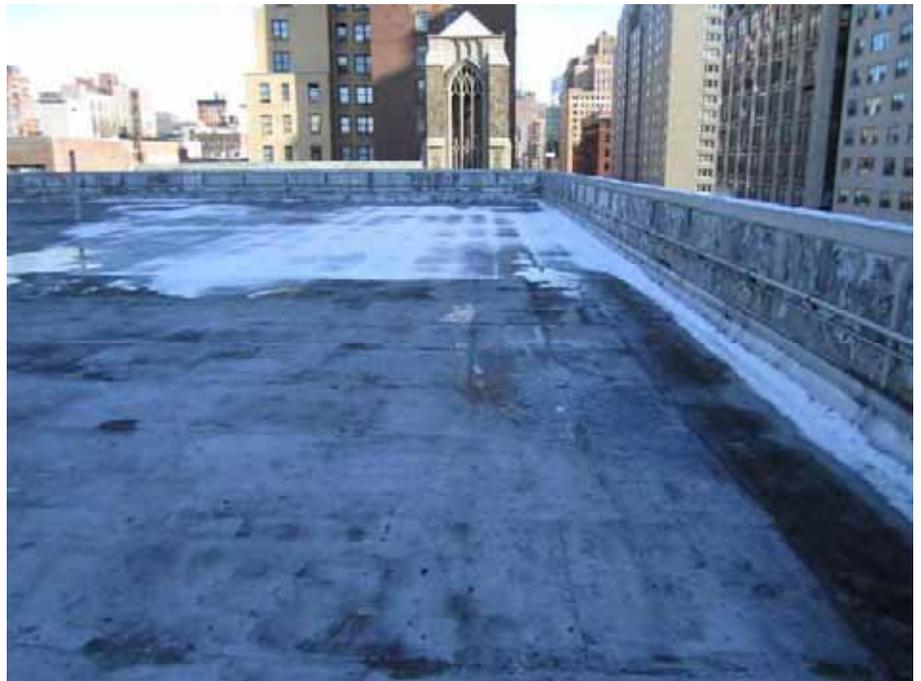
Photograph # 37 & 38:

Main Roof:

Similar to above.

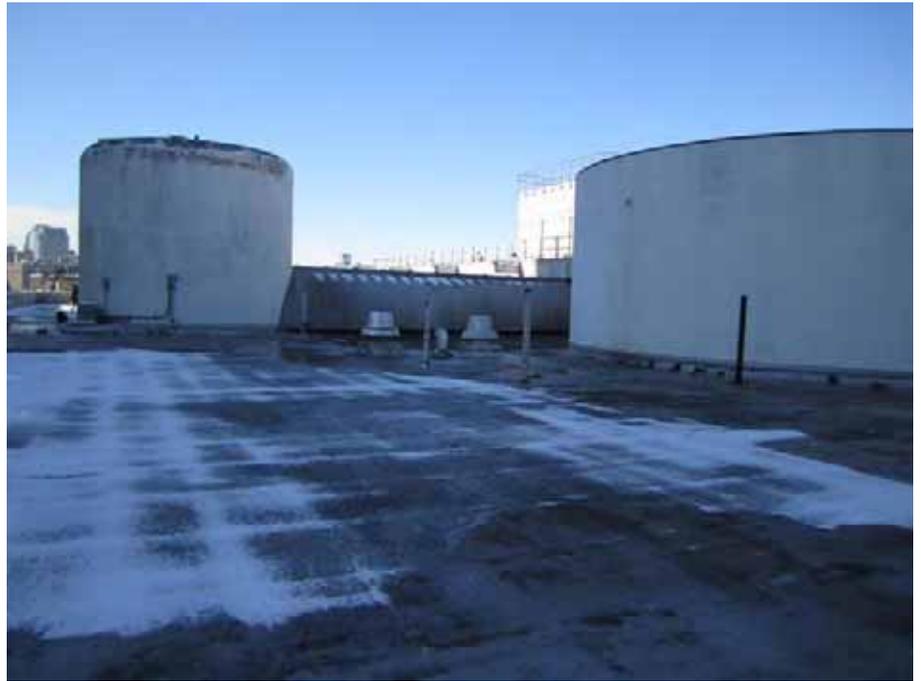
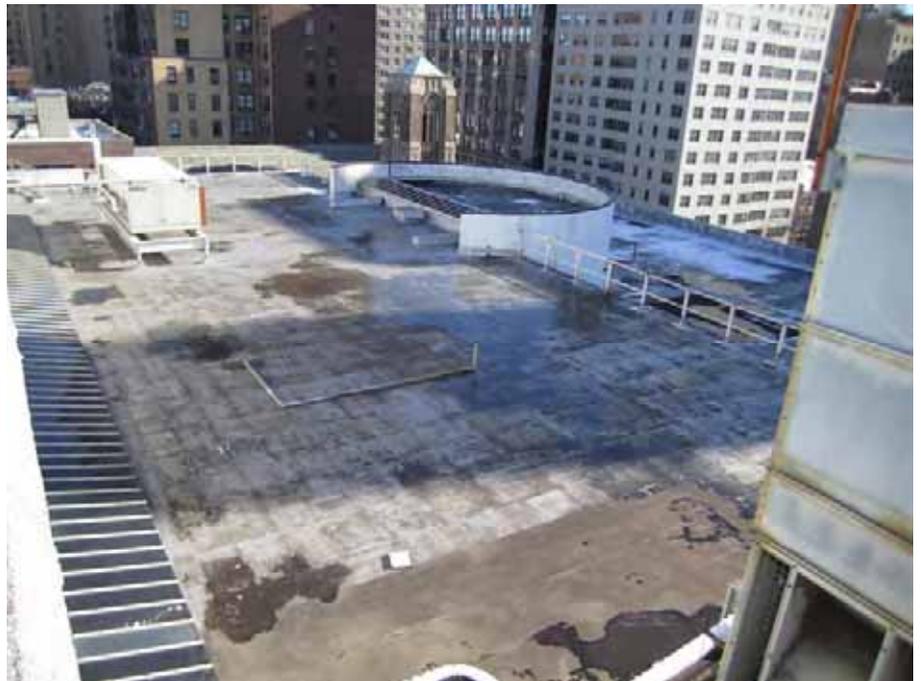
Photograph # 39 & 40:

Main Roof.

Multiple Probes were performed to investigate the condition of the roofing assembly. All of the probes exposed trapped water and saturated insulation at all locations tested.

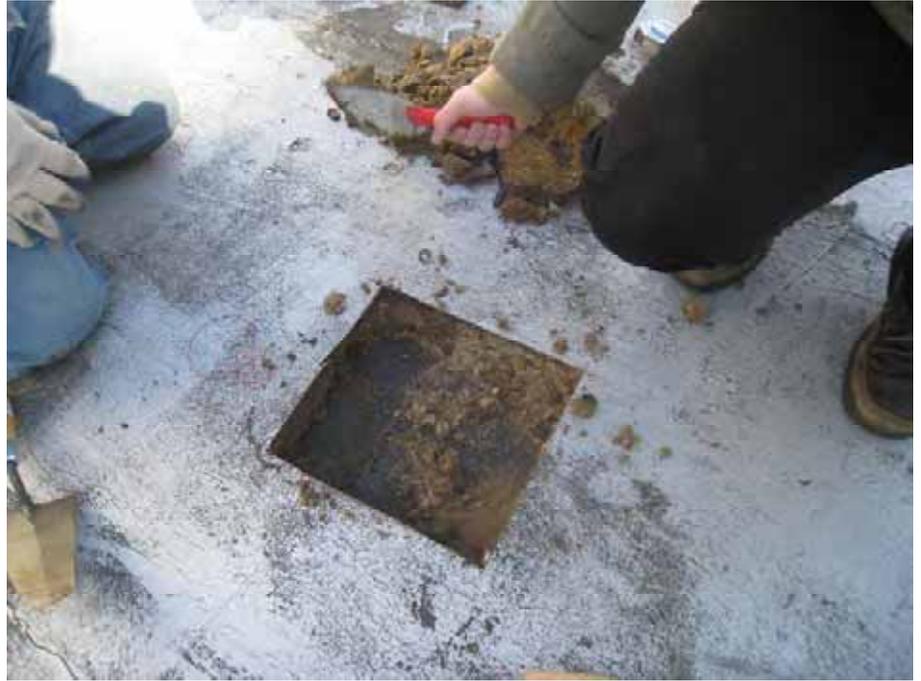
Photograph # 41:

Typical Roof Probe:

The existing roof assembly consists of an original multi-layer built roof system that has been re-covered with a perlite coverboard and 2 layers of smooth surfaced torch applied modified bitumen roofing.

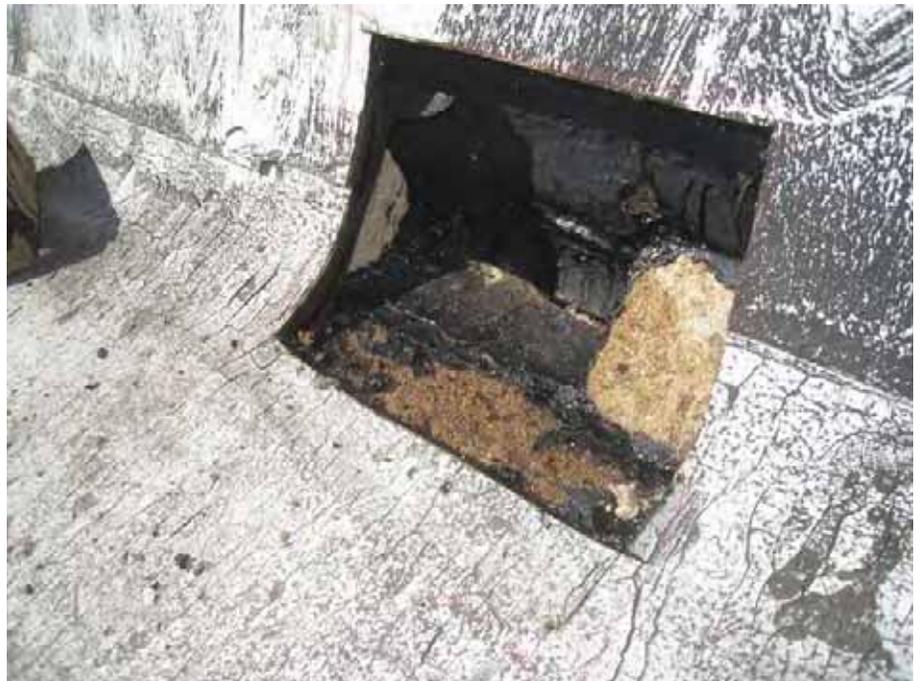
Photograph # 42:

Base Flashing probes were performed to verify condition and assembly

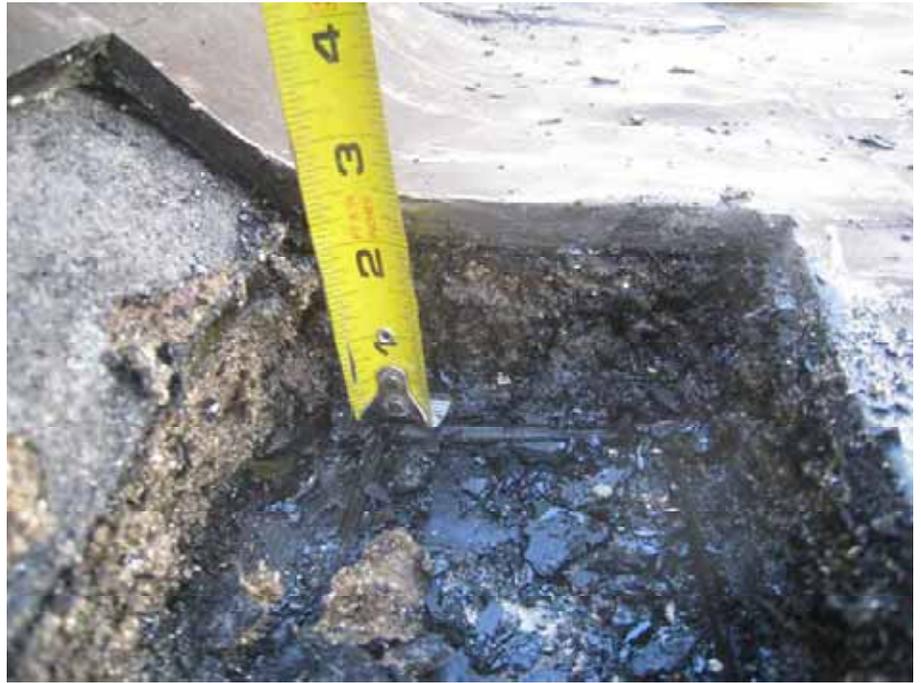
Photograph # 43:

Roof Probes:

The average depth of the roof system is 2.5 – 3 inches.

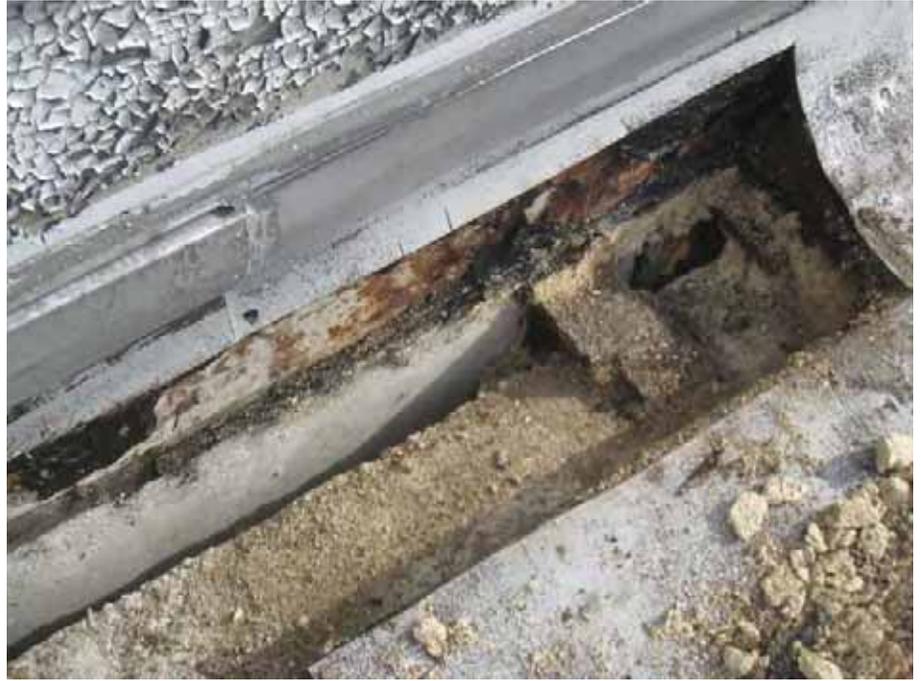
Roof Probes:

Exposed steel clip and shims. Shims are stacked and welded, minor corrosion was noted. However the attachments appear sound, there has been no evidence of shifting, jacking or other irregular movement associated with the pre-cast concrete panels of the façade.

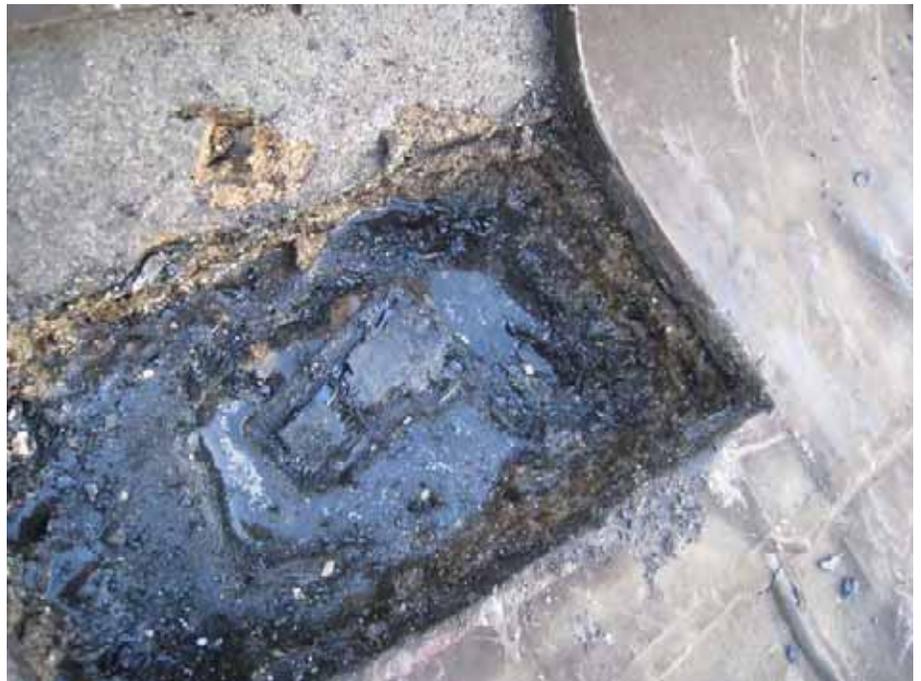
Photograph # 46:

Roof Probes:

Standing water was noted in the roof system at many of the roof probes.

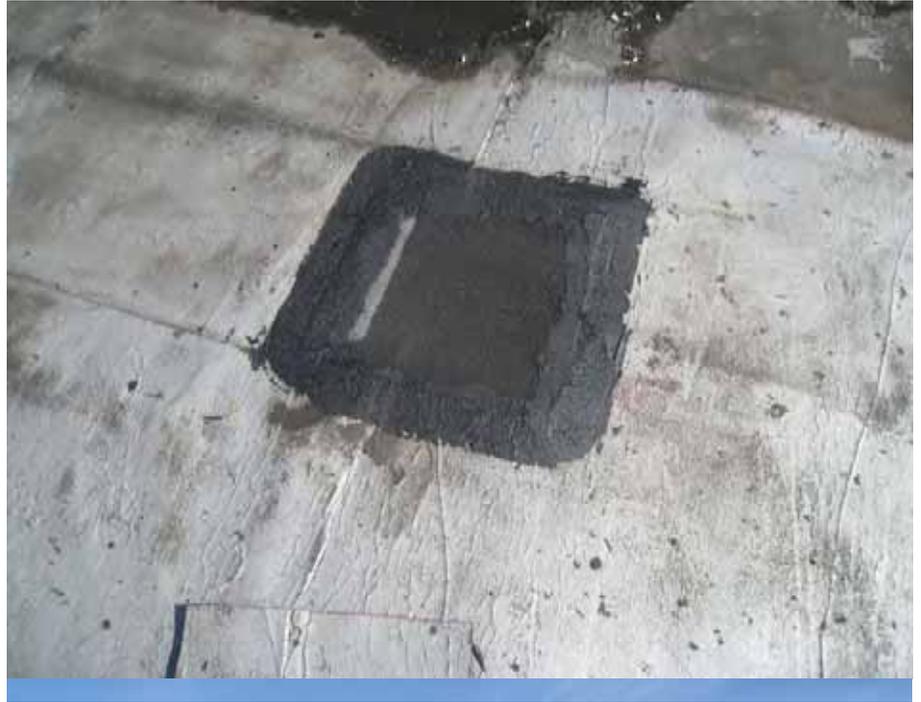
Photograph # 47 & 48:

Roof Probes:

Completed patch following roofing investigation.
