Safe Streets for Seniors

Greenpoint, Brooklyn

FINAL REPORT
September, 2011

Safe Streets for Seniors
GREENPOINT

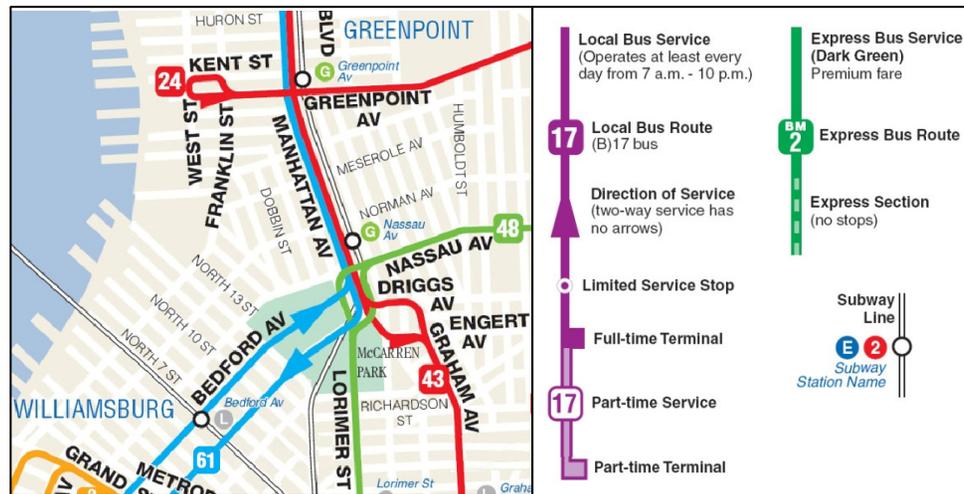
EXHIBIT 4 – TRANSIT MAP

The G (Brooklyn-Queens Cross town) and L (14th Street-Canarsie) Local Lines run through the study area. A subway station for the G line is at the intersection of Nassau Avenue and Manhattan Avenue. A station for the L line is located at the intersection of Bedford Avenue and North 7th Street (Exhibit 4).

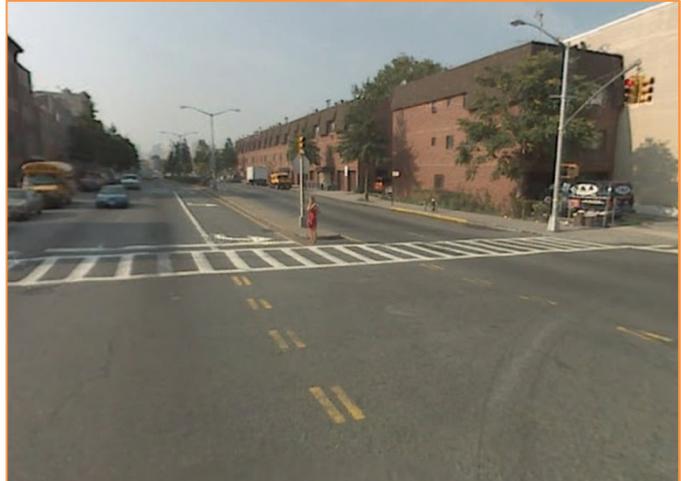
Photo No. 1: McGuinness Blvd. & Norman Ave.

The Greenpoint Study Area consists of one major north-south corridor, McGuinness Boulevard (Photo No. 1). The existing street geometry of McGuinness Boulevard includes four moving lanes, two in each direction with parking lanes on each side. There are medians separating the traffic directions as well as left-turn bays at many of the intersections.

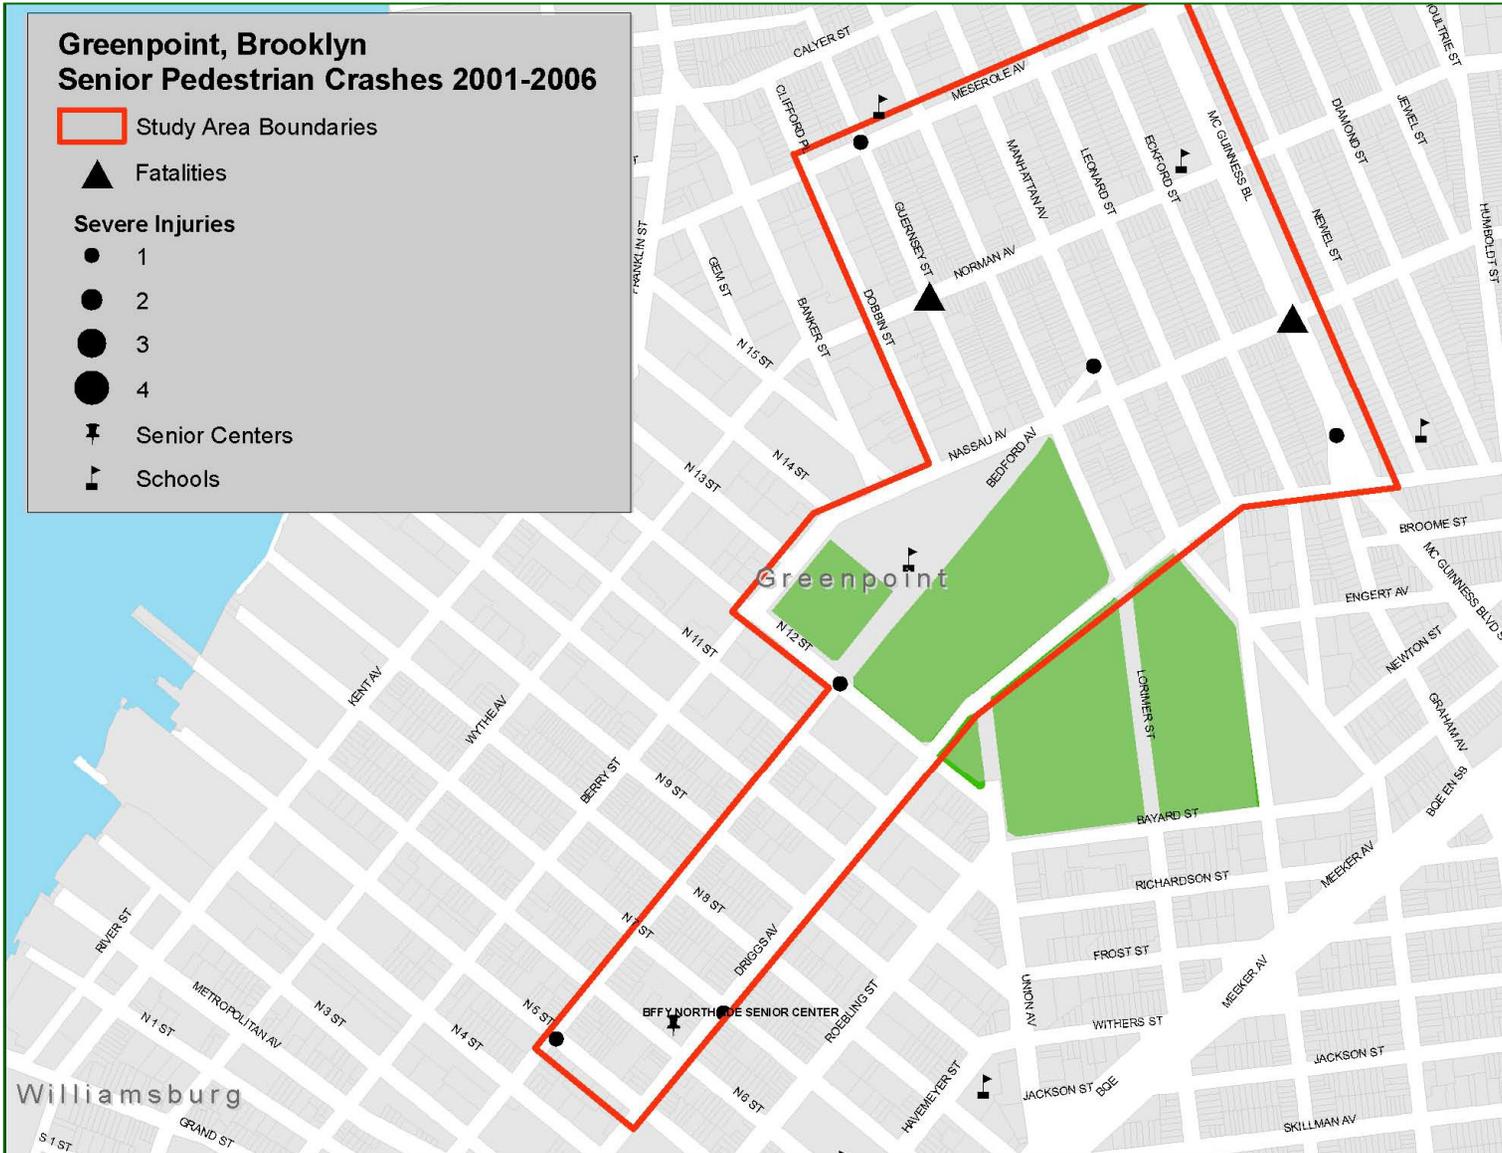
EXHIBIT 5 – PEDESTRIAN CRASH STATISTICS (2001-2006)

Crash data was obtained from the New York City Department of Transportation (NYCDOT) in the Greenpoint Study Area from 2001 through 2006. This data provides some detail relating the circumstances and cause of each crash. Table 1 and Exhibit 5 show a summary of crashes.

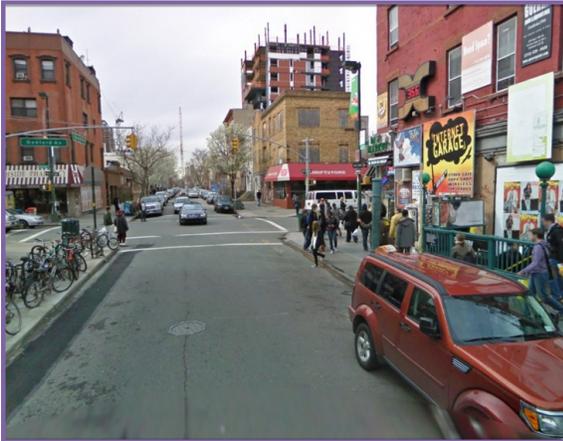
Photo No. 2: N 7th St. & Bedford Ave. (looking west)

North 7th Street is a 30-foot wide southbound street with one moving lane and parking on both sides. The intersections of North 7th Street and Bedford Avenue and North 7th Street and Driggs Avenue have heavy vehicular and pedestrian volumes (Photo No. 2). Pedestrians were observed crossing midblock and ignoring the traffic signal and many seniors raised concerns about these particular intersections. Additional pedestrian traffic is generated from the 'L' Train entrances/exits at the northeast and southeast corners of both intersections. There is also a bus stop for the B61 line on the east leg of Bedford Avenue and on the east leg of Driggs Avenue.

The pedestrian ramps on the northeast corner of North 7th Street and Bedford Avenue should be replaced with new NYCDOT standard pedestrian ramps and ADA safety surfaces.

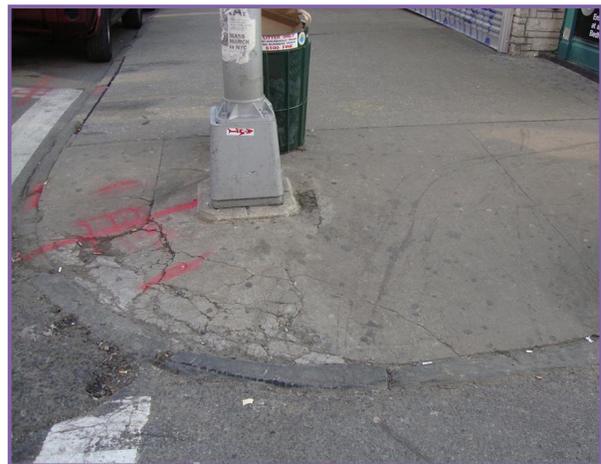
Photo No. 3: N 7th St. & Driggs Ave. (northeast corner)

The northeast and the southeast corners of North 7th Street and Driggs Avenue are missing pedestrian ramps. NYCDOT standard pedestrian ramp and ADA safety surfaces are recommended at these locations. On the northeast corner, a street light may need to be relocated to accommodate the ramps (Photo No. 3).

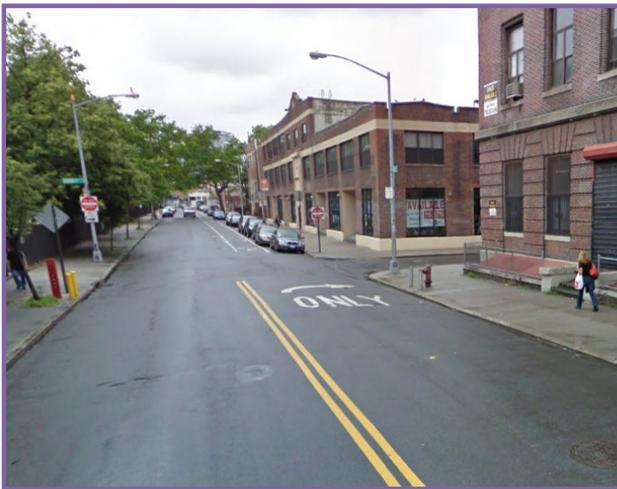
Photo No. 4: Nassau Ave. & Guernsey St. (looking west)

Near McCarren Park, Nassau Avenue is a one-lane eastbound street with a bike lane and parking on both sides. The traffic flow changes between Guernsey Street and Lorimer Street to a two-way street with one moving lane in each direction and a shared bike lane for eastbound traffic (Photo No. 4).

With the sudden change in traffic flow at Nassau Avenue and Guernsey Street, blockbuster striping is recommended for the northwest corner to channelize the eastbound vehicles away from the oncoming two-way traffic. Currently, there is no crosswalk on Guernsey Street at this location. It is recommended that a raised crosswalk is installed on Guernsey Street. A raised crosswalk will reduce the speed of turning vehicles from Nassau Avenue improving the safety of both pedestrians and vehicles.

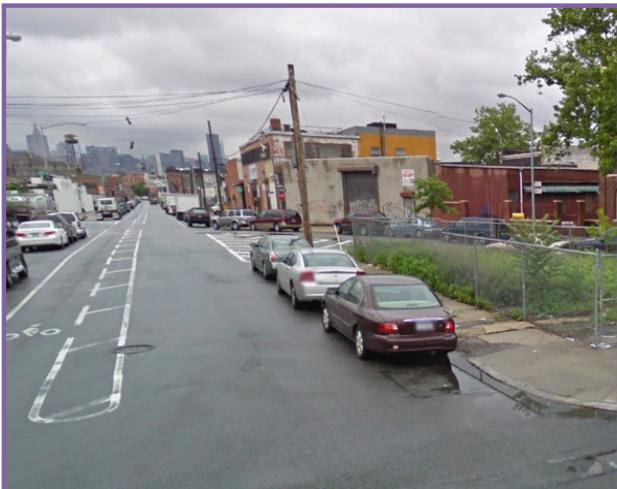
Photo No. 5: Banker St. & Nassau Ave. (looking north)

At the intersections of Nassau Avenue and Banker Street and Nassau Avenue and North 15th Street, there are no crosswalks across Banker Street and North 15th Street (Photo No. 5). Specific recommendations to improve senior pedestrian safety at this intersection are under consideration by NYCDOT as part of Capital Project HWK476B.

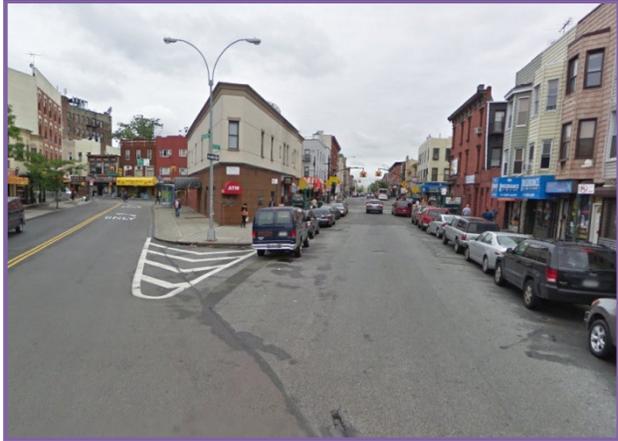
Photo No. 6: Nassau Ave. & Manhattan Ave. (looking west)

There is heavy pedestrian volume at the island located between Nassau Avenue, Bedford Avenue, Lorimer Street and Manhattan Avenue. The volumes are generated from the G Train entrances/exits at all four corners of Nassau Avenue and Manhattan Avenue and the bus stops for the B61 line on the north side of the island and for the B48 line on the east leg of Nassau Avenue (Photo No. 6).

This intersection is under review by NYCDOT as part of Capital Project HWK476B.

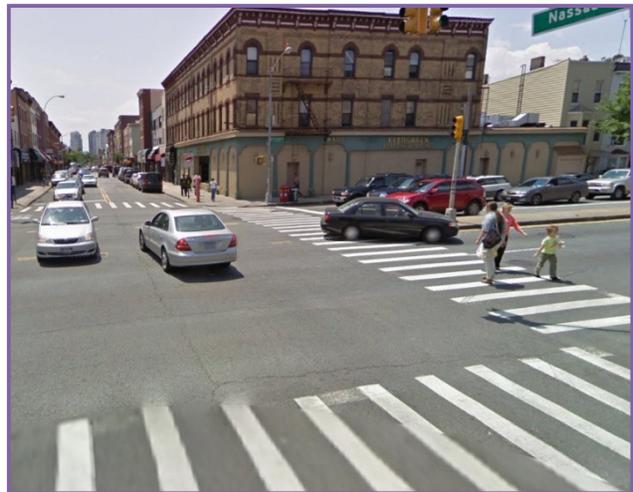
Photo No. 7: McGuinness Blvd. & Nassau Ave.

McGuinness Boulevard is a 75-foot wide street with two travel lanes in each direction and parking on both sides. It is a designated truck route and has heavy pedestrian and vehicular volumes (Photo No. 7). During the field visit, pedestrians were observed stuck at the median, unable to cross McGuinness Boulevard in one signal cycle. Pedestrian countdown signals are recommended for the following intersections:

Parking lane striping is recommended for both sides of McGuinness Boulevard from Meserole Avenue to Driggs Avenue. This measure will narrow the travel lanes and slow down moving traffic.

Channelization striping along McGuinness Boulevard and Graham Avenue is recommended to keep moving traffic in-line and to prevent the drivers from using the extra space to pass each other.

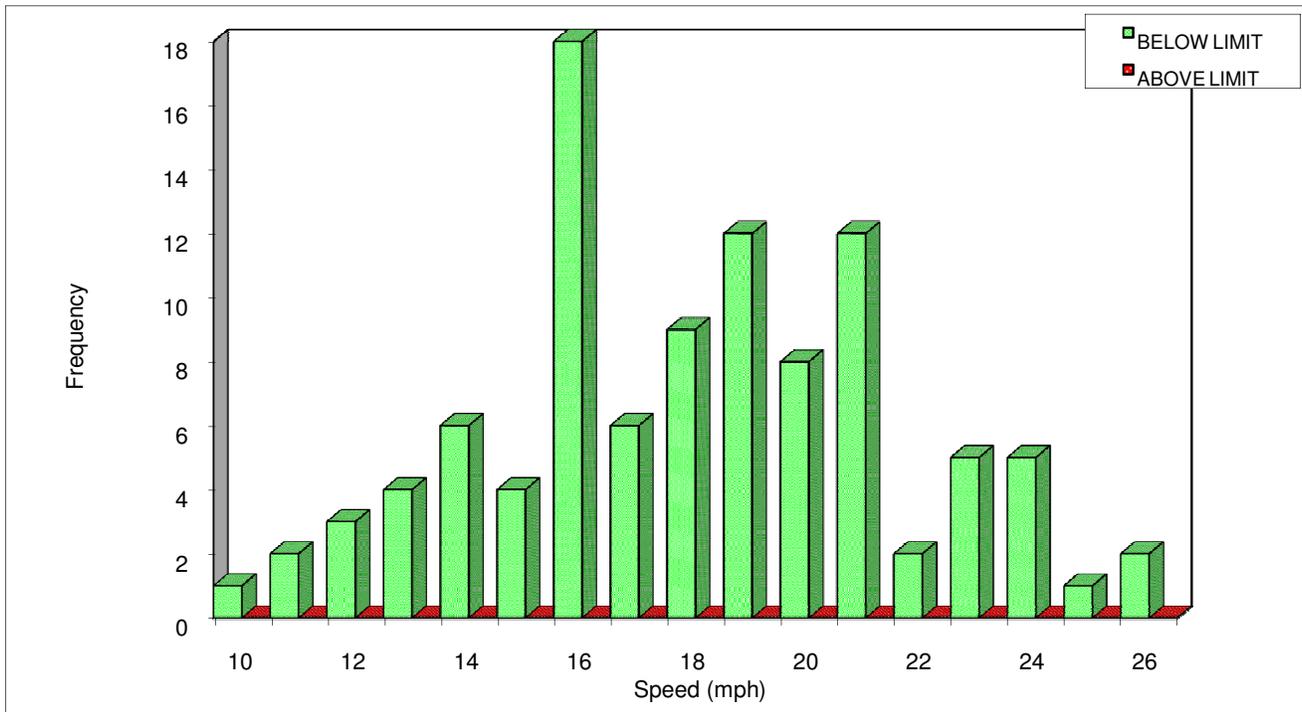
RADAR SPEED SURVEY

Boro:	BK	Average Speed:	18.1 mph
Date:	05/15/10	15th Percentile:	14.0 mph
Day:	Sat.	50th Percentile:	18.0 mph
Weather:	Clear	85th Percentile:	21.2 mph
Time:	10:00 - 14:00		
Speed Limit:	30 mph	Above Speed Limit:	0.0 %
Sample Size:	100	Minimum Speed	10.0 mph
		Maximum Speed	26.0 mph
Type of Roadway:	Two-way	Pace:	14.0 - 24.0 mph
Width of Road by Direction:		In Pace:	87.0 %
Number of Moving Lanes:		Below Pace:	10.0 %
Number of Parking Lanes:		Above Pace:	3.0 %
Observer:	0	Standard Deviation:	3.5 mph
