**New York City Department of Transportation
Office of School Safety Engineering**

School Safety Engineering Project

FINAL REPORT: I.S. 252, Arthur Somers School, Brooklyn

Prepared by
The RBA Group/Urbitrans Associates

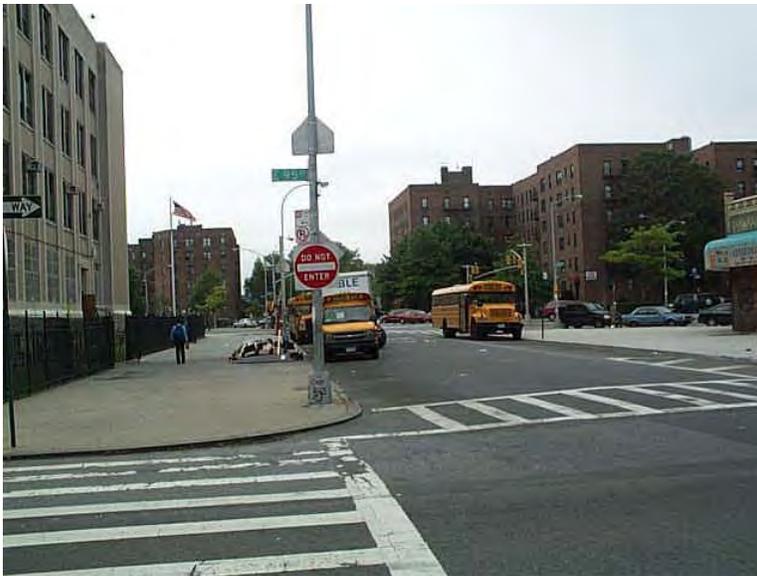
Figure 1 – Looking south on Lenox Road, toward Kings Highway, Brooklyn, I.S. 252 is at left

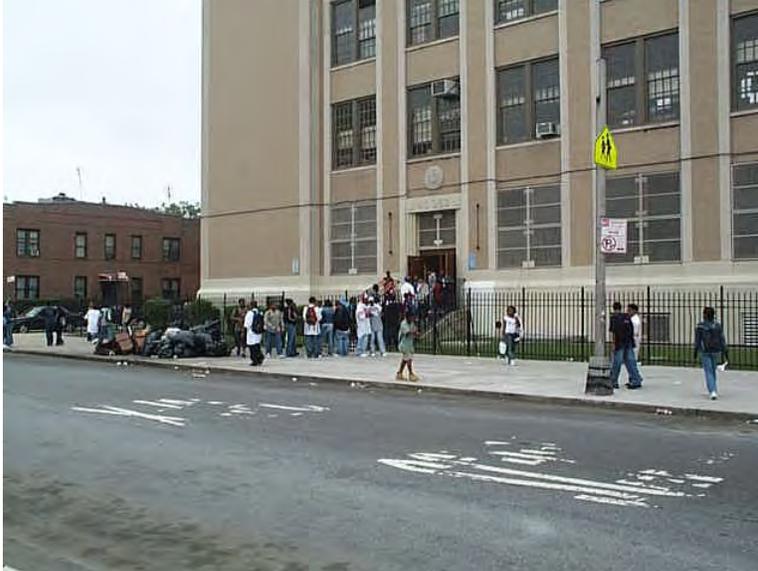
Figure 2: School entrance on Lenox Road at dismissal time

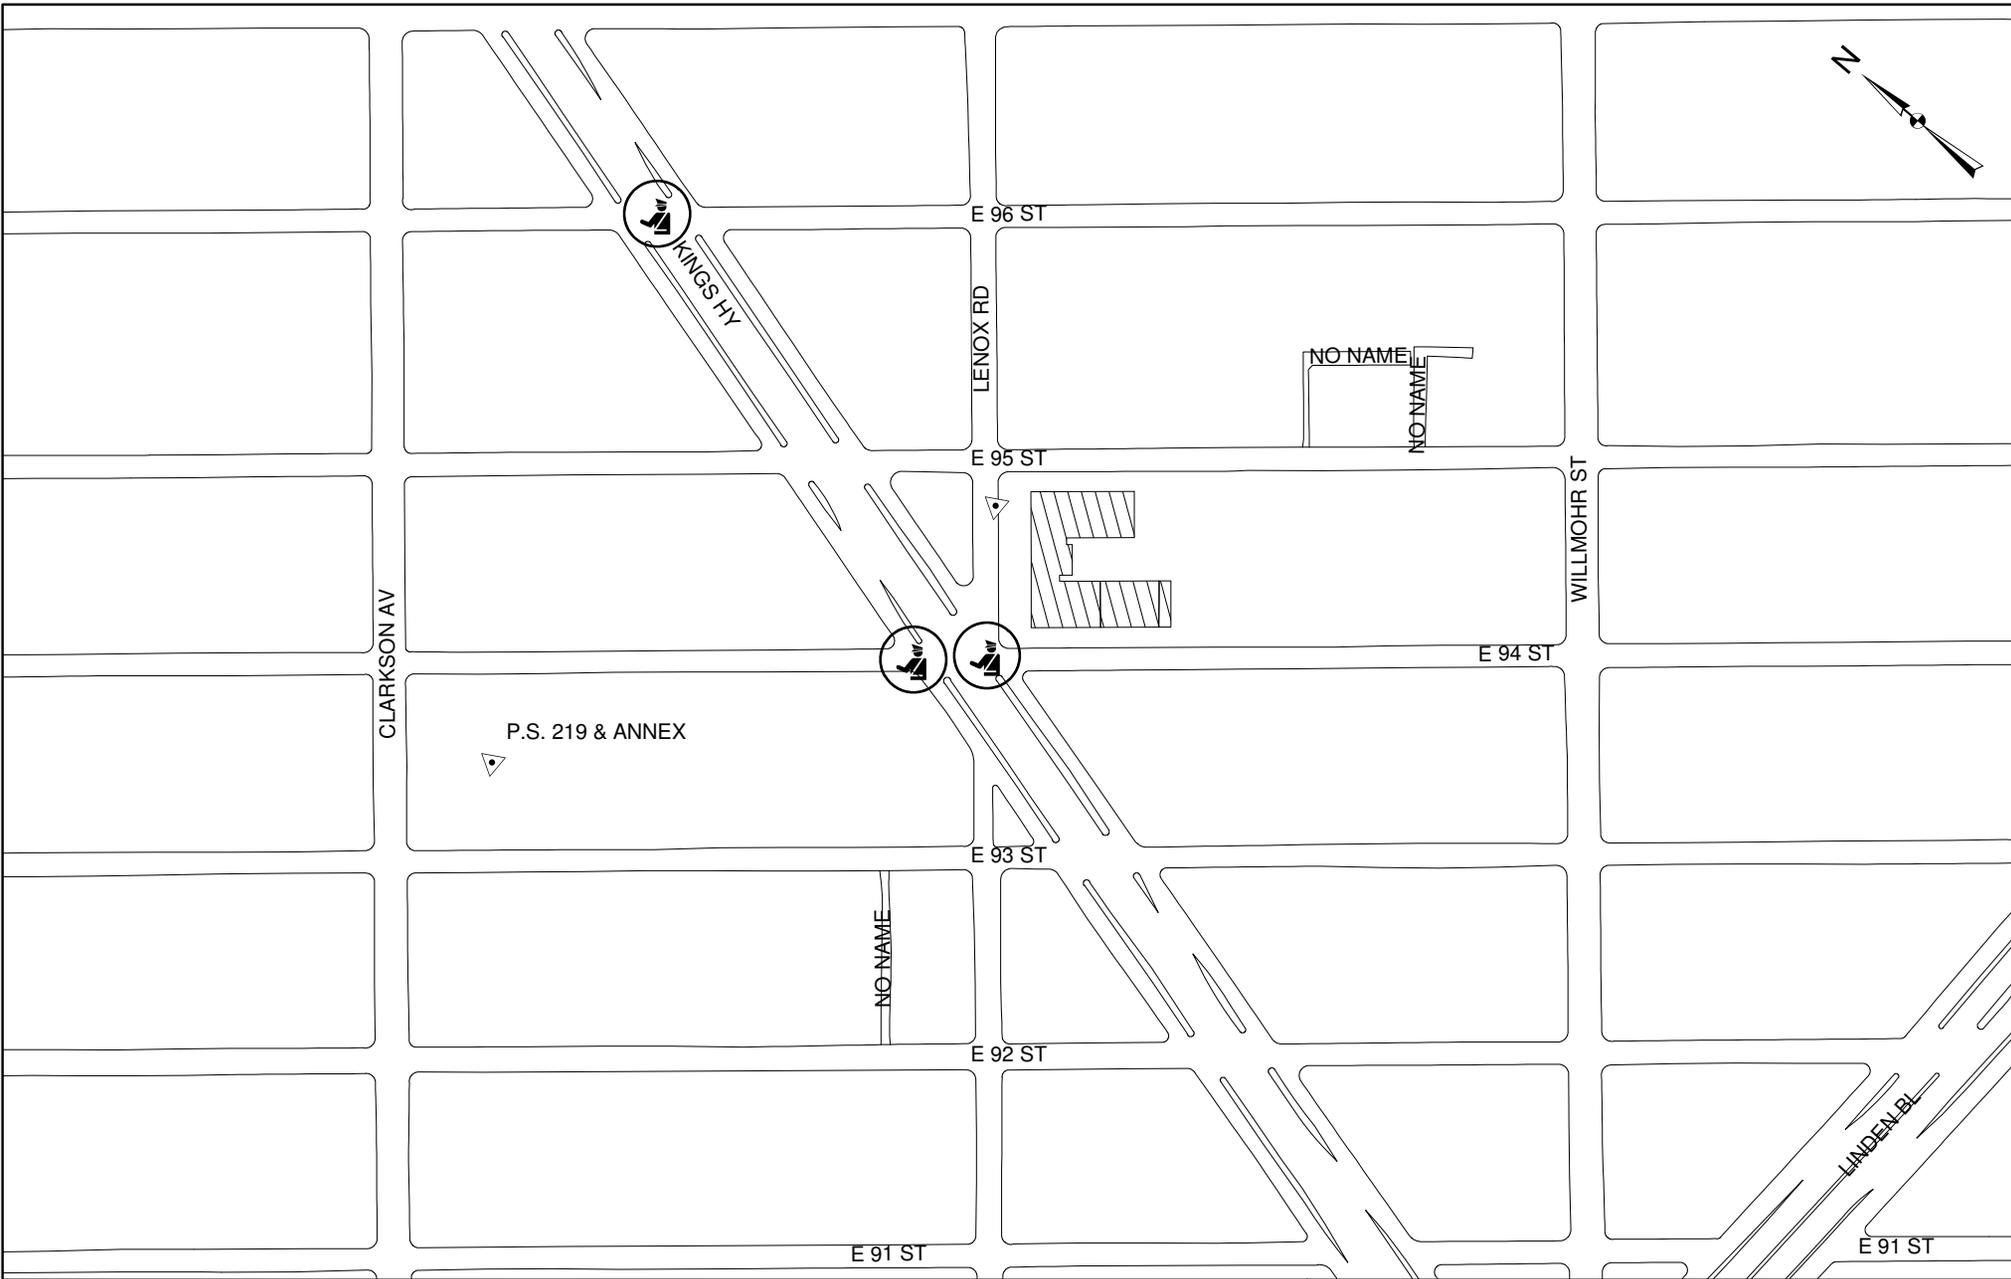
EXHIBIT 4

There are no crossing guards assigned to I.S. 252. However, there are three crossing guards assigned to P.S. 219 stationed at the following intersections:

- Kings Highway and East 94th Street (two crossing guards)
- Kings Highway and East 96th Street

CROSSING GUARDS

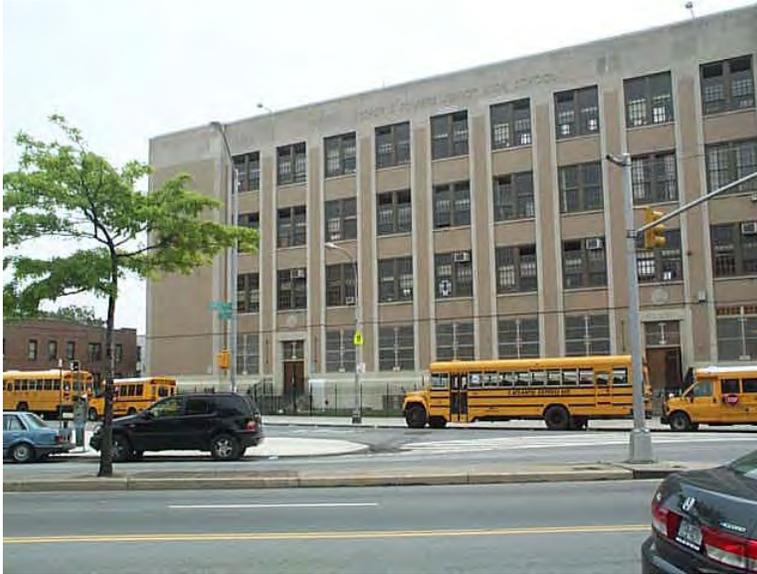
According to the school principal, school buses provide transportation only for students with special needs. During arrival time, buses drop off students on Lenox Road in front of the main entrance. During dismissal time, school buses line up at the curb on Lenox Road (Figure 3), within the “No Parking” zone in front of the school.

Figure 3 – School buses lining up on Lenox Road prior to dismissal of I.S. 252

“NO PARKING 7AM-4PM, SCHOOL DAYS” parking regulations on Lenox Road between East 94th and East 95th Street should be replaced by “NO STANDING 7AM-4 PM, SCHOOL DAYS” to provide sufficient clear frontage for school buses to drop-off and pick-up students.

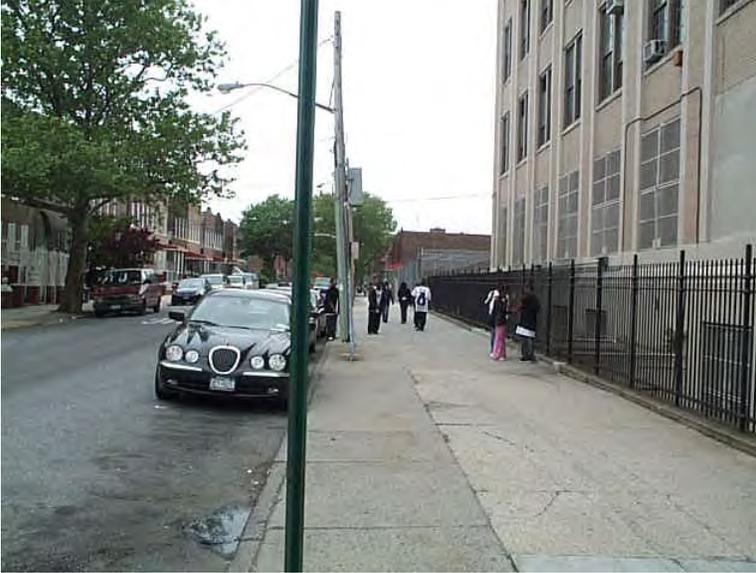
During dismissal, parents or guardians wait on East 95th Street for dismissed students. They park their vehicles in available spots or double-park. There were no operational issues observed on East 95th Street due to double-parked vehicles during arrival and dismissal.

Figure 4 – East 95 Street at I.S. 252 dismissal time, looking west

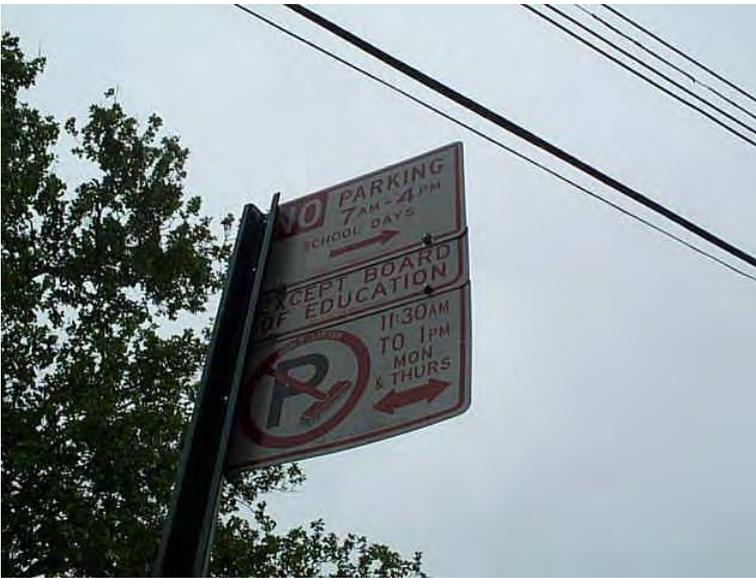
A “NO PARKING 7:00 AM TO 4:00 PM SCHOOL DAYS” parking regulation is posted on Lenox Road between East 94th Street and East 95th Street. A “NO PARKING 7:00 AM TO 4:00 PM SCHOOL DAYS, EXCEPT BOARD OF EDUCATION” parking regulation is provided on both East 94th Street and East 95th Street. Street cleaning regulations, which prohibit parking on alternating sides of the roadways, are present near the school.

Figure 5 – Parking regulation signs on East 95th Street

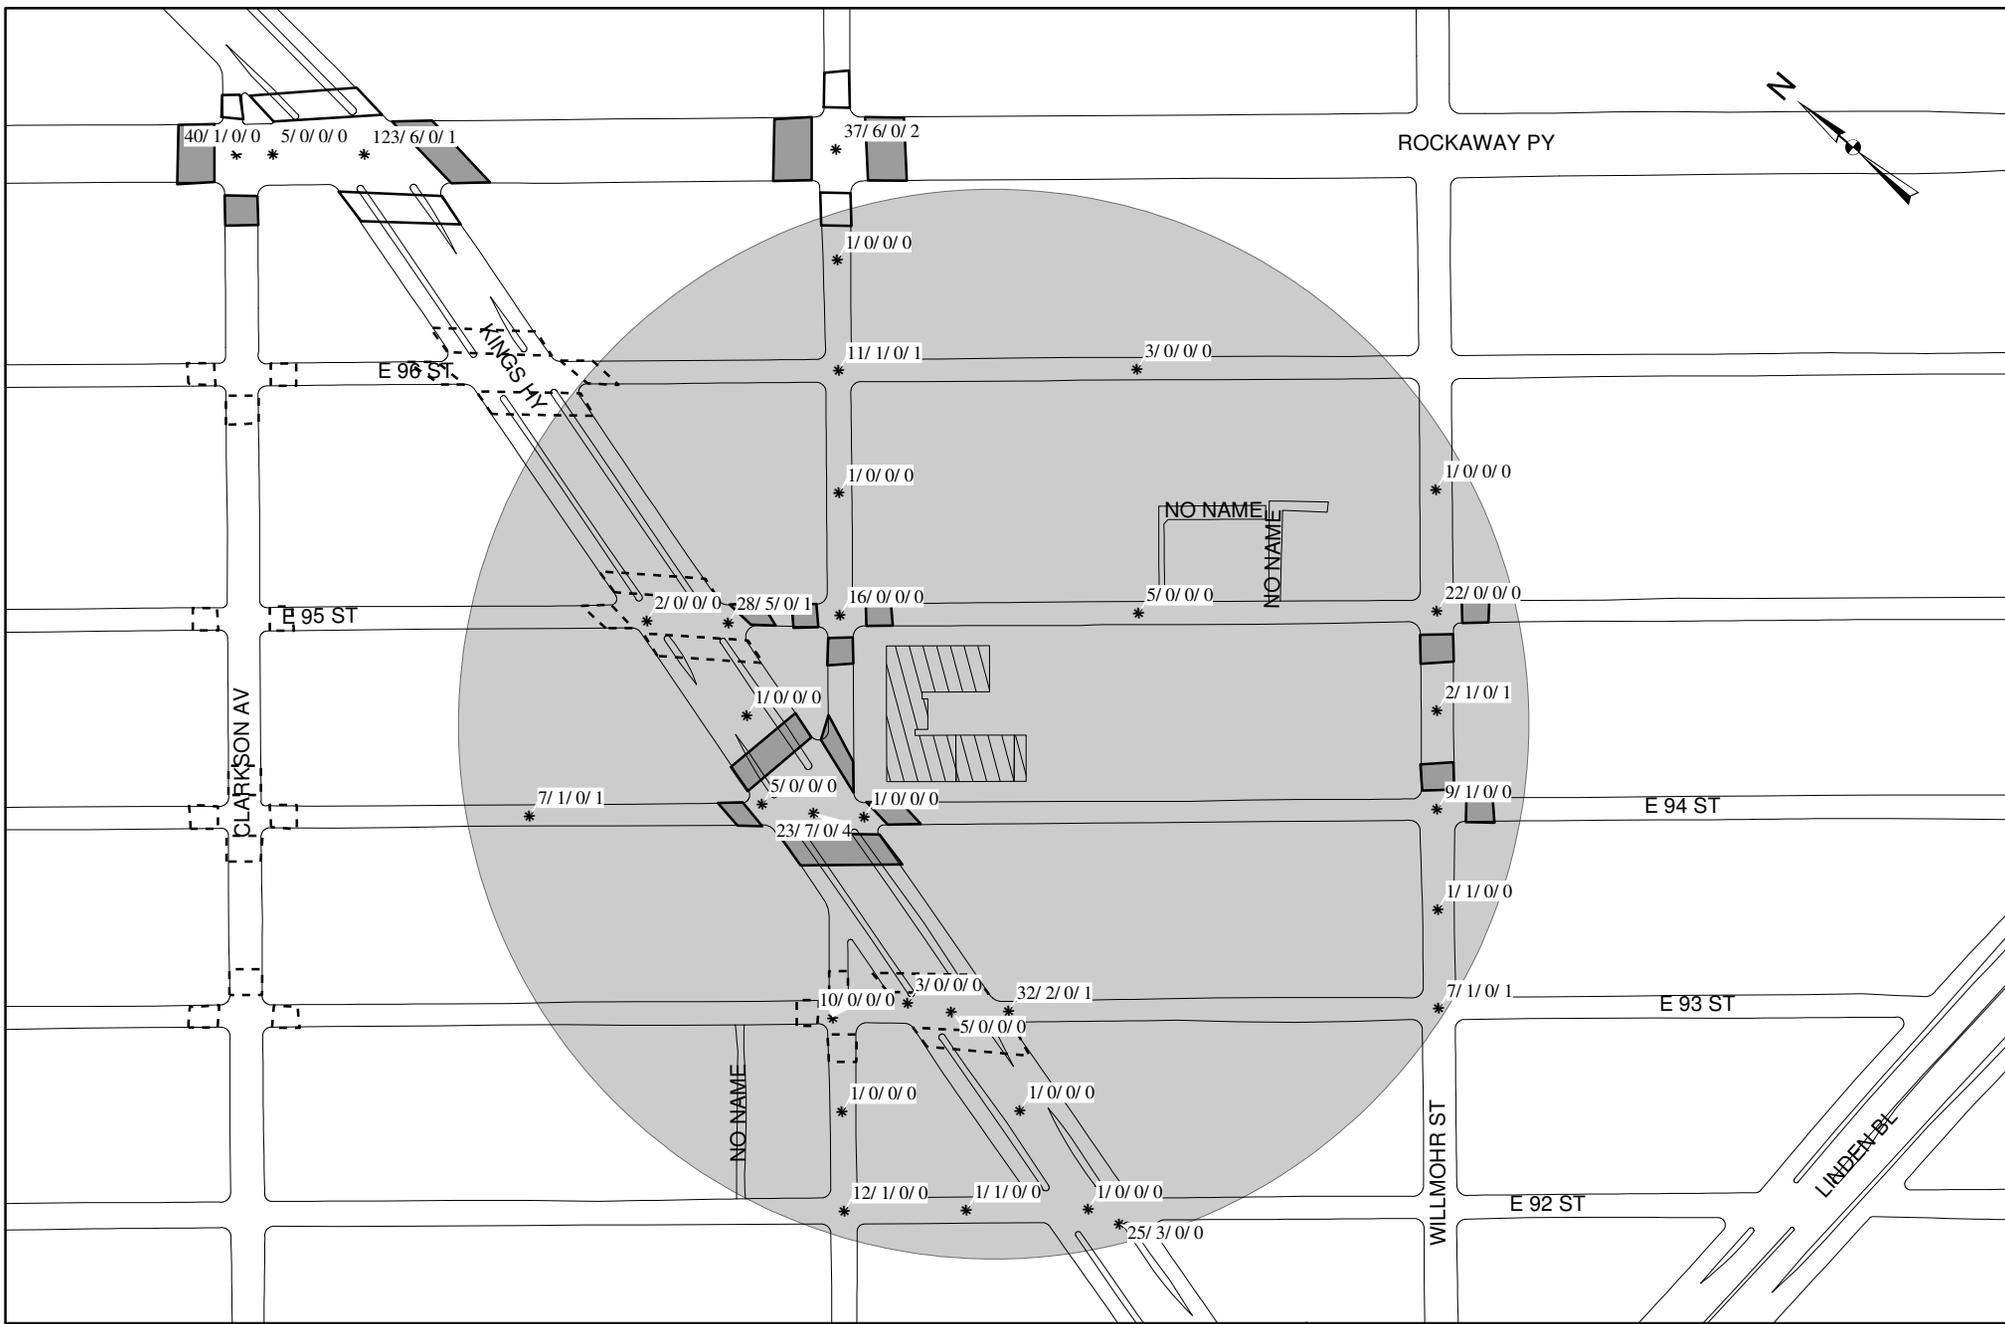
EXHIBIT 6
I.S. 252, BROOKLYN
ARTHUR SOMERS SCHOOL
ACCIDENT SUMMARY
THREE YEAR PERIOD
(1998-2000)

Exhibit 6 and Table 2 show a summary of accidents, as obtained from the New York State Department of Motor Vehicles (DMV), in the vicinity of I.S. 252 for the three-year period from January 1, 1998 through December 31, 2000. The DMV data provides some detail relating to the circumstances and cause of the accidents. Table 3 is a summary of more recent accident data obtained from the NYC Police Department (NYPD). Though current through 2004, the NYPD data does not provide the same level of detail as the DMV data.

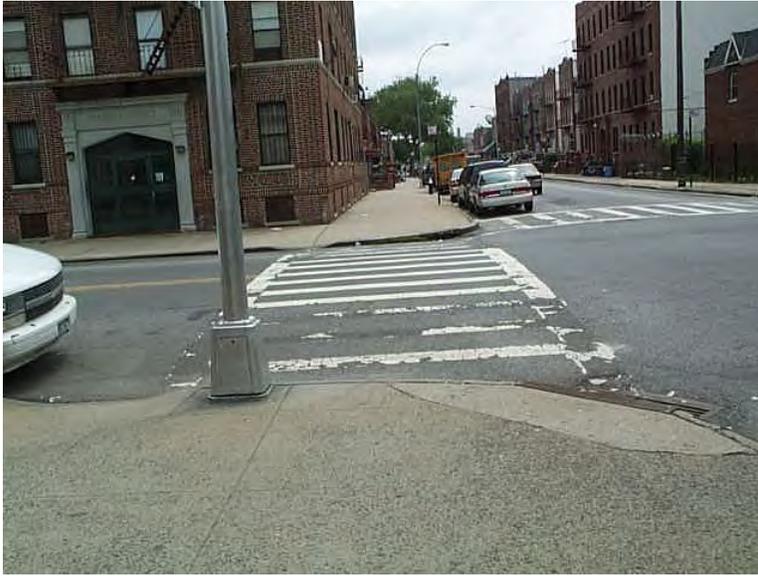
To determine the level of vehicle and pedestrian conflicts, a one-hour turning movement count was performed on Tuesday, May 24, 2005 from 7:30 am to 8:30 am (Exhibit 7A). The results show that 36 pedestrians used the uncontrolled crosswalk, whereas between 34 to 38 pedestrians crossed each of the other three legs during the one-hour count.

A Multi-way or All-way stop was considered to mitigate the uncontrolled crosswalk. However, the moderate vehicle volumes (81 southbound, 88 northbound, 34 westbound) and pedestrian volumes do not meet the required warrants.

Figure 6 - Uncontrolled school crosswalk at the north leg of Willmohr Street and East 94th Street (looking to east)

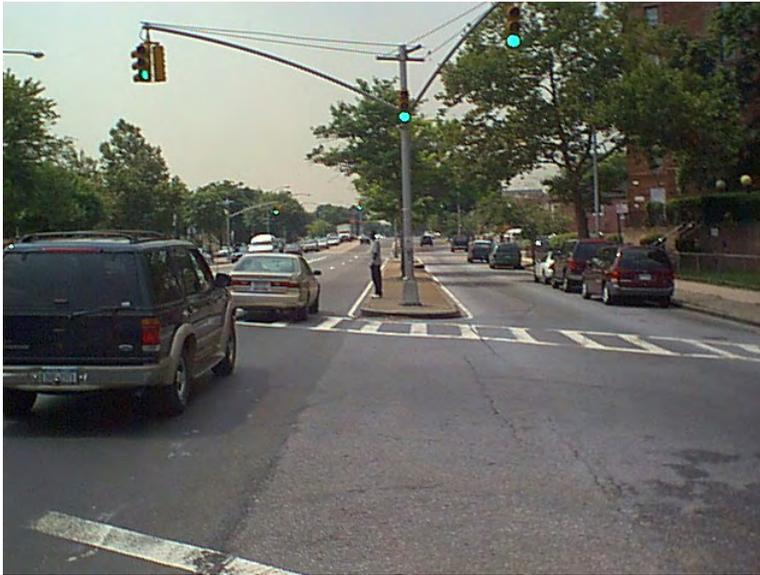
Review of the existing signal timing indicates that a school age pedestrian needs two signal cycles to cross at three feet per second, stopping at the raised medians (refuge) separating Kings Highway and the service road to wait between cycles. However, all the raised medians observed do not extend through the crosswalks (Figure 9).

There were thirty-seven accidents at this intersection in the 1998-2000 study period. Two accidents included pedestrians, one of which involved a school age child. A nine-year-old was crossing against the signal when struck. A driver failing to yield was the cause of the other pedestrian accident.

Figure 7: Kings Highway at East 93rd Street, looking south

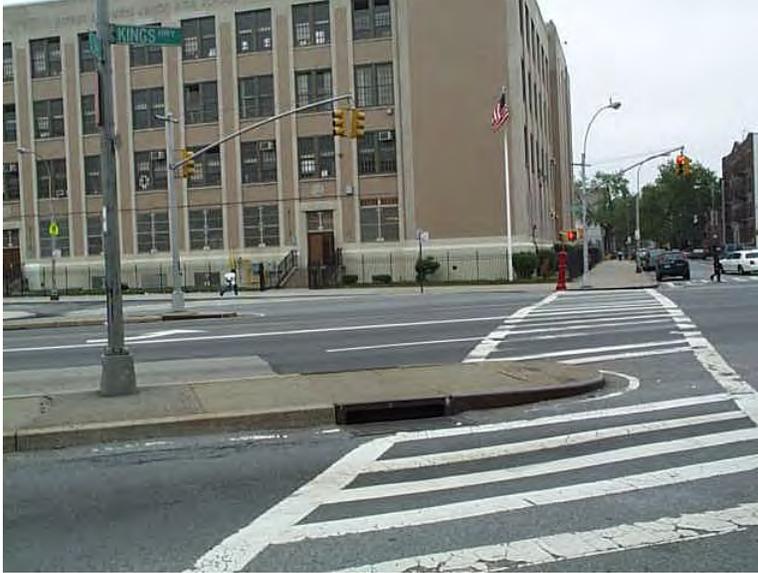
Review of the existing signal timing at this intersection indicates that a school age pedestrian needs two signal cycles to cross at three feet per second, stopping at the raised medians (refuge) separating Kings Highway and the service road to wait between cycles. However, the east median ends 40 feet short of the existing north crosswalk and is not raised at the crossing (Figure 8). The other three raised medians observed do not extend through the crosswalks. In addition, there are bus stops along the mainline which pick-up and drop-off pedestrians on the raised medians.

Figure 8 – Intersection of Kings Highway and East 94 Street, looking to east

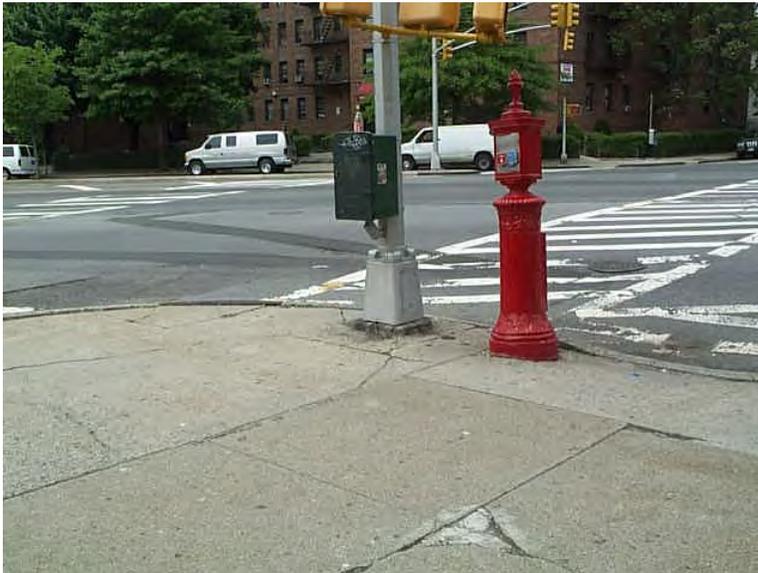
Ramps are not positioned correctly due to conflicts with signal poles or fire alarm boxes (Figure 9). Pedestrian ramps were observed to be missing on the southeast corner of Kings Highway and East 94th Street and the southeast corner of 94th Street and Lenox Road. Two crossing guards assigned to P.S. 219 are stationed at this intersection.

Figure 9 – Northeast corner of Lenox Road and East 94th Street

- Install or replace pedestrian ramps at all crosswalks where required

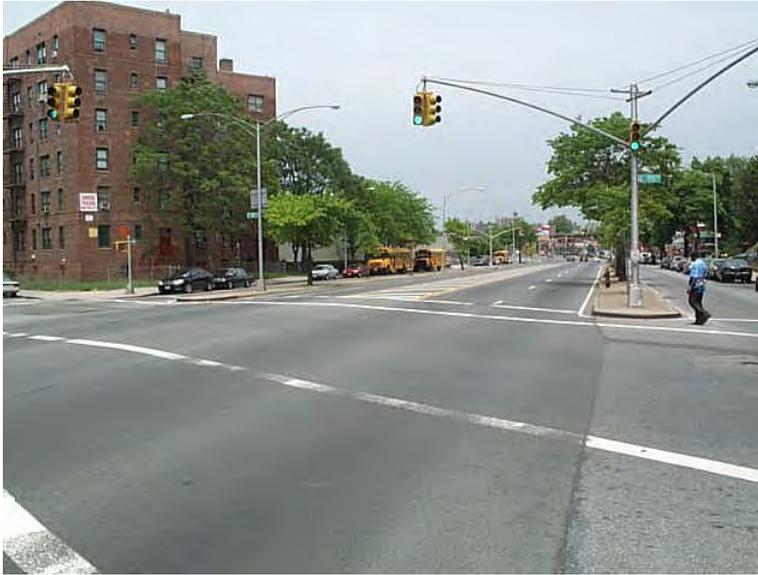
Review of the existing signal timing indicates that a school age pedestrian needs two signal cycles to cross at this location, while stopping at a median to wait between cycles. There are school crosswalks on the east and west legs of the intersection.

Figure 10 –Kings Highway and East 95th Street(looking north)

Thirty accidents occurred between 1998 and 2000. There were five pedestrian accidents, of which three involved school age children.

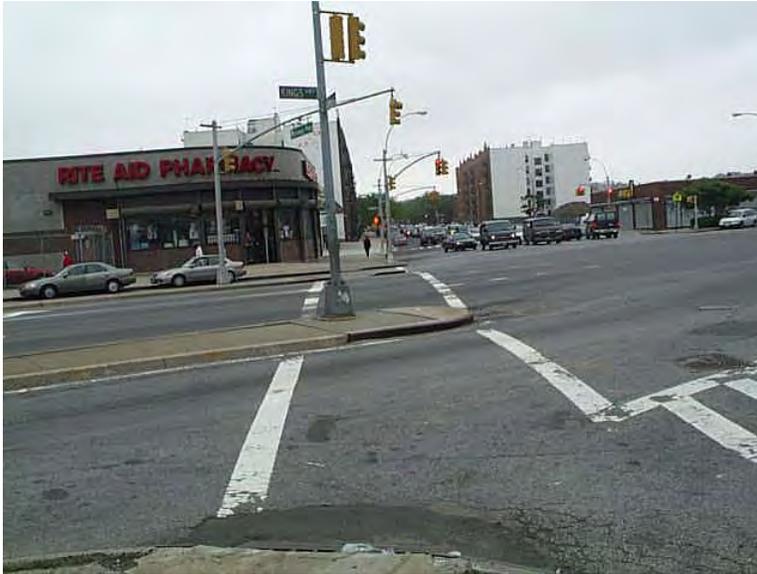
A total of 128 accidents occurred at this intersection in the 1998-2000 study period. There were six pedestrian accidents, one of which was school-related. Two pedestrians

including a seven-year-old, were crossing Kings Highway against the signal when struck. One pedestrian was struck by a vehicle backing up. Two other pedestrians were struck by vehicles making right turns. Details for the sixth pedestrian accident were not reported.

Figure 11– Looking west on the south side of Kings Highway at Rockaway Parkway

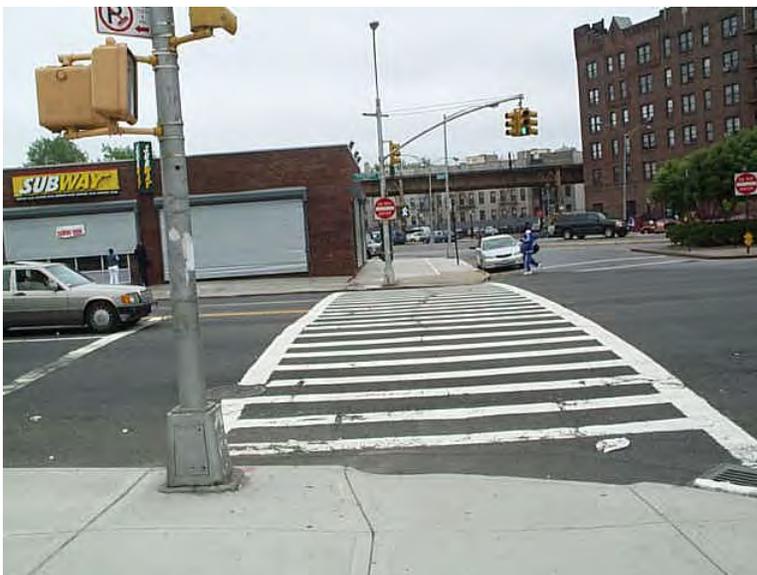
Clarkson Avenue is a 42-foot wide two-way roadway with one travel lane in each direction and parking on both sides. There are school crosswalks on the west and south legs of the intersection (Figure 12).

This signalized intersection had 40 accidents during the 1998-2000 study period. One accident involved a pedestrian, but no school children were involved. A 74-year old pedestrian was crossing Clarkson Avenue against the signal when struck by a southbound vehicle.

Figure 12 – Intersection of Rockaway Parkway and Clarkson Avenue (looking north)

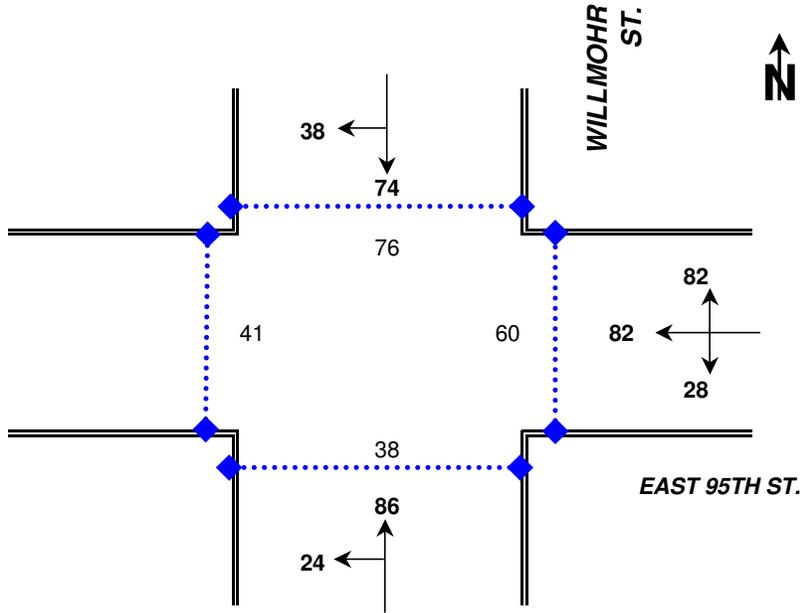
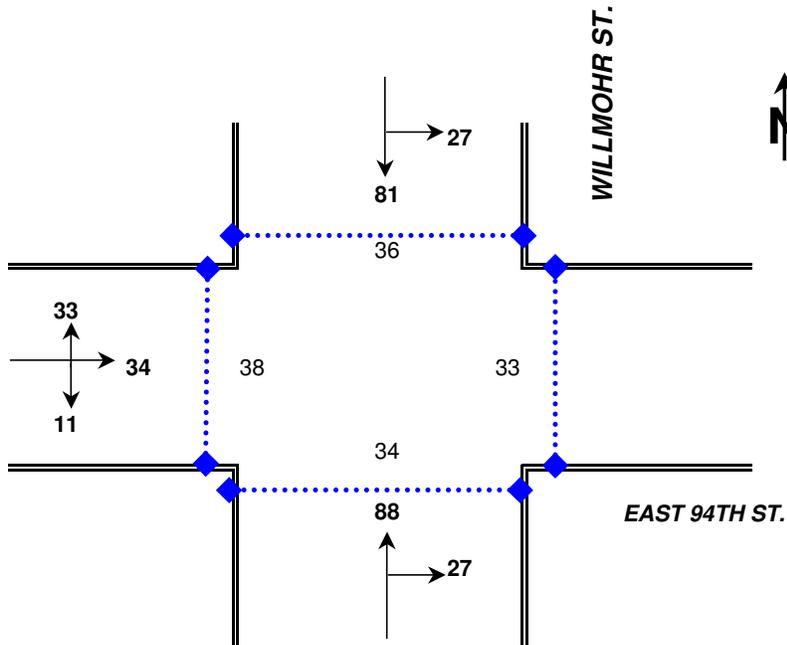
EXHIBIT 7A
I.S 252 , BROOKLYN ARTHUR SOMERS SCHOOL
TURNING MOVEMENT COUNTS

Intersection of E. 95 Street and Willmohr Street
(7:30 AM - 8:30 AM MAY 26, 2005)

Intersection of E. 94 Street and Willmohr Street
(7:30 AM - 8:30 AM MAY 23, 2005)

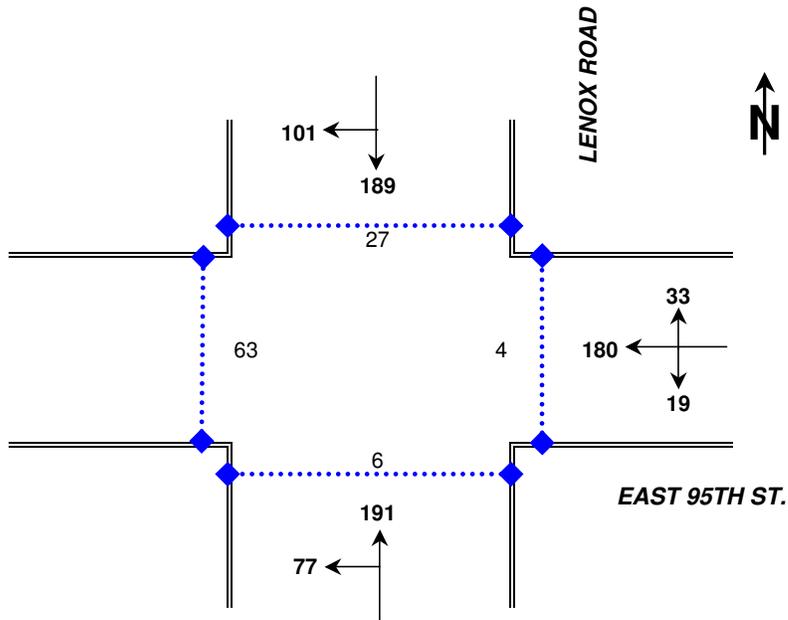
EXHIBIT 7B
I.S 252 , BROOKLYN ARHTUR SOMERS SCHOOL
TURNING MOVEMENT COUNTS

Intersection of E. 95 Street and Lenox Road

A one-hour traffic count was performed at the intersection on Thursday, May 5, 2005 from 7:30 am to 8:30 am (Exhibit 7B). The results indicated that six pedestrians used the uncontrolled school crosswalk at the south leg during the one-hour count. However, 27 pedestrians used the north leg of Lenox Road, where no crosswalk is provided. Therefore, current traffic and pedestrian volumes do not meet the criteria for either signaling the intersection or installing an all-way stop control.

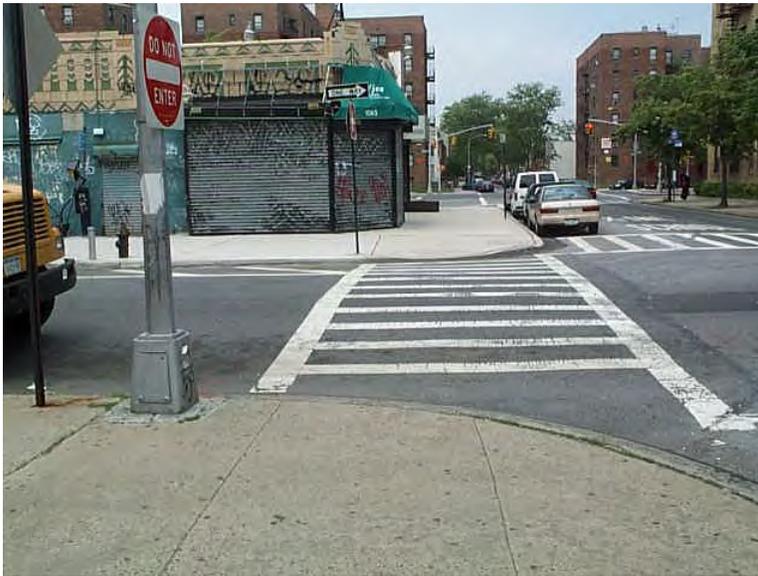
Figure 13 –Lenox Road and East 95th Street.

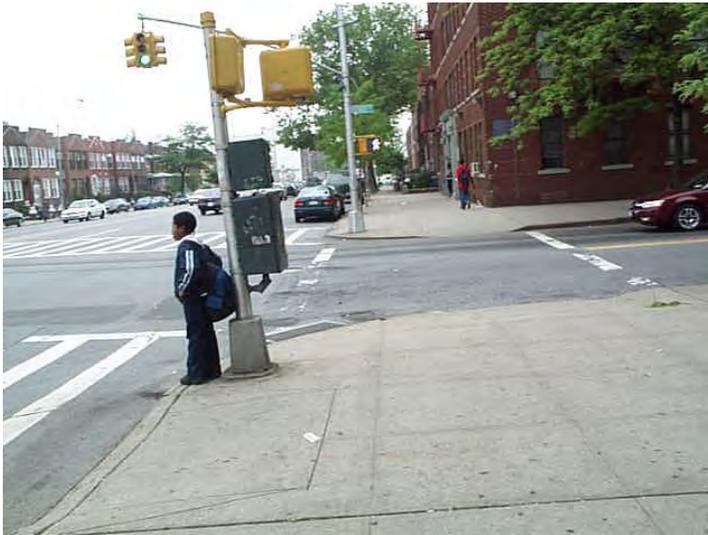
There were 37 accidents during the 1998-2000 study period. Six accidents included pedestrians and four involved school age children. Two of the four accidents involving school age children are classified as school-related accidents because the other two occurred outside of school hours or days.

Two children (8 and 13 year old) were crossing Rockaway Parkway against the signal when struck. Two other children (13 and 15 years old) were struck by turning vehicles failing to yield.

Figure 14 – Pedestrian crosswalk on Rockaway Parkway at Lenox Road

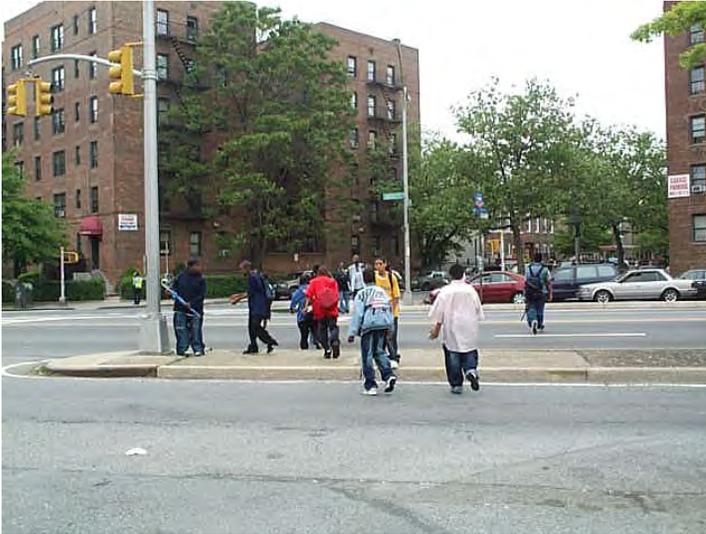
Figure 15 – Students crossing Kings Highway at East 94th Street

It is recommended that the NYCDOT- Safety Education Program work with the school to educate the students on pedestrian safety including crossing the street with the WALK phase, and the meaning of WALK - FLASHING DON'T WALK - DON'T WALK pedestrian signal sequence. It is also recommended that students be educated to utilize raised medians on Kings Highway while waiting for the next signal cycle.

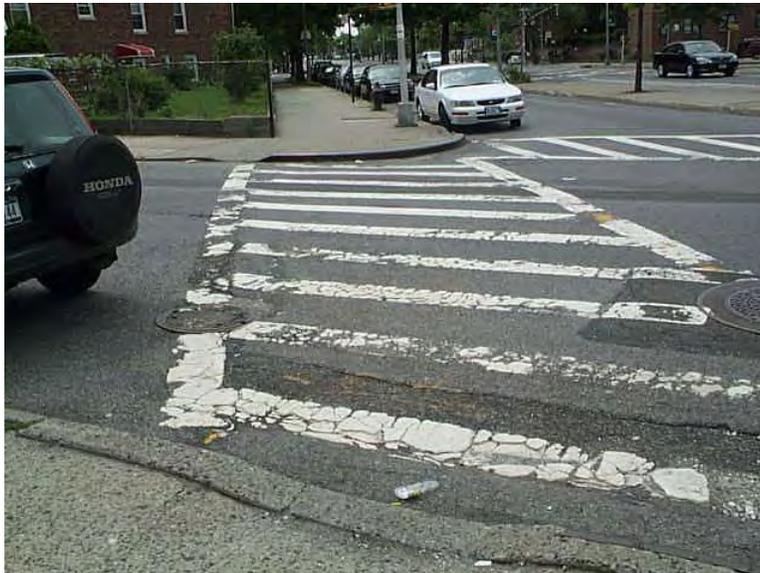
Figure 16 – Existing east school crosswalk at East 94th Street at Kings Highway

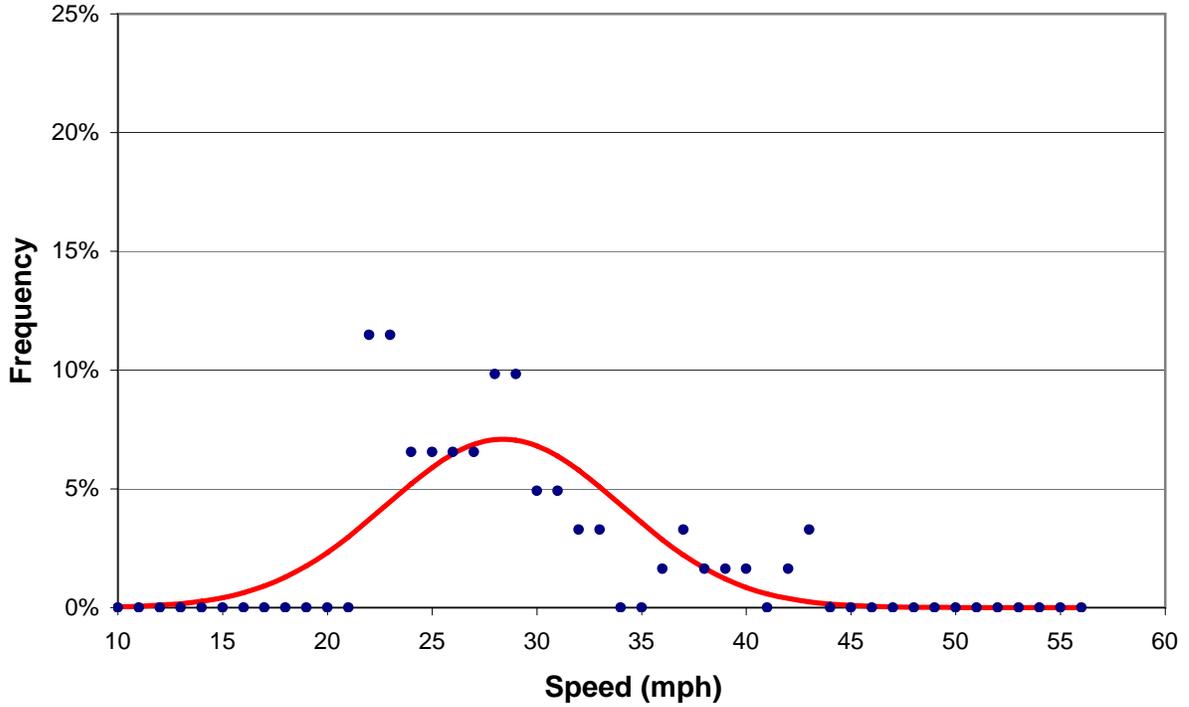
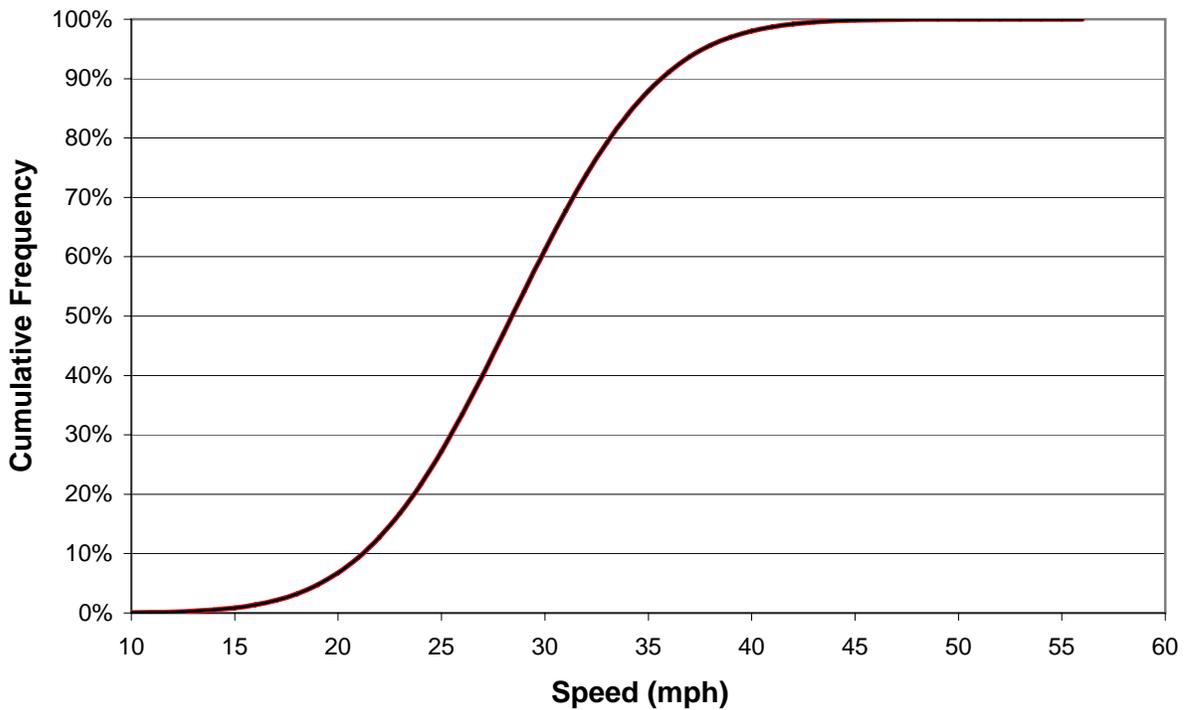
Mean Speed = 28.4 mph
Standard Deviation = 5.6 mph
Margin of Error (95% Confidence) = ± 1.4 mph

Median Speed = 28.4 mph
15th Percentile Speed = 22.6 mph
85th Percentile Speed = 34.2 mph
