**New York City Department of Transportation
Office of School Safety Engineering**

School Safety Engineering Project

FINAL REPORT: P.S. 155, Nicholas Herkimer School, Brooklyn

**Prepared by
The RBA Group/Urbitrans Associates**

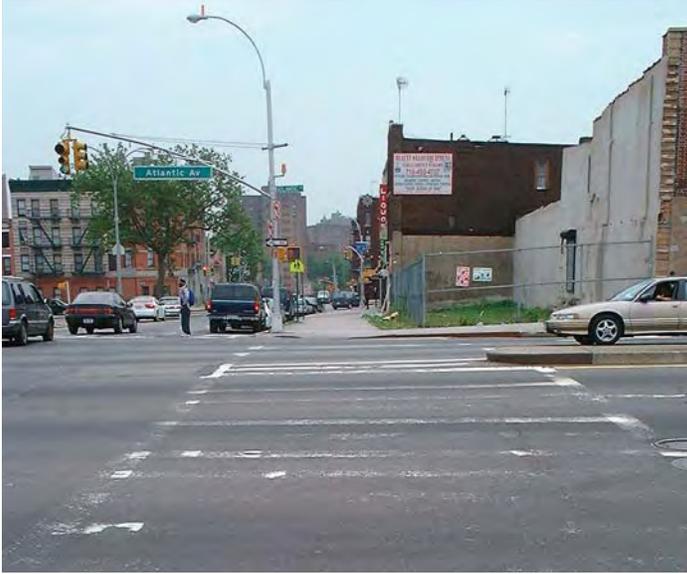
Figure 1: Looking south on Eastern Parkway at Atlantic Avenue

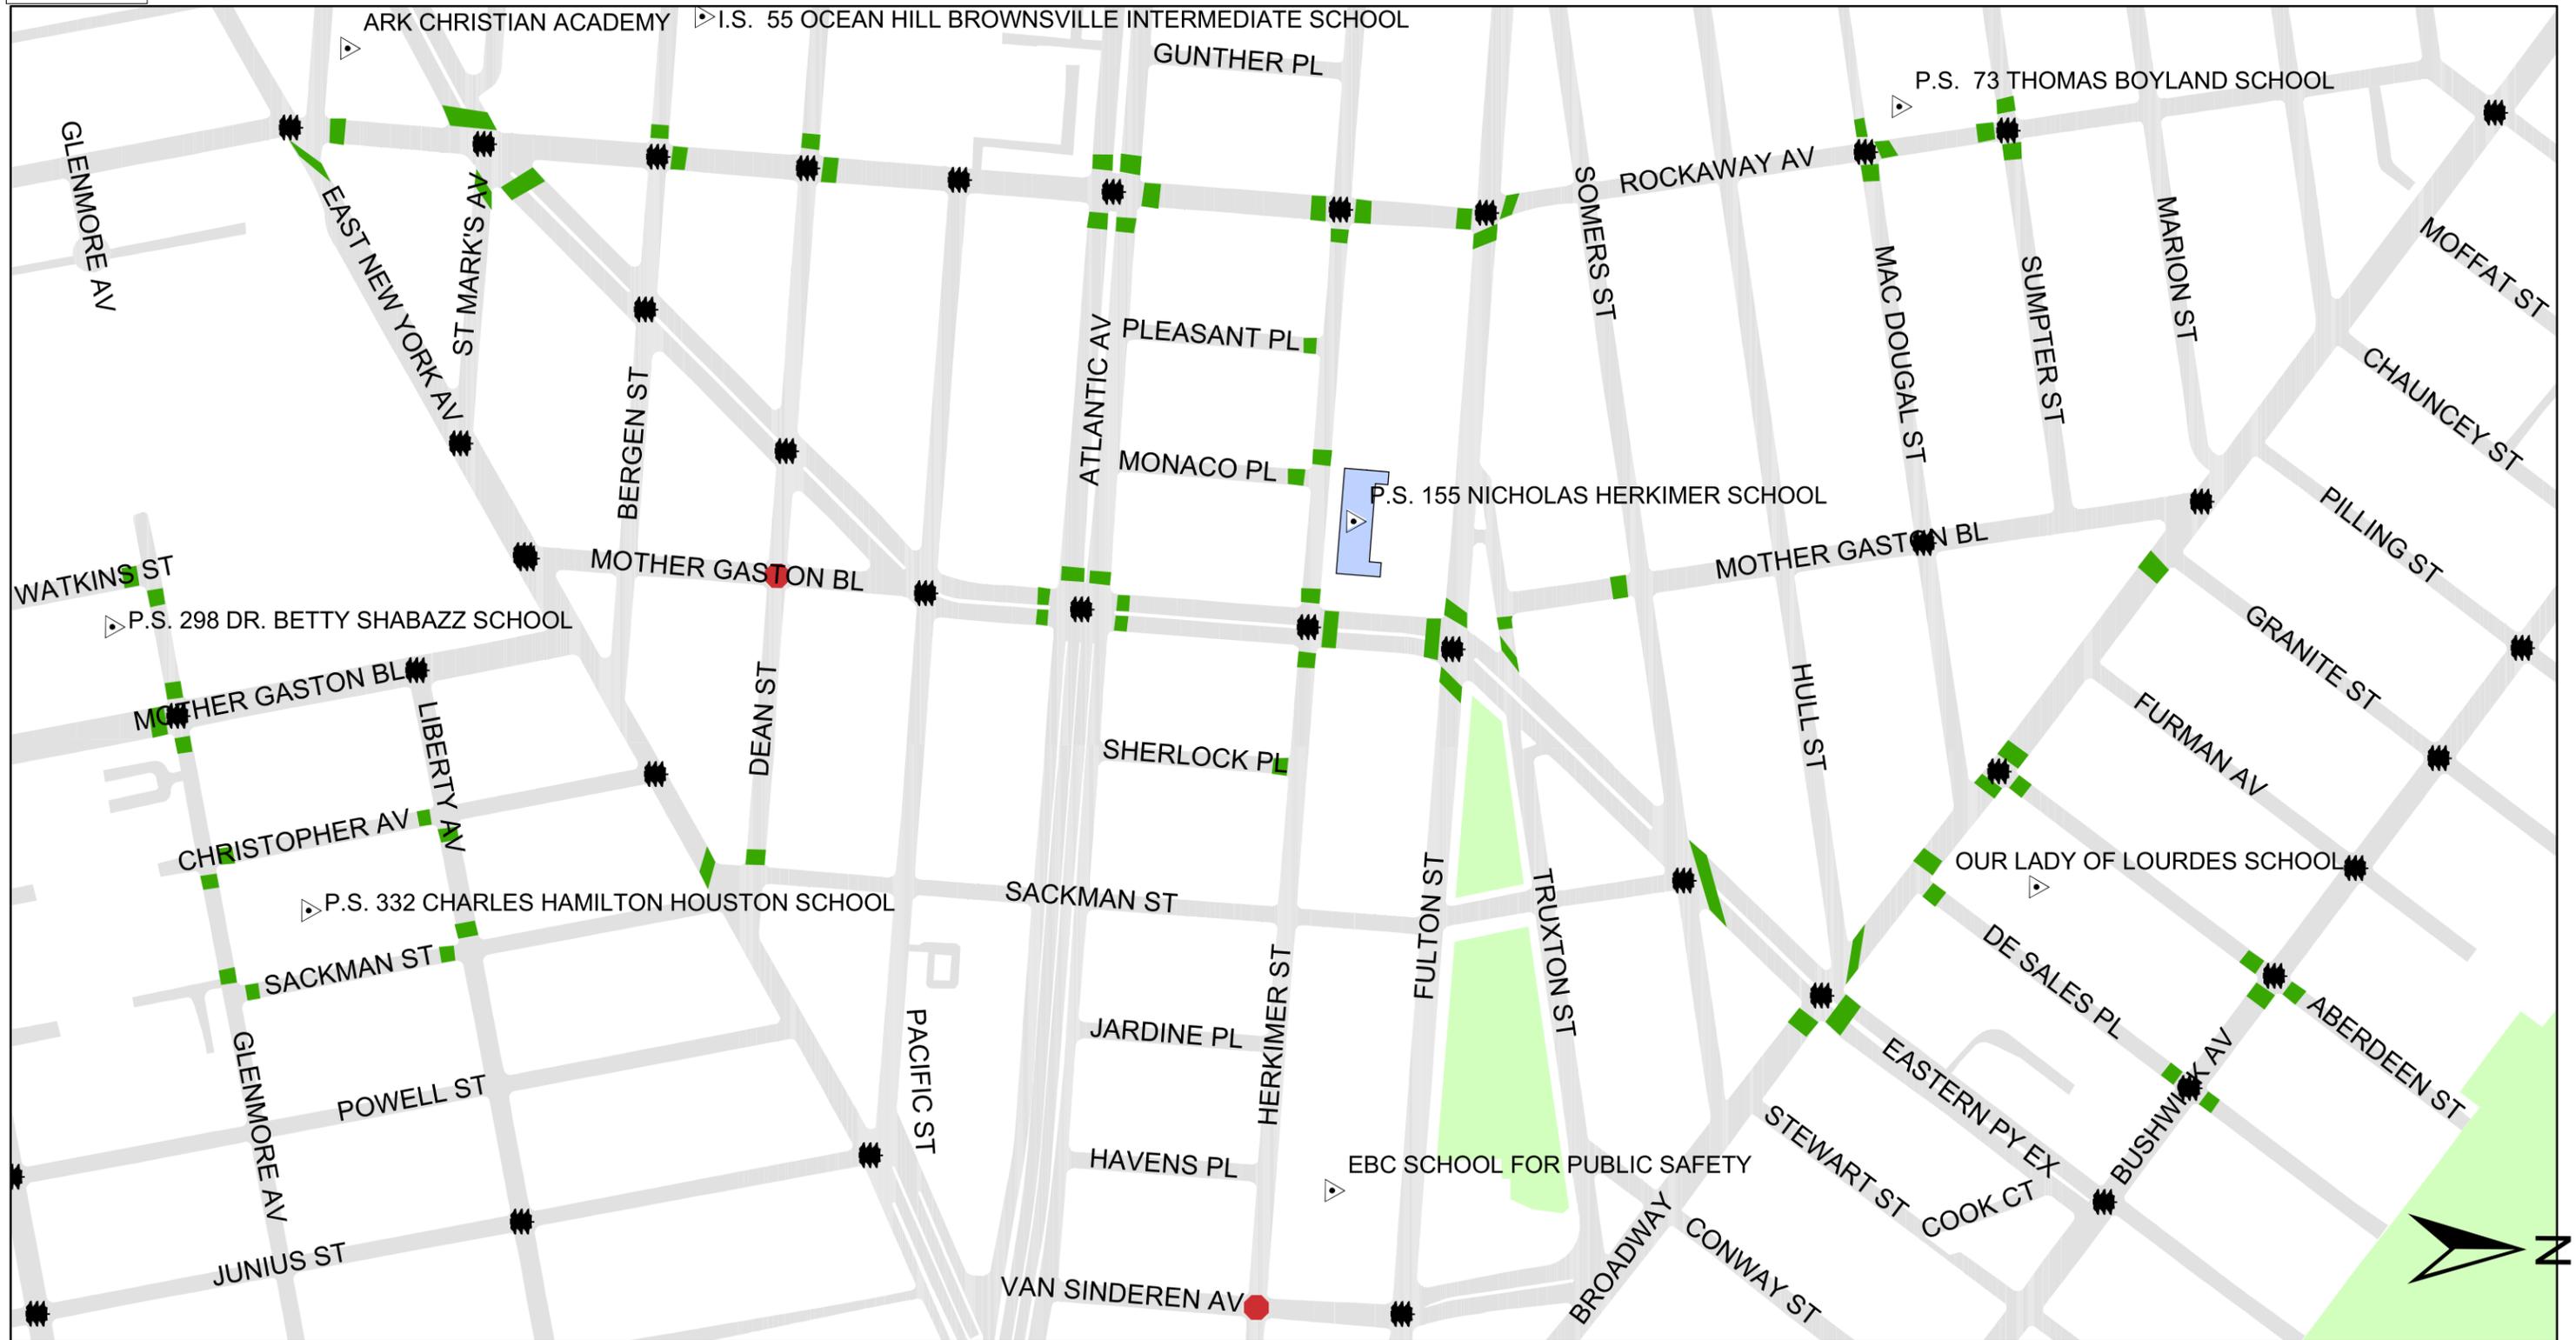
EXHIBIT 3

The School Traffic Safety Map was established to help provide the maximum degree of safety for children going to and from school - by indicating the location of speed reducers, school crosswalks and some traffic control devices. (While virtually all intersections in NYC benefit from traffic control devices - such as stop signs, traffic signals, yield signs, and all way stop signs - this map shows only traffic signals and all way stop signs.) The school crosswalks that are shown are ladder striped and make the crosswalk more visible to drivers and help make the intersection safer. These crosswalks are where school children are recommended to cross.

The Traffic Safety Map, Exhibit 3, shows existing crosswalk pavement markings. It is noted that a citywide signage program is currently underway to upgrade school signage to current Federal Manual of Uniform Traffic Control Devices (MUTCD) standards of fluorescent yellow-green signs accompanied by downward pointing arrows. Signs scheduled to be installed under this program are shown as “existing” on Exhibit 8.

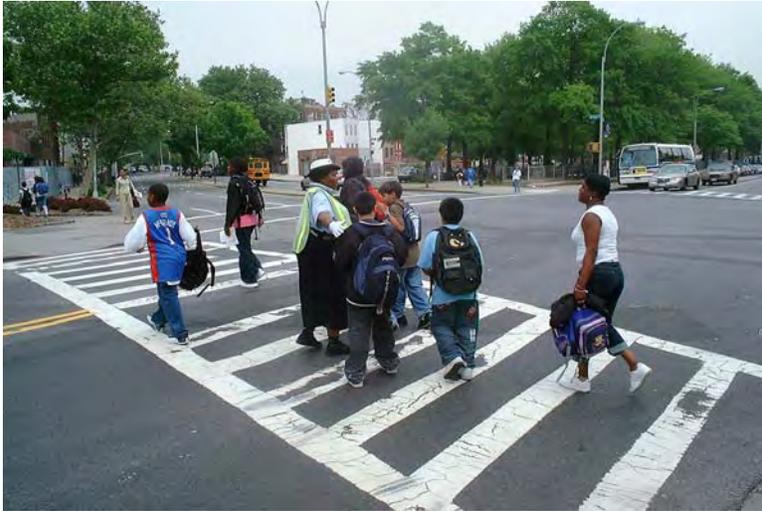
Figure 2: Looking north on Eastern Parkway at the intersection of Fulton Street adjacent to P.S. 155 during dismissal

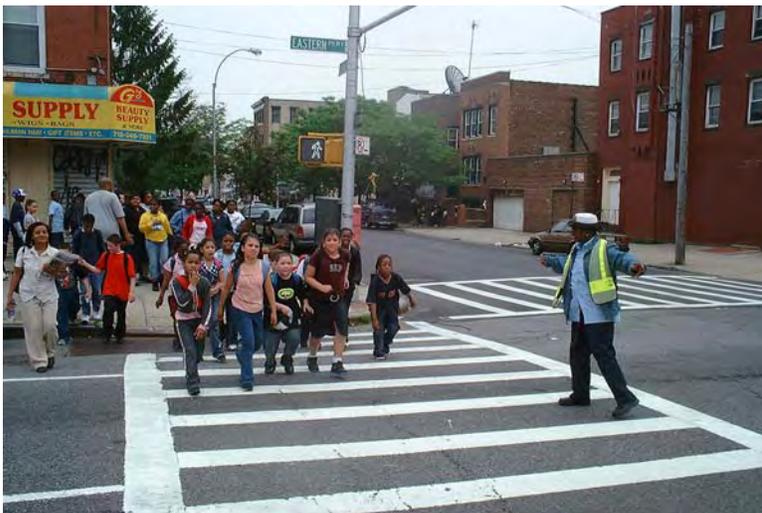
Figure 3: Looking east on Herkimer Street at the intersection of Eastern Parkway

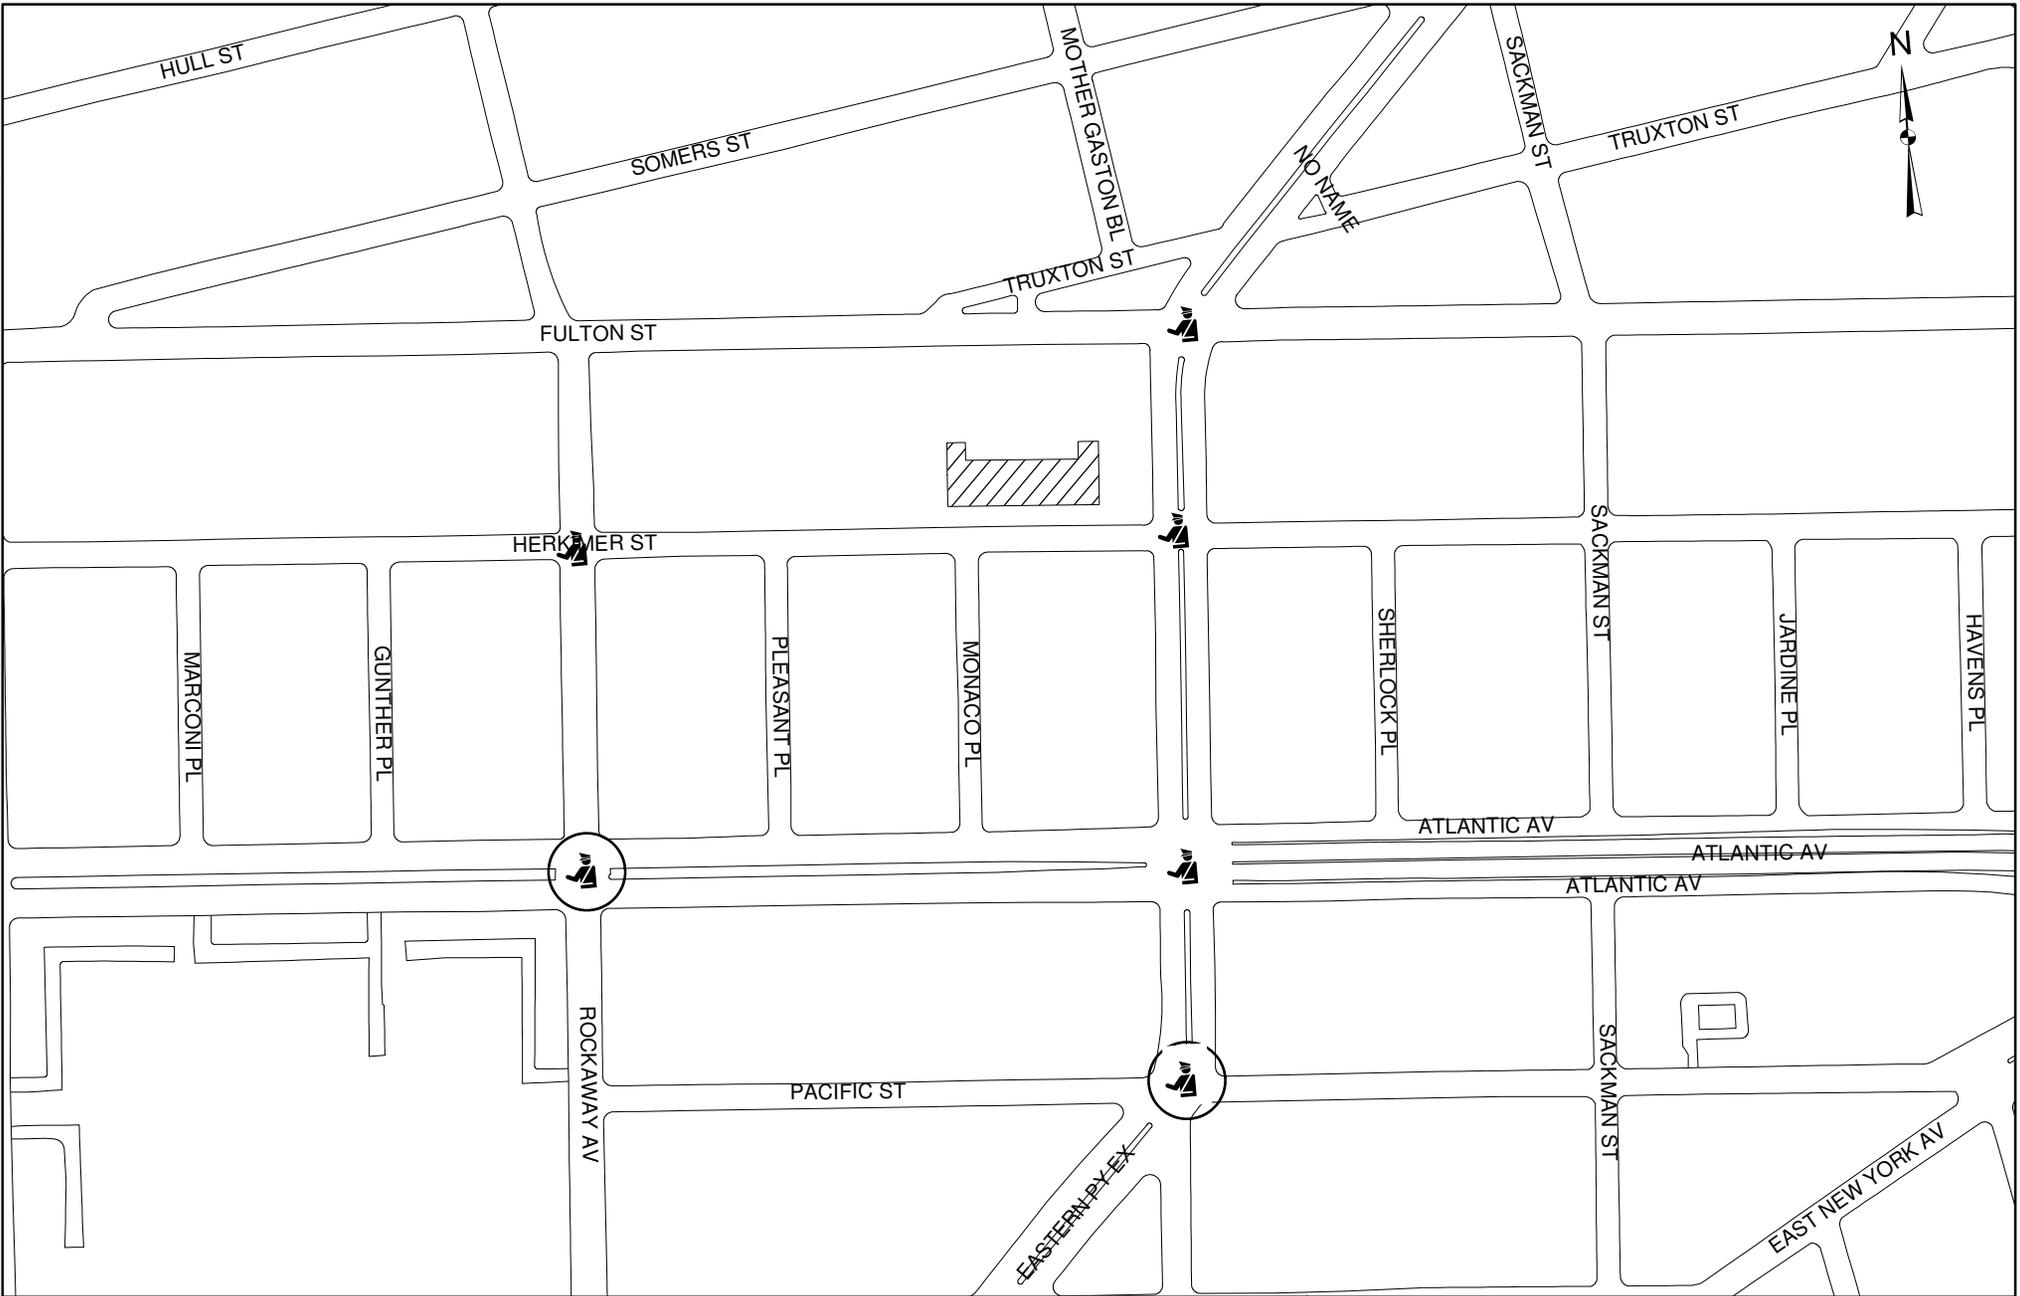
EXHIBIT 4

Crossing guards are also located at the intersection of Atlantic Avenue and Rockaway Avenue, and at Eastern Parkway and Pacific Street, although these intersections are assigned to other schools in the area (see Exhibit 4 for detail).

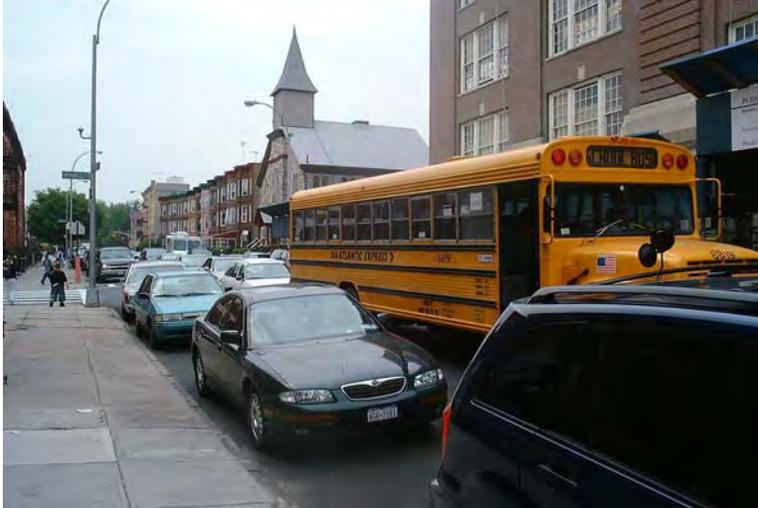
According to school officials, 3% of students from P.S. 155 are transported to and from school by school bus. School representatives noted that four school buses drop off and pick up students in front of the school entrance on Herkimer Street. Field observations indicated that due to current parking regulations, school buses must double park on Herkimer Street while loading and unloading students.

Figure 4: School buses on Herkimer Street in front of P.S. 155

“NO STANDING SCHOOL DAYS 7AM-4PM” signs should be installed on Herkimer Street from the west end of the school to the intersection of Herkimer Street and Eastern Parkway. This zone will keep the entrance of the school clear, to provide better visibility between students and vehicles as well as providing an area for buses to unload and load students.

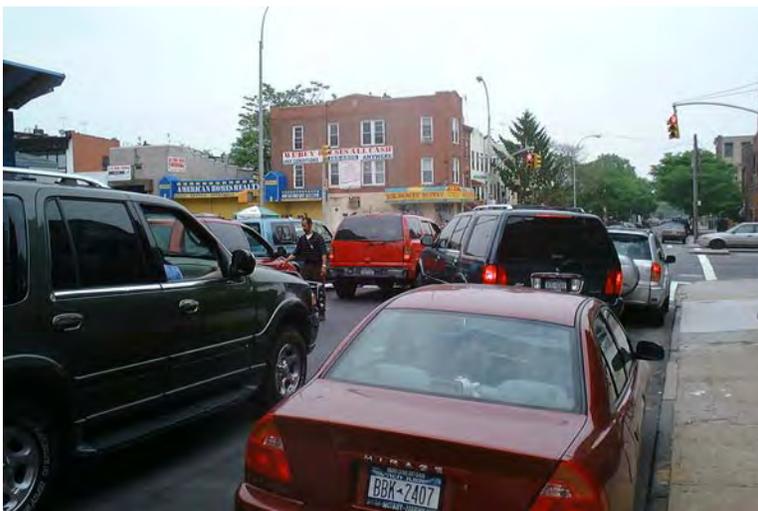
According to the survey provided by the school representatives, 2% of students from P.S. 155 are driven to and from school by parents or guardians. Vehicles double park during arrival and dismissal time, which results in congestion on Herkimer Street.

Figure 5: Vehicles double parked on Herkimer Street during afternoon dismissal time

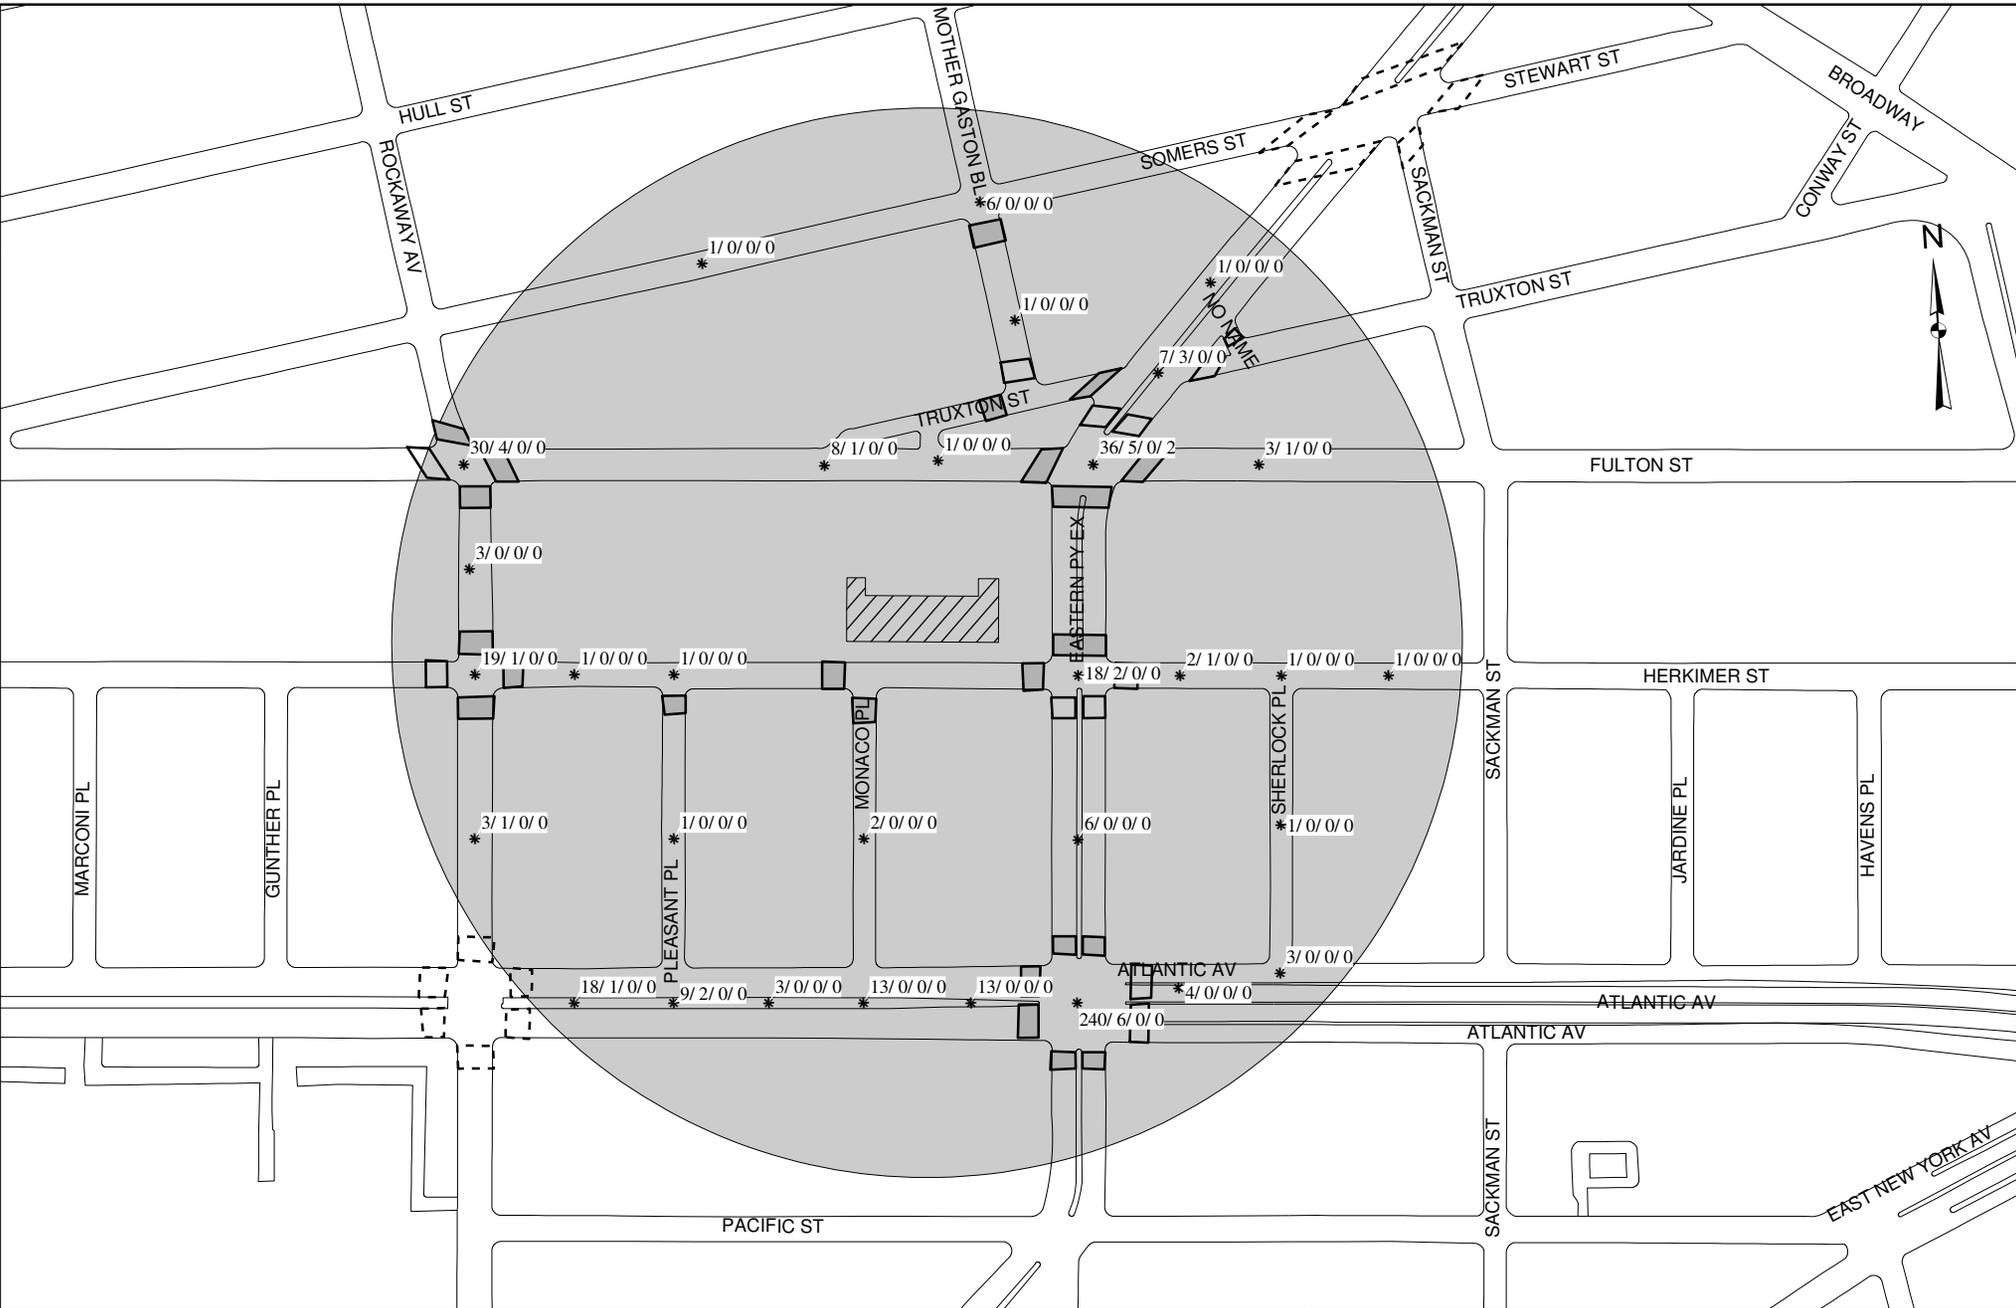
EXHIBIT 6
P.S. 155, BROOKLYN
NICHOLAS HERKIMER SCHOOL

Exhibit 6 and Table 2 show a summary of accidents, as obtained from the New York State Department of Motor Vehicles (DMV), in the vicinity of P.S. 155 for the three-year period from January 1, 1998 through December 31, 2000. The DMV data provides some detail relating to the circumstances and cause of the accidents. Table 3 is a summary of more recent accident data obtained from the NYC Police Department (NYPD). Though current through 2004, the NYPD data does not provide the same level of detail as the DMV data.

ACCIDENT SUMMARY
THREE YEAR PERIOD
(1998-2000)

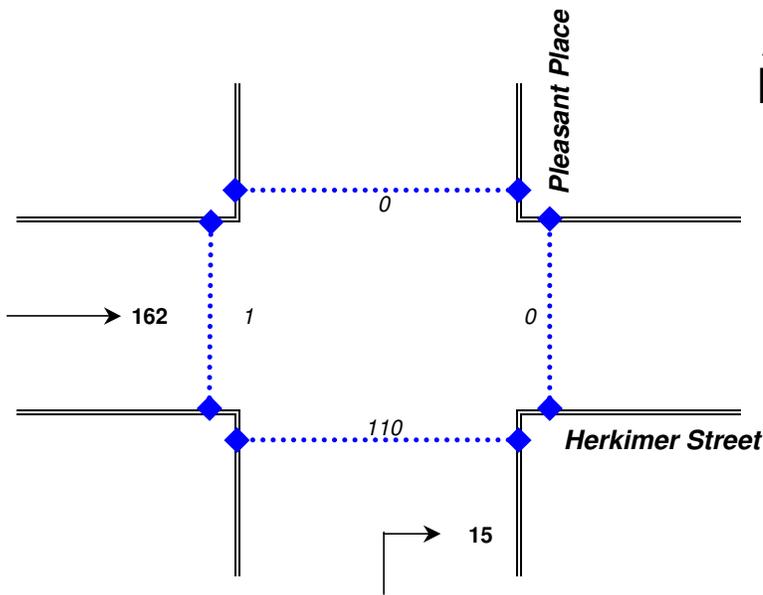
Intersection of Herkimer Street and Pleasant Place
(7:30 AM - 8:30 AM June 6, 2005)

Traffic counts were conducted at this intersection on Monday June 6, 2005. The counts show that the school crosswalk, on the south leg, was utilized by 110 pedestrians. Only 15 vehicles used Pleasant Place during the study hour (see Exhibit 7).

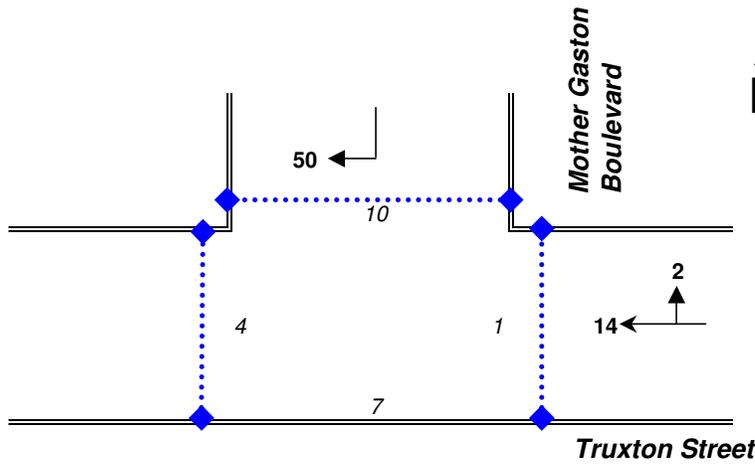
Intersection of Mother Gaston Boulevard and Truxton Street
(7:30 AM - 8:30 AM June 9, 2005)

The accident data for the 1998-2000 study period was not available. Traffic counts taken on Thursday June 9, 2005 indicated that very few pedestrians and vehicles used this intersection (see Exhibit 7).

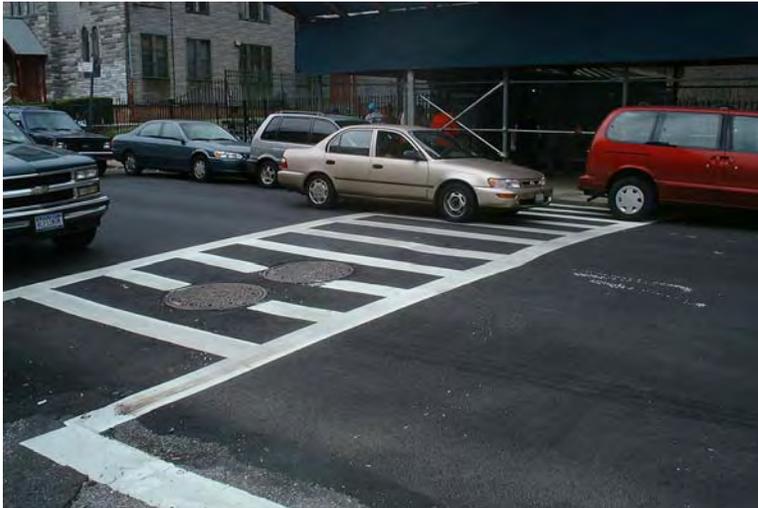
Monaco Place, like Pleasant Place, is a one block long 30-foot wide, one way (northbound) local street that connects Atlantic Avenue to Herkimer Street. The roadway has one travel lane and parking on both sides. This intersection is stop controlled with a stop sign on Monaco Place. There is a school crosswalk on the south leg crossing Monaco Place, and an uncontrolled school crosswalk on the west leg crossing Herkimer Street. School representatives noted that private vehicles use this area heavily during arrival and dismissal time while cars are often parked within the crosswalk (Figure 6).

Figure 6: Looking north across Herkimer Street from Monaco Place

- Southeast corner of Monaco Place and Herkimer Street

The intersection of Monaco Place and Herkimer Street has school crosswalks on the west, and south legs. The west leg, which serves as a primary school crosswalk for students en route to P.S. 155 is uncontrolled. Traffic volumes on Herkimer Street are relatively low; however students use this intersection en route to P.S. 155. Therefore it is recommended that a crossing guard be assigned to this intersection to assist students crossing Herkimer Street.

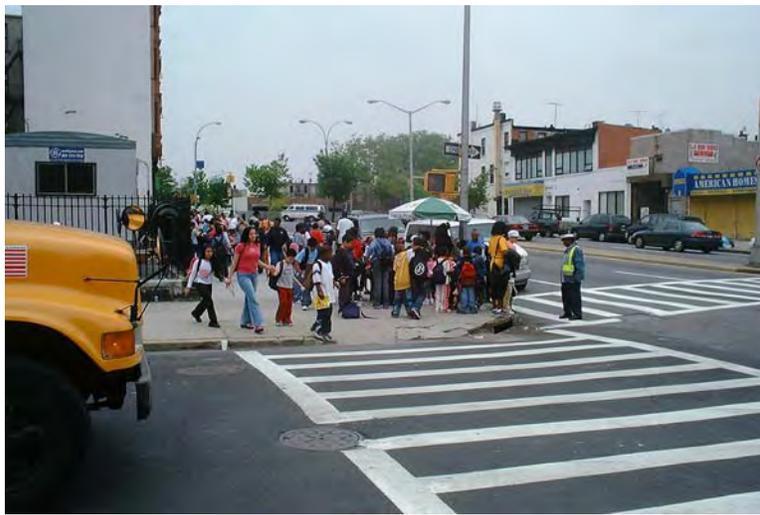
Eastern Parkway is a two-way arterial with four travel lanes and parking on both sides. Northbound and southbound traffic are separated by a six-foot wide raised median. This is a signalized intersection with school crosswalks on the north, east and west legs of the intersection. School officials noted that heavy vehicular traffic and speeding on Eastern Parkway create dangerous conditions for children crossing this intersection. As indicated in Section 2.8, a crossing guard is assigned to this intersection to assist the students.

There were 18 accidents at this location during the 1998-2000 study period. Two accidents involved pedestrians. None were school-related. Both pedestrians were struck by northbound vehicles while crossing Eastern Parkway against the signal.

Figure 7: Looking north on Eastern Parkway at Herkimer Street

- East and west side of Eastern Parkway at Herkimer Street
- North and south side of Atlantic Avenue at Eastern Parkway

- Eastern Parkway and Atlantic Avenue – northwest corner
- Eastern Parkway and Herkimer Street – northwest corner
- Rockaway Avenue and Herkimer Street – northeast corner

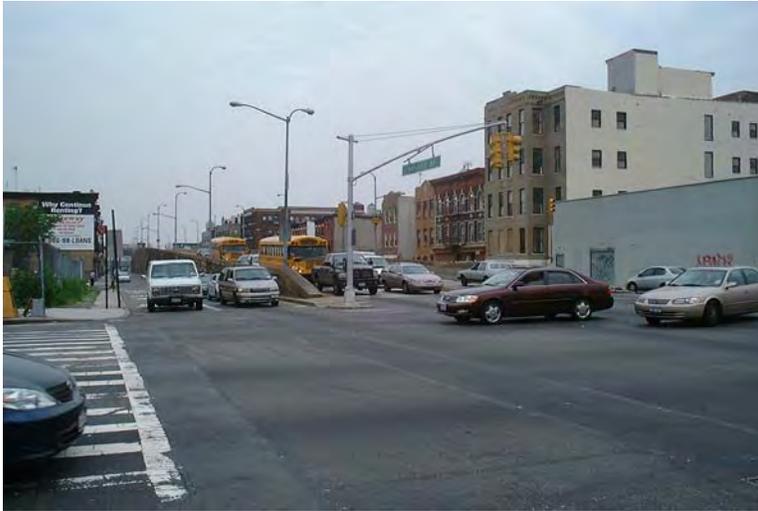
The intersection of Eastern Parkway and Atlantic Avenue is a heavily utilized signalized intersection. Atlantic Avenue is a two-way arterial with six travel lanes and parking on both sides. There is a dedicated right turn lane for westbound vehicles turning north onto Eastern Parkway. There are school crosswalks on all legs of this intersection except the east leg across Atlantic Avenue. School officials indicated that both roadways are very wide for the children to cross. However, signal timing analysis confirms that there is sufficient time for students to cross the street (see Section 3.7).

There were 240 accidents at this location during the 1998-2000 study period. Six of these accidents involved pedestrians; none of them were school-related. Three pedestrians were crossing with the signal when struck by vehicles failing to yield; two of the vehicles were making right turns onto Eastern Parkway and the other was traveling southbound on Eastern Parkway. Another two accidents involved pedestrians crossing against the signal. The sixth accident was a pedestrian walking along Eastern Parkway; the driver was traveling north at excessive speed.

Figure 8: Looking east on Atlantic Avenue at the intersection of Eastern Parkway

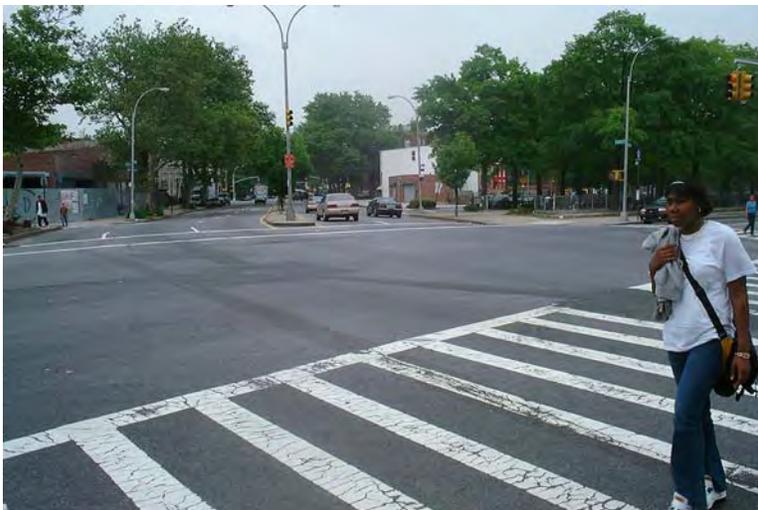
The intersection of Fulton Street and Eastern Parkway is signalized and has school crosswalks on all legs except for the north leg. The raised medians on Eastern Parkway do not extend through the crosswalk.

The accident data indicate that 36 accidents occurred at this intersection during the 1998-2000 study period. Five accidents involved pedestrians, of which two were school-related. Three of the accidents occurred because pedestrians crossed the street against the signal. One accident was due to driver inattention while making a left turn onto Eastern Parkway. No information was available regarding the fifth accident.

Figure 9: Looking north on Eastern Parkway at Fulton Street

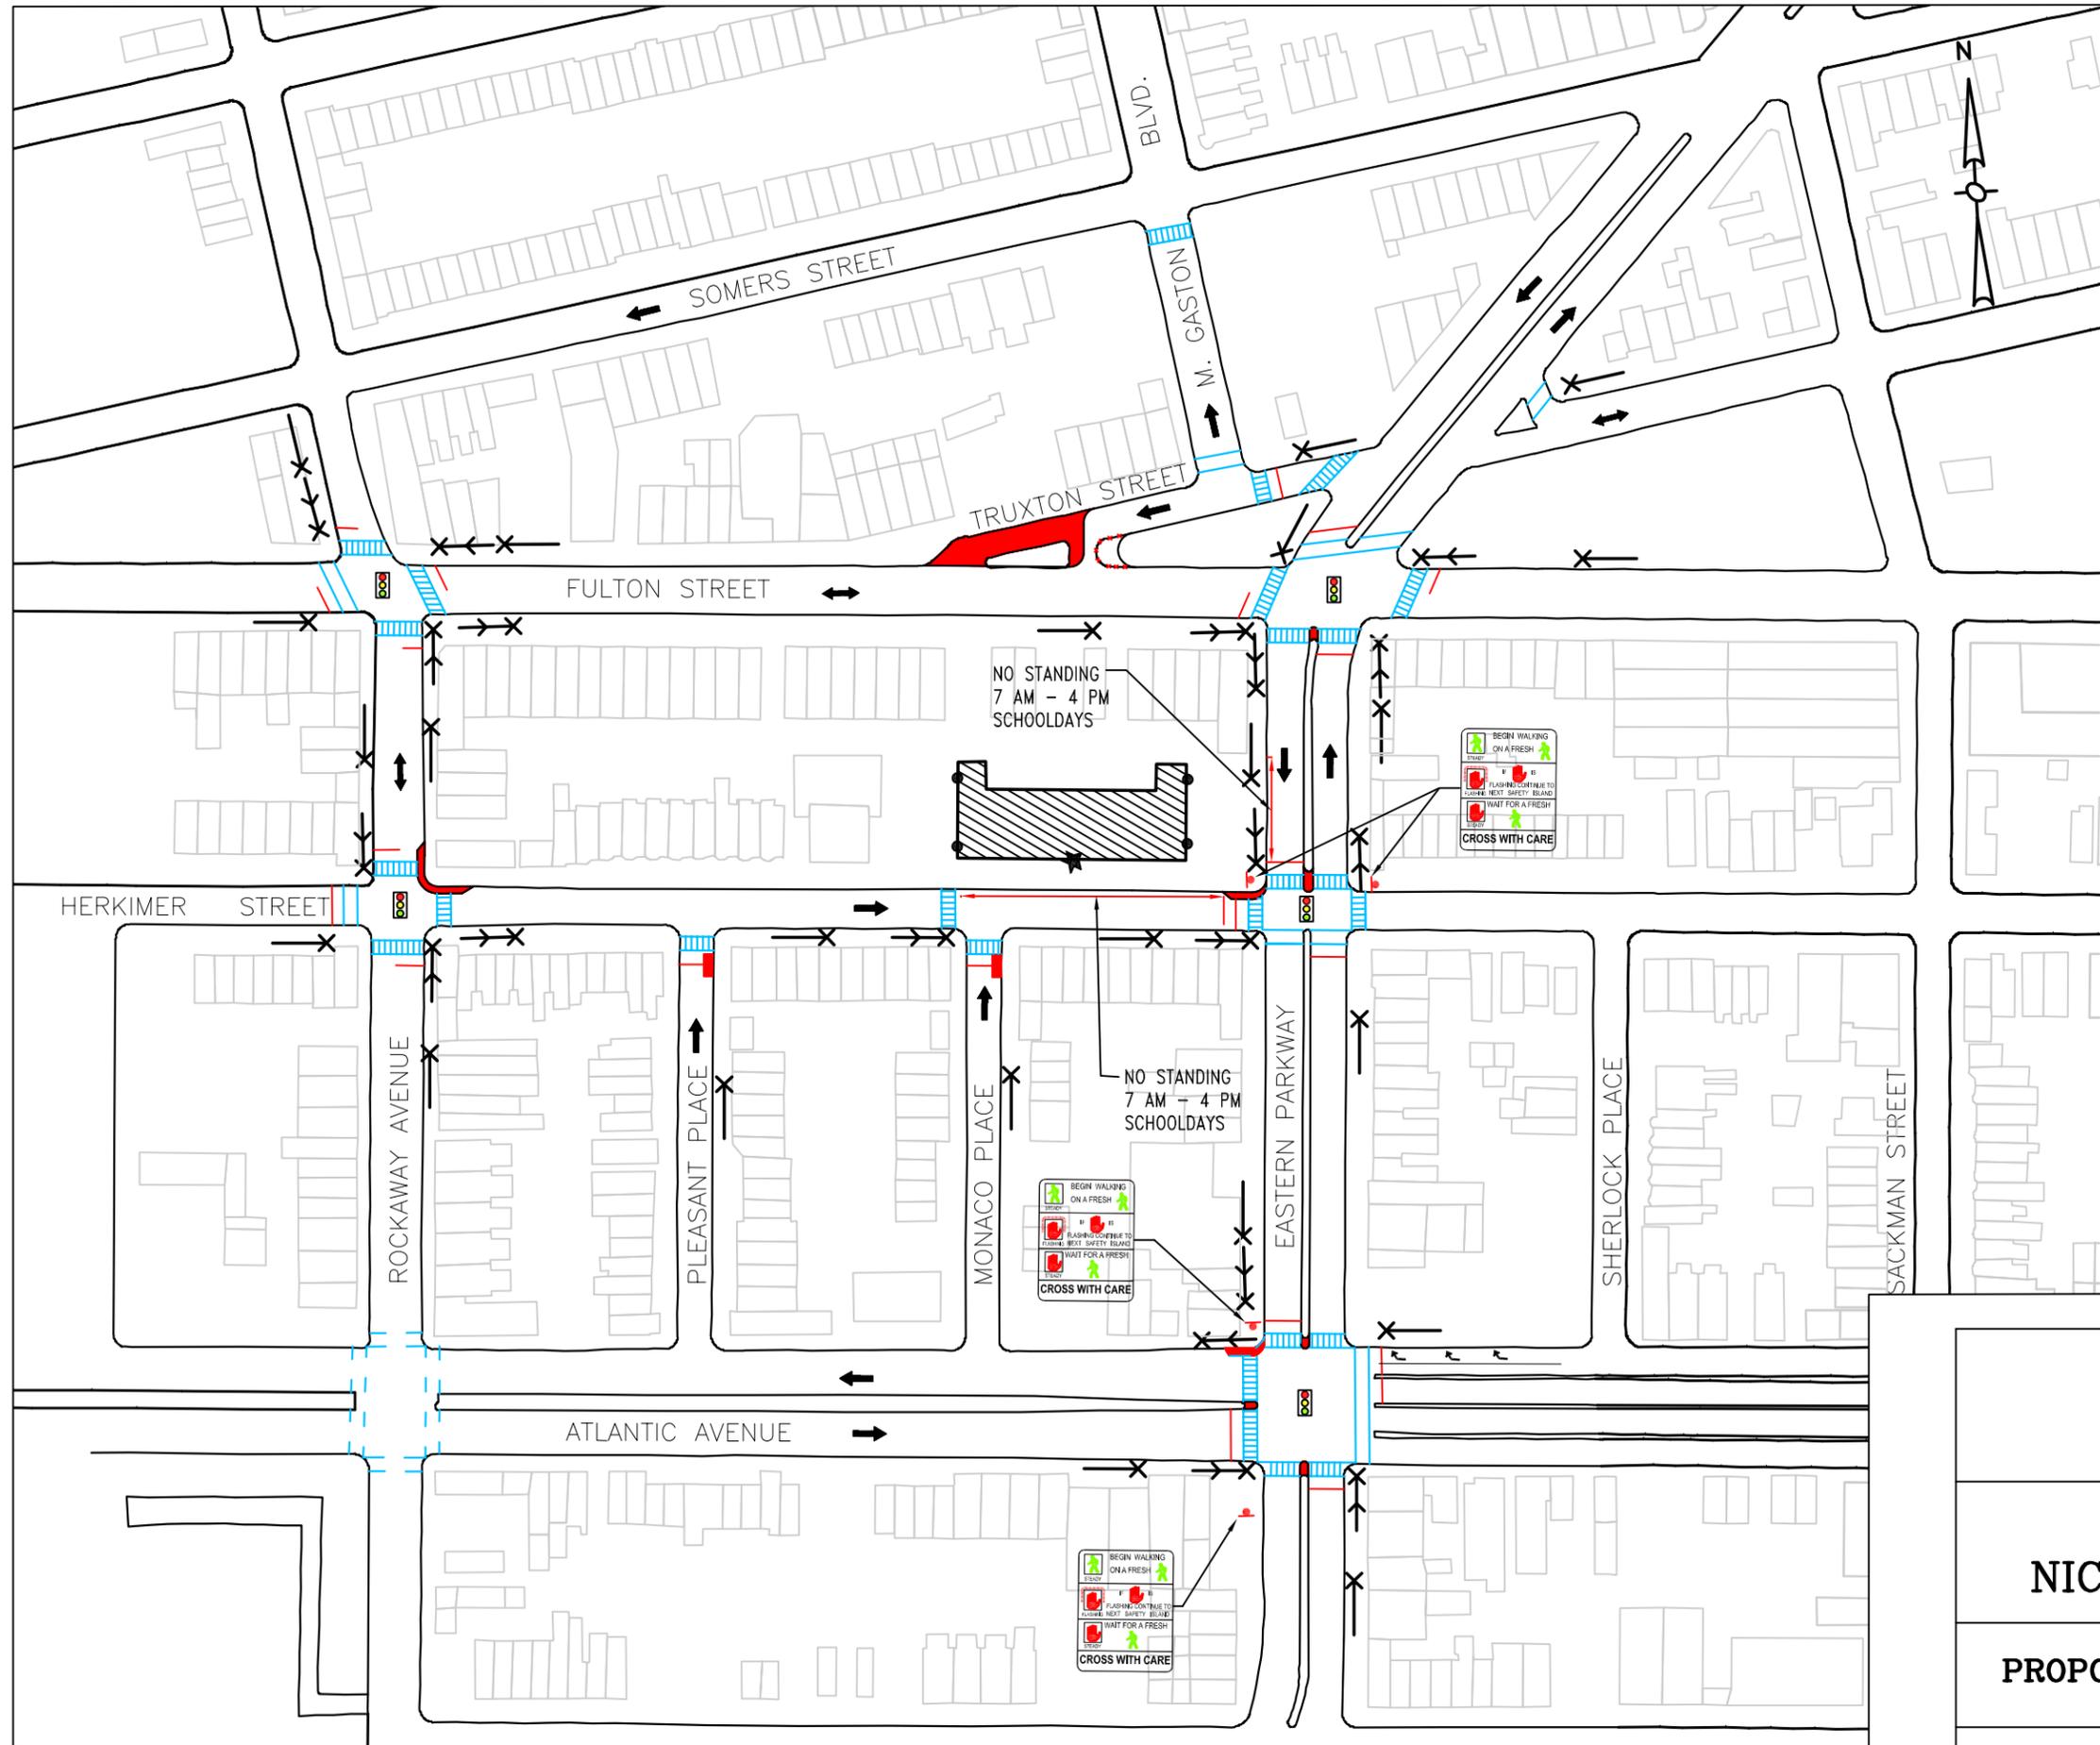
PROPOSED MEASURES TO IMPROVE SAFETY

Curb extensions should be considered at the corners as shown in Exhibit 8.

To minimize driver and pedestrian conflicts, it is recommended that the slip lane at the intersection of Truxton Street and Fulton Street is eliminated. This reduces the number of pedestrian crosswalks and therefore the number of times student pedestrian comes in conflict with a turning vehicles. The re-aligned intersection forms a T-intersection.
