**New York City Department of Transportation
Office of School Safety Engineering**

School Safety Engineering Project

FINAL REPORT: P. S. 5 (Ronald E. McNair School), Brooklyn

**Prepared by
The RBA Group/Urbitran Associates**

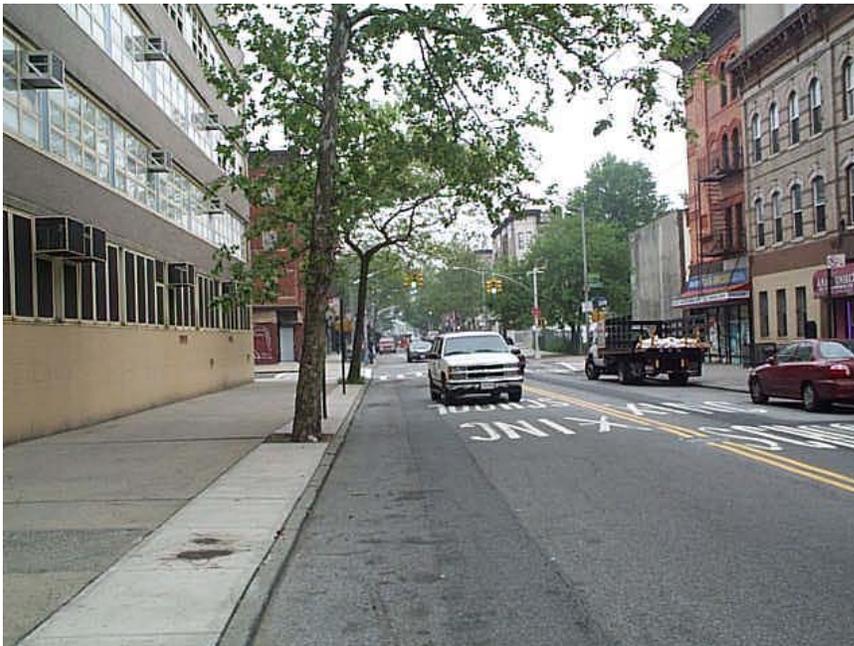
Figure 1: From Hancock Street, looking south on Ralph Avenue, Brooklyn

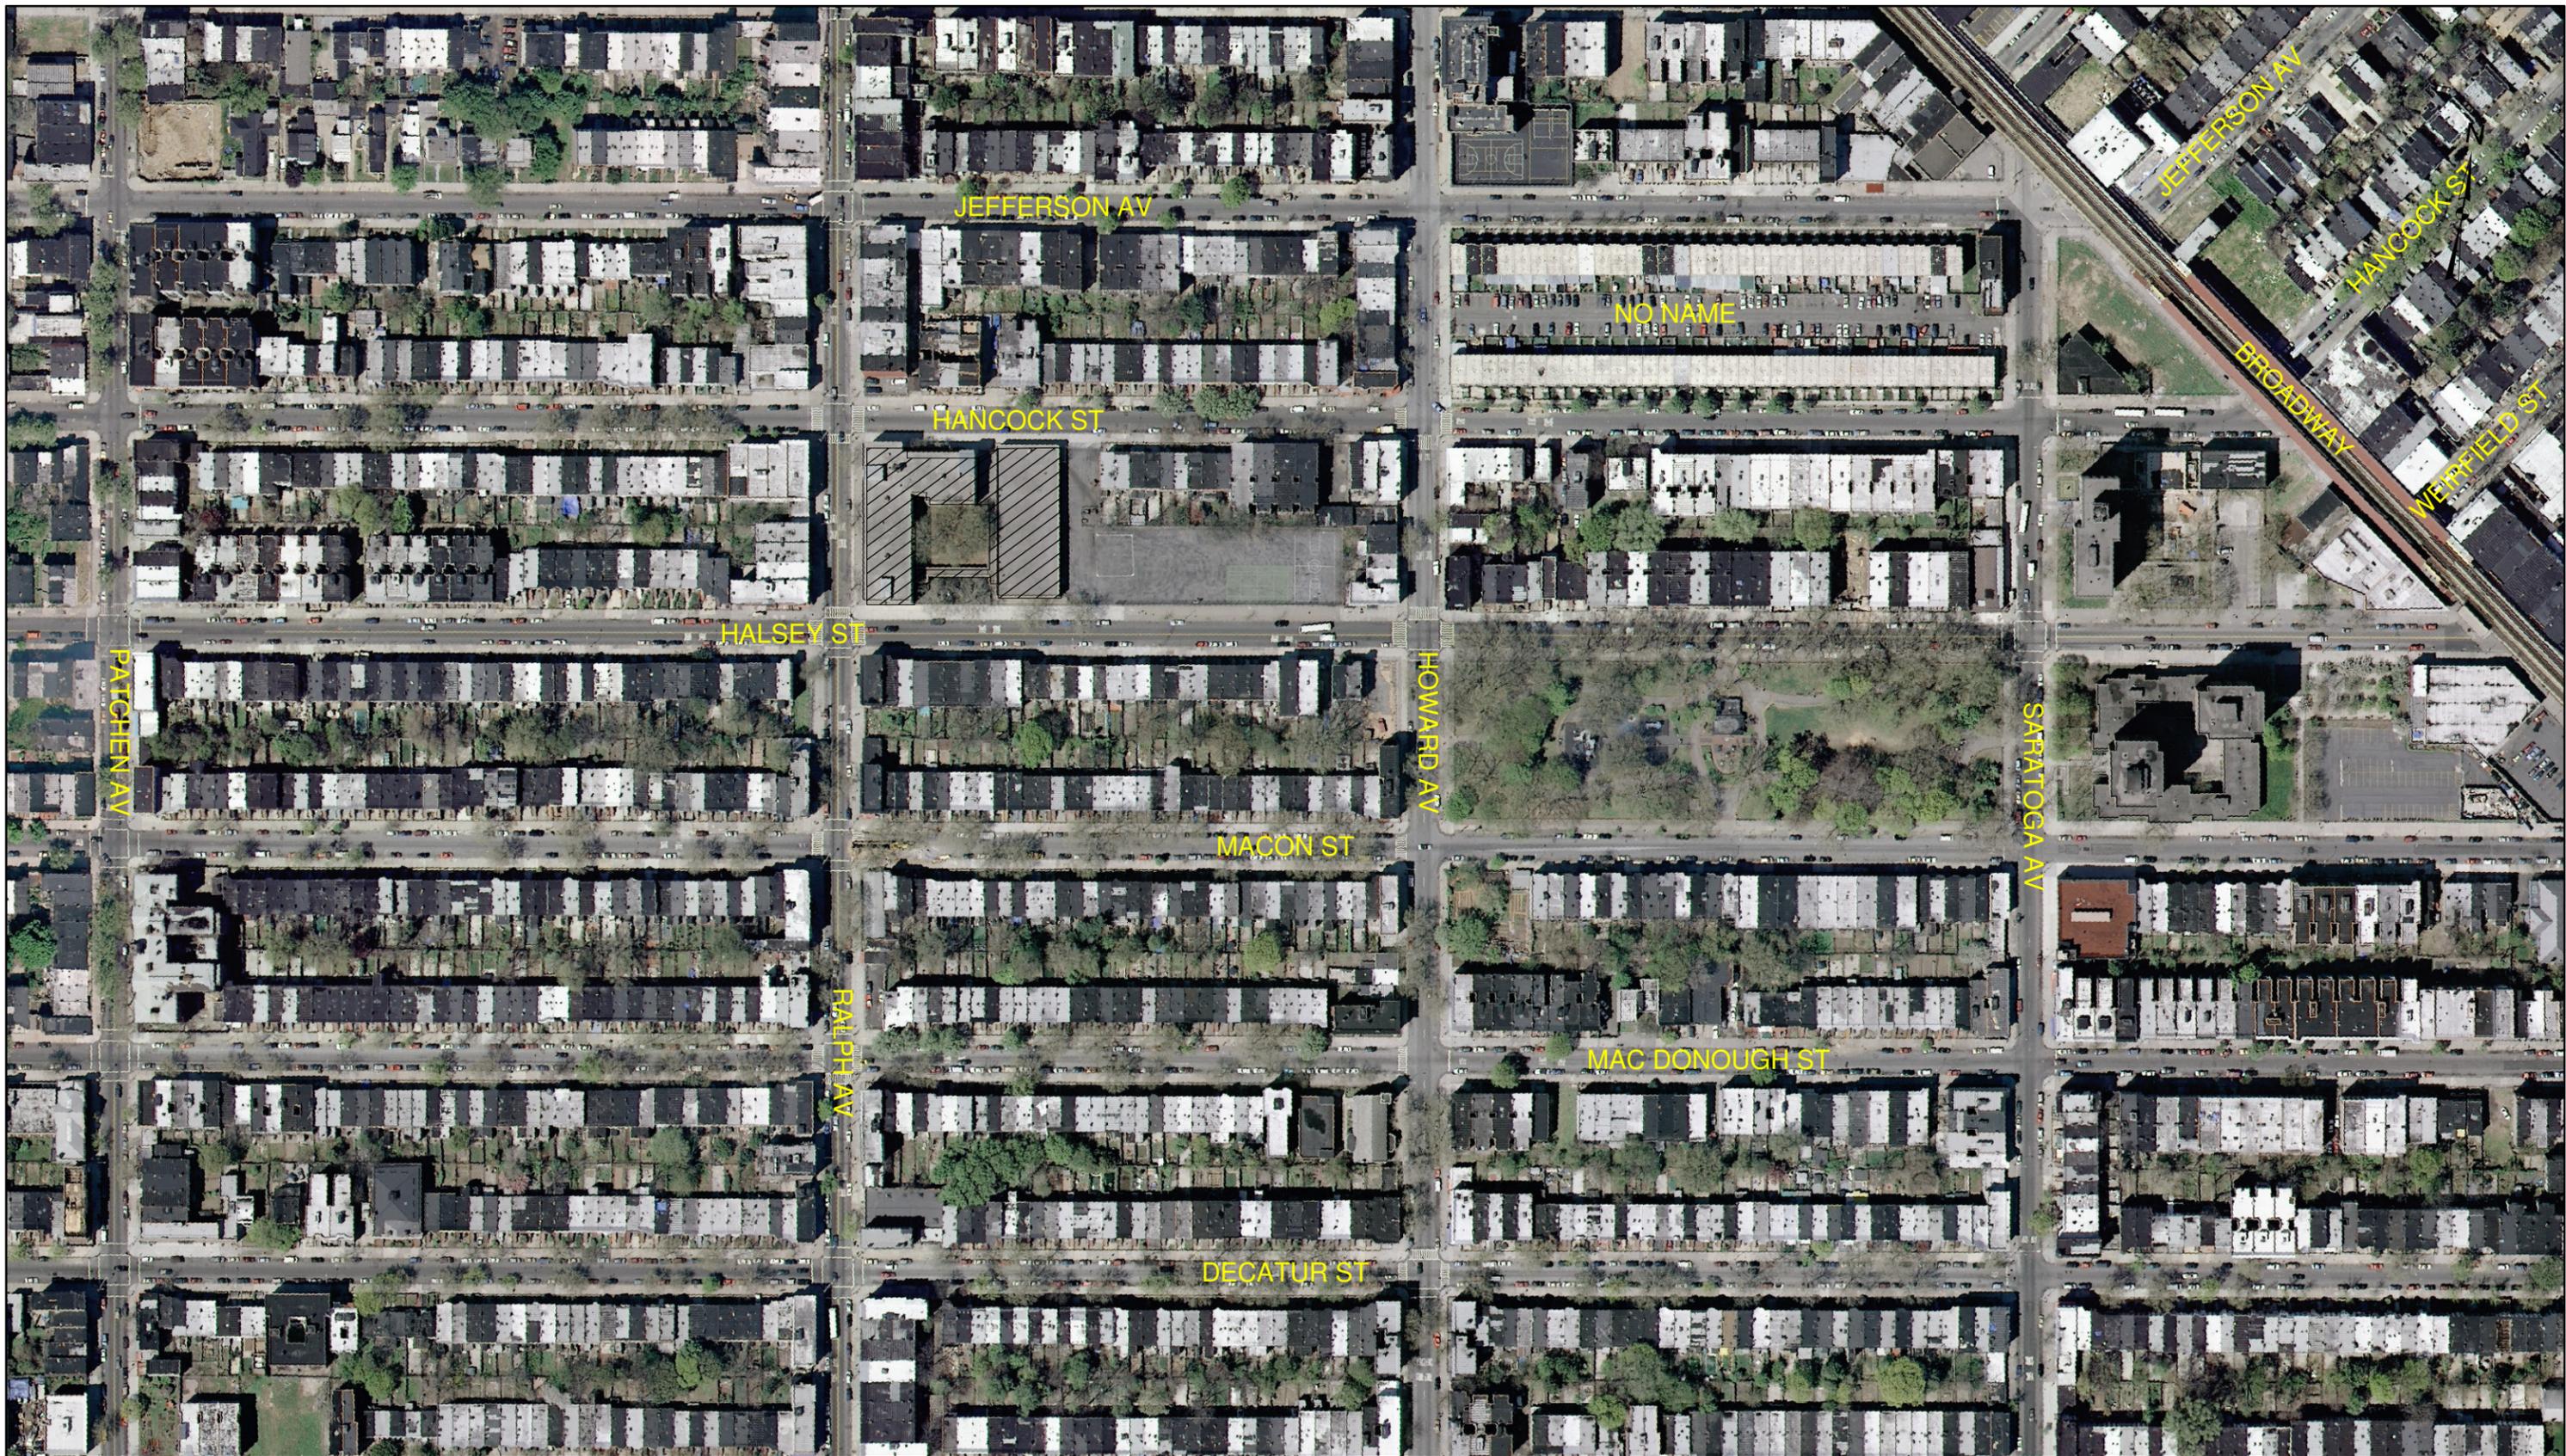
EXHIBIT 1
RONALD E. MCNAIR SCHOOL
P.S. 5, BROOKLYN
AERIAL PHOTOGRAPH

Hancock Street, Halsey Street and Howard Avenue are primarily residential roadways. Ralph Avenue is a mixed-use roadway with multi-story buildings with first floor commercial establishments. Located in the vicinity of P.S. 5 are grocery stores, other commercial store fronts, a public park and many multi-floor apartment buildings (See Exhibit 1 for aerial photograph).

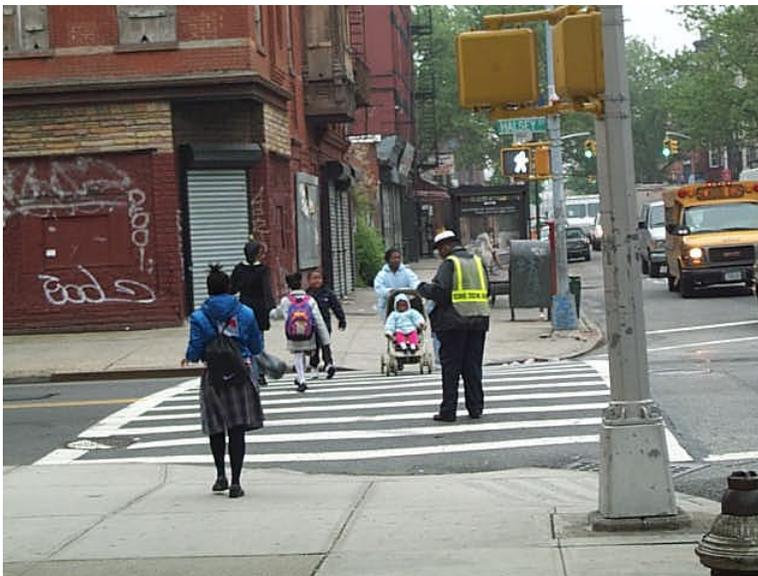
Figure 2: Crossing guard at Ralph Avenue and Halsey Street intersection

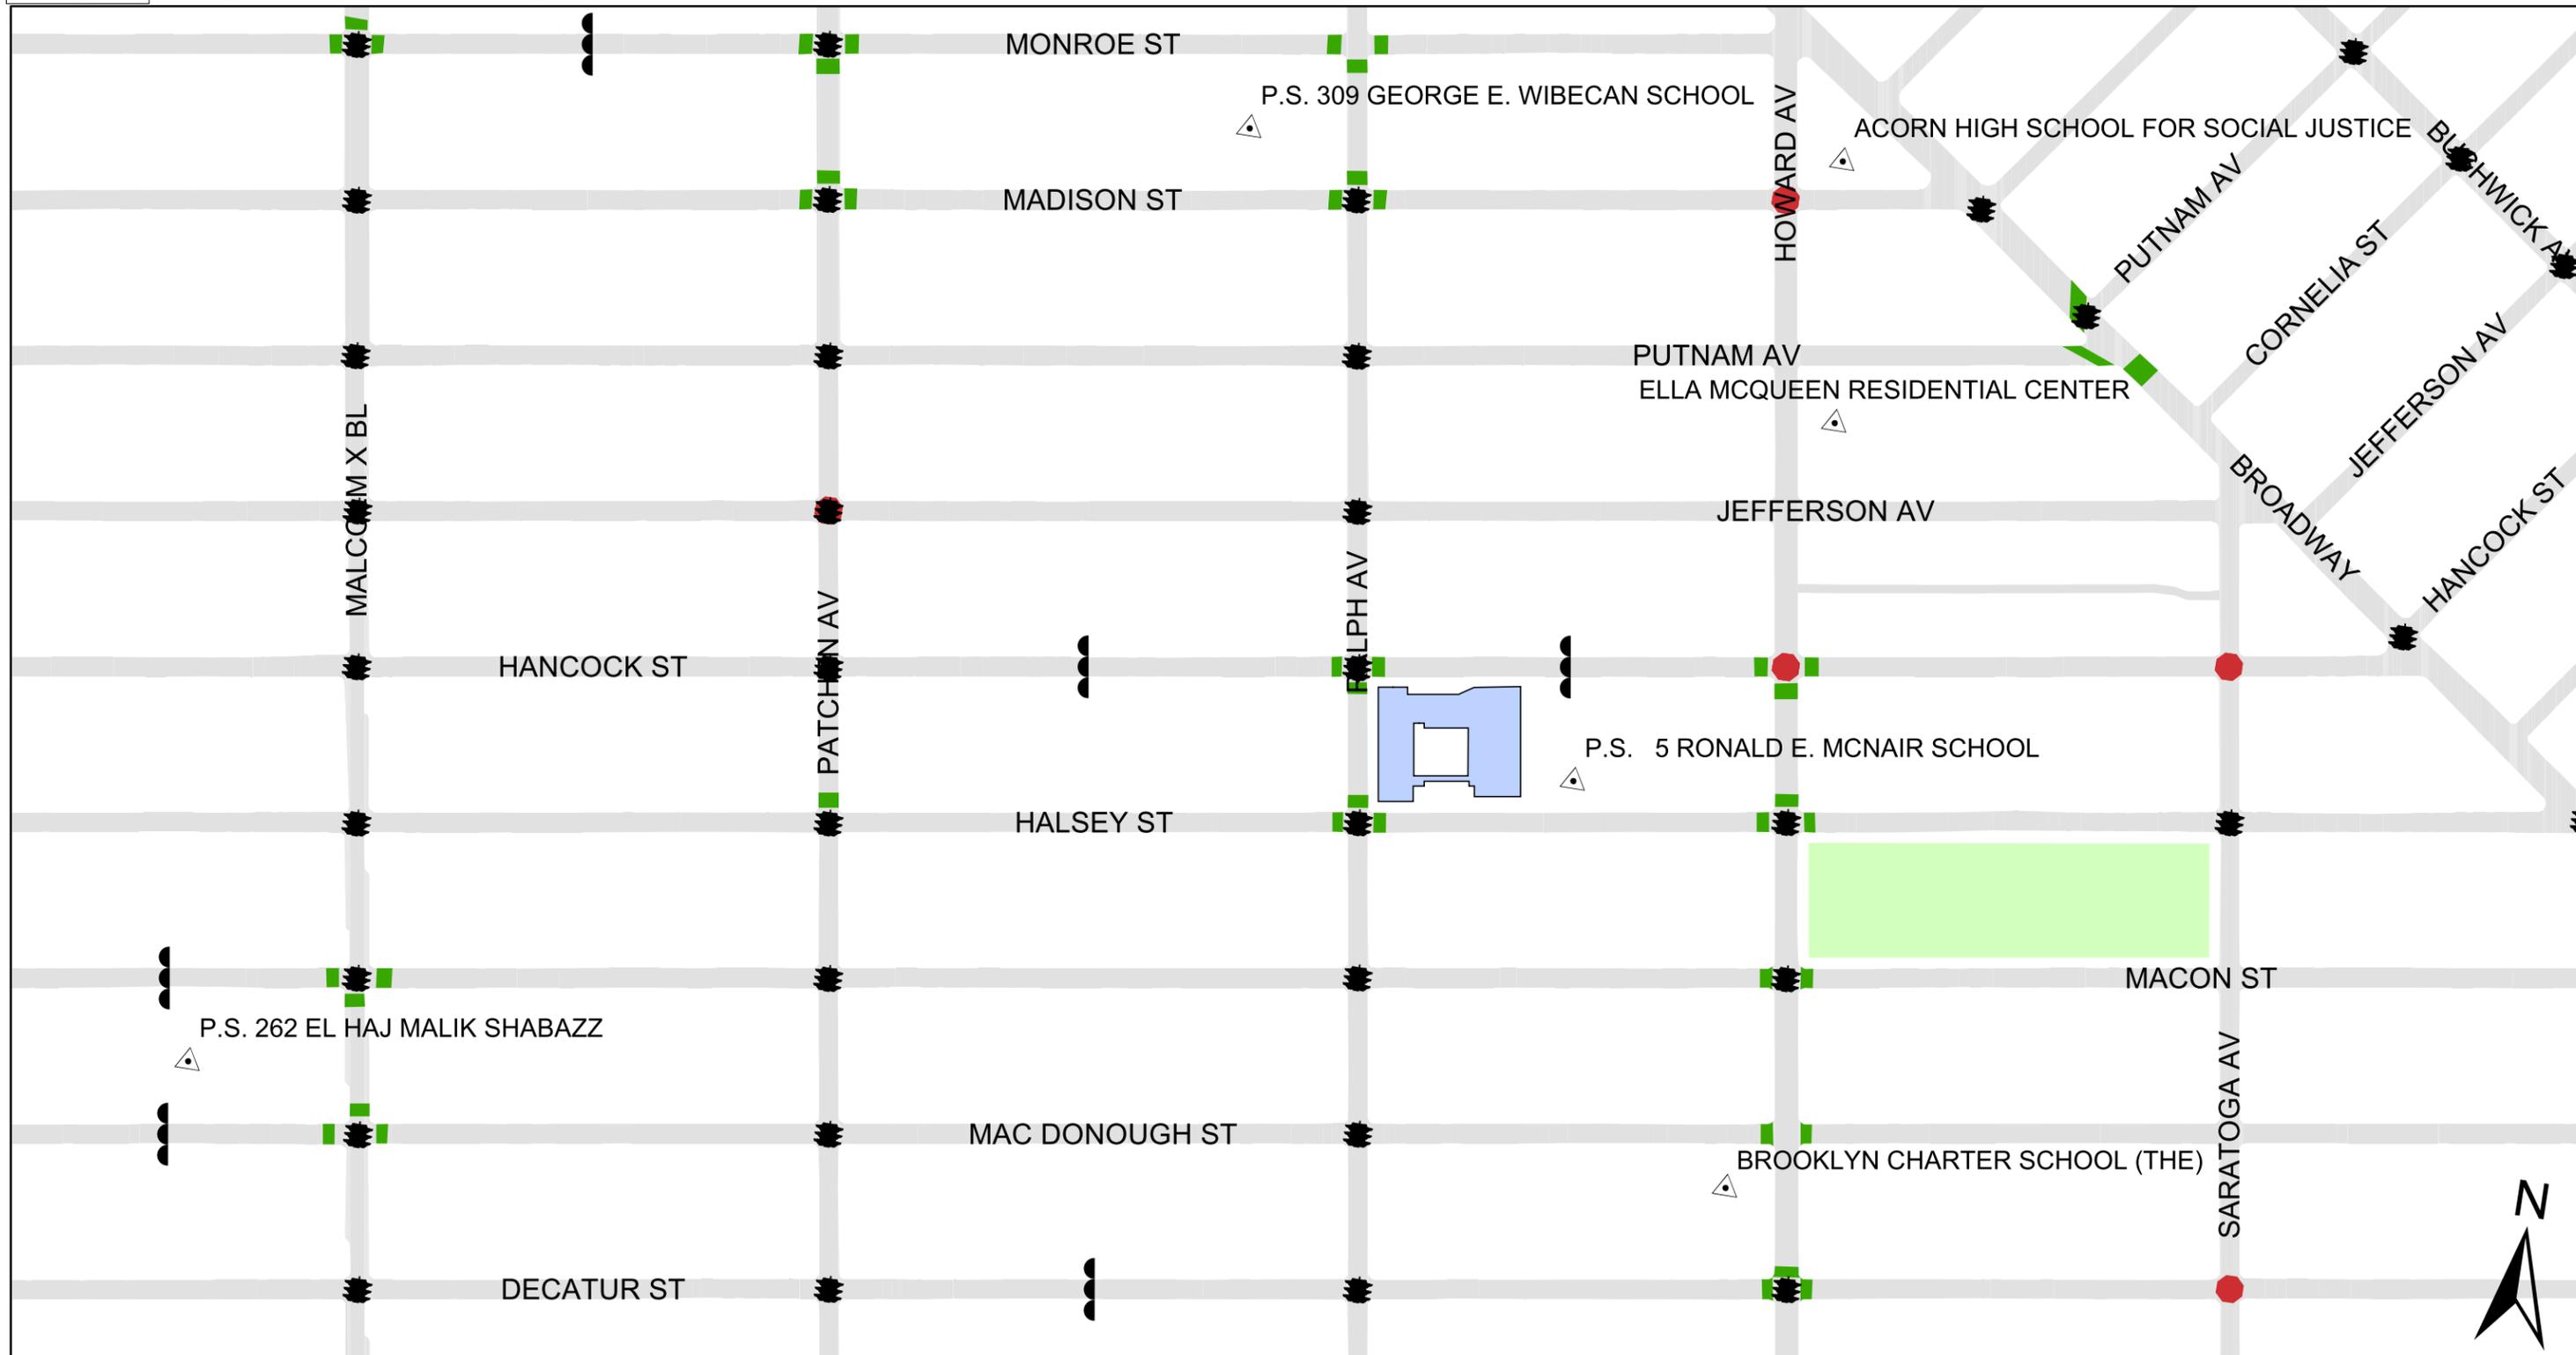
EXHIBIT 3

The School Traffic Safety Map was established to help provide the maximum degree of safety for children going to and from school - by indicating the location of speed reducers, school crosswalks and some traffic control devices. (While virtually all intersections in NYC benefit from traffic control devices - such as stop signs, traffic signals, yield signs, and all way stop signs - this map shows only traffic signals and all way stop signs.) The school crosswalks that are shown are ladder striped and make the crosswalk more visible to drivers and help make the intersection safer. These crosswalks are where school children are recommended to cross.

The Traffic Safety Plan, Exhibit 3, shows existing signs, signals and pavement markings as of June 2004. It is noted that a citywide signage program is currently underway to upgrade school signage to current MUTCD standards of fluorescent yellow-green with downward pointing arrows. Signs scheduled to be installed under this program are shown as "existing".

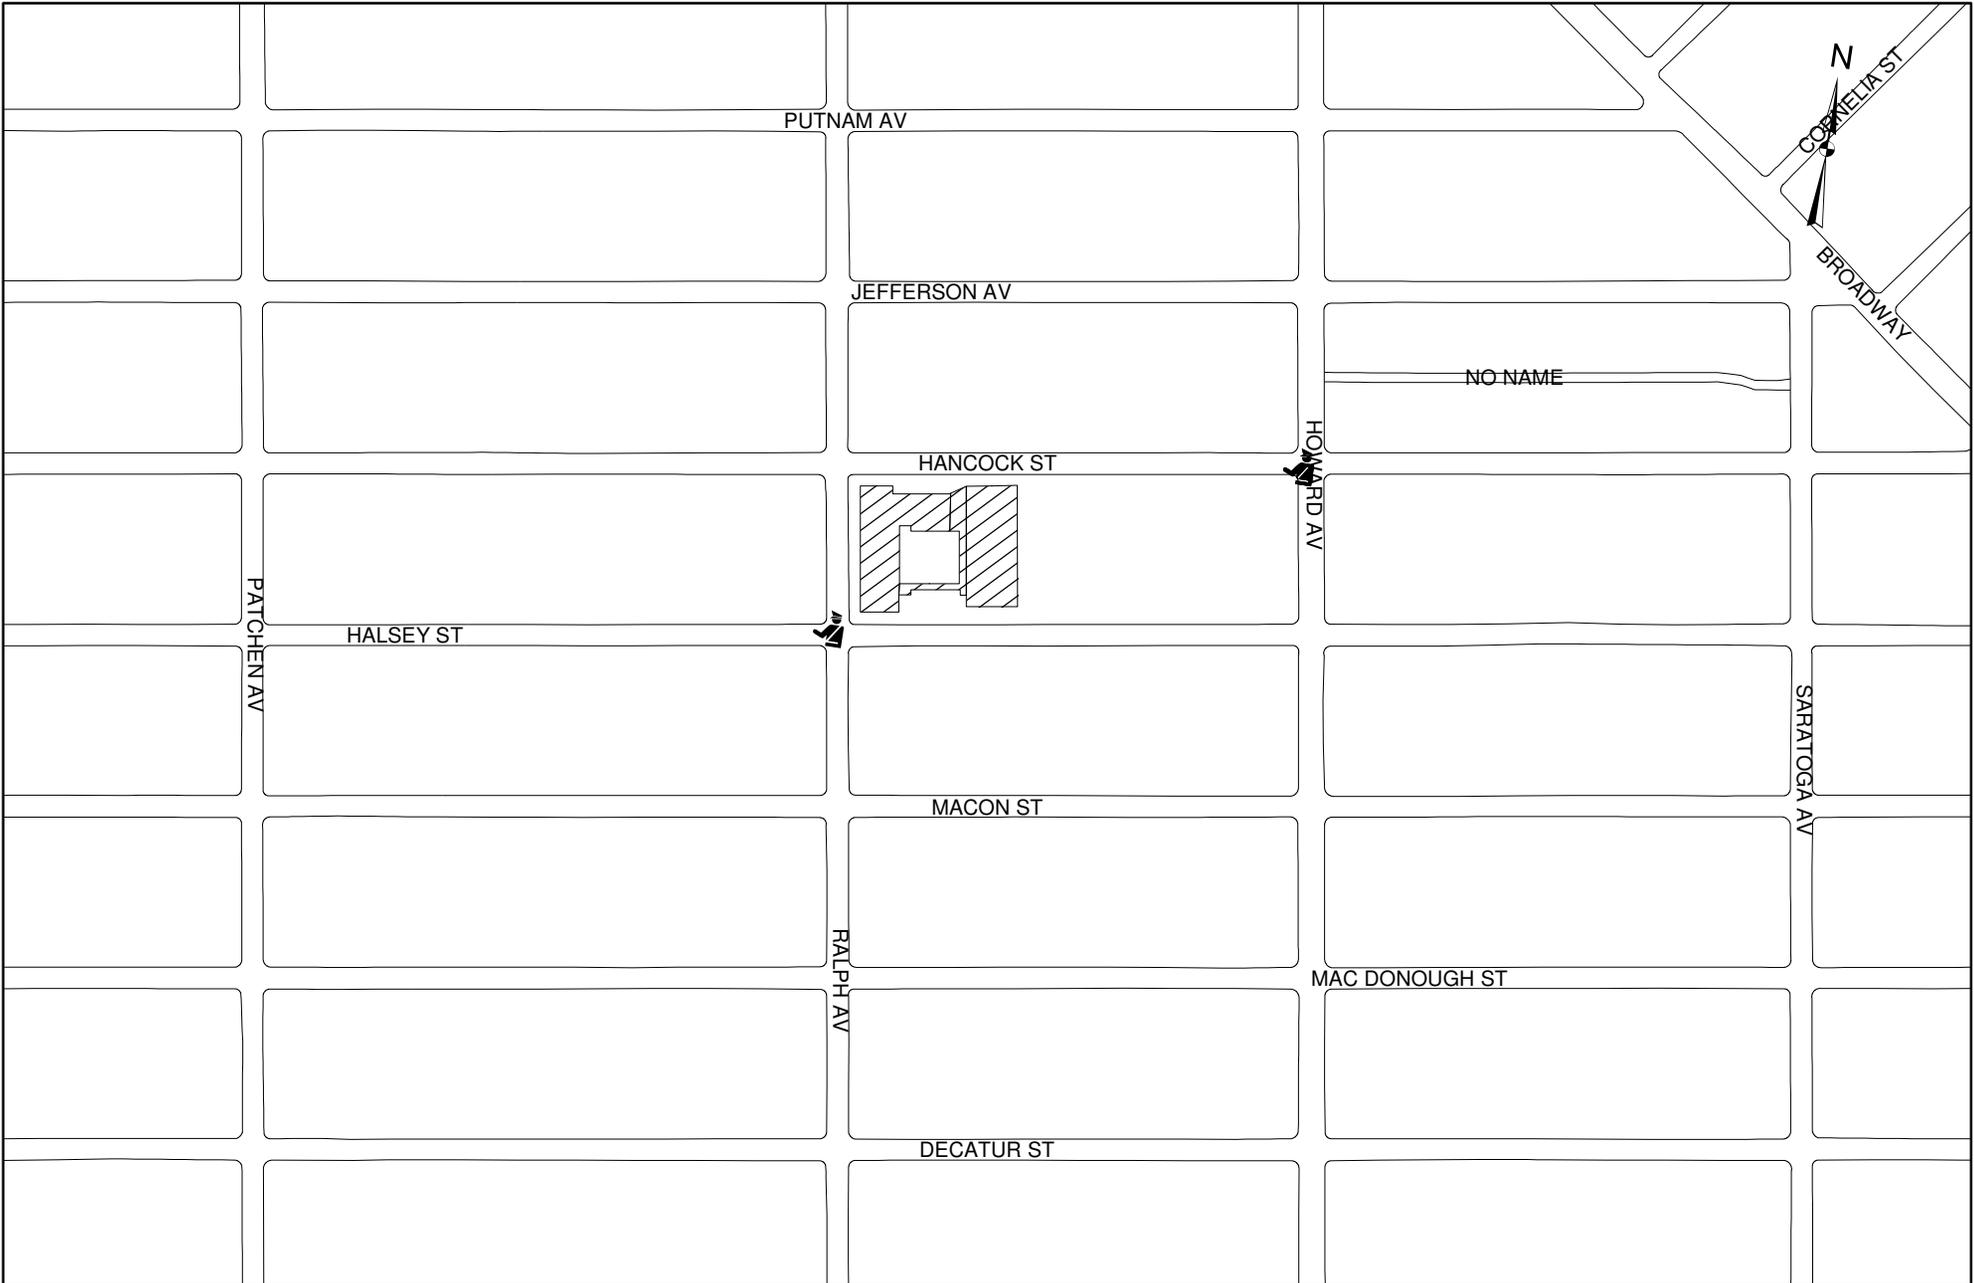
EXHIBIT 4

According to field observations, there are two crossing guards assigned to P.S. 5. Crossing guards are stationed at the Ralph Avenue and Halsey Street and Hancock Street and Howard Avenue intersections. See Exhibit 4 for a map of crossing guard locations.

School crossing guard assigned to P.S. 5

Three days a week, students are dismissed from an after school tutoring program after the crossing guards have ended their day. In fact, more than 50% of the students participate in after school programs and are dismissed when there are no longer crossing guards present. It is recommended that crossing guard hours be extended to cover after school dismissal.

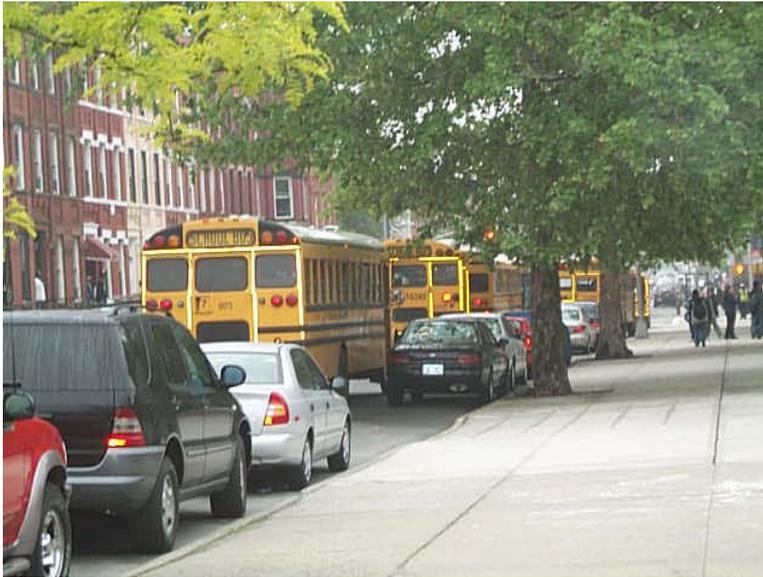
According to the P.S. 5 principal, all school bus activity is on Halsey Street, near Ralph Avenue facing the rear door to the school. Buses double-park on Halsey Street and dismiss students at the curbside, within the No Parking Zone in front of the school. However, during field observations, some buses were observed dismissing students while double-parked, requiring students to navigate through parked vehicles in order to reach the school entrance (See Figures 3 and 4).

Figure 3: Double-parked school buses on Halsey Street in front of P.S. 5 entrance.

“No Standing 7am – 4 pm, School Days” parking regulations should be extended approximately for the length of 60 feet in front of the school’s back entrance on Halsey Street in order to provide sufficient clear frontage for school buses to drop off and pick up students.

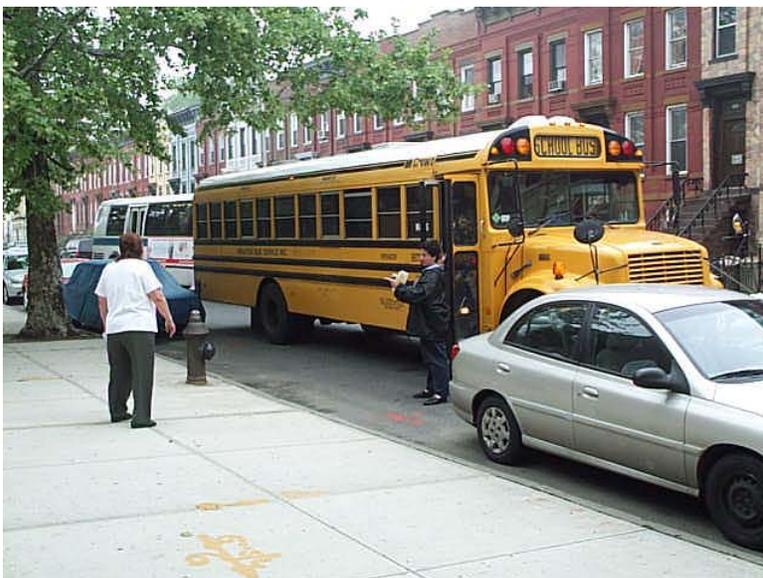
Figure 4: Double-parked school bus dropping students off on Halsey Street.

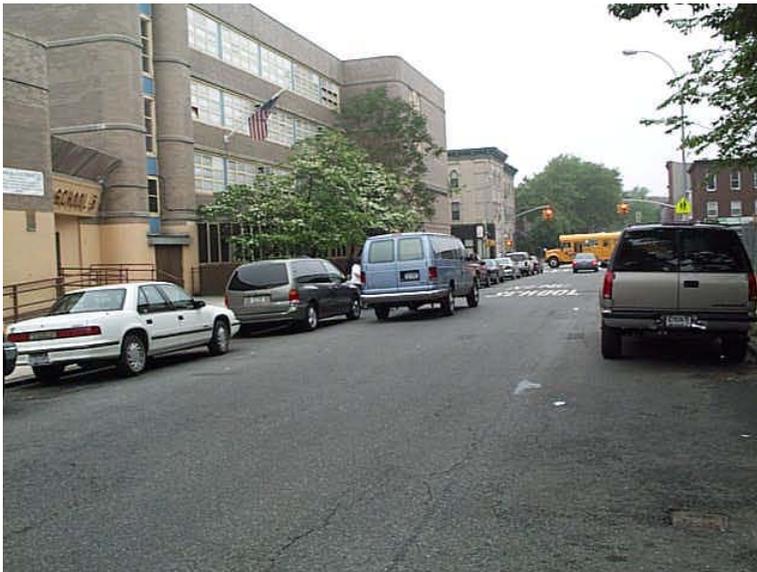
Field observations indicated that parents commonly use Hancock Street as a student drop-off point. Parents were observed to park on south side of Hancock Street and walking student to the school entrance; double-park on Hancock Street and letting students walk by themselves to the school; or, park on north side of Hancock Street and accompany students while performing a mid-block crossing.

Figure 5: Vehicle double-parked in front of P.S. 5

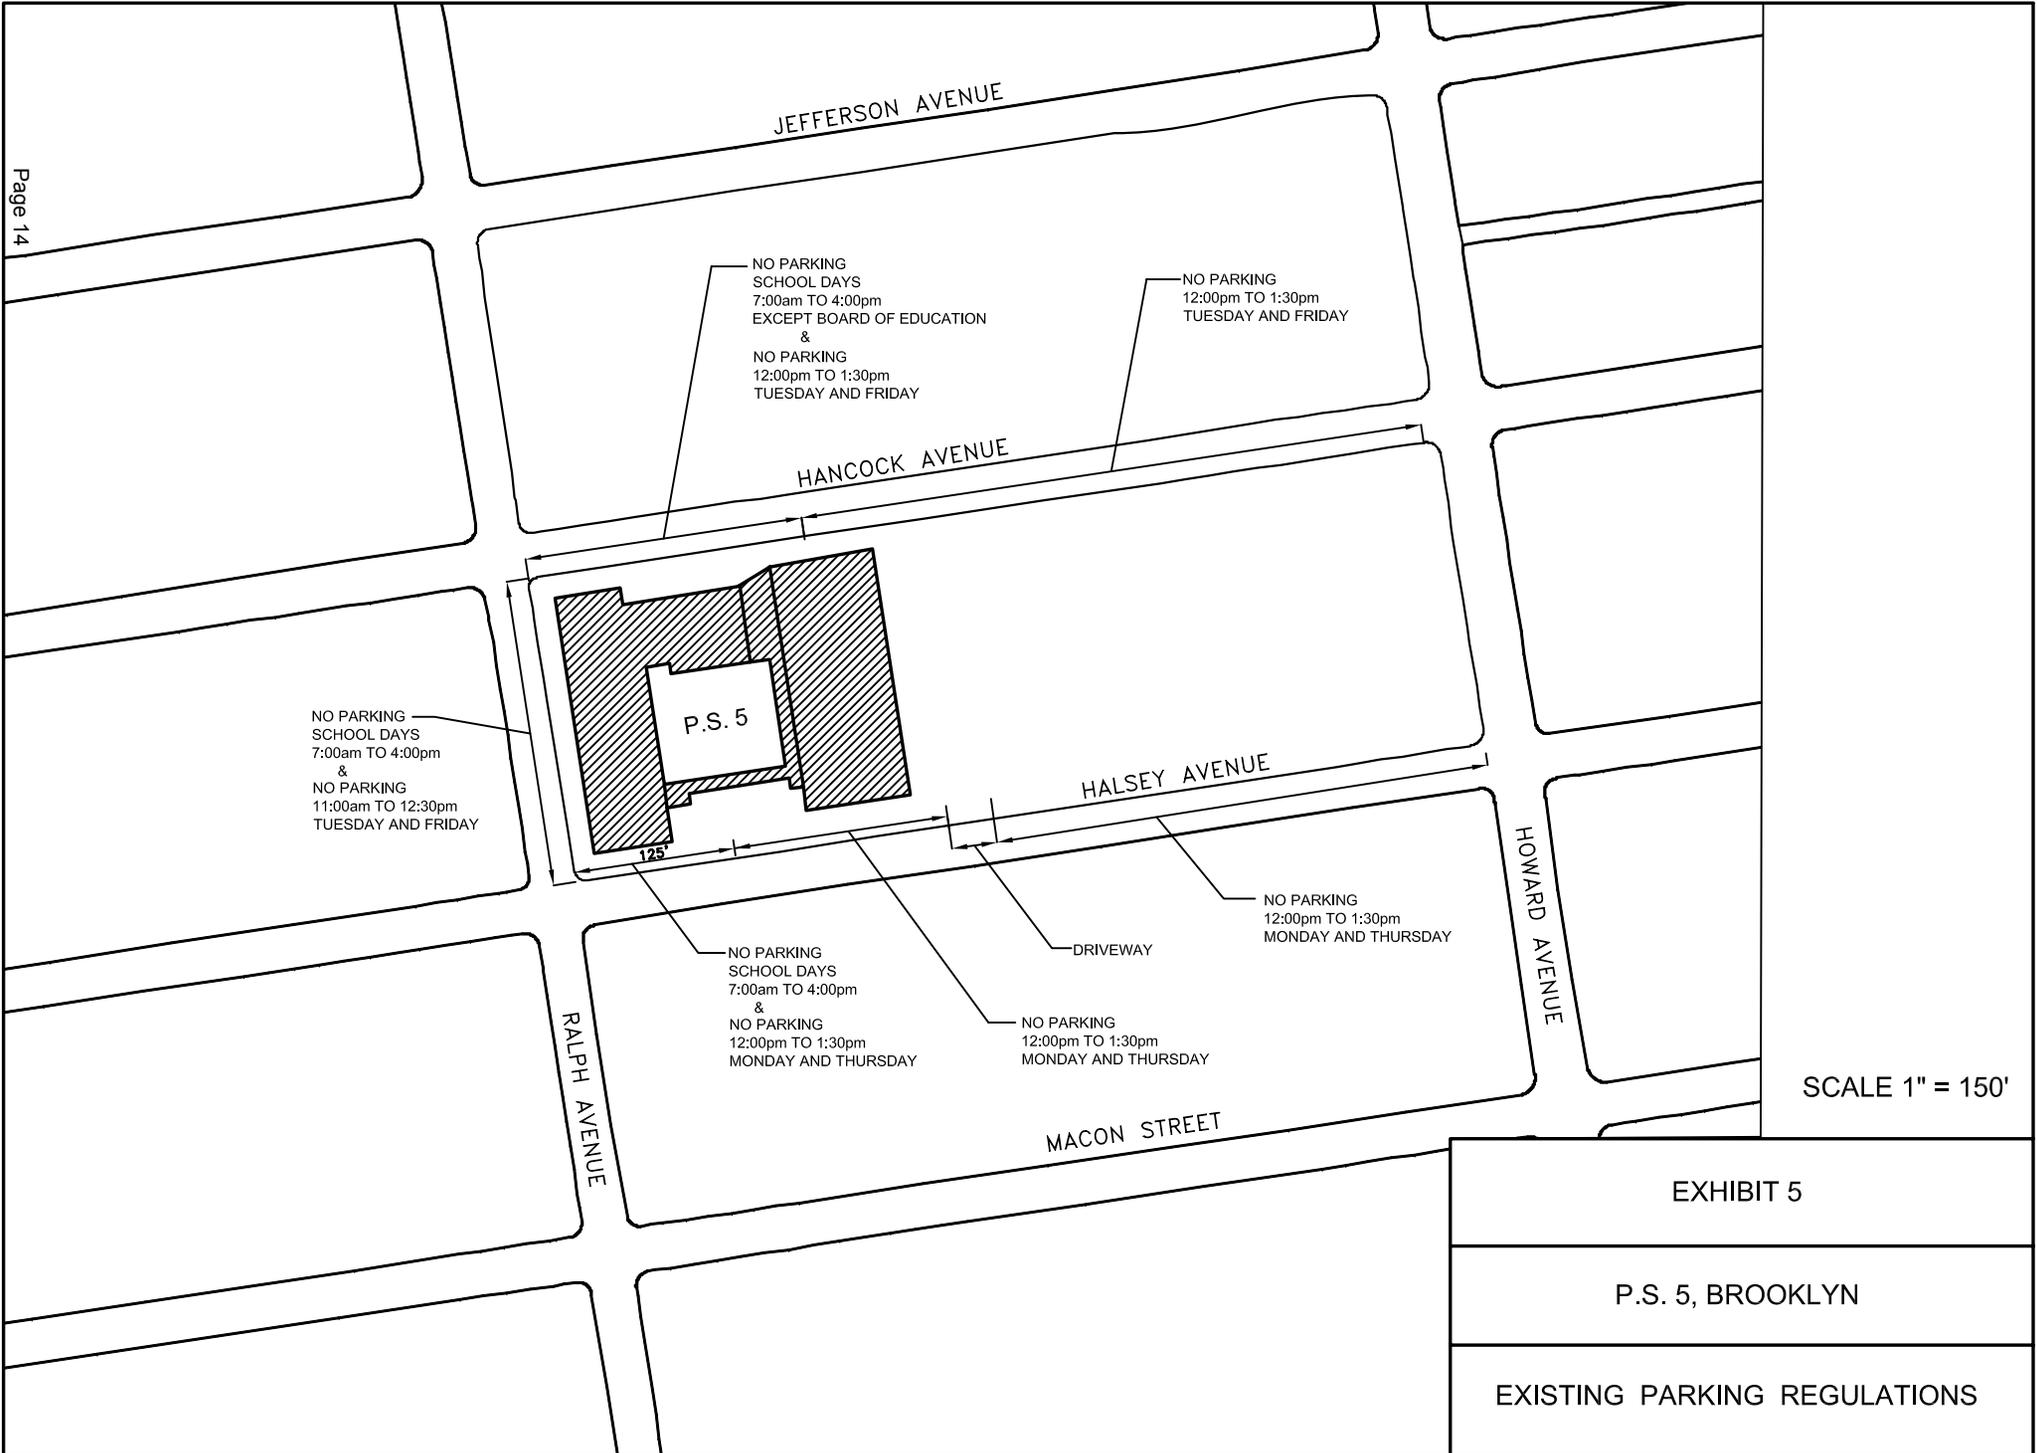
EXHIBIT 5
P.S. 5, BROOKLYN
EXISTING PARKING REGULATIONS

Halsey Street, Ralph Avenue and Hancock Street are posted as “NO PARKING, SCHOOL DAYS, 7 AM - 4 PM” in the vicinity of the school. Parking is prohibited on alternating sides of the roadways between 12:00 pm and 1:30 pm. Exhibit 5 shows parking details in the vicinity of P.S. 5.

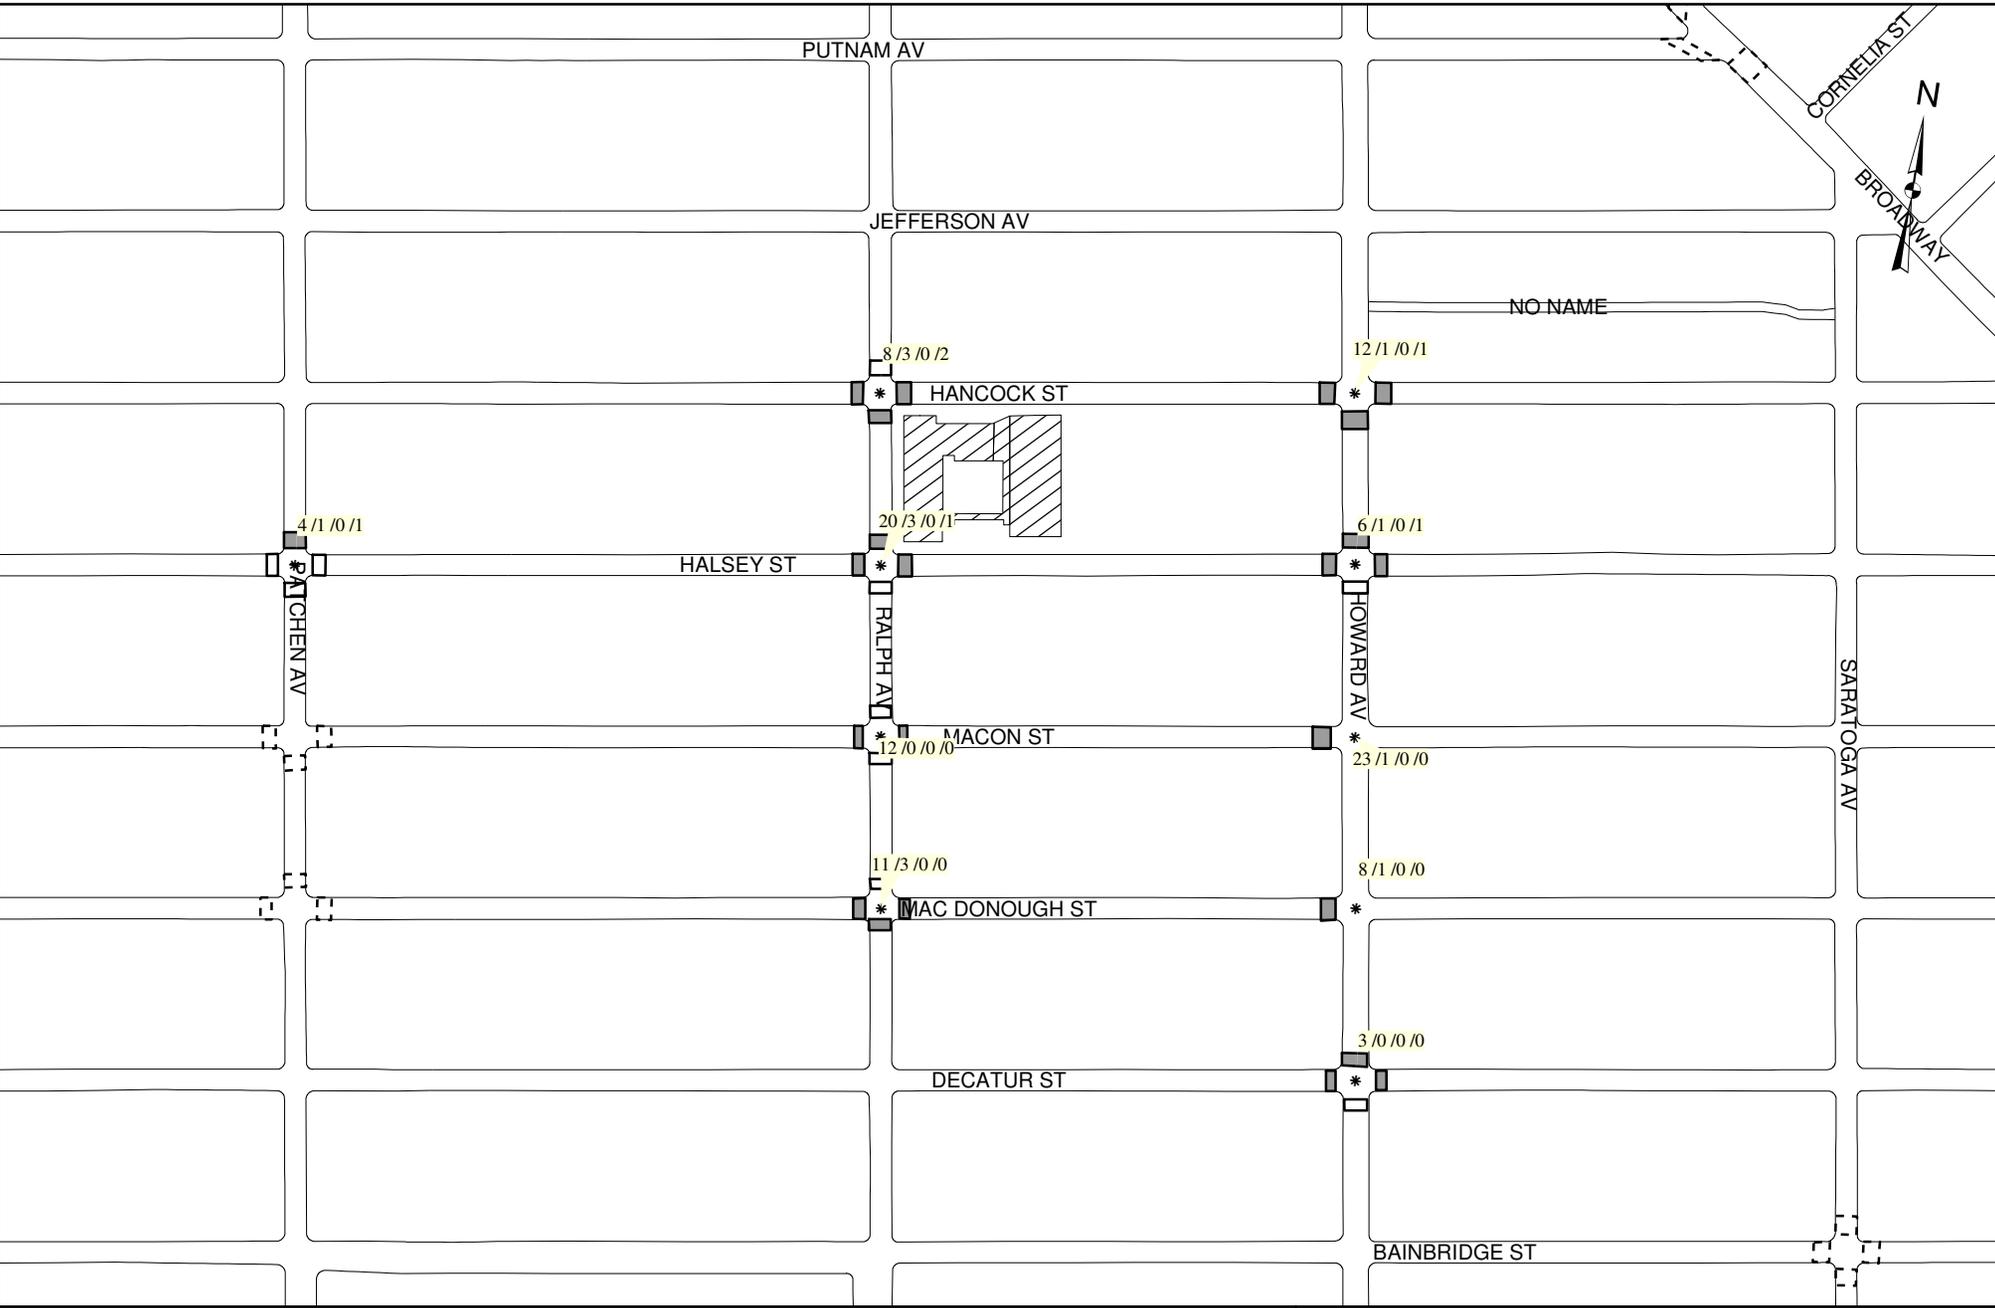
EXHIBIT 6

Exhibit 6 and Table 2 show a summary of accidents, as obtained from New York State Department of Motor Vehicles (DMV) in the vicinity of P.S. 5 for the three-year period from January 1, 1998 through December 1, 2000. The DMV data provides some detail relating to the cause of the accident. Table 3 is a summary of more recent accident data obtained from the NYC Police Department (NYPD). Though current through 2004, the NYPD data does not provide the same level of detail as the DMV data. Accidents are discussed in Section 3.6, Traffic Operations and Issues.

**RONALD E. MCNAIR SCHOOL
P.S. 5, BROOKLYN
ACCIDENT SUMMARY
THREE YEAR PERIOD
(1998-2000)**

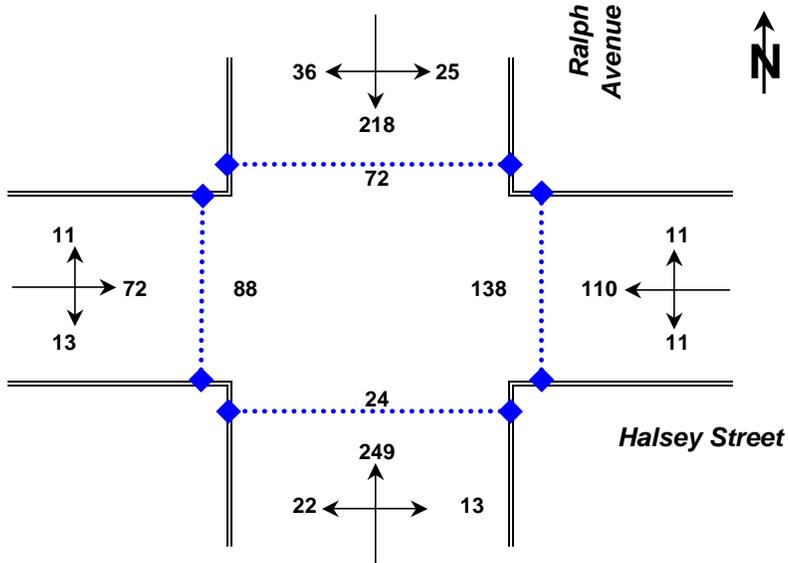
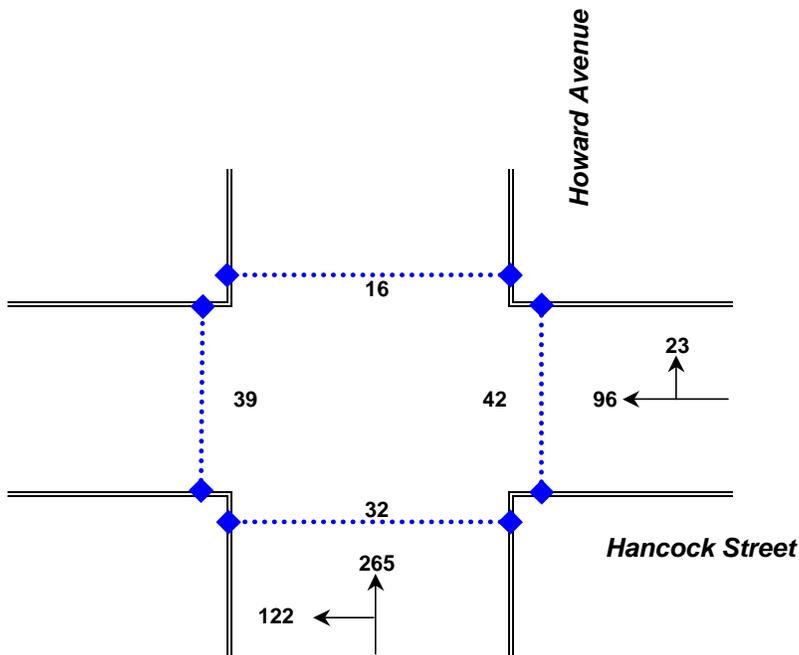
EXHIBIT 7A
P.S. 5
TURNING MOVEMENT COUNTS

Intersection of Halsey Street and Ralph Avenue
(7:30 AM - 8:30 AM September 23, 2004)

Intersection of Hancock Street and Howard Avenue,
(7:30 AM - 8:30 PM June 15, 2005)

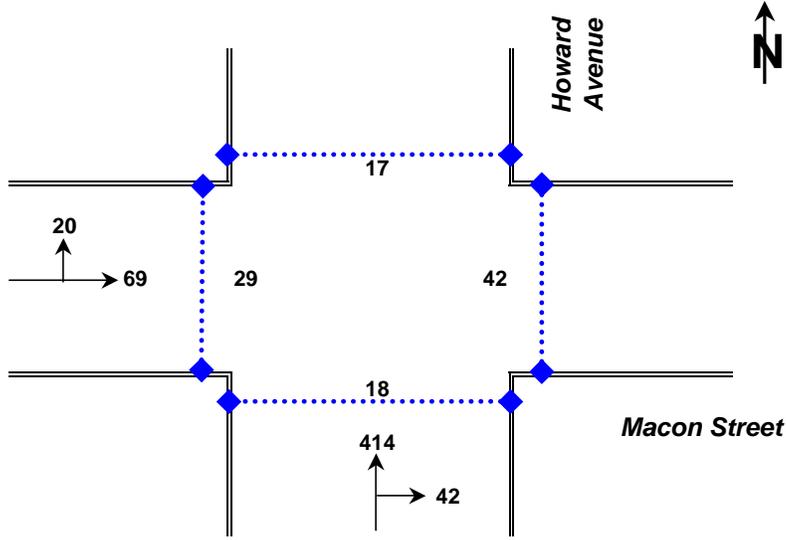
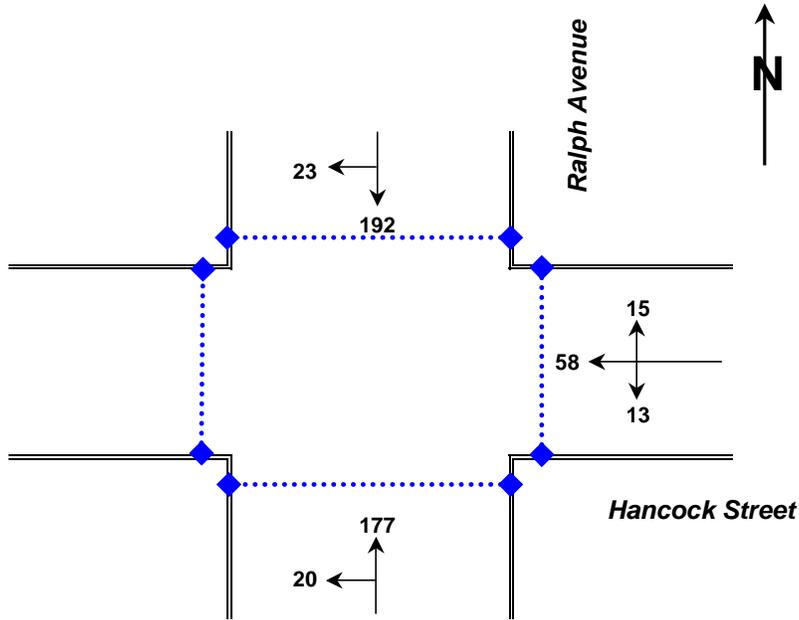
EXHIBIT 7B
P.S. 5
TURNING MOVEMENT COUNTS

**Intersection of Macon Street and Howard Avenue,
(7:30 AM - 8:30 AM June 15, 2005)**

**Intersection of Ralph Avenue and Hancock Street,
(7:30 AM - 8:30 AM August 26, 2004)**

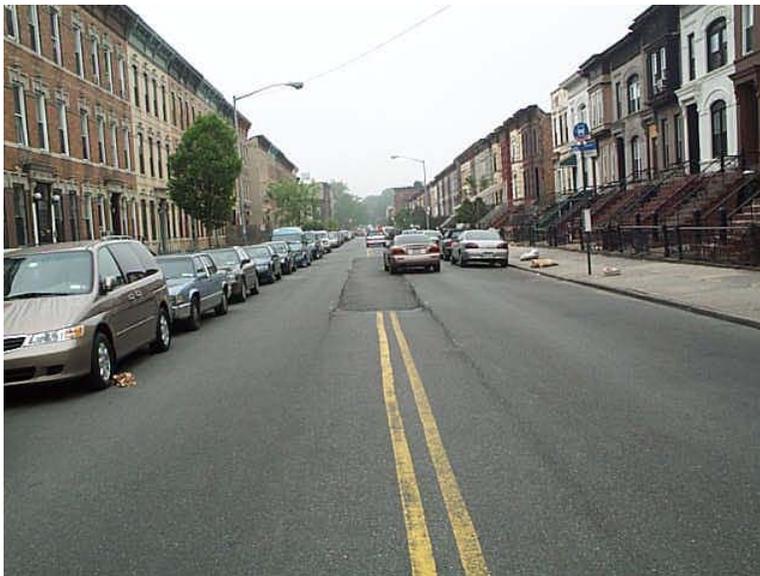
The roadways were found to generally be in good condition. However, on Halsey Street, 100 feet east of Patchen Avenue, there is some pavement settlement along a sewer trench. In addition, on Macon Street, west of Howard Avenue, there also appears to be subsidence in the location of a sewer line.

Figure 7: Depressed sewer trench on Halsey Street, east of Patchen Avenue

- Repair the settled pavement on Halsey Street and Macon Street

The depressed areas should be repaved in accordance with NYCDOT standards for permanent pavement restoration.
