**New York City Department of Transportation
Office of School Safety Engineering**

School Safety Engineering Project

FINAL REPORT: P. S. 5 (Ronald E. McNair School), Brooklyn

**Prepared by
The RBA Group/Urbitran Associates**

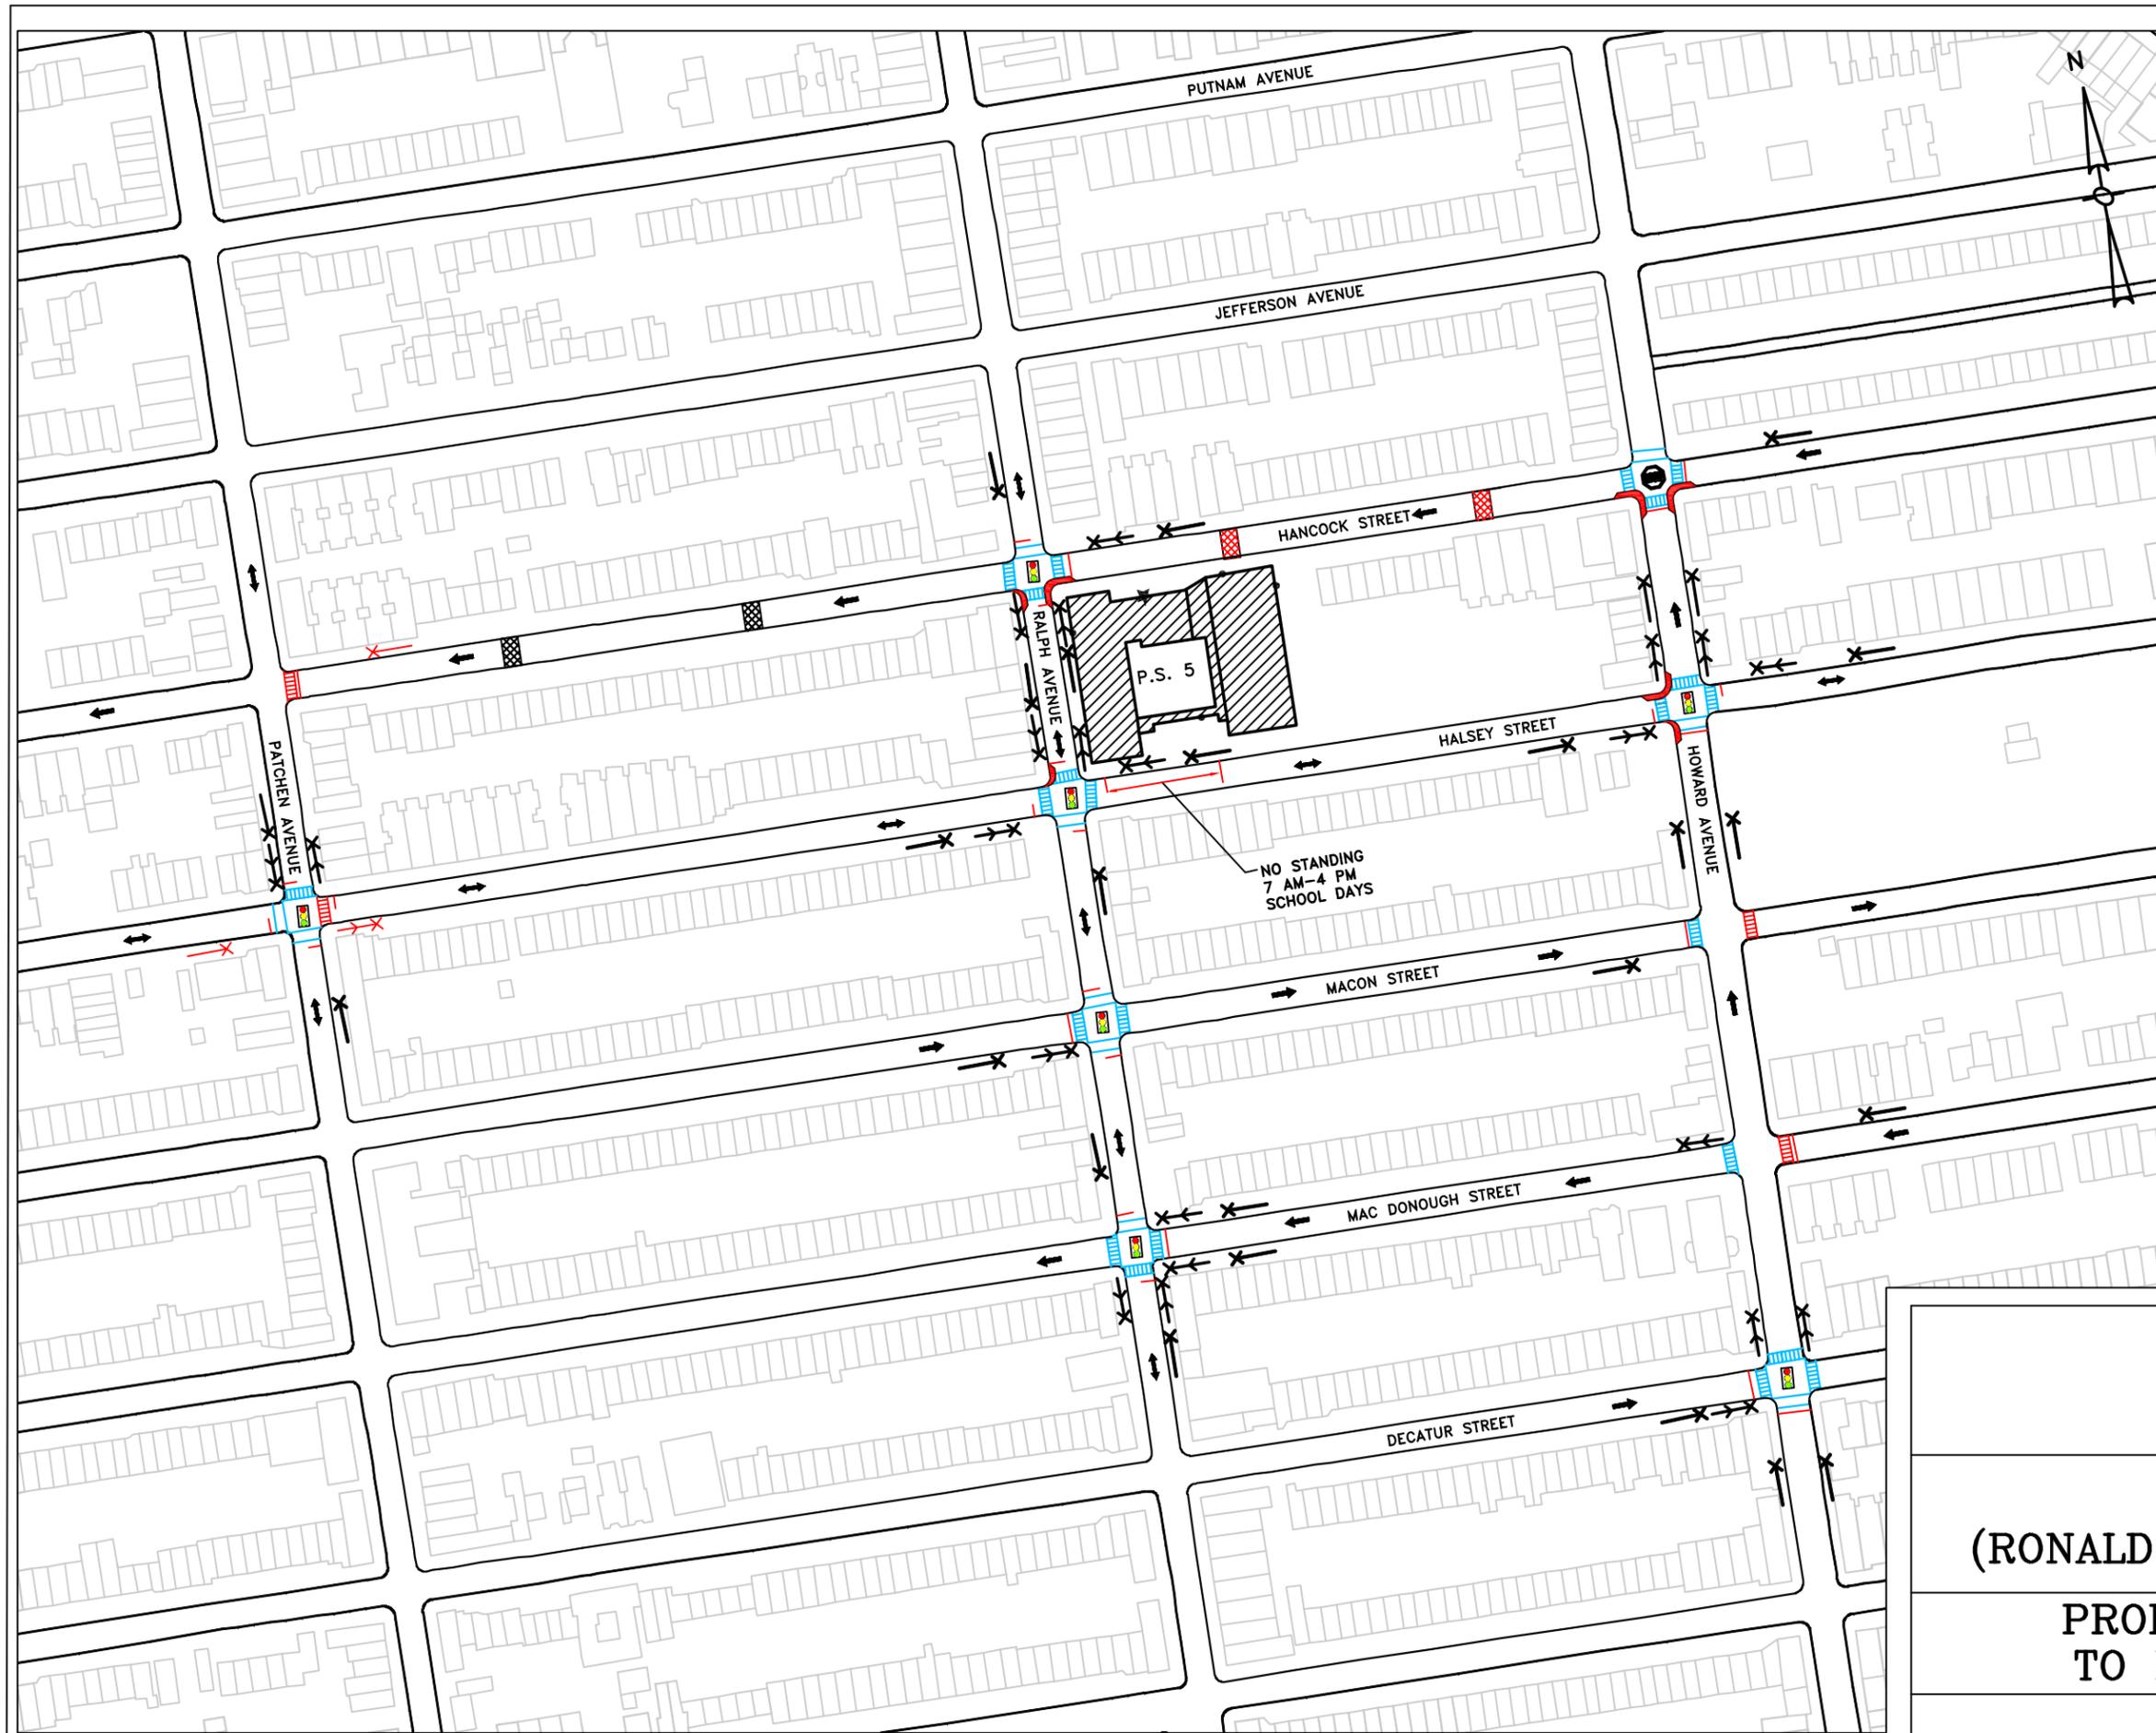
EXHIBIT 8

Curb extensions should be installed at the corners as shown in Exhibit 8.

The purpose of the curb extensions is to reduce speeds of vehicles approaching and turning at these heavily utilized school crosswalks.

PROPOSED MEASURES
TO IMPROVE SAFETY

These curb extensions will not eliminate or reduce the width any moving lanes. Curb extensions are not proposed where they would hinder the ability of vehicles to turn. Final details pertaining to curb extensions will be developed during the Final Design/Contract Document preparation.

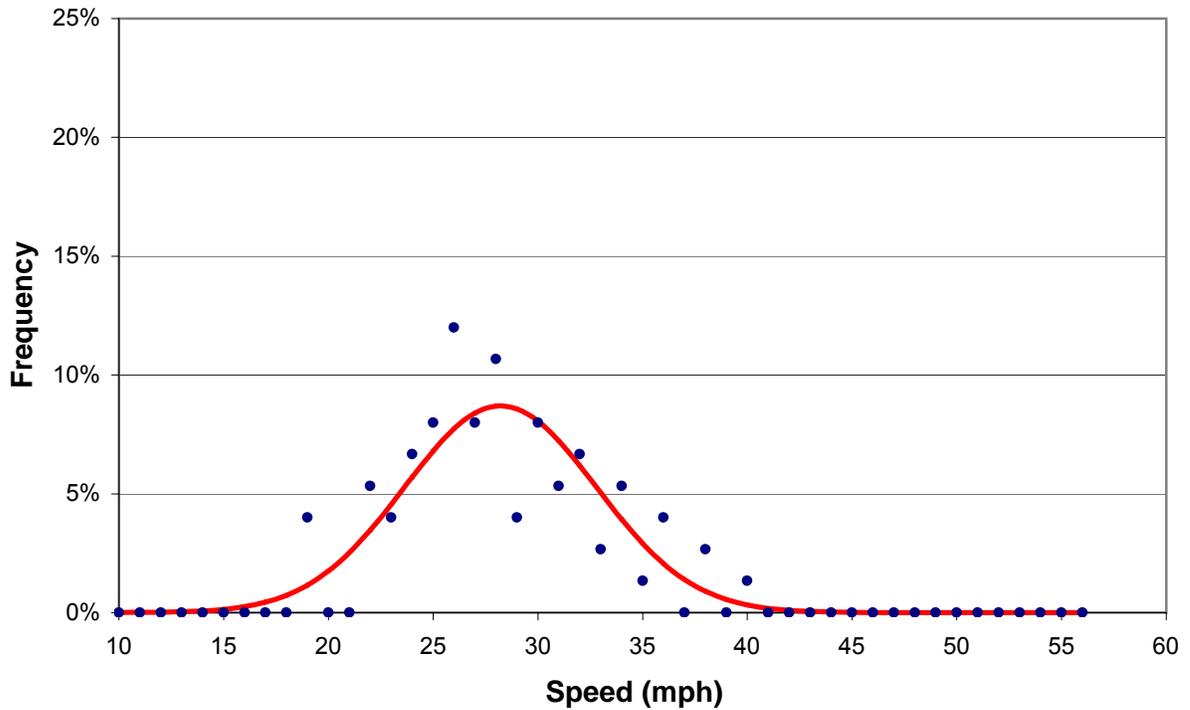
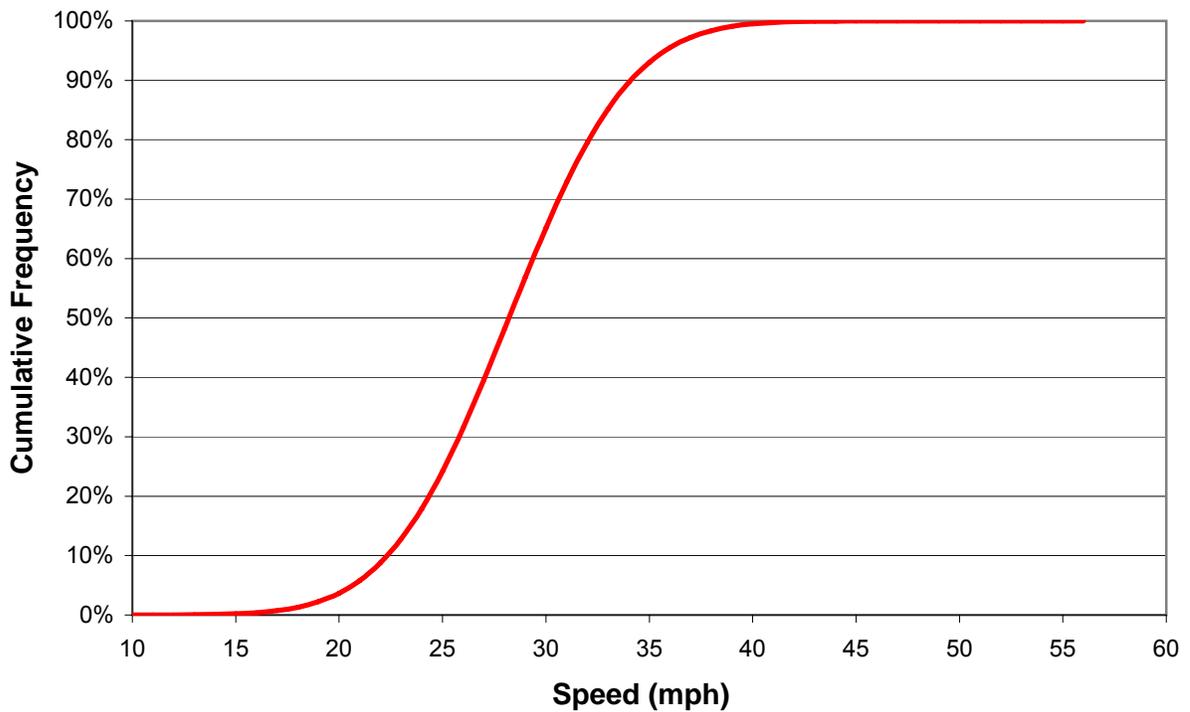
SPOT SPEED STUDY

Date: **August 17, 2005** Time: **10:30 am - 11:30 am**
 Location: **Hancock Avenue btw. Ralph Avenue & Howard Avenue**
 Surveyor: **The RBA Group**

Mean Speed = 28.2 mph Median Speed = 28.2 mph
 Standard Deviation = 4.6 mph 15th Percentile Speed = 23.5 mph
 Margin of Error (95% Confidence) = ± 1.0 mph 85th Percentile Speed = 33.0 mph

The speed study results are shown in Table 5 and in the Appendix. The 85th percentile speed is 33 mph on Hancock Street, 31 mph on Halsey Street and 29 mph on Howard Avenue. Therefore, to reduce speeding in the vicinity of P.S. 5, two speed reducers (humps) should be considered on Hancock Street between Howard Avenue and Ralph Avenue. Speed reducers (humps) are not recommended for Howard Avenue since the 85th percentile speed (29 mph) does not exceed the legal speed limit of 30 mph, and Halsey Street because it is a bus route.

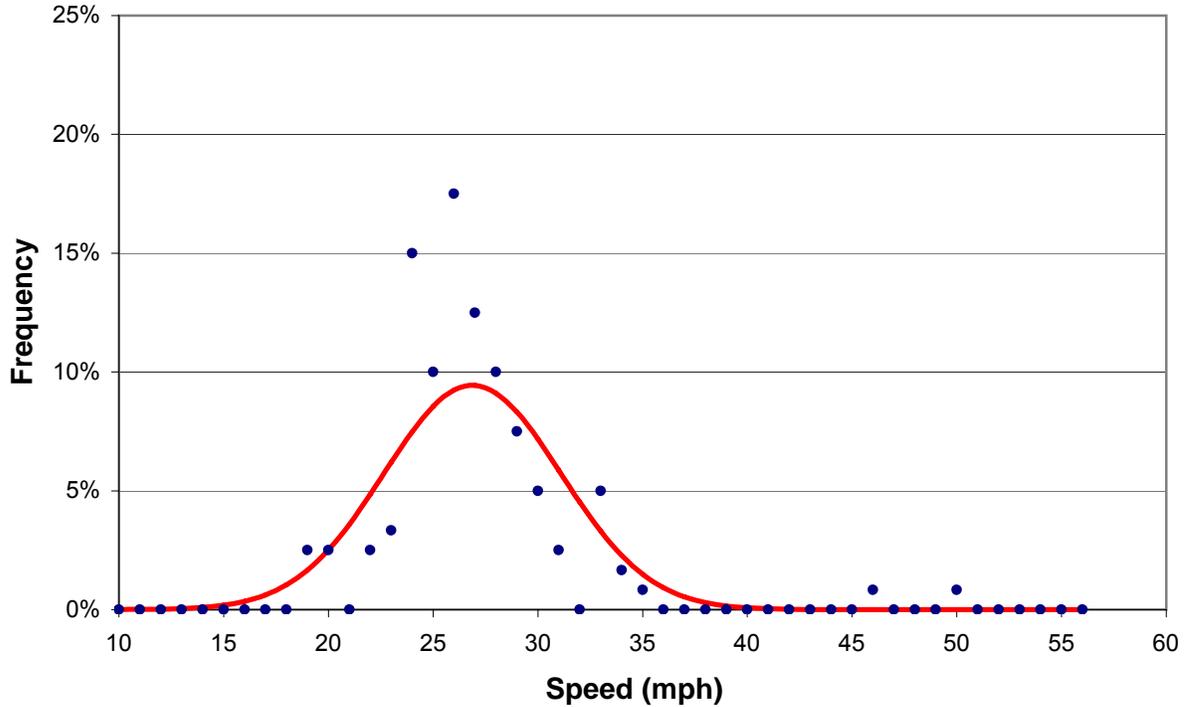
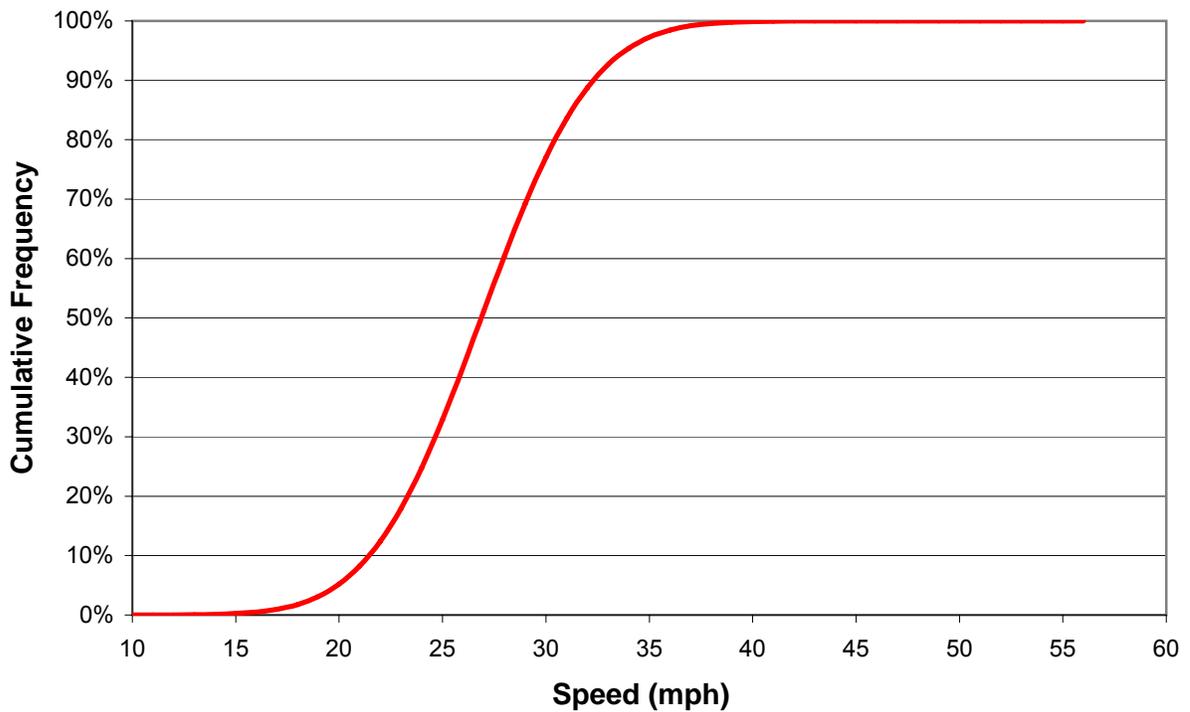
SPOT SPEED STUDY

Date: **August 17, 2005** Time: **8:30 am - 9:30 am**
 Location: **Hasley Street btw. Ralph Avenue & Howard Street**
 Surveyor: **The RBA Group**

Mean Speed = 26.9 mph Median Speed = 26.9 mph
 Standard Deviation = 4.2 mph 15th Percentile Speed = 22.5 mph
 Margin of Error (95% Confidence) = ± 0.8 mph 85th Percentile Speed = 31.3 mph

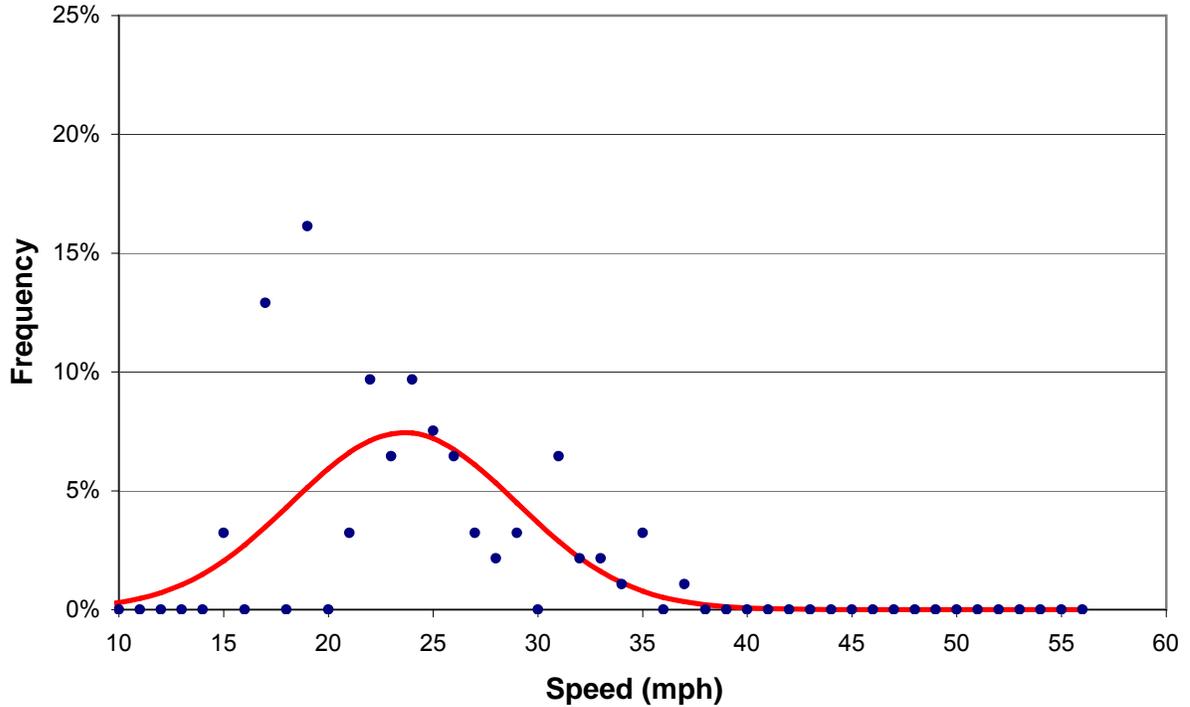
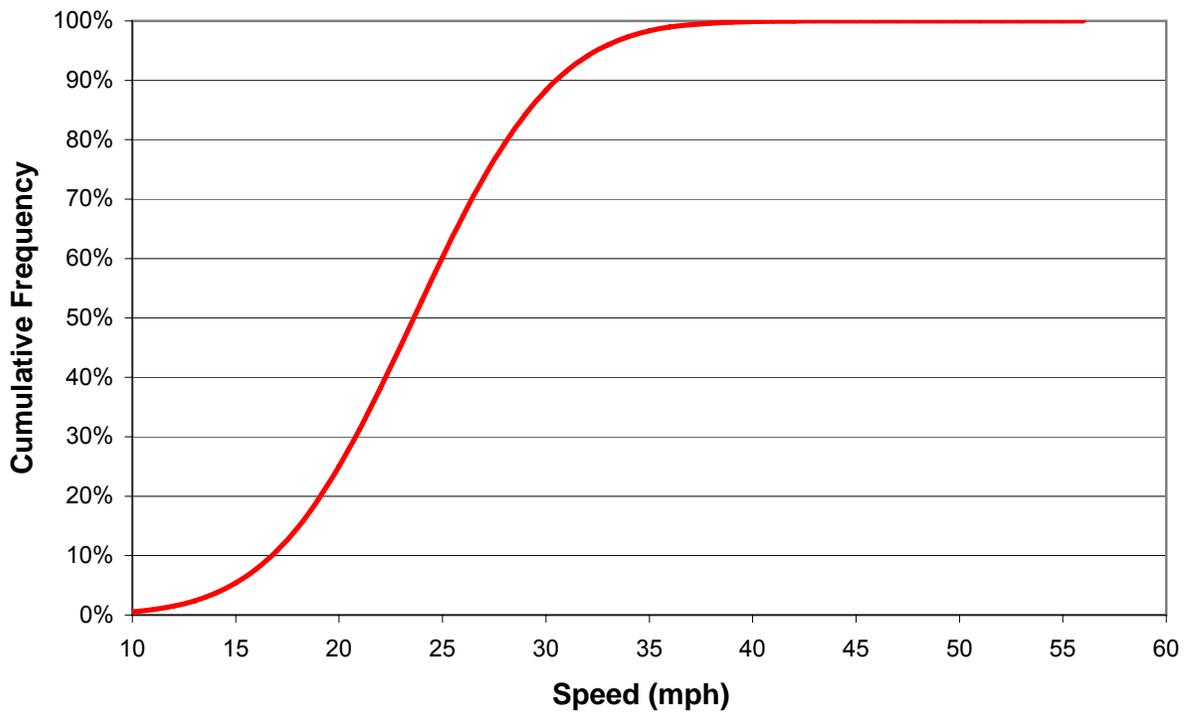
SPOT SPEED STUDY

Date: **August 17, 2005** Time: **9:30 am - 10:30 am**
 Location: **Howard Avenue btw. Hancock Avenue & Hasley Street**
 Surveyor: **The RBA Group**

Mean Speed = 23.6 mph
Standard Deviation = 5.4 mph
Margin of Error (95% Confidence) = ± 1.1 mph

Median Speed = 23.6 mph
15th Percentile Speed = 18.1 mph
85th Percentile Speed = 29.2 mph
