**New York City Department of Transportation
Office of School Safety Engineering**

School Safety Engineering Project

FINAL REPORT: C.E.S. 55 (Benjamin Franklin School), Bronx

**Prepared by
The RBA Group/Urbitran Associates**

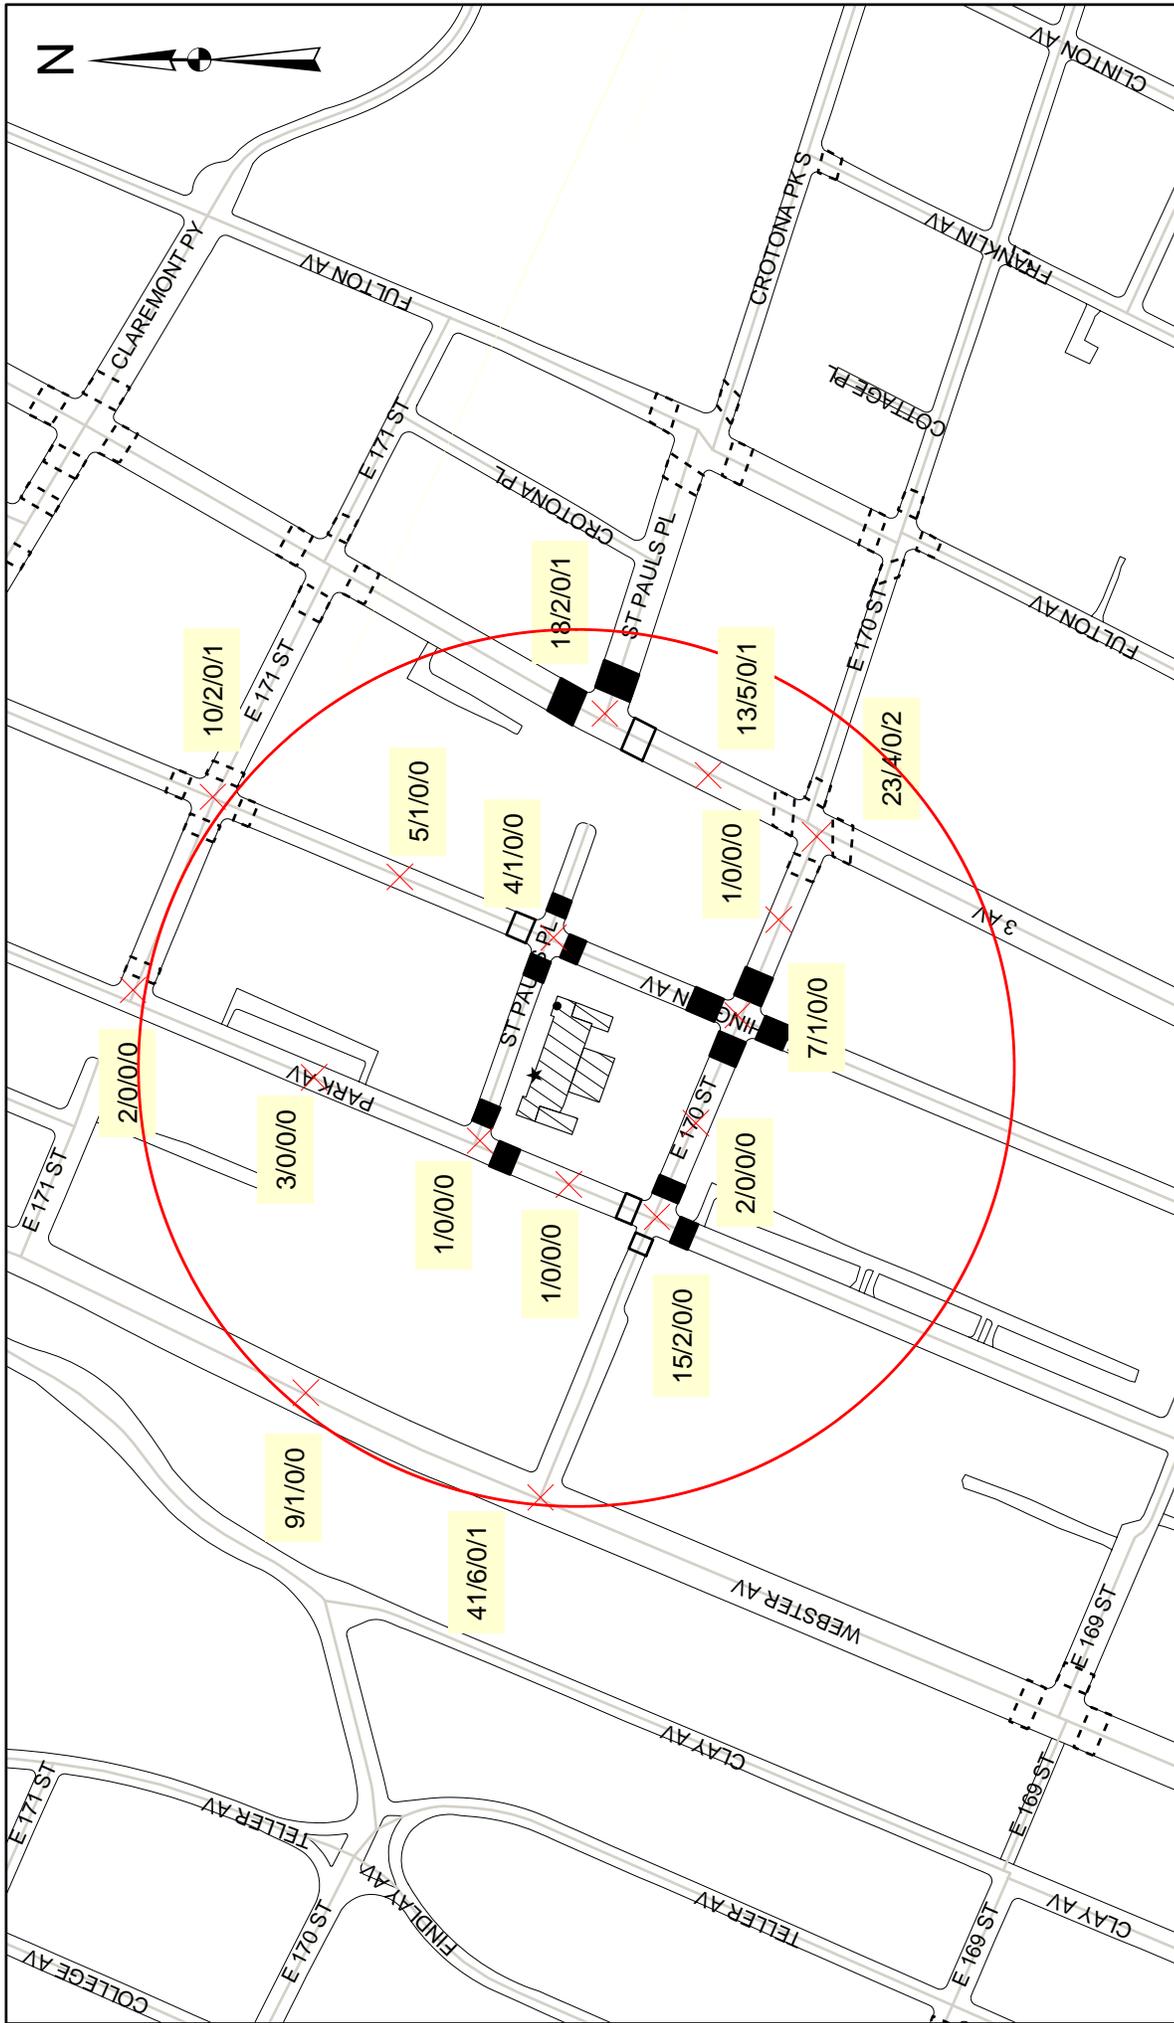
EXHIBIT 6
C.E.S. 55 BRONX
BENJAMIN FRANKLIN SCHOOL
ACCIDENT SUMMARY (1998-2000)

Exhibit 6 and Table 2 show a summary of accidents, as obtained from the New York State Department of Motor Vehicles (DMV), in the vicinity of C.E.S. 55 for the three-year period from January 1, 1998 through December 31, 2000. The DMV data provides some detail relating to the circumstances and cause of the accident. Table 3 is a summary of more recent accident data obtained from the NYC Police Department (NYPD). Though current through 2004, the NYPD data does not provide the same level of detail as the DMV data.

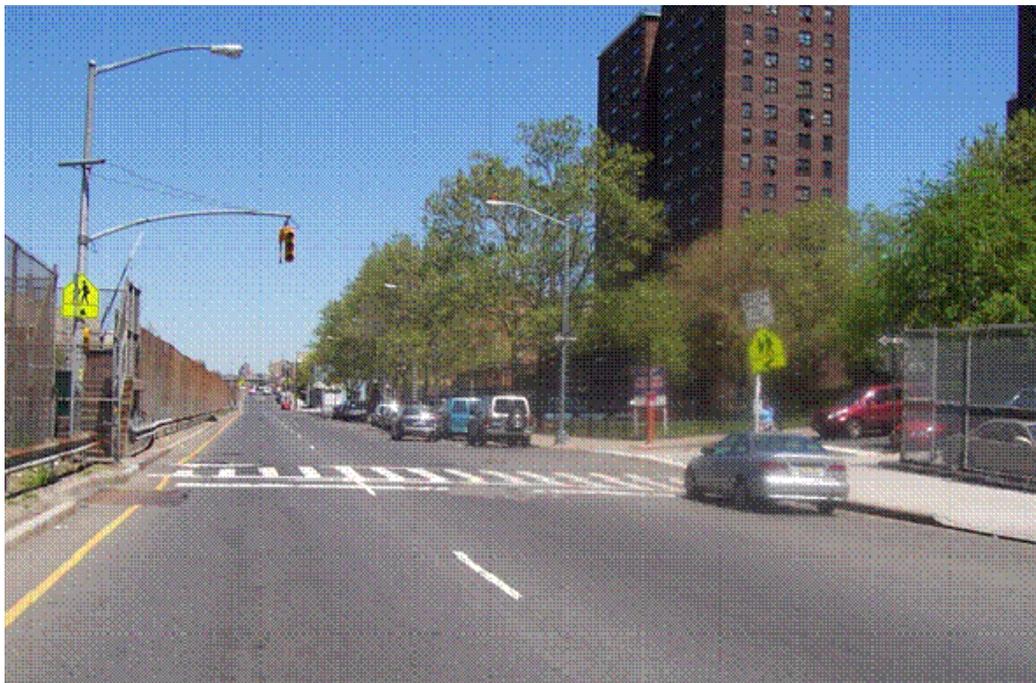
Figure 5: Looking north along Park Avenue across west end of St. Paul's Place, guide rail and fencing block approaching driver's view of pedestrian bridge landing area

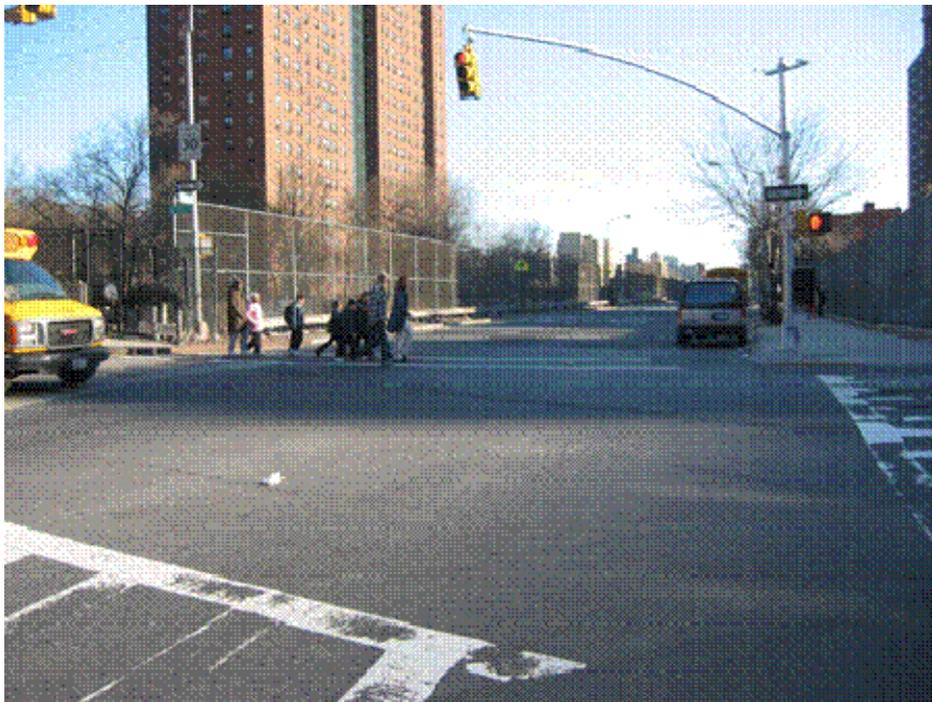
Field observation noted that children are utilizing the north and west crosswalks (as seen in Figure 8 and 9), when walking to school, and not many were observed utilizing the designated school crosswalks across the south and east legs of the intersection.

Figure 8: Looking north along Park Avenue across East 170th Street

Field observation noted that children are utilizing the north and east crosswalks of the 170th Street & Park Avenue intersection (as seen in Figures 8 and 9) when walking to school, and few students were observed utilizing the designated school crosswalks across the south and east legs of the intersection.

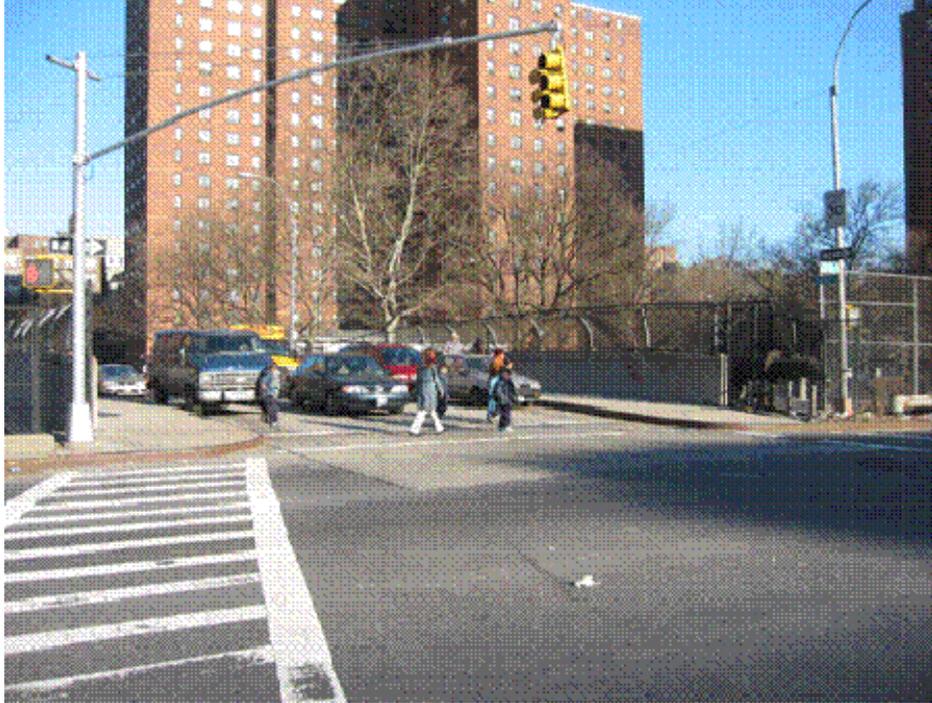
Figure 9: Looking west on East 170th Street across Park Avenue

- Missing pedestrian ramps for all four locations on west side of Park Avenue on both north and south corners of East 170th Street (see Figure 9).
- Utility pole obstructing the crosswalk located across the north leg of Third Avenue on the west side of Third Avenue at St Paul's Place (see Figure 15).

- Install the pedestrian ramps for all four locations on the west side of Park Avenue that are missing on both north and south corners of East 170th Street (see Figure 9).

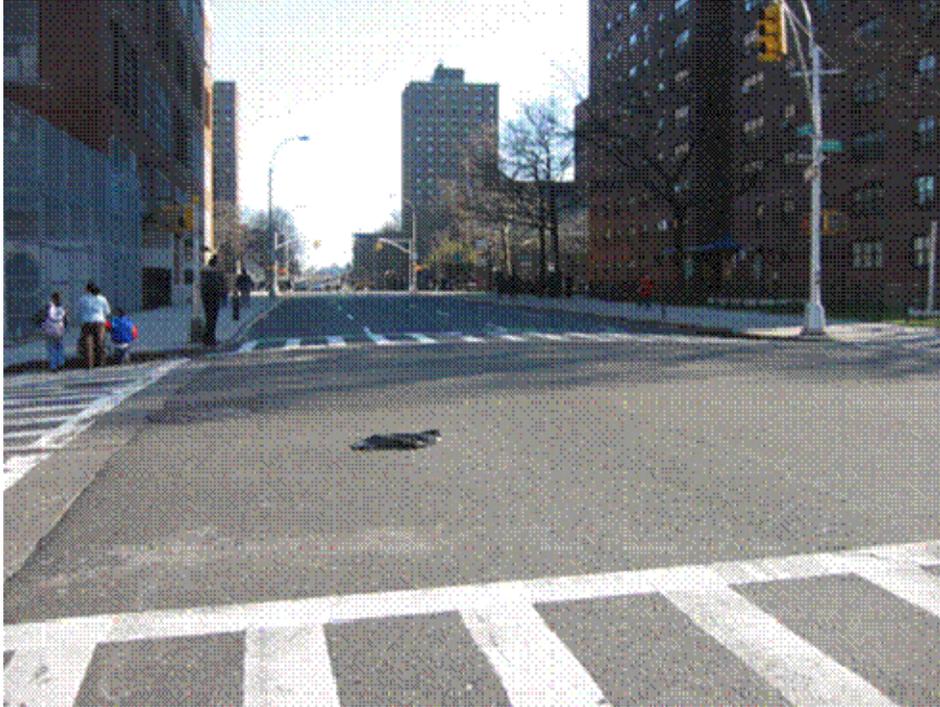
Figure 10: Looking north along Washington Avenue across East 170th Street

- A misaligned pedestrian ramp on the northwest corner of East 170th Street & Washington Avenue for the crosswalk located across the west leg (see Figure 10)

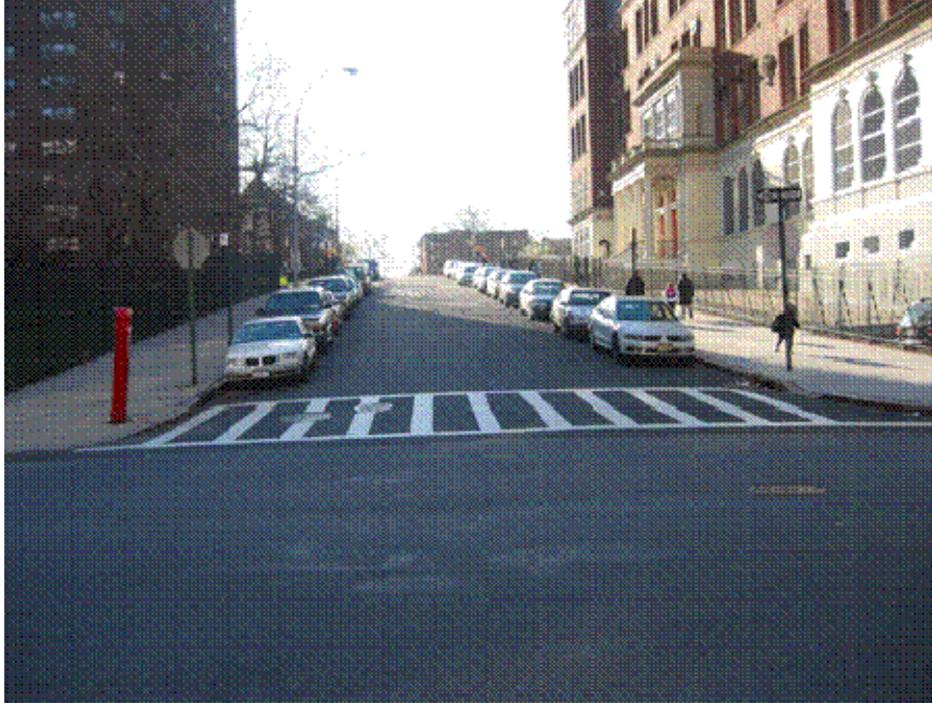
Figure 12: Looking east along St. Paul's Place across Park Avenue, note misaligned pedestrian ramps and utility stanchion obstructing crosswalk path

Several pedestrian ramps are misaligned, missing, or obstructed by utility poles at several locations as described in Section 3.8.2 - Pedestrian Ramps. It is therefore recommended to:

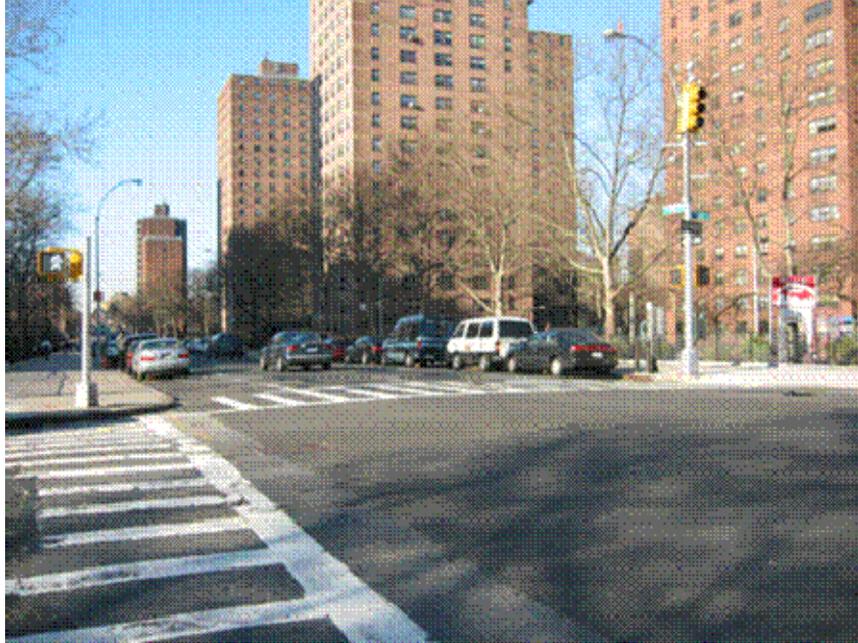
- A missing pedestrian ramp on the southeast corner of Washington Ave & East 170th Street for the crosswalk located across the south leg (see Figure 13).

Figure 13: Looking south along Washington Avenue across East 170th Street, note traffic signal pole obstructing the crosswalk on south east corner

- A traffic signal pole on the southeast corner of Washington Ave & East 170th Street is obstructing the path of the crosswalk located across the east leg (see Figure 13). It is therefore recommended to relocate and reconstruct the ramp located at the southeast corner of the Washington Avenue and East 170th Street.

- Install a pedestrian ramp on the southeast corner of Washington Ave & East 170th Street that is missing for the crosswalk located across the south leg (see Figure 13).

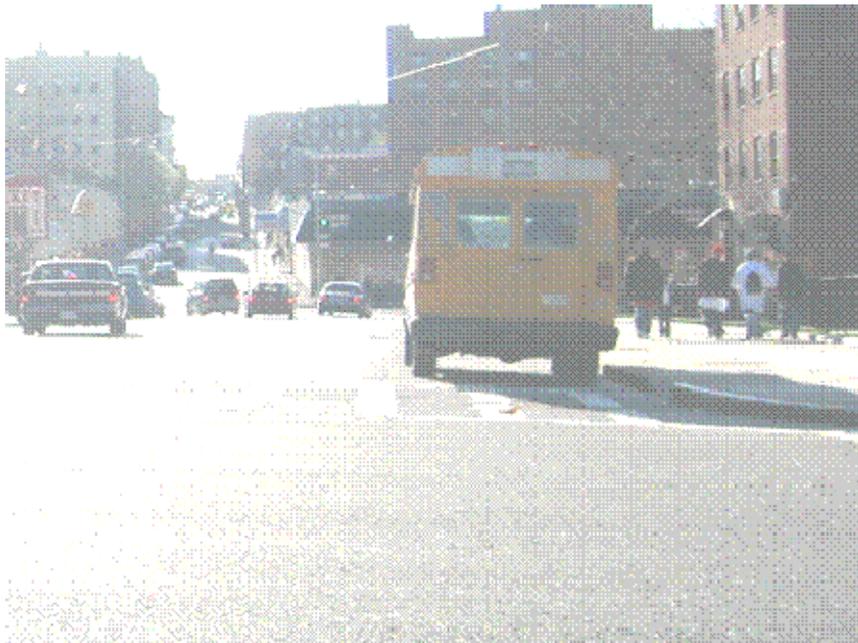
Figure 14: Looking at small and misaligned pedestrian ramp on south east corner of Washington Ave & East 170th St

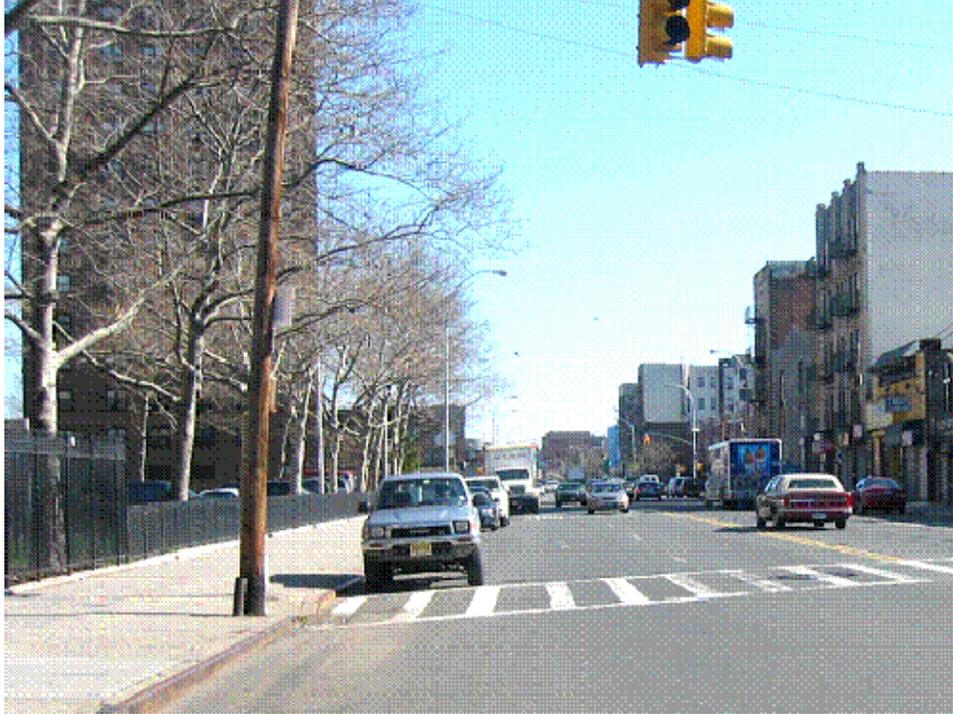
Figure 15: Looking north along Third Avenue across St. Paul's Place at utility pole obstructing west end of crosswalk located across north leg of intersection

- Relocate and reconstruct the ramp located on the west side of Third Avenue, as a utility pole is obstructing the crosswalk located across the north leg of Third Avenue at St Paul's Place (see Figure 15).

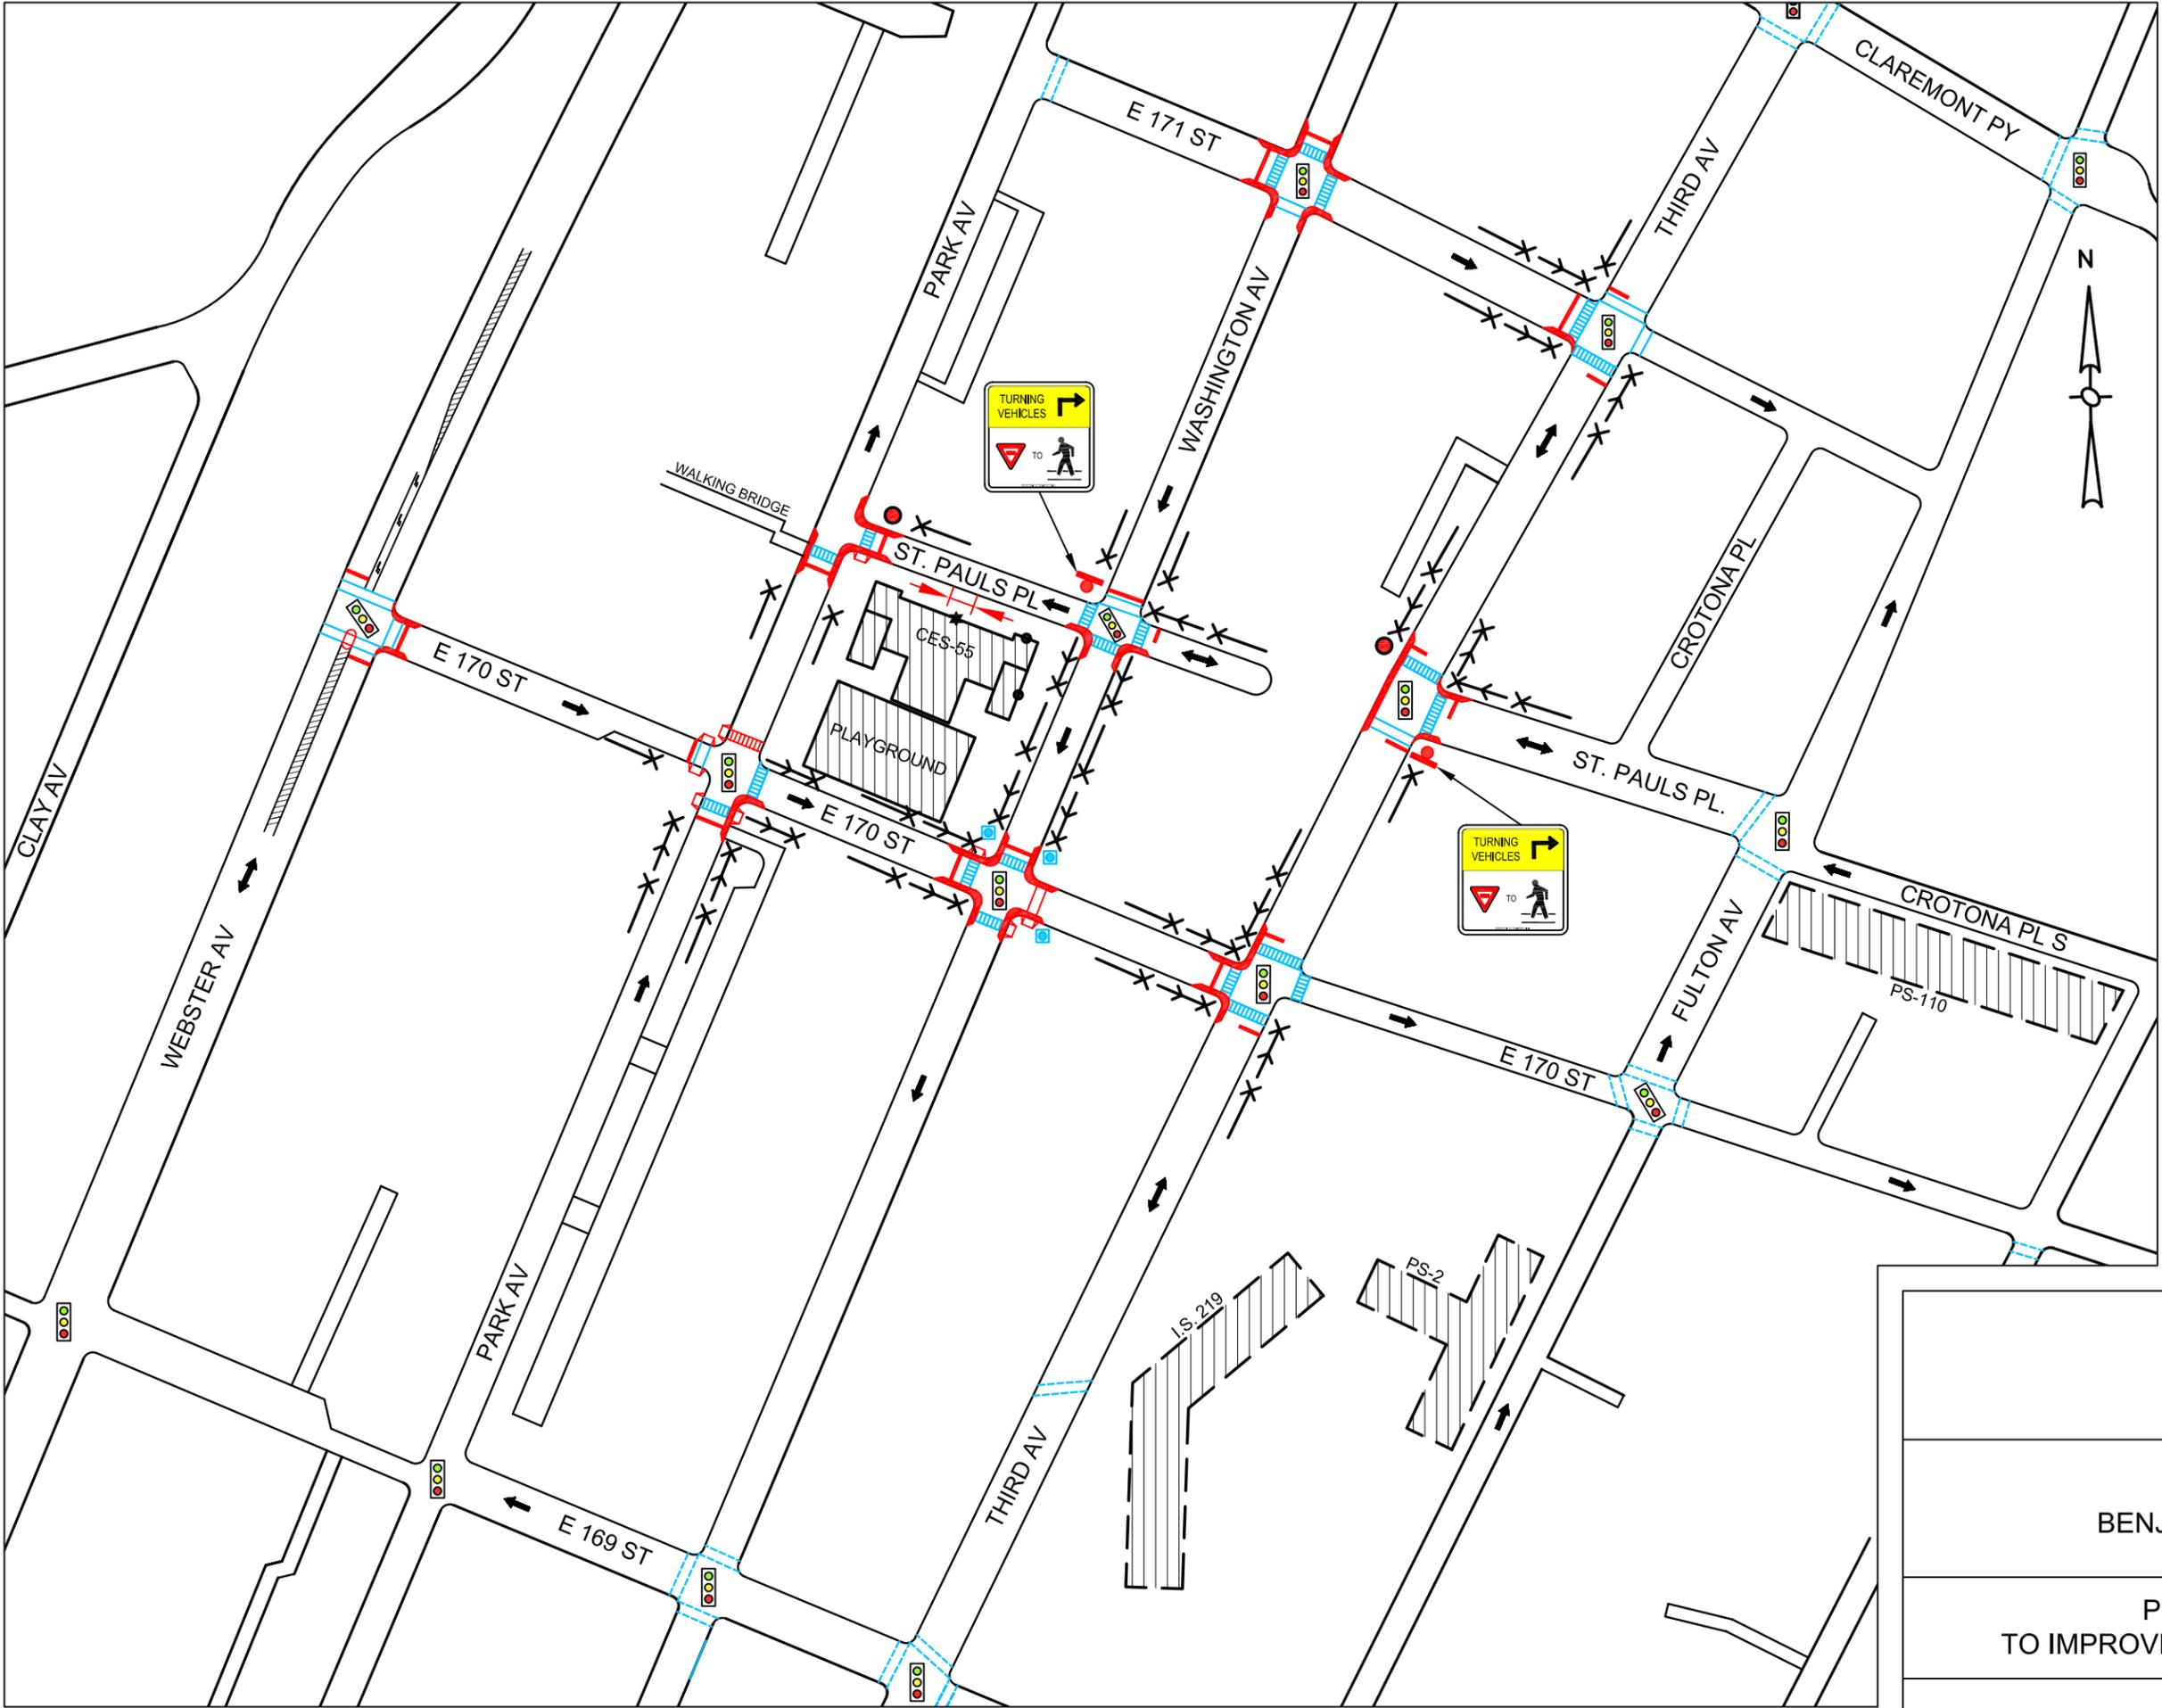
PROPOSED MEASURES
TO IMPROVE SCHOOL PEDESTRIAN SAFETY

This section describes proposed measures to improve school pedestrian safety around C.E.S. 55. The proposed recommendations are divided into short-term and long-term measures. Short-term measures are those that potentially can be performed in-house. Long-term measures involve capital improvements. Each of the short- and long-term measures recommended for C.E.S. 55 is discussed as follows, and is shown in more detail in Exhibit 7 at the end of this section.

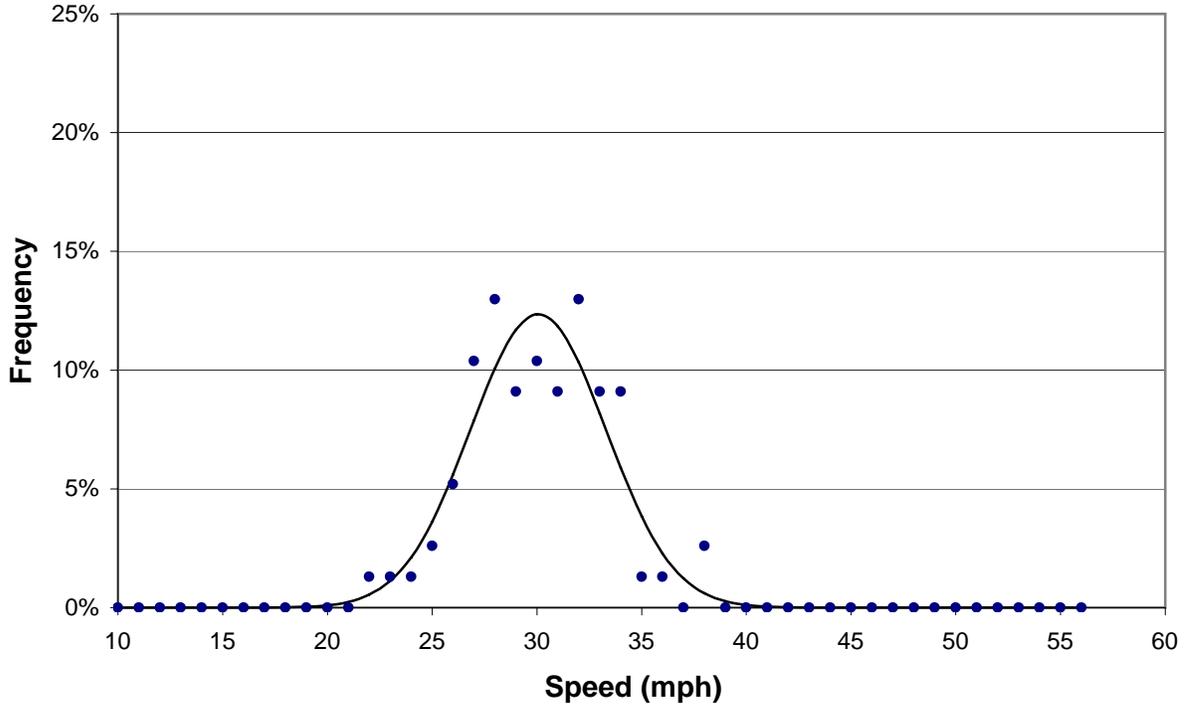
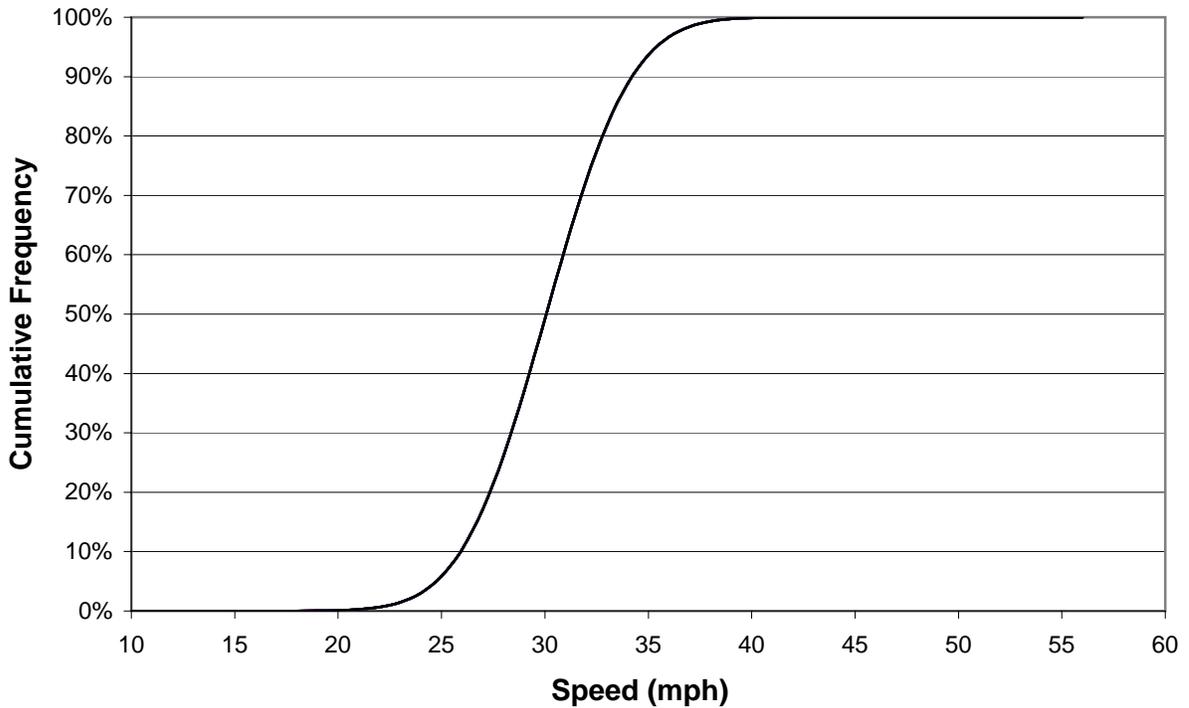
Date: **May 4, 2006** Time: **10:30-11:30 am**
 Location: **Park Avenue between E.170 Street and St. Paul's Place**
 Surveyor: **Richard Calvache**

Mean Speed = 30.1 mph
Standard Deviation = 3.2 mph
Margin of Error (95% Confidence) = ± 0.7 mph

Median Speed = 30.1 mph
15th Percentile Speed = 26.7 mph
85th Percentile Speed = 33.4 mph

The northbound vehicles on Park Avenue between St. Paul's Place and East 170th Street were found to be traveling with an 85th percentile speed of 33 mph. The 85th percentile speed is considered to be the representative speed for the street segment. Speeds above the 30 mph threshold would indicate a speeding problem and may require appropriate traffic calming measures.

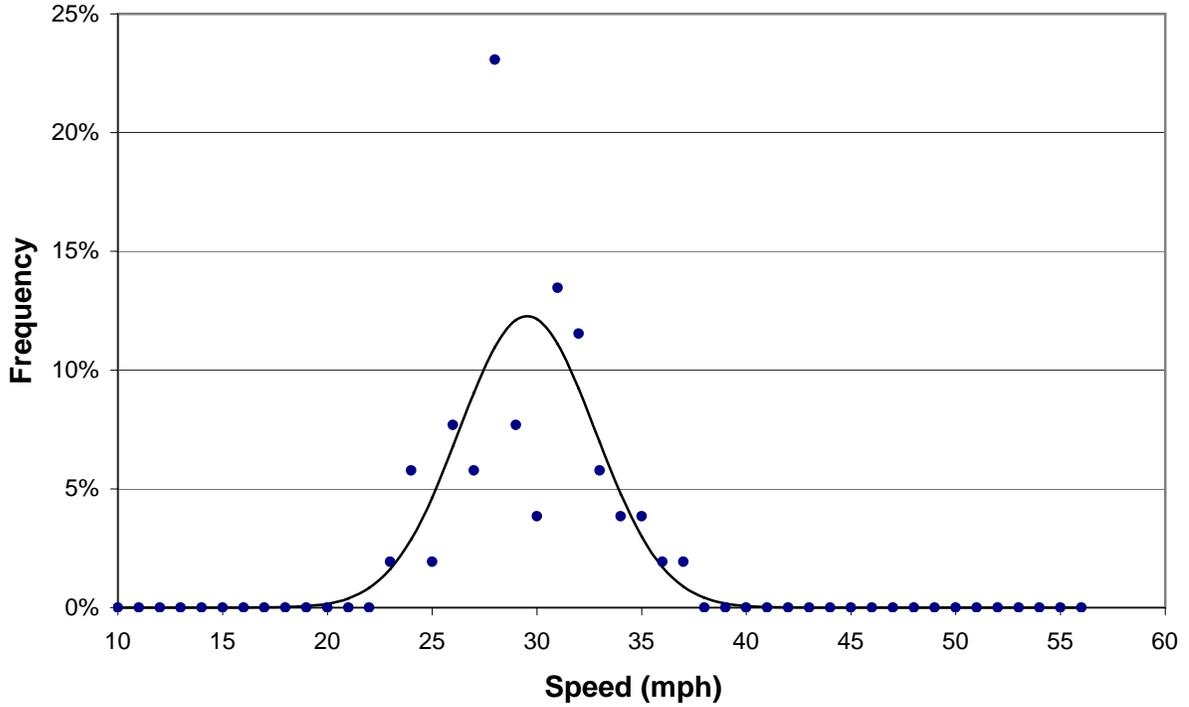
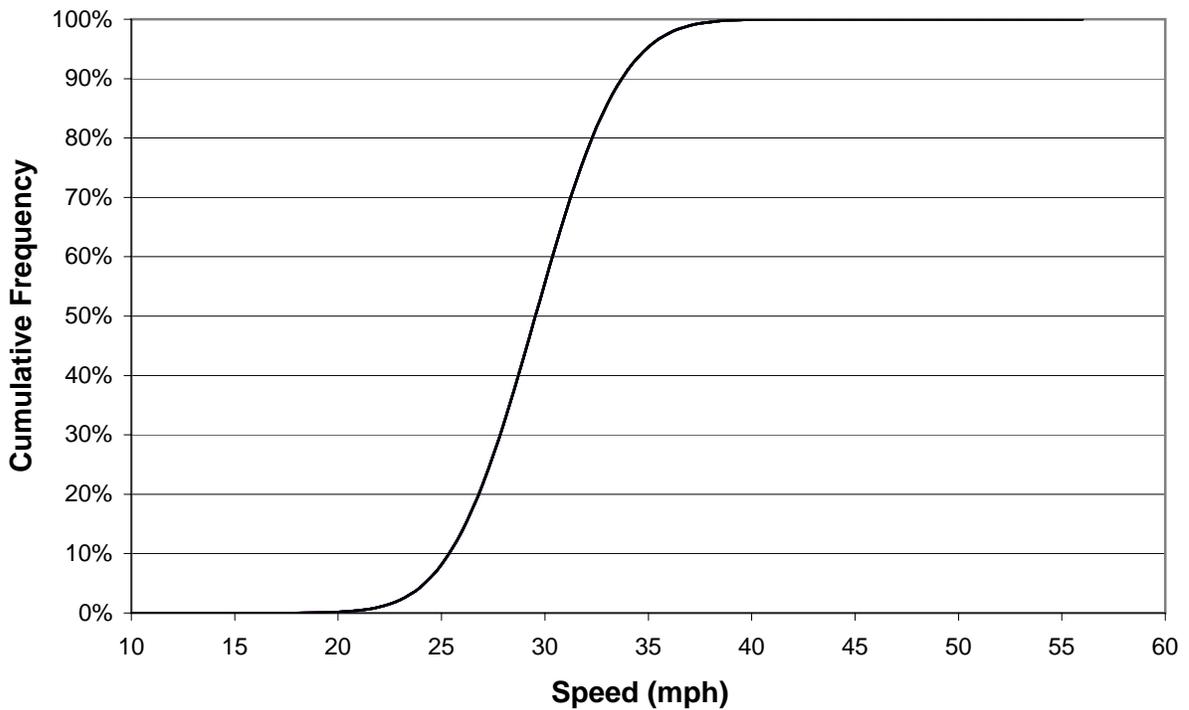
Date: **May 23, 2005** Time: **9:30 am**
 Location: **Washington Ave between St. Pauls & 170 St**
 Surveyor: **Richard Calvache**

Mean Speed = 29.5 mph
Standard Deviation = 3.3 mph
Margin of Error (95% Confidence) = ± 0.9 mph

Median Speed = 29.5 mph
15th Percentile Speed = 26.2 mph
85th Percentile Speed = 32.9 mph

The southbound vehicles on Washington Avenue between St. Paul's Place and East 170th Street were found to be traveling with an 85th percentile speed was 33 mph. The 85th percentile speed is considered to be the representative speed for the street segment. Speeds above the 30 mph threshold would indicate a speeding problem and may require appropriate traffic calming measures.
