**New York City Department of Transportation
Office of School Safety Engineering**

School Safety Engineering Project

FINAL REPORT: M.S. 399 (The Elizabeth Barrett Browning School), Bronx

**Prepared by
The RBA Group and URBITRAN Associates Inc.**

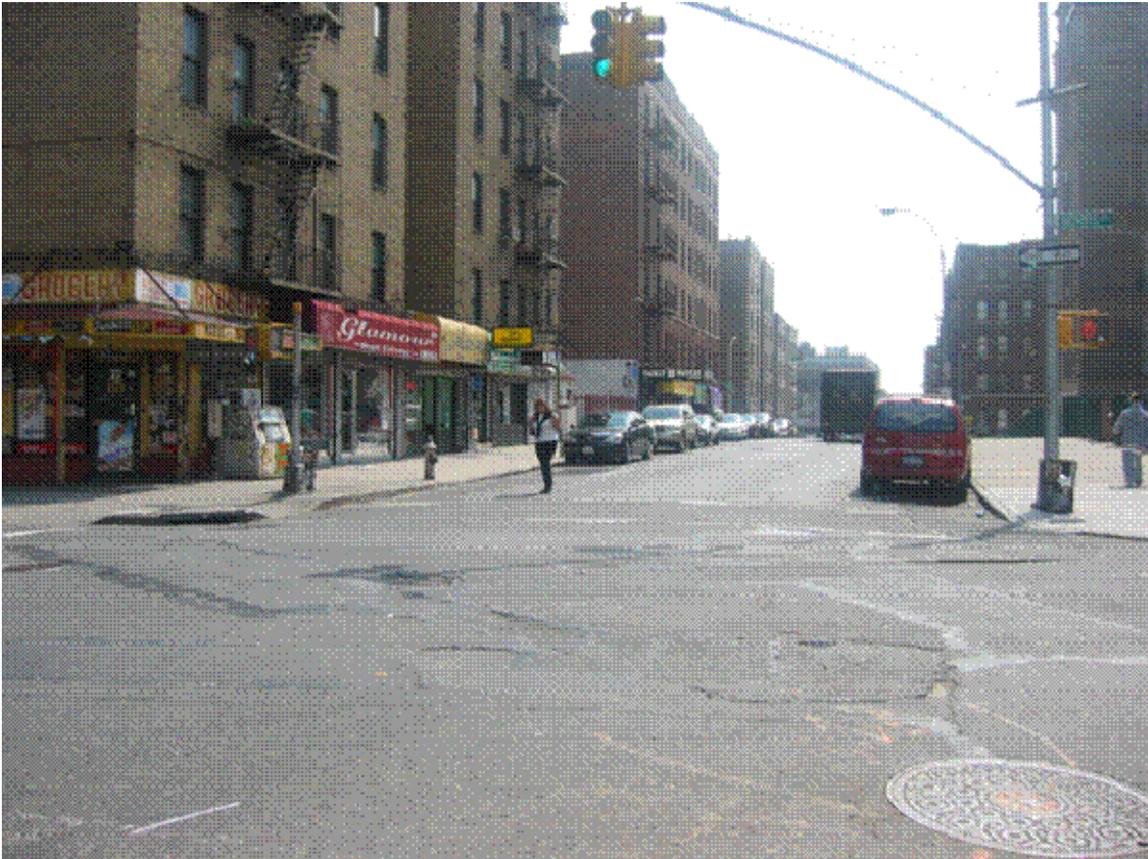
There is a fenced-in playground on the west side of Morris Avenue, across from the school, that attracts students from M.S. 399. There are various stores along East 184th Street across from the school, such as grocery stores, that also attract M.S. 399 students.

Figure 2: Looking northeast at a grocery store and other stores across the street from M.S. 399

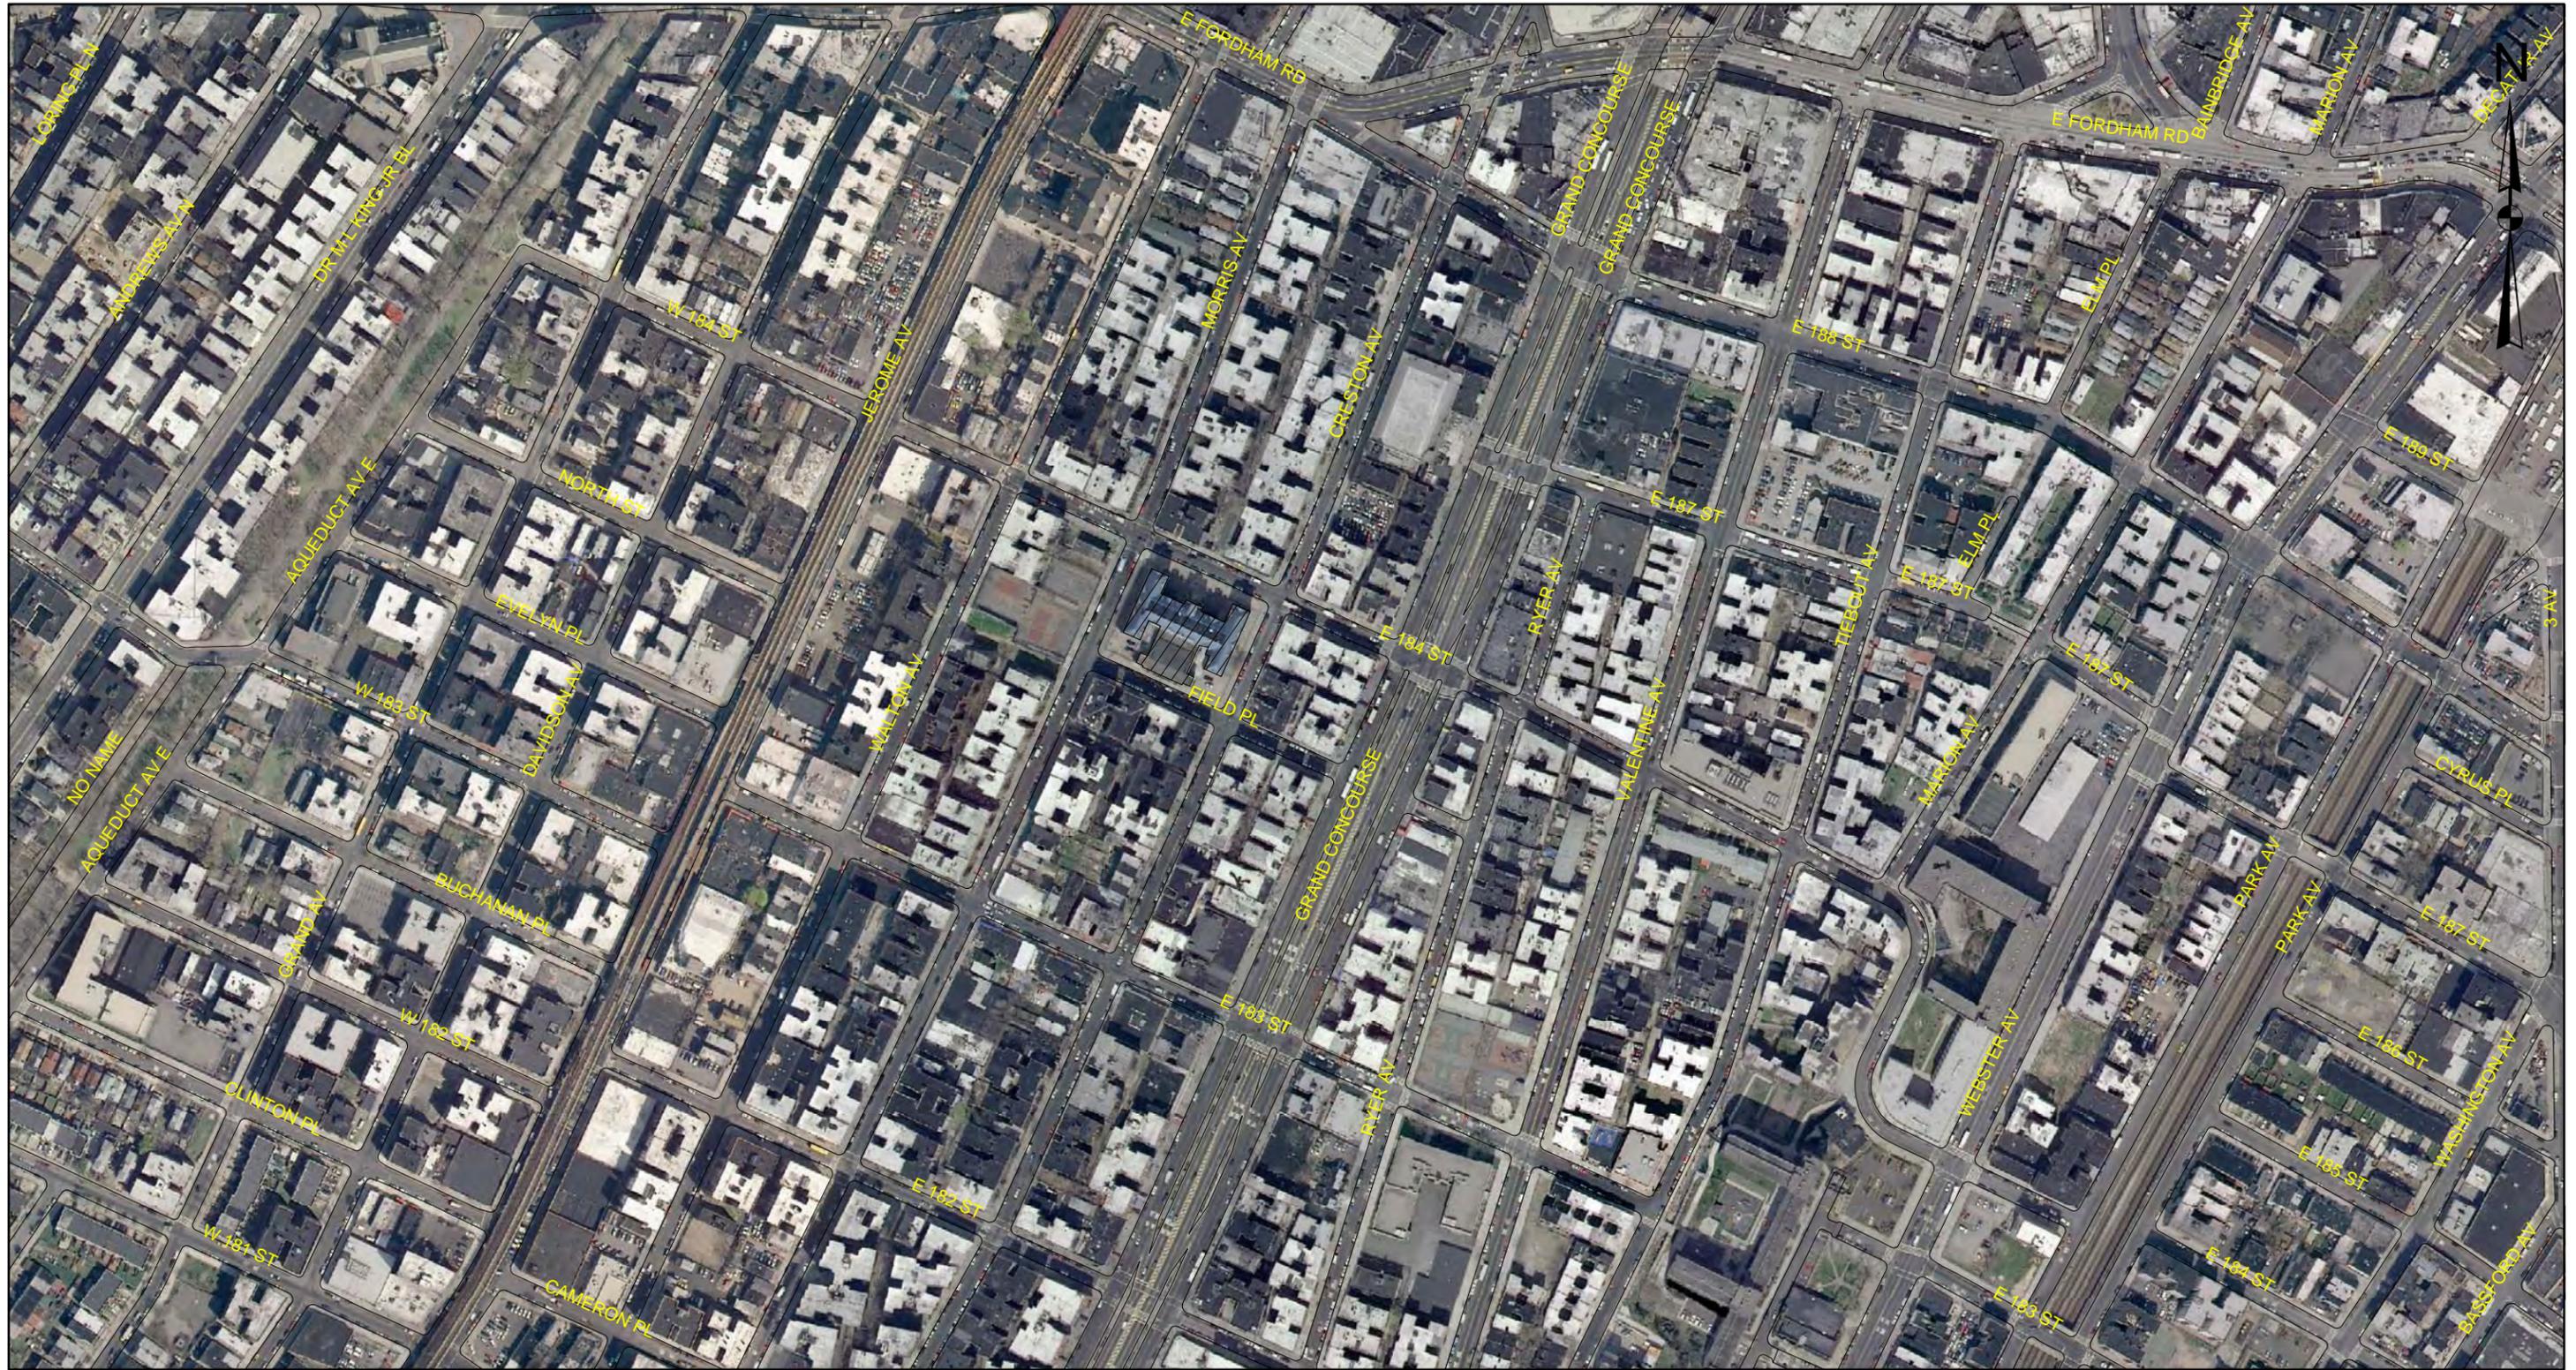
EXHIBIT 1

Exhibit 1 shows an aerial view of the neighborhood surrounding the school. M.S. 399 is bounded by Creston Avenue to the east, Field Place to the south, Morris Avenue to the west, and East 184th Street to the north. The area surrounding the school is generally residential in character with some commercial uses.

AERIAL PHOTOGRAPH

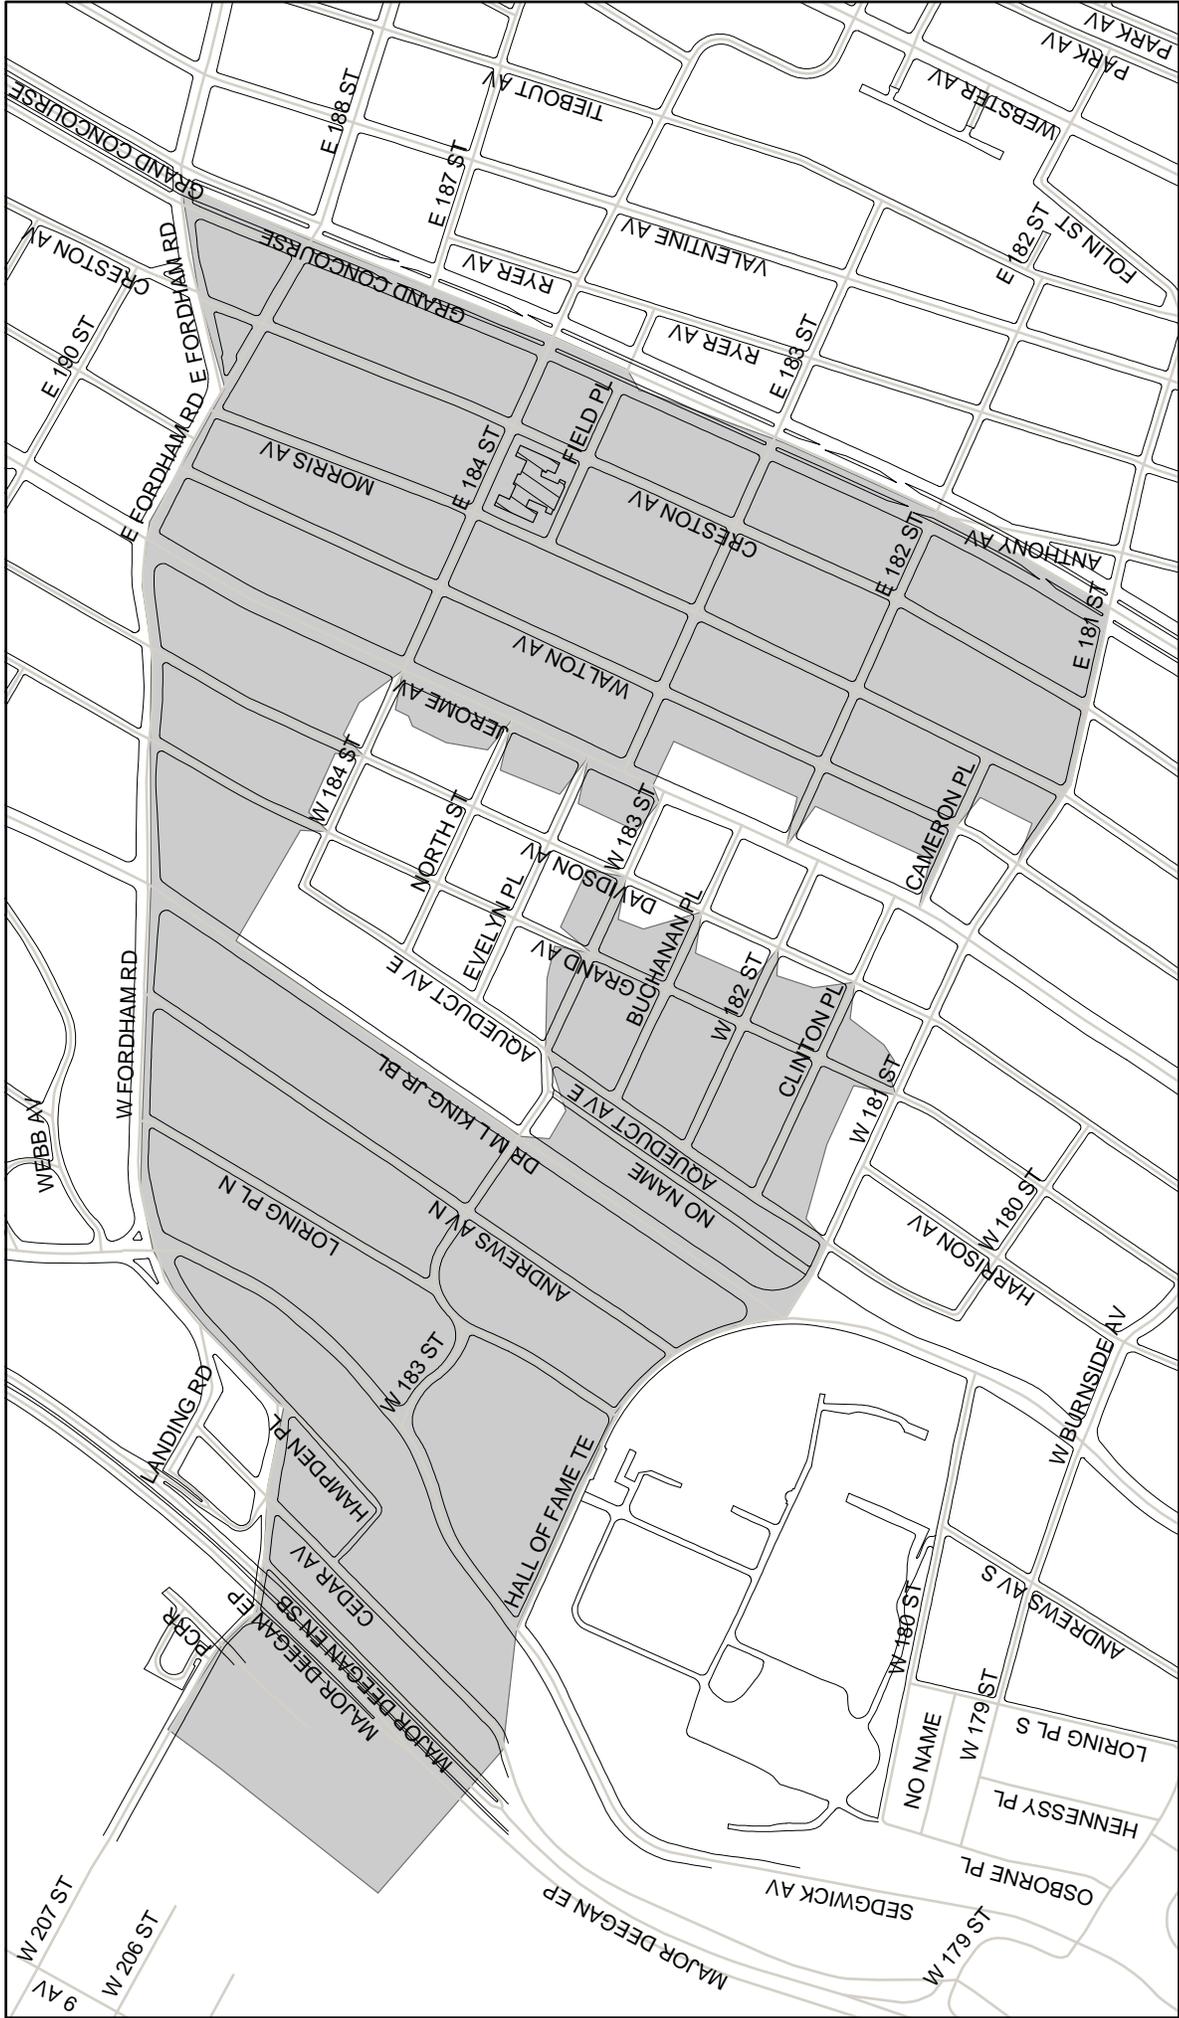
EXHIBIT 2

The school’s “catchment area” as defined by the Department of Education is shown in Exhibit 2.

The school’s catchment area is roughly bounded by the Grand Concourse to the east (although some of their students do come from across the Grand Concourse); West 181st Street to the south (with some exceptions to the area between Jerome Avenue and Martin Luther King Jr. Boulevard/University Avenue); the Major Deegan Expressway to the west; and Fordham Road to the north..

CATCHMENT AREA

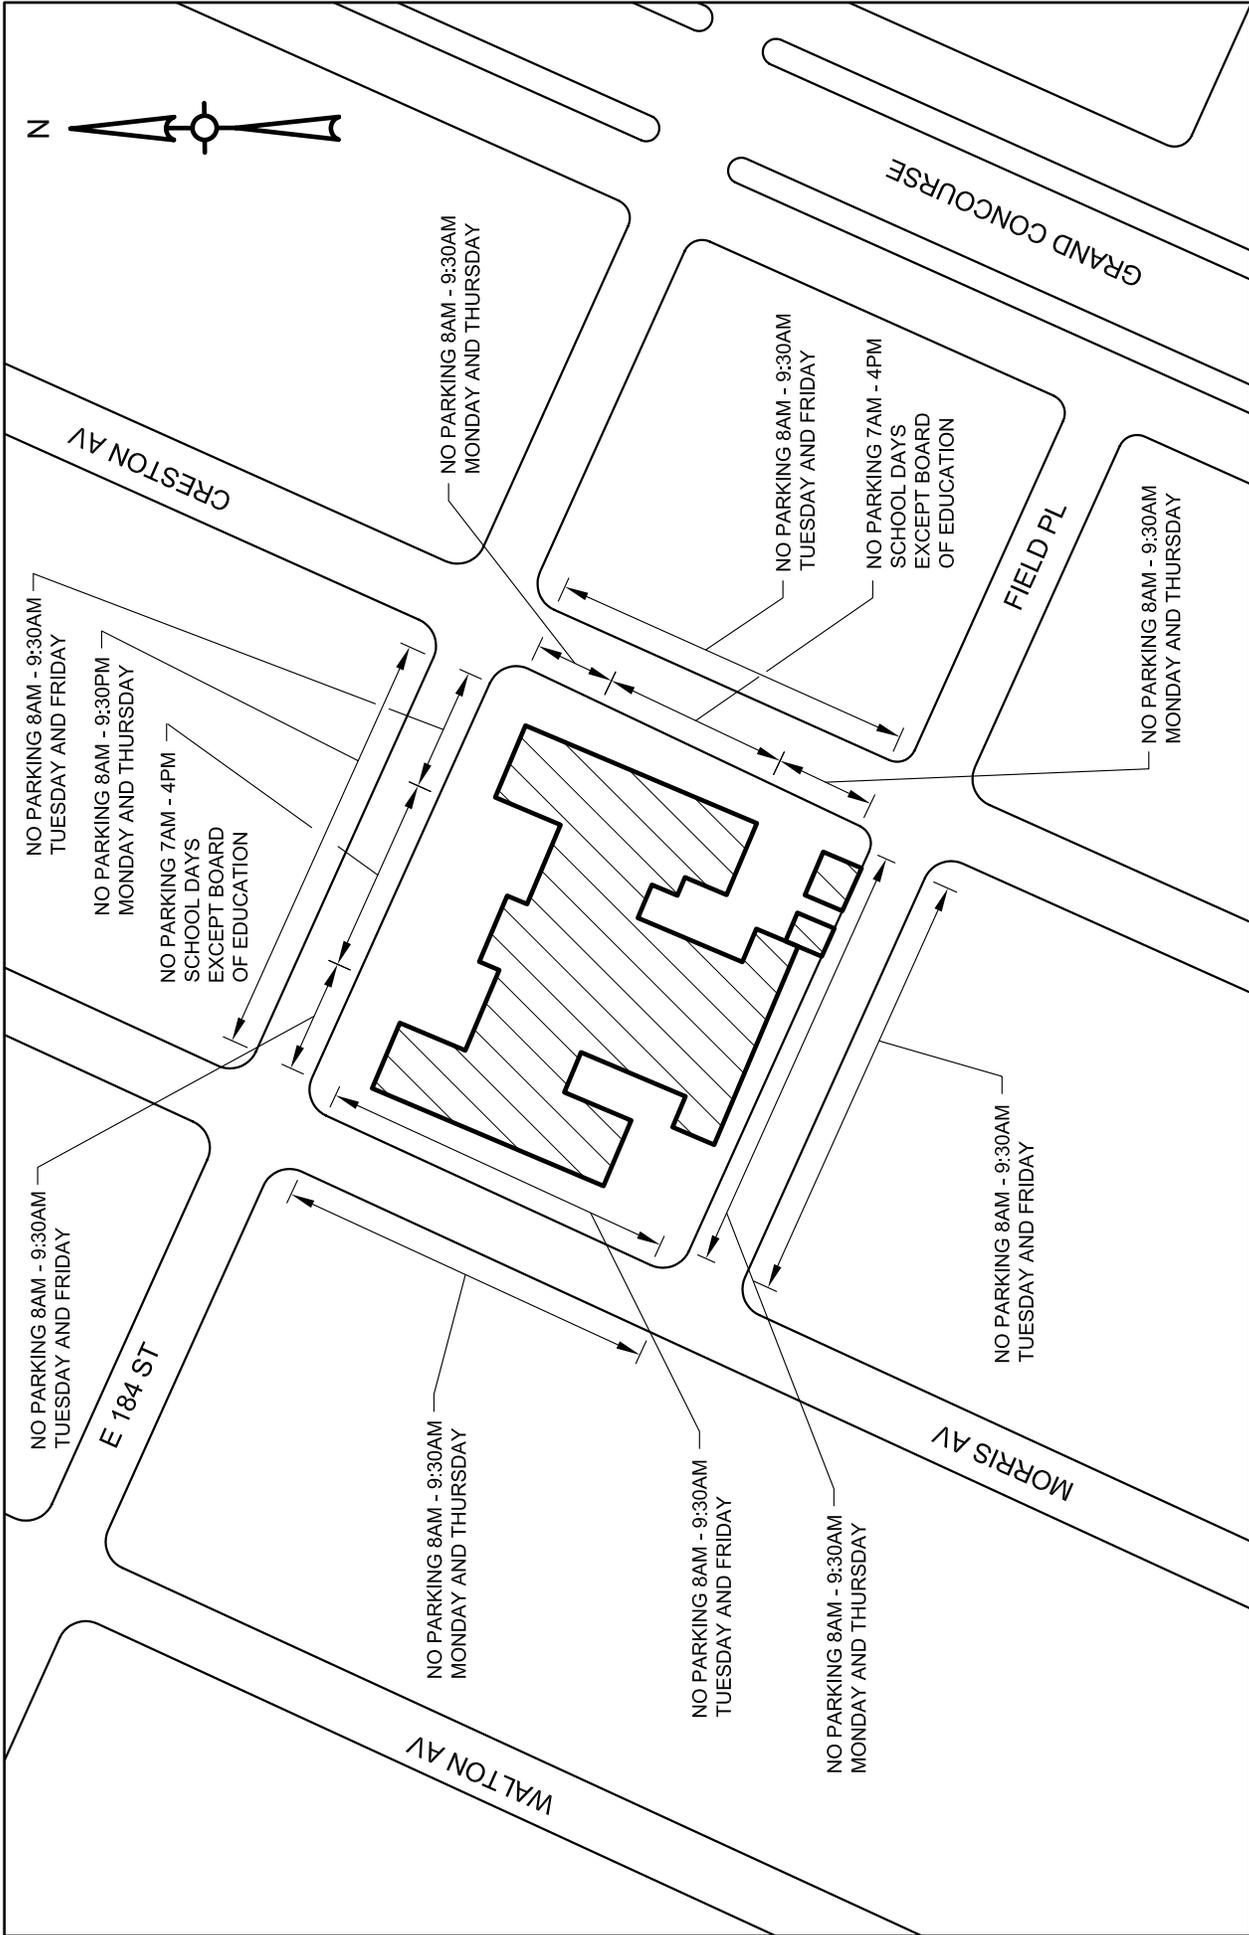
EXHIBIT 4
M.S. 399/M.S. 319 BRONX

Parking regulations around the school block are shown in Exhibit 4.

EXISTING PARKING REGULATIONS

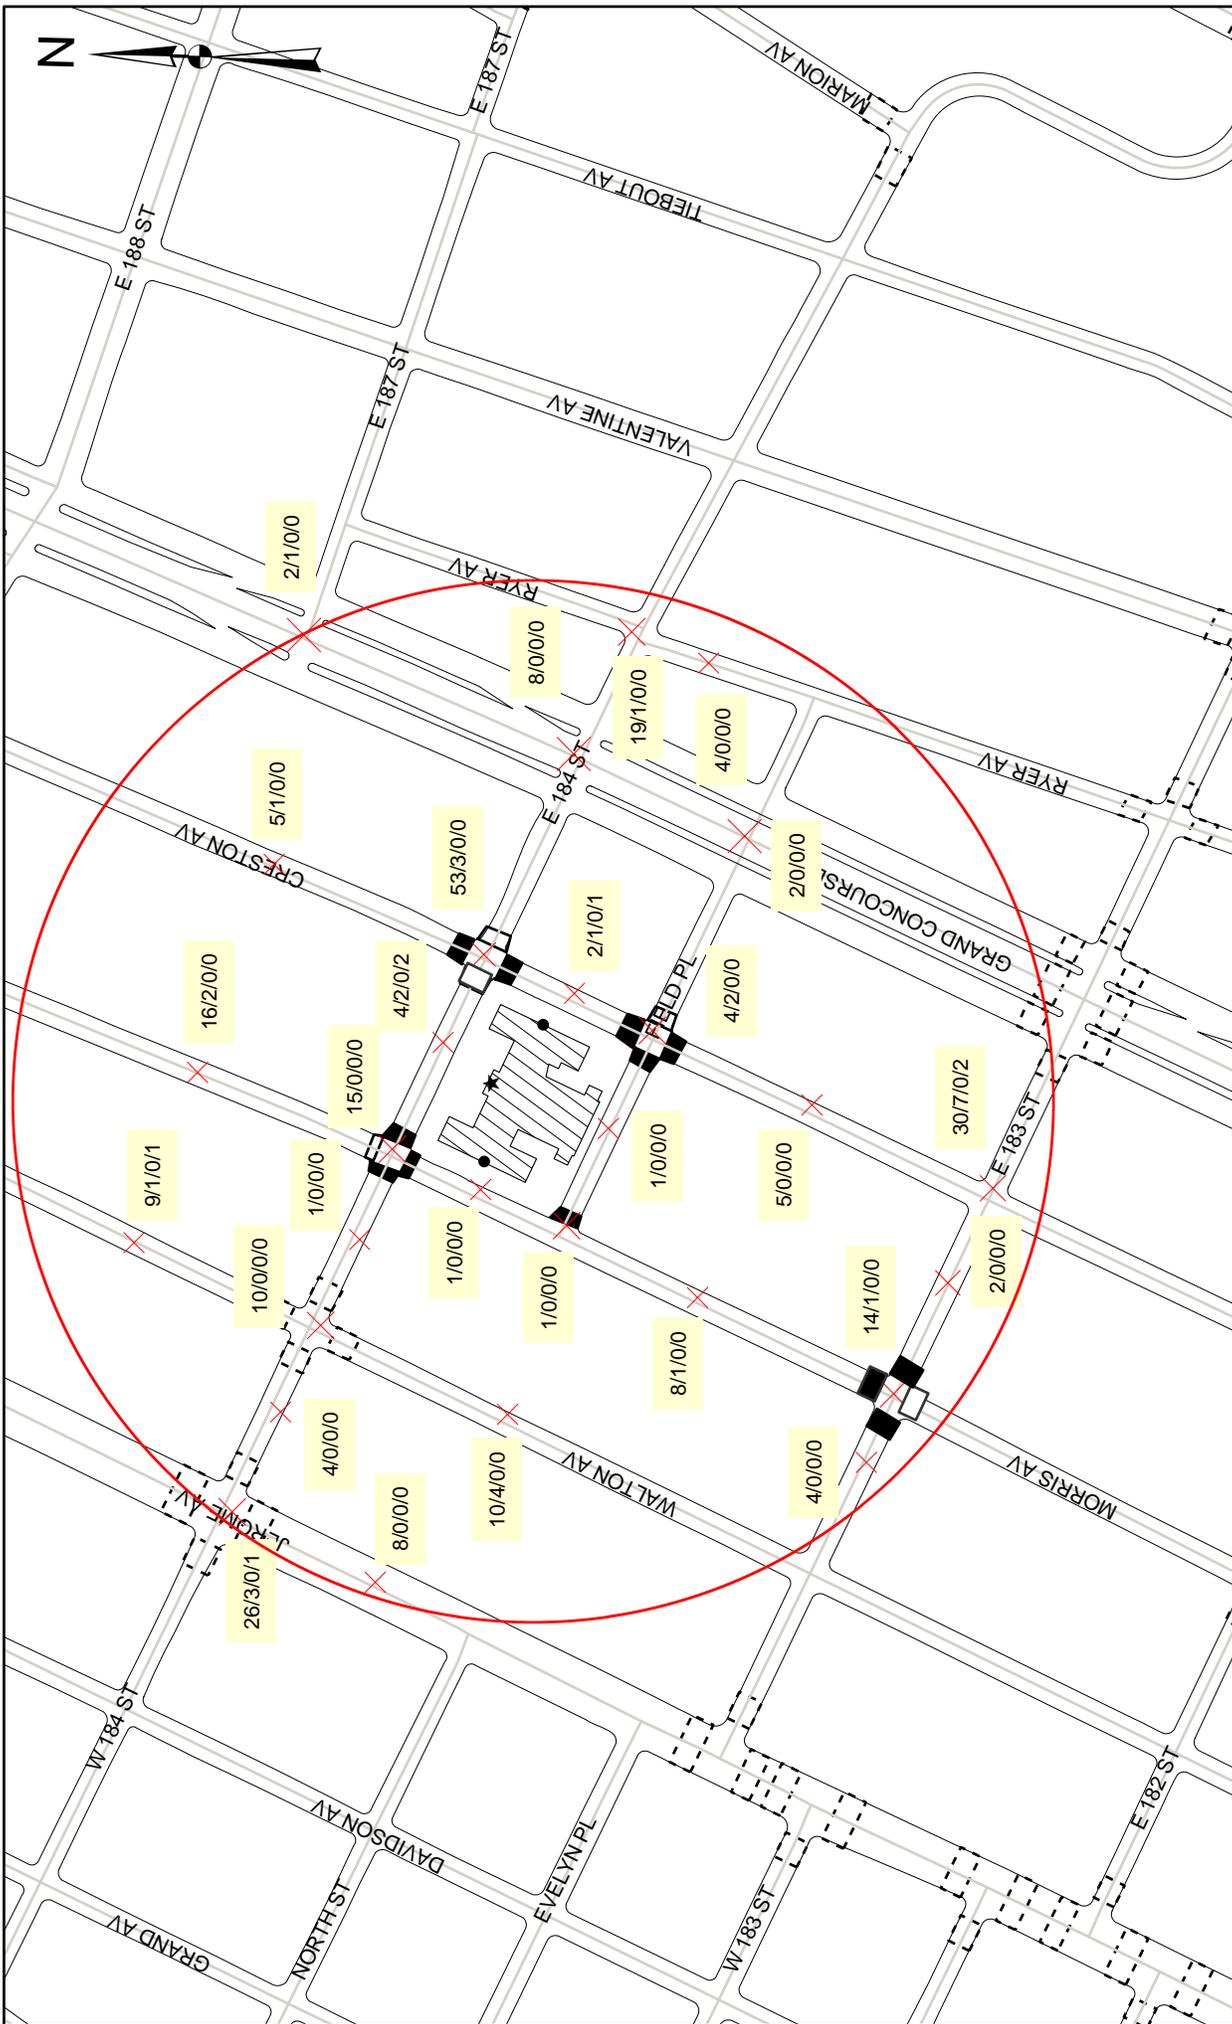
EXHIBIT 5

Exhibit 5 and Table 2 show a summary of accidents, as obtained from the New York State Department of Motor Vehicles (DMV), in the vicinity of M.S. 399 for the three-year period from January 1, 1998 through December 31, 2000. The DMV data provides some detail relating to the circumstances and cause of the accident. Table 3 is a summary of more recent accident data obtained from the NYC Police Department (NYPD). Though current through 2004, the NYPD data does not provide the same level of detail as the DMV data.

**M.S. 399 / M.S. 319 BRONX
ACCIDENT SUMMARY (1998-2000)**

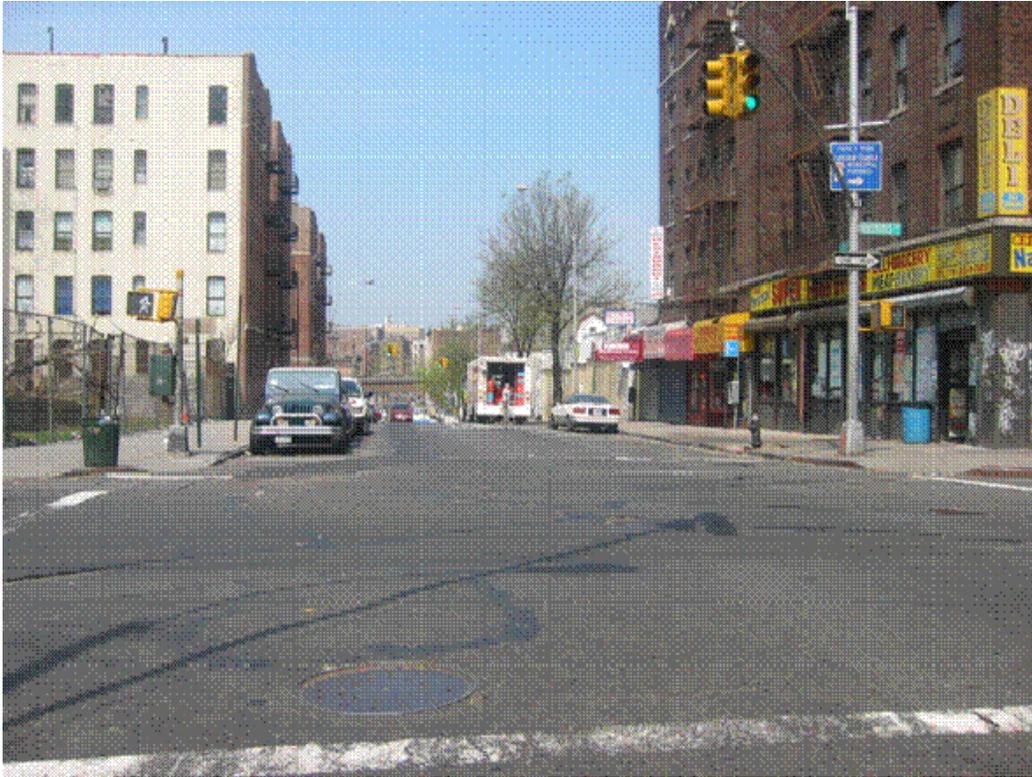
This is a signalized intersection with school crosswalks located across the east leg of East 184th Street and the north and south legs of Morris Avenue. East 184th Street is a two-way street with one traffic lane and one parking lane on each side of the roadway. Morris Avenue is a one-way northbound street with one traffic lane and parking on both sides of the roadway. Higher volumes of traffic use East 184th Street. All M.S. 399 students enter and exit the building using the Morris Avenue entrance between East 184th Street and Field Place. There are problems crossing Morris Avenue during fire drills and dismissals, since drivers often will not stop for students crossing the street, even with faculty out in the street indicating for them to stop.

The school principal reported a speeding problem on Morris Avenue. Therefore, a speed survey was conducted on Morris Avenue between Field Place and East 184th Street in order to verify the existence of a speeding problem and to determine its extent.

The northbound vehicles on Morris Avenue between Field Place and East 184th Street were found to be traveling with an 85th percentile speed of 26 mph.

Figure 3: Looking west along East 184th Street across Morris Avenue (school is off to the left)

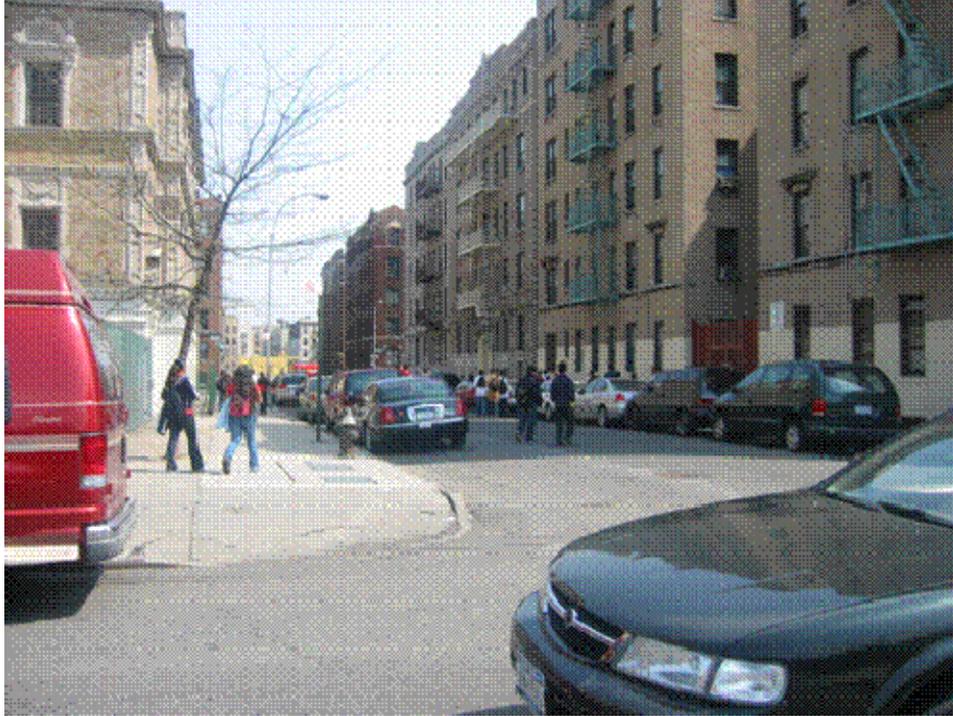
This is an unsignalized T-intersection with a school crosswalk located across the east leg of Field Place. Morris Avenue is a one-way northbound street with one traffic lane and parking on both sides of the roadway. Field Place is the stem of the “T” and is a one-way eastbound street with one traffic lane and parking on both sides of the roadway.

This intersection was the site of one accident between 1998 and 2000 (Table 2). There were no pedestrian fatalities during this time period.

Figure 4: Looking east along Field Place from Morris Avenue (school is on the left)

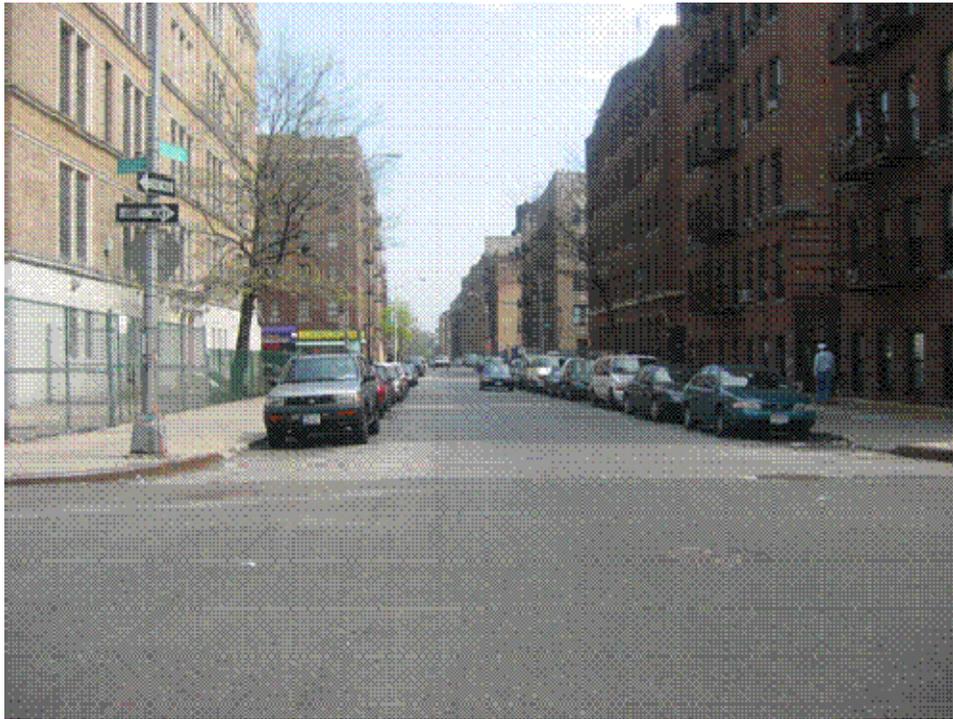
This is an unsignalized intersection with school crosswalks located across the north and south legs of Creston Avenue and the west leg of Field Place. Creston Avenue is a one-way southbound street with one traffic lane and parking on both sides of the roadway. Field Place is a one-way eastbound street with one traffic lane and parking on both sides of the roadway. Higher volumes of traffic use Creston Avenue.

This intersection was the site of four accidents between 1998 and 2000 (Table 2). Two of these were pedestrian accidents, but were not school-related. There were no pedestrian fatalities during either this period.

Figure 5: Looking north along Creston Avenue across Field Place (school is on the left)

- Consider curb extensions at the following locations:
 - Northwest corner of East 183rd Street and Morris Avenue intersection.
 - Northeast corner of Morris Avenue and Field Place intersection.
 - Northeast and southeast corners of Creston Avenue and East 184th Street intersection.
 - Northwest and southwest corners of Creston Avenue and Field Place intersection.

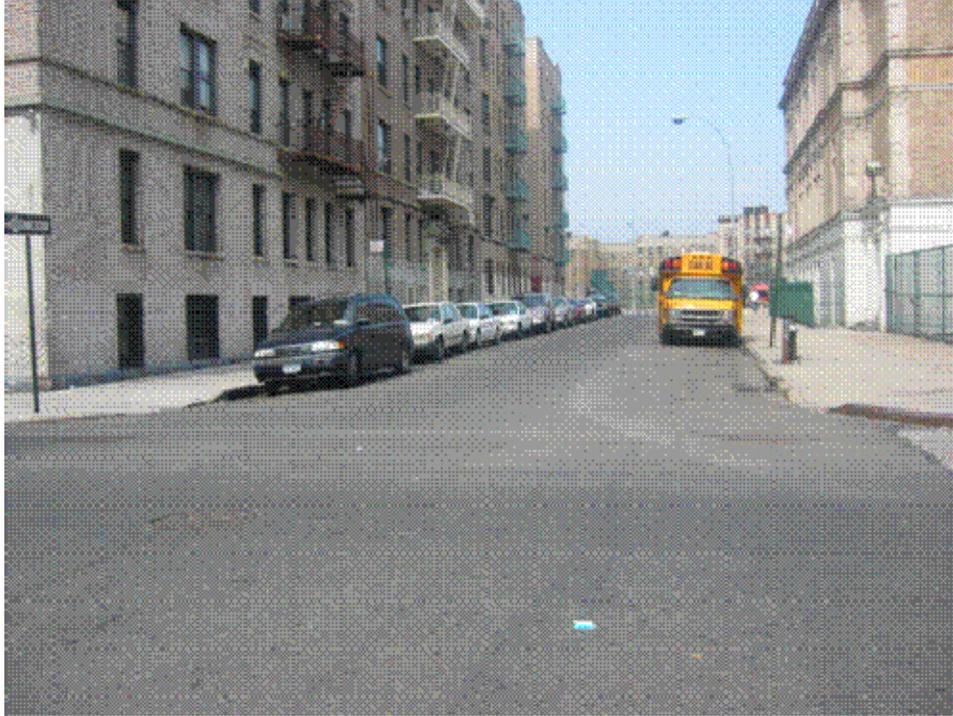
Figure 6: Looking west along Field Place across Creston Avenue (school is up the street on right)

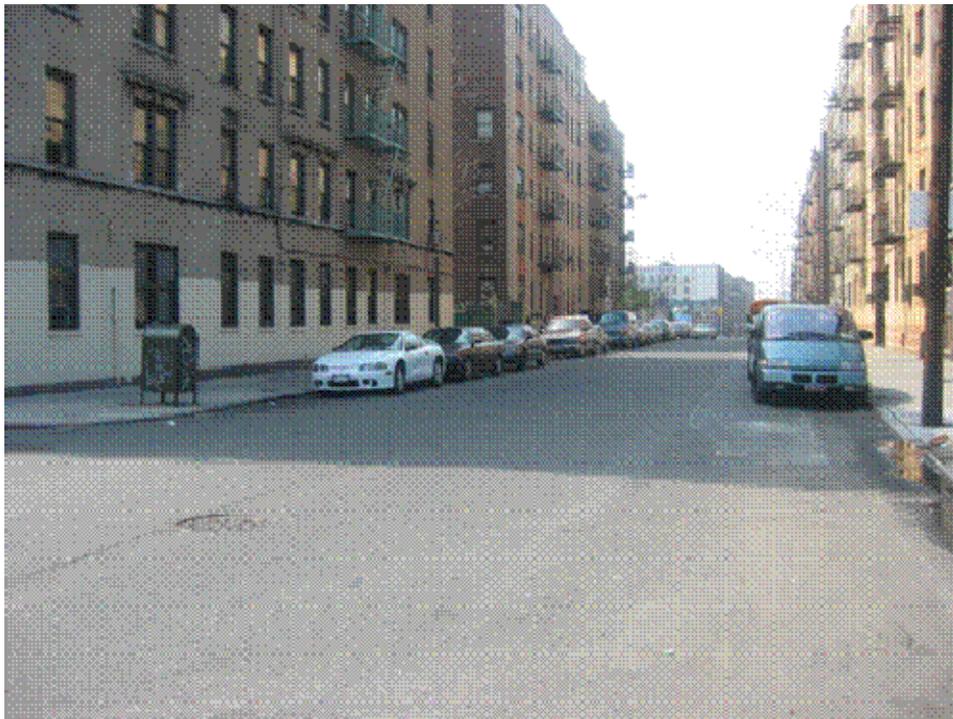
Overall, pedestrian ramps in the area of the school appear to be standard, except for the southeast corner of Morris Avenue and Field Place where a pedestrian ramp is missing.

Figure 7: Looking south along Morris Avenue at Field Place. Note missing pedestrian ramp on southeast corner

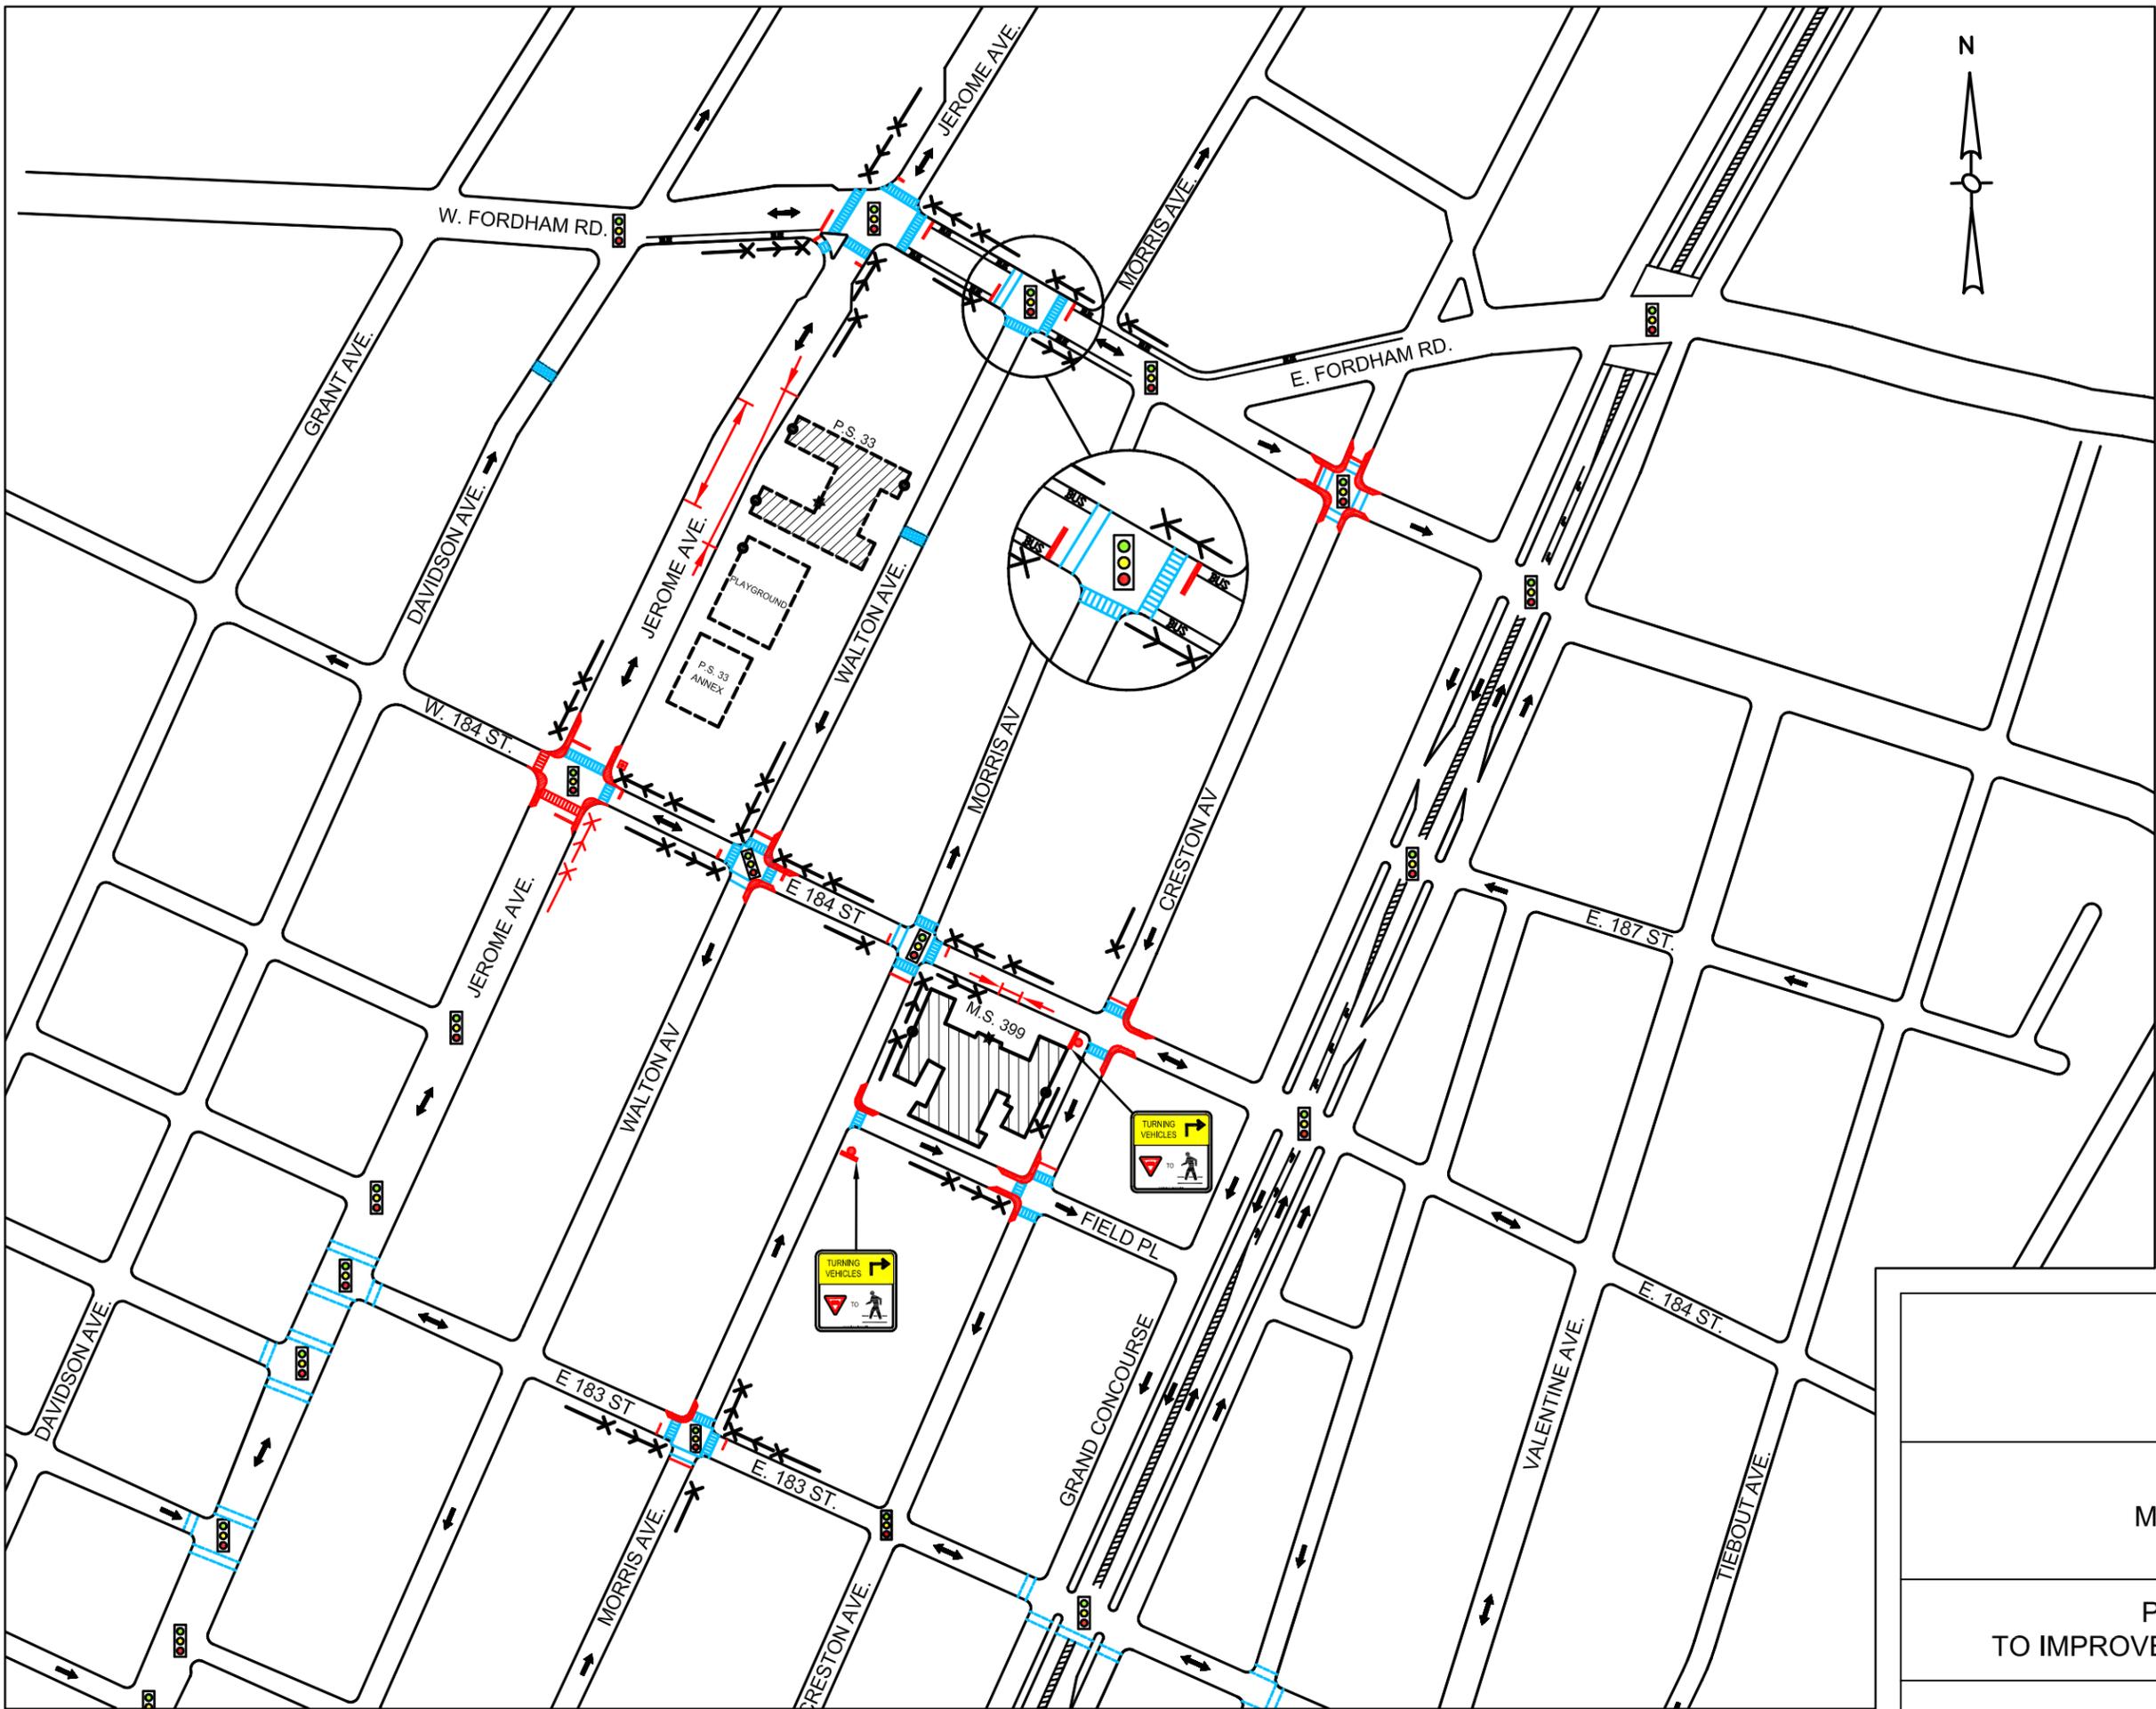
POTENTIAL MEASURES TO IMPROVE STUDENT PEDESTRIAN SAFETY

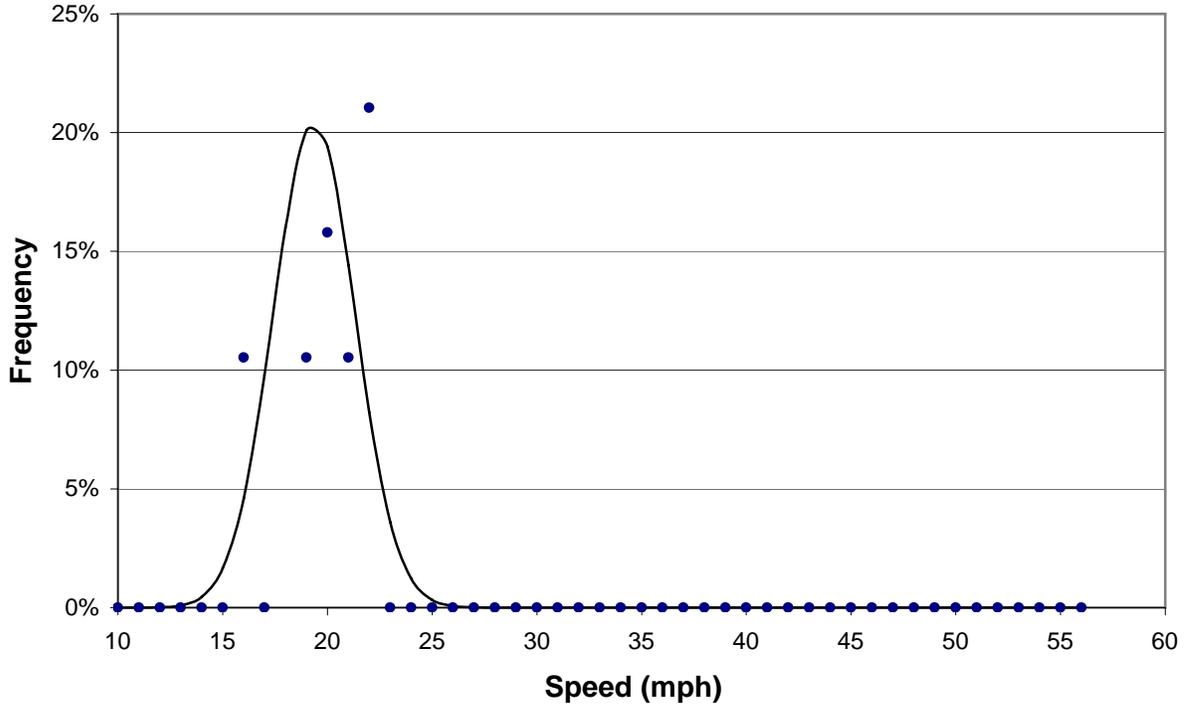
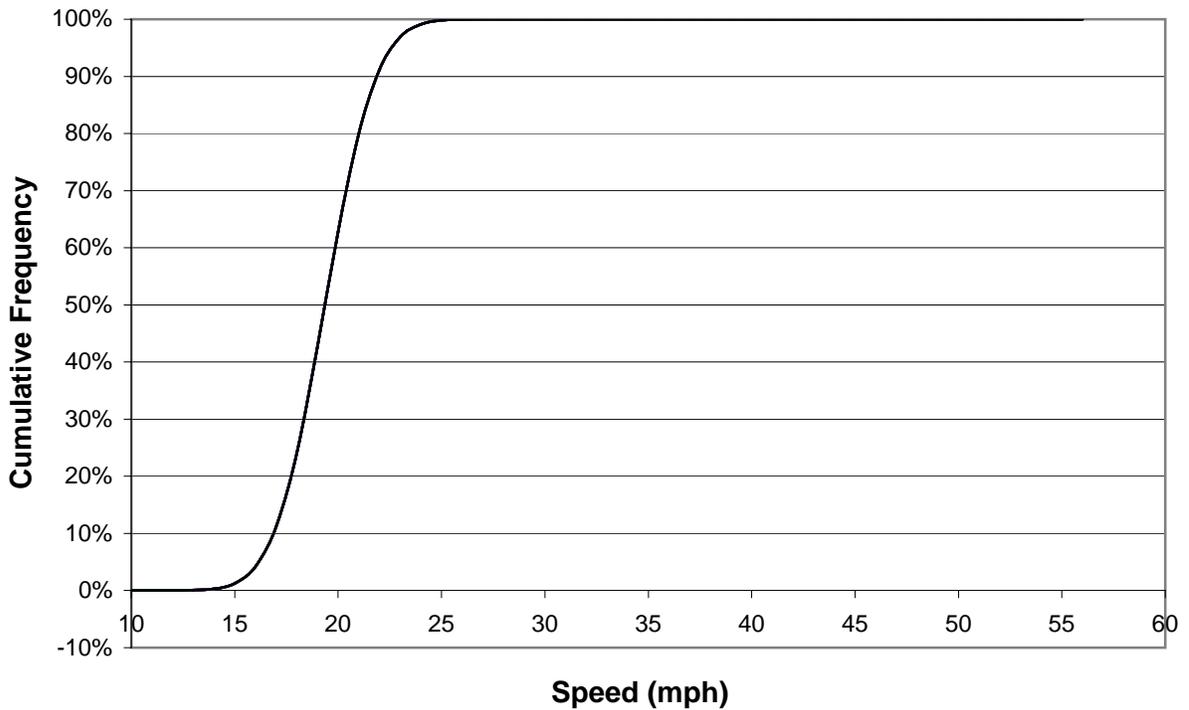
SPOT SPEED STUDY

Date: **June 1, 2005**
 Location: **184th Street between Morris Avenue & Creston Avenue**
 Surveyor: **Richard Calvache & Hugo Salinas**

Mean Speed = 19.4 mph
 Standard Deviation = 1.9 mph
 Margin of Error (95% Confidence) = ± 0.9 mph

Median Speed = 19.4 mph
 15th Percentile Speed = 17.3 mph
 85th Percentile Speed = 21.4 mph
