**New York City Department of Transportation
Office of School Safety Engineering**

School Safety Engineering Project

FINAL REPORT: M.S. 399 (The Elizabeth Barrett Browning School), Bronx

**Prepared by
The RBA Group and URBITRAN Associates Inc.**

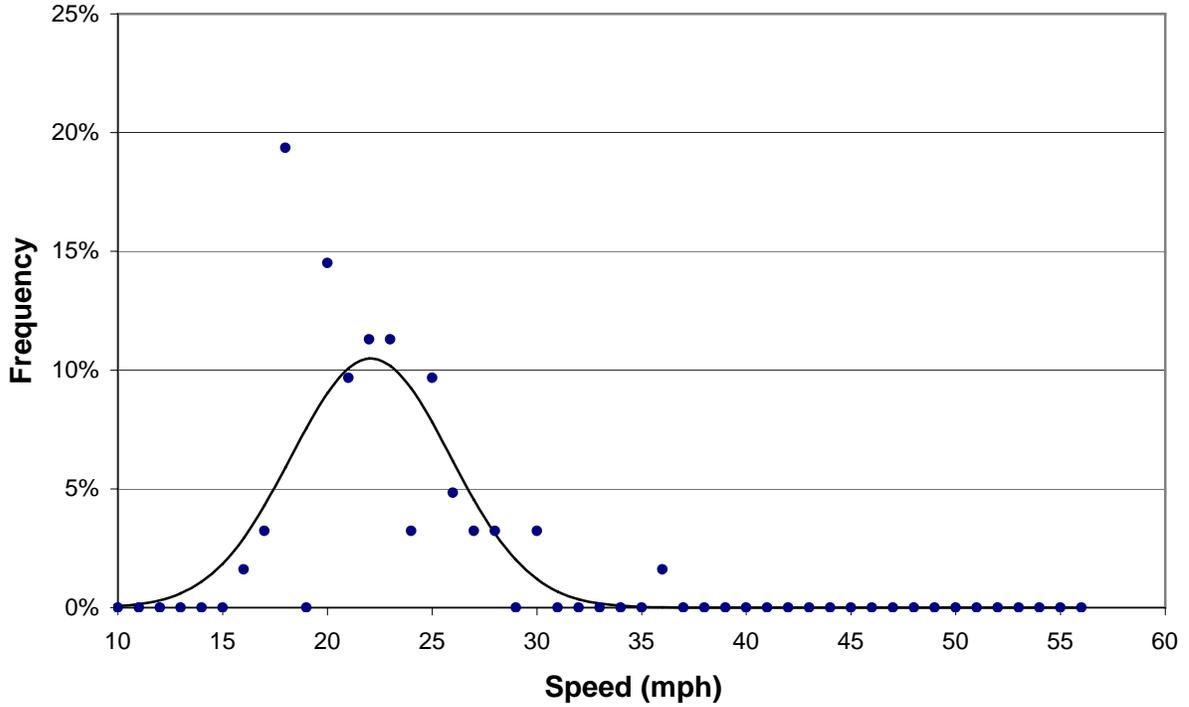
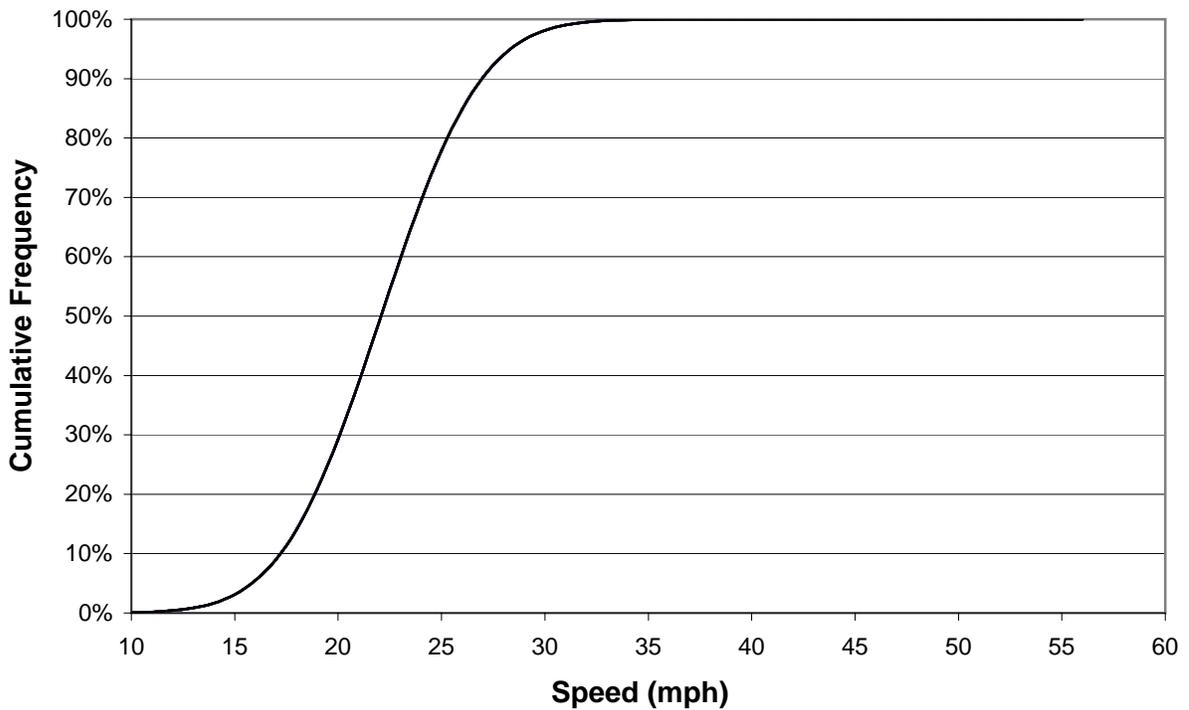
SPOT SPEED STUDY

The northbound vehicles on Morris Avenue between Field Place and East 184th Street were found to be traveling with an 85th percentile speed of 26 mph.

Date: **June 1, 2005** Time: **12:35 pm**
 Location: **Morris Avenue south of 184th Street**
 Surveyor: **Richard Calvache & Hugo Salinas**

Mean Speed = 22.1 mph
Standard Deviation = 3.8 mph
Margin of Error (95% Confidence) = ± 0.9 mph

Median Speed = 22.1 mph
15th Percentile Speed = 18.1 mph
85th Percentile Speed = 26.0 mph

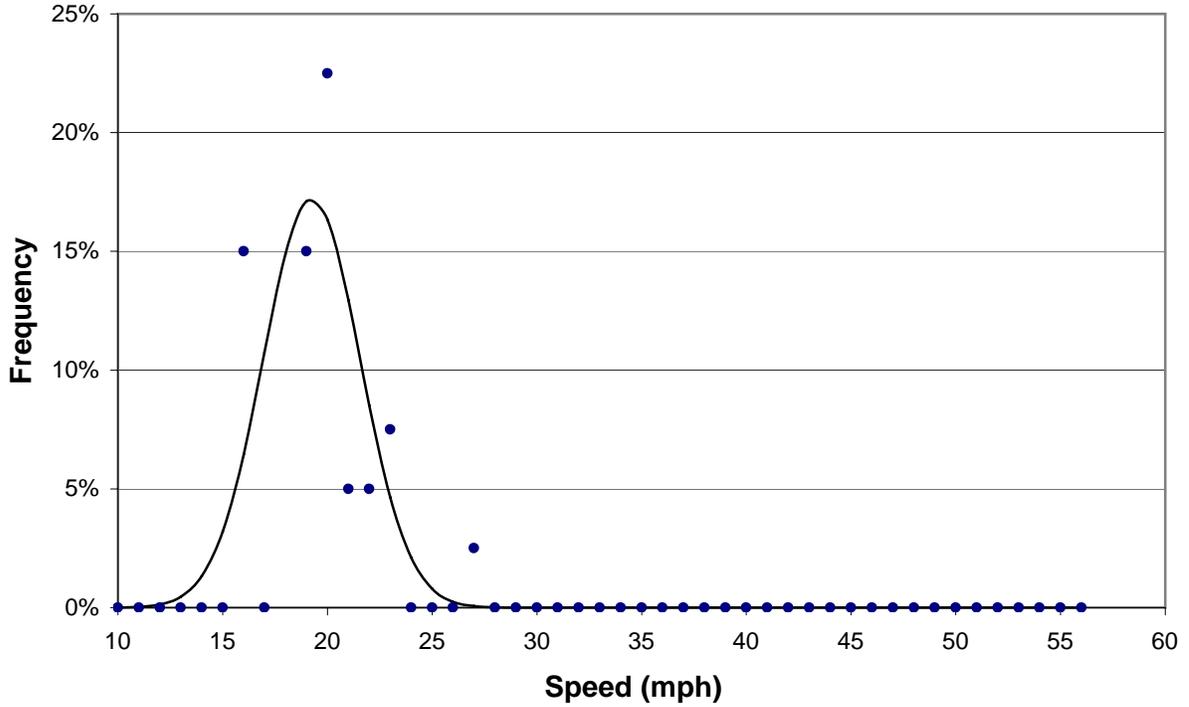
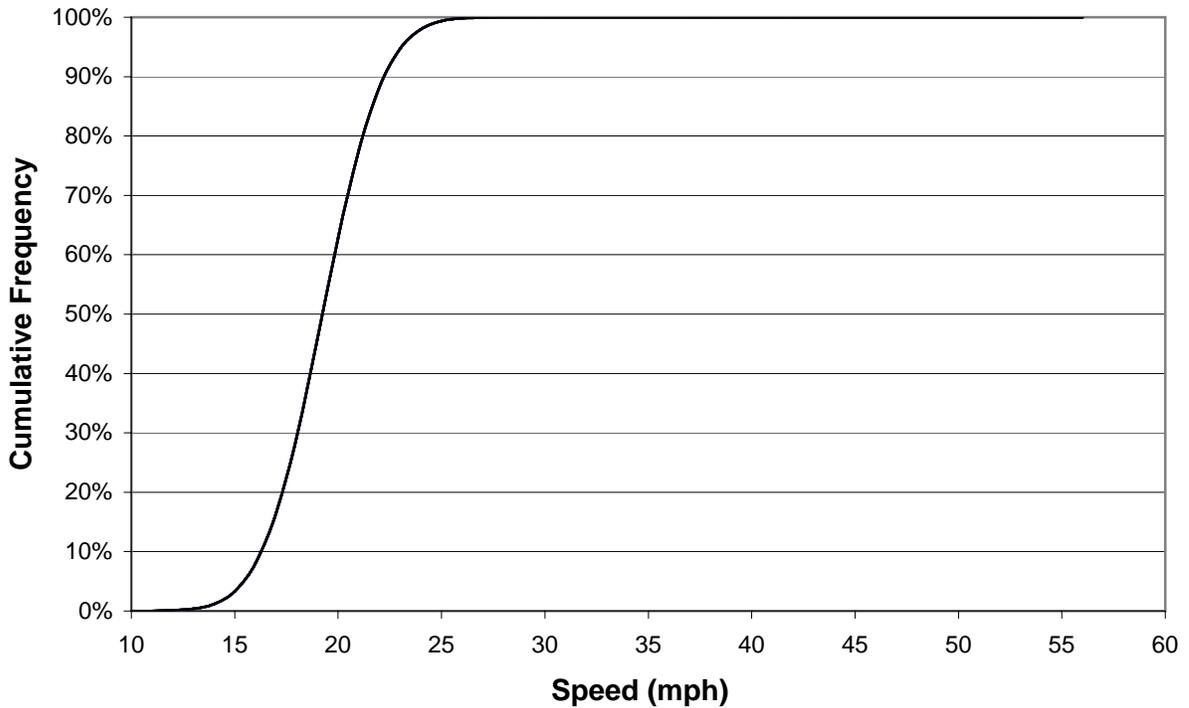
SPOT SPEED STUDY

Date: **June 1, 2005**
 Location: **184th Street between Morris Avenue & Creston Avenue**
 Surveyor: **Richard Calvache & Hugo Salinas**

School: **M.S. 399**
 Direction: **Westbound**
 Comments:

Mean Speed = 19.3 mph Median Speed = 19.3 mph
 Standard Deviation = 2.3 mph 15th Percentile Speed = 16.8 mph
 Margin of Error (95% Confidence) = ± 0.7 mph 85th Percentile Speed = 21.7 mph
