**New York City Department of Transportation  
Office of School Safety Engineering**

**School Safety Engineering Project**

**FINAL REPORT: St. Simon Stock, Bronx**

**August 1, 2006**

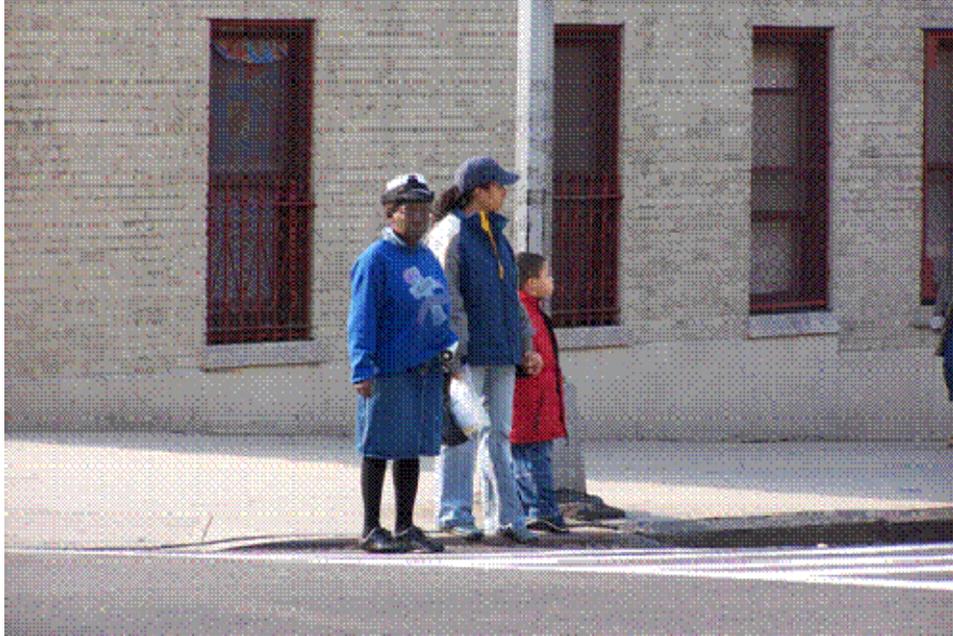
According to the school principal, one school crossing guard is assigned to the intersection of Valentine Avenue and East 182<sup>nd</sup> Street.

*Figure 3: Crossing guard at the intersection of Valentine Avenue and East 182<sup>nd</sup> Street at arrival time*

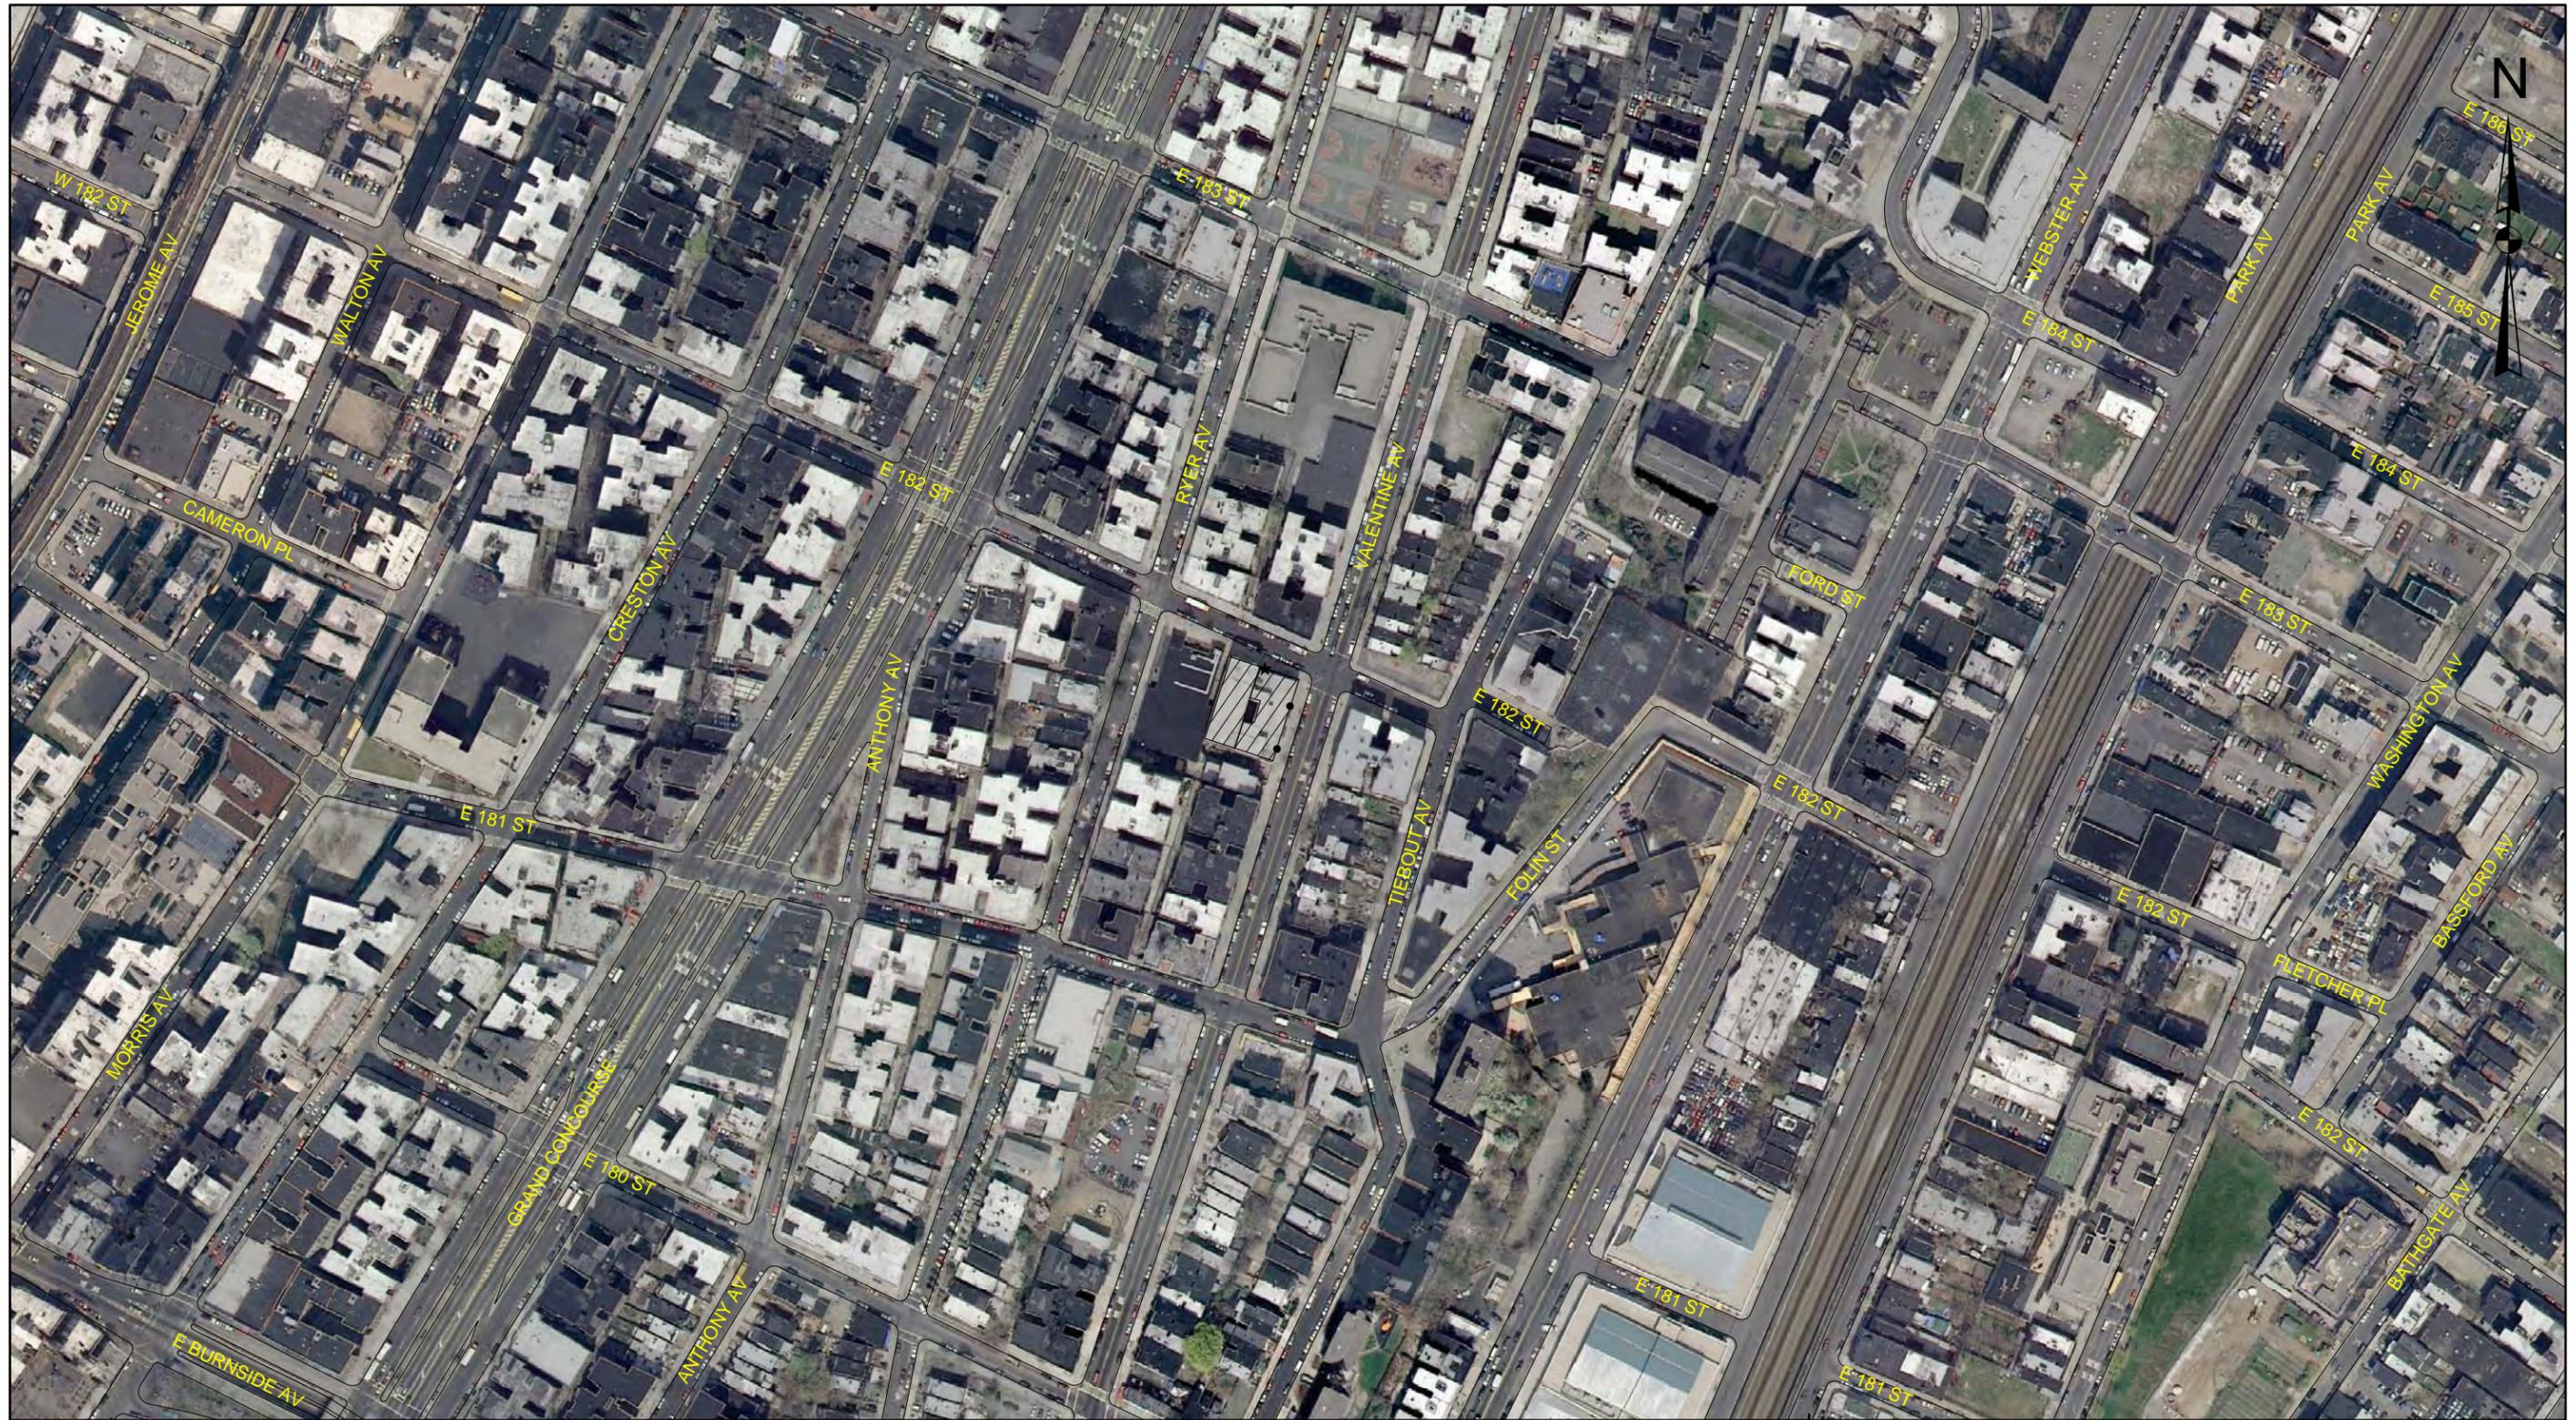
**EXHIBIT 1**  
**ST. SIMON STOCK SCHOOL BRONX**  
**AERIAL PHOTOGRAPH**

Exhibit 1 shows an aerial view of the neighborhood surrounding the school. St. Simon Stock School is bounded by East 182<sup>nd</sup> Street to the north, East 181<sup>st</sup> Street to the south, Valentine Avenue to the east, and Ryer Avenue to the west. The area surrounding the school is generally residential in character with primarily high-density, multi-story, apartment buildings. Webster Avenue, two short blocks to the east and the Grand Concourse, two short blocks to the west, are major commercial corridors with significant vehicular and pedestrian traffic.

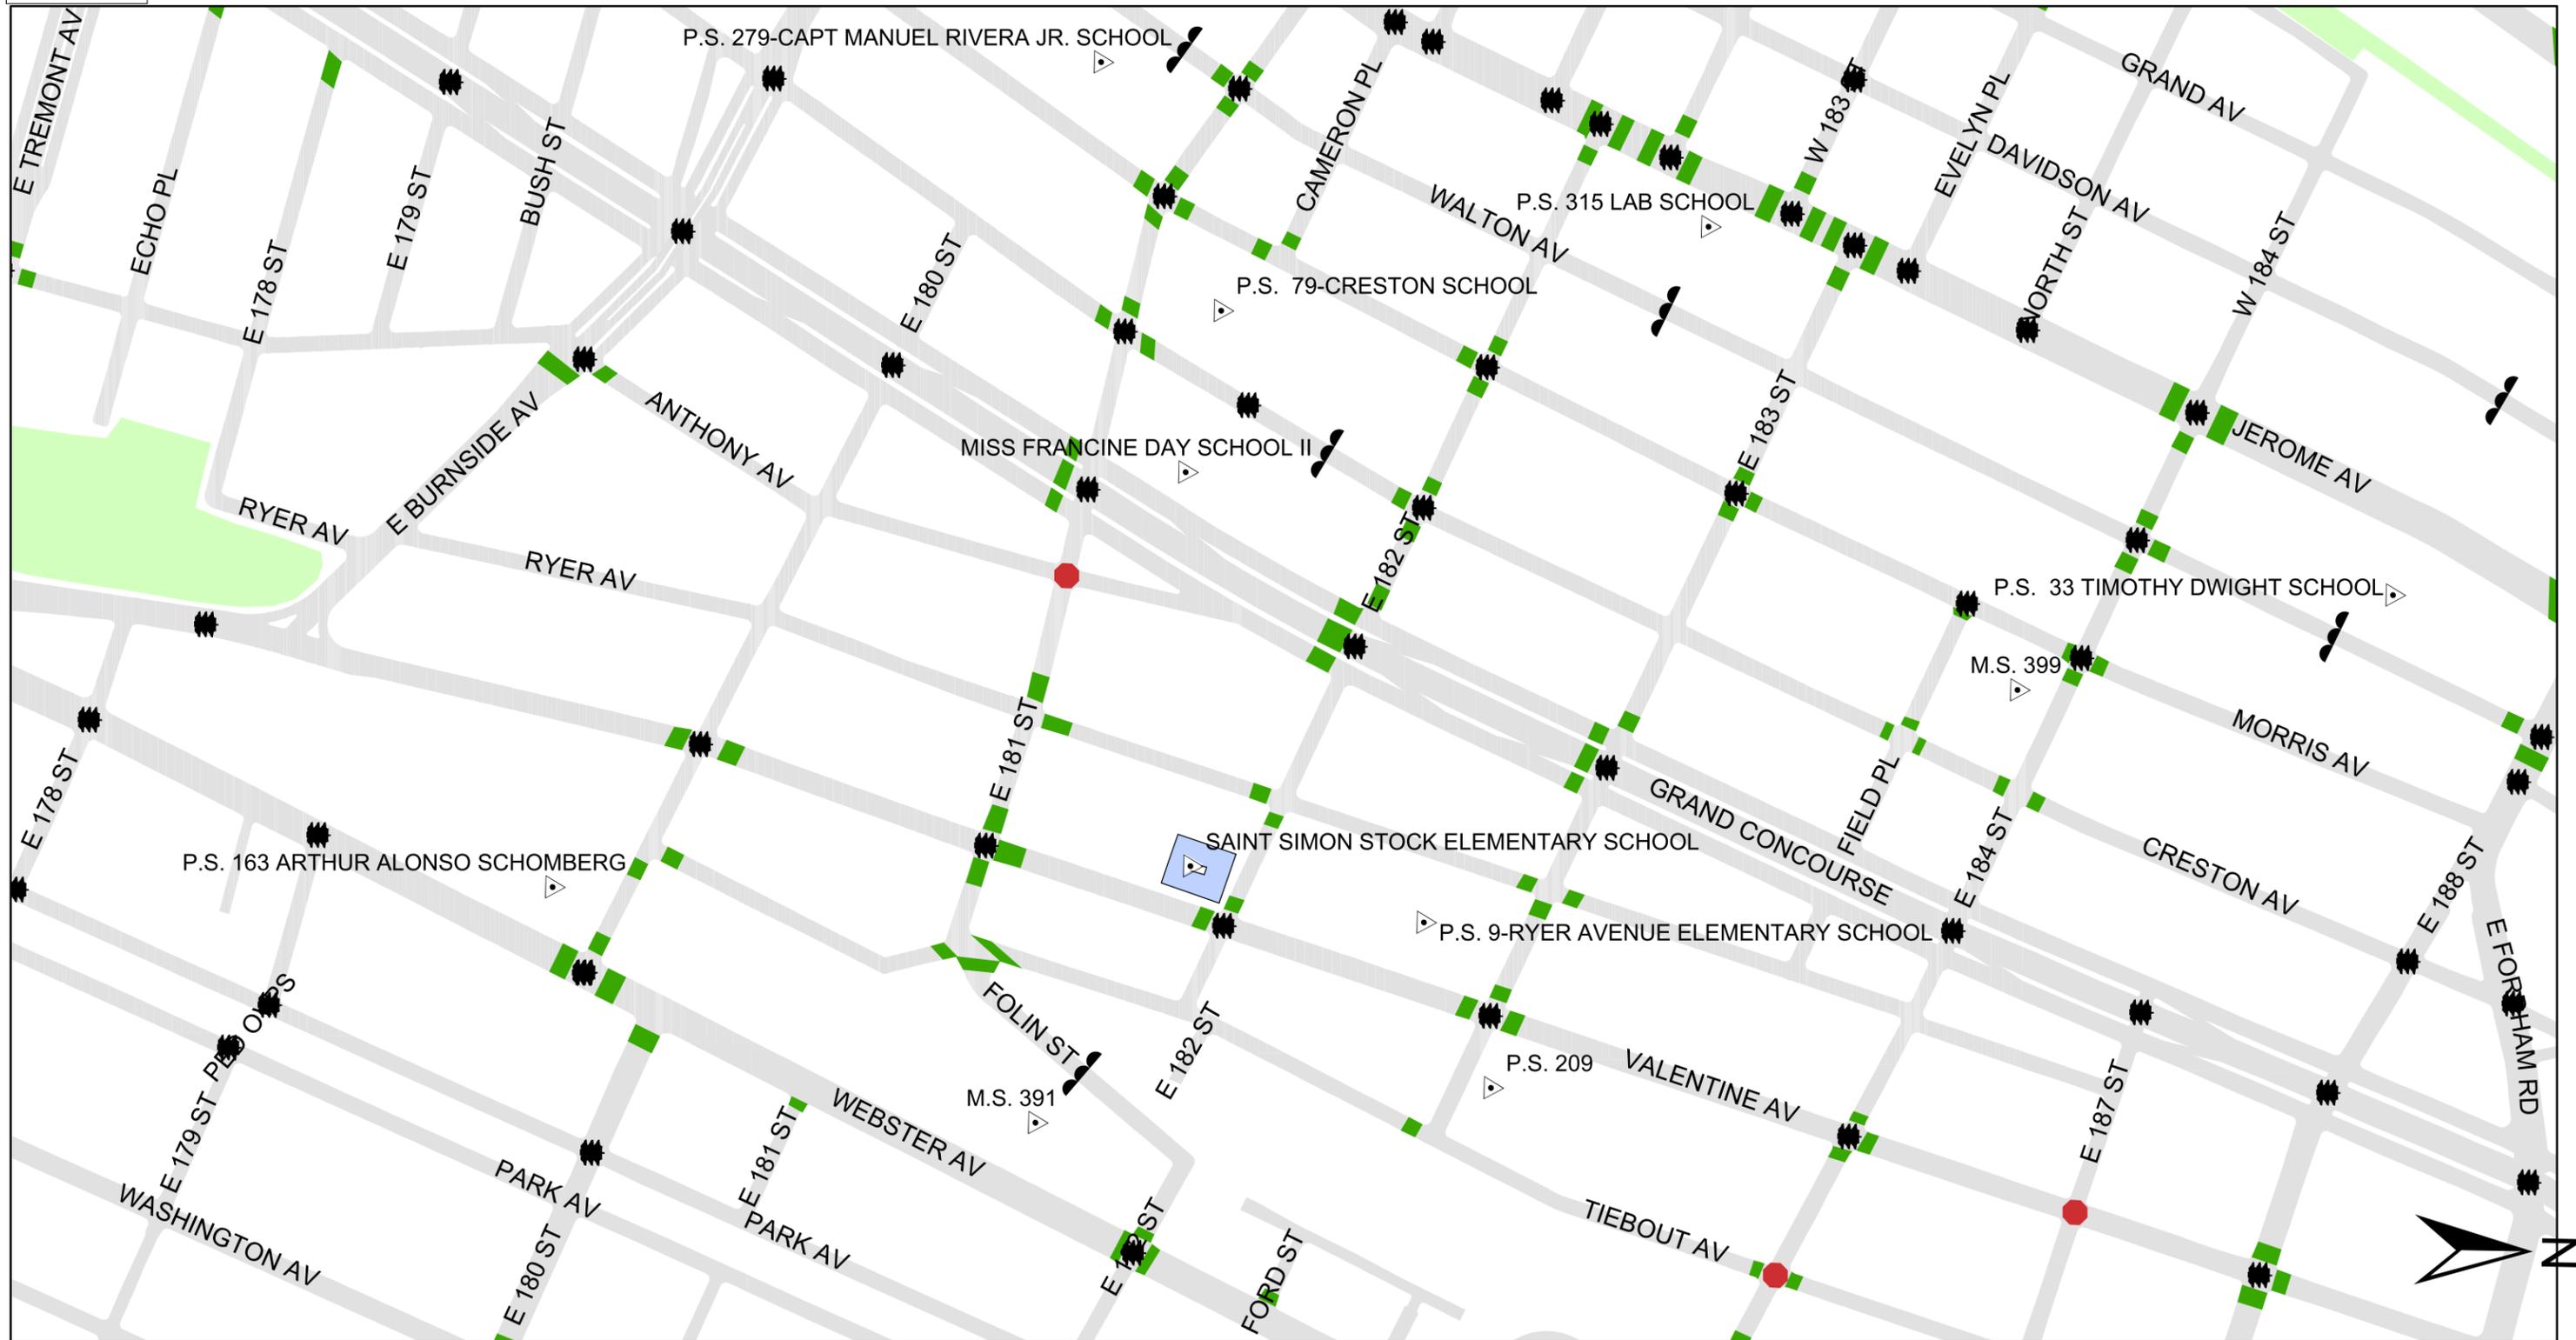
**EXHIBIT 2**

The School Traffic Safety Map was established to help provide the maximum degree of safety for children going to and from school - by indicating the location of speed reducers, school crosswalks and some traffic control devices. (While virtually all intersections in NYC benefit from traffic control devices - such as stop signs, traffic signals, yield signs, and all way stop signs - this map shows only traffic signals and all way stop signs.) The school crosswalks that are shown are ladder striped and make the crosswalk more visible to drivers and help make the intersection safer. These crosswalks are where school children are recommended to cross.

Exhibit 2 shows the existing school signals and pavement markings around the St. Simon Stock School. It should be noted that a citywide signage program is currently underway to upgrade school signage to the current edition of the Federal Manual of Uniform Traffic Control Devices (MUTCD) standards of fluorescent yellow-green signs accompanied by downward pointing arrows. (Signs scheduled to be installed under this program are shown as “existing” in Exhibit 6.)

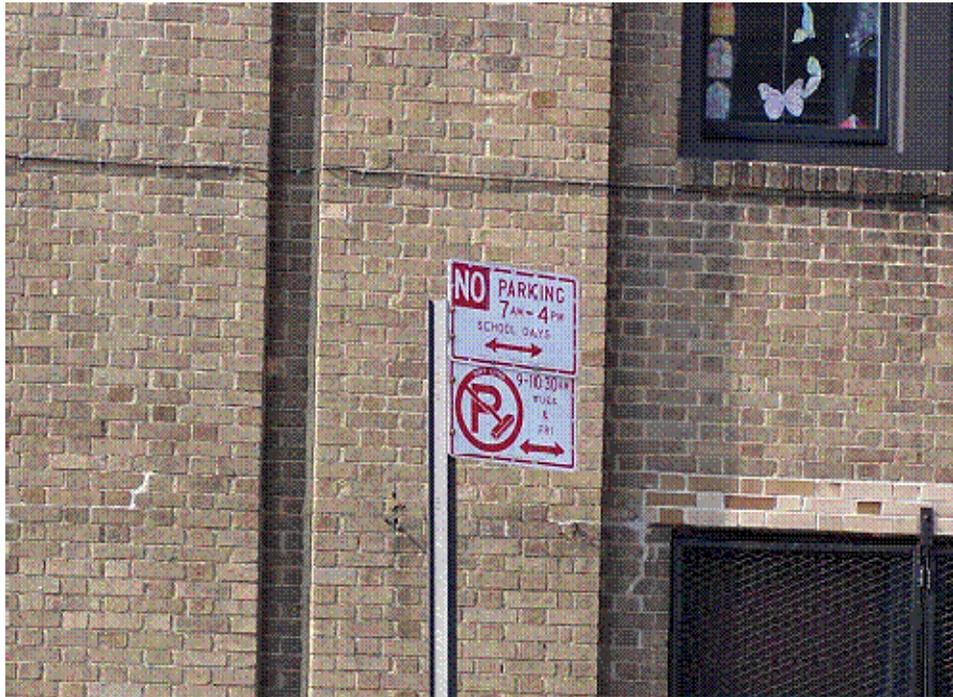
Parking regulations around the school block-faces are shown in Exhibit 4.

*Figure 4: Typical parking regulations adjacent to the school*

Install “NO STANDING 7AM-4PM SCHOOL DAYS” signs for thirty feet (30’) in front of the school at the main entrance of the school. (This is a typical requirement for all NYC schools in order to provide for emergency access to and from the school.)

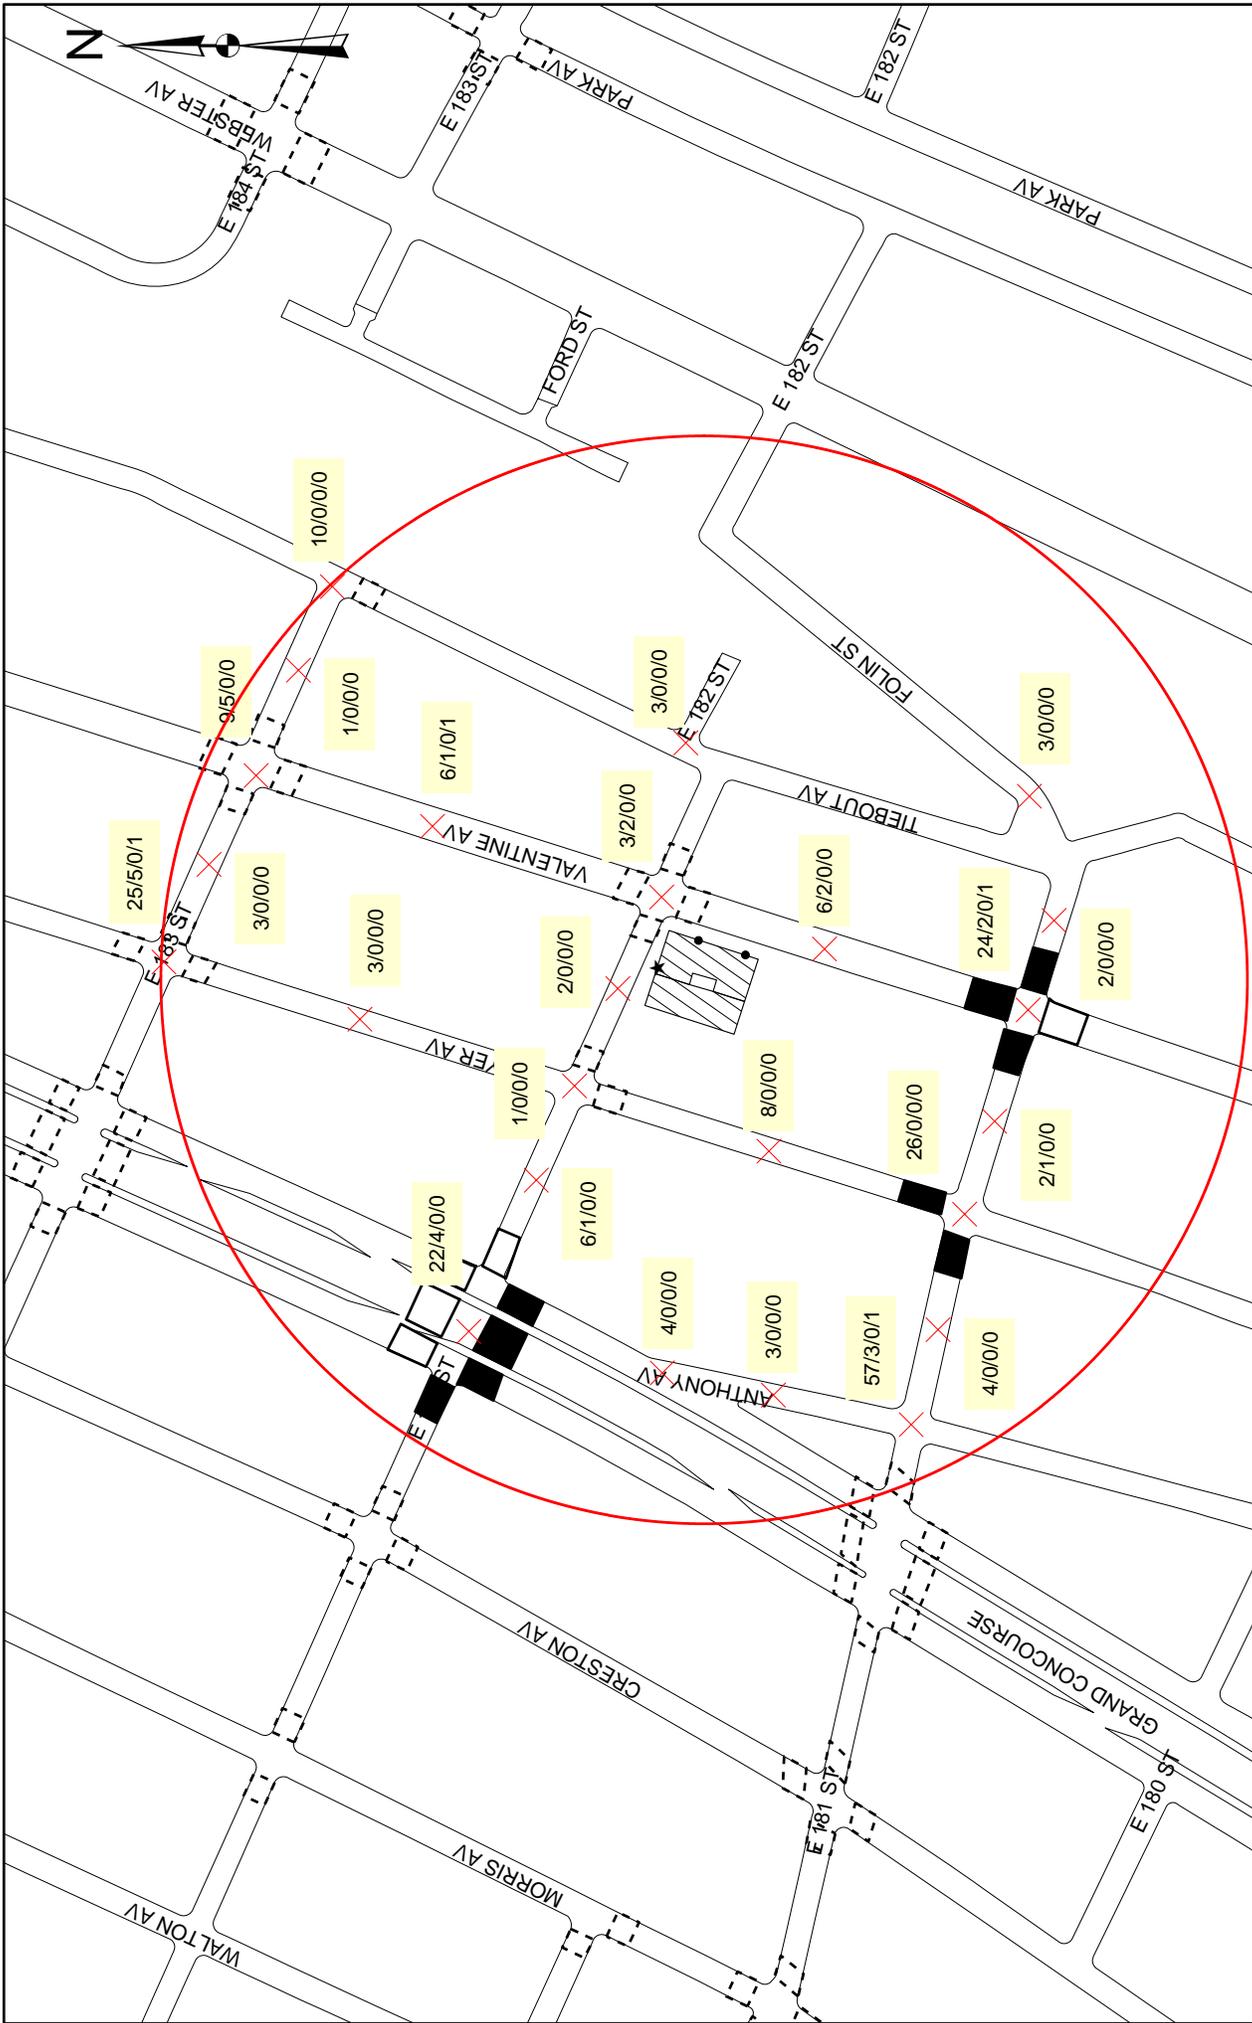
**EXHIBIT 5**

Exhibit 5 and Table 2 show a summary of accidents, as obtained from the New York State Department of Motor Vehicles (DMV), in the vicinity of St. Simon Stock School for a three-year period from January 1, 1998 through December 31, 2000. The DMV data provides some detail relating to the circumstances and cause of an accident. Table 3 is a summary of more recent accident data obtained from the NYC Police Department (NYPD). Though current through 2004, the NYPD data does not provide the same level of detail as the DMV data.

**ACCIDENT SUMMARY (1998-2000)**

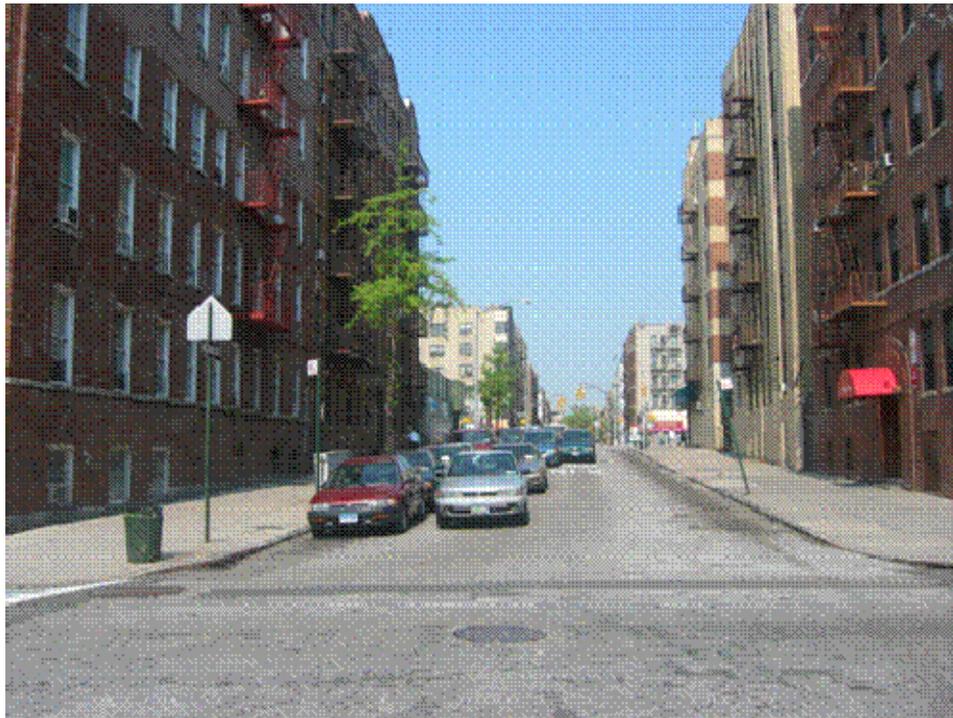
This is a four-leg unsignalized intersection with school crosswalks located across the south leg of Ryer Avenue and the east leg of East 182<sup>nd</sup> Street. East 182<sup>nd</sup> Street is a one-way eastbound street with one travel lane and on-street parking permitted on both sides of the roadway. Ryer Avenue is a one-way southbound street with one travel lane and on-street parking permitted on both sides of the roadway. The southbound approach of Ryer Avenue is controlled by a stop sign.

There was one accident reported at this intersection between 1998 and 2000 (Table 2). It did not involve a pedestrian. There were no pedestrian fatalities reported at this intersection.

*Figure 5: Looking west on East 182<sup>nd</sup> Street from Ryer Avenue intersection*

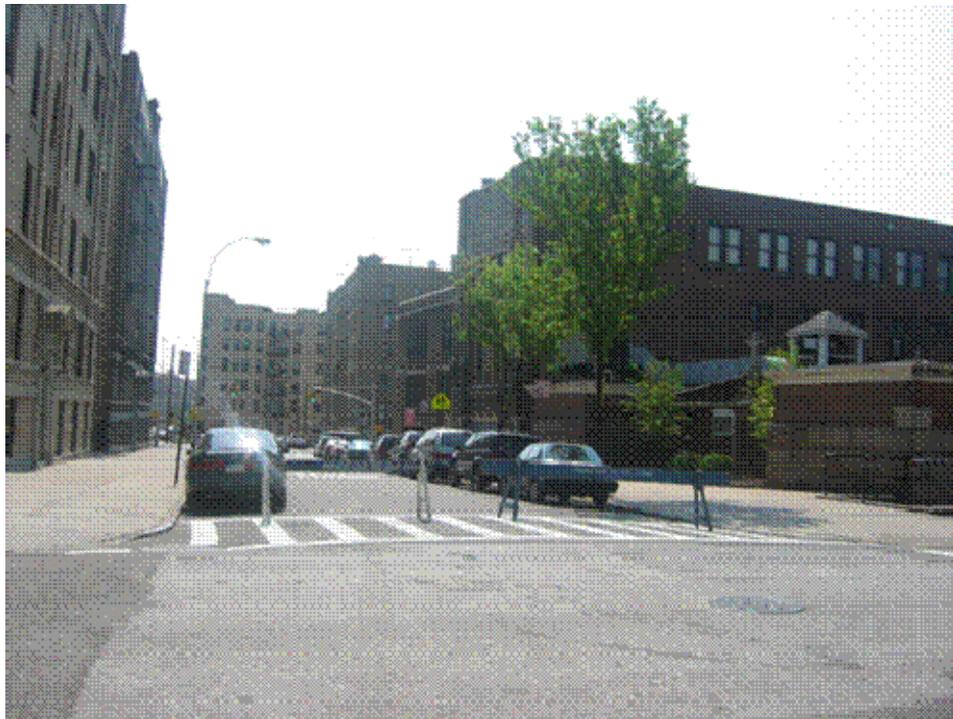
*Figure 6: Looking east on East 182<sup>nd</sup> Street across Ryer Avenue intersection*

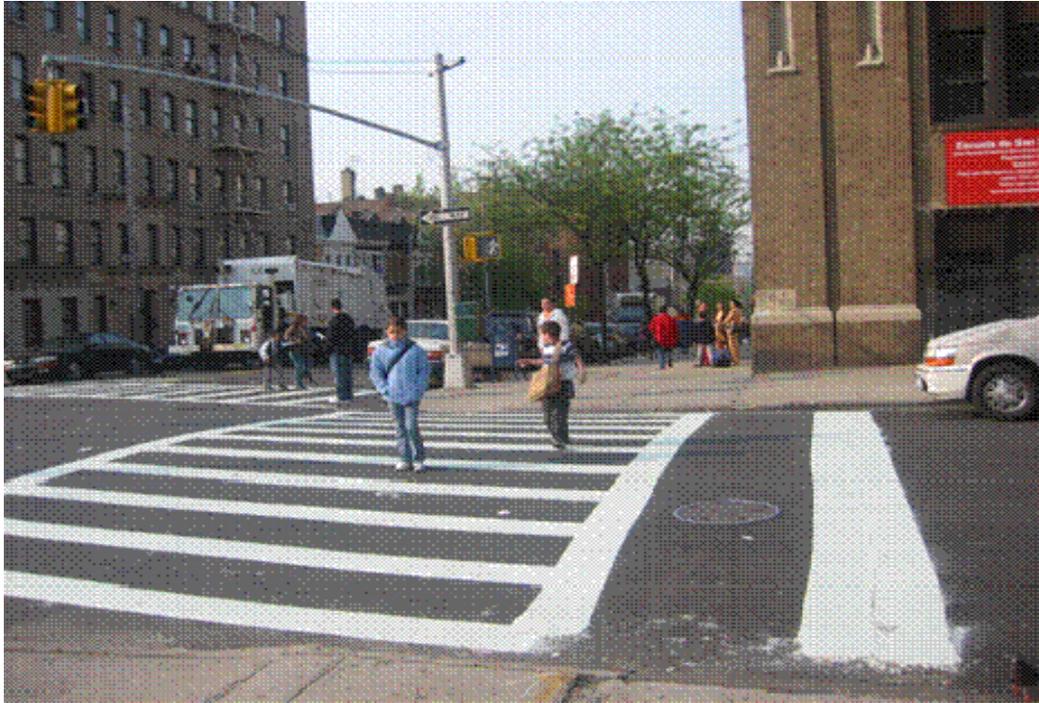
This is a four-leg signalized intersection with school crosswalks located across the south leg of Valentine Avenue and the west leg of East 182<sup>nd</sup> Street (these school crosswalks are not assigned to St. Simon Stock School). There is a pedestrian crosswalk located across the north leg of Valentine Avenue. East 182<sup>nd</sup> Street is a one-way eastbound street with one travel lane and on-street parking permitted on both sides of the roadway. Valentine Avenue is a two-way north-south street with one travel lane and a parking lane on both sides of the roadway.

There were three accidents reported at this intersection between 1998 and 2000 (Table 2); two were pedestrian accidents. None of the pedestrian accidents were school-related. There were no pedestrian fatalities reported at this intersection.

*Figure 7: Looking south on Valentine Avenue across East 182<sup>nd</sup> Street*

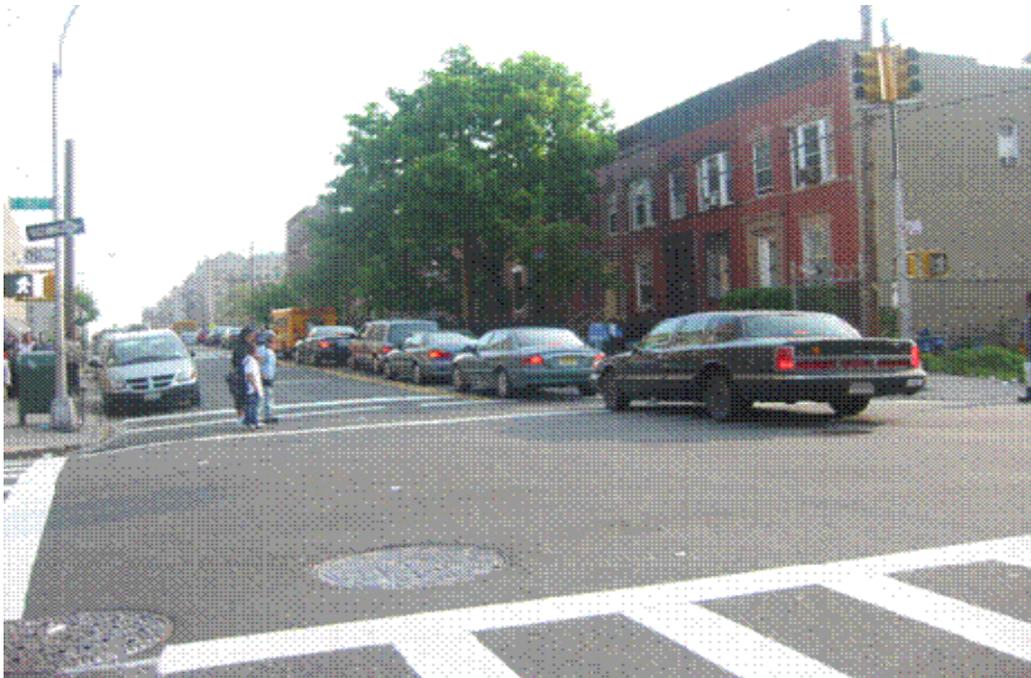
*Figure 8: Looking north along Valentine Avenue across East 182<sup>nd</sup> Street*

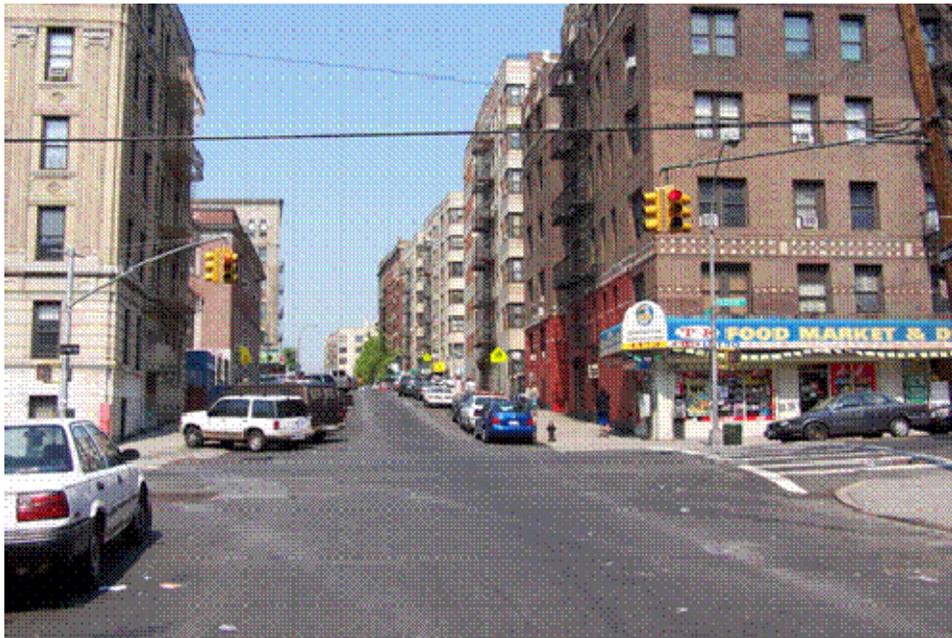
This is a four-leg signalized intersection with school crosswalks located across the north leg of Valentine Avenue and the east and west legs of East 181<sup>st</sup> Street, and a pedestrian crosswalk located across the south leg of Valentine Avenue.

East 181<sup>st</sup> Street is a one-way westbound street with one travel lane and parking on both sides of the roadway. Valentine Avenue is a two-way roadway with one travel lane and a parking lane on each side of the roadway. East 181<sup>st</sup> Street has angle-parking along the south side of the roadway between Valentine Avenue and Ryer Avenue.

There were 24 accidents reported at this intersection between 1998 and 2000 (Table 2). There were two pedestrian accidents reported during the same three-year period; one of the pedestrian accidents was school-related. In the school-related accident, a 12-year-old pedestrian suffered an incapacitating injury while crossing against the signal. The accident occurred on Thursday, June 11, 1998 at 2:00 pm. The road surface was dry and the weather was cloudy. There were no pedestrian fatalities reported at this intersection.

*Figure 9: Looking west on East 181<sup>st</sup> Street across Valentine Avenue*

The ramp for the crosswalk located across the south leg of Valentine Avenue is missing at the southwest corner of Valentine Avenue and East 181st Street.

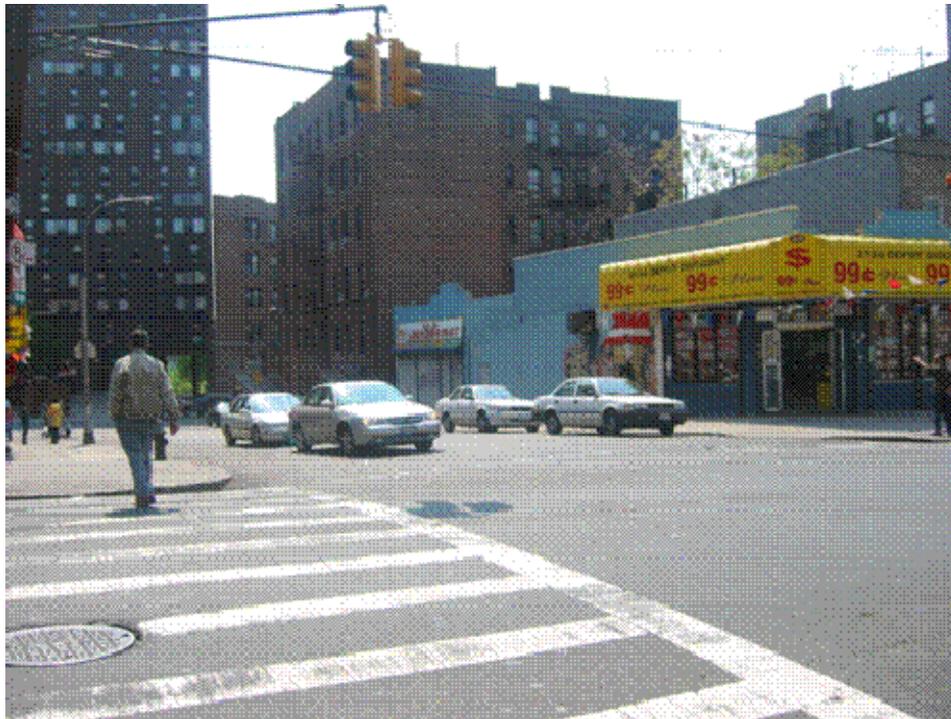
*Figure 10: Looking east at East 181<sup>st</sup> Street across Valentine Avenue*

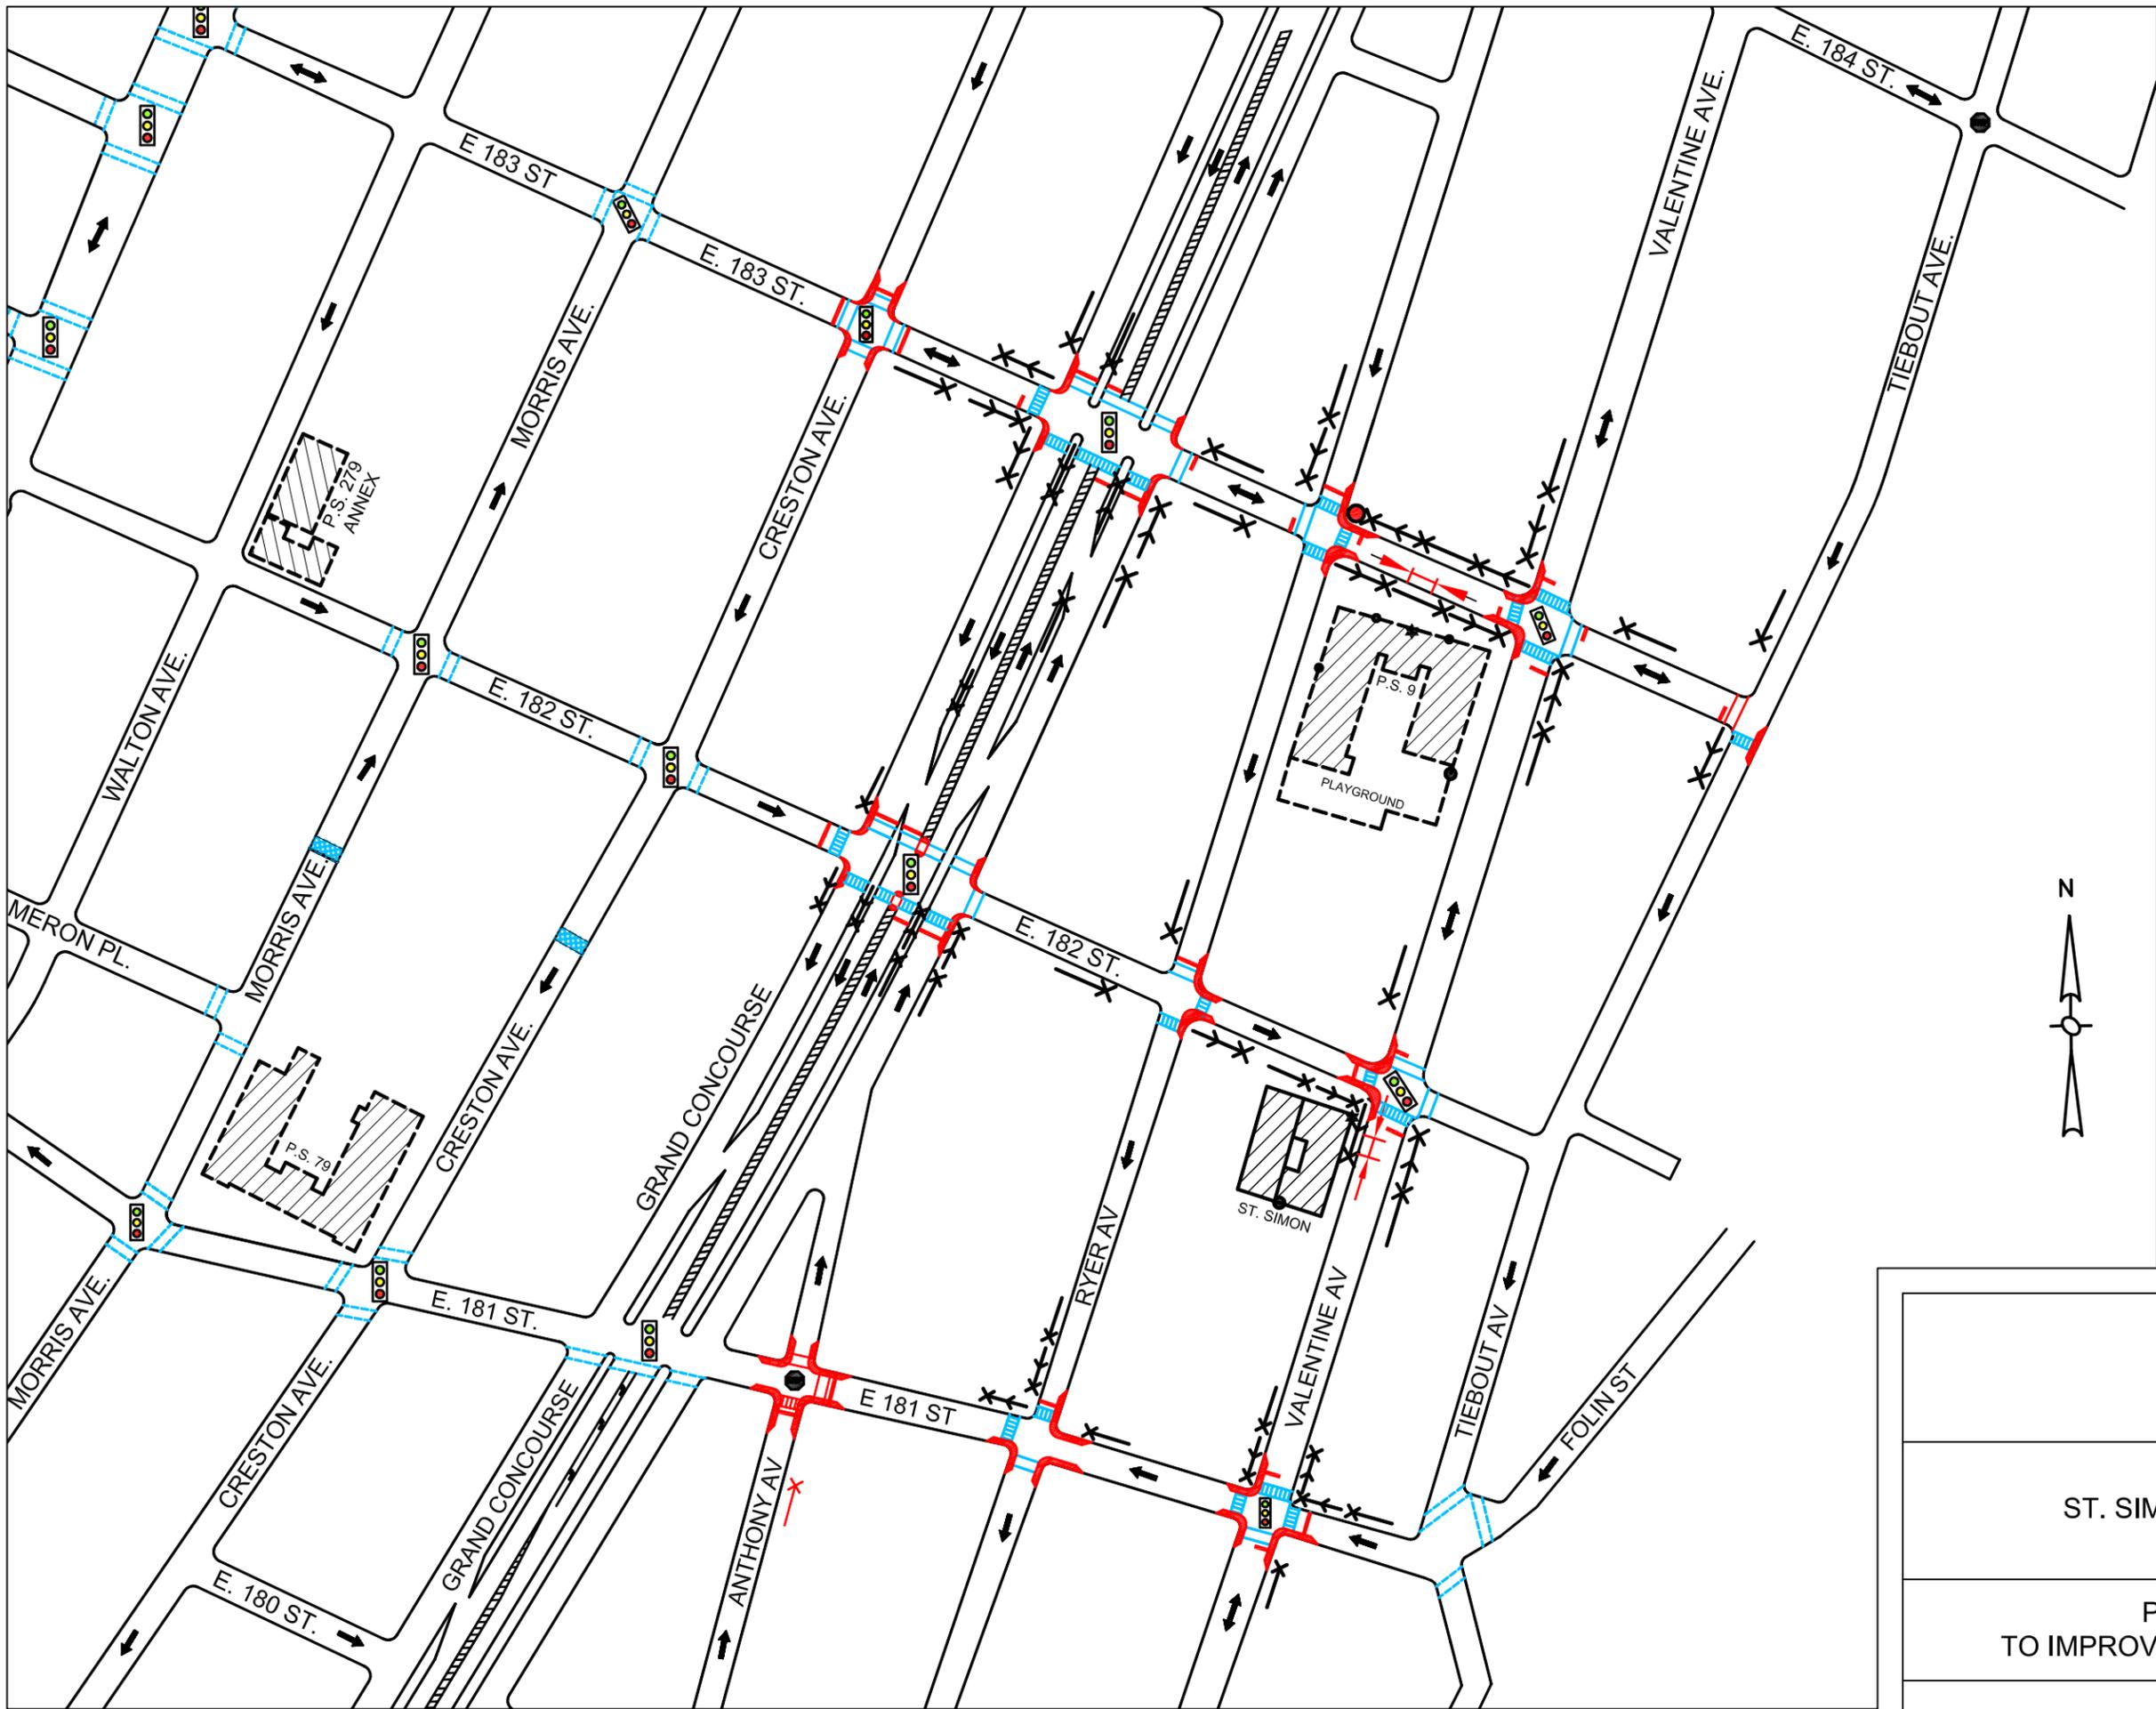
PROPOSED MEASURES  
TO IMPROVE SCHOOL PEDESTRIAN SAFETY

This section describes the proposed measures to improve school pedestrian safety around St. Simon Stock. The proposed recommendations are divided into short-term and long-term measures. Short-term measures are those that potentially can be performed in-house. Long-term measures involve capital improvements. Each of the short- and long-term measures recommended for St. Simon Stock is discussed as follows, and is shown in more detail in Exhibit 6 at the end of this section. See section 4.3 for additional recommendations for this area from the report on P.S. 9, a nearby priority school.
