The Citywide Congested Corridor Project

Church Avenue from McDonald Avenue to Utica Avenue

Borough of Brooklyn

Final Report

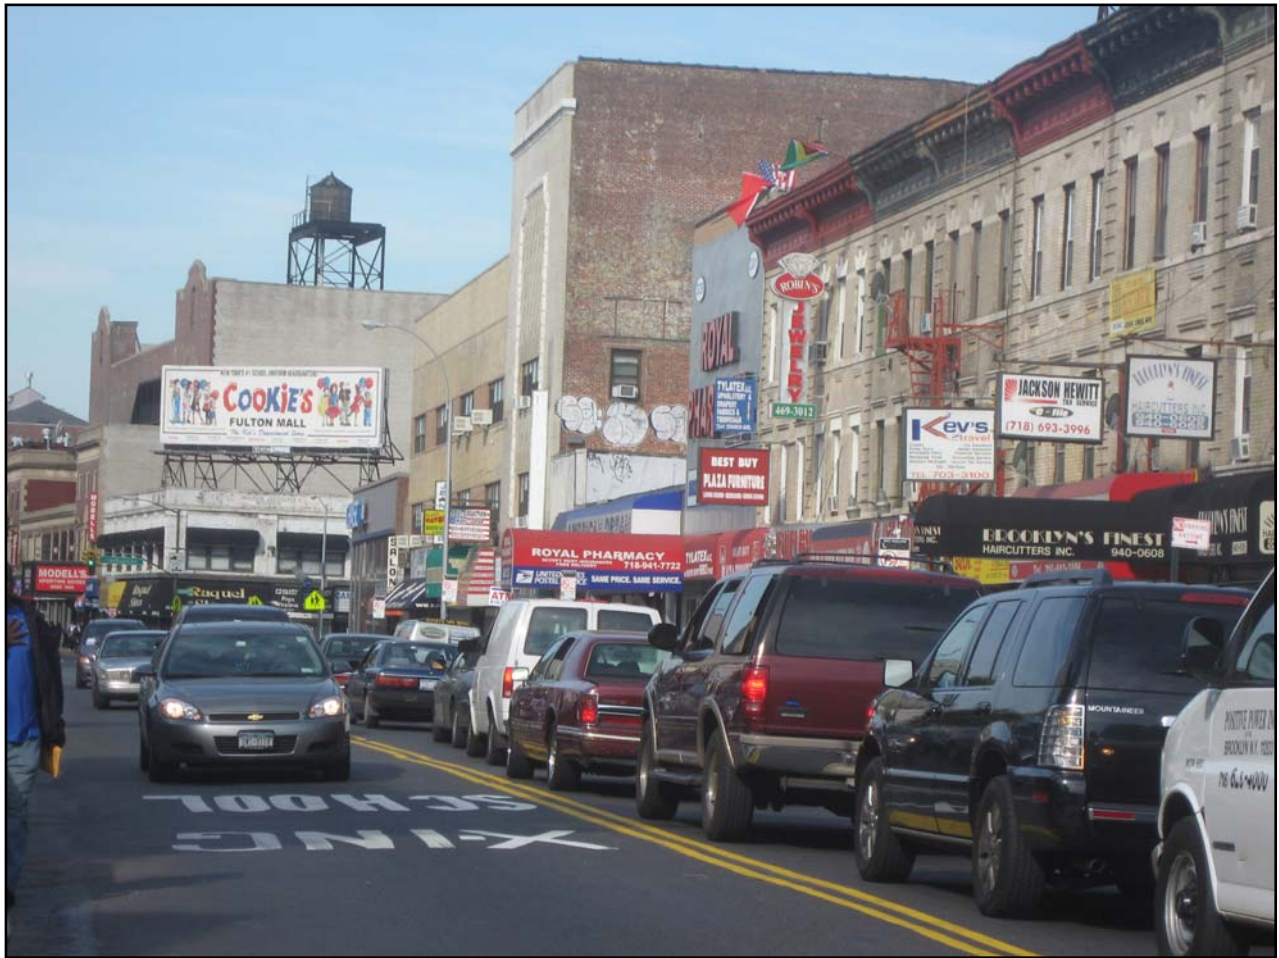
Figure 2: Church Avenue Looking West Near Flatbush Avenue

The study area consists of diverse neighborhoods with heavy concentrations of retail, commercial and residential land uses. The study segment of Church Avenue typically consists of one travel lane and a curbside parking lane in each direction (Figure 2). In recent years, heavy traffic and pedestrian activities on Church Avenue have created operational and safety deficiencies that require development and implementation of a congestion mitigation program.

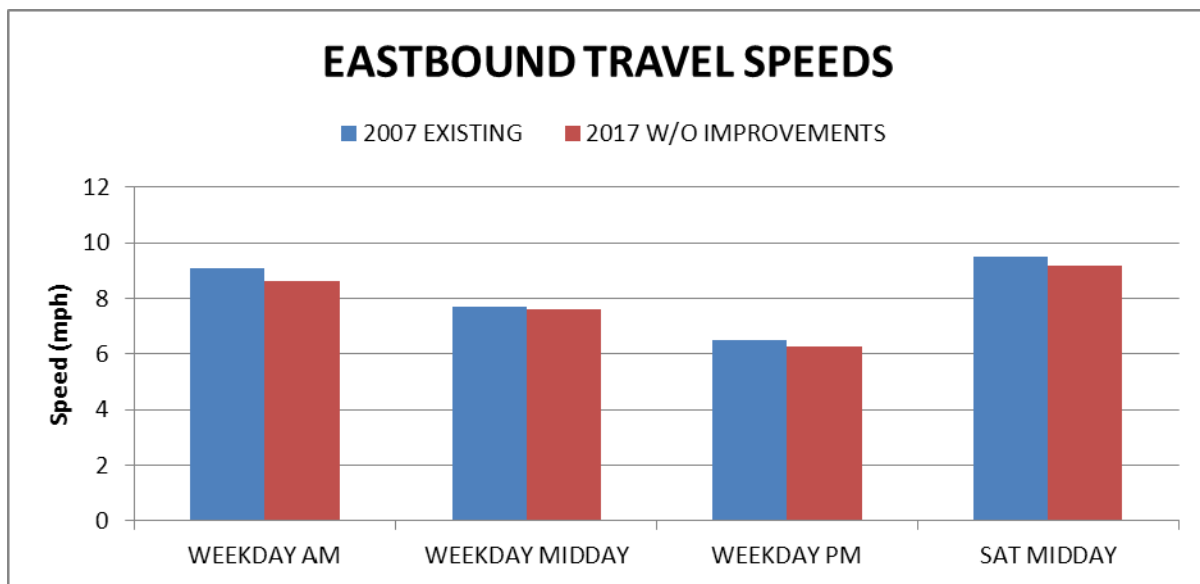
Figure 3: Eastbound Peak Period Travel Speeds for Church Avenue from McDonald Avenue to Utica Avenue

Existing travel speeds during the four peak periods of study varied between 6.5 and 9.1 mph. Congested conditions are projected to worsen in the future without any improvements. Figure 5 illustrates congestion in the eastbound direction during the weekday PM peak period, where 2017 future without improvements travel speed is projected to average 6.3 mph. For the westbound direction, the Saturday peak period 2017 future without improvements travel speed is projected to average 6.4 mph.

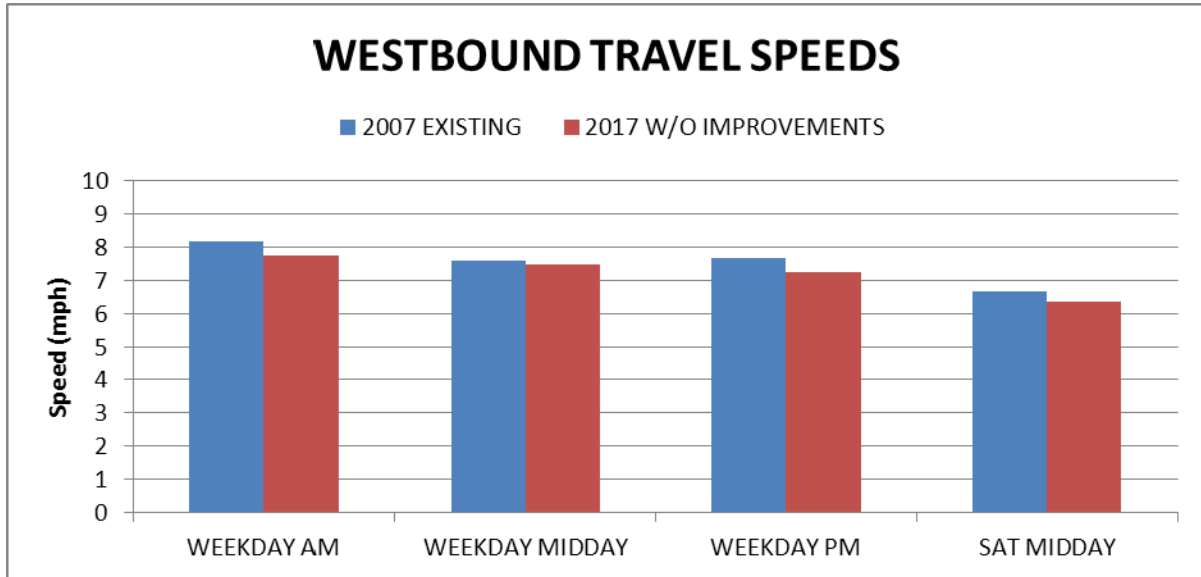
Figure 4: Westbound Peak Period Travel Speeds for Church Avenue from McDonald Avenue to Utica Avenue

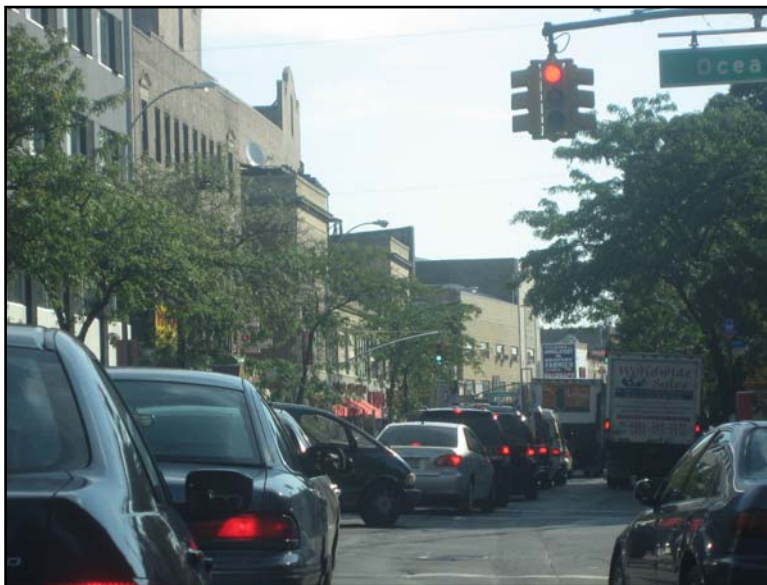
Figure 5: Church Avenue at Ocean Avenue, Looking East

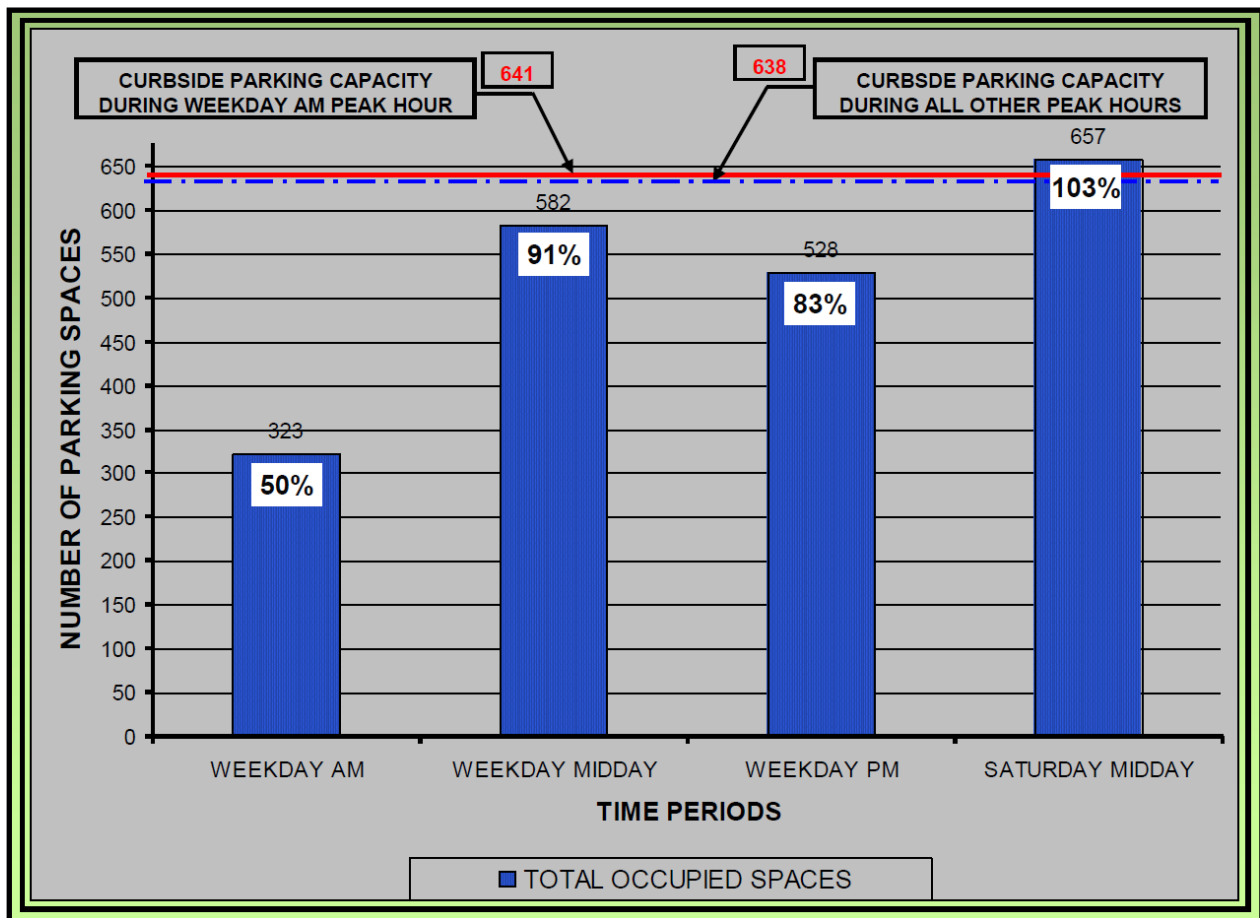
Figure 6: Church Avenue Peak Hour Curbside Parking Utilization

There are approximately 640 legal curbside parking spaces on Church Avenue between McDonald and Utica Avenues, not including side streets (Figure 6). While there is excess capacity during the weekday AM peak hour, the vast majority of parking spaces are occupied during the other three peak hours, especially the weekday midday and Saturday midday peak hours. Illegally parked vehicles during these peak hours further exacerbate roadway safety and operations. The lack of loading zones makes it difficult for trucks to make deliveries. Figure 7 illustrates double-parked trucks causing through vehicles to cross the double yellow line. High parking utilization also results in increased congestion due to the circulation of traffic on Church Avenue as motorists attempt to find vacant parking spaces near their desired destination point.

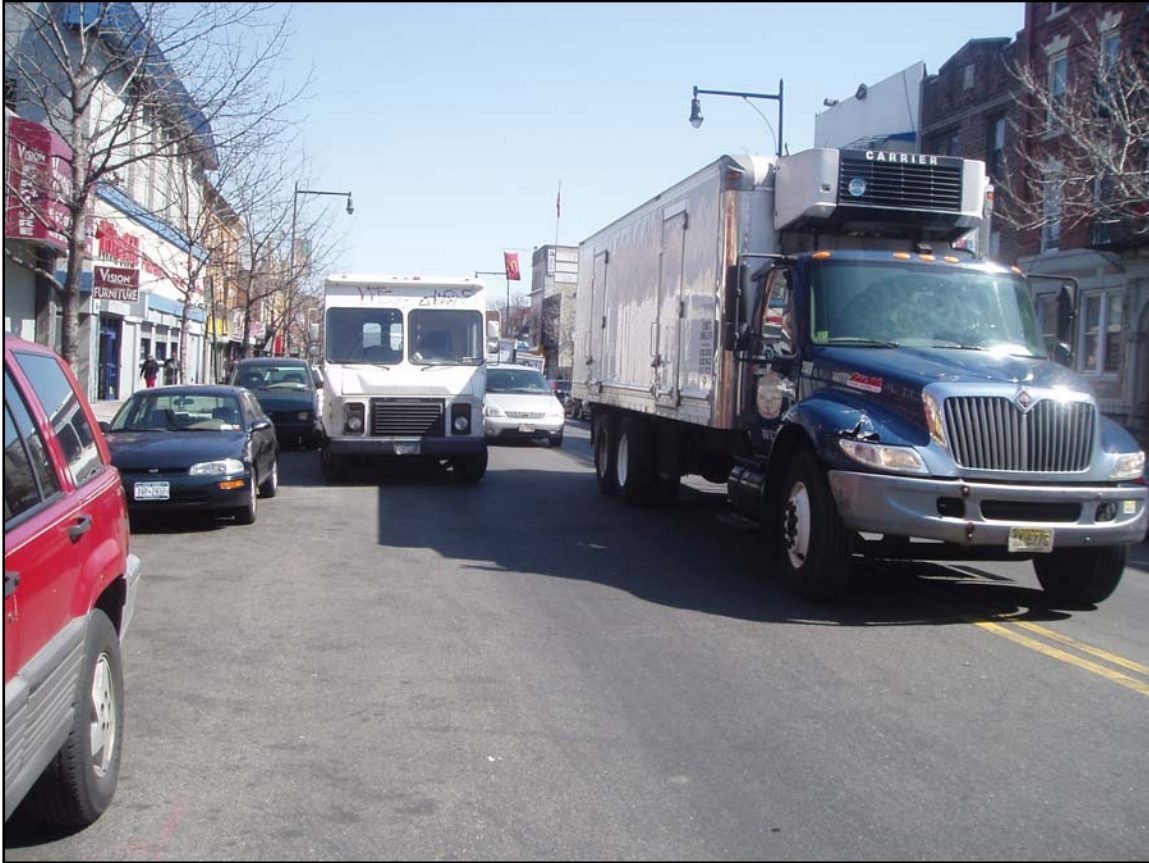
Figure 7: Typical Illegal Double Parking Activity along Church Avenue

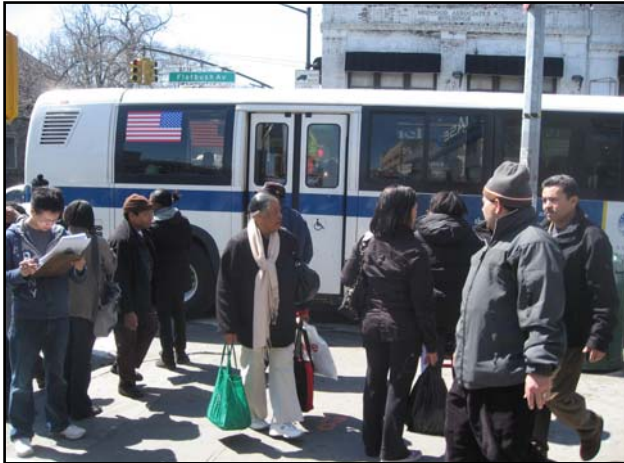
Figure 9: Pedestrian Activity at Church Avenue and Flatbush Avenue, Northeast Corner

The intense retail activity and bus stops for multiple routes at Flatbush Avenue (Figure 9) generates the largest pedestrian volume in the study area. At Nostrand Avenue (Figure 10) and East 18th Street, subway stations generate large numbers of pedestrians. At Nostrand Avenue, New York Avenue and Utica Avenue, the effective sidewalk widths are narrowed due to surrounding store encroachments, subway staircases and fencing, which has resulted in reduced sidewalk capacity.

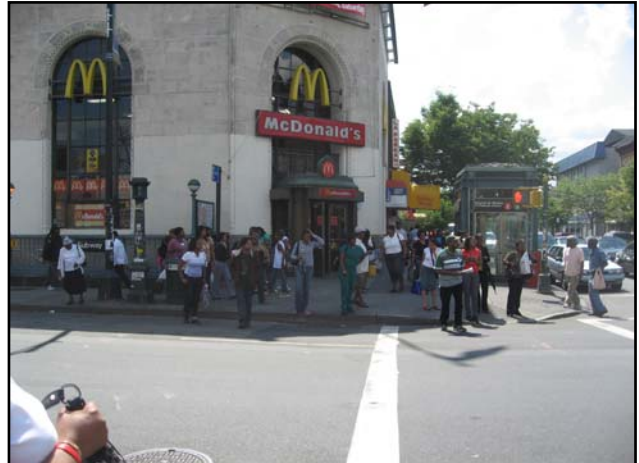
Figure 10: Pedestrian Activity at Church Avenue and Nostrand Avenue, Southwest Corner

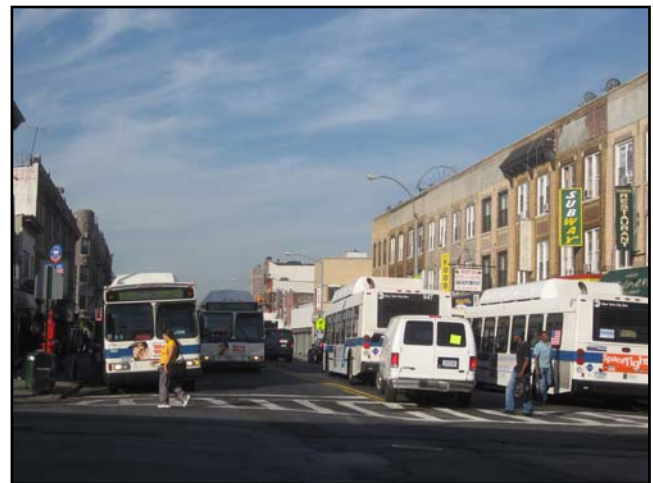
Figure 11: Church Avenue at McDonald Avenue, Looking West. Buses Arriving Simultaneously, Competing for Bus Stop Space

The B35 bus operates along Church Avenue throughout the entire length of the study area. In addition, six bus lines traverse Church Avenue: B67, B68, B41, B44, B46 & B49. Due to the delays in the traffic stream on Church Avenue, the B35 bus is often not able to keep up with the schedule. Also, buses have been observed to “bunch,” with multiple buses arriving at a single bus stop simultaneously (Figure 11). This creates unnecessary backup and queues, especially when hanging out of a far-side bus stop, blocking the adjacent crosswalk, and sometimes spilling back to the adjacent intersection.

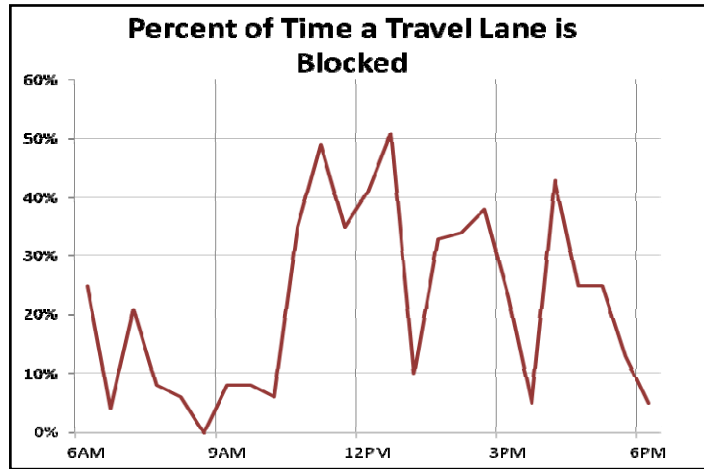
Figure 13: Weekday Lane Blockage on Church Avenue between East 16th Street and East 21st Street

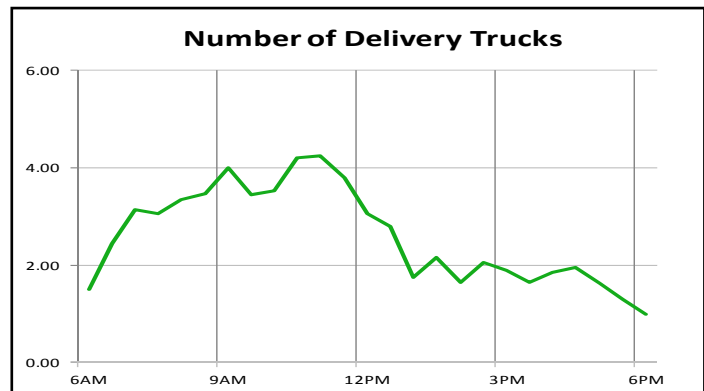
Figure 14: Weekday Number of delivery Trucks on Church Avenue between East 16th Street and East 21st Street

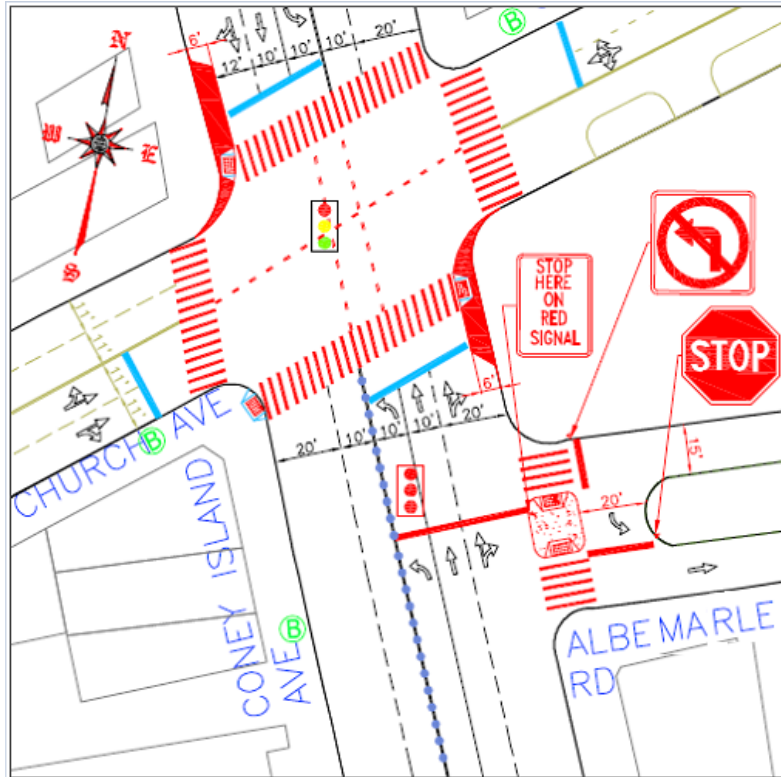
- A pedestrian refuge island has been provided along the east side of Coney Island Avenue crossing Albemarle Road.
- Curb extensions and pedestrian ramps will be installed on the east side of the south crosswalk, and the west side of the north crosswalk at Coney Island Avenue Avenue and Church Avenue.

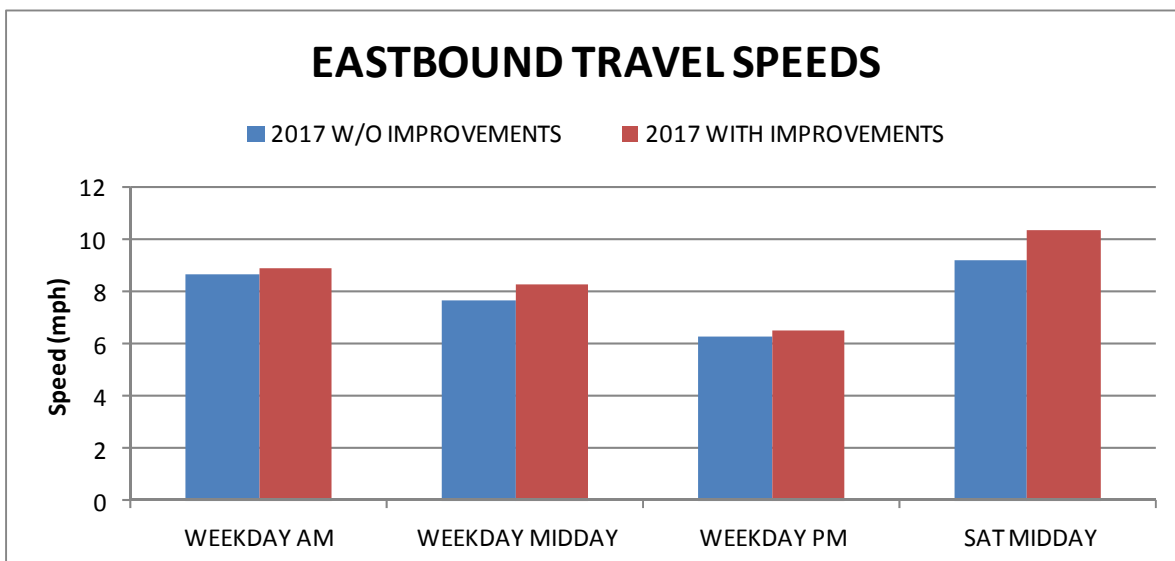
Figure 25: Eastbound Peak Period Travel Speeds for Church Avenue from McDonald Avenue to Utica Avenue

**TABLE 4
PROJECTED TRAVEL SPEEDS ON CHURCH AVENUE BETWEEN MCDONALD AND UTICA AVENUES**

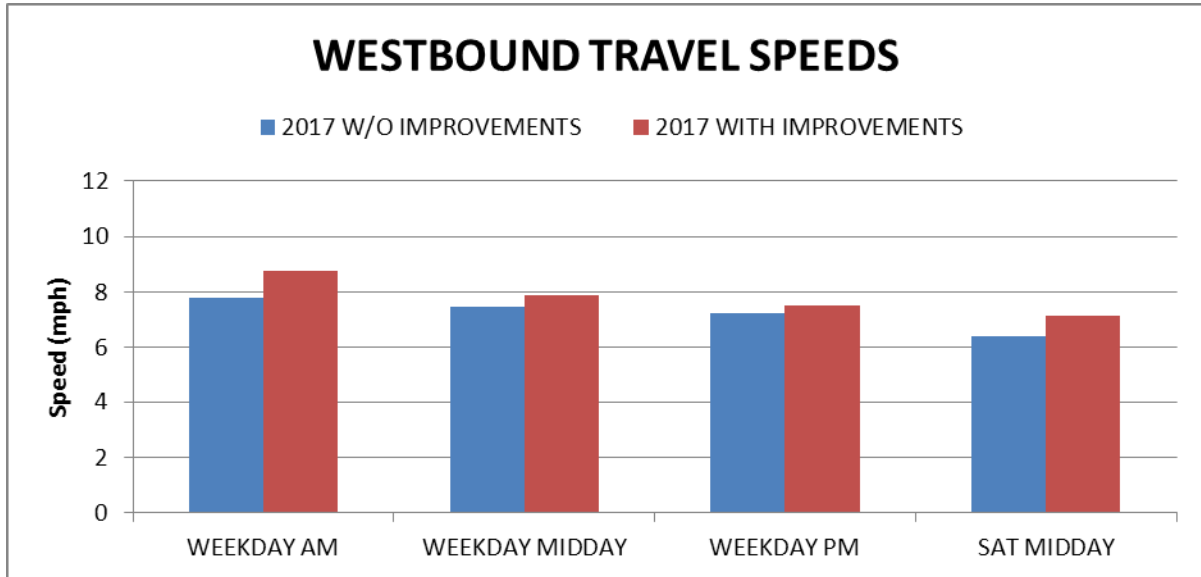
Figure 26: Westbound Peak Period Travel Speeds for Church Avenue from McDonald Avenue to Utica Avenue
