2017 NYC DOT

Bridges & Tunnels Annual Condition Report

NEW YORK CITY DEPARTMENT OF TRANSPORTATION DIVISION OF BRIDGES 2017 BRIDGES AND TUNNELS ANNUAL CONDITION REPORT

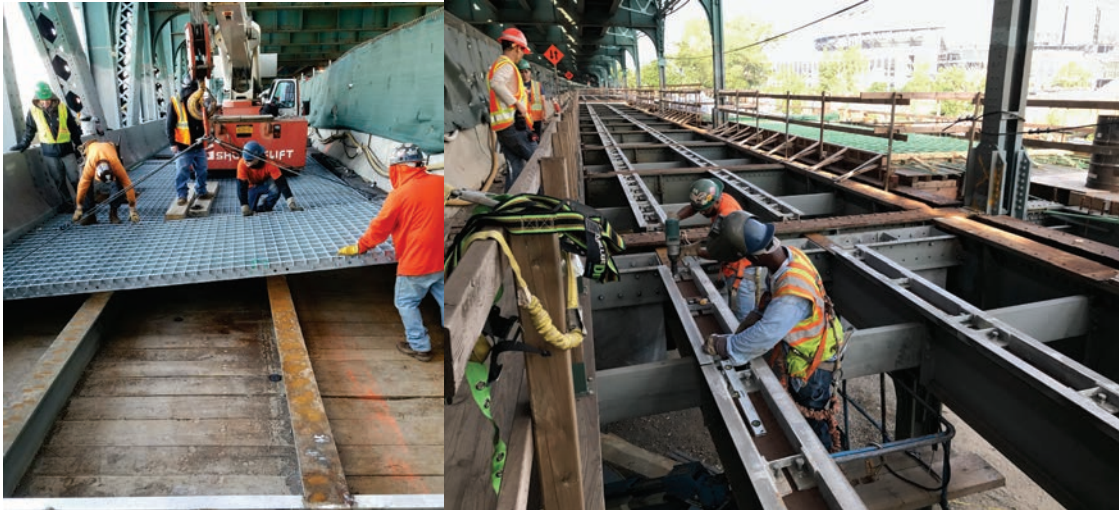
Contractors Installing the New Bascule Span Grid Deck on the Roosevelt Avenue Bridge in Flushing in March 2017. The Bridge is Permanently Set in a Closed Position Since the Late 1950's. Installing Haunch Angles at the West Viaduct Roadway Deck in July 2017.

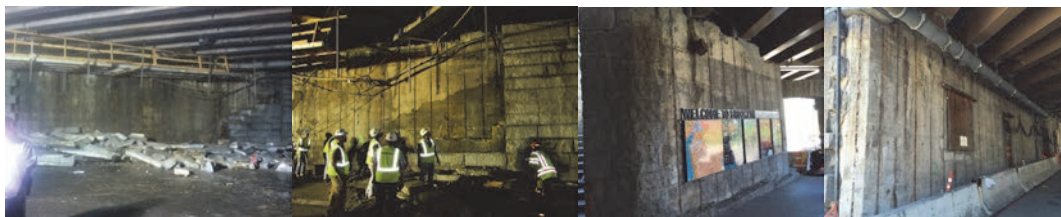
The masonry façade at the east abutment of Prospect Street under the Brooklyn approach suddenly collapsed in July of 2014. Immediate measures were taken to inspect and evaluate the collapse. All additional loose masonry cladding was removed from the abutment wall, including a portion of the wingwall. The remainder of the east wingwalls were found to be in good condition, but based on the condition of the east wall, the decision was made to secure the masonry to the existing walls. The condition of the Washington Street abutment façade was assumed to be similar to Prospect Street and a decision was made to remove the portions of the masonry cladded walls below the bridge seat and along the sidewalks. All of the loose and unsecured stone was removed to a staging area for possible reinstallation.

Prospect Street East Abutment Collapse in July 2014. Washington Street East Abutment.

The scope of work for this project includes: Manhattan Approaches (Ramps C, D, F, G, H, and I) - the removal and replacement of masonry cladding at the walls and abutments including the removal and resetting of capstones; the removal and replacement of sidewalks along the walls; the repair of spalls on the walls as necessary; Park Row Walls - the replacement of the masonry stones wall façade at the west abutment; the repair of spalls on the walls as necessary; the repointing of the masonry stones at the east abutment; cleaning, repointing and the anchoring of the masonry stones at the northwest and southwest wingwalls; Prospect Street - the replacement of the masonry stones at the wall façade at the east abutment; repointing of the masonry stones at the west abutment; the removal and replacement of the masonry stones at the southeast wingwall as required with remaining areas to be anchored; the repair of spalls on the walls as necessary; Washington Street - the replacement of the masonry stones at the wall façade at the east and west abutments; cleaning and repointing of the masonry stones at the round column and cross girder on the north side of the west abutment; cleaning, repointing and anchoring of the masonry stones at the northeast and southwest wingwalls; the repair of the spalls on the walls as necessary; replacement of windows with double hung aluminum frames and iron bars security guards; installation of roll-up door and two doors on the abutment; Sands Street - anchoring of masonry stones at the north wall adjacent to the structure.

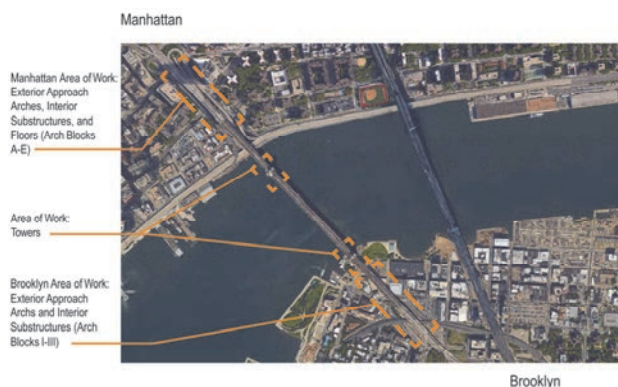
The Manhattan Approach is a continuous arch masonry structure consisting of brick, granite, limestone and infill concrete. The arches run between the Manhattan Anchorage at the east and

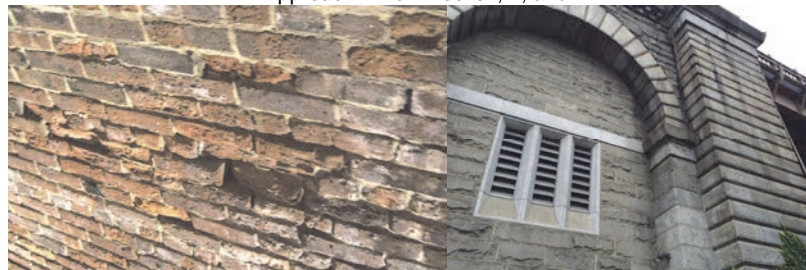
Brooklyn Approach Arch Block I: Deteriorated Brick on the East Face of the Barrel Wall. South Elevation - Staining and Loss of Mortar at the Joints and Arch Stones.

The current project (Contract #7) is needed to correct structural deficiencies related to the substructures of the bridge, including the masonry approaches, towers and approach ramps.

Specifically, the project will address the rehabilitation of the interior brick walls, floors, foundations and granite façade of the masonry arches of the Manhattan Masonry Approach, as well as the brick infill walls of the granite façade arches. Similarly, the project will address rehabilitation of the masonry towers and substructure strengthening of the Approach Ramps to correct existing structural deficiencies. Construction work at the towers will be avoided during the nesting period of the peregrine falcons that may nest in an opening of the tower legs. On the Brooklyn Masonry Approach, the project will address rehabilitation of the granite masonry infill walls and facades as well as rehabilitation of the Washington Street abutment. Finally, the project also includes the rehabilitation of a few suspended span components such as the roadway expansion joints, and footwalk widening.

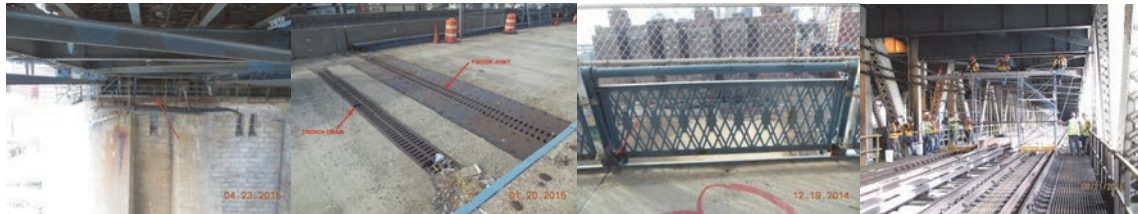
Manhattan Anchorage Maintenance Platform. Looking Northeast at a Trench Drain and Finger Joint on the Parking Deck. First South Rail at South Walkway. 2016: Inspecting the Bridge Using a Rolling Platform. (2016 Credit: NYSDOT)

The scope of work for the upcoming structural and component rehabilitation will include: replacement of the south fascia railing and fencing; replacement of the dehumidification system in the cable anchorages; rehabilitation of the masonry and cable housing at the anchorage; rehabilitation of the truss gusset plates at the approach and suspended spans to improve the load rating to HS20; replacement of the work platform at the anchorages; resealing of the relief joints in the south upper roadway; refurbishing the existing fire standpipe system; and strengthening of the subway floorbeam connections in the approach spans.

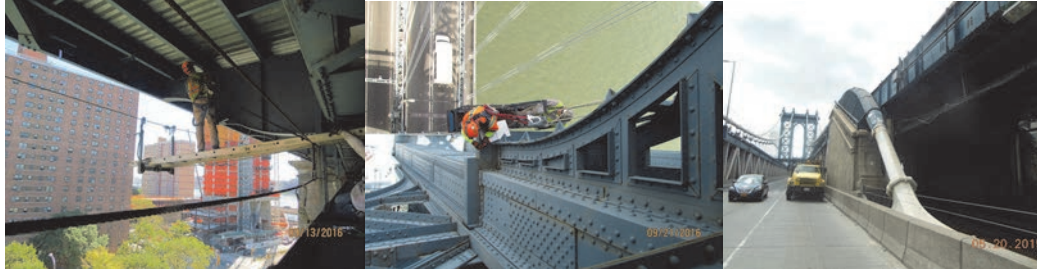
2016: Inspecting the Bridge Using a Scaffold and Sky Climber. (Credit: NYSDOT) Bridge Saddle.

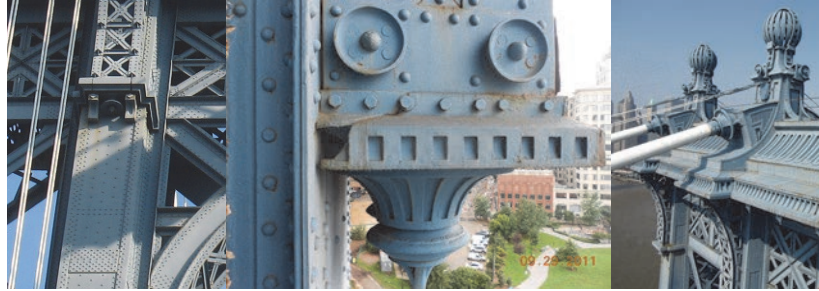
Ornamental Bordure, Horizontal Plate Supporting Rosette, Rosette, and Bracket. Ball, Ornamental Cable Band, Ornamental Top Castings, Rosettes and Castings, Rosettes and Ornamental Ceiling Brackets, and Bands Around the Ball.

The scope also includes the removal and replacement of the tower ornamental cornices, globes, cable collars and brackets. These features of the bridge are constructed from cast iron (an alloy of iron and carbon) and are quite heavy. Cast iron is hard and brittle. It tends to crack rather than bend when subjected to tensile forces, like those imposed by pack rust. They are installed at the top of the towers and are exhibiting connection problems. Some of these elements are cracking and the connection bolts are severely corroded or missing. They have been red flagged under the biennial inspection program and need to be replaced. Ductile cast iron is much stronger, tougher and more ductile than conventional cast irons. The replaced elements will be produced from molds cast from the original pieces. Their appearance will be virtually identical. Undamaged rosettes will be refurbished and reinstalled. A few are missing and will be replaced. The Notice to Proceed for this two and a half year construction project is expected in summer 2018.

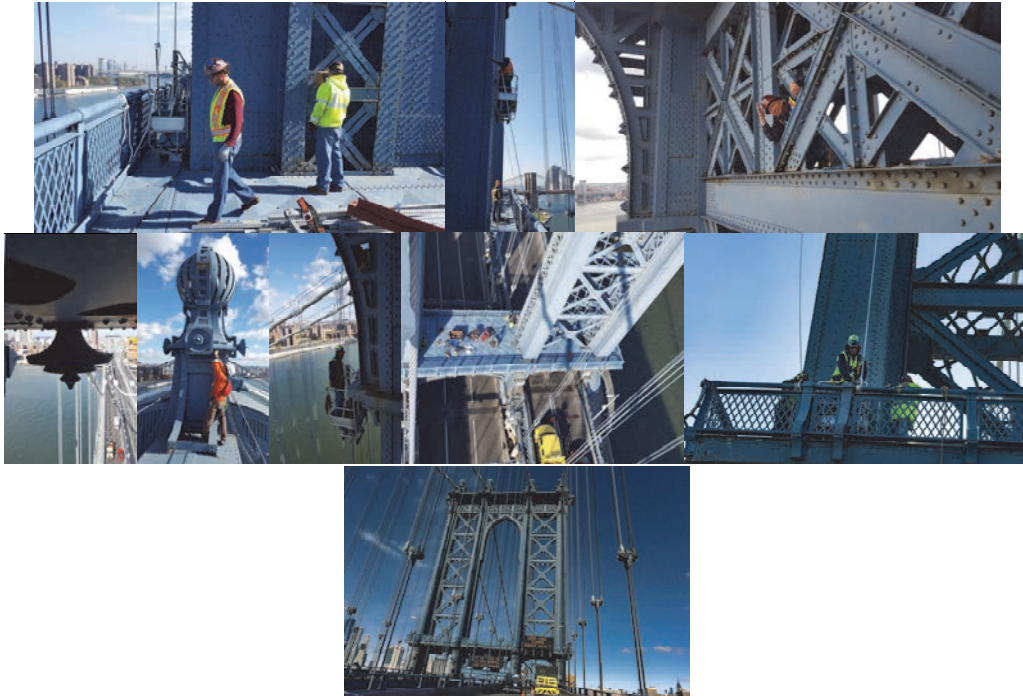
Ornaments on the Manhattan Bridge Towers Were Flagged as Potentially Hazardous and Removed by In-House Ironworkers in October and November 2016. (Credit: Bojidar Yanev) Using Spider to Remove Ornament at Cable C West in 2016. (Credit: Samuel Teaw)

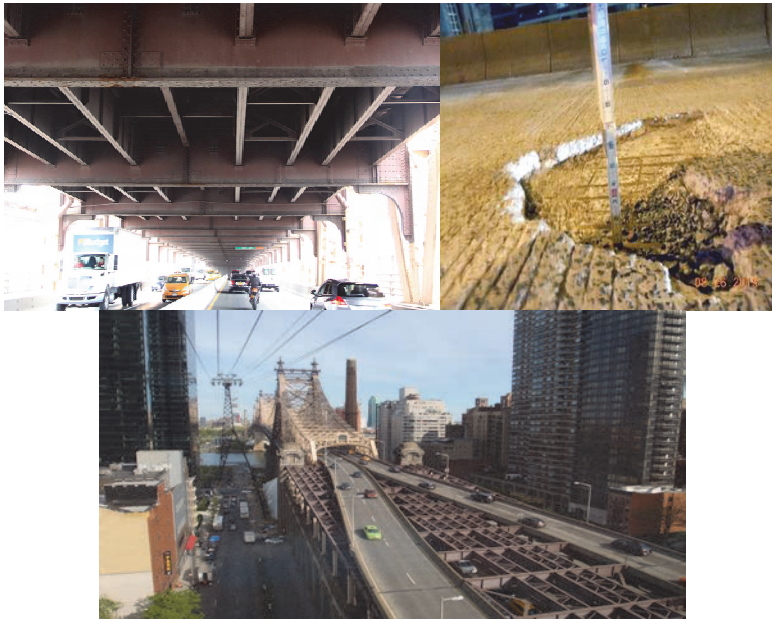
Current Roadway Condition.

The Notice to Proceed for this four and a half year construction project is expected in spring 2018. The actual replacement of the upper roadway will begin summer 2020.

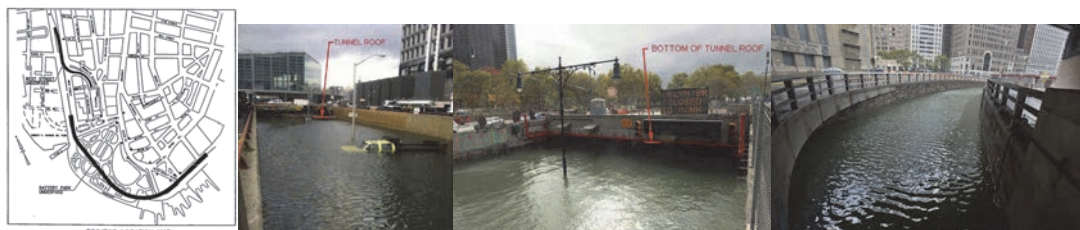
The Battery Park Underpass is a two-span rigid frame reinforced concrete tunnel structure connecting eastbound and westbound traffic between the FDR Drive and West Street (Route 9A) at the southern end of Manhattan. The West Street Underpass is a one-span rigid frame reinforced concrete tunnel structure connecting southbound traffic from West Street heading toward the entrance to the Brooklyn Battery Tunnel (Hugh L. Carey Tunnel).

Battery Park and West Street Underpasses. October 2012 - Battery Park Underpass - View Looking West at the South Portal Entrance Near the FDR Drive. View Looking South at the North Portal Entrance Near West Street. West Street Underpass – Approach at South Portal Looking Southeast. Both Tunnels Were Flooded to Their Roofs, Which Means That all Tunnel Ventilation, Electrical, and Mechanical Systems Were Entirely Submerged in Saltwater.

On October 29, 2012, the New York Metropolitan area was impacted by Hurricane Sandy, causing flooding, loss of power and damage to many components of New York City's infrastructure. On October 30, 2012, a site inspection by the Department revealed major damage to both underpasses. Specifically, certain electrical, mechanical and structural issues with regard to the tunnels had to be addressed.

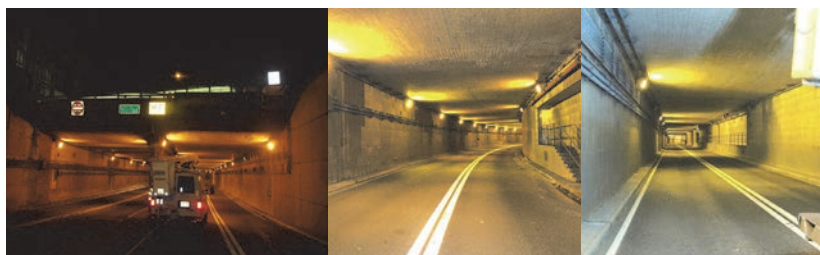
Battery Park Underpass - September 2013 - Span 2 Looking Westbound (FDR Drive to West Street). June 2014 – The Underside of the Tunnel is Completely Covered With Tiles.

Salt water penetrated the electrical and mechanical equipment in both underpasses, including but not limited to, motors, lighting and pumps. It was therefore, necessary to solicit the services of a specialty contractor to perform all necessary repairs. The original design from 1946 and 1947, as well as previous contracts from 1996, 1997 and 2004 utilized some equipment and systems which are now outdated and were superseded by newer products, as well as code changes which required design modifications in order to be compliant with current codes.

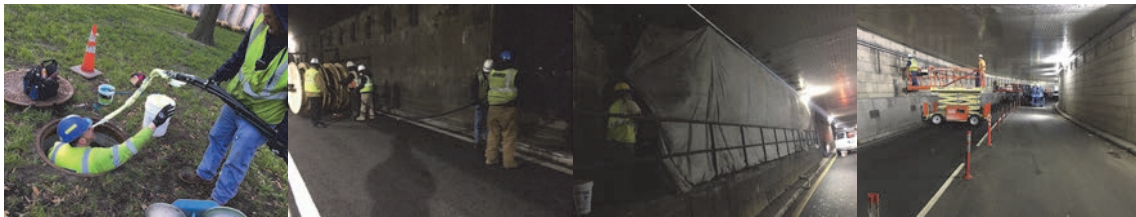
April 2016 - Installing Cables. July 2016: Painting Standpipe in the Southbound Battery Park Underpass. August 2016: Installing Conduits in the West Street Underpass.

A Letter of Intent for the emergency repairs of these underpasses was issued to the contractor with a start date of February 17, 2015. The scope of work includes replacement of all of the exhaust fans, motors, sump pumps, traffic signals/VMS, heating and ventilation units, fire and CO monitoring control systems, and the street lighting and emergency response systems. The scope of work also includes the installation of a SCADA system (Supervisory Control and Data Acquisition) for the remote monitoring and control of all systems. Construction is expected to be complete in July 2018.

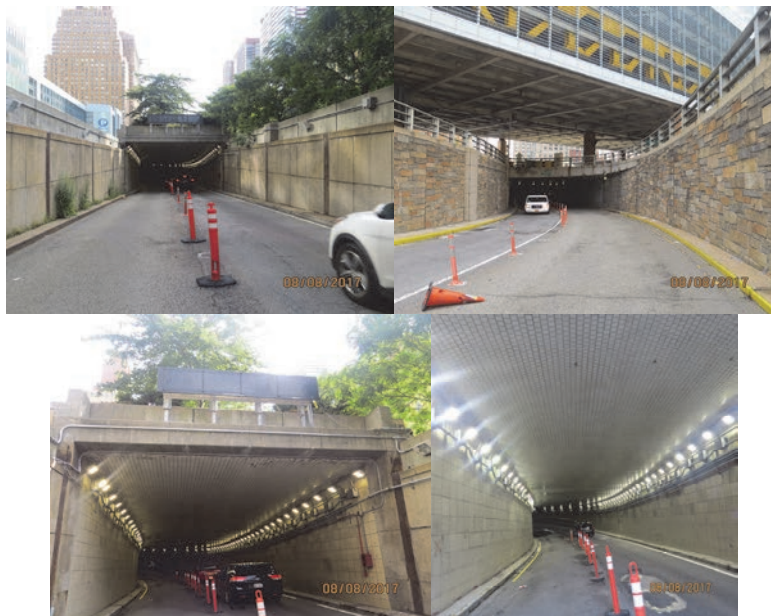
August 2017: West Street Underpass Elevation North and South. North Concrete Portal. Variable Message Board Will Be Replaced.

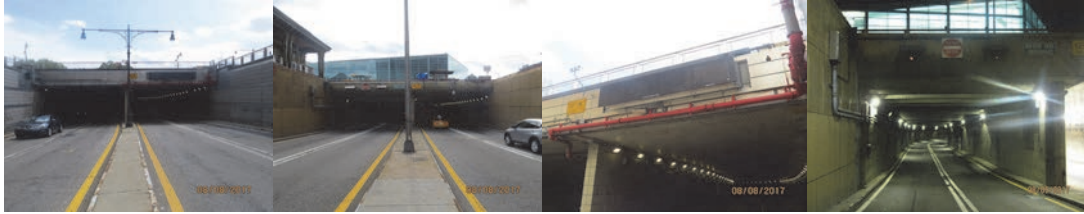
August 2017: Battery Park Underpass Elevation South and North. South Tube North Portal. Variable Message Board Will Be Replaced.

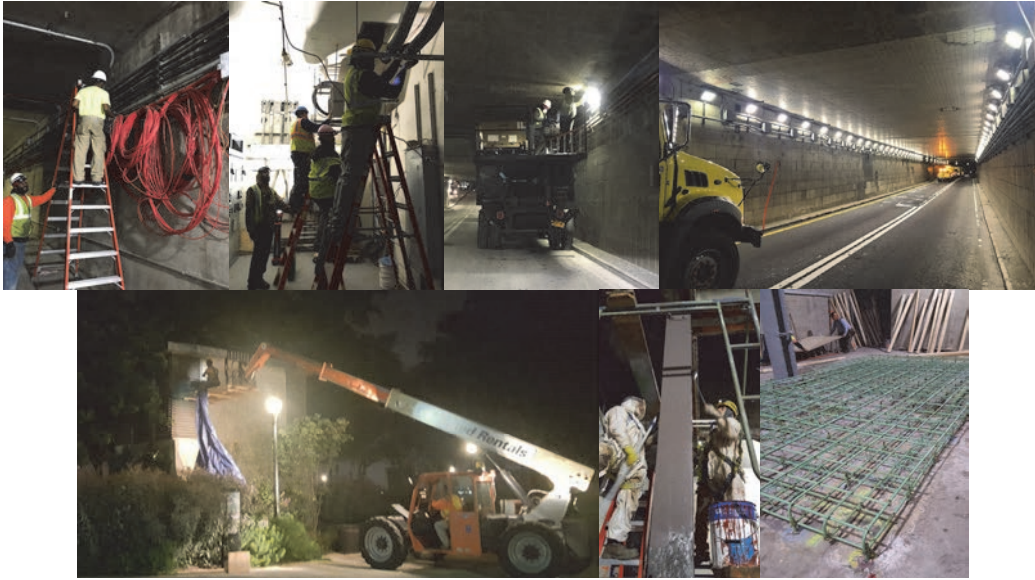
Battery Park Underpass – June and November 2017 – Installation of Cables and Conduits. January and July 2017: Lighting Fixture Repairs. August 2017: Surface Preparation for Turning Vane Painting. Intumescent Painting Application. October 2017 – Placement of Reinforcement for the New Fans' Bases. (Credit: Darlyn Alvarez)

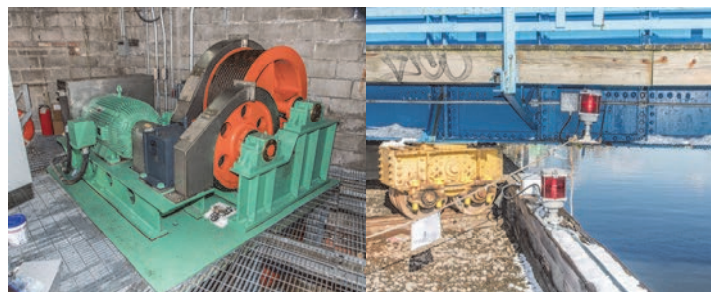
December 2017: Touch-Up Painting on Carroll Street Bridge Machinery. Pier Lights.

The contractor performed the following work on the Carroll Street Bridge in 2015: installed a new temporary operating system; removed the existing operating machinery from the control house; repaired the deteriorated sections of the existing rail tracks; removed the existing conduits and wiring in control house and pier; and repaired the leaking control house roof. The following work was performed in 2016: demolished the existing conduits and wiring in the control house and pier; casted, poured, and tested the new hoist; rehabilitated 80% of the machinery; installed new navigation lights and their respective conduit and wiring; and erected a new steel platform in the control house. The following work was performed in 2017: installed the rehabilitated bridge machinery and the new control desk; replaced the span drive wire ropes and hardware; replaced the motor, secondary resistors, brakes and limit switches; replaced the cable reel assembly including motor and junction box; replaced the conduits and wiring in the control house and on the pier; replaced the navigation lights, conduit boxes and associated wiring; and raised the operating machinery and electrical equipment in the control house.

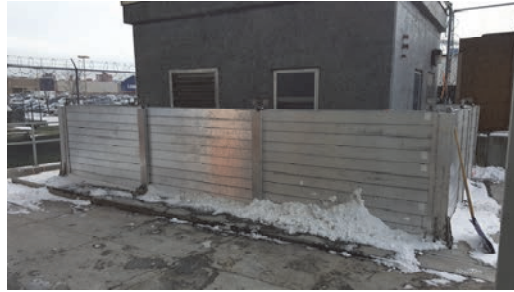
2017: Completed Ninth Street Bridge Flood Barrier.

and wiring. The following work was performed in 2016: replaced the span locks, including the motors, limit switches, brakes, and gear reducers driving the limit switches; completed 90% of the electrical installations, including conduit, junction boxes and wiring; installed and tested the flood barrier system; installed and tested the new generator; installed HVAC systems; waterproofed the generator house; and performed intermediate bridge balancing. The following work was performed in 2017: installed and tested the new emergency generator; installed the HVAC systems; waterproofed the generator house; replaced the navigational lighting system on the fenders along with conduit, boxes, and wiring, installed the new transformer and performed associated work to incorporate the existing with the new generator; installed a new Automatic Transfer Switch (ATS); and performed the final bridge balancing.

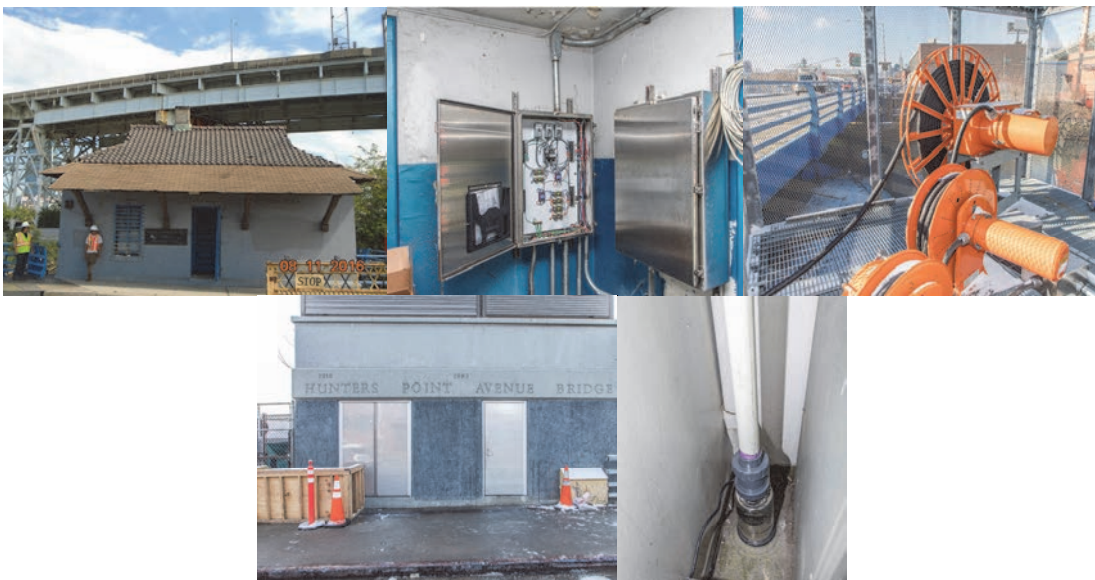
2016: Borden Avenue Bridge Operator House. 2017: Borden Avenue Bridge Traffic Panel. Submarine Cables. 2017: Hunters Point Avenue Bridge New Double Doors. Sump Pump and PVC Pipe.

The contractor performed the following work on the Borden Avenue and Hunters Point Avenue Bridges in 2016: completed asbestos abatement work; continued the electrical installation of wiring and conduit; and removed the mechanical machinery and sent it to the manufacturer for rehabilitation. The following work was performed in 2017: installed the submarine cables using the directional drilling method; replaced the motor disconnect switch, conduit boxes, flexible cables and wiring on the west pier; installed a new support and platform for the terminal box; replaced conduit, boxes and wiring in the operator house basement and along the pier. At the Hunters Point Avenue Bridge, the contractor removed and replaced span and tail lock actuators; replaced all electric motors, limit switches, tachometers, and over speed switches; replaced the motor brakes and machinery brakes; replaced conduits, boxes and wiring in the bascule pier and span lock area; replaced the northeast warning gate arm; and installed and successfully tested the flood resistant doors.

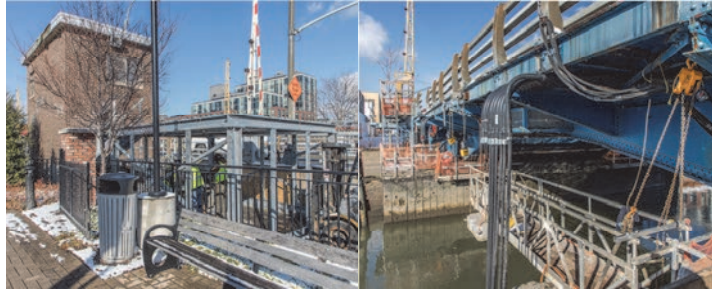
December 2017: Third Street Bridge Generator Platform. Droop Cables.

The contractor performed the following work on the Third Street Bridge in 2016: accepted bridge turnover from NYCDOT; began mechanical component removals; and began installation of the temporary operating system. The following work was performed in 2017: completed the rehabilitation of the gear reducers and completed their reinstallation; replaced roller bearings, span drive motors, brakes, limit switches, over speed switches, tachometer, and position transducers; installed the elevated platform for the new generator; and replaced the warning gates.

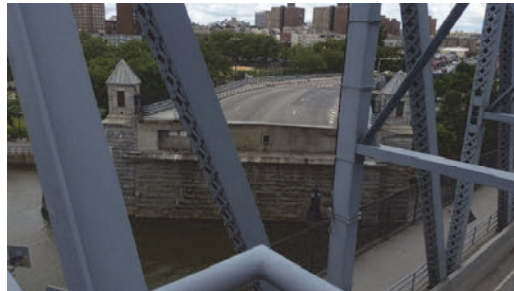
2017: Madison Avenue Bridge During Test Opening.

The contractor performed the following work on the Madison Avenue Bridge in 2016: installed and tested the flood barrier systems on the Bronx and Manhattan sides; made repairs to the electrical equipment in the Manhattan side transformer vault; replaced the navigation lights, and installed the new sump pump in the Manhattan side transformer vault. The following work was performed in 2017: installed the flood barrier systems on the Bronx and Manhattan electrical vaults, and replaced the cabling between the main circuit breaker and the transformer.

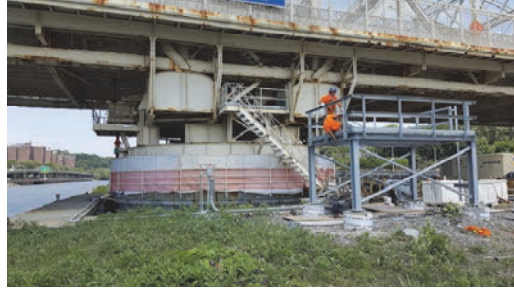
2016: Macombs Dam Bridge CO2 Containment.

work was performed in 2017: removed the existing submarine cables from the center pivot pier to both rest piers and installed new submarine cables; replaced all navigational lights, conduit, junction boxes and wiring on the center pivot pier fender; installed the new automatic transfer switch (ATS) cabinet and navigational lighting cabinet; and installed new platform with a ladder for access for the ATS and navigational lighting cabinets.

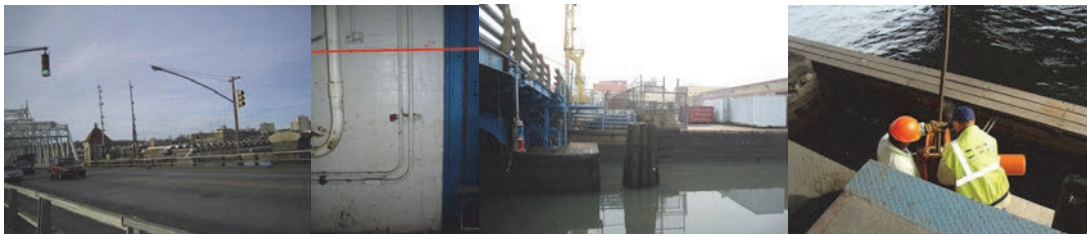
Inspection in Late 2012: East End of the West 207th Street Bridge - Missing Traffic Signal was Knocked Down by the Hurricane Winds. Borden Avenue Bridge Operator's House Basement Level – Depicted Flood Line was Approximately 5 Feet Above the Floor. Third Street Bridge – Northwest Channel Light Missing. Ninth Street Bridge – Manually Pulling the Cable Reel Because the Motor Failed.

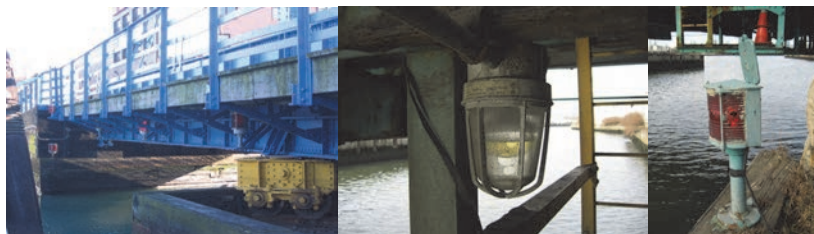
Inspection in Late 2012: Carroll Street Bridge - Navigational Fixtures on North Side of Span – Only the Center Span Fixture was Operational. Grand Street Bridge – Standing Water in the Access Light Fixture at the East Wedge Walkway. Typical Impact Damage to Pier Light.

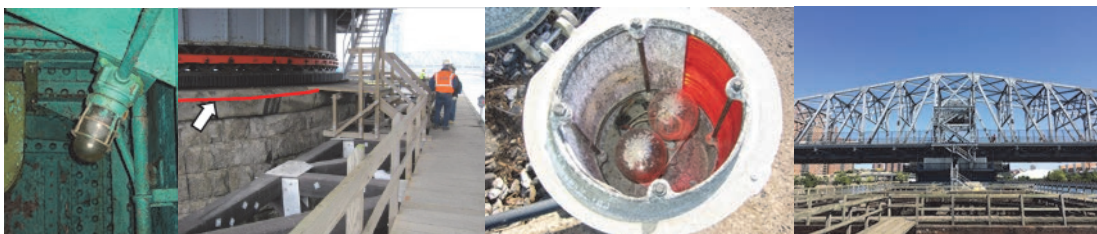
Inspection in Late 2012: Union Street Bridge – Standing Water in East Span Maintenance Light. Madison Avenue Bridge - General View of Fender and Center Pier—the Red Line Depicts the Approximate Water Level. Macombs Dam Bridge – Pier Lighting Fixture with Cover Removed – Silt Deposit on Lamp Tops, and Corrosion on the Fixture Frame. 145th Street Bridge in August 2015. (Credit: Lity Barreto)

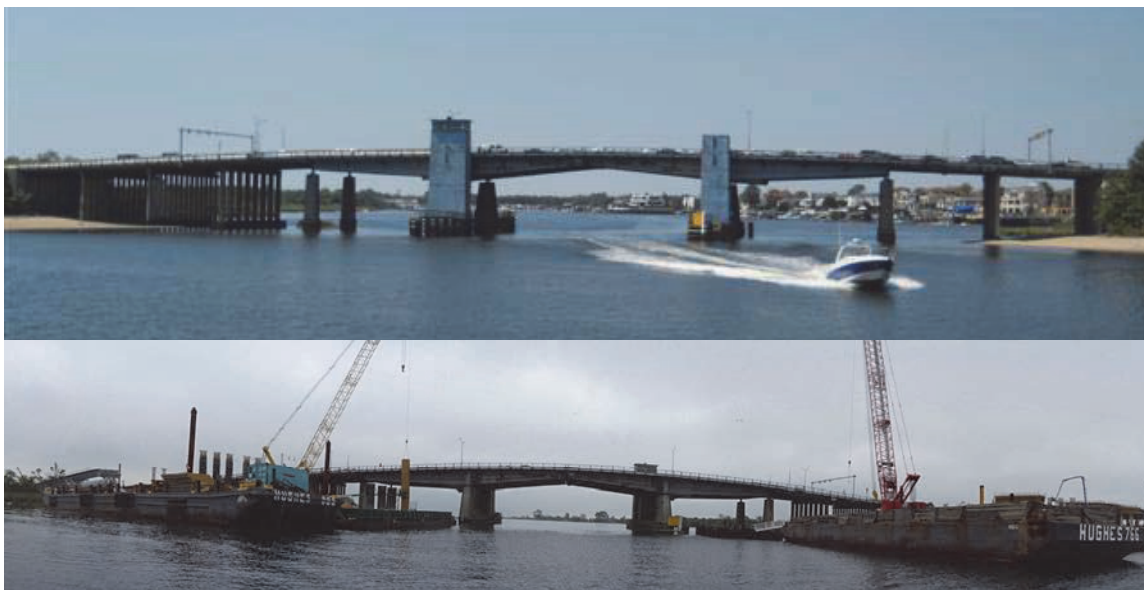
Mill Basin Bridge in 2010. (Credit: NYSDOT) Construction Site in October 2016.

In 2015, on a New York State-mandated scale from 1 to 7, this bridge had a condition rating of 3.209, or “fair.” While the bridge was not in any immediate danger of structural failure, its reconstruction was required in order to maintain mobility and public safety on this vital artery.

The old Mill Basin Bridge was 864-feet long and 14 spans, including double movable leaf bascule spans and a steel superstructure, supported on reinforced concrete pier on timber piles, and abutments supported on pre-cast concrete piles. The existing structure and immediate approaches will be demolished and replaced.

The replacement will be a 2,645-foot long, 17 span, 60-foot high fixed bridge. It will consist of a steel composite superstructure and reinforced concrete substructure on piled footings, and will be constructed on a new alignment set on the north side of the existing bridge and partially overlapping with the existing bridge. The new bridge and approach will have three 12-foot wide traffic lanes, a 12-foot wide right shoulder on the bridge, a 10-foot wide right shoulder on the approaches, and a minimum left shoulder in each direction. The eastbound side will carry a dedicated pedestrian/bicycle path along the south fascia. The new bridge will be a fixed structure with a 60-foot vertical clearance over Mean High Water, obviating the need for opening and closing the structure to accommodate tall vessels. The new design of the bridge will result in increased sight distances, an increase in lane width from 11-feet 4-inches to 12-feet, and the inclusion of safety shoulders in both directions. The channel will remain navigable during construction, and the clear channel width will remain the same after the new structure is in place. A new fender system will be installed to protect the bridge substructure from marine traffic. The reconstruction of the Mill Basin Bridge (part of the second Belt Parkway Group) is scheduled to last approximately 4 years. A Notice to Proceed for the replacement of this bridge was issued to the contractor with a start date of June 22, 2015.

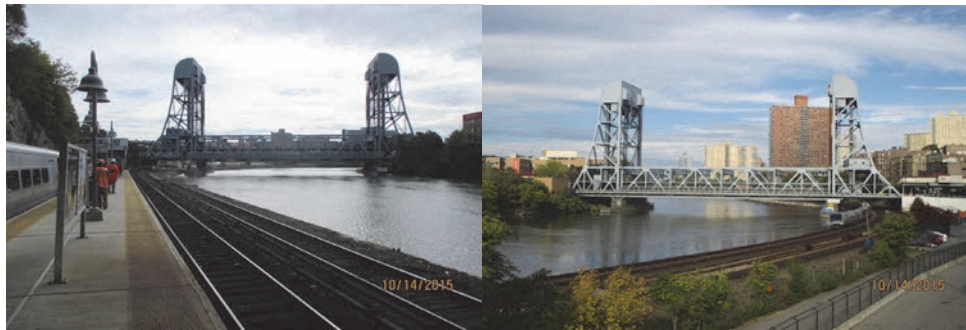
The vertical lift bridge is the third movable steel structure at this location. The original steam powered single-deck swing span built in 1895 carried only highway and pedestrian traffic. The first swing span was moved to a new nearby location as the University Heights Bridge. The second structure was built in 1905 to accommodate the extension of IRT subway into the Bronx from Manhattan. The second bridge was again a double level swing span to carry the subway line on the upper deck and highway traffic on the lower deck. The current structure, a double level vertical lift bridge to carry the subway and vehicular traffic, was built in 1960.

Broadway Bridge – West and East Elevations.

A major reconstruction project is currently anticipated to start in the summer of 2018. The project's scope of work includes a major rehabilitation of the roadway deck, superstructure steel and substructure elements of the vertical lift span, as well as the approach spans, and the repair of the truss members (chords, batten plates, gussets and lacings) throughout the structure. It will also include the replacement/rehabilitation of the electrical and mechanical components of the vertical lift span, provision of access to bicyclists in the outer roadway lanes, of the granite on the river piers, rehabilitation of the control house, the two machinery houses, the gate house, and the two gateman's shelters (including asbestos abatement), replacement of the pedestrian fencing, and installation of pigeon-deterrent, intrusion, and shielding measures. Construction is anticipated to be complete in the summer of 2021.

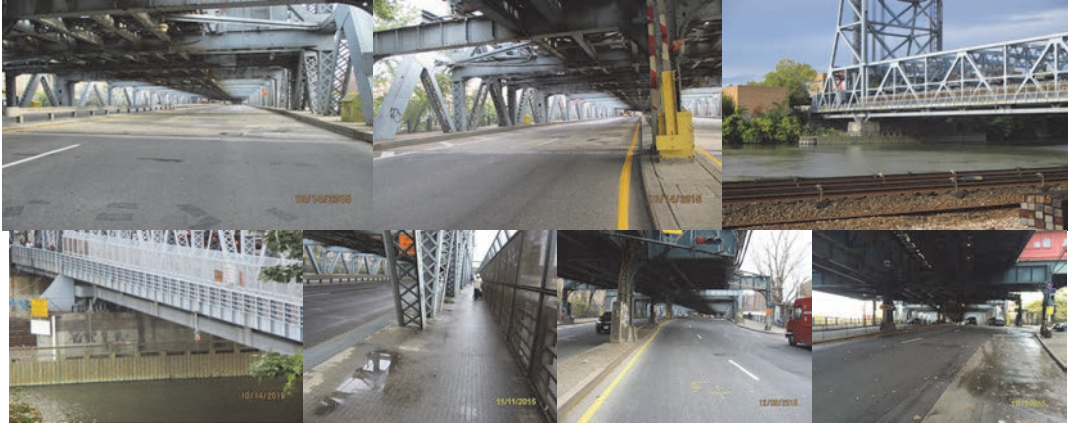
2015: Northbound and Southbound Roadways. South and North Piers. November 2015: Span 2 Right Sidewalk, Beginning and End Approaches, (Credit: NYSDOT)

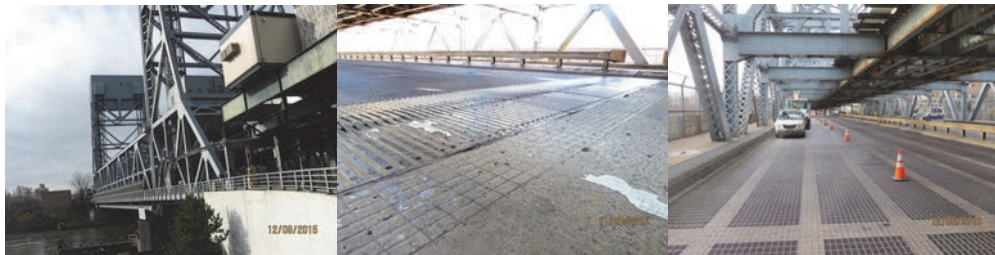
2015: Framing Span 2. November 2016: Pier 1, Finger Joint at Southbound Roadway - Misaligned Fingers. December 2016: Span 2, Northbound Roadway - General View of Steel Grid Deck. (Credit: NYSDOT)

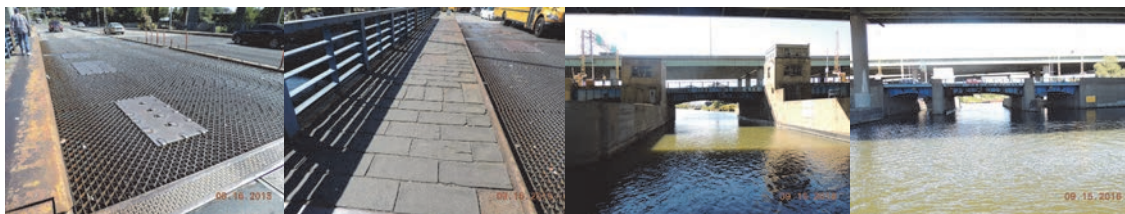
2015: Span #9, Open Deck Grating at Westbound Roadway, Looking Ahead and Right. Loose and Bouncing Plates. Plastic Delineator Posts Mounted to the Concrete Median are Missing the Majority of Posts Due to Vehicular Impacts. Span #9 Right Sidewalk, Looking Back. Asphalt Tiles Over the Bascule Span are Severely Deteriorated and Exhibit Several Missing Tiles. Existing Bridge in September 2016 – Left and Right Elevations. (Credit: NYSDOT)

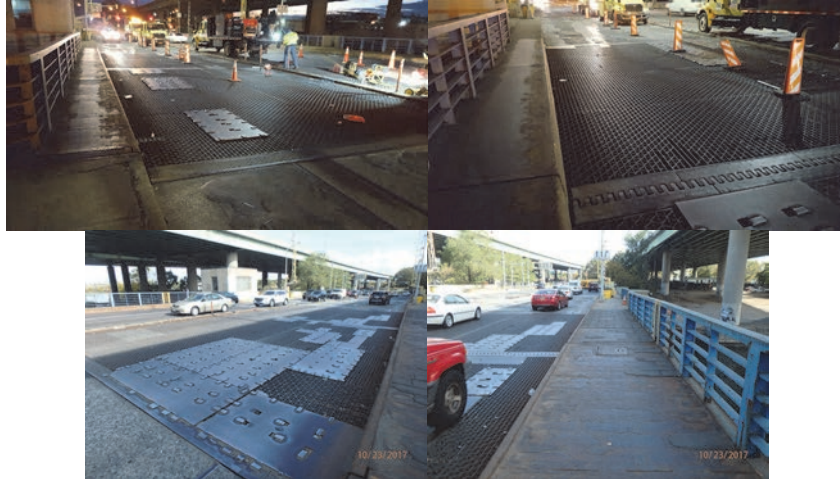
January 2017: Bridge Grating. October 2017: Span 9, Right Side, Eastbound Travel Lanes. The Top of the Steel Open Grid Deck has Multiple Steel Plates Installed Throughout the Eastbound Lanes to Cover the Damaged Areas of the Gratings. Span 9 Right Sidewalk. (Credit: NYSDOT)

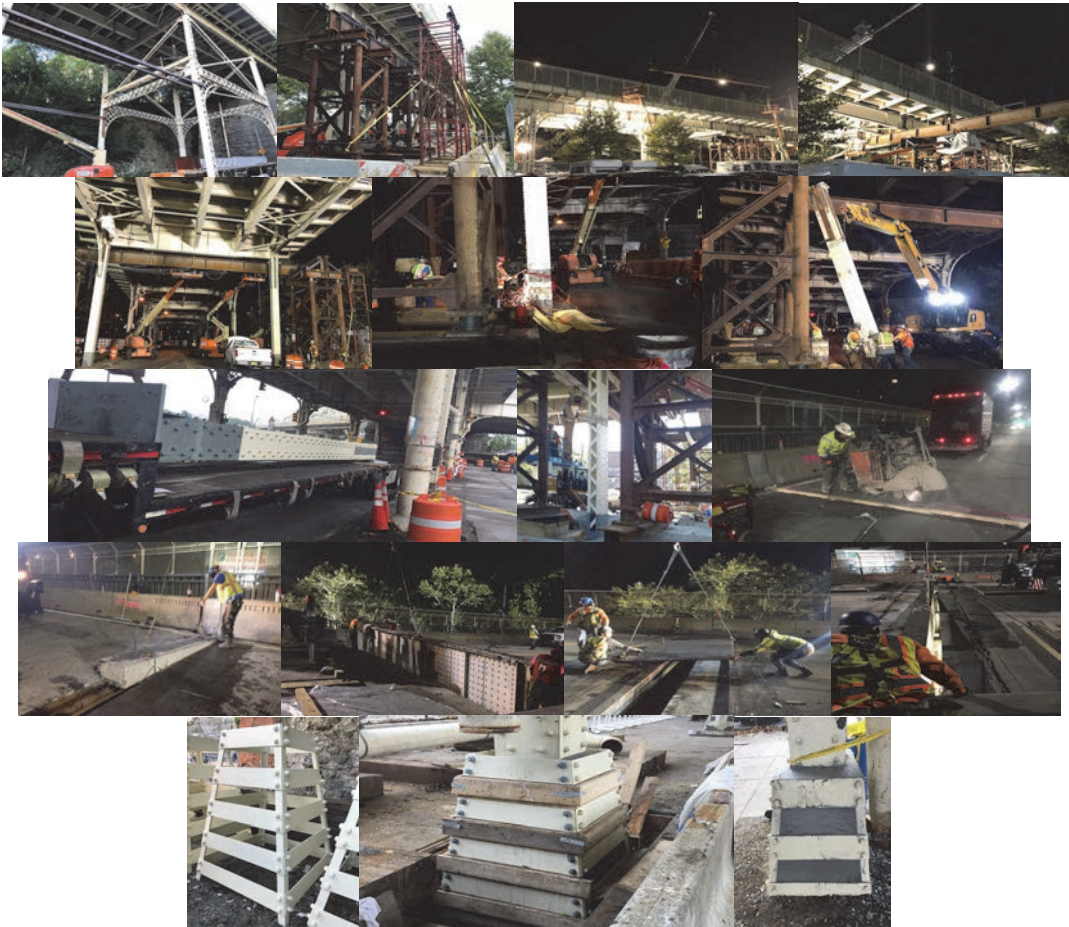
Steel Repairs at the Viaduct Began in Summer 2017. Temporary Supports for New Strut Replacement. Temporary Shoring Tower System Assembly. "Flying" 12T Jacking Beams from Top of Viaduct and "Sliding" Them Below the Viaduct Atop the Supports. Removing Existing Column. Installing New Column. Sawcutting and Removing the Deck. Removing Existing Floorbeam. Steel Roadway Plates Placed Over the Cut Section of the Deck. New Floorbeam Installation. New Column Wheelguard.

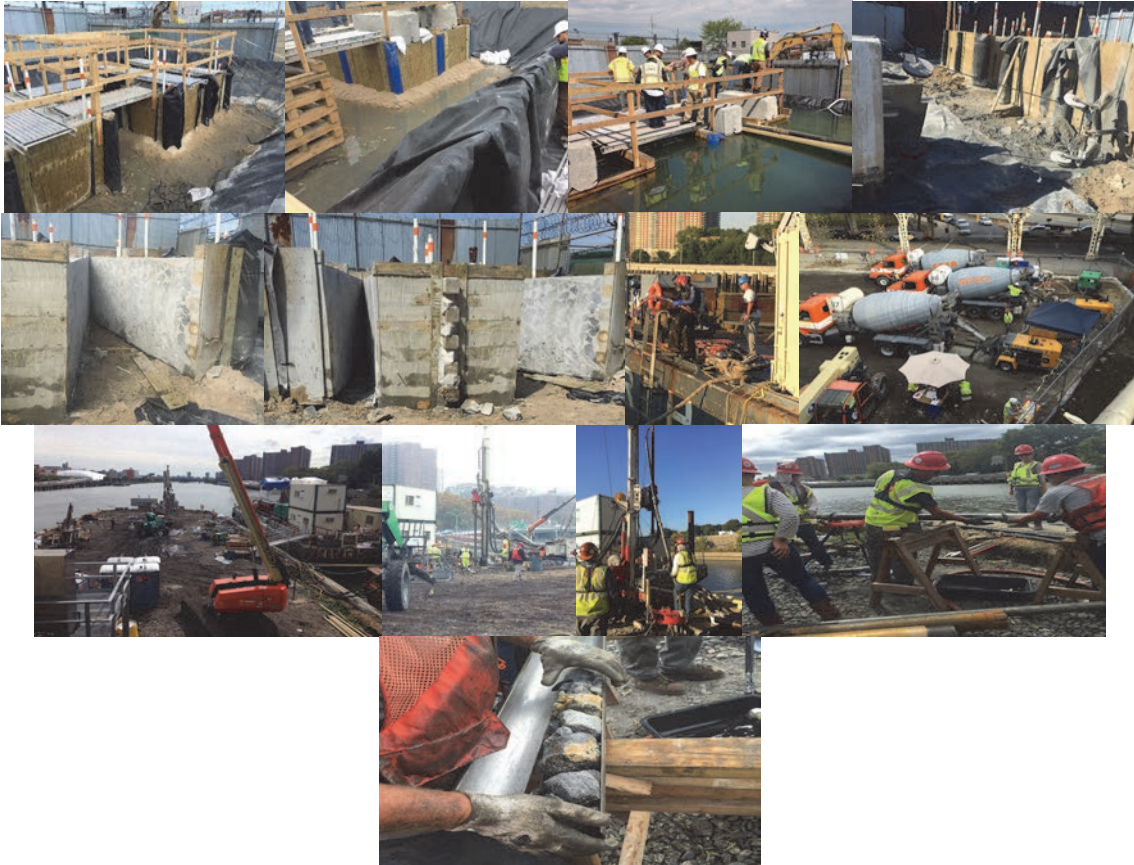
Fender Grouting - Started Spring 2016- Completed Summer 2017. Grouting Test Sections Filled with Stones Were Constructed Offsite, Inside a Port-a-Dam (Similar to a Pool), with Placed Concrete in a Manner Simulating the Fender Conditions. The Grouting Test Sections Were Cut in Sections and Confirmed that the Grout Moves Around Underwater and Encapsulates the Stones and Timber. Divers Installed Underwater Formwork on the Cribbing Around the Fender. Grouting Operations Started with Pumps on Land. Grouting Slick Lines Transfer the Concrete from Land Through the Sidewalks and Down to the Fender (About 800' Away). Typical Drilling at the Fender to Install Grouting Tubes all the Way to the Bottom of the Fender Cribbing (About 30-40' from Top of Ground). Drilling for Core Samples to Verify the Grouting. Core Samples Extracted.

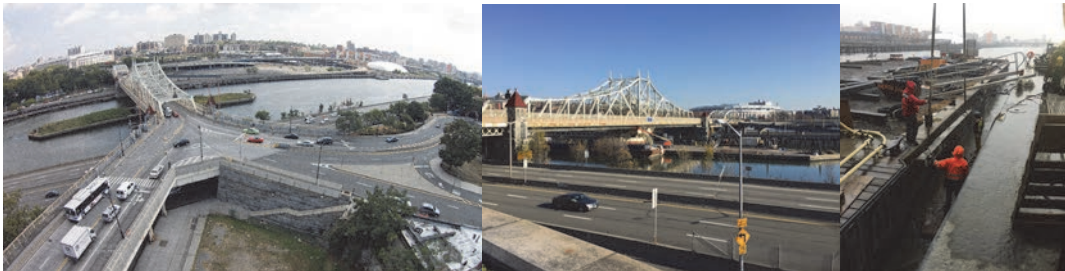
Fender System Rehabilitation Began in Summer 2017. Aerial View Prior to Construction. General View of the Fender and the Swing Span. Removal of the Existing Timber Rubbing Strips From the Fender.

The existing swing span fender is misaligned with the swing span in open position, and the timber cribbing is under attack by marine borers which could lead to the failure of the timber cribbing and the collapse of the stone fill. In 2016, the contractor installed formwork around the perimeter of the existing fender, filled the voids in the fender with sand-cement grout, and bonded the existing timber and rock into one solid mass. This grouting work was completed in 2017. The rest of the structural repair work also progressed in 2017. Remaining work includes the construction of a fender extension on the northeast corner. In addition, in connection with the fender repair, the work activities will include removal of debris located on the river bottom in the channels adjacent to the swing spans. Construction is anticipated to be substantially complete in July 2019.

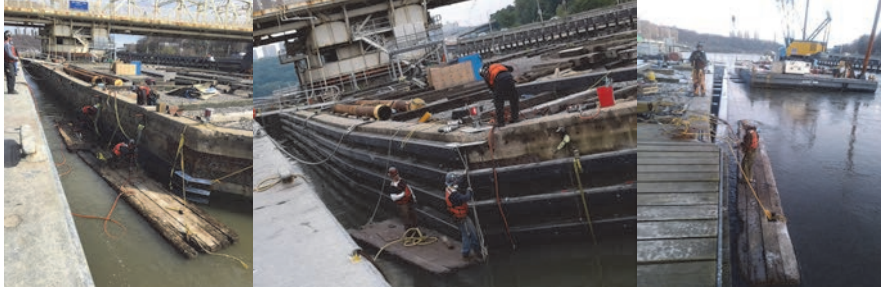
Installation of New Lumber on the Existing Fender. Building an Extension at the Northeast Side of the North Fender with New Lumber.

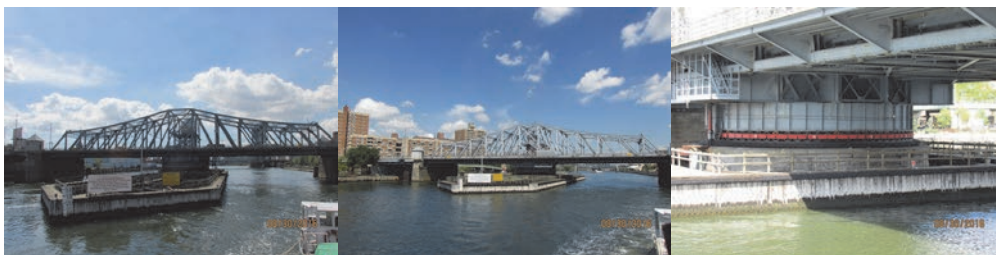
Madison Avenue Bridge in 2016: Left and Right Elevations Spans 12 to 15. Pier 13 – Existing Rack and Pinions. (Credit: NYSDOT)

A project for electrical, mechanical, and miscellaneous operating system-related work is necessary, as the bridge is currently operating with very old machinery components, along with a temporary electrical system known as the "Interim Drive System" installed during the 1994 rehabilitation contract. Some of the machinery components currently in service are over 100 years old and have far exceeded their service life. Moreover, the bridge does not have any back-up operating system which renders the bridge inoperable in case of failure of any component of the Interim Drive System. The preliminary design phase of this project began in early 2011, and was completed in January 2016. The final design was completed in September 2017. The scope of work will also include the replacement of the navigation lighting system, the rehabilitation of the traffic gates, architectural repairs to the gate houses and machinery room (including the removal of lead paint from the gatehouse walls), and the replacement of the end dam at the rest piers. Construction is anticipated to begin in summer 2018. In 2016, the bridge carried approximately 44,338 vehicles per day.

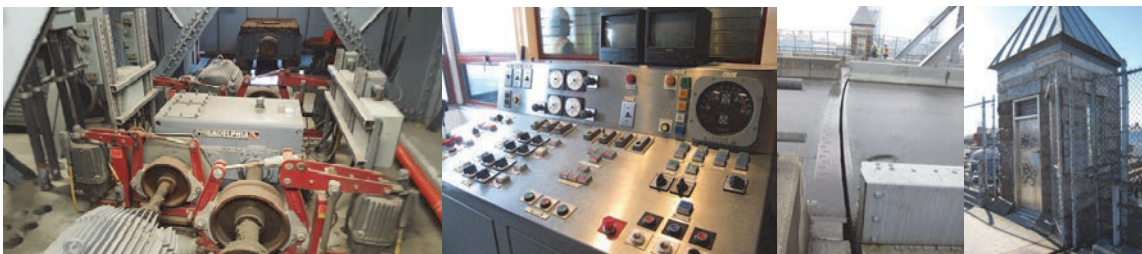
Non-operational Span Drive Machinery. Current Operator Desk and Bronx Approach End Dam. Gate House.

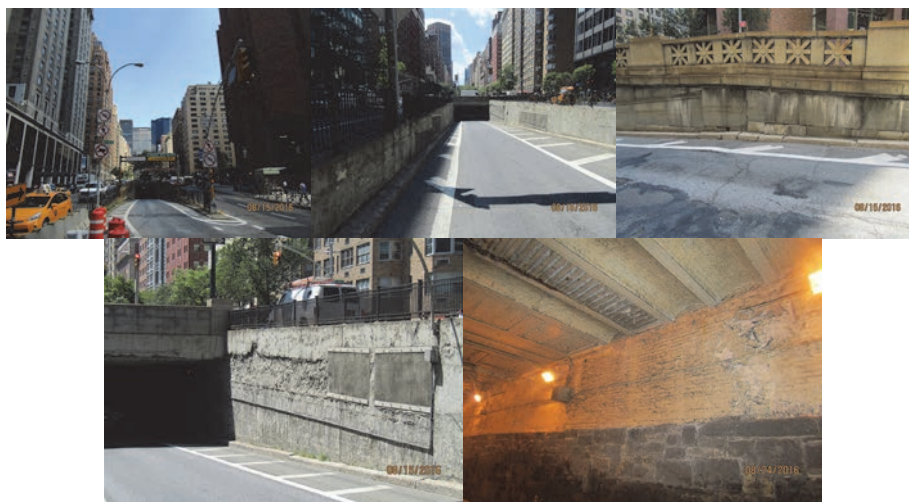
Park Avenue Tunnel – Left and Right Elevations in 2016. Begin Left Wingwall - Stones are Partially Dislodged, Cracked and With Missing Mortar. End Right Wingwall - Wall is Spalled and Exhibits Hollow Concrete Areas That are Shielded With Wire Mesh. End Abutment (Near South Portal) – Bricks Exhibit Deteriorated Mortar. (Credit: NYSDOT)

Some rehabilitation work was completed on the tunnel in November 2005. That contract included the rehabilitation of the fans and the ventilation system. A Notice to Proceed for this rehabilitation project was issued to the contractor with a start date of July 25, 2016. The scope of work encompasses complete rehabilitation of the civil and structural components of the tunnel, including: removal and replacement of the tunnel and approach roadway pavements and curbs; removal of the existing corrugated metal cladding and stainless steel gutters at the brick arch section; waterproofing the brick arch from the inside of the tunnel; strengthening the brick arch section of the tunnel with shotcrete reinforced with lattice girders; removal and replacement of the roof slab and stringers at the Park Avenue median and the south side of 34th Street; repairs to the

concrete tunnel roof and beams at the south and north portal sections; repairs to the joints at the tunnel abutment walls; repairs to the stone masonry walls and parapets of the south open approach; repairs to the concrete walls at the north portal section and installation of architectural precast concrete wingwall fascia panels to simulate south open approach masonry wingwalls; repairs to the concrete walls and metal picket fence at the north open approach; replacement of the catch basins and manholes; replacement of the storm sewer line; cleaning and painting the steel stringers; repairs to the damaged sections of the iron fence; cleaning and painting of the iron fence; lead abatement of various tunnel components; replacing in kind missing sections of the stone parapet walls located at the south portal and at the north end of the east wingwall of the south open approach at the Park Avenue median; modifying the parapet wall at the north portal; milling and re-grading at the 33rd and 40th Street intersections; providing a concrete median and picket fence extending from the south wingwall to the pedestrian refuge area at 33rd Street; providing a traffic railing along Park Avenue at both wingwalls of the north and south open approaches; extending the median refuge area at 38th Street; installing a concrete barrier with integrally cast stone masonry veneer at the 34th and 38th Streets median refuge area; and cleaning the exposed walls and ceiling associated with the tunnel. It will also include safety improvements at the East 33rd, 34th, and 39th Street intersections. Construction is anticipated to be complete in January 2019.

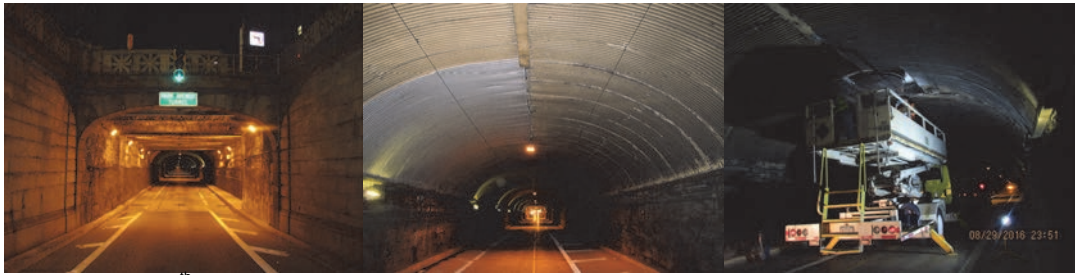
March 2016: 34th Street Entrance, Looking Northeast. March 2016: Missing Joint Plates at Tunnel Crown.
August 2016: Performing Overnight Preventive Maintenance.

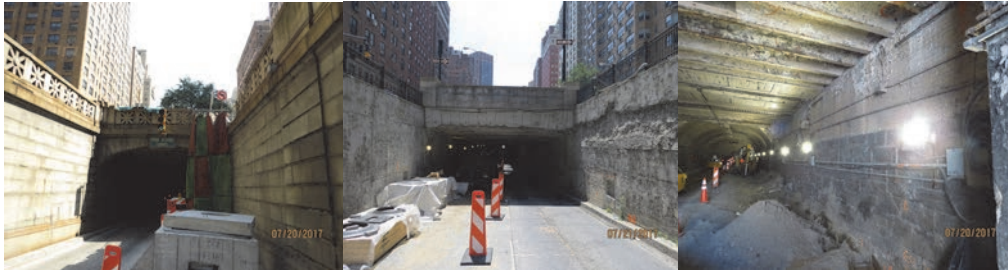
July 2017: Elevation South and North. South Portal Segment, Looking Northeast - Concrete Slab on Grade is Removed. Temporary Lighting Fixture Installed on the East Liner.

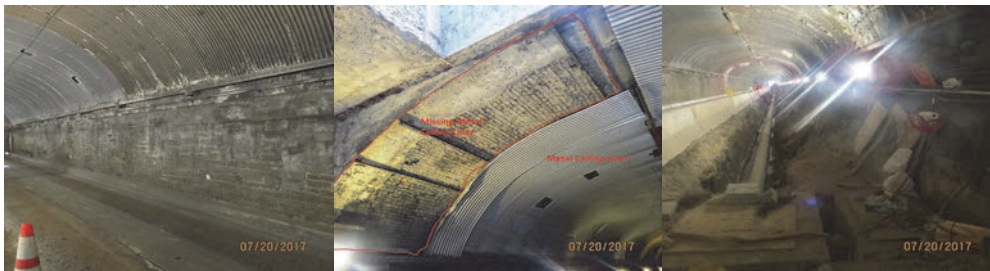
July 2017: West Tunnel Liner, Looking West - Efflorescence and Water Leakage and Missing Mortar Between the Masonry Stones. North Side End of Brick Arch, Looking Southeast - Missing Section of Metal Ceiling Liner and Mortar Between Bricks. East Side of Tunnel, Looking Northeast - Installation of New Drainage Pipe.

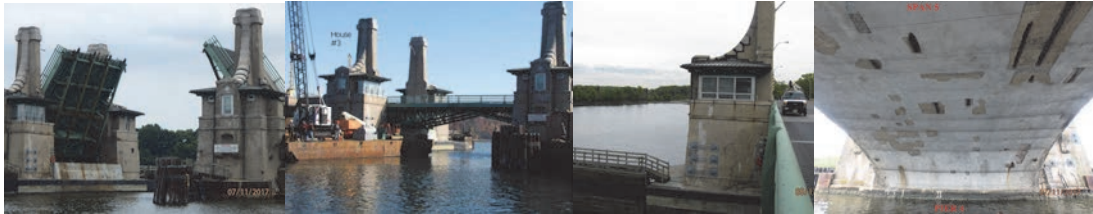
Bridge Open in July 2017. (Credit: NYSDOT) General View of Bridge Operator House #3 in 2011. Bridge Operator House #3 Exterior Wall in 2016, Looking Northwest. July 2017: Underside of Arch Span # 5 - Spalled Concrete With Exposed Rebar is Secured With Netting.
