2017 NYC DOT

Bridges & Tunnels Annual Condition Report

NEW YORK CITY DEPARTMENT OF TRANSPORTATION DIVISION OF BRIDGES 2017 BRIDGES AND TUNNELS ANNUAL CONDITION REPORT

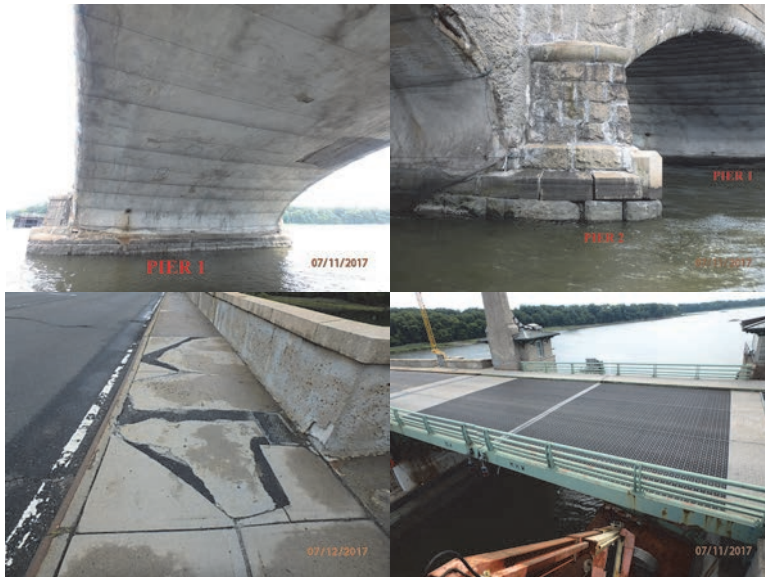
July 2017: Pier 1 Begin Face. Pier 2, Left End of Pier Nose - Typical Mortar Loss Between Stones. Span 6 Right Sidewalk Exhibits Full Width Shallow Spalls – Partially Patched by With Asphalt. Top of Span 4. (Credit: NYSDOT)

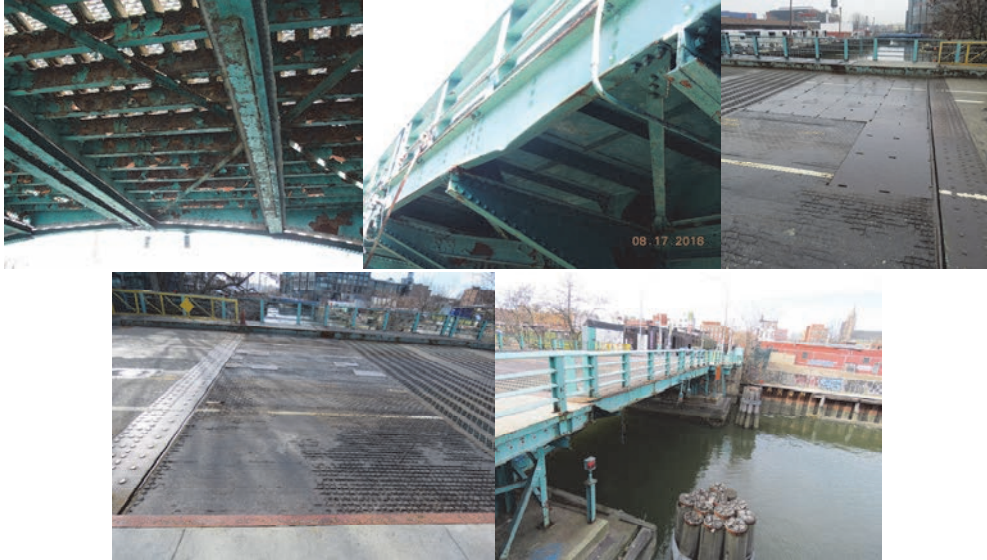
Union Street Bridge - 2016: Severe Corrosion and Peeling Off Paint Under Deck of Span #3. Span 3 - The Left Fascia Stringer Exhibits Impact Damage. (Impact Credit: NYSDOT) April 2017: Steel Plates Covering the Steel Grid Deck. December 2017.

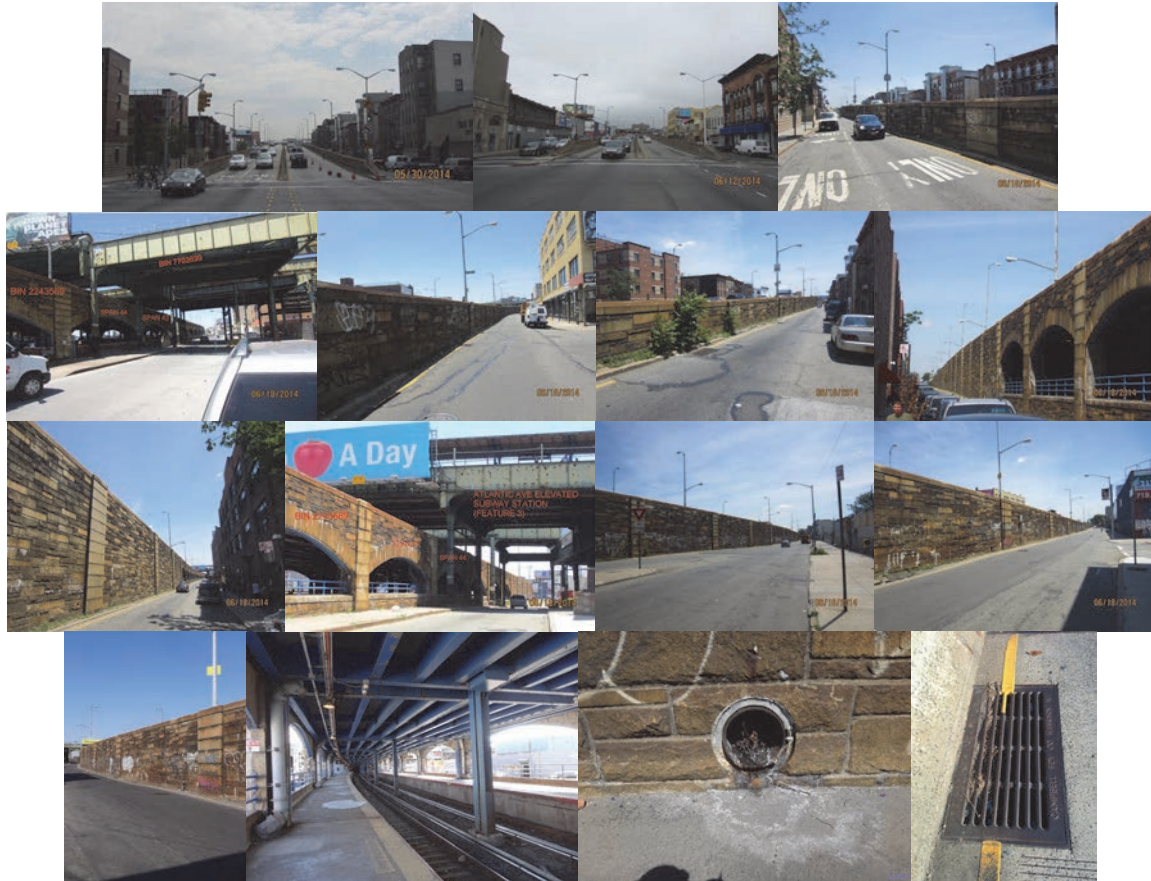
Beginning and End Approaches in 2014. Elevation Left – Spans 1 – 20, 38 – 45, and 50 - 75. Elevation Right Spans 1-20, 5 – 34, 28 – 43, 43 - 52, and 48 - 58. (Credit: NYSDOT) Stone Curtain Wall. Typical Scupper, Downspout and Outlet to Street.

The project will include rehabilitating the deteriorated steel members, concrete abutments and bearing walls; replacing the existing reinforced concrete bridge deck, drainage scuppers, and expansion joints; performing localized concrete deck repairs; and retrofitting the viaduct to meet current seismic requirements. In addition, the action includes the rehabilitation or replacement of the end approach slab and travel lane approach pavement milling and resurfacing as necessary, milling and resurfacing of the adjacent Atlantic Avenue service roads, concrete barrier end terminal improvements, roadway and under bridge lighting repairs, the removal of graffiti, and new reflectorized pavement markings. The bridge will still consist of two 11-foot travel lanes in each direction, separated by a 2-foot wide concrete median barrier. The existing horizontal and vertical alignment will remain unchanged. The coping stones are to be stored during construction and reinstalled in its original location. The contractor will have new steel ready on site prior to deck removal operations so the rehabilitation can begin immediately as each span of the deck is removed. Before the retrofit construction begins, the LIRR will temporarily relocate the third rail to the opposite side of both tracks for the duration of the project.

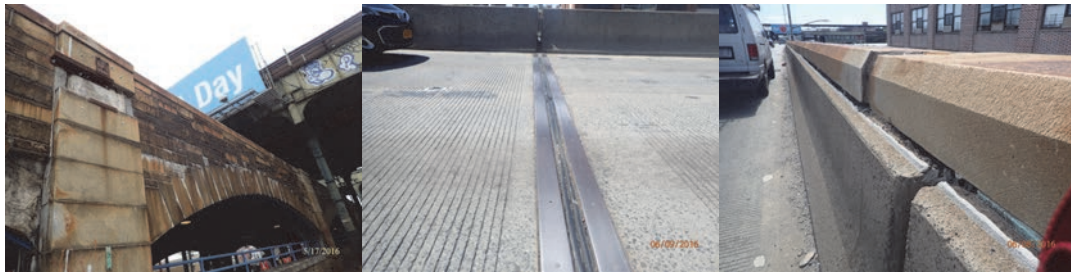
May 2016: Span 43, Right Side Fascia - the Stone Masonry Curtain Wall Exhibits Localized Moderate to Heavy Efflorescence Formation at Several Mortar Joints at the Outside Face and at the Underside of the Arch. Pier 19 Joint, Atlantic Avenue Westbound - Approximately 40% Length of Joint Compression Seal is Slightly Debonded. Spans 33 thru 35, Top of Deck, Right Fascia at Right Bridge Railing - Separation (up to 2") of the Fascia Stones From the Bridge Railing. (Credit: NYSDOT)

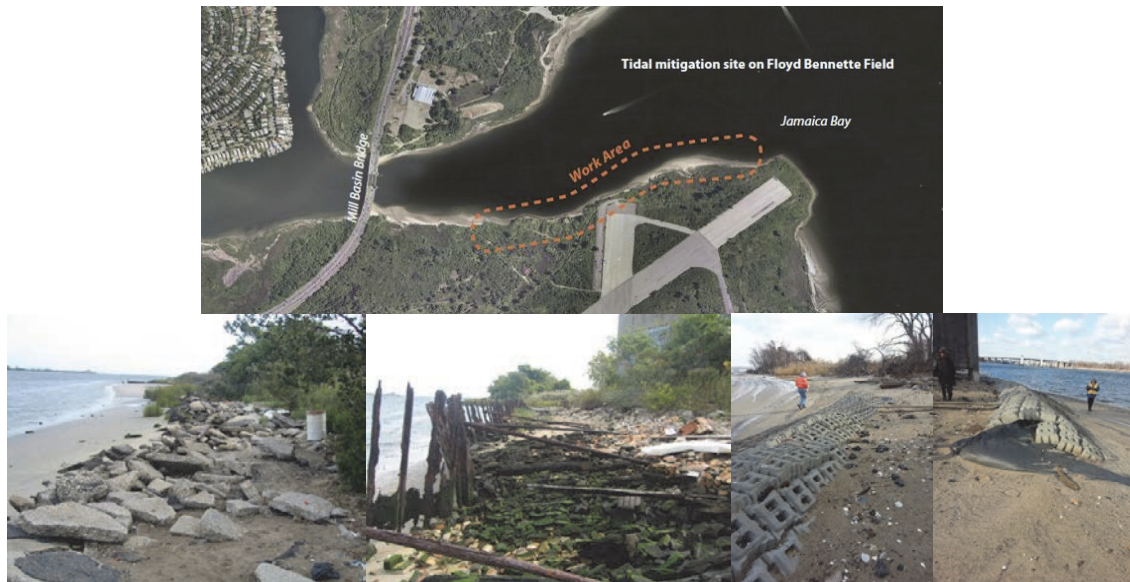
Tidal Wetland Mitigation Site. Before Mitigation – Large and Heavy Surface Debris and Deteriorated Bulkhead. Inspecting the Hurricane Sandy Damage at the Site in January 2013.

On October 29, 2012, Hurricane Sandy impacted the east coast and caused major damage. A survey after the storm discovered severe plant and revetment damage at the contract site. The established site grades were overwhelmed by the storm surge, ground protection and slope stabilization measures were displaced, and the plantings were uprooted and washed away. The

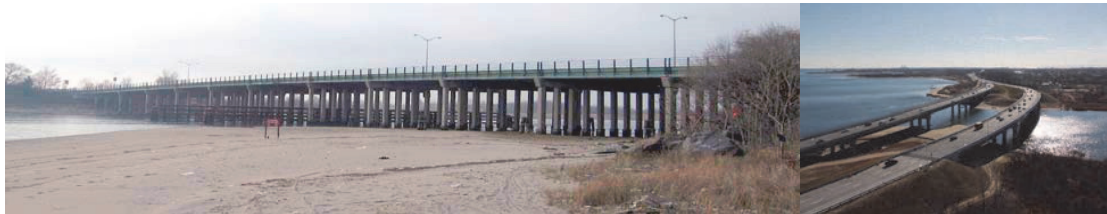
Old Paerdegat Basin Bridge. New Bridges in November 2013.

The old Paerdegat Basin Bridge was a 692-foot long, 13 span, multi-girder, simple supported steel superstructure, supported on reinforced concrete pier cap beams and abutments supported on reinforced concrete piles. The bridge had two 34-foot wide roadways carrying three lanes of traffic in each direction, with a 3-foot safety walk on the north side, a 4-foot wide center median/barrier, and an 8-foot wide south pedestrian/bicycle sidewalk. The existing structure and immediate approaches were demolished and replaced by two new bridges and new approach roadways on split alignments. The existing structure was permanently closed to traffic on December 20, 2012, upon opening of the new westbound structure. Demolition of the existing structure was completed in May 2013.

The two replacement bridges consist of trapezoidal steel box girder structures: the 825-foot, 3 span westbound bridge, north of the existing structure, and the 1,227-foot, 5-span eastbound bridge, south of the existing structure, remaining at 28 feet over the navigable channel. Both bridges have a 36-foot wide roadway with a 12-foot wide right shoulder. The eastbound bridge has a 4-foot wide left shoulder, while the westbound bridge has a 10-foot wide left shoulder. The southern structure carries eastbound traffic while the northern structure accommodates westbound traffic. Both the horizontal and vertical alignments changed, resulting in improved sight distances on the bridges and their approach roadways. The bridge carrying eastbound traffic also has a dedicated pedestrian/ bicycle path along the south side. The pedestrian/bicycle path is separated from traffic lanes by a concrete barrier on the bridge, and by a 15-foot wide grass mall on the approach roadways.

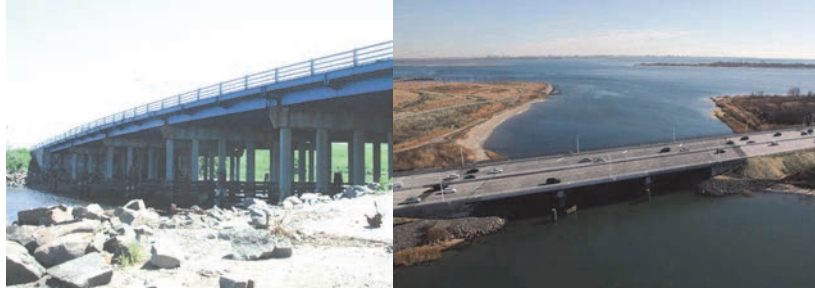
Old Fresh Creek Bridge. New Bridge in November 2013. (2002 Credit: NYSDOT)

The Fresh Creek Bridge was a 264.5 foot, 5-span, multi-girder, simple supported steel superstructure, supported on pre-cast concrete columns founded on four reinforced concrete piers on concrete piles with concrete gravity abutment walls on timber piles. One navigation channel passed under the bridge. The bridge had two 34'-2" wide roadways, a 5-foot wide center median/barrier, and a 10-foot wide south sidewalk. The parkway, east and west of the bridge, has a 10-foot wide bicycle/pedestrian path on the south side. The existing structure and immediate approaches were demolished in spring 2012, and the replacement structure was fully opened in August 2013.

The replacement bridge is a 316-foot, 3-span structure; the new structure has only two support piers, resulting in a wider channel. The bridge deck and approaches were widened to 126 feet from the former 86 feet to accommodate three 12-foot lanes in each direction, 12-foot wide right shoulders, and a 12-foot wide bicycle/pedestrian path, separated from the traffic lanes by a barrier system. The profiles of the approach roadways and bridge structure accommodate stopping sight distances for a design speed of 60 miles per hour. The remainder of the construction resulted in improved landscaping on the bridge approaches. The existing pedestrian and bicycle pathway were maintained and open at all times during construction.

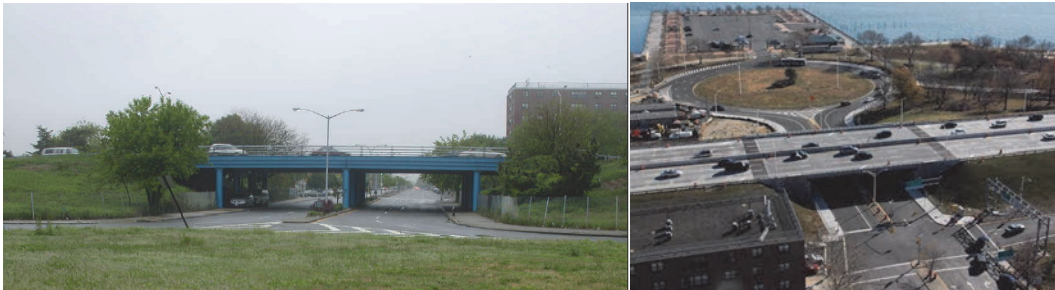
Old Rockaway Parkway Bridge. New Bridge in November 2013. (2002 Credit: NYSDOT)

The Rockaway Parkway Bridge was a 150-foot, 4-span, multi-stringer, simple supported steel superstructure, supported on steel cap beams on concrete filled steel pipe columns, and reinforced concrete abutment walls supported by concrete pile foundations. The bridge had two 34'-2" wide roadways, a 5-foot wide center median/barrier, and a 10-foot wide south sidewalk. The existing structure and immediate approaches were demolished in fall 2012, and the replacement structure was fully opened in August 2013.

The replacement bridge is a single span structure to improve visibility along Rockaway Parkway. The new structure was built in the same alignment as the existing bridge. The bridge deck was widened to 109 ½ feet from the former 84 feet to accommodate three 12-foot lanes with a 12-foot wide right shoulder and 4-foot left shoulder in each direction, including 5 ½ feet for median and parapet width. The right shoulder on each approach is 10 feet wide (while the width of the right shoulders on the bridge structure are 12 feet), with the other dimensions the same width as those on the bridge. In addition to reconstruction of the bridge, four access ramps were also reconstructed, as was Rockaway Parkway in the vicinity of the Belt Parkway.

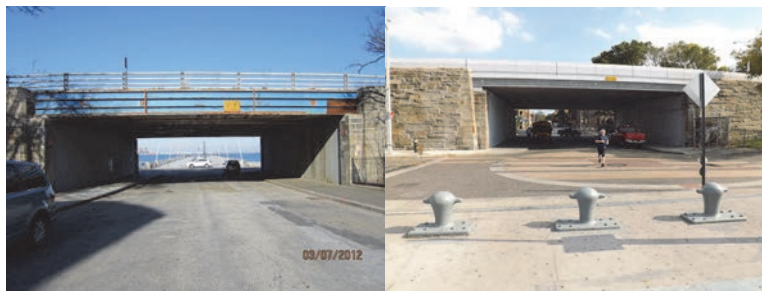
Old Bay Ridge Avenue Bridge in 2012. (Credit: NYSDOT) New Bridge in October 2016.

The Bay Ridge Avenue Bridge was a 58-foot long, single span, reinforced concrete deck on a multi-girder system superstructure over Bay Ridge Avenue. The superstructure is supported by concrete gravity type abutments on pile foundations. There is pedestrian access under the bridge to both the American Veterans Memorial Pier and the Shore Parkway Seawall pedestrian and bicycle paths. The underpass also serves as access to the NYCDEP Owl's Head Wastewater Treatment Plant. The existing superstructure was demolished and replaced.

The replacement bridge superstructure consists of precast, pre-stressed concrete box beams and a reinforced concrete slab. The bridge has three 12-foot wide lanes in the eastbound direction and two 12-foot wide lanes separated by a 4-foot wide painted stripe flush median in the westbound direction. There is no pedestrian/bicycle path on the structure. The clearance was increased to 14-feet 6-inches, which eliminated the need for clearance signs previously posted for a substandard condition. A Notice to Proceed was issued to the contractor with a start date of November 4, 2013.

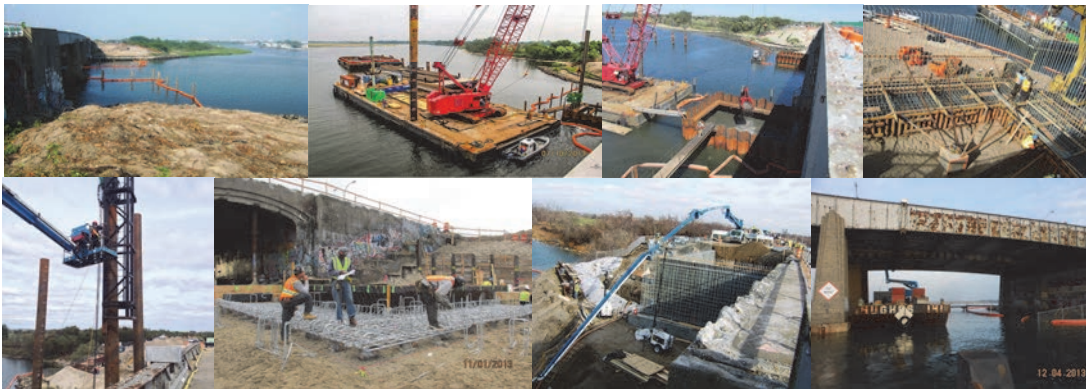
June 2013: North Side of Gerritsen Bridge - Turbidity Curtains Placed on Both Sides of Navigable Channel. July 2013: Work Barges Driving Steel Sheeting for Pier #1 Cofferdam. September 2013: Rebars and Form Work for Footing and Walls at the Northwest Abutment. Stage 1 Piles. October 2013: Inspecting Rebar. November 2013: Tremie Concrete Pour at Pier #2. December 2013: Inspecting Spans 7 and 8 of the Existing Bridge From a Barge. (Inspection Credit: NYSDOT)

Construction operations performed in spring 2013 included the installation of temporary concrete barriers as part of the Stage 1 maintenance and protection of traffic; the installation of construction fences and tree protection; clearing and grubbing along the north side of the parkway including the removal of existing trees as specified in the contract; and the installation of soil stabilization and erosion control measures. As the summer and Stage 1 progressed, the contractor installed earth embankments for the new eastbound and westbound approach roadways, installed new drainage structures and pipe, and repaired bridge flags on the existing bridge structure. In the fall, the Stage 1 abutment piles and footings were constructed, as were the two deep foundation cofferdams for the new water piers. The pier pile installation work was completed in December 2013, in advance of the substructure work, including the pier footings, plinths, columns and pier caps.

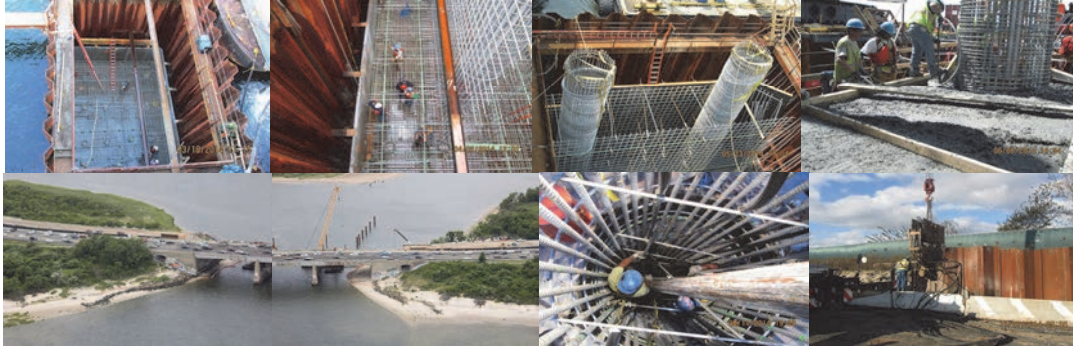
Gerritsen March 2014: Setting Footing Rebars Prior to Placing Pier Rebars and Concrete at Pier No. 2. April 2014: Setting Rebars for Footing and Pier Inside Cofferdam at Pier #1. May 2014: Plinth and Column Reinforcement Inside the Cofferdam for Pier 2. June 2014: Placing and Vibrating Concrete for Plinth at Pier #1. Rebars for Column in Place. West Abutment of Bridge. New Roadway Under Construction at top Next to Westbound Lanes. East Abutment of Bridge. Crane on Barge at Cofferdam for New Pier #2. August 2014: Workers Inside Rebar Cage During the Pumping Concrete Operation at the Pier #2 Column. November 2014: Steel Sheeting in Place for the East Approach Temporary Access Roadway.

In 2014, the contractor completed all of the Stage 1 (north side) substructure work, including the placement of the concrete piers and abutments. The Stage 1 concrete approach roadways on the north side of the project were also completed in 2014, as were the temporary asphalt transition areas on the approaches.

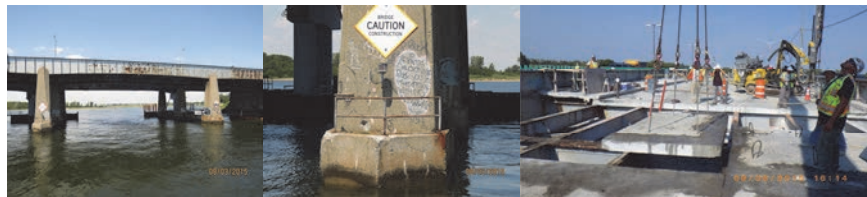
Old Gerritsen Inlet Bridge in August 2015 - Span 6, Right Fascia, Looking Left. Span 6, Pier 5, Column 3 – Construction Sign and Non-Functioning Light. (Credit: NYSDOT) September 2015: Removing Saw-Cut Deck Panels.

On August 14, 2015, the contractor transitioned to Stage 2, through the movement of all traffic to the new northern (westbound) section of the bridge. Stage 2 work completed in 2015 included the demolition of the northern portion of the existing bridge, placement of embankment material for the Stage 2 approach roadway, and installation of the Stage 2 drainage facilities. Installation of the Stage 2 cofferdams began in late 2015, and were followed by all foundation operations in early 2016.

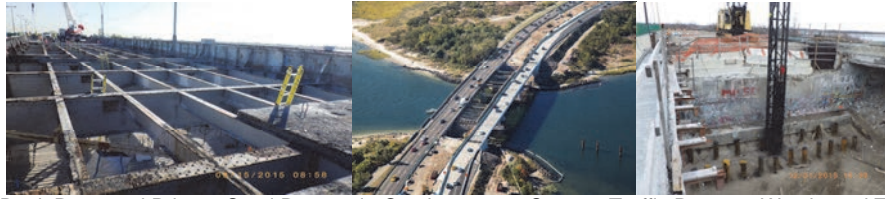
Deck Removed Prior to Steel Removal. October 2015: Stage 2 Traffic Pattern. Westbound Traffic at Right on New Bridge. Eastbound Traffic at Left on Existing Bridge. December 2015: Driving 14-Inch Diameter Steel Shell Piles at East Abutment - Facing East.

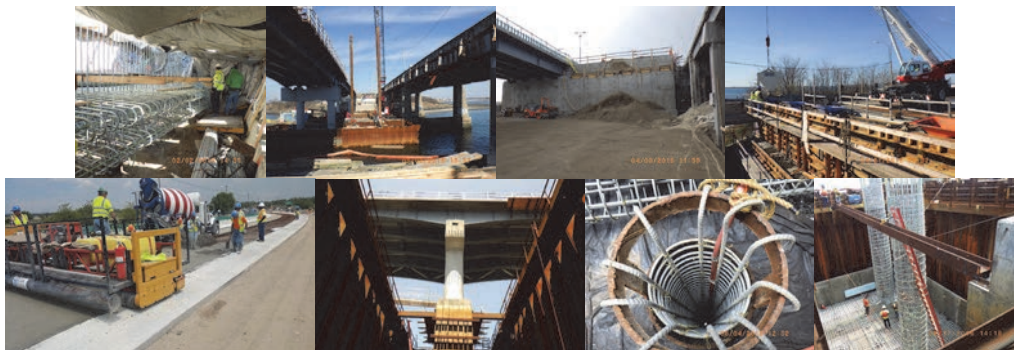
Gerritsen Inlet February 2016: Galvanized Rebars in Place for East Abutment Footing. March 2016: Driving 24" Diameter Steel Shell Piles at Extension of Pier #1 Cofferdam. New Westbound Bridge at Left. Existing Eastbound Bridge at Right. April 2016: Completed Portion of New East Abutment of the Bridge. New Bridge at Left. Placing Concrete at West Abutment Back Wall With a Crane and Bucket. May 2016: Placing and Finishing On-Grade Pavement at Approach. Cofferdam at Pier #2. Column, Pier Cap and Structural Steel Placed in Stage 1. June 2016: Rebar Cage Placed Inside Steel Pipe Pile Prior to Concrete Operation. Lowering Column Rebar Cage Onto Footing Rebars at Pier # 2.

In the spring and summer of 2016, the contractor embarked on an ambitious acceleration program with the goal of opening the Stage 2 bridge and roadway before Thanksgiving. By mid-July, the contractor had completed all substructure concrete placements, including the abutments, the pier footings, plinths, columns and pier caps. Steel erection was performed during overnight periods in August, and was followed by installation of the stay in place forms, and stud shear connectors. The concrete bridge deck placements were then completed in September and October. During November, the contractor completed placement of both approach slabs, the asphalt pressure relief joints, and the armorless joints. On November 18, 2016, the contractor transitioned from Stage 2 to Stage 3 by shifting all eastbound traffic from the existing southern half of the existing bridge to the center portion of the new structure. During stage 3, pedestrian/bike traffic was shifted to a temporary pathway on the new eastbound bridge on December 2, 2016.

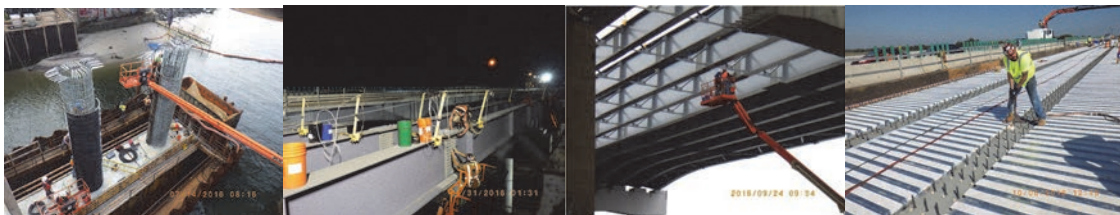
July 2016: Pier #2. Placing Pier Column Forms Around Galvanized Steel Rebar Cages on Top of Plinth. August 2016: Placing High-Strength Bolts Through Girder Splice Plates. September 2016: Torqueing Girder Web Splice Plate Bolts. October 2016: Welder Attaching Shear Studs to the Top Flange of the Eastbound Bridge During Stage 2.

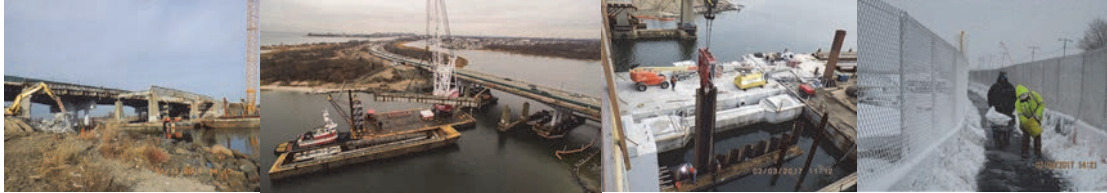
Gerritsen Inlet January 2017: Final Demolition of the West Abutment During Stage 3. Barge-Mounted Crane at Right in Process of Removing the Last Sections of Structural Steel From the Old Bridge. The Last Structural Steel Section of the Bridge Being Lowered Into a Barge for Removal From the Site. February 2017: Driving Sheet Piles for the New Bridge Pier #1 Cofferdam. Old Pier #4 After Columns Were Removed is Visible East of New Cofferdam. Clearing and Maintaining the Pedestrian/Bicycle Path in the Vicinity of the Bridge After the February 9 Snow Storm.

steel was started, and was completed on January 18, 2017, followed by removal of the existing concrete columns. On March 17, 2017 with approval from the NYFD, and USCG, the footings were demolished by blasting. The blasted pieces were removed from the navigable channel and the surrounding area.

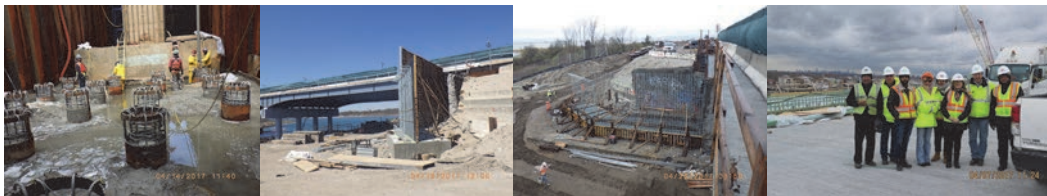
Gerritsen Inlet April 2017: Pier #1 Cofferdam. Pumping Concrete Into Steel Pipe Piles. New Pier #1 Footing and Plinth From Previous Stage Show in Background. East Abutment Footing With Rebars and Formwork for Abutment Wall. Stage 3 Completed Bridge is in the Background. West Abutment Forms and Rebars in Place for Footing. Concrete Abutment Wall Rebar Placement in Progress. Site Visit – Assistant Civil Engineers Khalid Mohammed, Yuriy Kheyman, and Juan Medina-Yan, Associate Project Manager Alina Platonova, Community Associate Shahnaz Begum, Associate Staff Analyst Vera Ribakove, Administrative Engineer Daniel Hom, and Civil Engineer Chetan Patel – (Credit: Eric Callender)

During the winter and spring of 2017, the contractor continued an accelerated program by constructing all of the substructures, including the abutments, the pier footings, plinths, columns and pier caps. During March, steel sheet piles were driven for the cofferdams at Pier # 1, and Pier # 2, and excavation commenced within the cofferdams. Marine piles and tremie concrete were completed in Pier # 1 by March 25, 2017. Pier # 2 piles and tremie were completed by mid-April 2017. Land piles at the east and west abutment were also completed.

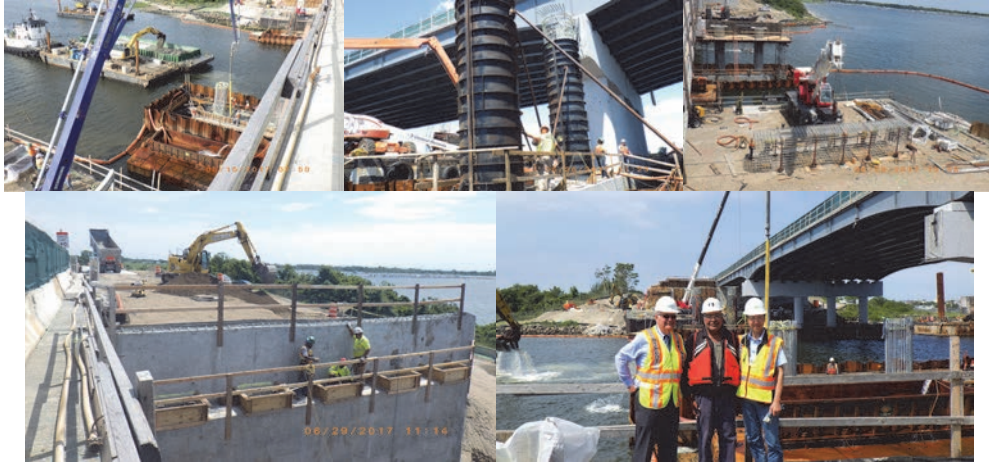
Gerritsen Inlet June 2017: Pumping Concrete for Plinth at Pier #2. Barge Mounted Backhoe Removing Blasted Concrete Debris From the Navigable Channel and Placing it on the Barge. Placing Reusable Column Forms on Top of Completed Plinth at Pier #2. Prefabricated Rebar Cage for Pier #1 Cap Beam to be Placed on Columns (Visible at Left) Completed Previously. Setting Forms for Bearing Pads at the East Abutment. Site Visit: Chief Bridge Officer Robert Collyer, Quality Assurance Assistant Civil Engineer Khalid Mohammed, and Administrative Engineer Daniel Hom.

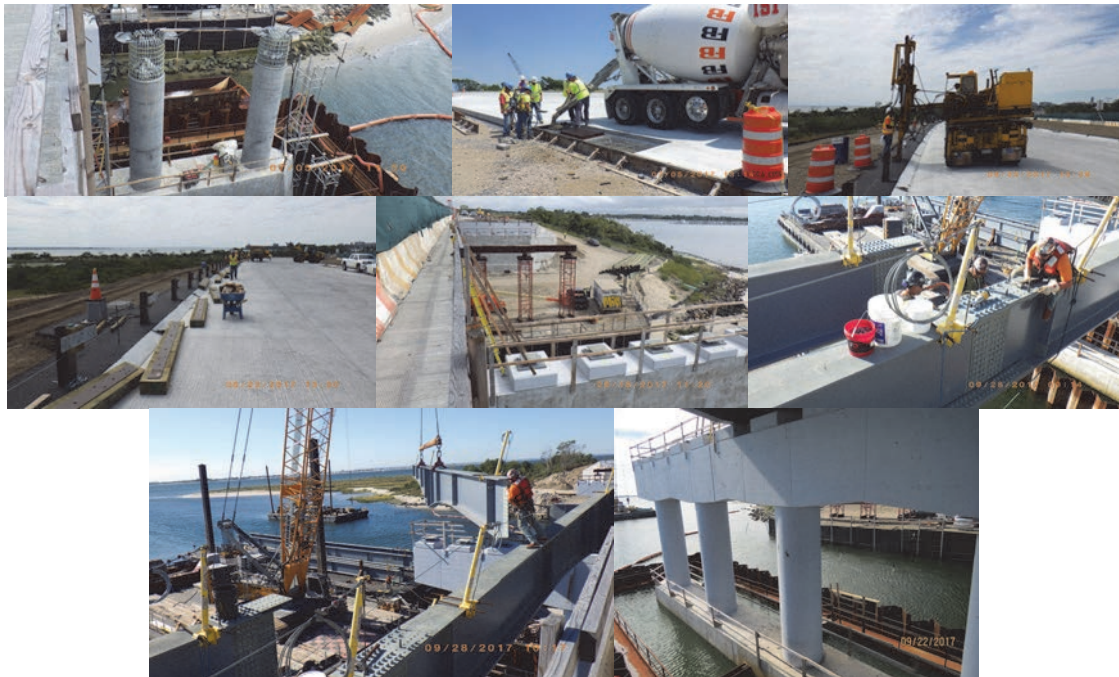
Gerritsen Inlet July 2017: Pier #2 - Plinth and Columns Completed Prior to Cap Beam Installation. Placing P.C.C. Pavement in Approach Roadway Block Out for Catch Basin Frame and Grate. August 2017: Driving Steel Posts for Steel-Backed Timber Guide Rail at Asphalt Shoulder of Approach Pavement. Installing the Rail. September 2017: East Abutment at Top. Pier #2 With Bearings In Foreground, and Temporary Support Between Pier #2 and the East Abutment, Prior To Delivery Of Eastbound Steel Girders. Iron Workers Bolting up Girder Splice at Pier #2 on The Eastbound Side Of the Bridge. Girder Being Lowered Onto Pier #2 and Temporary Support. Pier #1 – New Pier Wall.
(Pier#1 Credit: NYSDOT)

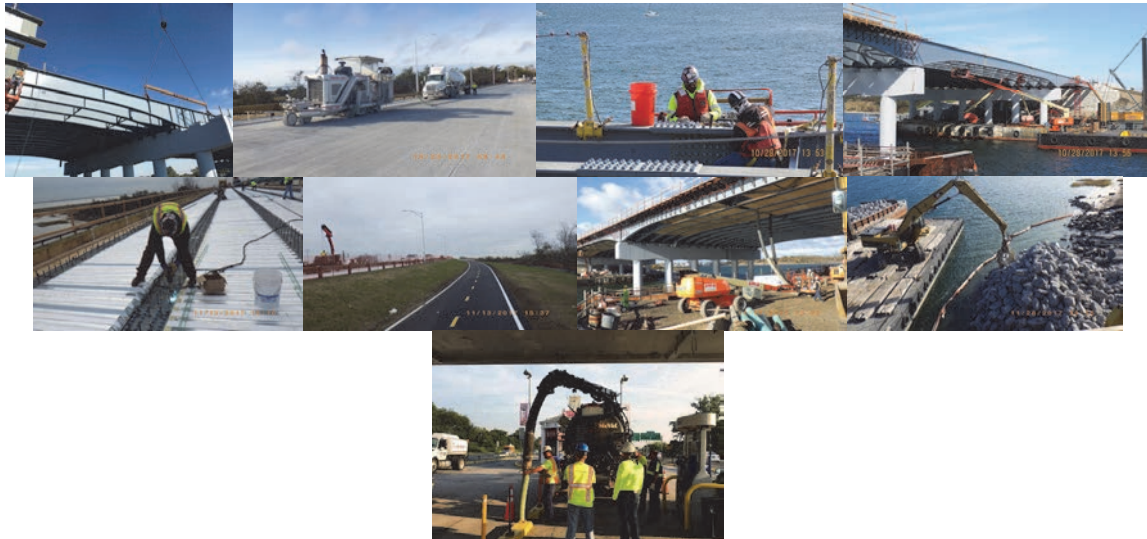
Gerritsen Inlet October 2017: Erecting Final Eastbound Girders at the Gerritsen Inlet Bridge. Pier #1 at Right. Westbound Approach Pavement of the Bridge During Pavement Grinding Operation. Grinder at Left, Water Truck at Right. Working From Man-Lifts on Barges Bolting the Steel Connections. (Manlift Credit: Jessica Wang) November 2017: Welding Shear Stud Connector to Top Flange of the Bridge Girders on the Eastbound Side. Newly Paved Bicycle/Pedestrian Asphalt Path on the Eastbound Side of the Belt Parkway at the West Approach to the Bridge. Pier #2 Facing West, Hot Air Hoses in Place Which were Used to Maintain Curing Temperatures When the Eastbound Deck Concrete was Placed in Late November 2017. Barge-Mounted Crane Placing Riprap Stones on the South Slope of Gerritsen Inlet at the West Abutment. The Turbidity Curtain Prevents Contamination of Jamaica Bay Riprap Placement Will be Completed in Spring 2018. Crew Members Clean out the Drainage Pipe at the Gas Station Near the Bridge to Alleviate Long-Term Flooding Conditions on the Belt Parkway.

Structural steel was erected during the Stage 3 phase for the new eastbound bridge starting in late September 2017, and was completed by October 27, 2017. Following the installation of the stay-in-place forms and the shear stud connectors, the concrete bridge deck placements were completed in November using winter concrete procedures. In December, the contractor completed the placement of the concrete bridge barriers and installation of the bridge railing systems, as well as the placement of the approach slabs, the pressure relief joints and the armorless joints. In January 2018, the contractor will transition from Stage 3 to Stage 4 by shifting the eastbound traffic on to the new bridge structure. This will be the start of Stage 4A, during which a work zone will be created at the center of the bridge to allow for the construction of the final median barrier.

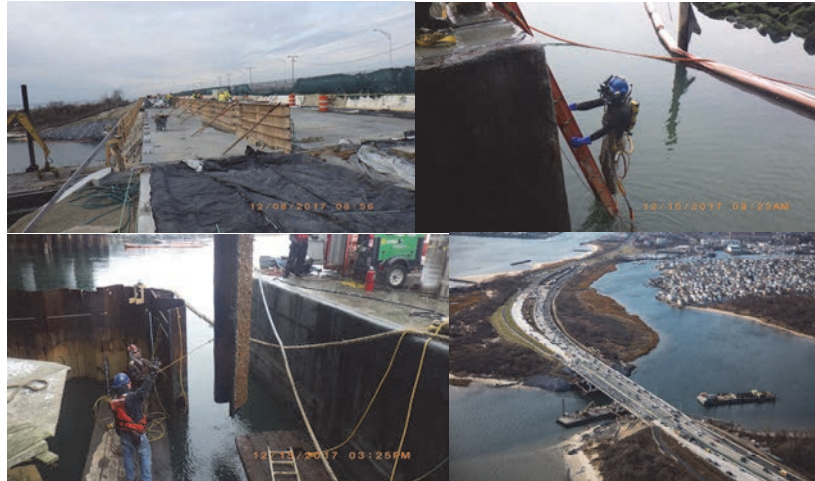
December 2017: Wood Forms Erected on the Bridge for the Future Concrete Barrier Separating the Pedestrian/Bicycle Walkway from the Future Eastbound Belt Parkway Traffic. Pedestrian Fence Anchor Bolts at Left. Diver at Pier # 2 Entering the Waterway to Cut the Steel Cofferdam Sheeting Prior to Removal. Removing Steel Sheeting Cut from Cofferdam #2. Gerritsen Inlet Bridge in December 2017.

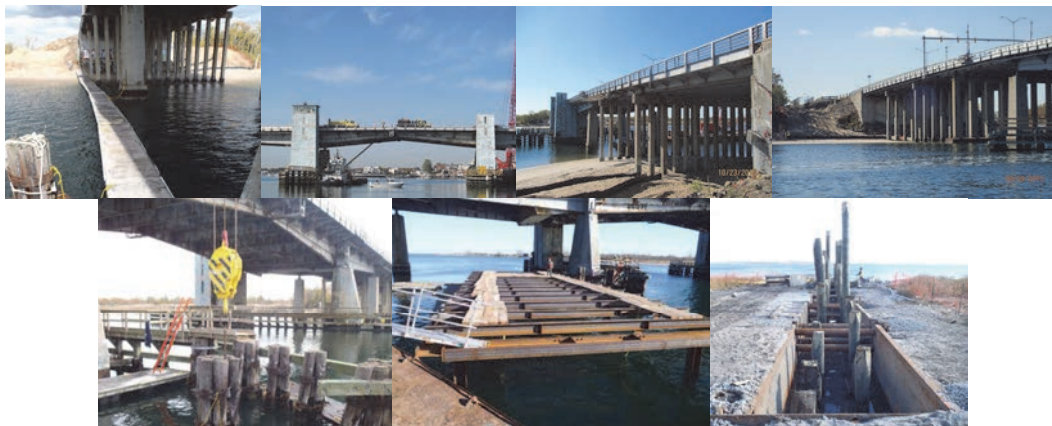
October 2015: Temporary Walkway on North Side of Bridge for Access to Pier #9. Elevation Left Span Elevation Right Span 8, 9-14, 1-7. (Inspection Credit: NYSDOT) November 2015: Extracting Wood Piles From the Existing Bridge Fender System at New Pier #9 Site. Pier #9 Steel Framing for the Cofferdam on the West Side of the Existing Bridge. December 2015: Outfall #2. Pressure Treated Wood Piles – Facing East.

Substructure work, including the installation of cofferdams, excavation of footings, and installation of piles, began in the fall of 2015. The installation of drainage facilities also began in 2015.

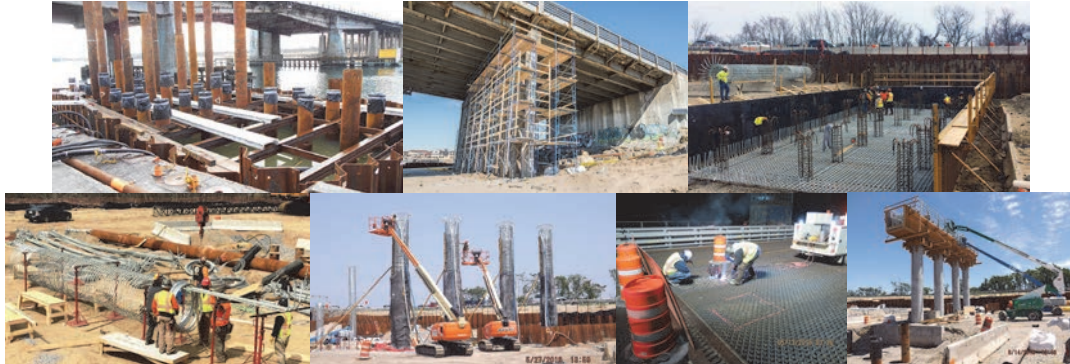
Mill Basin January 2016: New Pier #9. Cofferdam With 24-Inch Steel Shell Pipe Piles. Existing Moveable Span at Upper Right. March 2016: Scaffolding in Place at Pier #11 for Flag Repairs of Existing Bridge. North Abutment at Right. April 2016: Pier #3 of New Bridge. Footing, Rebars, and Top of Pile Rebars in Place. Galvanized Rebar Columns Cage at Left Prior to Setting on Footing. On-Site Fabrication of Pier Column Galvanized Steel Reinforcement Bar Cages. May 2016: Galvanized Steel Rebar Cages for Columns at Intermediate Pier. Nighttime Repair – Westbound Deck Grating. June 2016: Setting Forms and Placing Rebars for Intermediate Pier Cap on the South Side.

Each pier consists of a rectangular concrete footing, which supports a series of concrete columns and a concrete pier cap. On each side of the waterway are six pairs of piers, and within the channel are four single pier structures.

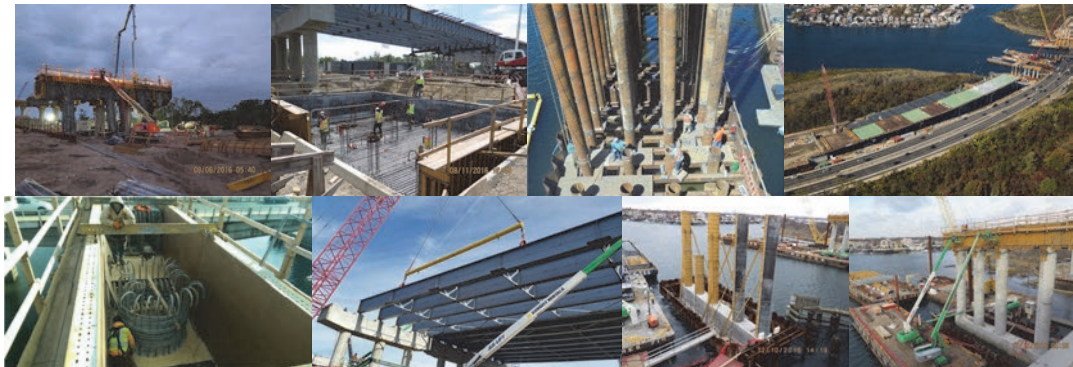
August 2016: Concrete Pour for Pier 14 Cap at Sunrise. Southwest Quadrant Pier Footing. September 2016: Pumping Concrete for Columns at Pier # 15 for the Westbound Bridge. October 2016: Between the South Abutment and the Waterway. Stay-in-Place Forms, Epoxy-Coated Rebars and West Deck Curing in Progress. North Abutment at the Top. November 2016: Setting Column Rebars Inside the Cap Beam at Pier #9. Setting Girders on Pier Caps in Southwest Quadrant. December 2016 Pier #8 Cofferdam. Footing and Plinth Completed. Setting Column Forms.

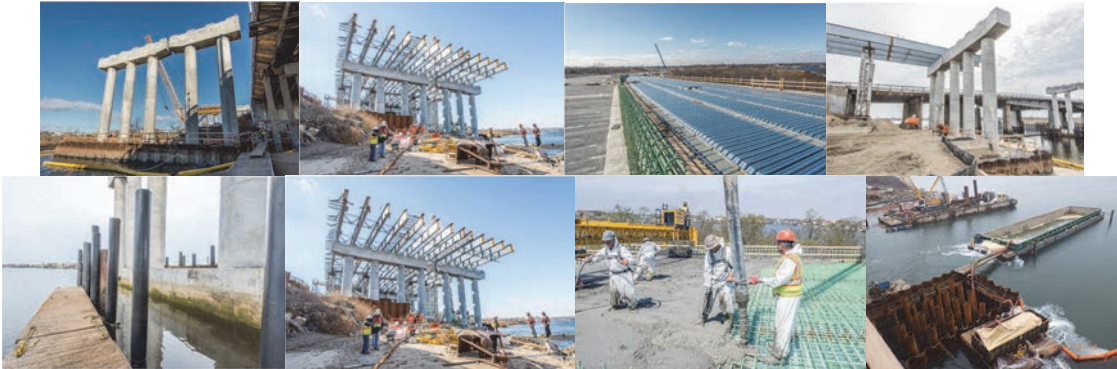
Mill Basin January 2017: Northwest Quadrant Pier #10 - New Columns and Cap Beams in Place. Existing Bridge Columns, Cap Beams, and Deck-Carrying Traffic at Right. Southwest Quadrant Pier #6. Southwest Quadrant Eastbound Deck Preparation at Pier #3 – Epoxy-Coated Rebars for Future Median. Completed Northbound Deck at Left. Stay-in-Place Galvanized Steel Forms at Right. February 2017: Structural Steel Set on Pier #10. The Existing Mill Basin Bridge is in the Background. New Pier #9 at Far Right. Fiberglass Reinforced Plastic Piles for Future Fender System at Pier #9. March 2017: Pier # 6 at the Southwest Quadrant. April 2017: Pumping and Finishing Deck Concrete at Pier #2, Unit 1, Westbound. Dewatering Pier#2 Cofferdam Into Barges to Settle and Filter Water Discharge Into Jamaica Bay.

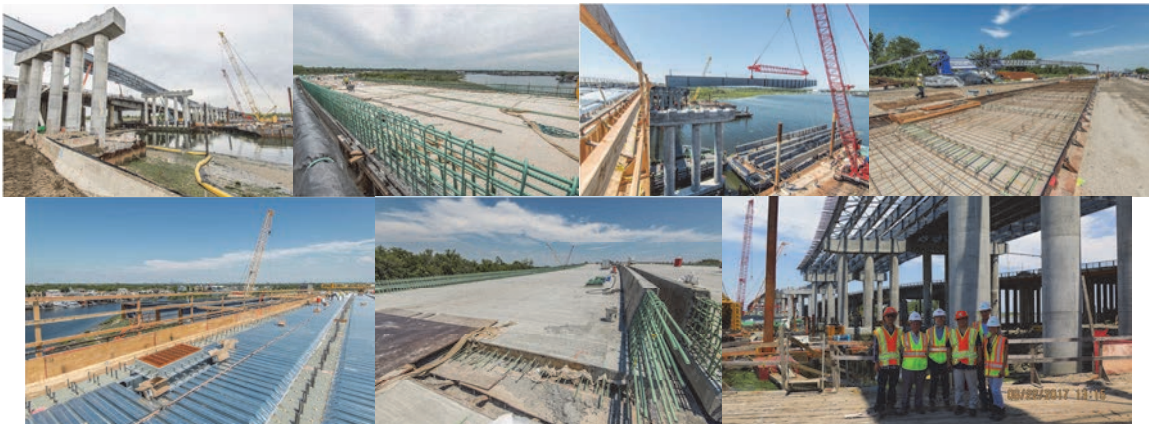
Mill Basin May 2017: New Mill Basin Bridge Columns, Cap Beams and Structural Steel in Place at Pier #10 Over the Navigable Channel. Old Mill Basin Bridge Carrying Belt Parkway Traffic is in the Background. Wet Cure of New Concrete Deck Over Pier #5. Epoxy-Coated Barrier Rebars in the Foreground. June 2017: Erecting Structural Steel in Northwest Quadrant Between Pier #8 and Pier #9. Placing P.C.C. Pavement at the Approach to the Bridge Utilizing a Conveyor. Pavement Forms, Reinforcing Mesh and Joint Dowels are in the Foreground. Stay-in-Place Galvanized Steel Forms, Shear Studs and Scupper in Place for Future Deck Concrete Placement. Westbound Roadway and Barrier. FHWA Site Visit and Project Review: Jason Lin (NYSDOT), Senior Area Engineer Region 11 Richard Beers (FHWA), Area Engineer Region 5 Lorin Willett (FHWA), King Fong (NYSDOT), Administrative Engineer Daniel Hom, and Associate Project Manager Jessica Wang.

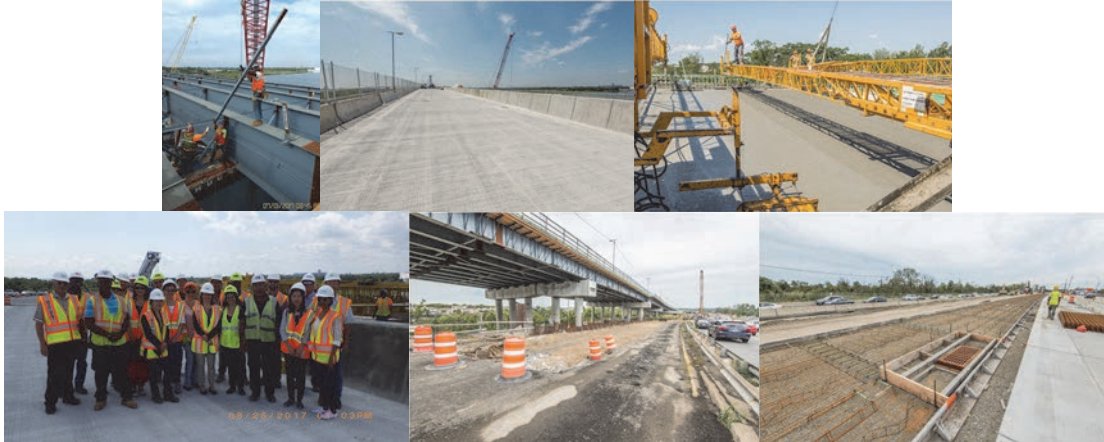
Mill Basin July 2017: Installation of Lateral Cross Frames for Span 9 Westbound. (Credit: Jessica Wang) August 2017: Westbound Mill Basin Bridge: Prior to Shifting Westbound Traffic onto the New Bridge. Finishing the Concrete Deck From a Temporary Work Bridge. Project Visit by DOT Budget Office and NYC Office of Management and Budget: From far Left and Back, Construction Project Manager Amir Youssef, Highway Transportation Specialist Eric Callender, Resident Engineer Rudy Fogarty, Administrative Staff Analyst Lucia Candu, Community Associate Igor Yaroslavsky, Associate Project Managers Jessica Wang and Alina Platonova, Associate Commissioner for Budget and Capital Program Management Elisabeth Franklin, S. Chatthaworn (NYCOMB), Associate Director for Infrastructure and Capital Project Scope Development Lizette Christoff (NYCOMB), Assistant Civil Engineer Khalid Mohammed, Resident Engineer Paul Dombrowski, Asha Jayaraman (NYCOMB), and Administrative Engineer Daniel Hom. (Credit: Yuriy Kheyman) September 2017: New Mill Basin Bridge at Left Carrying Westbound Belt Parkway Traffic. Eastbound Belt Parkway Traffic at Right. Mill Basin Bridge Approach - Forms in Place for Future Eastbound PCC Pavement.

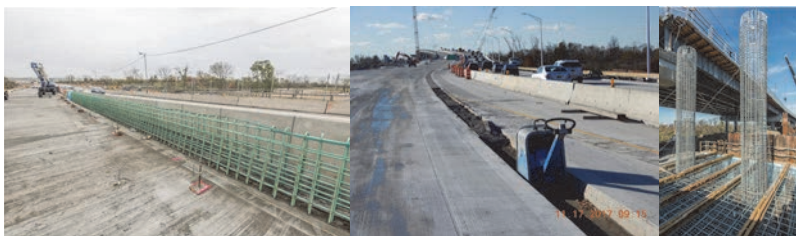
Mill Basin October 2017: Epoxy Coated Rebars for Future Left Side Barrier of Westbound Mill Basin Bridge. The Westbound Traffic is on the Eastbound Side of the New Bridge in This Stage. November 2017: Belt Parkway Roadway Facing South. Westbound Traffic on the Right Side Going Over the New Mill Basin Bridge. Left Side Shows New Roadway Prior to the Shift of Eastbound Traffic onto the New Bridge.

On August 30, 2017, the three westbound lanes of traffic were shifted from the old bridge to the new bridge during overnight operations. Westbound traffic was temporarily placed on the future eastbound lanes while the permanent westbound lanes remained under construction. On November 15, 2017, westbound traffic was shifted to the permanent westbound lanes.

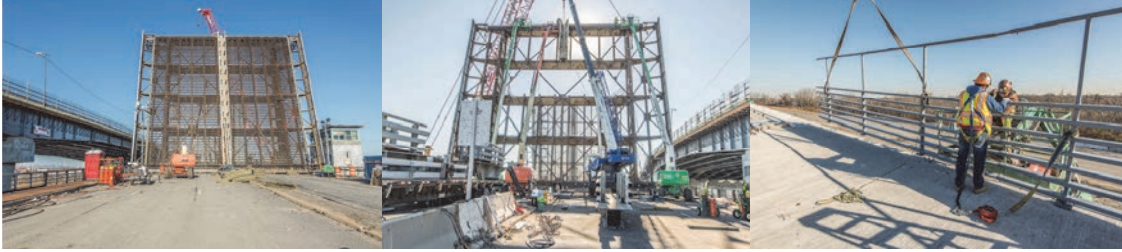
December 2017: South Leaf of the Mill Basin Bridge During Demolition. Sidewalk and Median Removed. The New Bridge is at Left Carrying Eastbound and Westbound Belt Parkway Traffic. North Leaf of the Mill Basin Bridge During Demolition. Steel Bridge Deck, Median, and Walkways are Removed. New Mill Basin Bridge is at the Right Side. Erecting the 7-rail Bridge Rail and Fence at the East Side of the Bridge for the Bicycle/Pedestrian Walkway.

On December 4, 2017, the three eastbound lanes of traffic were permanently shifted off the old bridge and on to the new bridge. Finally, the pedestrians and bicyclists were then shifted to the new bridge on December 8, 2017. The old movable span was locked into the upright position. At that time, the existing Mill Basin bridge was permanently taken out of service, and demolition was started.

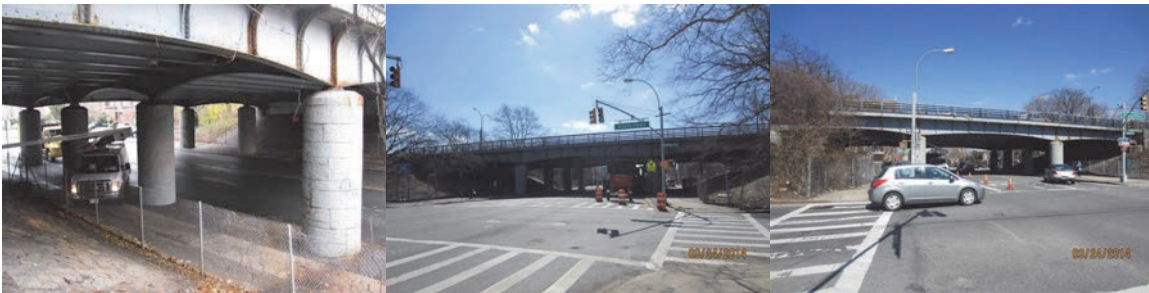
Nostrand Avenue Bridge Pier 1 and 2 Columns in December 2014. Left and Right Elevations in 2014. (Credit: NYSDOT)

The existing Nostrand Avenue Bridge is a 140-foot long, 3-span, multi-girder superstructure, consisting of a concrete deck with an asphalt overlay over Nostrand Avenue. The superstructure is supported by concrete pier columns with a steel cap beam, and abutments on concrete filled steel pile foundations. The existing structure and immediate approaches were to be demolished and replaced. This bridge was removed from the current Belt Parkway Project, and its design was terminated. It will be added to another Belt Parkway bridge project in the future. The condition rating of this bridge is better than the other remaining bridges in this program; rescheduling will not negatively impact the bridge users.

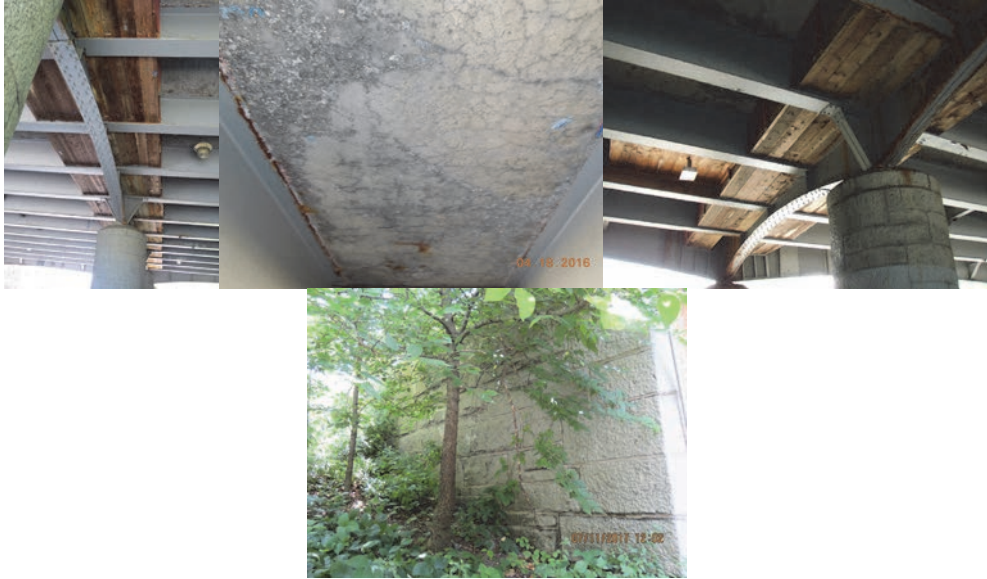
June 2015: Span 1 Deck – Hollow Sounding Concrete Areas are Covered by Timber Planks That are in Good Condition. April 2016: Span 2, Underside of Deck, Bay 3 - Exhibits Scaling, Mapcracking with Localized Efflorescence, and Dampness Over Approximately 50%-60% of its Surface. (Credit: NYSDOT) July 2016: Span 2 Timber Shielding. July 2017: Cladding on the Left Side of the End Abutment in Good Condition.

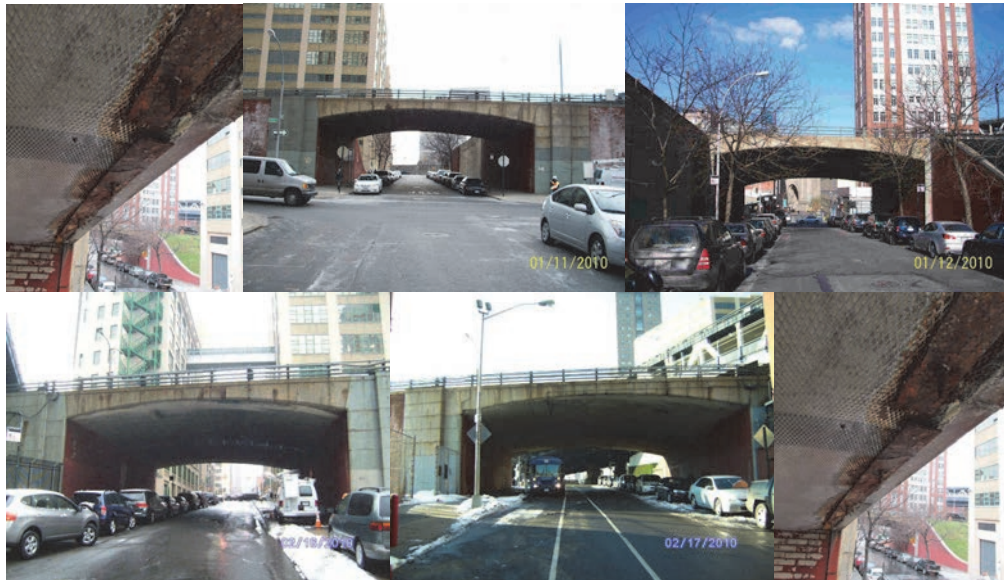
In general, the arch bridges have an adequate load-carrying capacity, however, there are areas of map cracking and visible leakage through the joints. Mesh has been installed at the underside of the deck to prevent debris from falling on vehicles or pedestrians below.

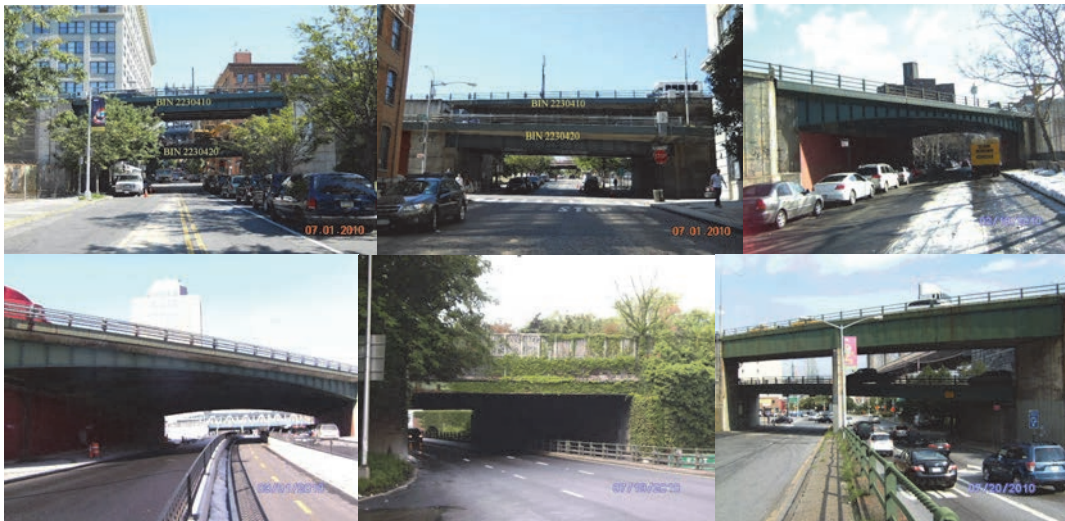
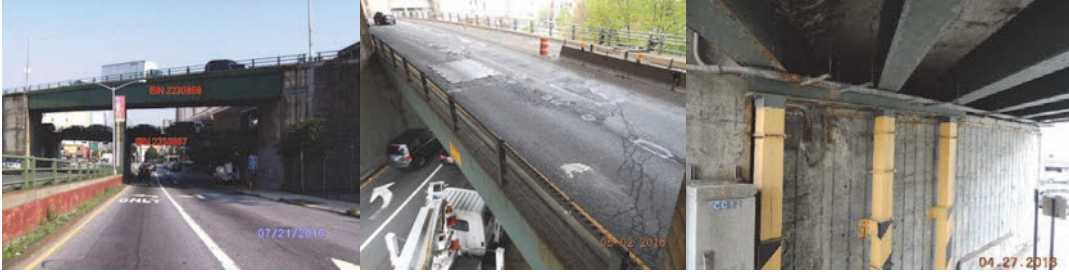
The joints at the multigirder bridges have deteriorated and the asphalt pavement exhibits alligator cracks and an uneven riding surface. Temporary supports have been placed at multiple locations to transfer the load from deteriorated bearings and/or bearing seats. The bridges have adequate load carrying capacity.

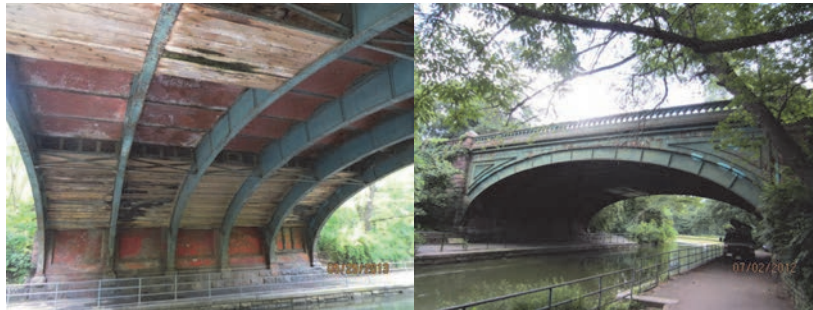
Hill Drive Bridge Span 2 Pier 1 End Face in 2013. View of Bridge in 2012. (Credit: NYSDOT)

This project will include the replacement of the existing masonry cellular abutments with new reinforced concrete abutments clad with existing stone and new brick masonry; the removal, storage, and reinstallation of the existing stone wing walls with a new reinforced concrete core; the replacement of the existing stringers and floor beams with new steel stringers; the reinforcement of the existing arch girders with new cover plates; the reinstallation of the steel arch girders at their current locations to replicate original construction; and the replacement of the existing masonry arches spanning between floor beams by masonry cladding on the underside of the new arched concrete deck. The concrete deck, approaches, sidewalk, and roadway will be replaced within the project limits.

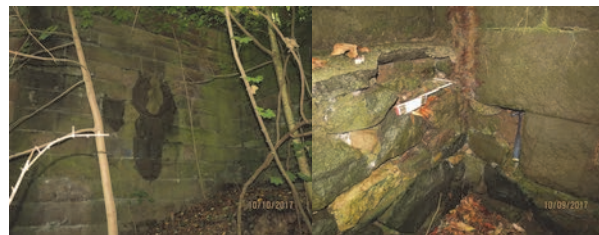
Hill Drive Bridge in 2017: Span 1, Left Exterior Enclosed Wall. End Abutment, Stones on Left Wingwall – Void Due to Missing Stones. . (Credit: NYSDOT)
