2017 NYC DOT

Bridges & Tunnels Annual Condition Report

NEW YORK CITY DEPARTMENT OF TRANSPORTATION DIVISION OF BRIDGES 2017 BRIDGES AND TUNNELS ANNUAL CONDITION REPORT

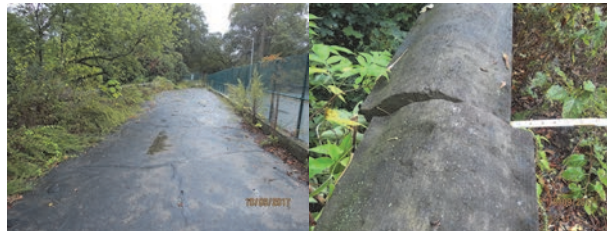
Hill Drive Bridge in 2017: Spans 1 Through 3, Asphalt Wearing Surface - The Deck Top Exhibits Large Areas of Cracked Pavement Due to Deck Deterioration Along the Entire Left Side of the Bridge for a Width of Approximately 12 feet. Most of These Cracks Have Been Sealed With Bituminous Material. Water Seeping Through These Sealed Cracks is Causing Heavy Deterioration of the Deck. Span 1, Stone Coping on Left Railing. (Credit: NYSDOT)

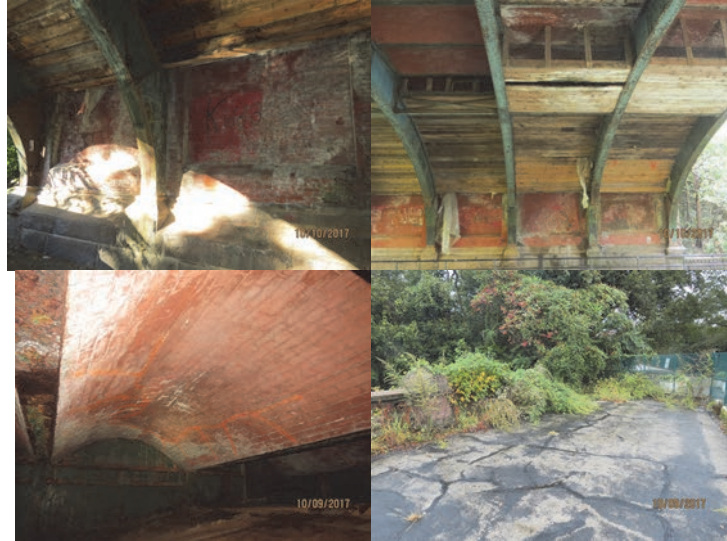
Pier 1 Solid Stem Wall Between Bays 4 and 5 – the Lower Portion of the Pier End Face (Below the Timber Shielding) Exhibits Efflorescence, Dampness and Leakage Over a Large Area. Span 2, Underside General View. Span 2, Underside Brick Arch at Girder Near Pier 2 Exhibits Efflorescence over Most of the Surface Area. Span 3, Left Parapet and Railing Interior Face. (Credit: NYSDOT)

This bridge is closed to vehicular traffic. The north half of the bridge is completely closed with chain link fencing, and the south side is open to pedestrians, but closed to vehicles by the use of large concrete planters. The design is expected to begin in fiscal year 2019, and the reconstruction in fiscal year 2021.

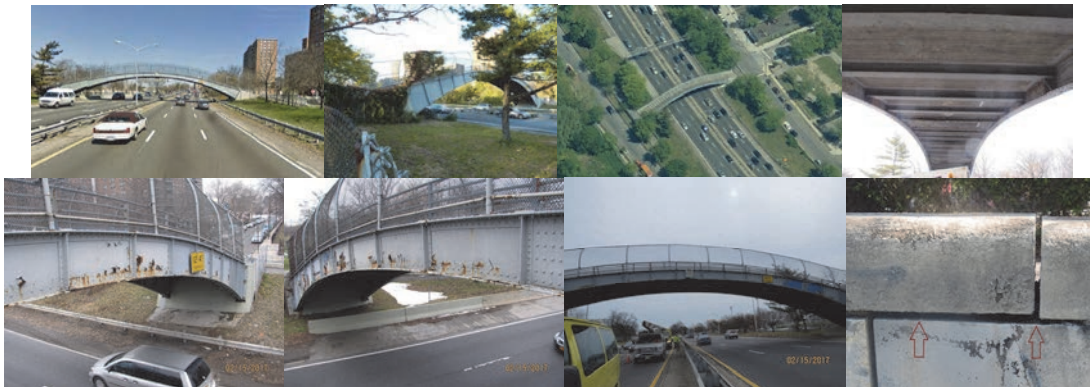
27th Avenue Bridge – Existing Conditions. March 2016 - Underside of Deck has Several Areas of Spalling Concrete With Wire Mesh Shielding. February 2017. Missing Mortar on Beginning Approach Wall in September 2017.

In this project, the overpasses at 17th and 27th Avenues will be completely replaced to meet the primary goals of increasing the vertical clearance and providing ADA compliant access for the community. The structures will be designed to current codes and standards and all substandard features will be eliminated. Additionally, as the existing bridges were constructed under the Robert Moses-era Master Plan for NYC, the proposed bridge designs will follow the Shore (Belt) Parkway Design Guidelines which were developed in November 2006, in order to preserve and reestablish the historic character of the parkway for drivers and pedestrians while enhancing and strengthening the visual cohesiveness of the greenspace connected to the adjacent park and recreation land. Construction is anticipated to begin in 2019, and is expected to be complete in 2021.

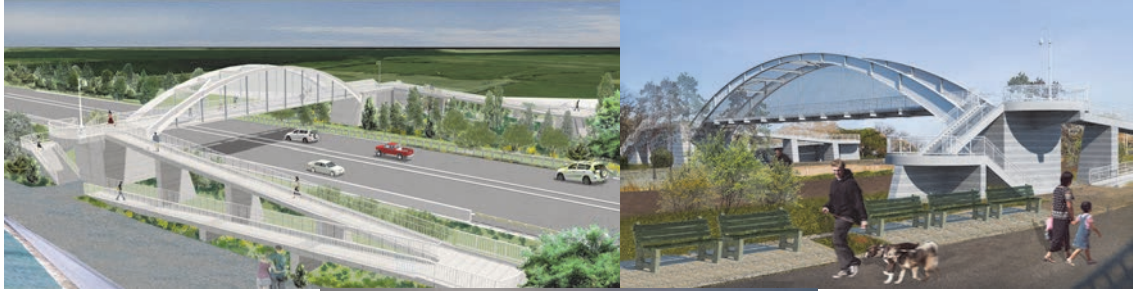
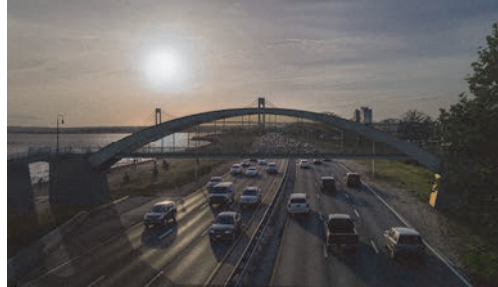
17th Avenue Bridge – Proposed Bridge and Perspectives.

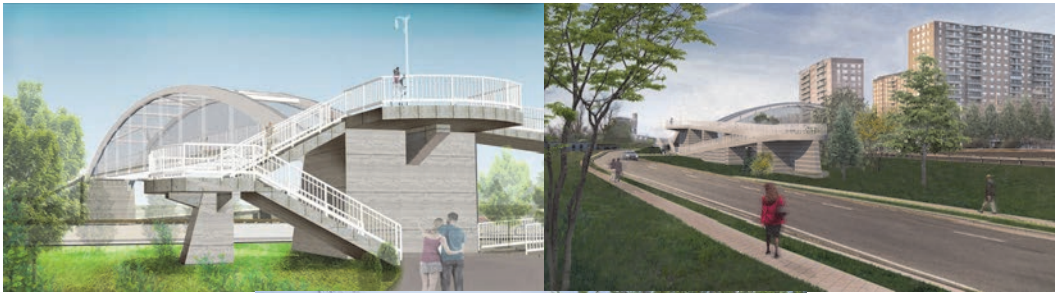
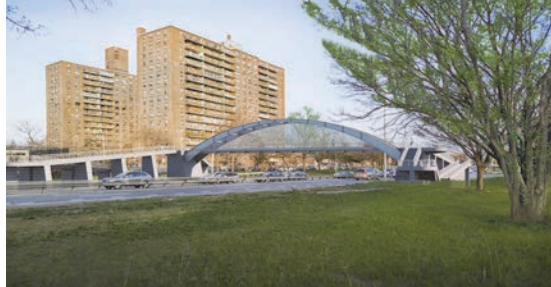
27th Avenue Bridge – Proposed Bridge and Perspectives.

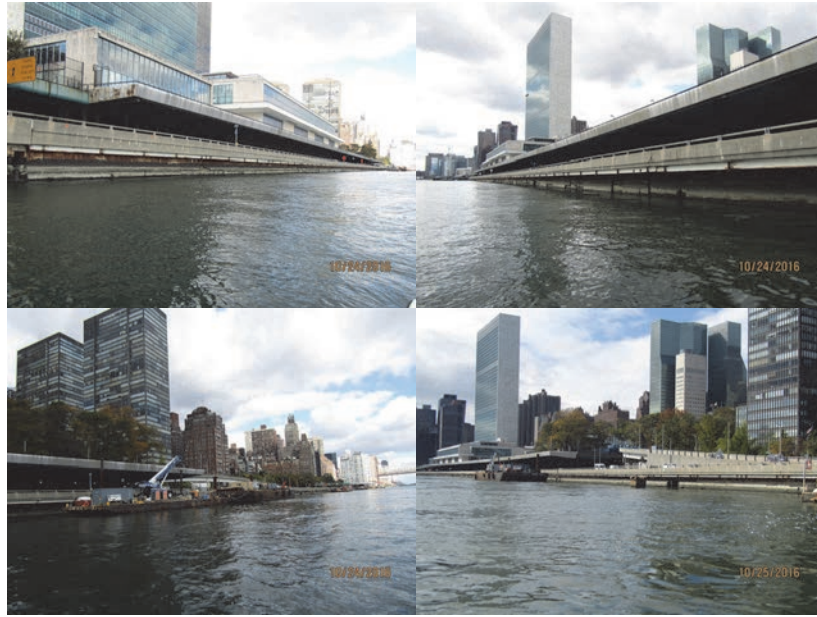
October 2016: Right Elevations. (Credit: NYSDOT)

This structure needs rehabilitation: the stringers exhibit moderate to severe corrosion and section loss, the metal stay-in-place forms under the deck are corroded, the asphalt pavement surface exhibits longitudinal cracking, there are missing and/or cracked granite cladding panels in the concrete bulkhead, and concrete wall above the granite cladding is deteriorated. The pavement of the northbound FDR Drive in the project area last underwent milling and overlay in 1997.

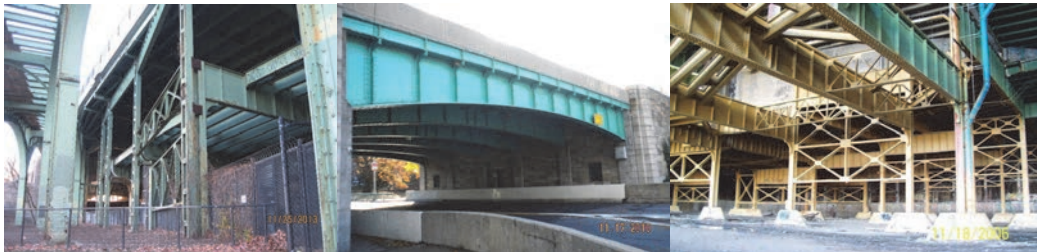
West 72nd Street Viaduct Left Elevation Spans #1 -5, and Span #107. Piers #3 – 10. (Credit: NYSDOT)

The viaduct was originally constructed in 1937. Since then, several rehabilitation projects were performed, including deck replacement and structural steel repair at various locations. This rehabilitation project will consist of partial repairs of the deck and steel elements of the viaduct superstructure in 145 spans from West 72nd Street to West 82nd Street, and 55 spans from West 94th Street to West 98th Street. The concrete repairs will include underdeck spall repairs, retaining wall spall repairs, concrete barrier repairs, deck joints replacement, and concrete column base repairs. The steel repairs will include installation of reinforcements to the deteriorated girders, floorbeams, stringers, columns, connections and bearings. Some of the stringers will be replaced. All of the superstructure and substructure steel will be painted. The top of deck work will be performed in stages to minimize the parkway closures.

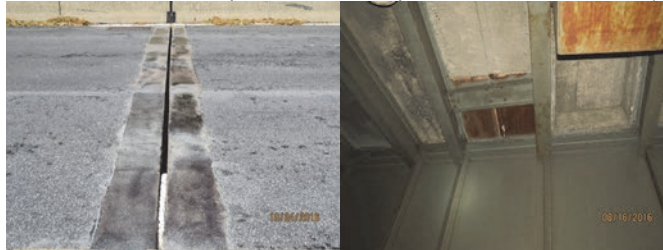
2016: Pier 102, Deck Joint at Southbound Roadway – Missing Joint Sealer Material. Span 143, Underside of Deck – Deep Spall. (Credit: NYSDOT)

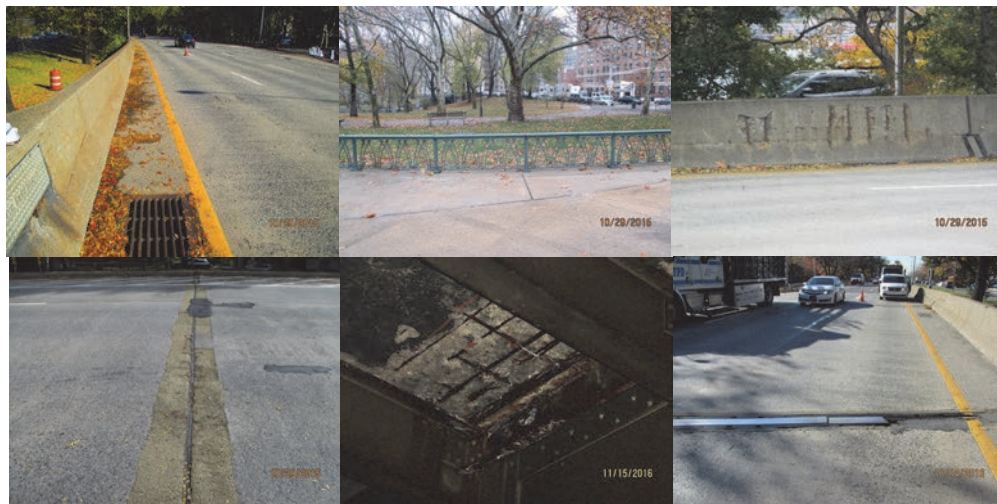
West 94th Street Viaduct – 2015: Span 34 Left Lane. Span 12 Right Railing and Left Side Concrete Parapet. Span 31 Top of Deck. 2016: Span 4 – Spall With Exposed Rebar. Pier # 3, Deck Joint, Northbound Henry Hudson Parkway, Left Lane – Joint Missing Metal Plate. (Credit: NYSDOT)

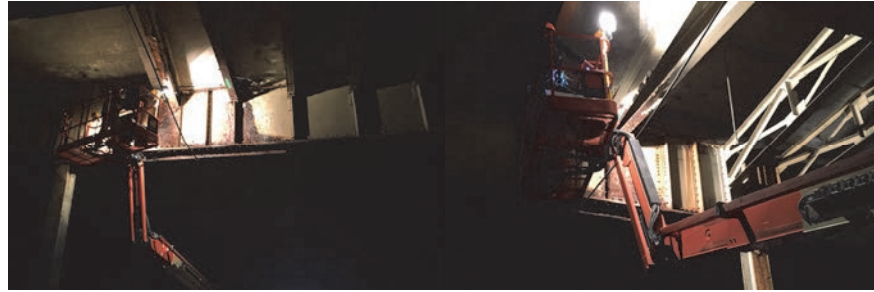
Field Measuring for Steel Repairs in September 2017.

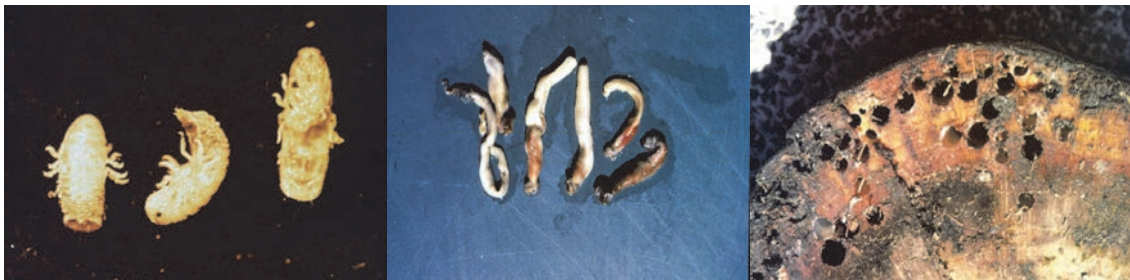
Marine Borer – Limnoria Species (the Common “Gribble,” a Genus of Crustacea Borers). Marine Borer – Teredo Species (a Genus of Molluscan Borers, Commonly Called the “Shipworm”). Teredo Damage (Holes up to ¼” Diameter).

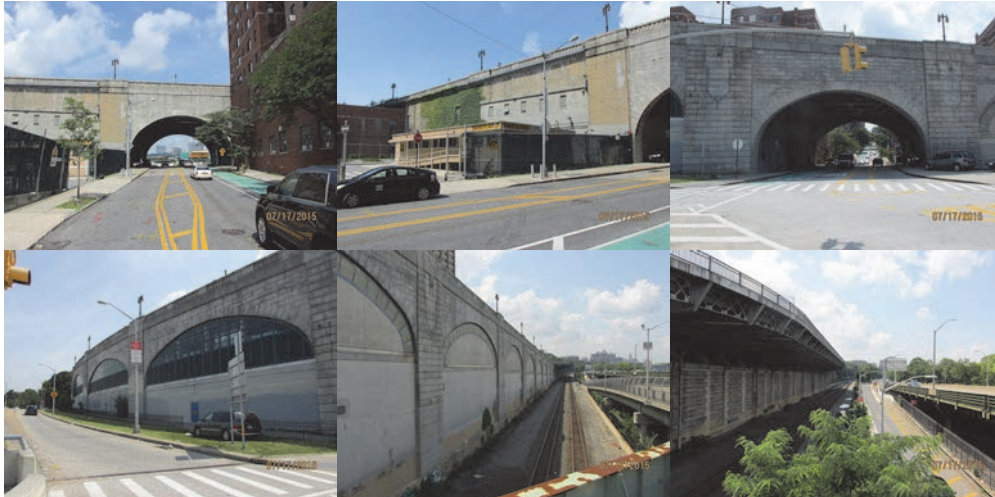
2015: Left Elevation Span 14, Spans 15 – 20. Right Elevation Span 14, Spans 13 – 1, 15 – 77, 41 – 77, and 43 – 13 (Section over NYCDOT Maintenance Garage Area). (Credit: NYSDOT)

Project work will include the repair of deteriorated structural steel members; replacement of the existing deck; abutment and retaining wall repair; repairs and replacement of concrete barriers and bridge rails; complete expansion joint replacement; approach slabs and pavement replacement; cleaning and necessary repairs of the drainage system (replacement of catch basins and grates within the bridge and at all approaches to the bridge in accordance with NYCDEP standards), as well as encasement removal, paint removal, lead abatement and recoating of steel. The scope also includes the replacement in-kind of the existing period lighting and the restoration of the historic parapet at deck level. The project will neither change the roadway configuration within the Riverside Drive Mainline nor impact the Viaduct facades. However, the Riverside Drive West branch alignment at the intersection of Riverside Drive West and Riverside Drive will be slightly altered to create a 12 foot radius at the northeast corner and the median will be re-aligned. As a result, the catch basins and catch basin connections will be relocated at this intersection.

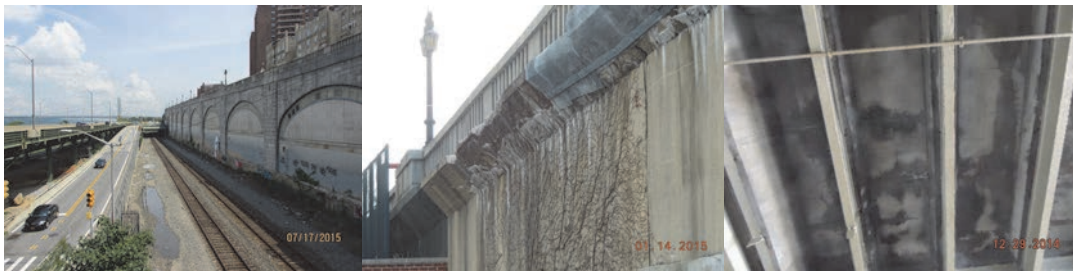
2015: Spans 19-21, East Fascia Overhang, Looking Southwest - Large Edge Spalls with Numerous Cracks and Heavy Efflorescence Throughout Overhang. Span 52 Looking South - General View of Underside of Deck Showing Extensive Dampness and Cracks with Efflorescence.

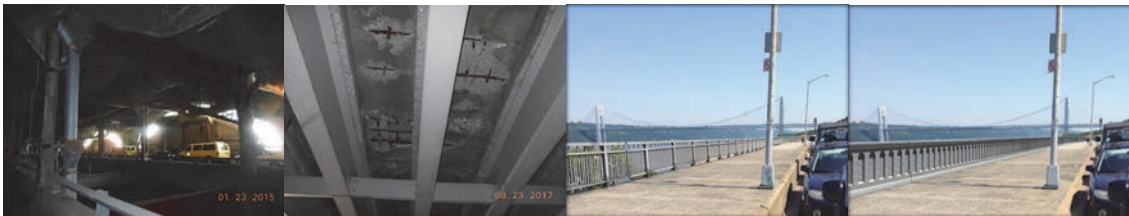
2015: Underside of Span 30, Looking Southwest (NYCDOT Maintenance Garage Area). 2017: Span 5 Underside of Deck Bays 16 and 17 - Spalls With Exposed Rebar. (Credit: NYSDOT) Current and Proposed Bridge Railing.

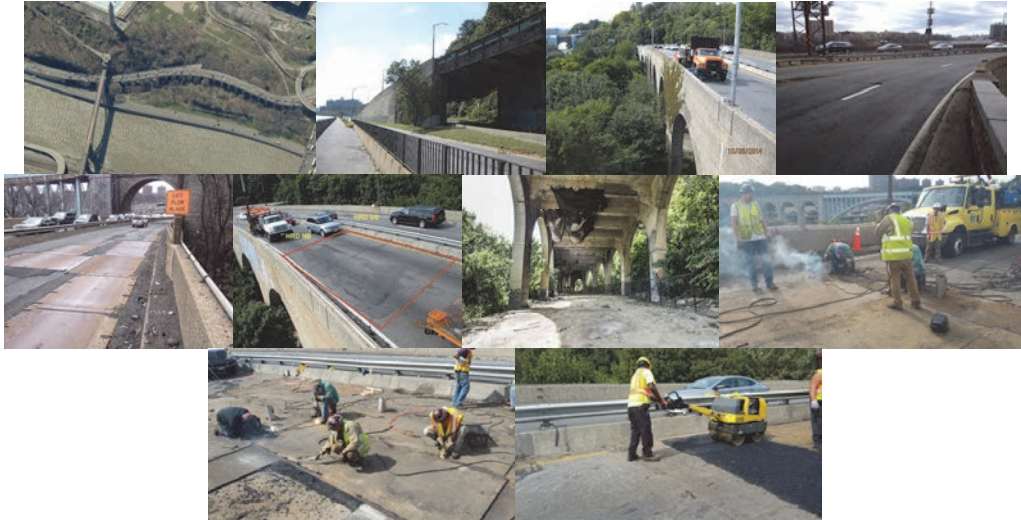
Aerial View. Trans-Manhattan Expressway Connector Ramp in 2014: Elevation Right Spans 1 – 25, 33 – 40. (Credit: NYSDOT) March 2015 Field Inspection. September 2015 - Span 42, Northbound Roadway, Looking Back. (Credit: NYSDOT) November 2015: Netting at Deck Underside. Repairing the Punch Through Holes on Top of the Deck.

During the winter of 2015, existing deck spalls developed into through holes at seven locations on both the south and north bound roadways. This situation was temporally rectified in September 2015 by Division personnel placing a number of steel road plates on the top of the holes to maintain traffic flow and keep the ramp open for the public. The repairs were then added to the contractor’s work scope. The revised total contract value was approximately \$15 million.

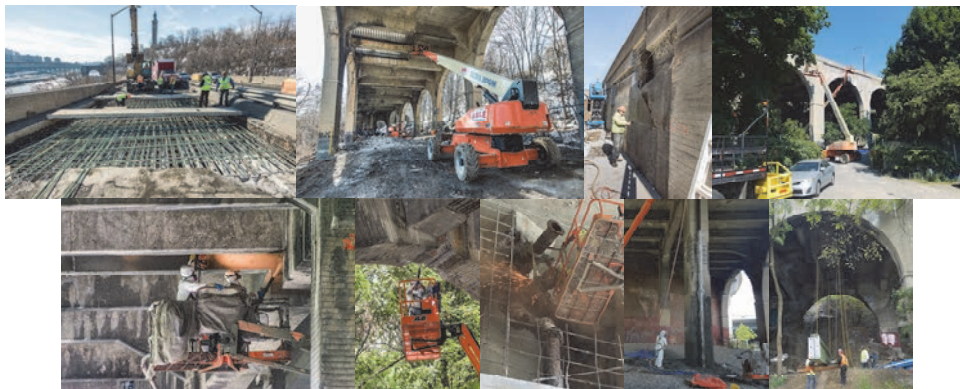
January 2016: Spans 42 and 43 Northbound Rebar Installation. Underside View. March 2016: Pier 3 Concrete Repairs. July 2016. August 2016: Shotcrete Application at Span 36. Chipping at Span 45. September 2016.

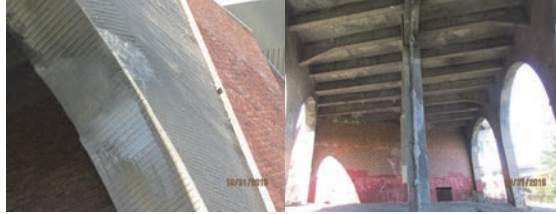
October 2016: Span 51, Underside of Right Arch - Concrete Repairs. Pier 49, at Center Column - Concrete Repairs.
(Shielding and Repair Credit: NYSDOT)

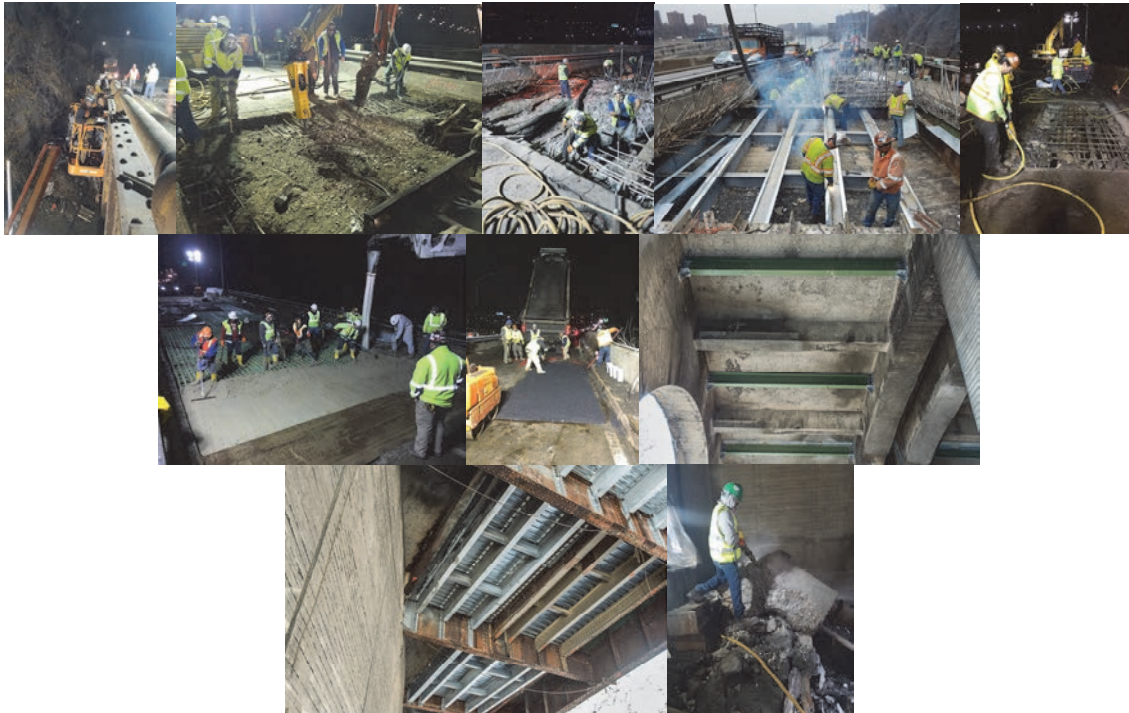
March 2017. Deck Removal During Northbound Repairs. Concrete Placement for Full-Depth Deck. Asphalt Placement Over Cured Deck. April 2017: Newly Installed Steel Angles Under Span 38, and Steel Installed Above the Harlem River Drive.

Upon recent inspection of the holes and the anchoring steel plates, it was noted that the holes were increasing in size and the plates were exhibiting excessive movement under normal traffic. This presented a public safety hazard and emergency repair procedures were developed immediately to remedy the situation and make it safe for the public. In October 2016, the emergency repairs were performed on the southbound side using full weekend closures of the ramp. The northbound emergency repairs were conducted in March 2017 with another full weekend ramp closure.

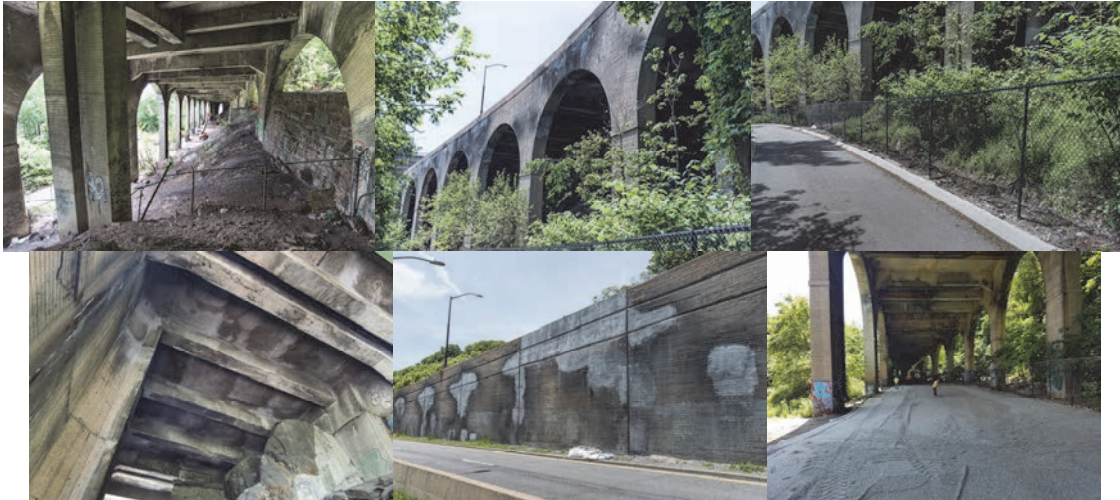
May 2017: Spans 36 to 25. Shotcrete Arch Repairs on Spans 34-32. Fence Restoration. Shotcrete Deck Repairs. Rebuilt Parapet.

Over the course of 2016 and half of 2017, the contractor applied over 16,000 square feet of shotcrete, and erected over 80 tons of steel. In addition, repairs/replacements were made to the curtain wall along the Harlem River Drive, steel beams were grouted, bearings were restored, and drainage repaired.

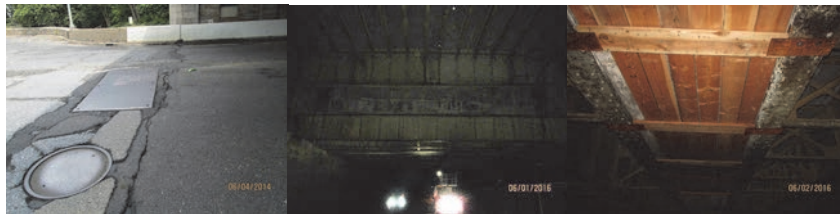
West 79th Street Bridge Over Amtrak in 2014 – Beginning Abutment Joint – Top of Deck. June 2016: Left Elevation. Underside of Deck, Bay 7 – Timber Shielding. (Credit: NYSDOT)

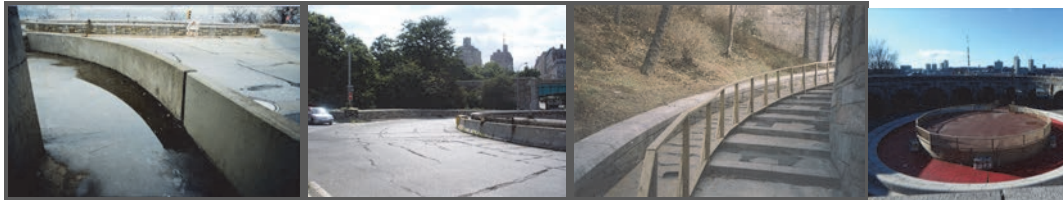
Traffic Circle Level: South Sidewalk Area - Extensive Water Ponding. Pavement - Widespread Cracking.
Pedestrian Plaza Level: North Stairway - Timber Delivery Ramp. Closed Fountain.

The project work will include the structural rehabilitation and architectural restoration of impacted portions of the plaza, as well as restoration of the fountain. The existing fieldstone flooring of the pedestrian plaza level, as well as the fieldstone steps will be salvaged and reinstalled (as applicable) to provide an ADA-compliant surface. The missing stone work in these locations will be replaced with historically sensitive, matching material. The ceiling vaults will be documented and replaced in accordance with the plans and requirements from the New York State Historic Preservation Office and the New York City Landmarks Preservation Commission. The restrooms will be upgraded and restored, and a Parks Department office with public access will be incorporated into the structure. Accessibility to the facility will also be improved by the addition of four ADA-compliant ramps as a part of the rehabilitation project. At the garage level, the connector ramps will be repaired, and stone masonry restored. As with the other areas of the structure, lighting and drainage will be replaced. In addition, the Parks Department operations office will be expanded and upgraded.

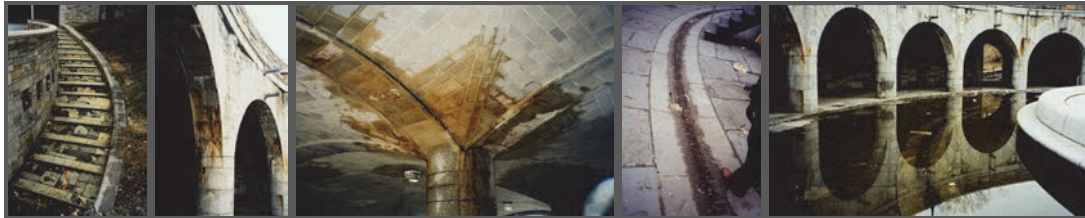
Pedestrian Plaza Level: South Stairway - Deterioration and Missing Stone Steps. Stone Clad Columns - Extensive Efflorescence and Staining. Guastavino Arch - Ponding Water and Efflorescence. Fountain Trench Drain - Deteriorated Grating and Clogged Drain. Extensive Water Ponding.

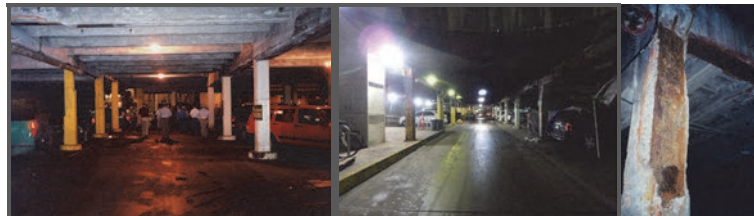
Garage Level – Debris Nets Below Ceiling. Column With Spalled Concrete Encasement.

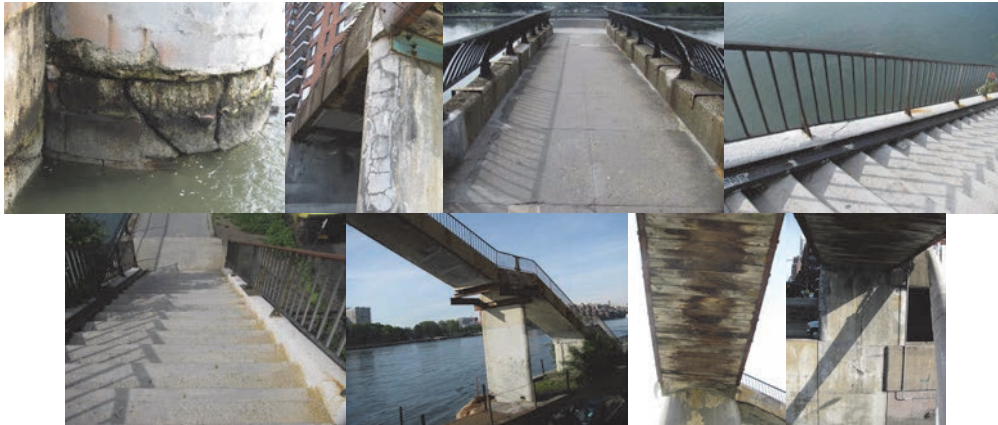
Bridge Conditions in June 2014. Pier 1 Over the East River – Close-up of 2 Wide Cracks. Begin Abutment Stem Right Side - Failing Patch and Map Cracking. Span 1 Deck Wearing Surface. Span 2 Railing. Span 3 Concrete Steps. Pier 2, Under Span 2, Looking Southwest – Spalled Concrete Area With Exposed Rebar at Bottom of Pier. Underdeck of Span 1. Begin Abutment Stem.

The new bridge complies with current standards and provides barrier free access. The reconstruction of the bridge was managed by the New York City Department of Design and Construction in partnership with the Department of Parks and Recreation and DOT.

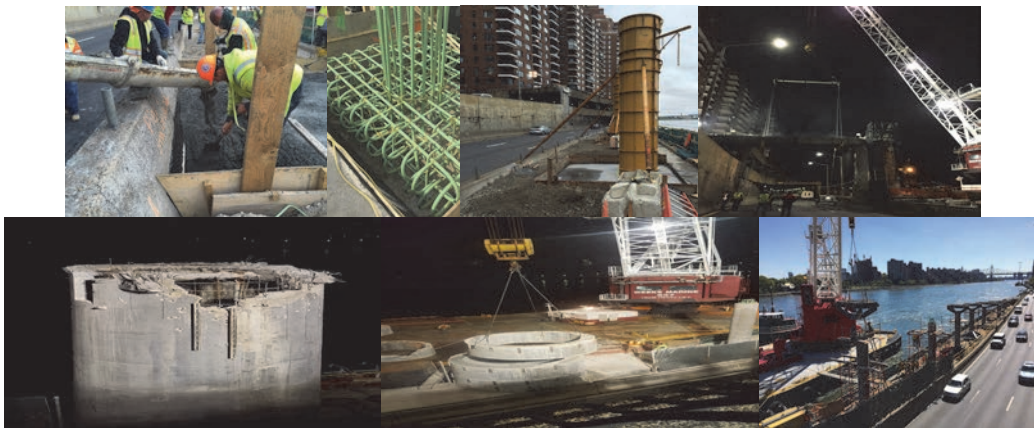
Installing Rebar Cages and Pouring Concrete for Pile Caps. Installing Pier Caps and Removing the Old Bridge. Demolishing the Concrete Tower. Installing the Hub and Arms. (Credit: NYCDDC)

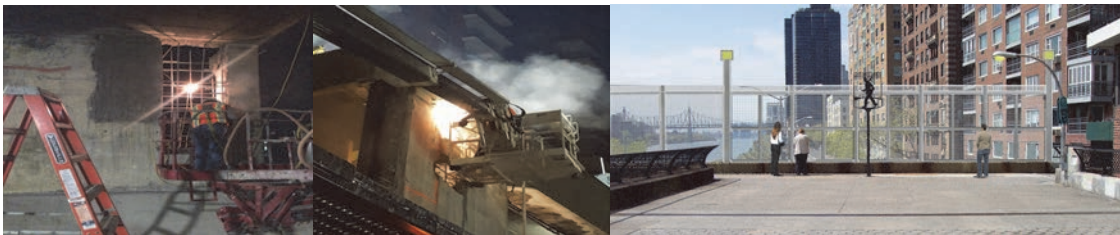
Retrofitting the North Abutment (8 Months). Rendering of the Viewing Window at the Southern Terminus of the John Finley Walk. (Credit: NYCDDC)

The construction project was nearly three years in the making, but was initially expected to be completed in 18 months. Three major factors prolonged the project: the north abutment retrofit, design changes, and stainless-steel fabrication. The initial survey of the north abutment (the column supporting the southeast corner of the John Finley Walk, between the north and southbound FDR Drive) indicated that a repair was needed and the contract included that repair work. After the project started and the column was further evaluated, it was clear that it would not be prudent to install a bridge on the north abutment without a more significant retrofit. It took approximately 8 months to design a repair, have the design approved by various agencies invested in the project, coordinate with the other projects working on the FDR, and execute the repair.

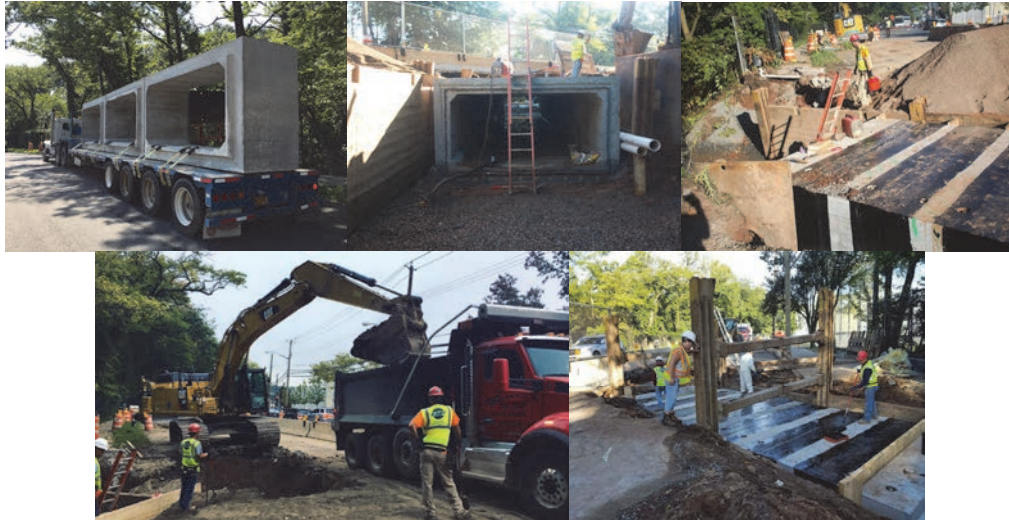
Midland Avenue Culvert in September 2017 – Precast Sections. Looking East - Precast Box Culvert Section Installation Complete. Looking North – Completed Installation of Waterproofing Membrane on the Outside of all Joints. Excavating. Assistant Civil Engineer Tatyana Krushelnitskaya (on Left) Inspecting the Waterproofing of the Culvert Box.

The Midland Avenue culvert consists of a single span reinforced concrete box, which will be replaced with a new pre-cast box culvert. It is located on Midland Avenue between Boundary Avenue and Mason Avenue. The rehabilitation will include replacing the existing concrete box structure with a new concrete box structure, new sidewalk, curb, pipe railing, chain link fence and asphalt wearing surface. The work will be performed in three stages, with one lane of traffic maintained in each direction at all times. Construction began on August 25, 2017. Installation of new culvert, sidewalks and moment slabs was completed in 2017. The new bridge railing will be installed in spring 2018.

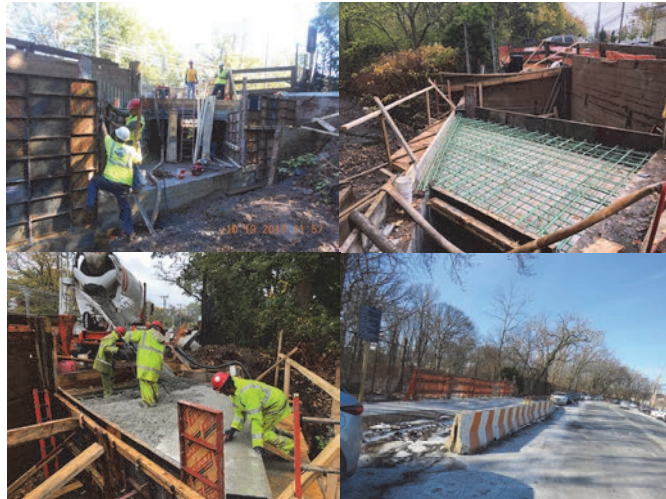
October 2017 – West Walls and Wingwalls Formwork. Looking West - Formwork and Rebar for the Roof Slab. Placing Concrete for the Roof Slab. Sidewalk.

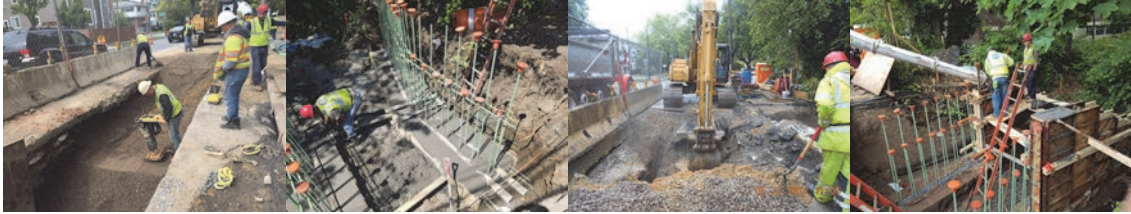
Forest Avenue Culvert over Randall Avenue in May 2017 - Looking West. Backfilling the Trench Over the New 20 Inch Iron Pipe Water Main. Looking South - Placing Rebar for Wingwall Footing. Looking West - Excavating and Removing the Old Culvert. Looking Northwest. Placing Concrete Into Formwork for the Wingwalls.

The Forest Avenue culvert over Randall Avenue is a single span concrete box culvert, located at Forest Avenue between Randall Avenue and University Place. It will be replaced with a new precast concrete box culvert with new sidewalks and asphalt pavement. The work will take place in three stages while maintaining one traffic lane in each direction during construction. Construction began on April 3, 2017, was completed in the fall, and an inspection was performed on November 6, 2017.

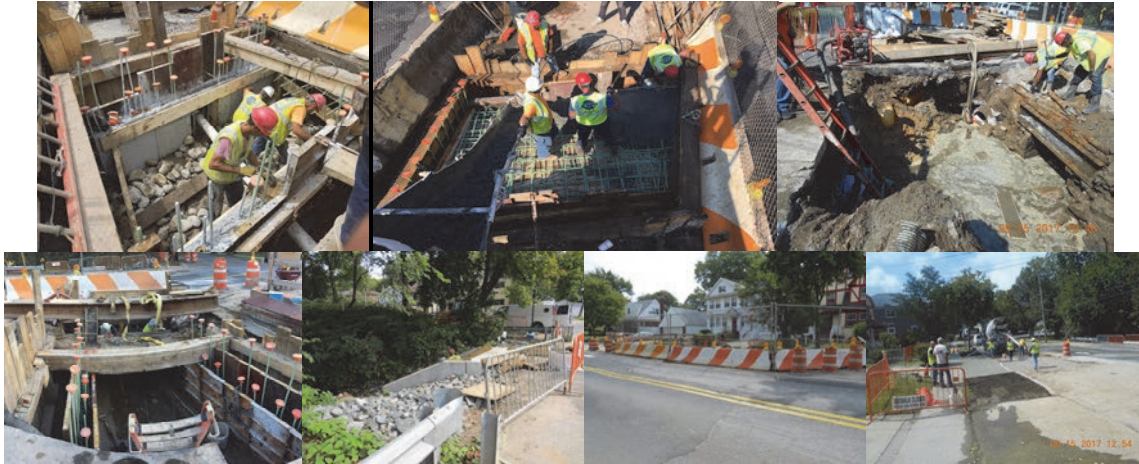
May 2017 - Looking West - Installing Shoring Around Excavation. Looking North - Placing Concrete for Footing. June 2017 - . Looking Down and Northwest Along Forest Avenue - Installing the New 12 Inch Water Main. Looking Northwest - Placing Temporary Asphalt Over 12 Inch Water Main Trench on Forest Avenue.

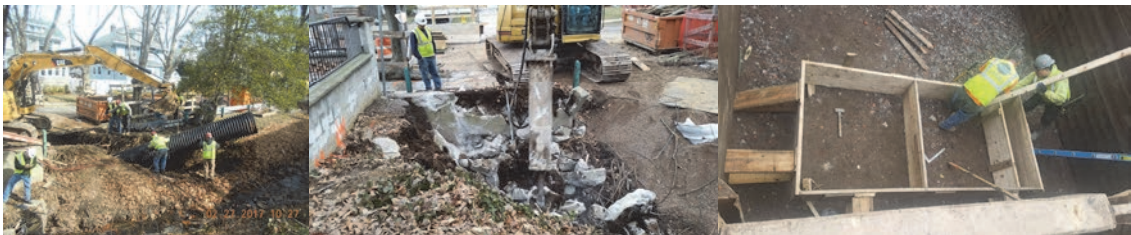
Gregg Place Culvert in February 2017. Looking Northeast - Installation of 30 Inch Pipe for Water Diversion Structure. March 2017 - Looking South - Forming up Footings for the Headwall.

The Gregg Place culvert is a single span reinforced concrete box culvert, located approximately 98.4' west of the intersection of Gregg Place and Randall Avenue. The rehabilitation includes replacing the southern portion with a new precast box culvert with new pavement. The construction is planned to be performed in one stage and the north side of the road will remain open to through traffic. Construction began on February 23, 2017, was completed in the fall, and an inspection was performed on November 6, 2017.

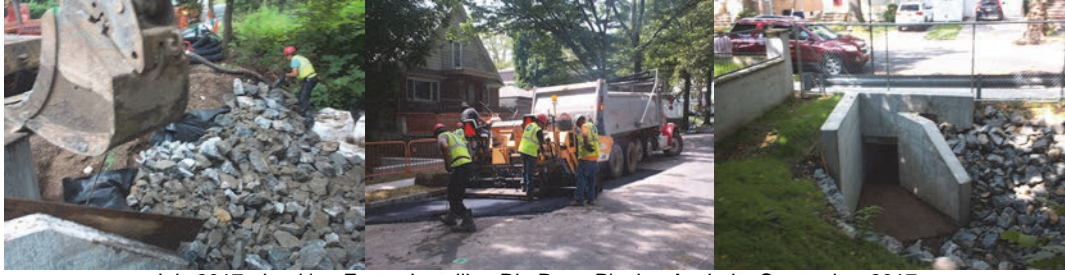
July 2017 - Looking East – Installing Rip Rap. Placing Asphalt. September 2017.

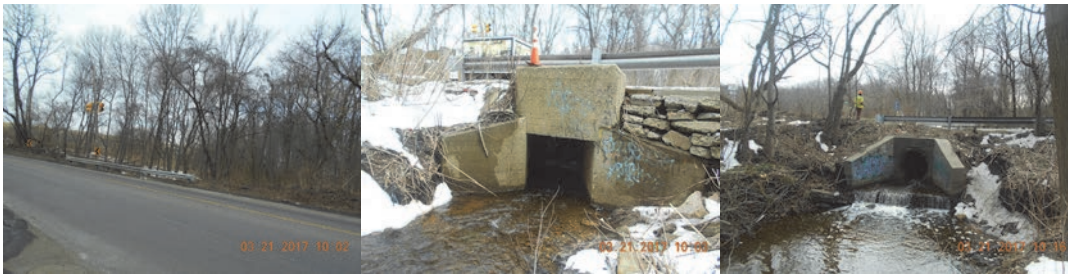
Arthur Kill Road Culvert over Muldoon Avenue in March 2017 - Looking Northwest at the North Side. Looking North at the South Headwall and Wingwall, and Looking South at the North Headwall and Wingwall.

The Arthur Kill Road culvert over Muldoon Avenue consists of a reinforced concrete pipe at north and a reinforced box culvert at south. It is located on Arthur Kill Road between Muldoon Avenue and Arden Avenue. The box culvert will be replaced with a new box culvert, and a structural lining will be installed in the pipe culvert. The construction will be performed in one stage with one lane of traffic maintained in each direction. Construction began on April 10, 2017.

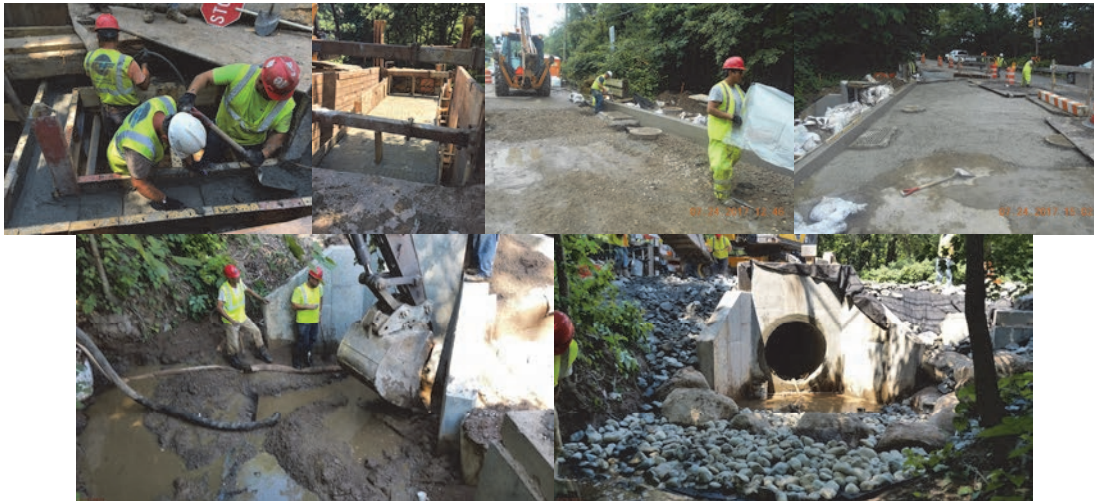
June 2017 – Pouring Manhole Walls. July 2017 – Placement of Low Strength Concrete Complete. Placement of Concrete Curb Along the South Gutter Line. Placing Roadway Base. Excavation of Material on Top and in Front of the Apron Slab. Placement of River Bed Stones, Medium Stones, and Boulders Adjacent to the Culvert Walls and Apron Slab.

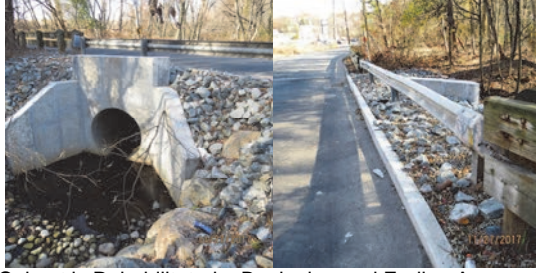
November 2017 – Half of the Culvert is Rehabilitated – Beginning and Ending Approach Right Side Embankments are Repaired. New Guide Railing, Bridge Railing, Curb and New Asphalt Pavement.

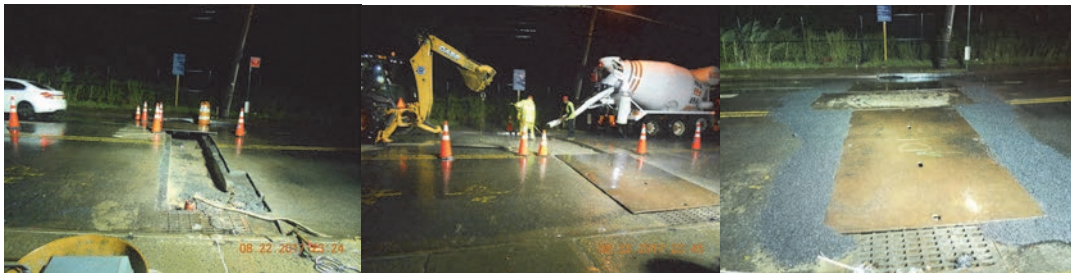
Arthur Kill Road Culvert over Ridgewood Avenue in August 2017 - Cut Back Asphalt Wearing Surface. Placing Concrete Base. Plates Installed Over Trench for the New 20 Inch Diameter Iron Pipe.

The Arthur Kill Road culvert over Ridgewood Avenue consists of a non-reinforced concrete pipe at south and a corrugated metal pipe at north. It is located approximately 100' west of the intersection of Arthur Kill Road and Ridgewood Avenue. The rehabilitation work will include installing a structural lining inside the concrete pipe and repairing the concrete at the head walls and catch basins. There will be one stage of construction and one lane of traffic will be maintained in each direction. The project was well advanced by the fall of 2017.

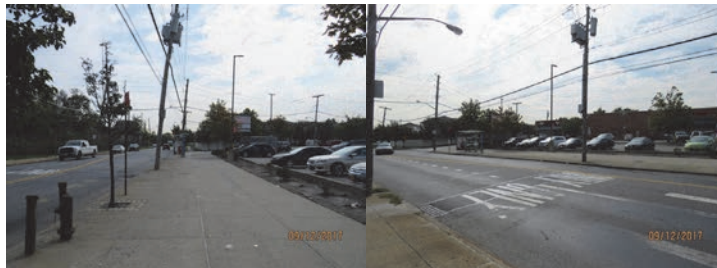
September 2017 – Right Sidewalk and Roadway Wearing Surface.

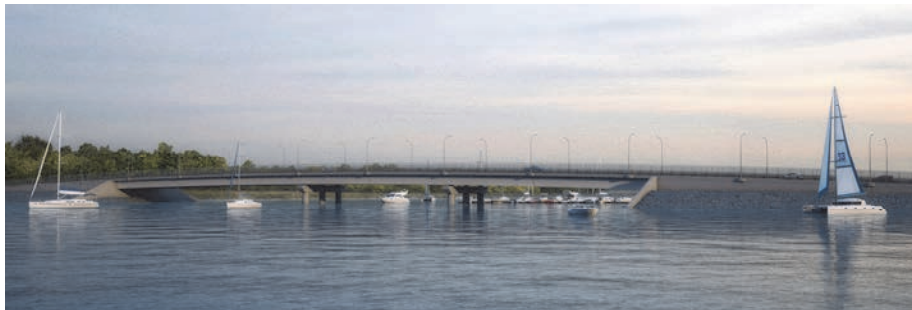
Side View Rendering of New Bridge.

The bridge was replaced along the same alignment with a new three span bridge with two piers in the water. The new bridge is approximately 17 feet wider than the old one to accommodate three standard 12-foot wide traffic lanes, a 6-foot wide bicycle lane and a 6-foot wide pedestrian walkway on each side. The new bridge is a multi-girder continuous bridge with an integral deck. Galvanized steel stay-in-place forms were used for the deck to both facilitate deck placement and shield the concrete from the corrosive environment of the saltwater bay below. The stainless steel rebar will also not be vulnerable to the deicing salt in the same way that epoxy coated rebar is. Therefore, the deck will have a much longer life expectancy since rebar corrosion is a primary factor in the deterioration of concrete. The new bridge was designed to current standards and with its wider roadway width, will allow future repair and rehabilitation to be carried out while maintaining one 12-foot lane in each direction. It also eliminates the vehicle height restriction caused by the previous overhead truss. In order to maintain traffic during the demolition of the existing bridge and construction of the new bridge, a temporary bridge was constructed on the south side of the existing bridge. Marine traffic remained undisturbed beneath the bridge during peak boating season.

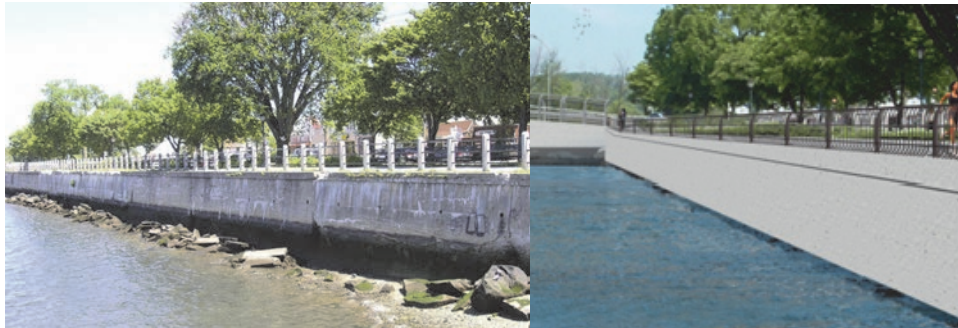
Existing Seawall. Proposed Treatment.

At the City Island side there is a seawall along the shore which is about 500 feet in length starting from the bridge and heading in a southerly direction. This seawall will be rehabilitated and turned over to the Department of Parks and Recreation along with the esplanade which it is supporting. The rehabilitation of the existing concrete seawall will include a steel rod tieback system as a precaution against loss of stability due to overturning or sliding. In addition, all unsound concrete will be removed from the face of the wall and a new reinforced concrete facing will be cast along the entire length. The esplanade will receive landscape improvements such as a new railing above the wall, new plantings, trees, grass, and paver blocks.

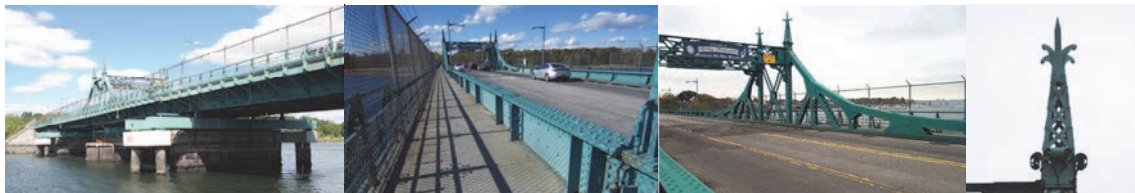
City Island Road Bridge in 2010. (Credit: Bojidar Yanev) Span 4, Right Sidewalk Near Pier 4 in October 2013. Vertical Clearance Posting. (Credit: NYSDOT) 9 Foot Tall Ornamental Finial.

The original City Island Road Bridge was built in 1901 and was the only vehicular, bicycle and pedestrian access between the mainland Bronx and City Island. In 2015, the bridge carried 15,292 vehicles per day. The bridge is part of City Island Road, which is located within Pelham Bay Park and crosses over Eastchester Bay. With seven spans and six piers in the water, the bridge outlived its useful life and required extensive continuous maintenance. Spans two and three were supported by an overhead truss that originally functioned as a movable swing span but was permanently fixed in 1963.

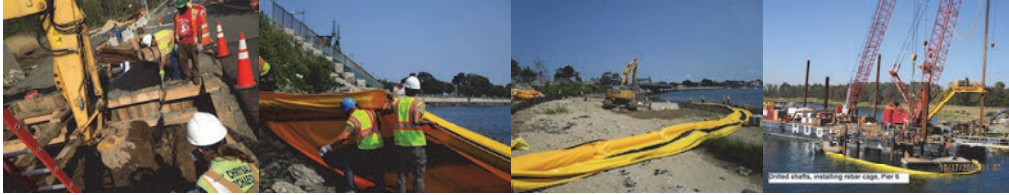
August 2014: Excavating on the West Side of the Bridge in the Presence of an Archeologist. Approximately 300 Linear Feet of a Turbidity Curtain was Installed on the Southwest Side of the Bridge to Protect the Shore During Construction. A Turbidity Curtain is a Floating Barrier Designed to Contain and Control the Dispersion of Sediment. October 2014: Drilled Shafts – Installing Rebar Cage at Pier 6.

A Notice to Proceed for the project was issued to the contractor with a start date of September 30, 2013. At the end of 2013, the contractor started mobilizing the project activities. During 2014, the contractor surveyed the area, set up temporary work zone traffic control devices, installed temporary signals, relocated the 16 inch water main on the existing bridge, and started and installed most of the foundation work for the temporary bridge. Stage 1 of the Turtle Cove culvert replacement also began in 2014.

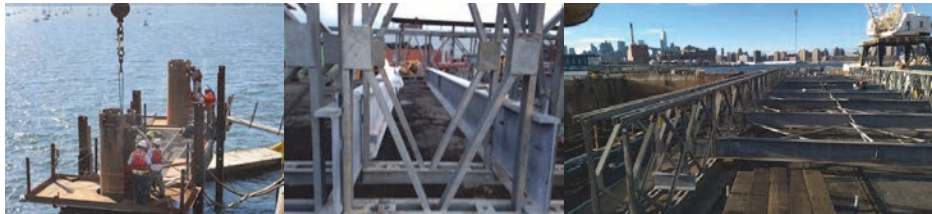
October 2014: The Contractor Airlifted Drilled Shaft Casings Into Position on a Platform Constructed Beside a Construction Barge. The Contractor Assembled the Temporary Bridge Segments at the Brooklyn Navy Yard. The Pieces Were Transported to City Island by Barge.

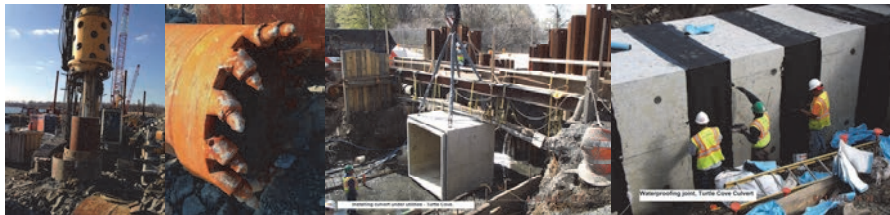
January 2015: Drilling Rig Construction Vehicle Used to Install Land-Based Drilled Shaft Casing for the Temporary Bridge. The Bucket Drills Carve Out the Casings With Teeth Capable of Tearing Through Rock. April 2015: Turtle Cove Culvert Replacement. Installing Culvert Under the Utilities. May 2015: Waterproofing the Joint.

During 2015, the contractor constructed the remainder of the substructure and superstructure for the temporary bridge. Temporary water mains, gas main and other utilities were installed on the temporary bridge. Opening of the temporary bridge to traffic and closure of the existing bridge for demolition was expected in early 2016. On December 16, the Division conducted strength testing of the temporary bridge roadway. Heavily equipped vehicles from the FDNY's Engine 70 Ladder 53 station crossed the temporary bridge to demonstrate the structural integrity of the roadway. The larger of the two vehicles weighed approximately 80,000 pounds, and the smaller vehicle weighed closer to 60,000 pounds. On December 18, all City Island Bridge traffic (vehicular and pedestrian) was transferred onto the temporary bridge. Stage I work of the Turtle Cove culvert replacement was completed and Stage II work was in progress at the end of 2015.

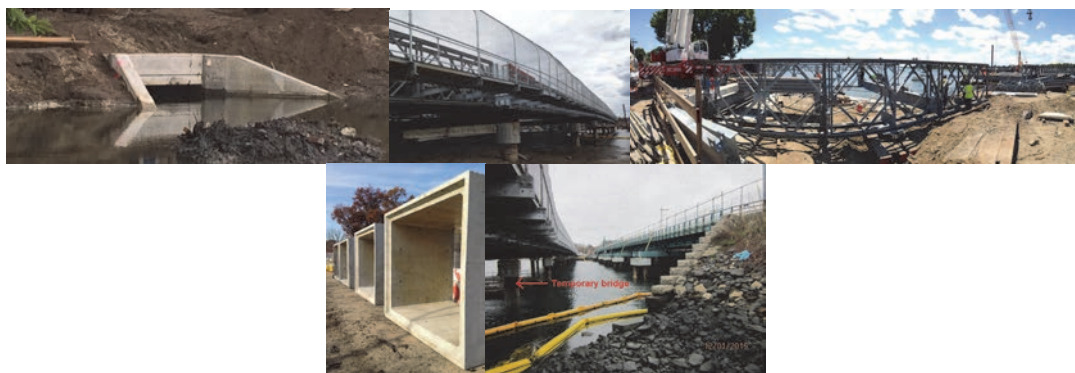
2015: Completed Stage 1. Water Flow Inside the Culvert was Restored on May 18. The New Culvert is an 8 Foot by 7 Foot Concrete Box - About a 3x Larger Capacity. April 2015: - Installation of the Pedestrian Walkways for the Temporary Bridge. The contractor Constructed 2 Cantilevered Sidewalks - Approximately 5.5' Wide With a Chain-Link Fence. July 2015: Installing Decking for Span 15. November 2015: New Culvert Boxes to Replace the Aging Conduit that Connects the Bay with Turtle Cove, Located Beneath City Island Road. December 2015: Temporary Bridge at Left. (Temporary Bridge Credit: NYSDOT)

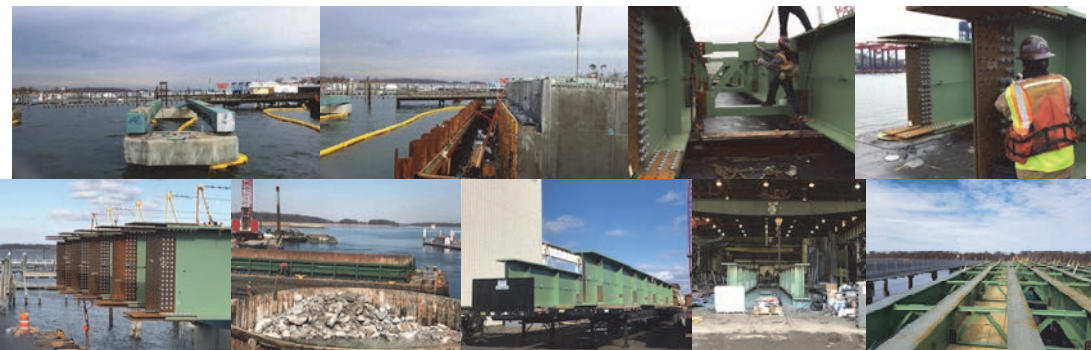
January 2017: Most of the Superstructure of the Old Bridge Removed. New Bridge Abutment Seat That Will Support the New Bridge Deck. Two Girders are Attached With a Diaphragm. A Worker Installs Bolts at the Splice Location Prior to Shipment to the Site. The Bridge Steel Beams Were Installed at the Footprint of the Original Structure. The American Steel was Fabricated in Southfield, New Jersey and Sent to Elizabeth, New Jersey, Where it was Loaded on Barges and Sent to City Island. Upon Arrival, Construction Workers Offloaded the Steel and set it in its Final Place. February 2017. Steel Fabrication. March 2017.

On January 17, 2017, the contractor started installing the west abutment cofferdam sheeting and performing the remediation measures for the walers, braces and treated rods, and continued with the demolition of the existing bridge and the removal of the excavated material to the stockpile in the south west quadrant of the bridge. On February 7, 2017, the steel to build the new bridge arrived by barge. On February 11, 2017, the contractor started erecting the "G" series girders of span 3. During the ongoing steel erection activity, the "F" series girders were spliced in the field to the in-place "G" series girders in order to complete the erection of the new steel girders of span 3. On March 17, 2017, the contractor completed the erection of the structural steel girders ("F&G") section of span 3 and started erecting the structural steel girders along span 2 and installing the cross frames (diaphragms) between girders.
