2017 NYC DOT

Bridges & Tunnels Annual Condition Report

NEW YORK CITY DEPARTMENT OF TRANSPORTATION DIVISION OF BRIDGES 2017 BRIDGES AND TUNNELS ANNUAL CONDITION REPORT

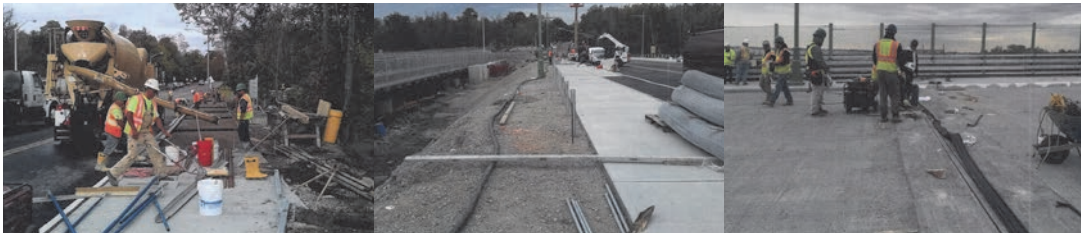
October 2017: West Approach Roadway – Placing Concrete at the North Approach. Installing Fencing Along the South Sidewalk. Bridge Deck – Completing the Installation of the Modular Joints.

On September 2, 2017 the contractor began saw cutting the bridge deck, installing the steel faced curb, and installing the electrical conduits. On September 22, 2017, the concrete along the west approach was placed. On October 14, 2017, the contractor completed installing the steel-faced curb along the sidewalk, began and completed the installation of the modular joints at the east and west abutment and completed installing the sub-base and placing the PCC concrete foundation for the roadway.

On October 27, 2017, the contractor completed installing the electrical conduits for the street lighting along the entire north and south sides of the roadway, the light poles, and the control cabinet. In addition, the contractor completed installing the fence posts and the railing from the east abutment to the west abutment along the bridge. On October 28, 2017, the contractor began and completed the asphalt placement and the striping of the road as required, diverting the traffic from the temporary bridge to the permanent bridge.

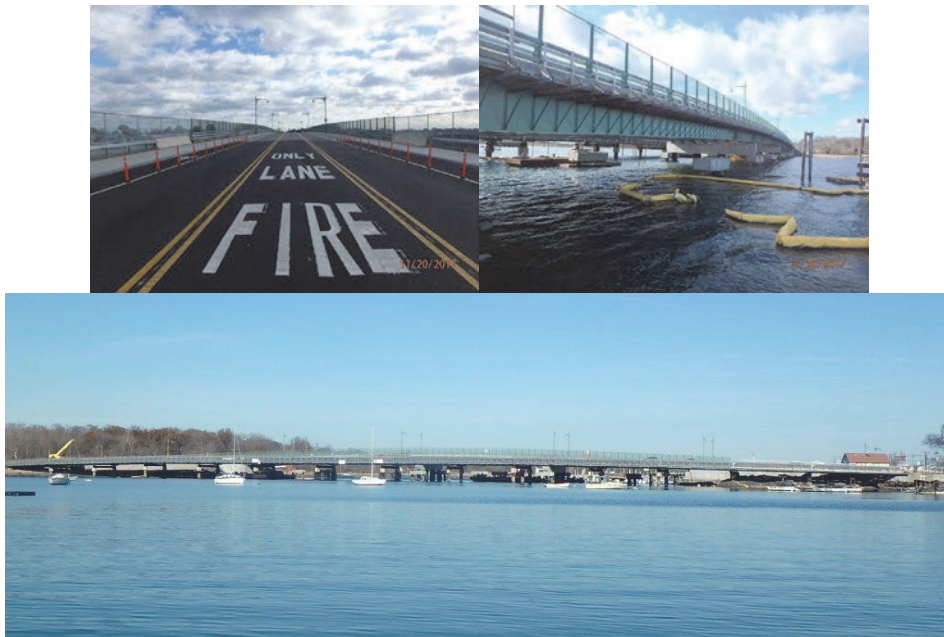
November 2017: Approach Beginning, Elevation Left and Right. (Credit: NYSDOT)

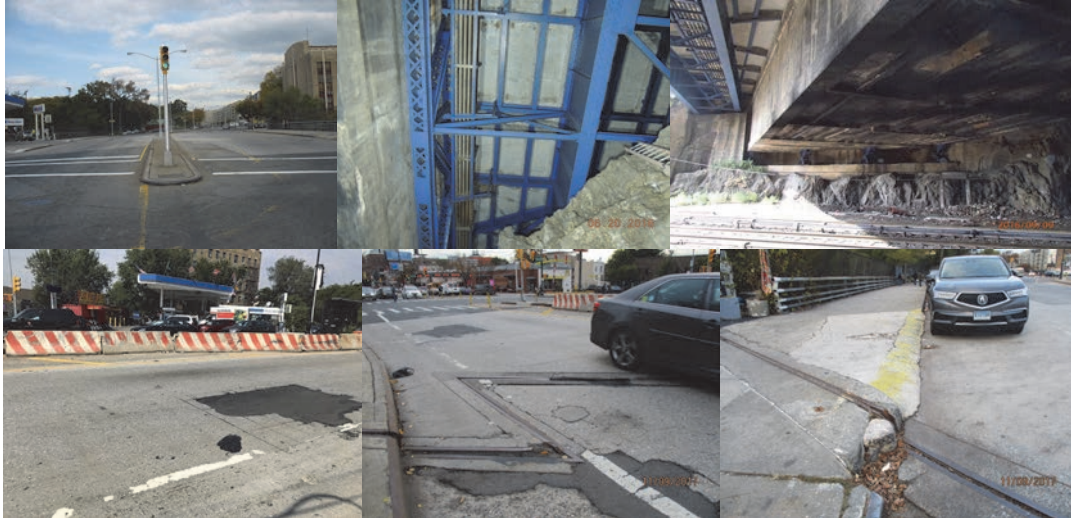
Top of Bridge. June 2016: Roadway Deck Underside of Span 1, Transverse Cracks With Efflorescence and Hollow Sections. (Credit: NYSDOT) September 2016: Southeast Portion of the South Abutment - Underside Framing. September 2017: Jersey Barriers on Beginning Approach. November 2017: Beginning Abutment Joint Northbound Roadway (Right Side) - Depressed Sealant, Missing Armor and Concrete Header. Left Curb Adjacent to Beginning Joint - Missing Steel Face. (November Credit: NYSDOT)

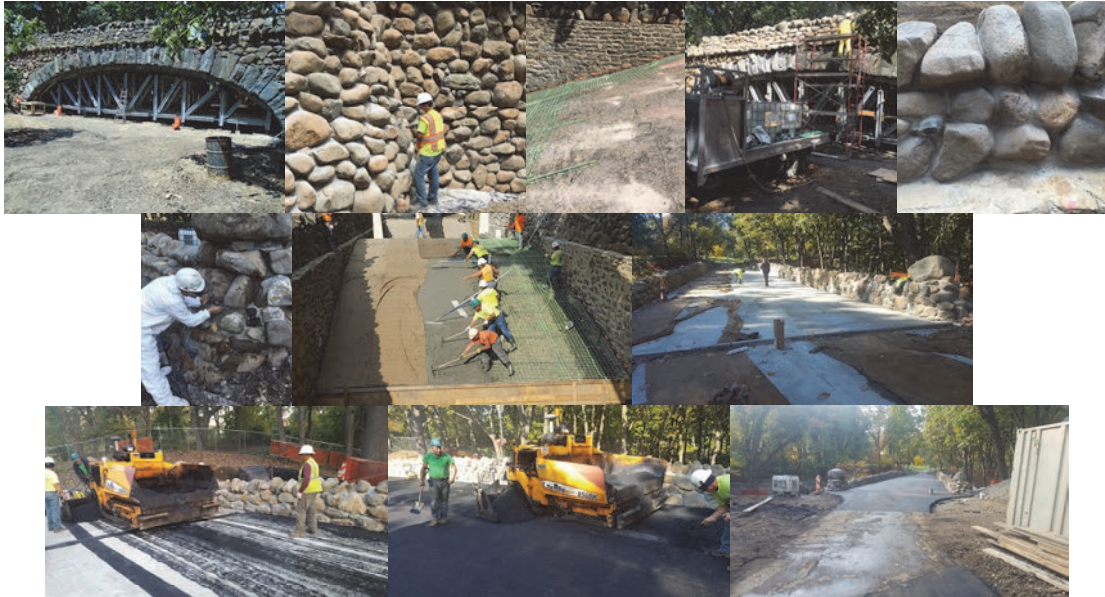
August 2016: Temporary Support Structure Under the Arch. Chipping Out Existing Mortar. Top of Arch - Layout of Epoxy-Coated Mesh Reinforcement and Dowels. South Fascia – Cleaning the Existing Stone. South Fascia Parapet - Finished area – Cleaning, Chipping, and Repointing. September 2016: Wet Burlap Placed Over Previously Finished Zones. September 2016: Center of the Bridge - After Backfilling, the Concrete Base for the Roadway was Placed. Following the Curing of the Concrete Base, Asphalt was Placed.

In 2016, the entirety of the stone masonry walls were cleared of graffiti, thoroughly cleaned, repaired, and repointed. The interior of the bridge was completely excavated to reveal the top of the arch, which was found to be in good condition. A reinforced concrete saddle was placed over the arch to bolster its strength, and a waterproofing membrane was installed over the arch and on the interior walls. The bridge was backfilled and a high performance paving material was placed for the roadway. The underside of the brick arch had all graffiti and paint removed. Final cleaning of the arch was ongoing at the end of 2016, as was the removal of old mortar.

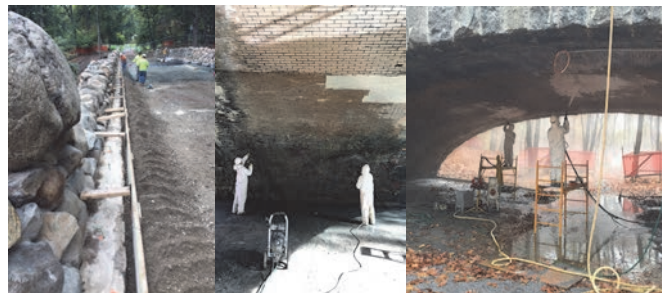
October 2016: Concrete Curb Layout. November 2016: Cleaning the Bricks Under the Bridge Arch. December 2016: Cleaning the Historic Stone Masonry and Removing Graffiti.

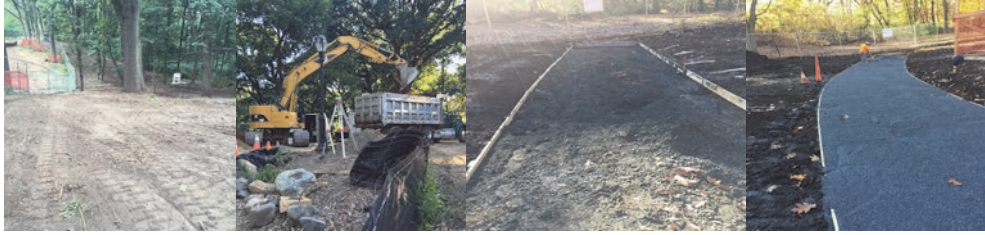
August 2016: North and South of Bridge – Clearing and Grubbing. November 2016 Placing Granular Fill Material (Crushed Stone) on the Bridge Pathway Under the Bridge Arch.

Beyond the bridge itself, much landscaping work was completed in 2016. The area directly surrounding the bridge was cleared and grubbed and the trees were pruned. A large tree near the bridge was identified as unsafe and in danger of falling and was cut down. Five lamp posts were removed (to be replaced later), and another post on the bridge was completely refurbished in place. The gravel path was installed everywhere except directly under the bridge, where work is ongoing. Subsequently, all of the landscape was restored with trees and shrubs.

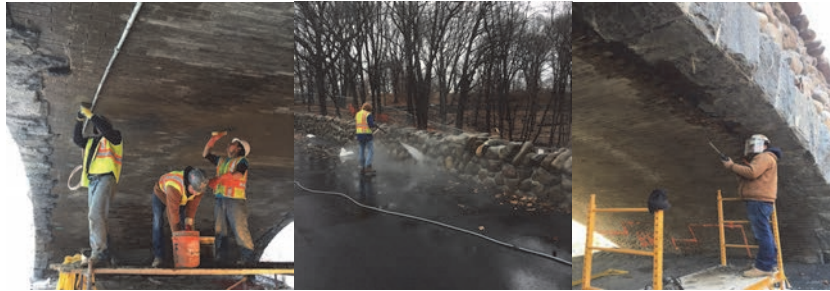
January 2017: Tuck Pointing the Bricks. Power Washing the North Parapet Wall.
February 2017: Underdeck Brick Removal - the Extent of the Deteriorated Bricks was Not Known Until Multiple Layers of Existing Paint Were Removed From the Underside Surface of the Bridge Arch.

In 2017, the deteriorated brick on the underside of the arch was successfully removed and replaced. New light poles were installed on the bridge as well. The project was substantially completed on April 24, 2017.

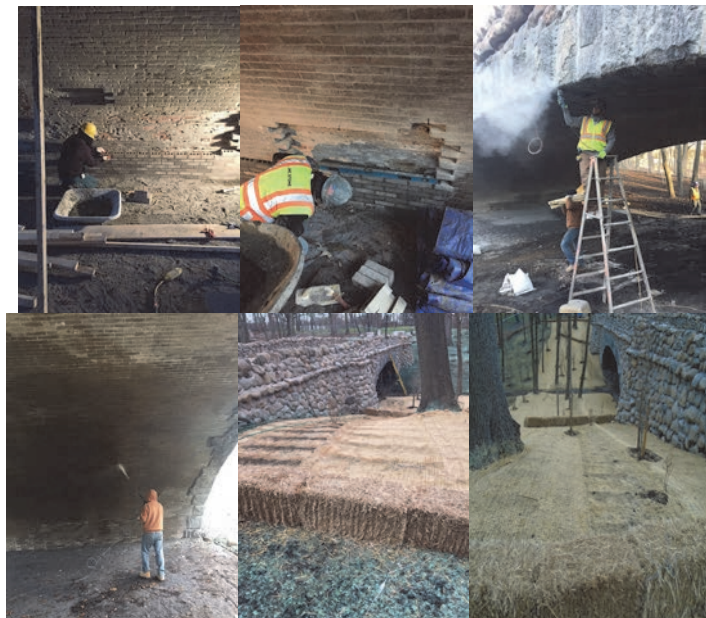
April 2017: Installing the New Underside Bricks - Matching Bricks in Color and Dimensions. Power Washing Under the Arch. Erosion Control Material Placed Over the Bridge Slope.

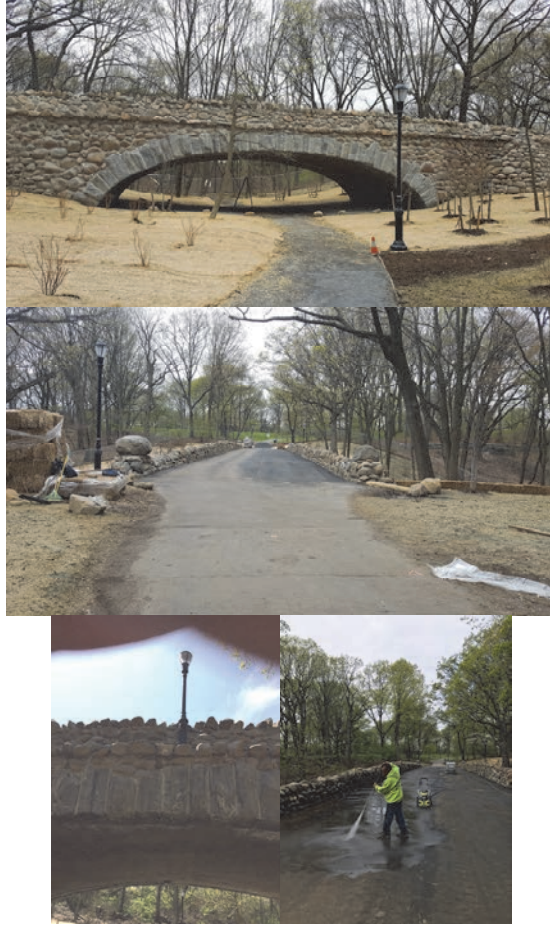
April 2017 - at Substantial Completion. New Light Pole on Bridge. May 2017 – Power Washing the Road Surface.

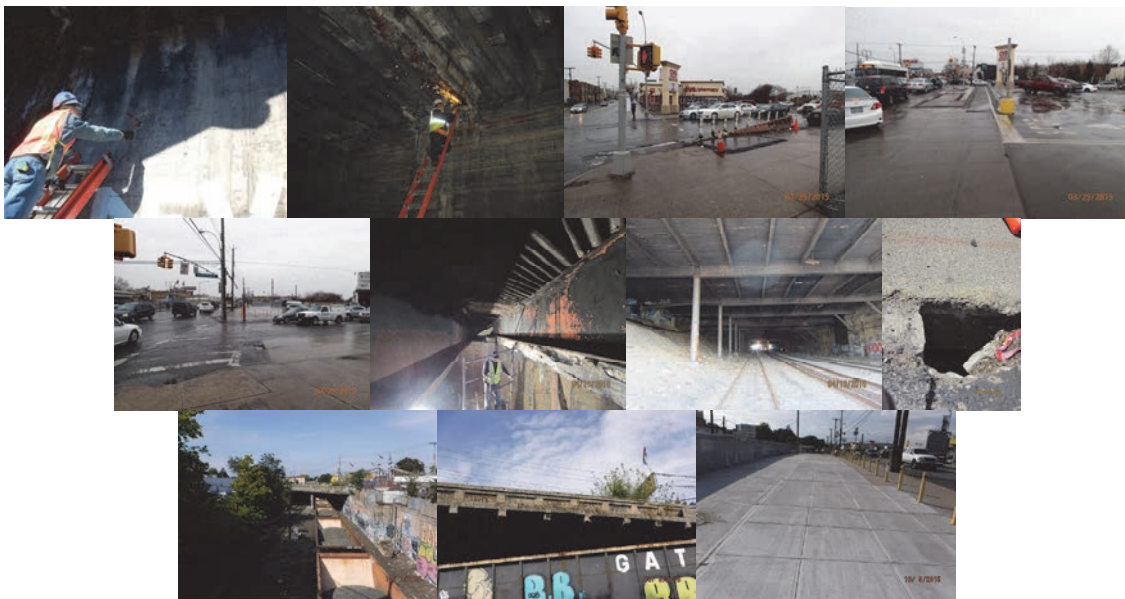
2010 Inspection - Hands-On Inspection of a Pier. Obtaining a Steel Coupon Sample From a Stringer. March 2015: Looking West, South, and East Across Bridge Deck. April 2015. October 2015: Elevation Right. Span 2 Right Parapet - The Outer Face Exhibits Spalls With Exposed Rebars. Spans 1 and 2 New Right Side Sidewalk. (Credit: NYSDOT)

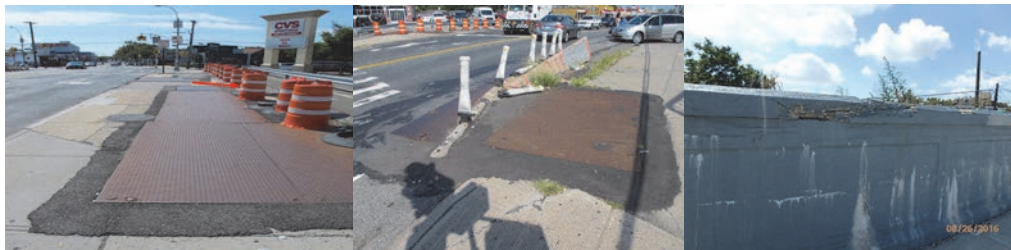
August 2016: Span 2 Left Sidewalk Looking South - Location of the Through Hole. Span 1 Right Sidewalk Looking North. Spalled and Cracked Areas on Top of Span 2 Parapet. (Parapet Credit: NYSDOT)

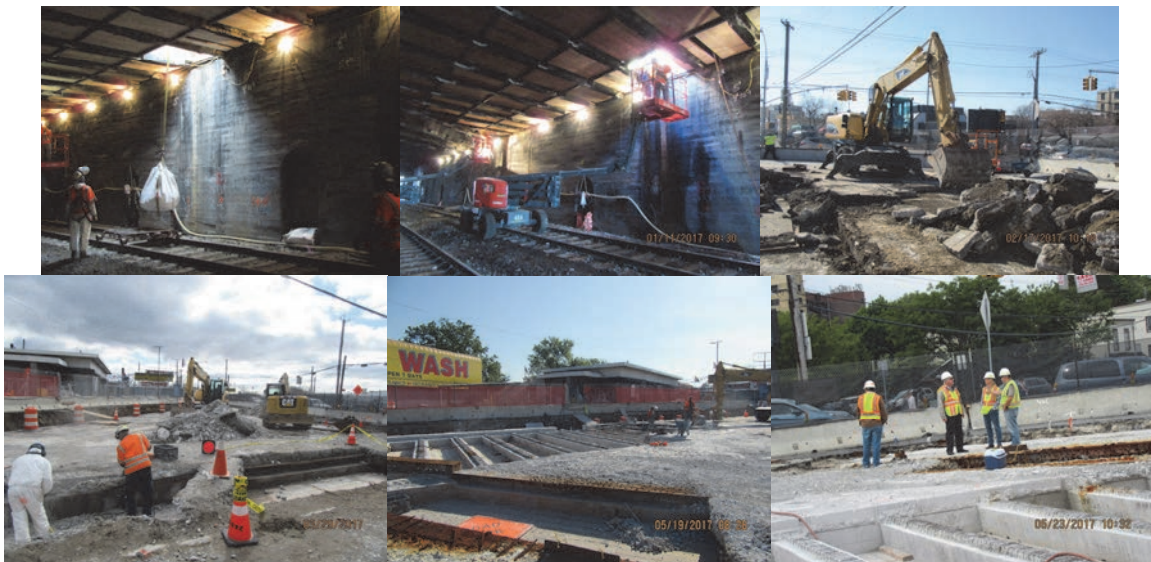
January 2017: Shielding Installation Below the Bridge Deck and Above the Railroad Tracks. Debris Removal Through Protective Shielding. February 2017: Stage 1 Demolition of Pavement and Concrete Overlays. March and May 2017: Stage 1 Demolition of Concrete Bridge Deck and Beam Encasements. May 2017: Site Visit – Assistant Civil Engineer Daniel Smith, Deputy Commissioner Robert Collyer, Community Liaison Nancy Catapano, and Resident Engineer Joe Catapano.

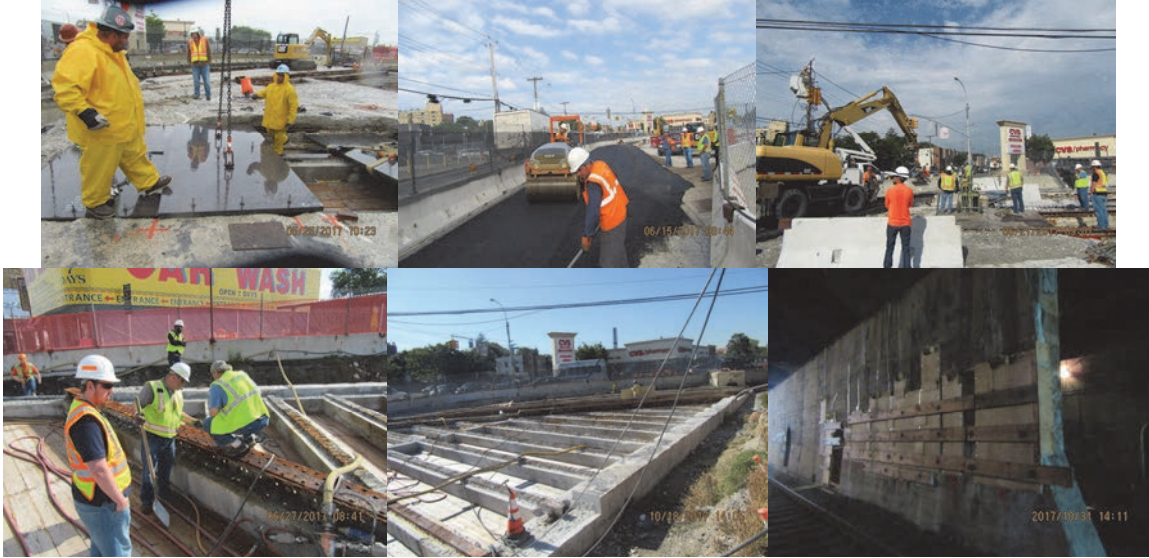
May 2017: Installing 2" Thick Steel Plates to Prepare for a Temporary Road Surface, Under Observation by Assistant Civil Engineer Daniel Smith. June 2017: Temporary Road Surface Paving to Open all Lanes on Metropolitan Avenue for Increased Bus Traffic During the M Subway Shutdown - Construction Superintendent Domingo Rodriguez, Assistant Civil Engineer Daniel Smith, and Resident Engineer Joe Catapano Observing. Pulling Back the Concrete Barriers Into a Modified Stage 1 Work Zone and Steel Inspection Survey - Assistant Civil Engineer Daniel Smith, Contractor Jeff Mazur, and Resident Engineer Joe Catapano. October 2017: Concrete Deck and Beam Encasement Demolition Progress for Stage 1. Spalled and Cracked Concrete Repairs on the Center Pier Below the Bridge at LIRR Track Level.

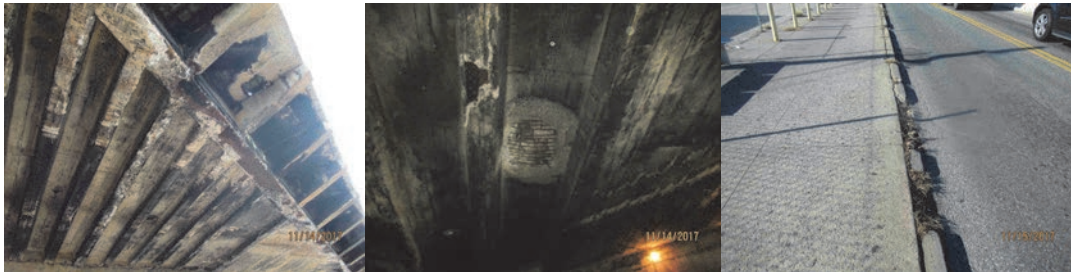
Span 2, Underside of Deck- Spalled Concrete Encasement and Deck. Exposed Rebar. Span 2, Top of Deck - Spalled and Missing Sections of Curb With Vegetation Growth. (Credit: NYSDOT)

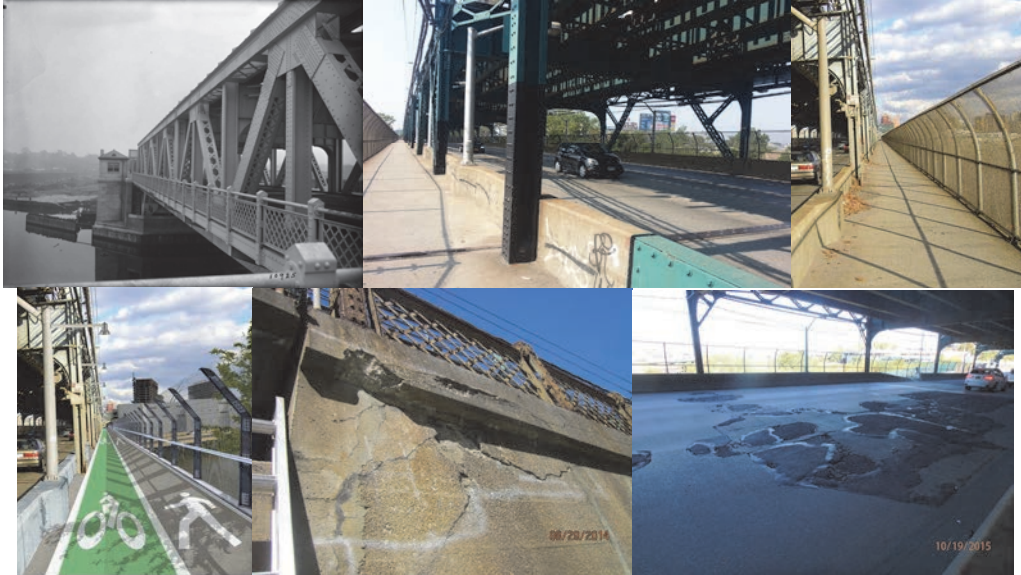
Roosevelt Avenue Bridge – In 1927. (Credit: NYC Records). Looking East. Existing and Proposed Bicycle/Pedestrian Path. 2014: Right Wingwall at the End Abutment. The Top Exhibits an area of Diagonal Cracks With Efflorescence and Spalls. The Deteriorated Concrete Areas are in Safe and Stable Condition. 2015: Spans 26 and 27 – Examples of Uneven Asphalt Patches and Broken Concrete Areas. (Credit: NYSDOT)

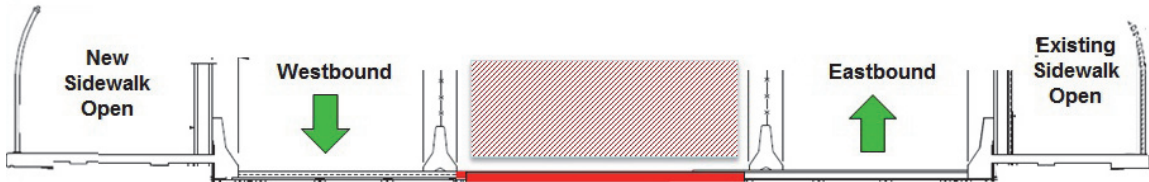
Stage 2 - Center Roadway - 12 Months. The Center Roadway will be Closed. All Traffic Shifts to One Eastbound and One Westbound Lane in Each Direction.

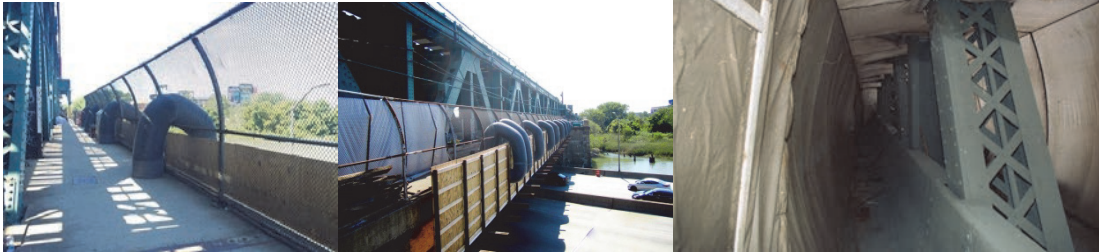
September 2016: - The Contractor Employs a Vacuum System to Capture Lead Particles During the Lead-Abatement Process. This is Done Using Negative Air Pressure to Prevent Emissions From the Abrasive Blasting Process Used to Remove Lead Paint. All Blasting is Done Within Negative Air Containment Units to Protect the Public From Emissions. View Inside the Containment – Bascule Span, Looking East.

Abrasive blasting and protective coating operations began in early 2016, and were substantially completed in late 2016. The first stage of the work consisted of lead paint removal by abrasive blasting. Since the existing paint contained lead, the work was performed within a sealed Class 1A Containment under negative pressure. Abrasive blasting involves use of compressed air to propel abrasive particles against the surface to be cleaned. Negative pressure maintained within the containment during blasting operations prevented paint dust from being released into the environment. The air in the area surrounding the containment enclosure was monitored and tested during the work. All lead paint waste was packaged and shipped from the site to a treatment and disposal facility, meeting all applicable local, state and federal guidelines, regulations and laws.

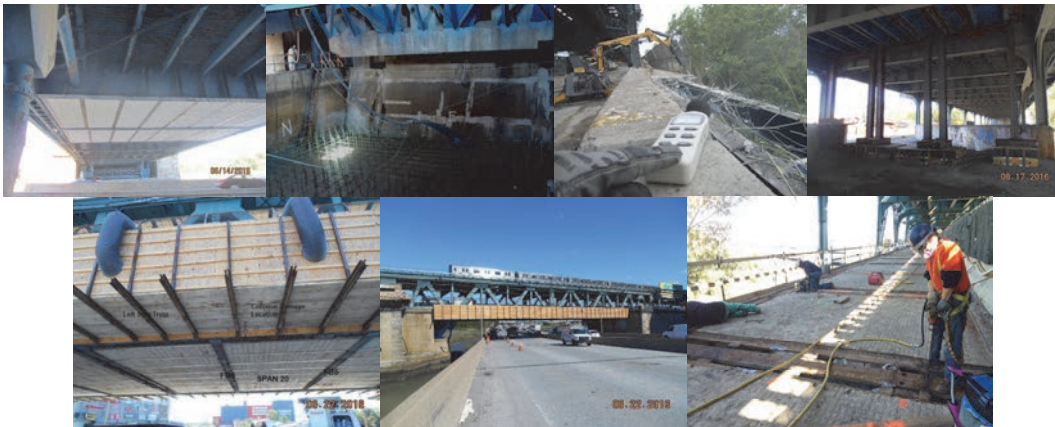
June 2016: Contractor Installs Shield Under the Bascule Span to Prevent any Debris From Falling onto the Van Wyck Expressway or Into the Flushing Creek During the Demolition Process. The Contractor Poured Lightweight Concrete on the Bridge's Counterweight Pits. These Pits, Located on the East and West Sides of the Flushing River, Were Necessary When the Bridge was a Drawbridge. Now That the Bridge is Locked in Place, the Agency Decided to Fill Them with Lightweight Concrete. This Will Prevent Them From Accumulating Water, Reducing a Potential Health Hazard. July 2016: Contractor Using a Robot to Break Through the Existing Sidewalk on the North Side of the Bridge. Using This Technology Reduces the Risk of Injury to Personnel During Demolition and Gives the Operator a Better View of the Actual Demolition. August 2016: Span 6 - Temporary Steel Shoring in Front of Pier 6. Span 20 Left Side - Encased Underside of the Span. Span 20 Elevation Right. (Spans 6 and 20 Credit: NYSDOT) October 2016: West Viaduct – Stage 1 Removing the Original Bridge Deck.

Stage 1 construction began in early 2016. It is expected to be complete by June of 2018. Major activities for Stage 1 include demolition and replacement of the two westbound traffic lanes, traffic barrier and North sidewalk. Included in this work will be substructure concrete repairs, bridge bearing replacement, and steel repairs. Other work including filling in the original bascule counterweight pits with lightweight concrete and demolition of the north operator house were completed in 2016.

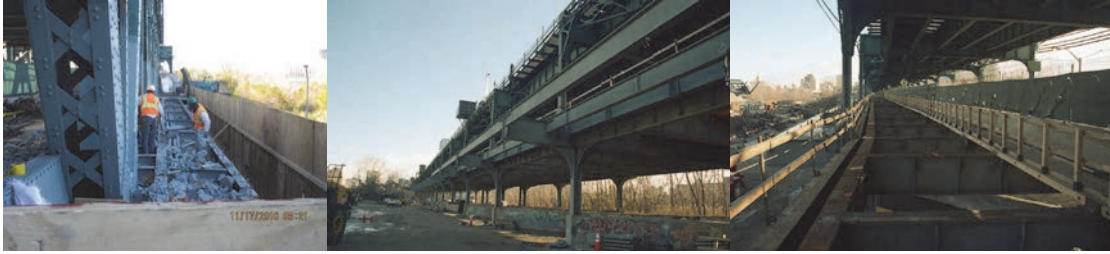
October 2016: Installing the New North Sidewalk – West Viaduct, Looking East. November 2016: Contractor Demolishes the Sidewalk over Van Wyck Expressway. East Viaduct – Stage 1 Installing the North Sidewalk Steel. December 2016: Installed North Sidewalk Stringers. West Viaduct – Roadway Deck Removed.

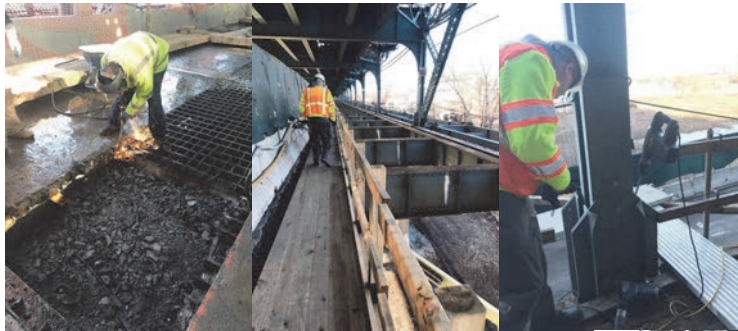
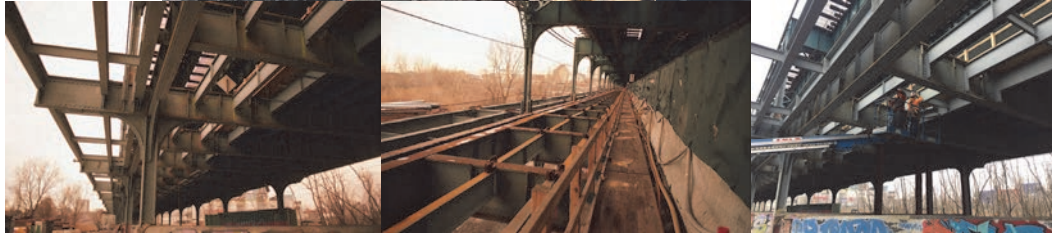
January 2017: Disconnecting the Existing Steel Grid Deck in the Bascule Span, Using a Torch, so That it can be Removed in Panel Sections. The Existing Grid Deck was Removed Entirely on the West Viaduct; the Existing Floor Beams Were Being Prepared for the Installation of New Stringers and Grid Deck Panels. On the Opposite Side of the NYC Transit Columns, New Sidewalk Steel was Being Installed. West Viaduct – Installation of Roadway Stringers for Stage 1. Inspecting the NYCT Columns and Removing Concrete Fill. February 2017: West Viaduct – Stage 1- Installing New Steel Under the Roadway Deck.

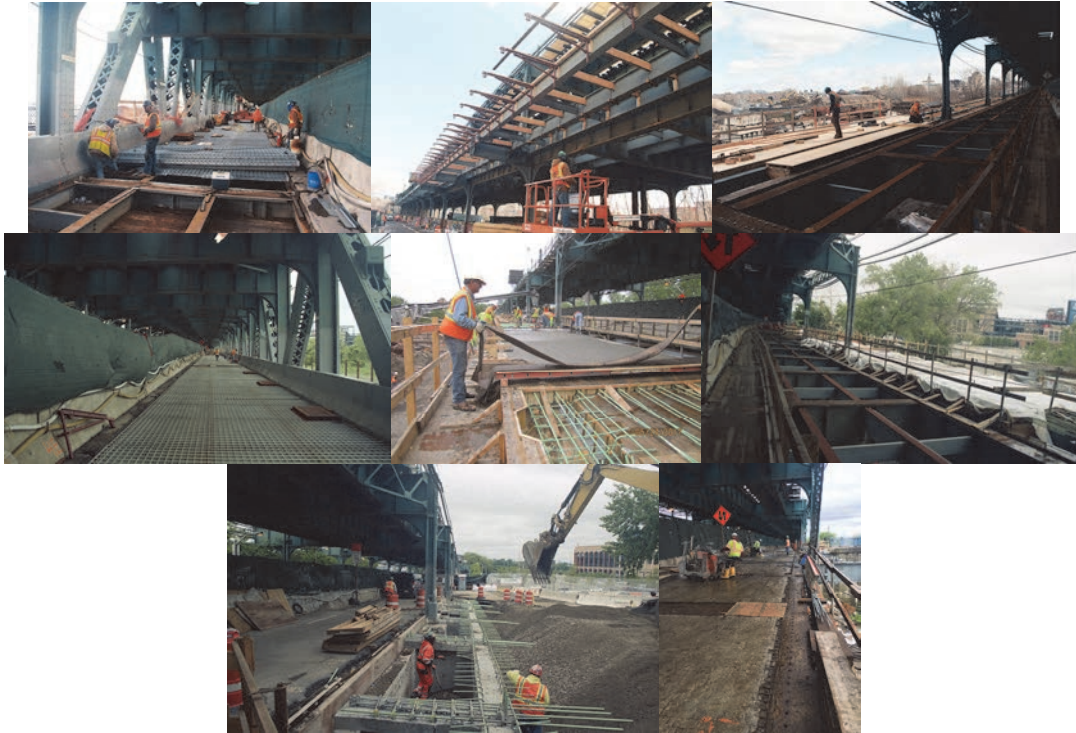
March 2017: Bascule Span - Installing Grid Deck for the Roadway. April 2017: West Viaduct – Formwork for the North Sidewalk. May 2017: Bascule Span Deck. West Viaduct – Stage 1 Sidewalk Test Panel Concrete Placement. West Approach – Stage 1 Sidewalk Preparation. East Viaduct – Stage 1 – Removing the Original Roadway Deck.

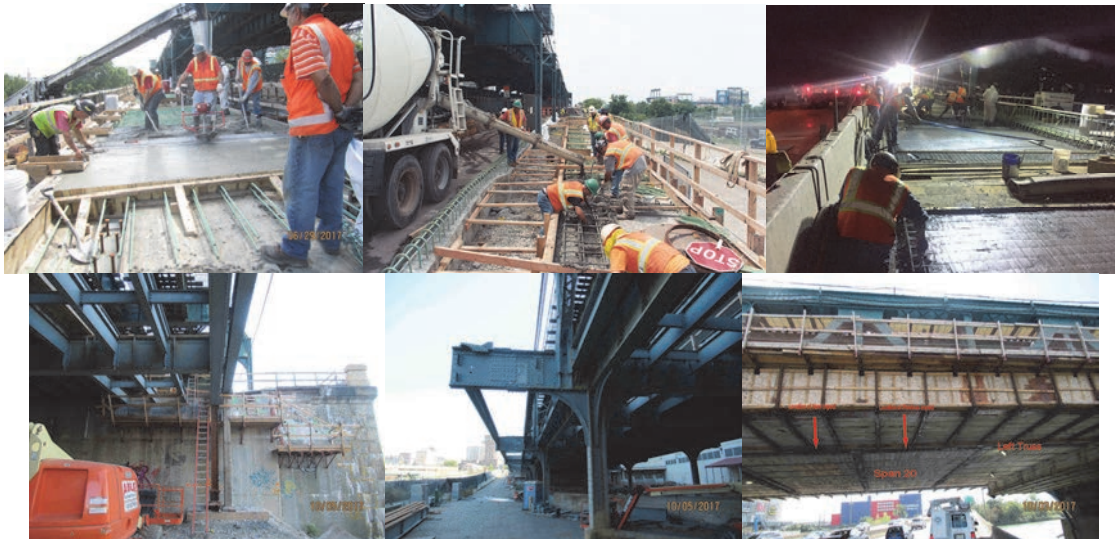
June 2017: West Viaduct – Stage 1 Placing the Sidewalk. August 2017: East Approach – Stage 1 – Placing Sidewalk Concrete. October 2017: West Viaduct – Stage 1 Filling the New Roadway Grid Deck With Concrete. Span 22. Span 20, Left Side, Impact Damage Location. (Spans 20 and 22 Credit: NYSDOT)

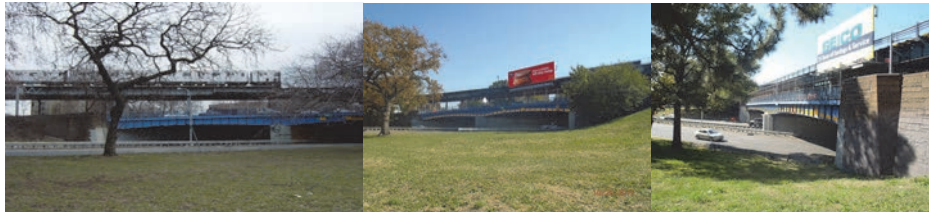
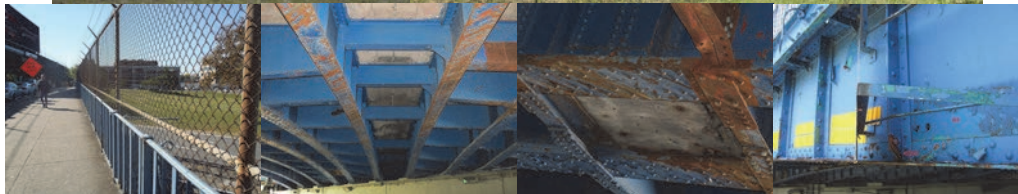
The bridge spans over the Hutchinson River Parkway and it supports the NYCT elevated subway structure of the Pelham Bay Line. Six of the transit columns are supported by the bridge girders. The bridge is located between Waters Place and Middletown Avenue. It has four travel lanes with parking lanes and sidewalks on both sides. This two span continuous multi-stringer bridge is supported by reinforced piers and abutments. It was built in 1940 by the Triborough Bridge and Tunnel Authority in conjunction with the construction of the Bronx-Whitestone Bridge approach. No major modifications to the bridge are recorded except for minor repairs at the south approach sidewalk and temporary flag repairs to bridge girders damaged by vehicle impacts in the southbound and northbound roadway. The underdeck at both spans is currently covered by approximately 154 square feet of timber planking. In addition, the underdeck at span 1 is covered with approximately 18 square feet of steel wire mesh netting.

Westchester Avenue Bridge in 2015. June 2016: Underdeck of Span #1 - Deteriorated Deck is Shielded With Timber Planks and Wire Mesh. Bent Stiffener at Span #1.

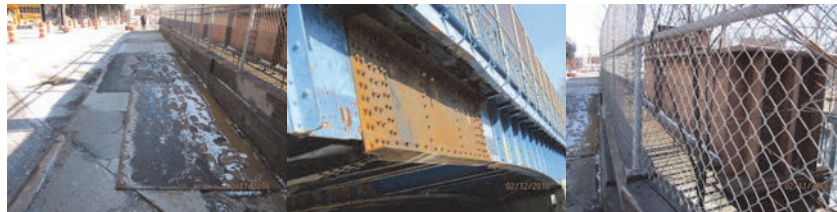
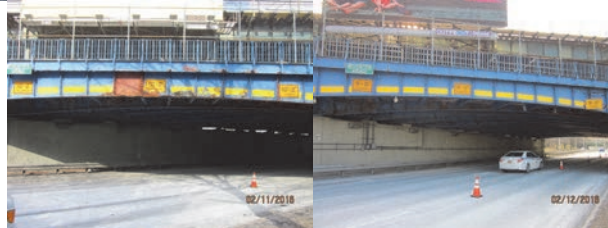
2016: Span 1 Right Sidewalk Near Beginning Abutment – Steel Plates. Girder Reinforced With New Steel Plate and Angles. Strongback Girder at Right Side of Span 1. Right and Left Fascia. (Credit: NYSDOT)

fascia girder, a section of the respective girder was removed by Division personnel to improve the clearance at that location. A strongback girder was placed on the south sidewalk above the damaged girder to provide additional support.

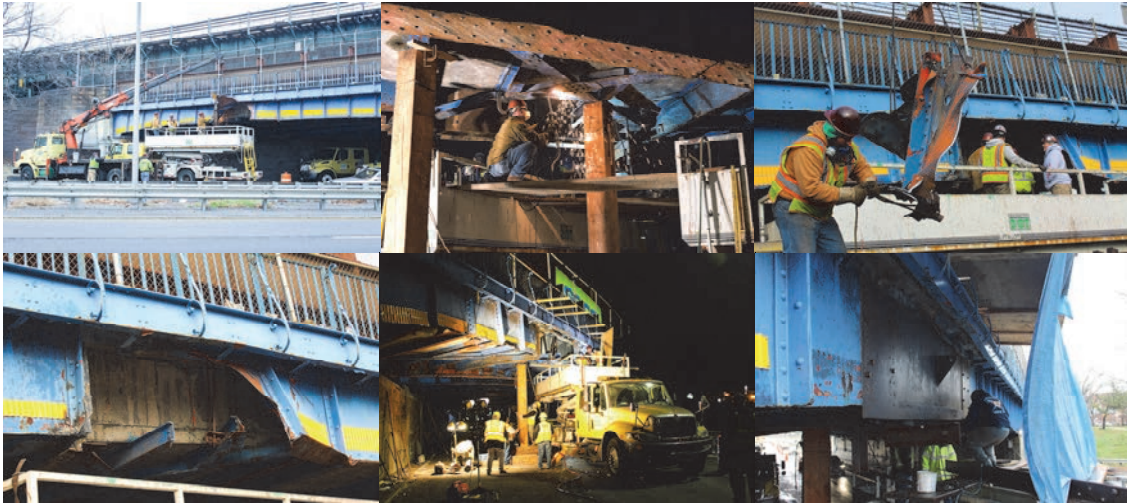
On January 9, 2016, a Truck Travelling South on the Parkway Struck the Bridge, Causing Damage to a Fascia Girder and its Preceding Girders, Stringers, and the Hanging Bars of a Strongback. Crews Responded, Cut a Portion of the Sheared Girder and Spliced it With a New Section and Installed Shoring.

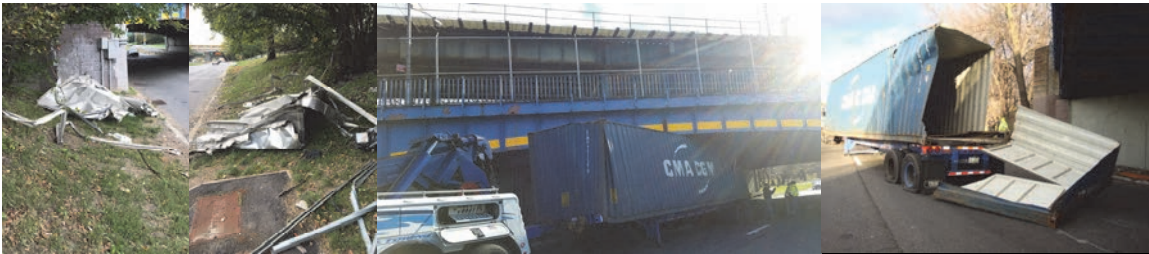
The Westchester Avenue Bridge's vertical clearance over the Hutchinson River Parkway is sub-standard. The existing posted vertical clearance of 10'-2" is far less than the 12'-6" minimum vertical clearance required per AASHTO standards for parkways with passenger cars only. Due to the number of truck and bus vehicles that mistakenly enter the Hutchinson River Parkway, where commercial vehicles are not allowed, the fascia steel girders of the bridge have been severely impacted and damaged numerous times. Between 2009 and October 2014, 32 freight vehicles struck this bridge at the southern approach. After a bridge strike, up to a four hour delay may occur before traffic can resume a normal pattern. Due to frequent impacts of the southwest

October 2016: Truck Debris Remaining at the South Side of the Bridge Along the Southbound Hutchinson River Parkway After a Bridge Strike. December 2016: Truck Tightly Wedged Under the Bridge.

The rehabilitation of the bridge will include the demolition and replacement of the bridge seat and back wall, existing bridge deck, and existing bridge parapets; the replacement of all girders and bearings; the reconstruction of the approach roadway, curb and sidewalk, and respective appurtenances; the relocation of two water mains and an addition of third water main; replacement of roadway lighting on Westchester Ave. and underdeck lighting on Hutchinson River Parkway; relocation of various utilities that are underground and between girders; and the rehabilitation of traffic signals at Waters Place and Ericson Place. The limits of the project will be from Waters Place just west of the bridge to Ericson Place, just east of the bridge.

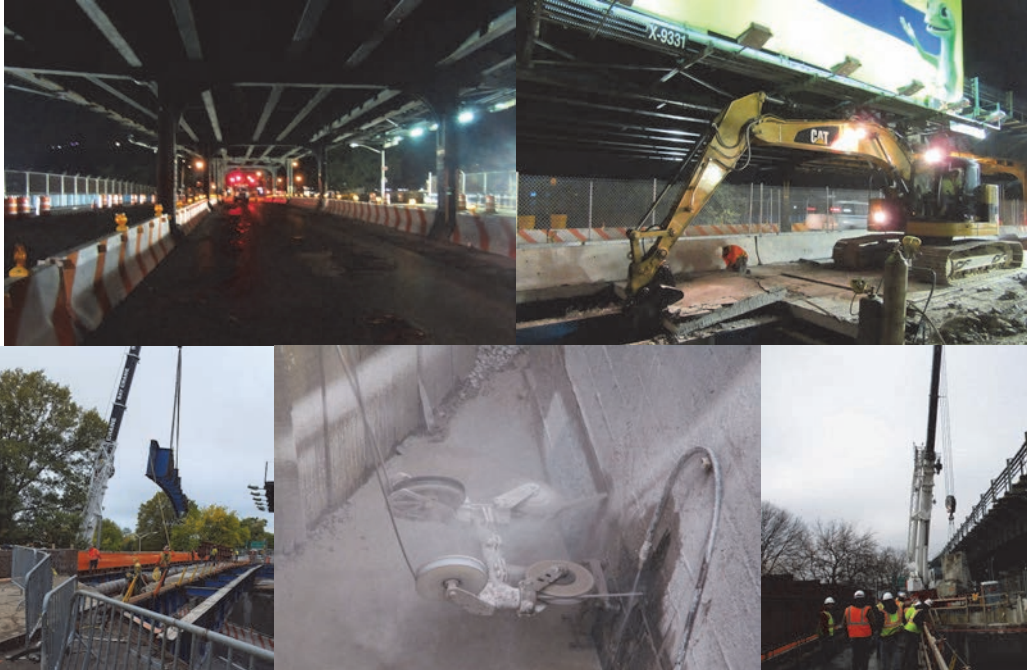
Night Work in August 2017. Stage 1 Deck Demolition in September. Stage 1 Steel Demolition Girder Removal in November 2017. December 2017 - Stage 1C Wire Saw Cutting at The West Abutment. Lifting Out the Cut Pieces.

The contractor set the staging area on-site, established the engineer's field office, and created the Stage-1 work zone on the south side of the bridge by making a traffic shift on Westchester Avenue. The Stage 1 B bridge steel removal operation was completed on the southbound Hutchinson River Parkway on November 5, and on the northbound side on November 12, 2017.

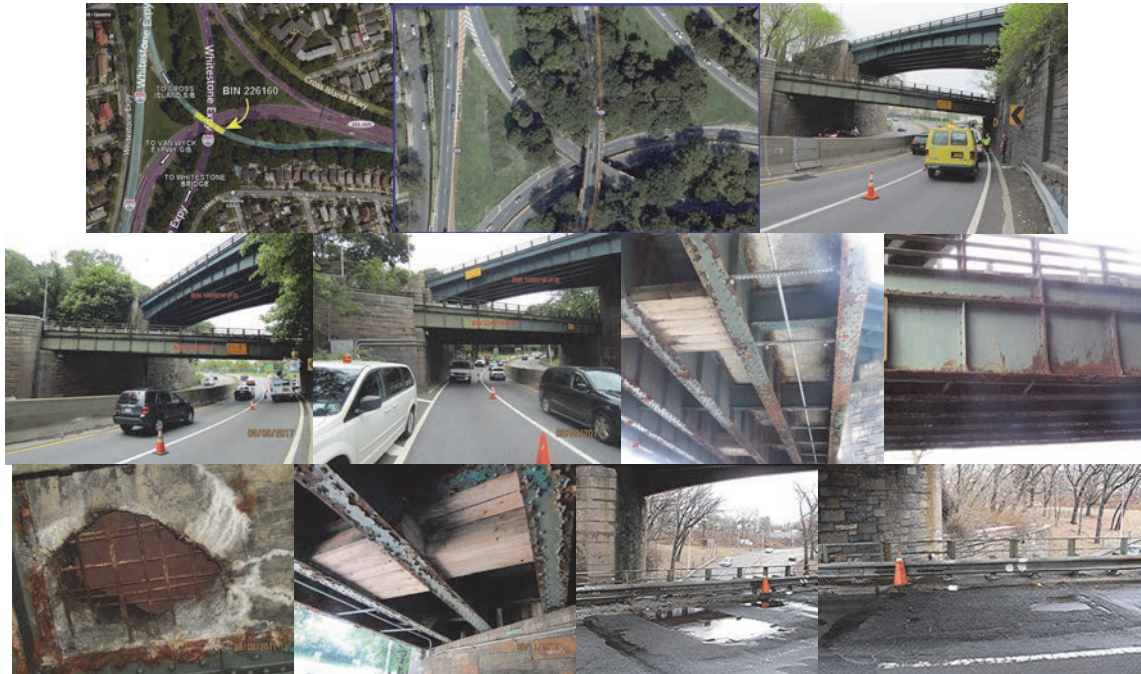
There are no records of any major rehabilitation work performed on this bridge since its construction. The structural deck is in poor condition with visible mapcracking, scaling, spalling,

and heavy efflorescence. Furthermore, the steel beams have deterioration at both the top and bottom flanges and there is deterioration of the expansion joints at the abutments. This reconstruction project will replace the structurally deficient roadway deck to provide a useful life of 75 years while also improving non-standard geometric features of the bridge.

Location Map. (Credit: NYSDOT). Aerial View. Bridge (Lower Structure) in April 2017. Left and Right Elevations in August 2017. (Elevation Credit: NYSDOT) Underside of Span #1 in April 2017 – Bottom Flanges of Girders are Rusted due to Deteriorated Paint. Span 1 Girder With Impact Damage Above the Right Lane of the Cross Island Parkway Westbound. August 2017: Underside of Deck at Bay 3 Near the Beginning Abutment; the Deck Exhibits a Punch-Through Area That is Covered on Top With Steel Plates. Underside of Deck at Bays 2 and 3 Near the End Abutment; General View of Timber Shielding. (August Credit: NYSDOT) March 2014: Steel Plates on Wearing Surface.

The reconstruction project will involve removing the entire existing steel girders, bridge slab, bearings, and railings, and reconstructing the existing abutments with new bridge seats, pedestal and backwall. The reconstruction of the substructure will accommodate the new superstructure, which includes a new reinforced concrete deck, steel girders, and parapets. Additionally, new asphalt pavement will be installed on approaches, new expansion joints will be installed at both abutments, and new rolled shape steel beams on elastomeric bearings will be installed.

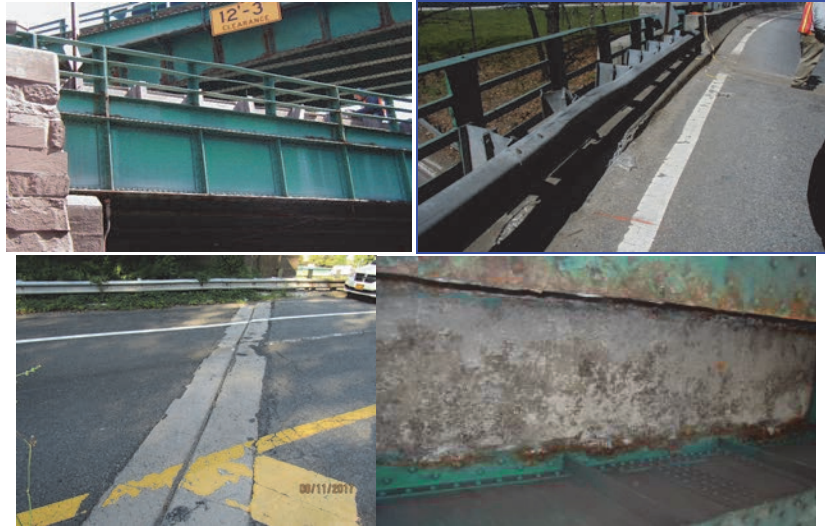
South and North Fascia - Along the Fascias are Built-Up Riveted Steel Girders. The Steel Railing Posts are Welded at the Base to the Top Flange of the Fascia Steel Girders. Deterioration of Joint at Abutment. Underside of Deck with Scaling and Efflorescence.

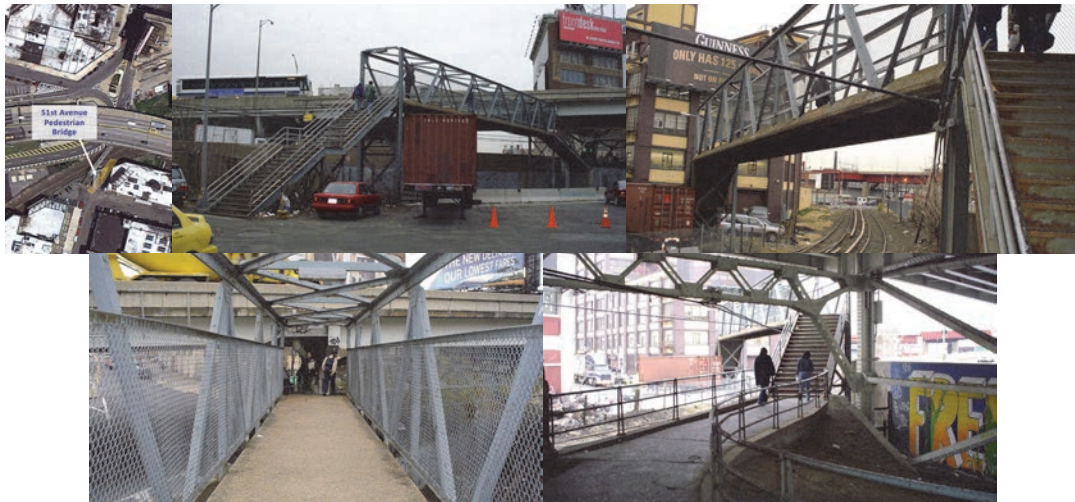
Aerial View. South Stairs and Bridge – Looking North. General View – Looking West. General View. North Stairs and Ramp – Looking South.

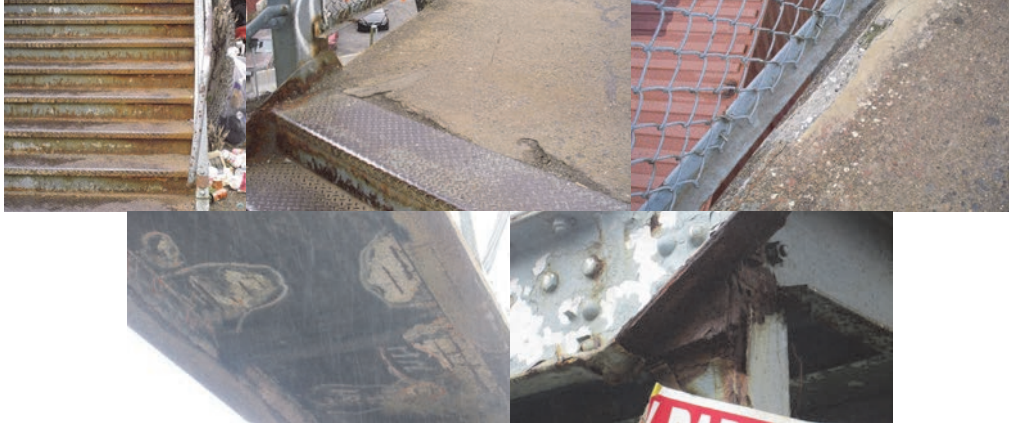
The structural steel and concrete are severely deteriorated, and the structure is not (ADA) compliant.

Existing Conditions: Rusted Steps and Damaged Railing. Deteriorated Deck. Spalled Concrete Deck on Main Span. Spalled Concrete – Underside of Deck. Deteriorated Steel.

The new bridge will comply with current standards and provide barrier free access. The reconstruction of the bridge will be managed by the New York City Department of Design and Construction in partnership with DOT. Construction is expected to begin in fiscal year 2019.

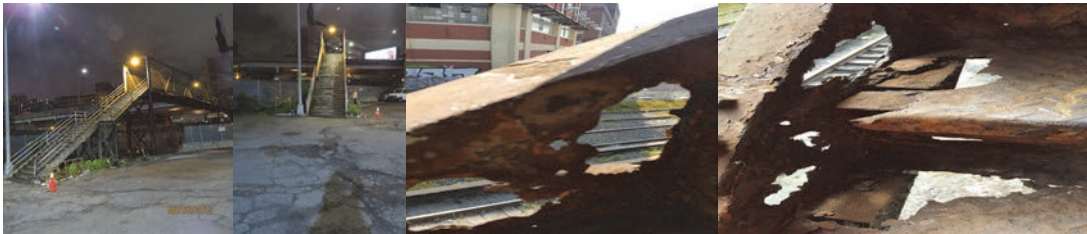
June 2017: Looking North at Spans 3-5, on Left Side - Staircase Stringers and Railing Exhibit Signs of Deteriorating Paint Throughout. End Approach, Looking Northeast – The Approach Wearing Surface Exhibits Spalls and Map Cracks Throughout. September 2017: Close-up View of Holes in Left Side Stringer, Steps and Risers.

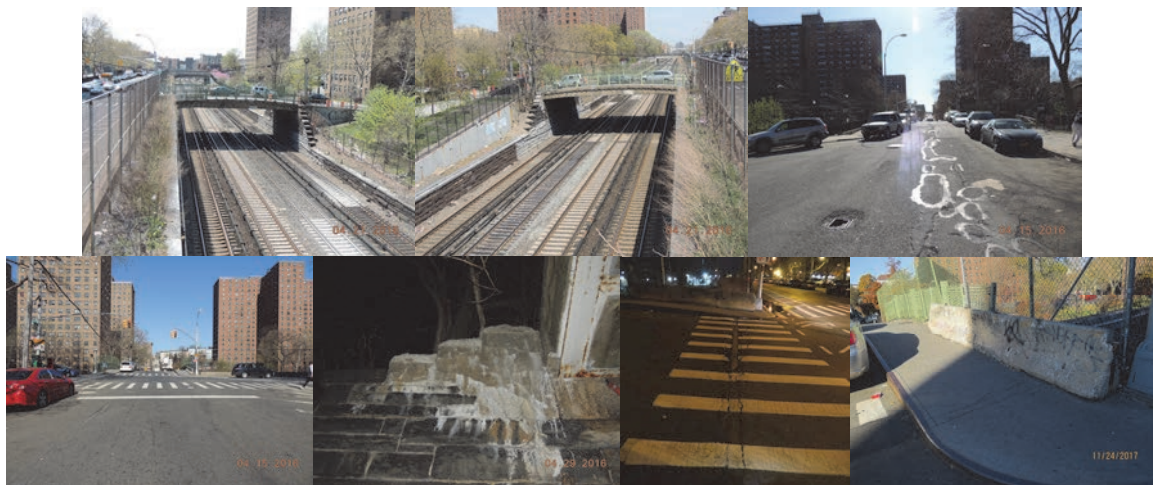
East 169th Street Bridge: April 2016 - Left and Right Elevations. Beginning and End Approaches. Moderate Map Cracking With Efflorescence in the Reinforced Concrete at the Top of the Beginning Right Wingwall. (Credit: NYSDOT) February 2017: End Abutment, Joint with Deck. Full Length Cracks With Deteriorated Wearing Surface. November 2017: Left Sidewalk Near End Abutment - Temporary Jersey Barrier in Place.

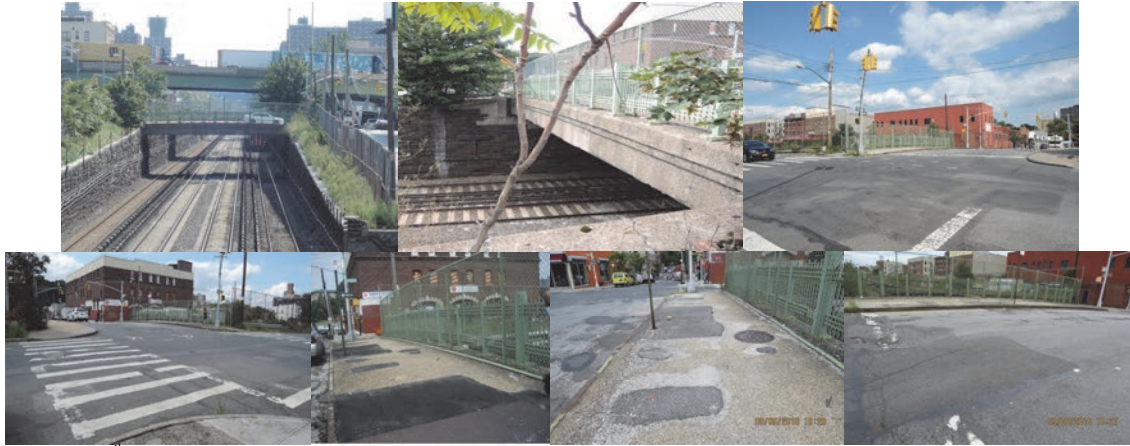
The East 175th Street Bridge over Metro North was originally built in 1889 and it underwent reconstruction in 1938. The reconstruction work included a new steel superstructure, concrete deck slab and sidewalk in conjunction with repairs to the existing stone masonry substructure and relocation of various utilities. It is a single span multi-girder steel structure with a steel reinforced concrete deck, and it measures 61.68 feet long from abutment to abutment and 60 feet wide from parapet to parapet. The bridge carries two 12' lanes of one-way westbound traffic with 5' shoulders and an 11' sidewalk on each side. The asphalt wearing course on the bridge is in poor condition with many areas of rutting and pattern cracking. There are several potholes along the bridge. The sidewalk on the bridge is also in need of repair with many cracks and uneven asphalt patches. On the approaches, the existing metal beam guiderail is in poor to fair condition with several sections that have been impacted.

East 175th Street Bridge View Looking South and North. Top of Deck Looking East and West. Sidewalk and Road Conditions in 2016.

The upcoming major rehabilitation will include replacing the existing single span steel multi-girder superstructure with a single span pre-stressed concrete box beam bridge in conjunction with replacement of the concrete bridge seat, back walls, top of the wingwalls and approach slabs of the substructure, replacing the utilities including watermain, gas, electric, with two new water mains, removing the abandoned gas line, and 6 new electric conduits, as well as partial depth repairs of the existing stone masonry.

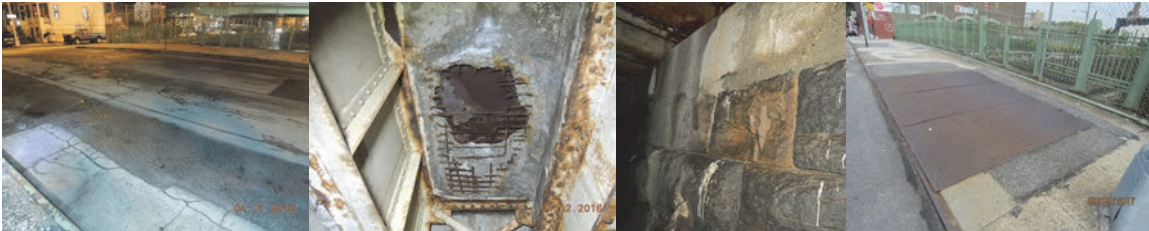
April 2016: Span 1, Wearing Surface at Mid-Span – Uneven Asphalt Patches on Approximately 40% of the Surface Area. Underdeck of Span 1- Through Hole and a Deep Spall With Exposed Rebar Near the End Abutment. There is a Steel Cover Plate Above. (April Credit: NYSDOT) February 2017: Beginning Abutment Masonry Stem Exhibits Missing Mortar Joint. September 2017: The 3 Steel Plates on the Left Sidewalk.

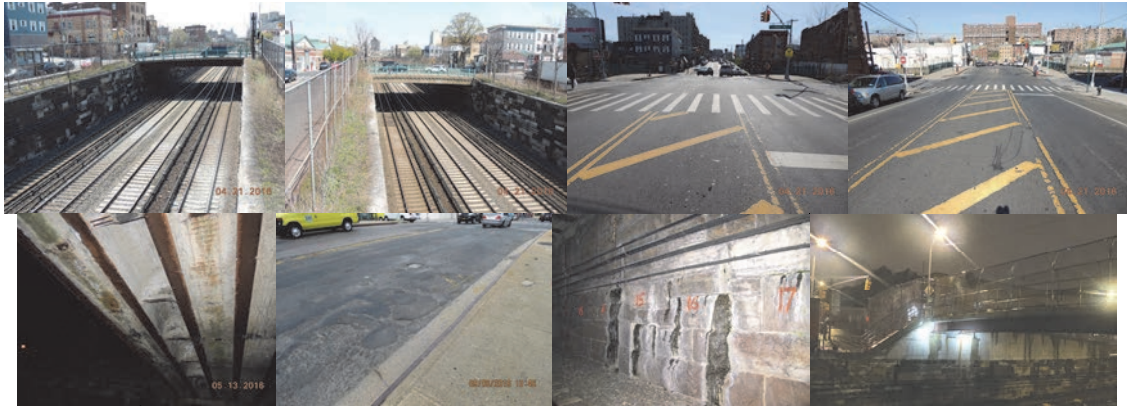
East 180th Street Bridge: April 2016 - Left and Right Elevations. Beginning and End Approaches. May 2016: Diaphragms in Bay 2 Exhibit Underside Spalling With Exposed, Debonded Rebar. (Credit: NYSDOT) September 2016: The Left Side of the Roadway Looking Toward the Beginning Abutment - The Wearing Surface Exhibits an Uneven Surface, Map Cracking and Small Potholes. February 2017: End Abutment Looking Northeast. Water Leakage Stains on the Bottom Portion of the Stem. Night View.

The upcoming major rehabilitation of the East 180th Street Bridge will include removing the entire bridge superstructure including the roadway, sidewalks, concrete encased stringers; removing the top portion of the existing substructure, including the bearings and top portion of the concrete abutments; reconstructing the top portion of the substructure and installing new bearings; repairing cracks, spalls and scaling at the surface of the existing abutments and wing walls that are to remain; installing new superstructure, deck, sidewalks, pedestrian fence and bridge railings; installing utilities as required; constructing a new approach slab and resurfacing the approach roadway; and installing new pavement striping and traffic signs within the project limits.
