2017 NYC DOT

Bridges & Tunnels Annual Condition Report

NEW YORK CITY DEPARTMENT OF TRANSPORTATION DIVISION OF BRIDGES 2017 BRIDGES AND TUNNELS ANNUAL CONDITION REPORT

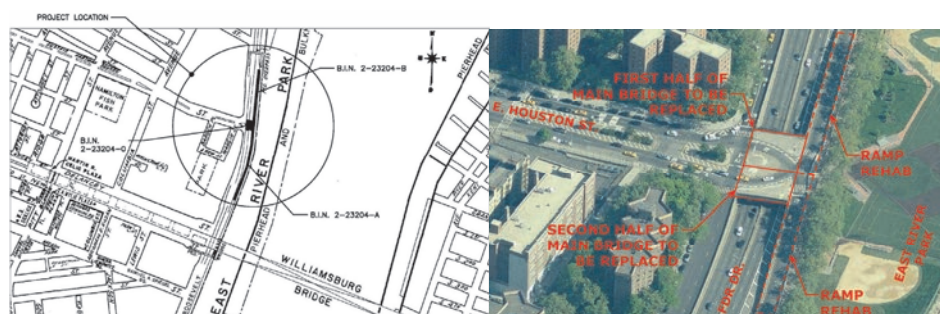
Project Location. Construction Staging.

The reconstruction of the main bridge was performed in two main stages, with half of the bridge being replaced at a time. A Notice to Proceed was issued to the contractor with a start date of January 4, 2016.

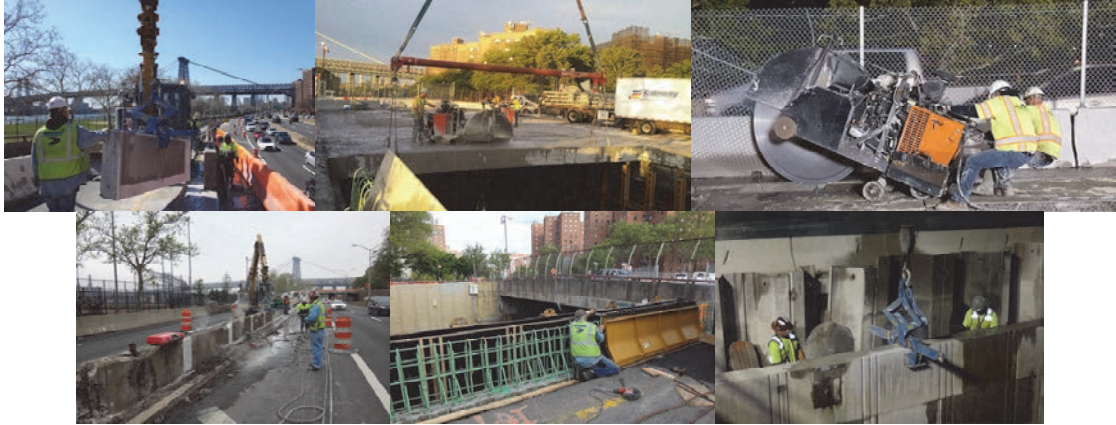
April 2016: Demolition of West Barrier Wall at Exit Ramp. May 2016: Saw Cutting the Existing Deck. Saw Cutting and Demolition of West Barrier Wall at Entrance Ramp. Erecting Forms for West Barrier Wall at Exit Ramp. July 2016: Saw Cutting and Demolition at West Abutment Wall.

The general scope of work for the main bridge structure included the demolition of the entire two-span, reinforced-concrete slab superstructure, and its replacement with new two-span pre-stressed concrete slab units, the demolition and replacement of the existing center pier cap and steel columns, and the reconstruction of the abutment walls for the substructure. The superstructure includes the deck slab, sidewalks, center median, parapets with fencing, lampposts, and signal posts.

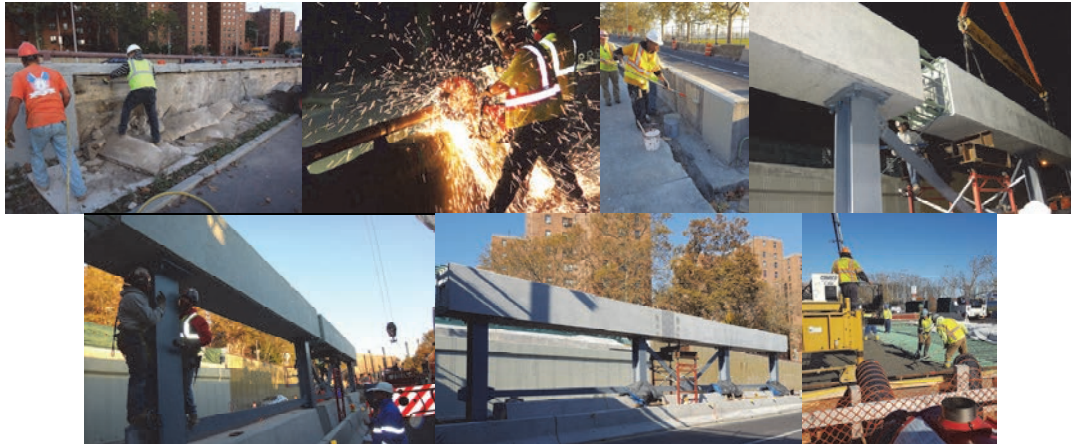
October 2016. November 2016: Stage 2 - Final Bolting and Alignment of Precast Pier Cap Segment. December 2016: Placing and Finishing Concrete for Deck Slab.

In 2016, the northern half of the main bridge was demolished, and pier columns and the pier cap were installed. Pre-cast concrete deck panels and concrete overlay were installed at the end of 2016. Vehicular traffic was switched over to the newly reconstructed northern half of the bridge by the end of 2016. Immediately thereafter, reconstruction of the southern half of the bridge began.

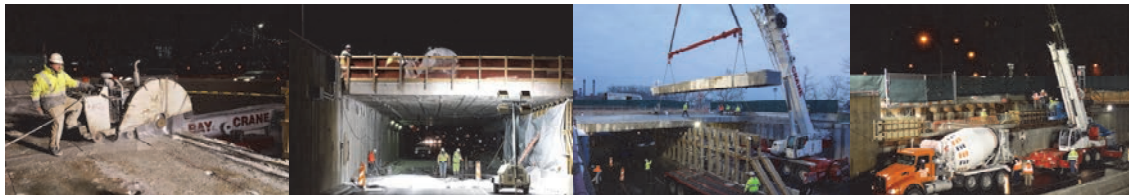
February 2017: Full Depth Saw Cutting of Deck Panels. Stage 3 - Protective Safety Shielding Over Highway. Loading of Deck Slab Panels for Disposal Off-Site. March 2017: Concrete Placement at West Abutment Wall Seat.

In 2017, project activities included the removal and replacement of the southern half of the main bridge, then center pier columns and the cap; the removal and replacement of the ramps overlay and expansion joint system; the repair of the pedestrian ramp; and the installation of the new light and signal poles. The FDR Drive at Houston Street Overpass project was substantially completed on November 15, 2017.

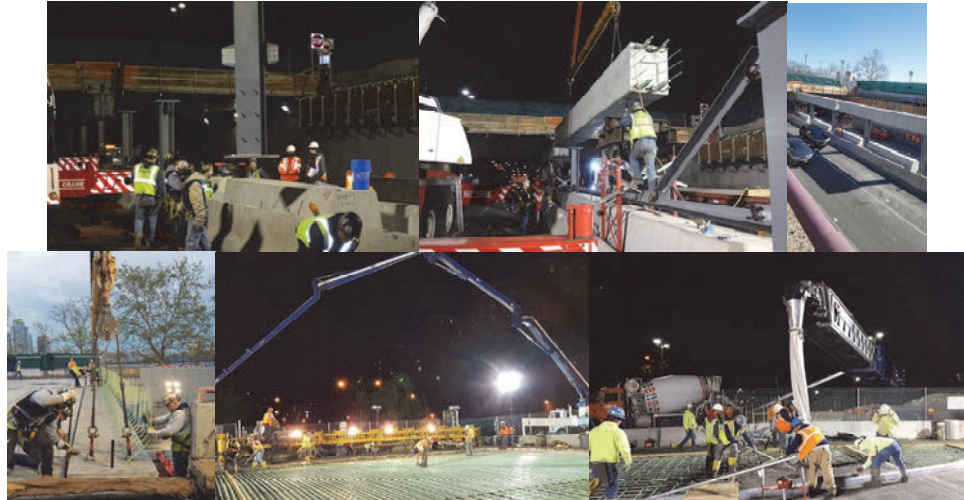
April 2017: Stage 3 - Erection of New Steel Columns and Pier Caps at the Center Pier. Alignment of Final Hollow Slab Unit for Stage 3. May 2017: Concrete Placement for Stage 3 Bridge Deck. June 2017: Concrete Placement for South Sidewalk and Median.

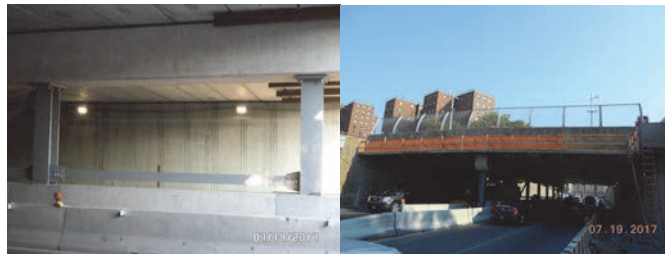
July 2017: Pier 1 New Columns of the Main Bridge. Elevation Right. (Credit: NYSDOT)

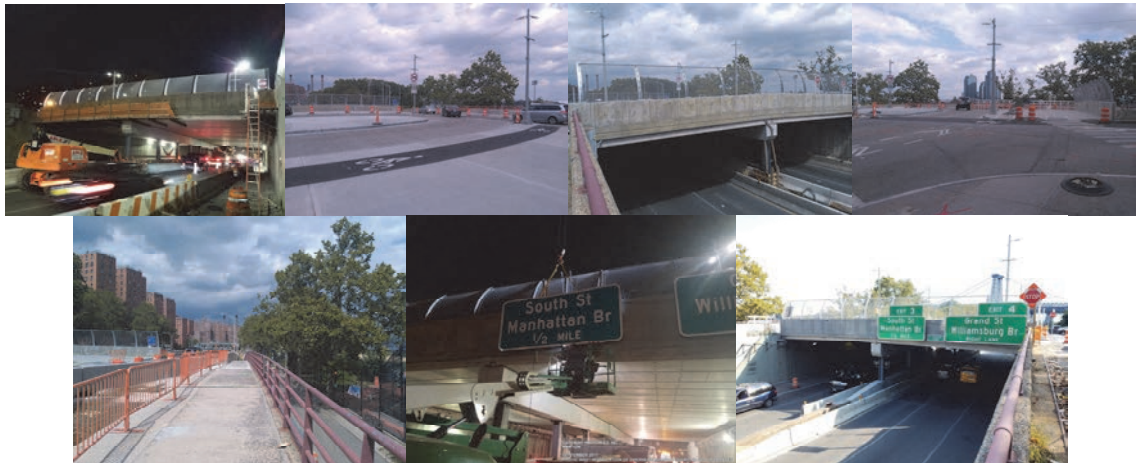
August 2017: Night Work. Overpass Open. September 2017: Installation of Overhead Roadway Signs on the North Parapet.

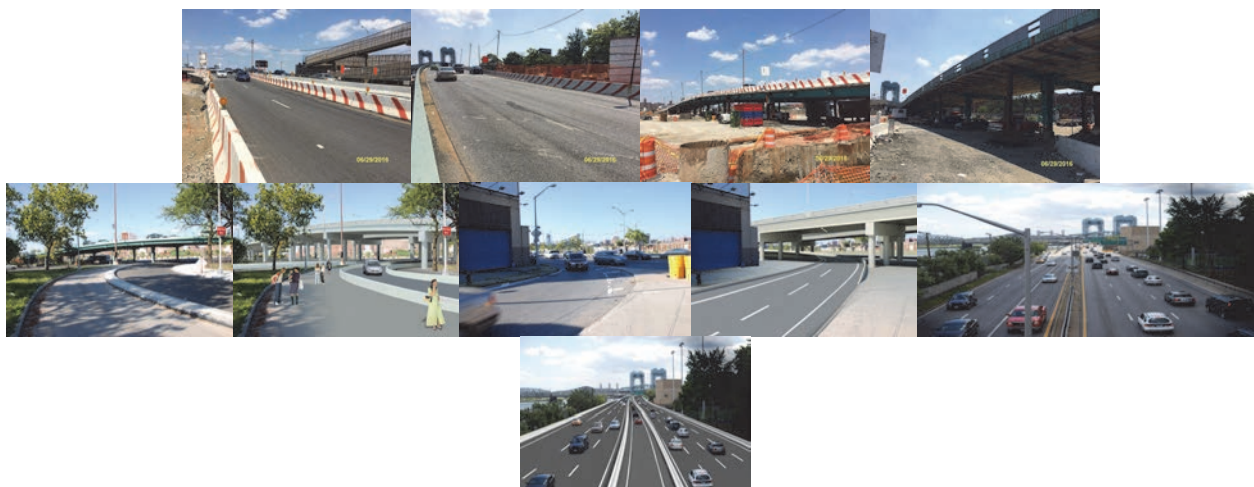
June 2016: Approach Begin and End. Left Elevation. Right Elevation Spans 3 – 7. (Credit: NYSDOT) Looking East at the 127th Street Off-Ramp: Current and Proposed View. Looking East at 2nd Avenue: Current and Proposed View. Looking South From 3rd Avenue Bridge: Current Harlem River Drive and 2nd Avenue Exit and Proposed Harlem River Drive With Left Lane Exit to 2nd Avenue.

This project includes over \$82 million in Federal funds. Construction will follow the on-line bridge replacement with auxiliary exit and entrance lanes and left-lane exit to Second Avenue. It involves the replacement of the existing 11 span bridge and the reconstruction of the Harlem River Drive between the Willis Avenue and Third Avenue Bridges, in addition to various highway improvements. The northbound and southbound structures will share a single south abutment, but will be supported by independent abutments at the north. The new bridge will carry two through lanes in the northbound direction, and three lanes in the southbound direction; each lane will have an average width of 11 feet. The new bridge will also include new fascia and median barriers. The abutments, wingwalls and piers will be replaced with new substructures that will conform to current seismic design criteria. The project length is approximately 3,280 feet.

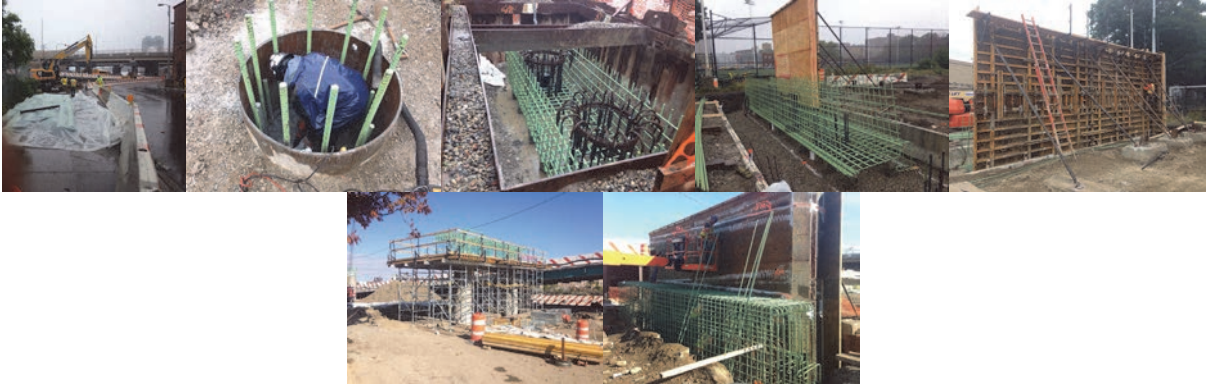
September 2016: North Abutment Pier 8 Foundation. Epoxy Reinforcement Bars to be Installed at South Abutment are Covered. Removing Concrete With a Chipping Gun. Reinforcement for Pile Cap. North Abutment - Reinforcement for the Stem and Forms. October 2016: Contractor Continued Installing Reinforcement and Forms for the North Abutment. November 2016: Pier 3 of Southbound Roadway - Pier Cap Almost Ready for Concrete Placement. November 2016: South Abutment Stem Wall. (Credit: Artemio Angeles)

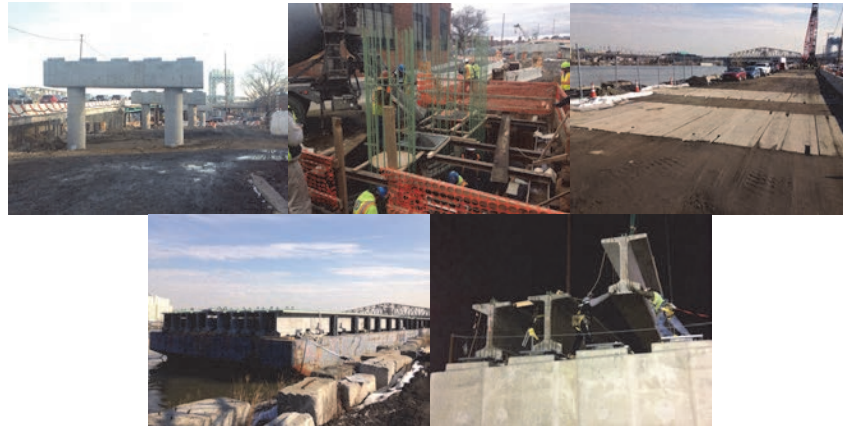
January 2017 – Mini Piles. February 2017 - Erection of the Concrete Beam – Timber Planks Over the Relieving Platform. Concrete Beams on Barge. (Credit: Artemio Angeles) Span 2.

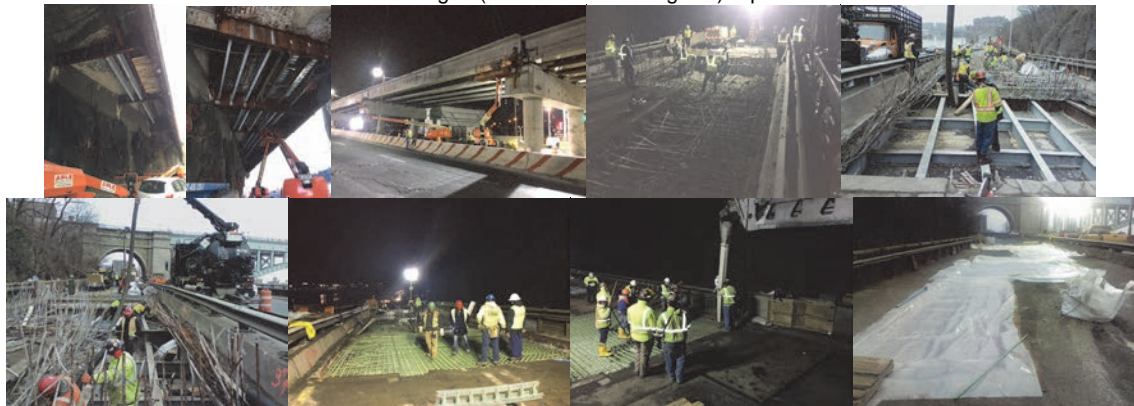
March 2017. Installing Stringers at Location #12. Through-Hole Repair.

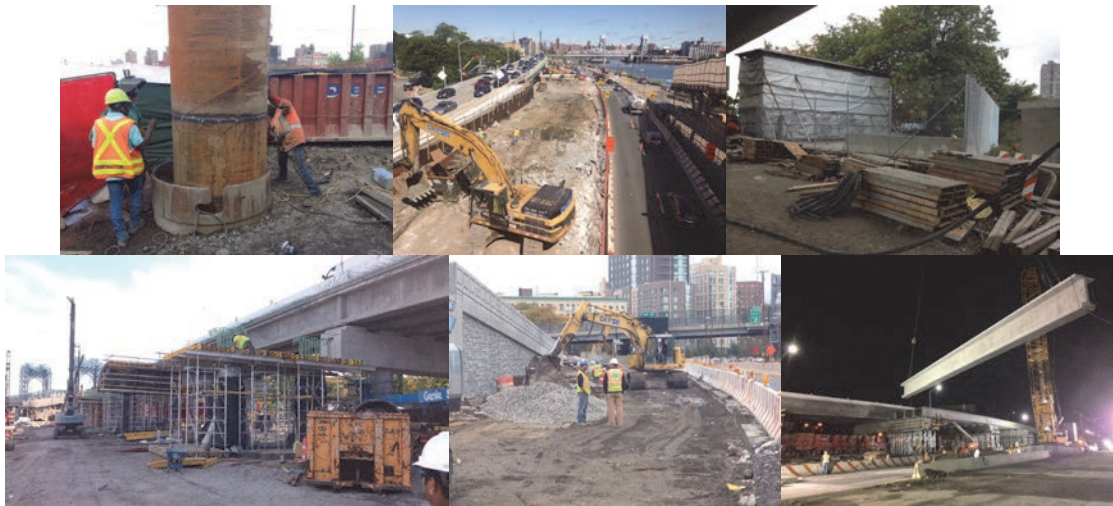
September 2017. October 2017: Enclosure to Protect the “Crack is Wack” Mural in the Park. Site View. Drainage Work at North Approach - Along Future Ramp D. November 2017: Last of the Pre-Stressed NEBT Girders for the Southbound Structure. (Credit: Artemio Angeles)

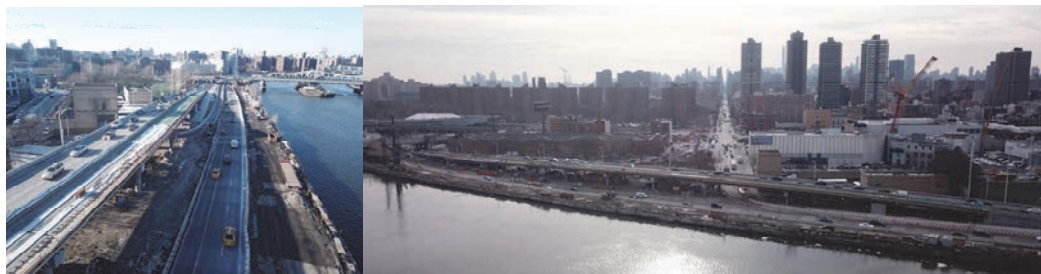
Drone Views: View North Along the Harlem River Drive – the Southbound Bridge Deck is Halfway Constructed. View South Down 2nd Avenue.

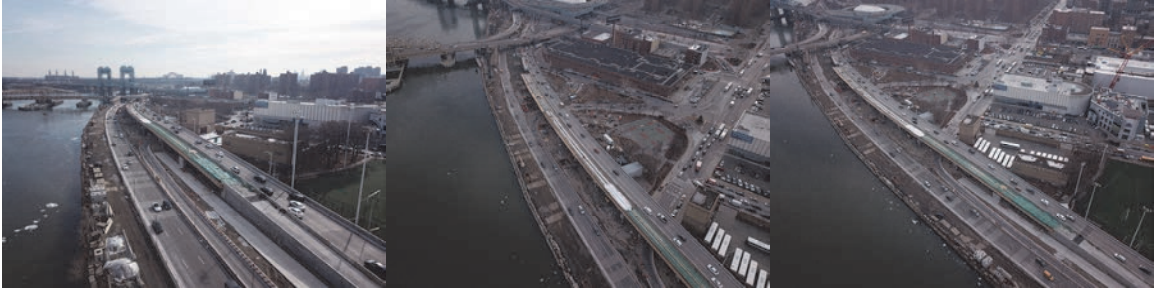
Drone Views: View South - Maintaining all Travel Lanes During Construction. View South From Above Bridge – Willis Avenue Bridge at Upper Left. View of Temporary Roadway for Northbound Traffic.

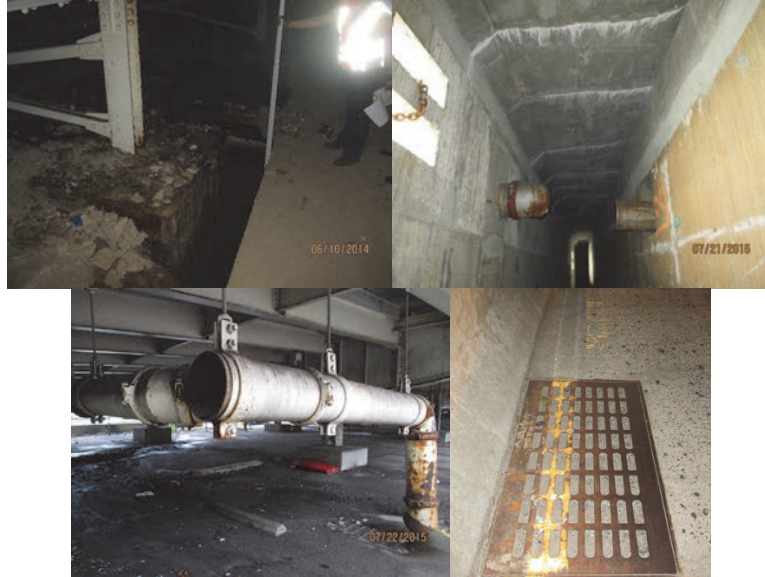
Given the proximity of the FDR Drive to the East River it is exposed to hazardous flooding during coastal storm events. This condition places the facility at risk of damage due to erosion and scour as well as loss of function while inundated by brackish flood waters. As a result, the first 6 spans of the bridge are presenting significant loss of retained soil fill material with exposed foundation elements which will require remediation and implementation of scour countermeasures.

Scour Hole at Pier #3 in 2014. 2015: Span 5 – Right side. Span 46 – Left Side. Downspout Near North Abutment.
(Credit: NYSDOT) Typical Clogged Scupper Inlet.

The overall intent of this project is to repair existing conditions that may have resulted from previous storms and to implement measures that will help monitor, prevent, manage, and minimize future damage to this segment of the FDR Drive due to flooding. Enhanced coastal resiliency is a key goal for the project.

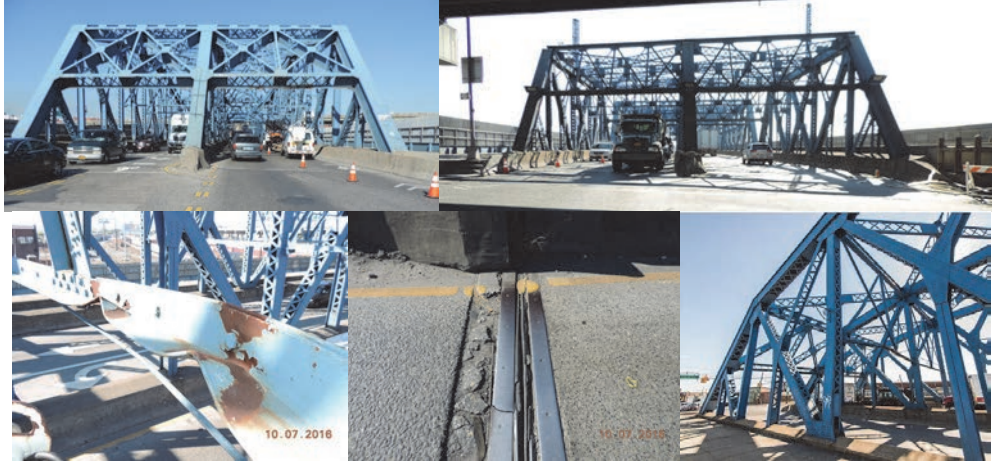
Leggett Avenue Bridge over Amtrak Before Construction. October 2016: Begin and End Approaches. Span 1, Bottom Sway Strut Bracing Exhibits Severe Deformation and Several Upward Bent Sections due to Vehicular Impact. End Abutment Transverse Deck Joint Steel Armor is Cracked. Deck Joint Header Exhibits Shallow Spalls. (Credit: NYSDOT) Southeast View.

The Leggett Avenue Bridge over Amtrak was built in 1906. It is a three span steel truss. There is a corrugated metal fence along both the east and west fascias of the bridge. The existing bridge geometry consists of two travel lanes and a sidewalk in each direction, divided by a 4'-10" wide concrete median barrier. The scope of rehabilitation work includes the following: removing and replacing deck joint, deck joint seals and portions of the concrete sidewalk; repairing concrete on the abutment and approach slab; repairing structural steel members and existing fuse box; installing pavement striping; and cleaning and painting steel surfaces and bottom of stay-in-place form. A bent column was discovered on this bridge after the initial contract scope was completed, and this repair work was then added through a change order. Vehicular and pedestrian access will be maintained during the rehabilitation period. Construction work began in February 2017.

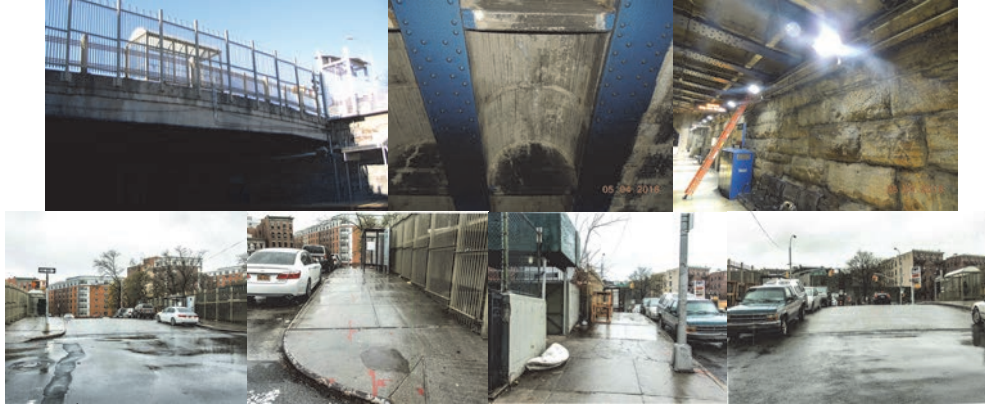
East 162nd Street Bridge over Metro North Before Construction. May 2016: Span 1, Underside of Deck Exhibits Longitudinal Cracks With Efflorescence. End Abutment Stem. (Credit: NYSDOT) Northeast Side. Southwest Pedestrian Crossing. North Sidewalk. East View.

The East 162nd Street Bridge over Metro North was built in 1888. It is a single span steel jack arch bridge with built-up steel beams encased in concrete. There is a fence along both the north and south fascia of the bridge as well as a non-standard decorative bridge rail along the north fascia. The existing bridge geometry consists of one travel lane, a parking lane and a sidewalk in each direction. The scope of rehabilitation work included the following: locally removing and replacing the asphalt and concrete overlays and sidewalk; installing pavement striping; repairing guide railing, concrete on the underdeck and abutment, and cracks in the asphalt overlay and sidewalk; cleaning and painting steel surfaces locally; resealing sidewalk joints; and repointing stone masonry. Construction work began in April 2016. The East 162nd Street Bridge was substantially completed on June 21, 2017.

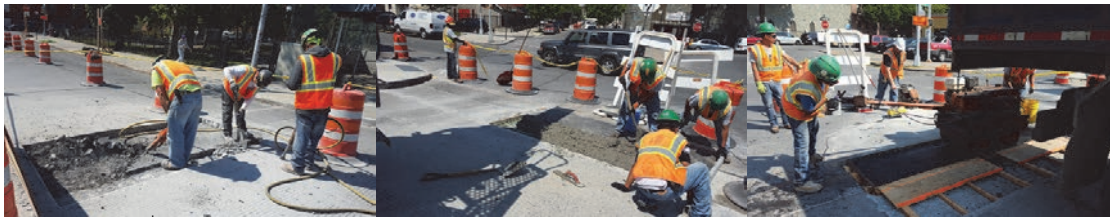
East 162nd Street Bridge During Construction - Overlay Excavation. Concrete Overlay. Asphalt Placement.

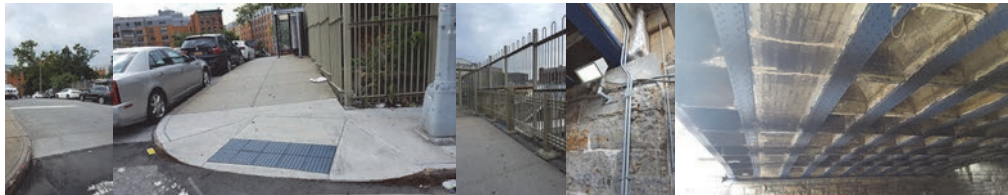
East 162nd Street Bridge After Construction – New Concrete Overlay. New Southwest Pedestrian Crossing. Repaired Pedestals. Painted Fence and Railing. Sealed Underdeck Cracks.

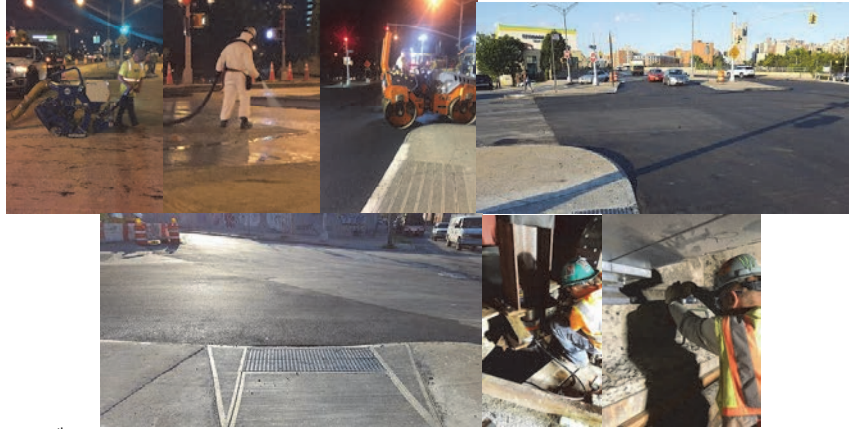
East 165th Street Bridge Under Construction. Summer 2016. Asphalt Placement. New Pedestrian Ramp. Bridge Jacking. Bearing Replacement.

The East 165th Street Bridge over Metro North was built in 1897. It is a single span steel jack arch bridge with built-up steel beams encased in concrete. A chain link fence runs in front of steel railing atop both the west and east fascia of the bridge. The existing bridge geometry consists of one travel lane in each direction on East 165th Street, and one travel lane, a turning lane and a sidewalk in each direction on Melrose/Webster Avenue. The scope of rehabilitation work includes the following: locally removing and replacing the asphalt overlay and sidewalk; repairing the concrete underdeck; cleaning and painting steel surfaces; resealing sidewalk joints; installing new multi-rotational bearings at the south abutment; partially removing and replacing the bridge seat at the new bearing locations; installing a temporary support system; and performing jacking operations. Vehicular and pedestrian access will be maintained during the rehabilitation period. Construction work began in June 2016. Work on the top of the bridge is complete and underdeck work continues. The underdeck cracks will be sealed by pressure injection. The work was delayed due to a Con Edison gas leak, which required shutting off the gas line in order to carry out the contract work.

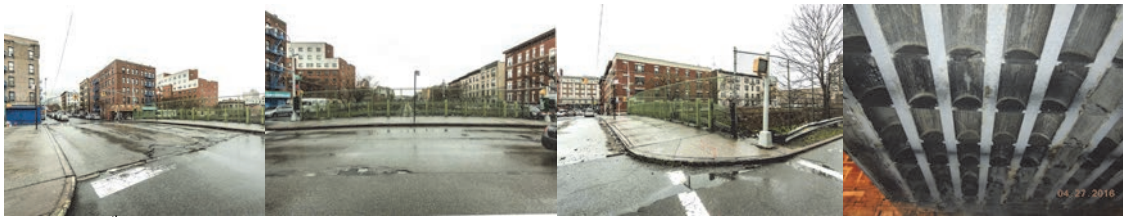
East 187th Street Bridge over Metro North Before Construction - Southeast and North Views. Southwest Crosswalk. April 2016: Span 1, Underside of Deck Exhibited Minor Mapcracking and Efflorescence. (Credit: NYSDOT)

The East 187th Street Bridge over Metro North was built in 1889. It is a single span steel jack arch bridge with built-up steel beams encased in concrete. The bridge has a chain link fence and a non-standard decorative bridge rail along both the north and south fascia. The existing bridge geometry consists of one 17' travel lane and an 11' sidewalk in each direction. The scope of rehabilitation work included the following: removing and replacing concrete overlay and waterproofing membrane, concrete sidewalk, corrugated guide rail, bridge railing, chain link fence wire mesh, and steel faced curb and handicap ramp at sidewalk corners; sealing the deck overlay; repairing the concrete underdeck; and cleaning and painting the steel surfaces locally. Construction work began in August 2016. The East 187th Street Bridge was substantially completed on June 21, 2017.

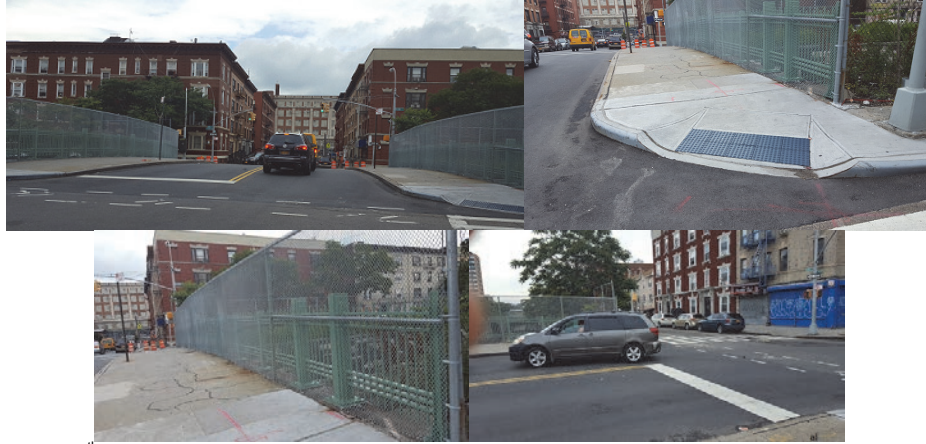
East 187th Street Bridge over Metro North After Construction – Asphalt Overlay. Southwest Pedestrian Crosswalk. New Chainlink Fence. North View.

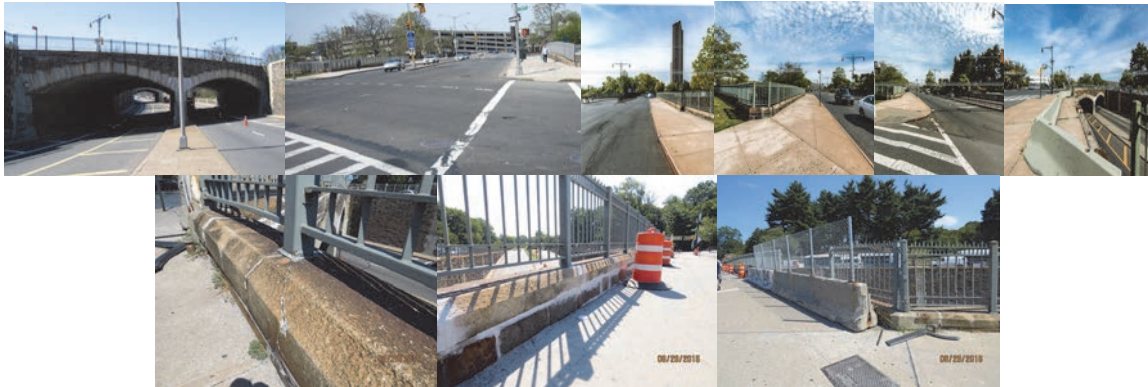
Southern Boulevard Bridge over East Fordham Road Before Construction. West Side, East Side, Eastbound Roadway, and Missing Section of Fence. August 2016: Cracked Cap Stone at Right Wingwall. Repaired Joints on Right Parapet. Jersey Barriers and Fence Above the Deck on Span 1.

The Southern Boulevard Bridge over East Fordham Road was built in 1962. It is a two span concrete arch bridge with stone masonry facing on the abutments and spandrel walls. The bridge has a concrete parapet with stone facing topped with a non-standard decorative bridge rail at both the east and west fascia. The existing bridge geometry consists of two travel lanes, a turning lane and a sidewalk in each direction, divided by a 4'-3" wide concrete median. The scope of rehabilitation work included the following: removing and replacing asphalt overlay, waterproofing membrane and pavement striping; repairing bridge railing, light fixtures and concrete on the underdeck and sidewalk; resealing sidewalk joints and vertical fascia joint at abutment; repointing and repairing cracks in stone masonry; installing weep holes in the underdeck and guide railing; and cleaning fascia stone masonry and catch basins. Construction work began in June 2016. The Southern Boulevard Bridge was substantially completed on May 18, 2017.

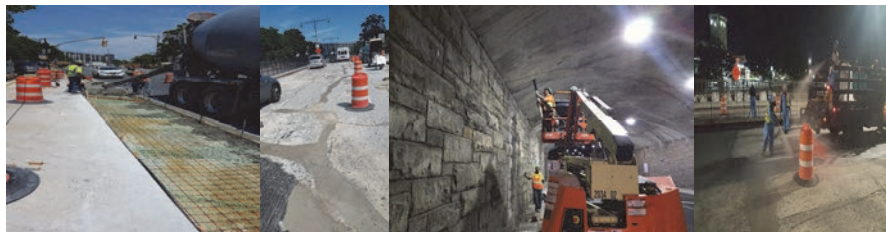
Southern Boulevard Bridge During Construction – Sidewalk Repair, Deck Repair, Weep Hole Installation, and Waterproofing.

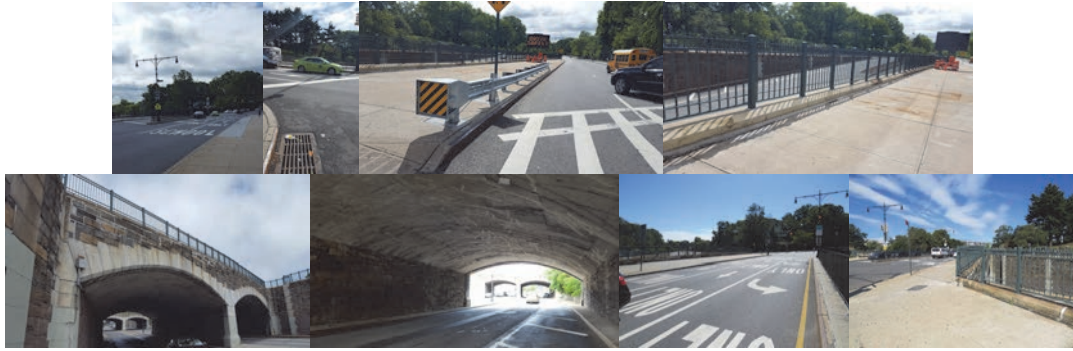
Southern Boulevard Bridge After Construction - New Asphalt at West Side and at the Eastbound Roadway. New Guiderail and Fence. Section of Fence. Repaired Joints at Fascia. Sealed Crack and Installed Weep Holes at Westbound Fordham Road. September 2017: Barriers Removed After Construction – Top of Span 2 Looking East. Top of Deck at Beginning Approach Looking West.

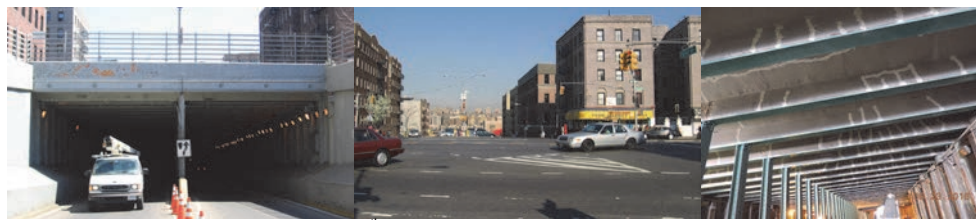
Grand Concourse Bridge over East 167th Street. June 2016: Span 1, Repaired Underdeck and Girder Concrete Encasement. (Credit: NYSDOT)

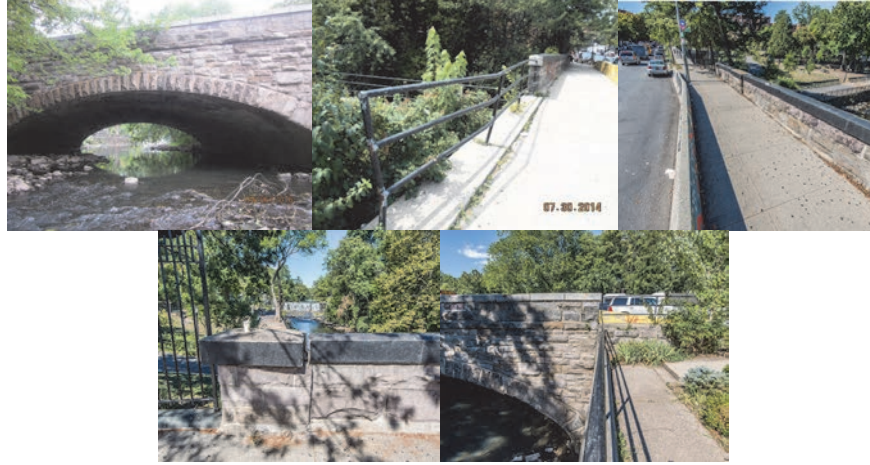
East 180th Street Bridge over Bronx River Before Construction. Elevation Right in September 2016. July 2014: Bent Railing at Side Approach. (Credit: NYSDOT) West View and the North and South Parapet Walls.

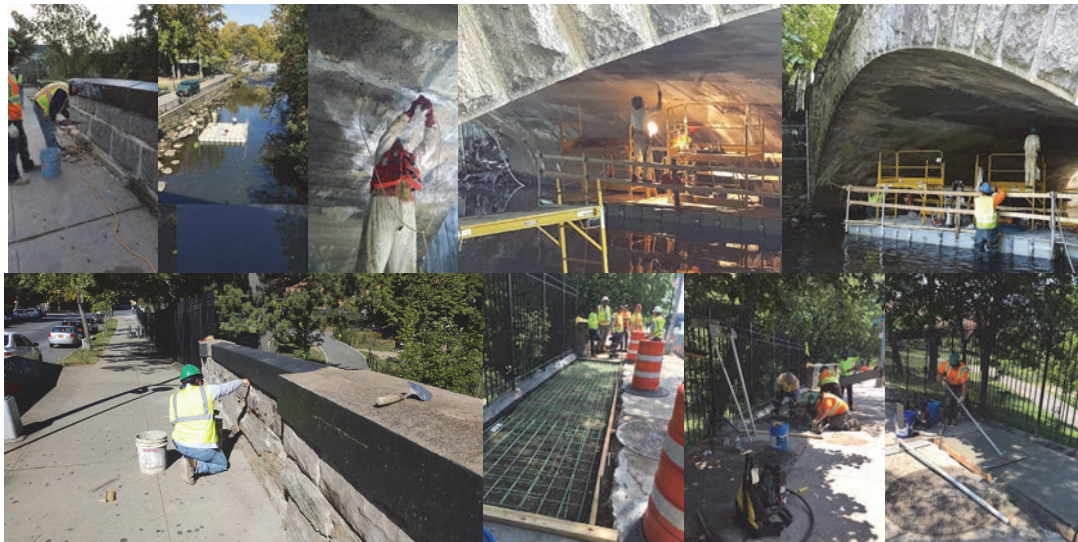
East 180th Street Bridge During Construction – South Parapet Wall, Working Platform, Crack Repairs, and Tuck Pointing. Sidewalk Repairs.

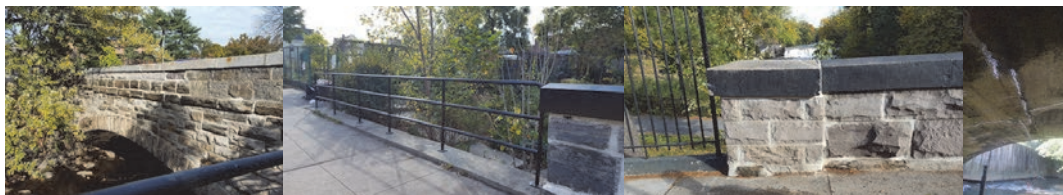
East 180th Street Bridge After Construction – South Wall, New Railing at South Sidewalk, North Parapet Wall, and Sealed Underdeck Cracks.

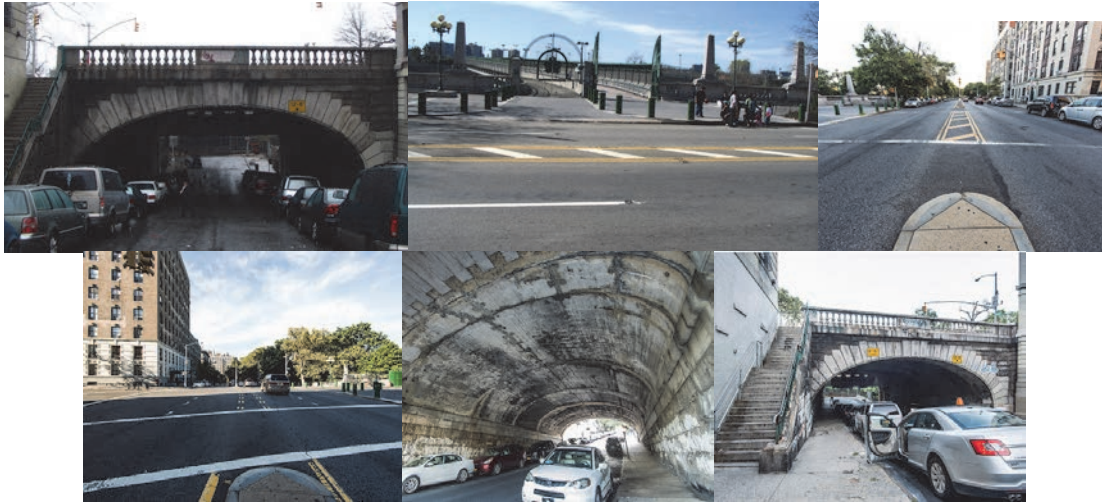
Riverside Drive Bridge over West 138th Street Before Construction. North and South View, Underdeck, and Stairway.

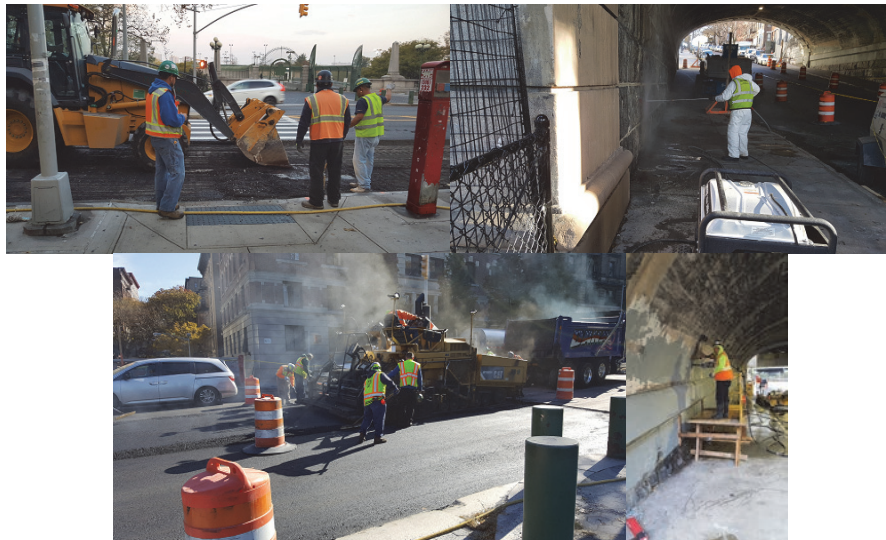
Riverside Drive Bridge over West 138th Street During Construction – Asphalt Milling, Power Washing, Asphalt Placement, and Weep Hole Drilling.

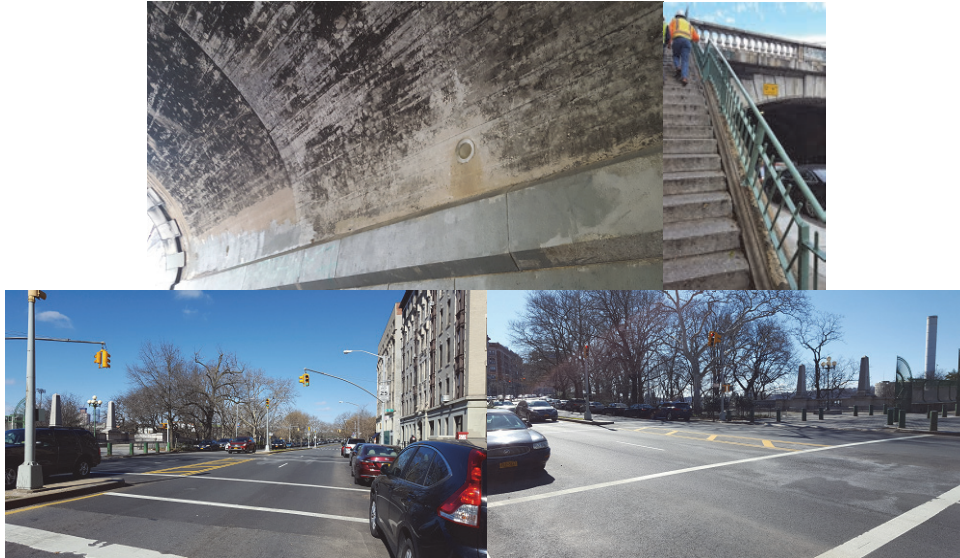
Riverside Drive Bridge over West 138th Street After Construction – Weep Holes Installed, Railing Painted. New Asphalt Overlay – North and South Views.

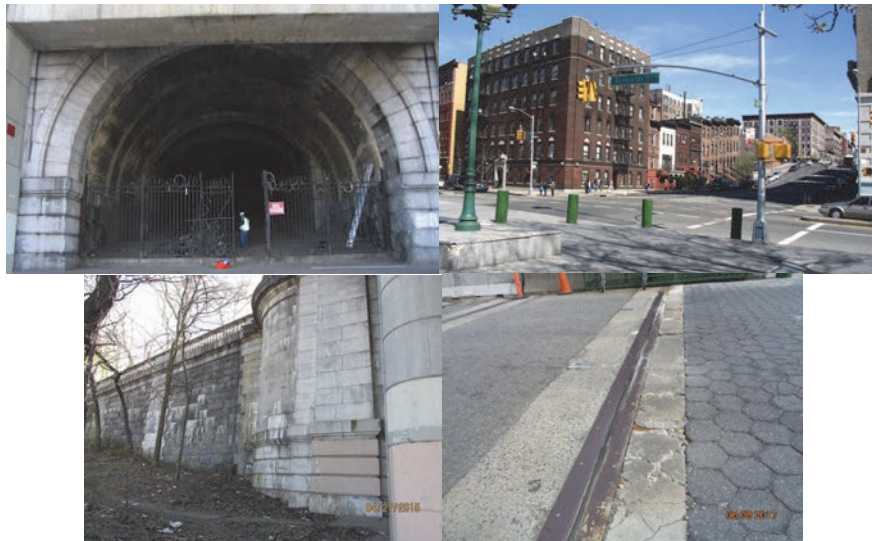
Riverside Drive Bridge over West 145th Street. April 2015: East Abutment Wingwall. April 2017: Top of Deck, at Entrance to Riverbank State Park. (Credit: NYSDOT)

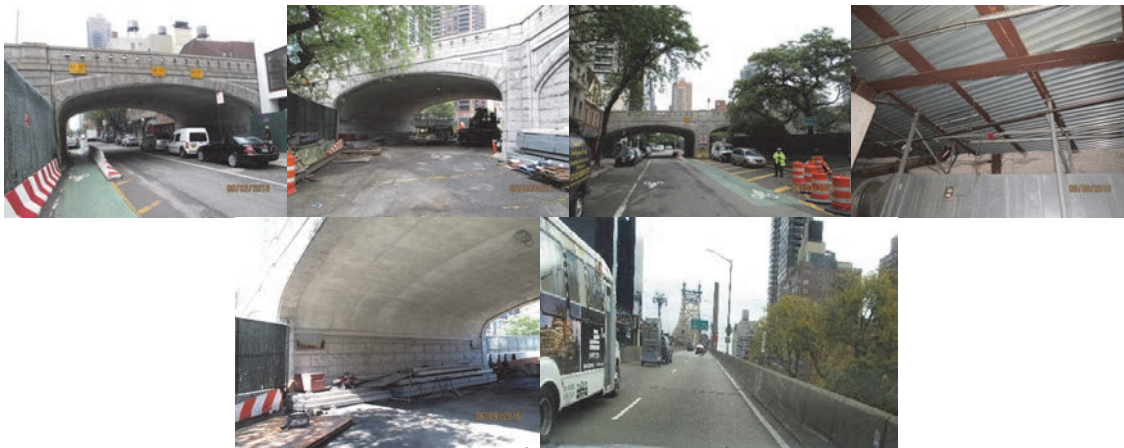
Ramp to the Ed Koch – Queensboro Bridge from East 58th Street over East 59th Street Before Construction. June 2016: Westbound Span 11 Vertical Clearance Signs. Span 10 – Left Elevation. Spans 10 and 11 – Left and Right Elevations. Span 8, Underside of Deck at Bay 2. Steel. Stay-in-Place forms Installed as Shielding. Pier 11.
(Credit: NYSDOT)

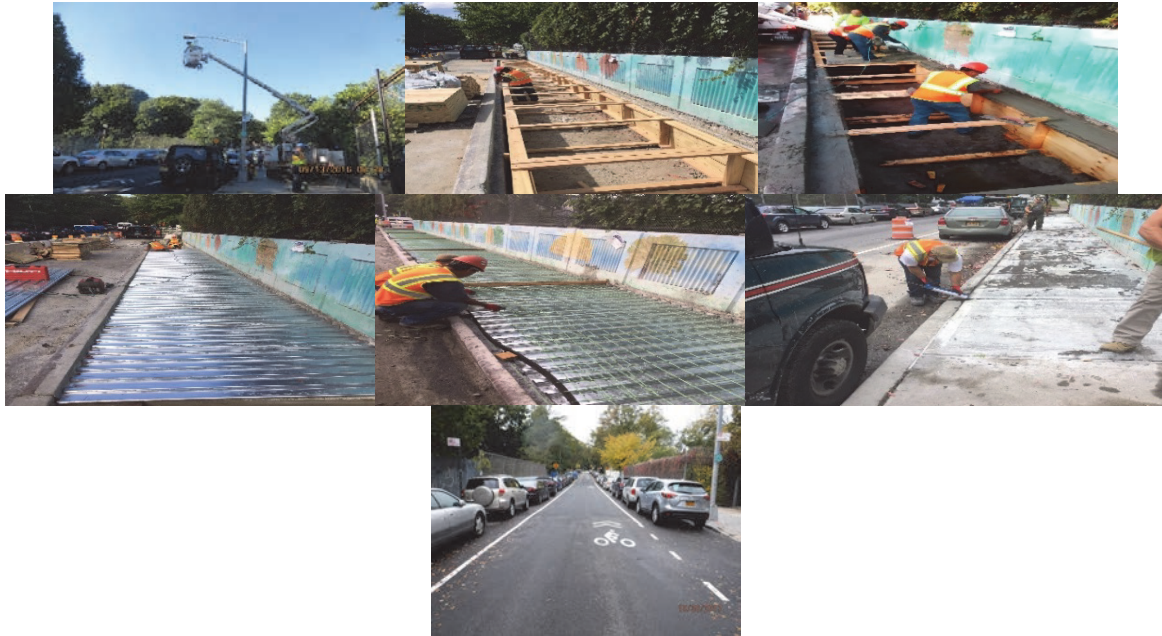
80th Road Bridge Under Construction. October 2017: End Approach Pavement and Spans 1 to 3 Wearing Surface Repaved With Asphalt Concrete. (October Credit: NYSDOT)

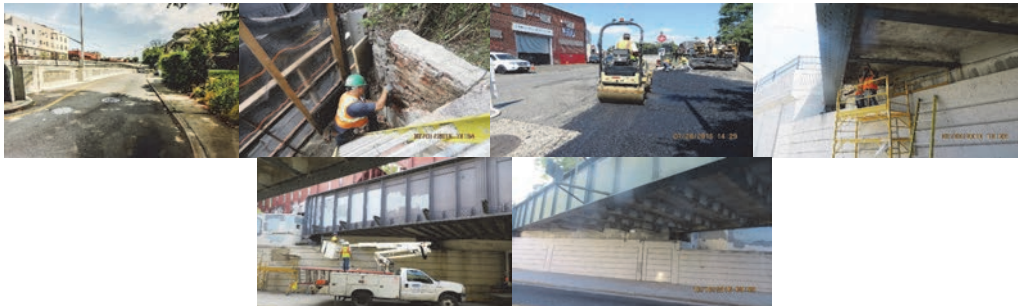
71st Avenue Bridge over Cooper Avenue. Before, During, and After Construction.

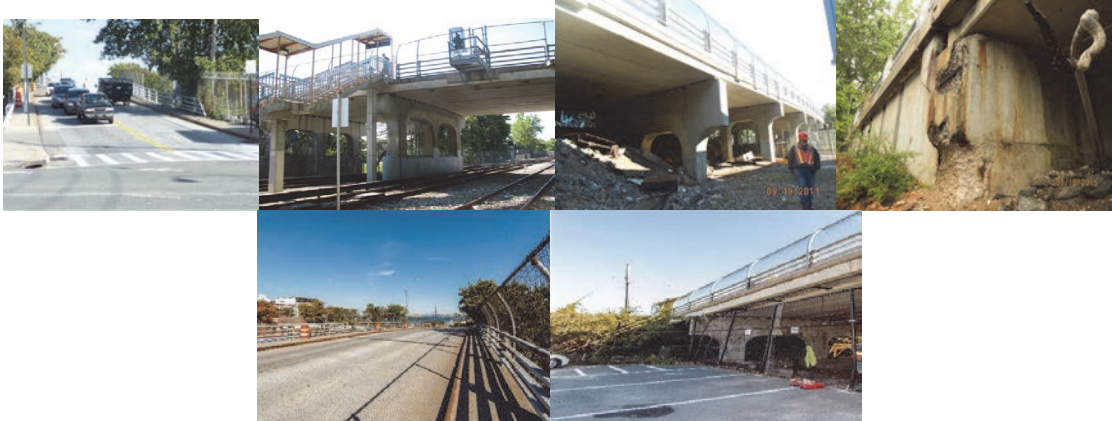
Hannah Street Bridge Over SIRT South Shore. Spans 1-4 - Right Elevation. October 2015: Large Deep Spall on Right Corner of Beginning Abutment. (Credit: NYSDOT) Before Construction.

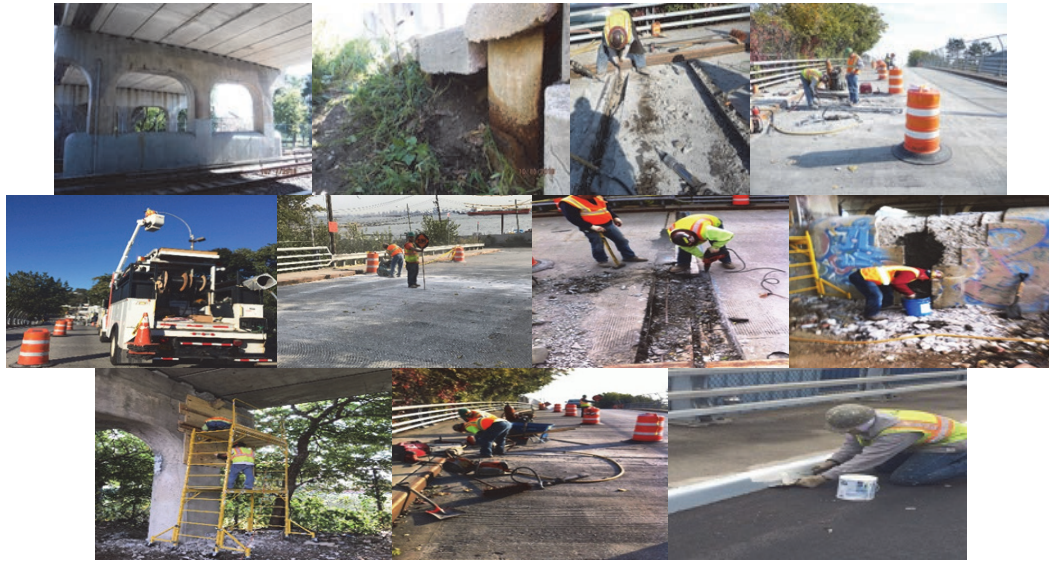
October 2016: Eroded Left Embankment at End Approach. (Credit: NYSDOT) November 2016. During Construction.

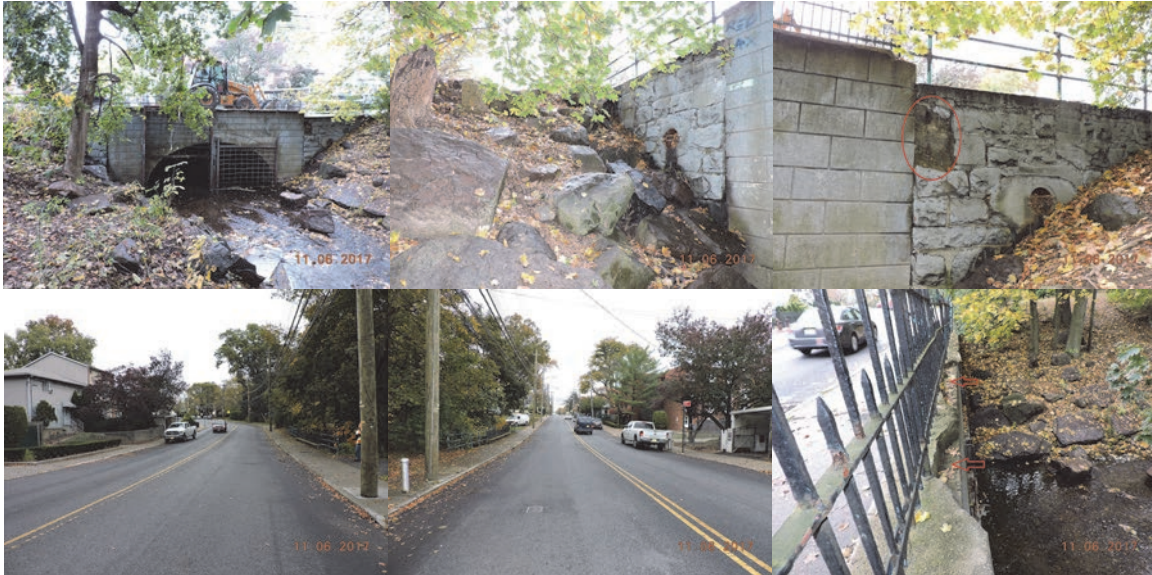
Forest Avenue Bridge Over Clove Lakes Park Stream. November 2017: Right Elevation at Upstream. Beginning Abutment Right Wingwall. End Abutment Stone Masonry Wingwall. Beginning and End Approaches. Right Side Parapet and Concrete Coping. (Credit: NYSDOT)

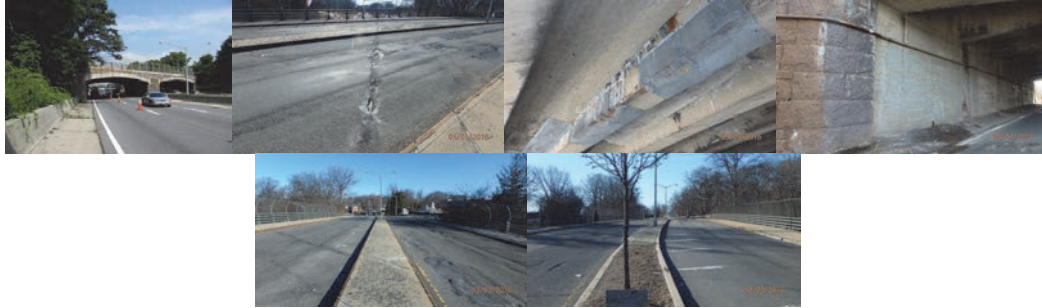
Douglaston Parkway Bridge Northbound Over Cross Island Parkway. March 2016: Top of Bridge, Asphalt Wearing Surface Above Beginning Abutment - Spalls and Uneven Wearing Surface. Span 1 - Deteriorated Concrete Covered With Wire Mesh. Abutment End. Approach Begin and End. (Credit: NYSDOT)

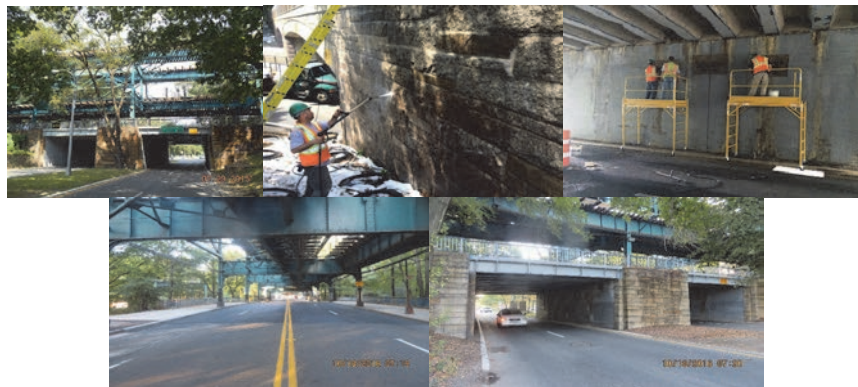
Roosevelt Avenue Bridge in July 2015: Elevation Right. (Credit: NYSDOT) Before, During (Stone Masonry Preparation, Underdeck Concrete Repair), and After Construction.

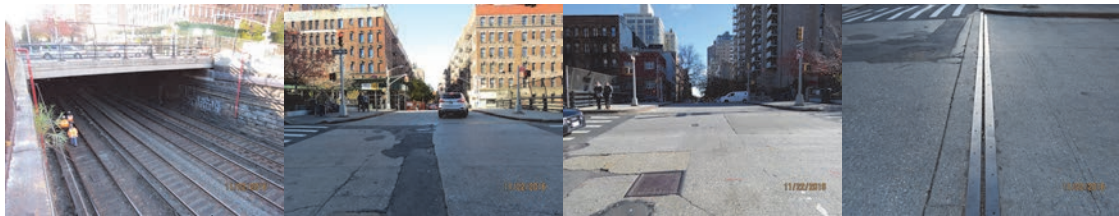
East 97th Street Bridge over Metro North. 2016: Beginning and Ending Approaches. Beginning Abutment Joint - Deteriorated Sealer Material. (Credit: NYSDOT)

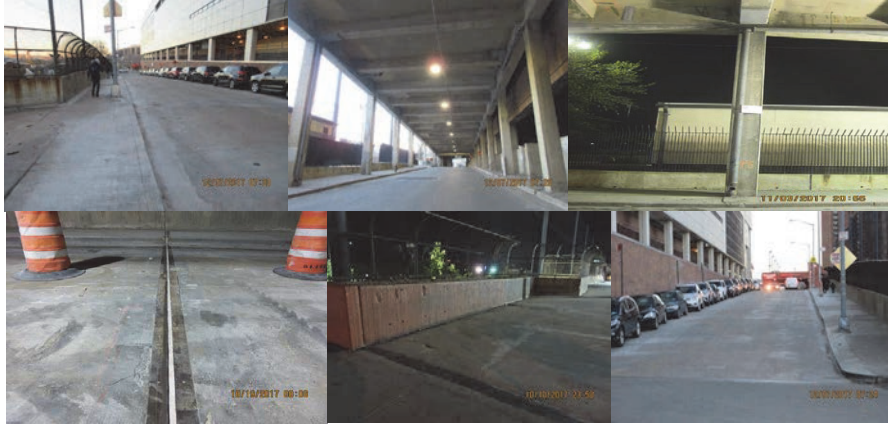
Matthewson Road Bridge After Construction.

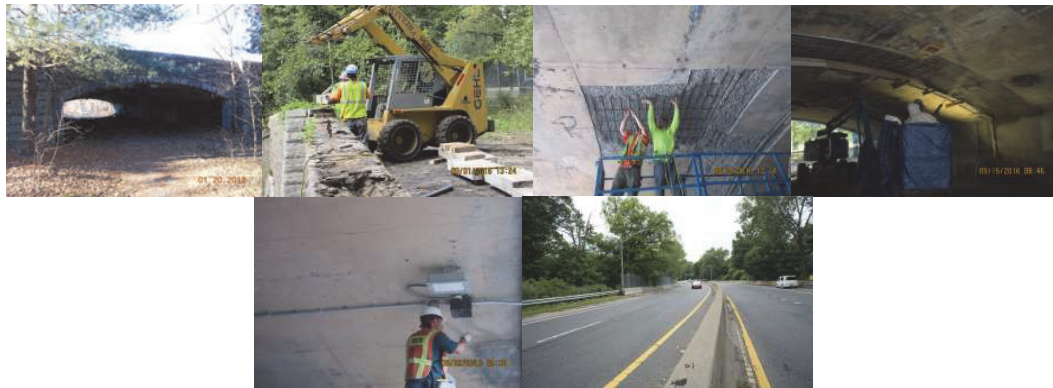
Mosholu Parkway Bridge over Equestrian Path. (Credit: NYSDOT) Bridge Before, During (Removing Stones and Stone Masonry, Removal and Repair of Deteriorated and Unsound Concrete, Repairing the Underdeck Lighting), and After Construction.

The Mosholu Parkway Bridge over Equestrian Path was built in 1951. The structure is a one-span reinforced concrete rigid frame arch. The bridge carries two travel lanes and a right shoulder lane in each direction of the Parkway. The roadways are divided by a concrete median. The roadway surface consists of an asphalt wearing surface on a concrete deck supported by subbase material on top of the arch. A stone masonry parapet was provided on the south fascia, and a concrete half-section barrier with a stone masonry parapet on the north fascia. Construction work began in June 2016, and the project was substantially completed on December 19, 2016.
