2017 NYC DOT

Bridges & Tunnels Annual Condition Report

NEW YORK CITY DEPARTMENT OF TRANSPORTATION DIVISION OF BRIDGES 2017 BRIDGES AND TUNNELS ANNUAL CONDITION REPORT

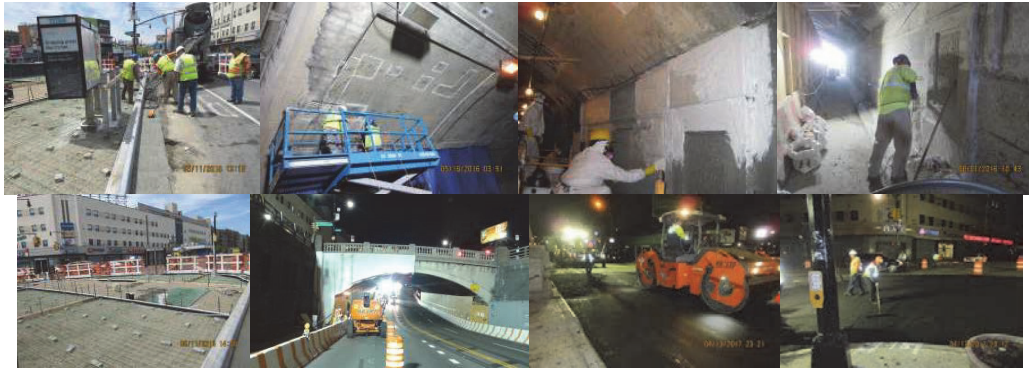
East Fordham Bridge During Construction.

The East Fordham Road Bridge over Grand Concourse was built in 1923. The structure is a one-span reinforced concrete rigid frame arch with a filled spandrel. The bridge carries two travel lanes and a bus lane in each direction. There is a concrete pavement slab on top of the fill beneath the asphalt wearing surface. There are no parking lanes on the bridge. Wide trapezoidal shape concrete sidewalks and concrete curbs with steel face were provided on each side of the bridge. The bridge railings consist of reinforced concrete parapets and balustrades with no protective screening. The scope of rehabilitation work included the following: removing the asphalt wearing surface on the bridge area; repairing the top of the concrete slab with a waterproofing membrane and two layers of asphalt; repairing the deteriorated areas of concrete at the abutments and the underside of the arch; removing the safety netting to repair the concrete; installing safety netting; repairing or replacing the concrete sidewalk; restoring the mortar joints at the spandrel stone copings; replacing sections of the steel faced concrete curbs and the roadway interface sealer; repairing the deteriorated concrete of the balustrades and parapets; and performing miscellaneous repairs to the underdeck lighting. Construction work on this bridge began in April 20, 2016, and was substantially completed on April 25, 2017.

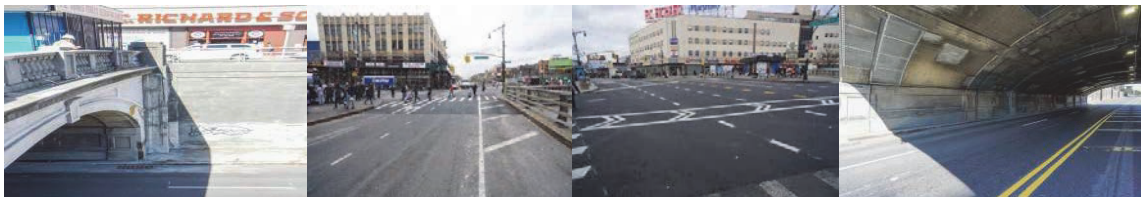
East Fordham Bridge After Construction.

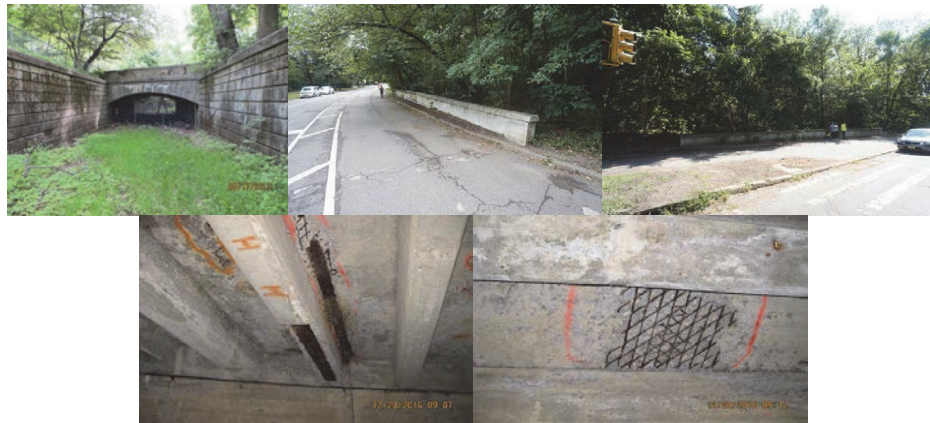
East Drive Bridge over Bridle Path Before Construction.

The East Drive Bridge over the Bridle Path in Prospect Park was built in 1910. The structure is a single span bridge that carries predominantly pedestrians and cyclists and two lanes of one-way vehicular traffic during restricted hours only. There is a safety walk along the left side of the bridge and a wide sidewalk along the right side, each with concrete parapets. The scope of rehabilitation work included the following: removing and replacing the asphalt wearing surface; installing a waterproofing membrane and two layers of asphalt; installing new bollards for the north sidewalk; repairing deteriorated areas of concrete at the underside of the deck, encasement and curbs; cleaning and painting the exposed structural steel members; and performing miscellaneous repairs to the underdeck lighting. The construction work on this bridge began in December 2016, and was substantially completed on May 24, 2017.

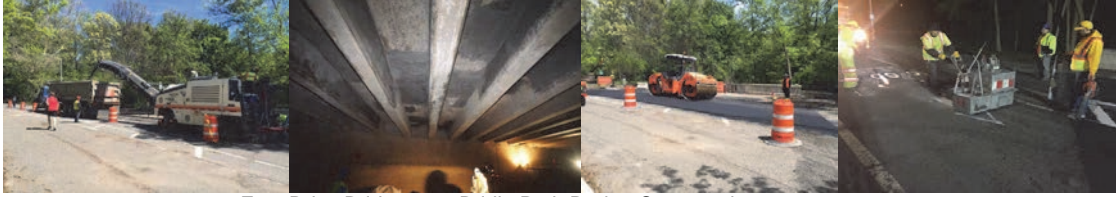
East Drive Bridge over Bridle Path During Construction.

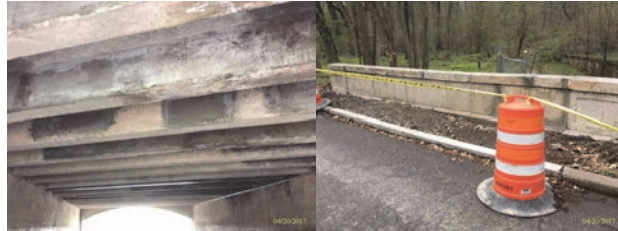
April 2017: Superstructure Framing – Repaired Concrete-Encased Steel Stringers and Concrete Underdeck. Begin Approach, Left Curb - New Segment of Concrete Curb. (Credit: NYSDOT)

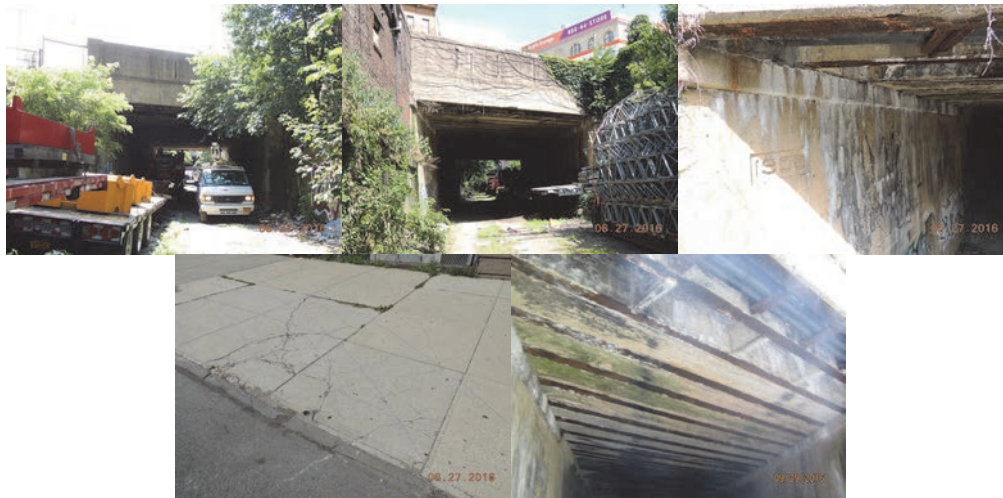
Southern Boulevard Bridge Over CSX. July 2016: Elevation Left and Right. Begin Abutment Stem Exhibits Vertical and Horizontal Cracks With Efflorescence, and Isolated Areas of Hollow-Sounding Concrete. Left Sidewalk at End Abutment. (Credit: NYSDOT) September 2016: Right Side Under Deck of span #1 – Mold is Present and the Bottom Flanges are Corroded.

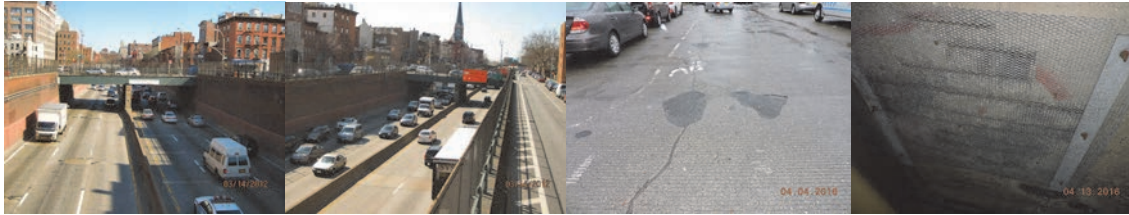
Sackett Street Bridge Over Brooklyn-Queens Expressway. March 2012: Elevation Left and Right. April 2016: Span 1 Wearing Surface. Span 2, Underside of Reinforced Concrete Deck Near the End Abutment - Exhibits a Spalled Area With Exposed and Corroded Rebars. This Location is Protected by Wire Mesh Netting. (Credit: NYSDOT)

abatement of asbestos containing materials, as required. Vehicular and pedestrian access will be maintained during the estimated 8-month rehabilitation period.

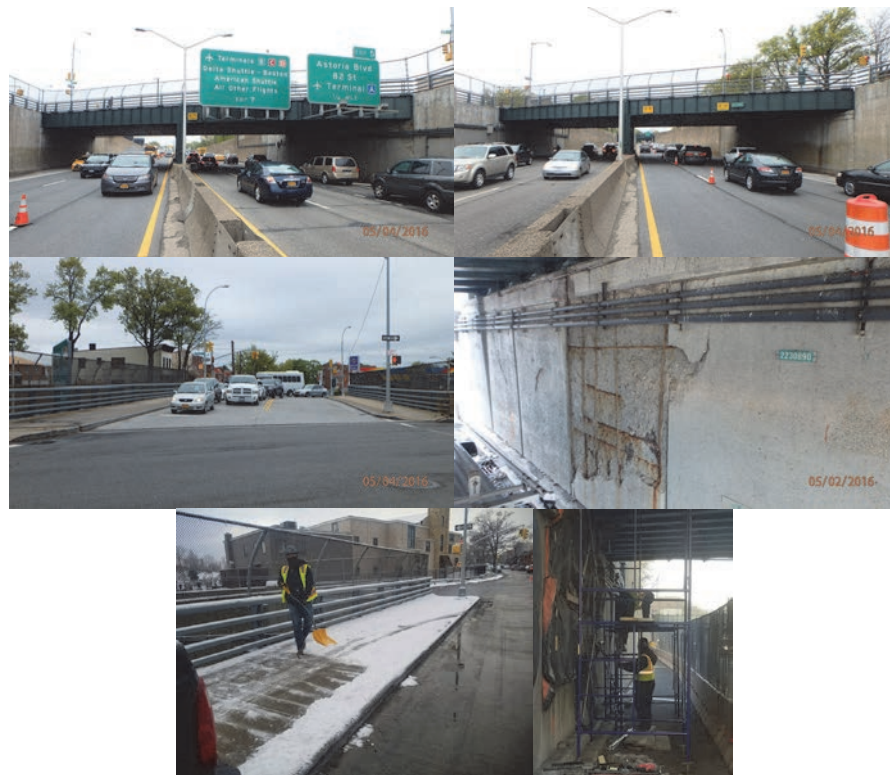
49th Street Bridge Over Grand Central Parkway. May 2016: Elevation Left and Right. Beginning Approach. Begin Abutment at Bays 9 to 14 - Spalls With Exposed Corroded and Debonded Rebars and Hollow-Sounding Concrete Areas. (Credit: NYSDOT) December 2017: Snow Removal. Erecting Scaffolding at the Abutment.

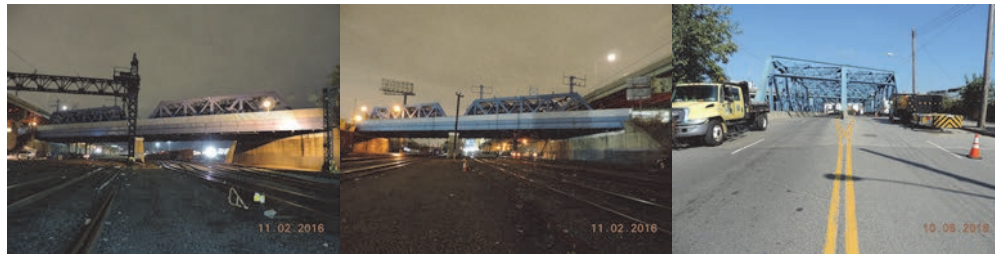
East 149th Street Bridge over Amtrak – CSX. November 2016: Elevation Left and Right. Beginning Approach. (Credit: NYSDOT)

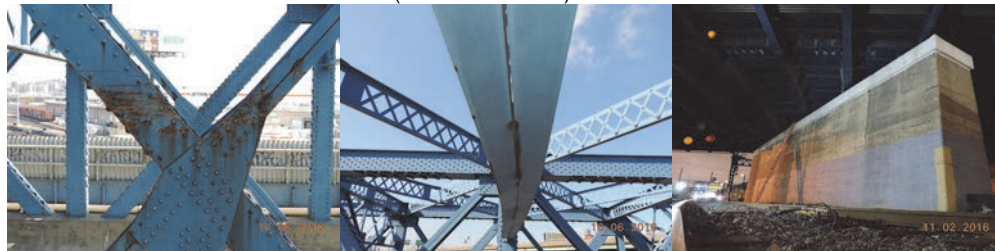
Span 2, Truss T2 - Left Face of the Gusset Plate and Adjacent Diagonal Member Exhibit Scrape Marks and Paint Loss With Minor Surface Corrosion Due to Vehicular Impact. Span 1, Sway Strut Bracing Between Truss T2 and T3 - Brace Bottom Flange Exhibits Bending Toward Span 2 due to Vehicular Impact. Pier 1. (Credit: NYSDOT)

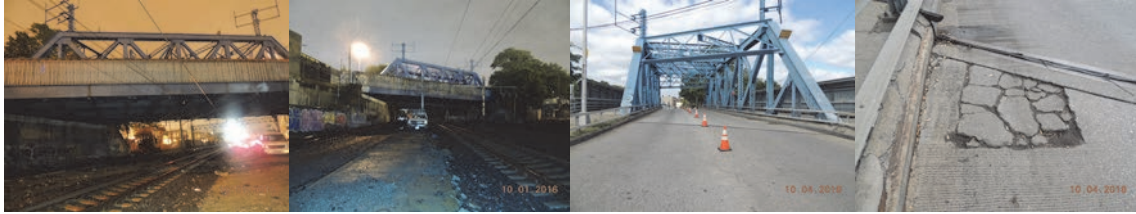
Unionport Road Bridge Over Amtrak – CSX. October 2016: Elevation Left and Right. Beginning Approach. End Approach, Top of Roadway at Right Truss- Exhibits a Spall and Joint Exhibits Torn Sealant. (Credit: NYSDOT)

The Unionport Road Bridge over Amtrak and CSXT was built in 1906. It is a single span truss bridge. The bridge is oriented in the northwest direction, and crosses over three rail road tracks used by Amtrak and CSX Transportation. The bridge carries a single lane of traffic traveling in each direction and two sidewalks. There is a 4-rail steel railing with an 8' high steel protective fence running along both sides of the bridge. The scope of rehabilitation work includes the following: abatement of asbestos containing materials, as required; minor clearing and grubbing; replacing armored joints with armorless joints; replacing the steel fascia girder pedestals in kind; replacing the bottom cover plates of the two floorbeams; steel rehabilitation/replacement of the deteriorated bottom plates at the northwest powerline tower on the top chord; surface preparation and protective coating of the steel; concrete rehabilitation of the south abutment bridge seat and the southwest wingwall; partial-depth reconstruction of the north approach slab over the westbound lane; replacement of the damaged approach guide railing; utility coordination of repairs.; and replacing the deteriorated rivets with high strength bolts. Vehicular and pedestrian access will be maintained during the estimated 10-month rehabilitation period. A full closure of the bridge will occur, however, during the replacement of the floor beam bottom cover plates and the fascia girder steel pedestals. There is a detour plan in place to accommodate this closing.

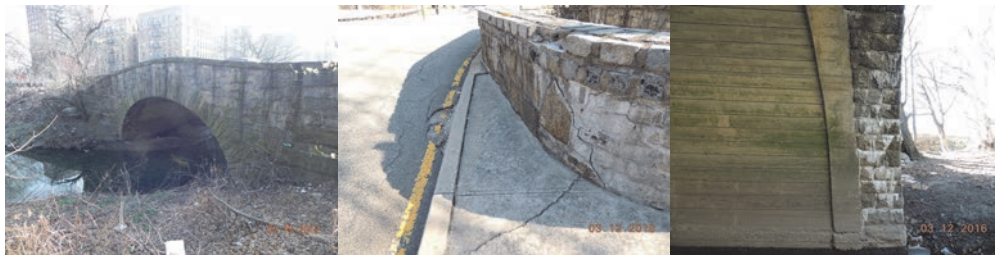
Bronx Boulevard Southbound Bridge Over Bronx River. March 2012: Elevation Left Span. March 2016: Span 1, Right Parapet - Exhibits Spall With a Full Height Vertical Crack. Span 1 – Efflorescence on Underside of Stone Masonry. (Credit: NYSDOT)

The scope of rehabilitation work for both bridges includes the following: clearing and grubbing to be done upstream, downstream and under the bridges; concrete rehabilitation of the cracks, delaminations and spalls at the underside of the arch and the east wingwalls; cleaning the stone parapets and wingwalls (including removing graffiti); repointing of all of the loose mortar; replacing the missing ashlar stones on the east parapet with Belgian blocks; removing and replacing the asphalt concrete overlay on the structure and south approach; placing a waterproofing membrane on the structure; removing silt and sand; and replacing damaged curb and sidewalk. Vehicular and pedestrian access will be maintained during the estimated 8-month rehabilitation period.

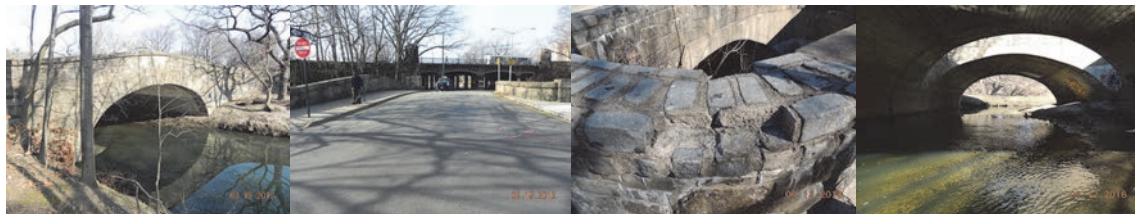
Bronx Boulevard Northbound Bridge Over Bronx River. March 2012: Elevation Right. End Approach. March 2016: Span 1, Left Stone Parapet - Spall Near Beginning Abutment. Span 1, Upstream Channel Looking Left - The Upstream Enters the Underside of the Bridge at a 45 Degree Angle Causing Erosion Along the Left Embankment. (Credit: NYSDOT)

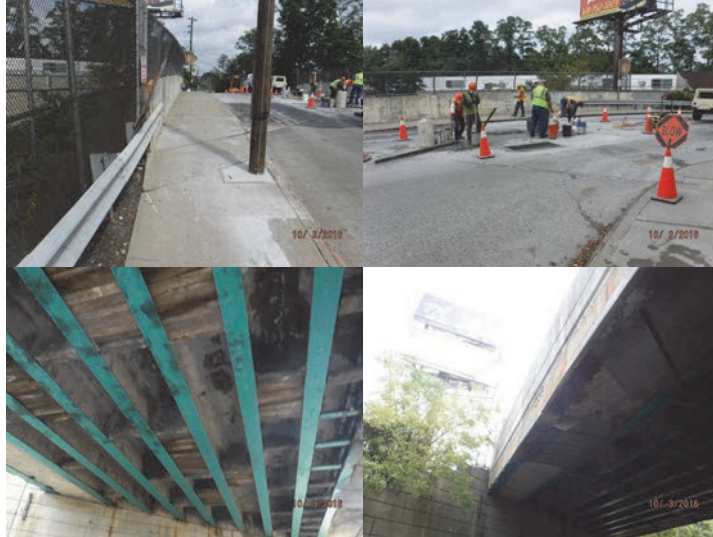
Arthur Kill Road Bridge Over SIRT South Shore. October 2016: Left Sidewalk. Repairing the Wearing Surface at the Beginning Right Side Near the Beginning Abutment. The Wearing Surface has Widespread Cracks and Uneven Asphalt Concrete Patches. Span 1 Underdeck General View of Timber and Wire Mesh Shielding. Stable Hollow-Sounding Areas and Shallow Spalls With Scaling and Efflorescence. (Credit: NYSDOT)

reconstruction of the existing remaining abutments and wingwalls (cracks, spalls, and delaminations); installing new steel framing; constructing a new approach slab and approach roadway; installing new guide railing on the approaches; replacing the water main; and abatement of asbestos containing materials, as required. Vehicular and pedestrian access will be maintained during the estimated 20-month rehabilitation period.

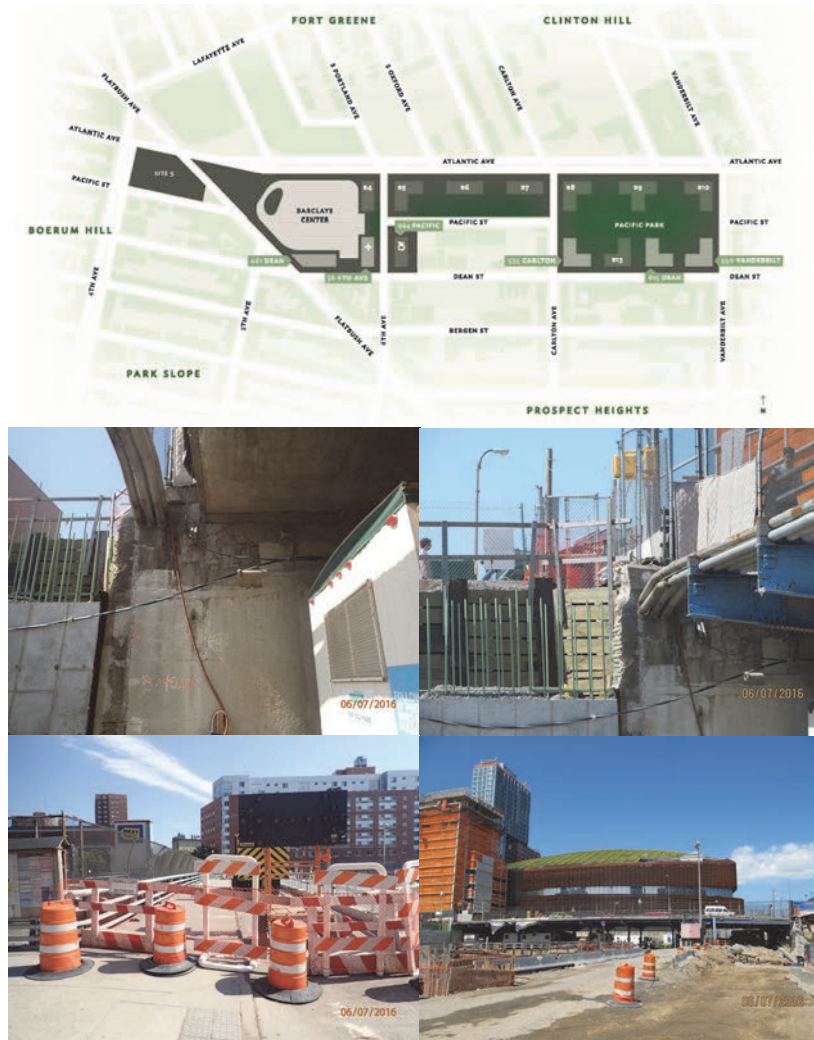
Pacific Park Site Map. (Credit: Greenland Forest City Partners) 6/7/16 6th Avenue Bridge over LIRR Atlantic Avenue. Begin Abutment Right Edge and Right Wingwall – a Large Part of the Wingwall was Saw Cut and Removed During the Ongoing Pacific Park Project. Beginning Approach - Left Sidewalk is Closed due to Ongoing Construction Next to the Bridge. Right Elevation. (Credit: NYSDOT)

In the summer of 2014, as part of the Pacific Park Project, previously known as the Atlantic Yards, Greenland Forest City Partners began major civil engineering and track work in the LIRR train yard east of the 6th Avenue Bridge. This work will facilitate the future construction of a platform over the yard between 6th Avenue and Vanderbilt Avenue. The project also involves construction of the west portal, which is a new tunnel that will connect the rail yard to the LIRR tracks running under Atlantic Avenue, north of the 6th Avenue Bridge. The west portal will allow empty trains to go directly from the terminal to the yard, rather than backtracking and making a large loop to enter the yard from the east. As a result, track time will be freed up for trains carrying passengers. The project also includes a ramp structure from the 6th Avenue Bridge to the rail yard below. Division staff are involved in reviewing the design of the underpinning of the south abutment, the support of excavation drawings behind the north abutment, and the temporary supporting system below the north approach slabs, and the review of the monitoring reports. The work in proximity of the 6th Avenue Bridge and the project are slated to run through 2018.

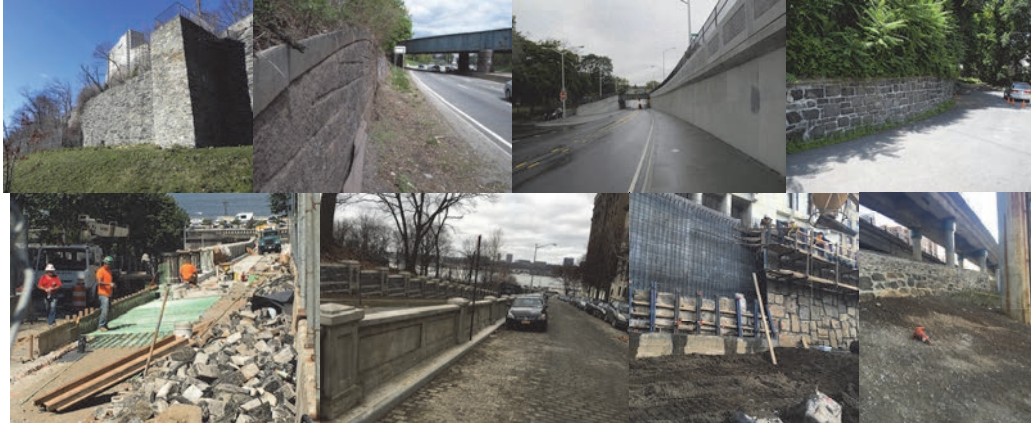
Retaining Walls: Irwin Avenue. Cross Island Parkway Southbound Before 100th Avenue. Cooper Avenue. Douglas Road. 2016: West 155th Street (Lower Level) Between Riverside Drive and Broadway During and After Rehabilitation by DDC. Riverside Drive (Northbound) to George Washington Bridge (West 168th to 171st Streets) During Rehabilitation. Riverside Drive Under George Washington Bridge Ramps (West 176th to 177th Streets). (2016 Credit: Jacob Ayman)

In May 2005, the Department started a program for the periodic inspection of City-owned retaining walls. The City currently owns 635 retaining walls. Those retaining walls were built during the interstate construction program between the 1940's and 1970's and are an important part of the city's street infrastructure. However, some of them are approaching the end of their service lives and are falling into poor condition due to various factors such as spalling/cracking of concrete, loosened mortar joints, broken stone masonry, falling coping stones, deteriorated joints, leakage through the walls due to improper drainage arrangements (clogged weep holes), bulging of walls due to hydrostatic pressure build-up on the back of the walls, and many other problems. In order to protect the infrastructure they support, the retaining walls require regular inspections and monitoring, and depending upon the condition of the walls, rehabilitation/replacement is required. Since 2005, 31 retaining walls have completed rehabilitation/replacement, and 5 retaining walls are in various stages of design and construction. The retaining walls which are in fair to poor condition will be in a capital program for future rehabilitation.

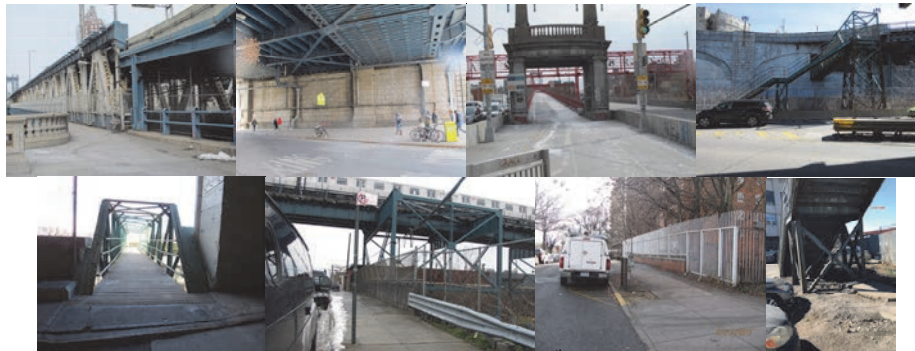
Winter Monitoring Locations: Manhattan, Williamsburg, and West 155th Street Pedestrian Bridge. Fire Hazard Locations: Glenmore Avenue and Ocean Parkway Bridges Over LIRR Bay Ridge, and 51st Avenue Pedestrian Bridge Over LIRR.

In 2017, Inspections covered 93 bridges and 510 spans. Emphasis was placed on ensuring public safety through the monitoring of potentially hazardous conditions and temporary repairs. The unit performed 1,176 monitoring inspections, including special winter monitoring inspections of cellular structures, shorings, and potential fire hazards. In addition, 173 emergency inspections were conducted in response to hot line calls, in-house requests, or citizen complaints.

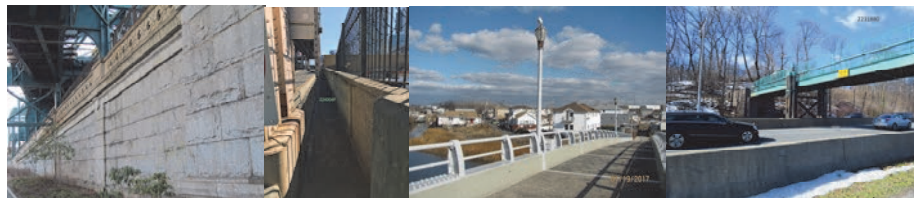
Winter Monitoring Locations: Cellular Structure Locations: Ed Koch – Queensboro Bridge, 163rd Avenue Pedestrian Bridge Over Hawtree Basin, and Crocheron Park Pedestrian Bridge Over Cross Island Parkway.

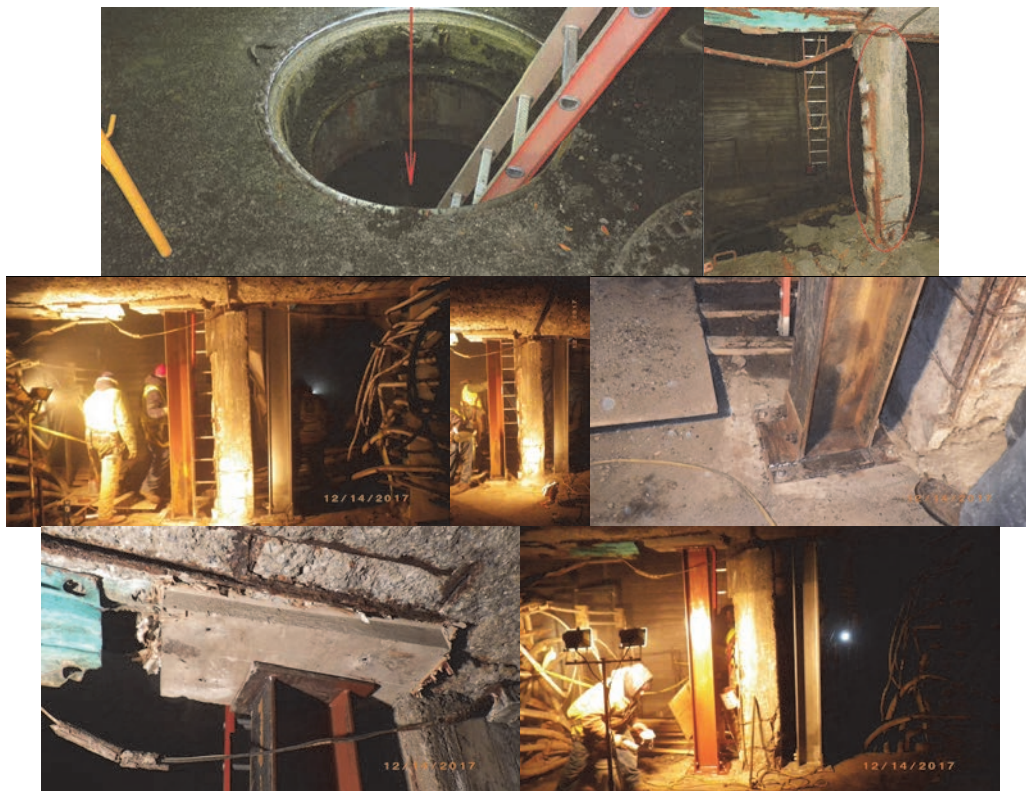
Entrance to the Confined Space. Span 34, Spalled Support Column with Exposed Main Rebars and Broken Stirrups. (Condition Credit: NYSDOT) Repairing the Flagged Conditions.

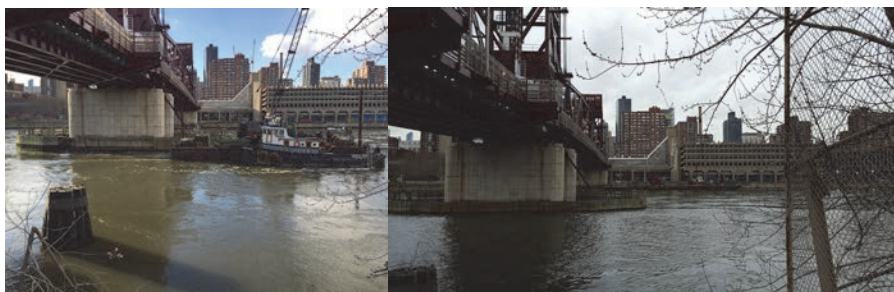
2017: Timber Fender Wall Repairs at the Roosevelt Island Bridge. (Credit: Thomas Leung)

Marine bridge repairs addressed in 2017 include the Roosevelt Island Bridge over the East Channel of the East River, the FDR Drive Cantilever Structure (under the United Nations Building) over the East River, and the West 207th Street Bridge over Harlem River.

Some of these locations experience rapid marine borer activity, causing accelerated deterioration, steel material corrosion due to weather and water elements, as well as repeated damage due to heavy marine traffic and/or a narrow channel. The issuance of new flags occasionally necessitates new visits to even recently completed projects. Timber fender systems especially susceptible to recurring hits by barge traffic, and consequently require periodic restoration in relatively short time periods.

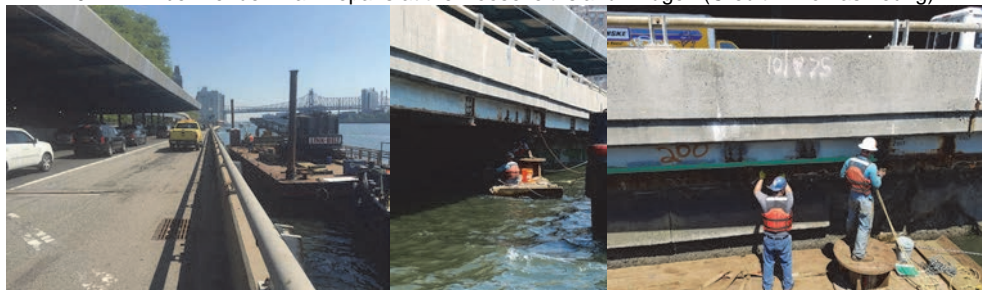
2017: Steel Repairs at the FDR Drive Cantilever Structure. (Credit: Thomas Leung)

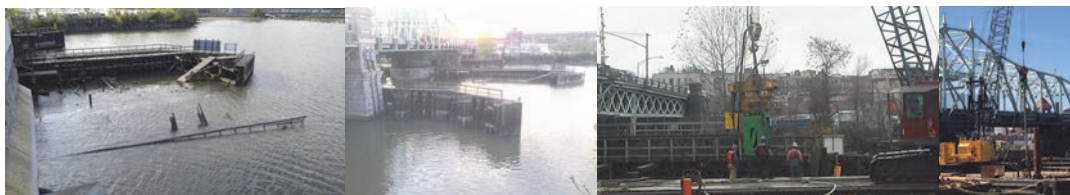
May 2015 – University Heights Collapsed Fender System. Collapsed Fender System in East Channel.
December 2015: Loosening the Existing Wooden Pile to Facilitate its Easy Removal From the River (Mud) Bed. The Vibrating Hammer is Attached to the Crane Initially to Vibrate it and Ultimately Loosen the Existing Piles. . April 2016: Pile Driving Operation.

During the construction phase of the project to replace the north and south fender system, further issues were found beneath the center pier system. Although a full-length timber pile was not feasible, the unit and its contractor determined a way to conduct a difficult but attainable repair. A change in design was initiated to introduce steel H-piles spliced together. This method made it feasible to install a full pile length under the bridge.

The salvage and restoration operations commenced in October 2015, utilizing barge-mounted cranes and associated salvage equipment situated in the East Channel. To date, all dislodged piles and bracing elements have been removed from the East Channel river bed, and the contractor installed 436 new timber piles, an interior timber frame structure, and walkway decking. In addition, an intricate steel frame structure was installed (driving 70 feet length of timber piles) under the bridge to address clearance height issues in 2017. The project is scheduled to be completed in spring 2018.

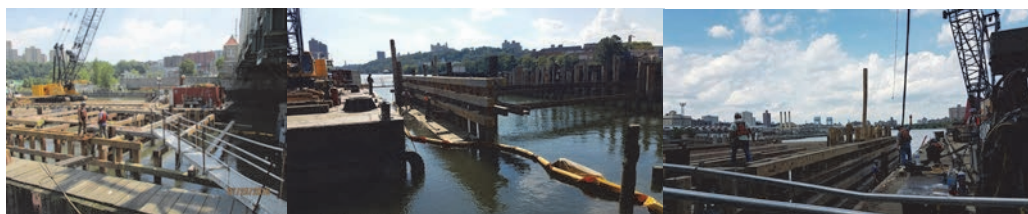
University Heights Bridge in July 2016: Pier 3, Left Side, Repaired Wooden Catwalk. (July Credit: NYSDOT)
September 2016: Installing and Securing the Whaler Timbers at the South and East Faces of the Fender.

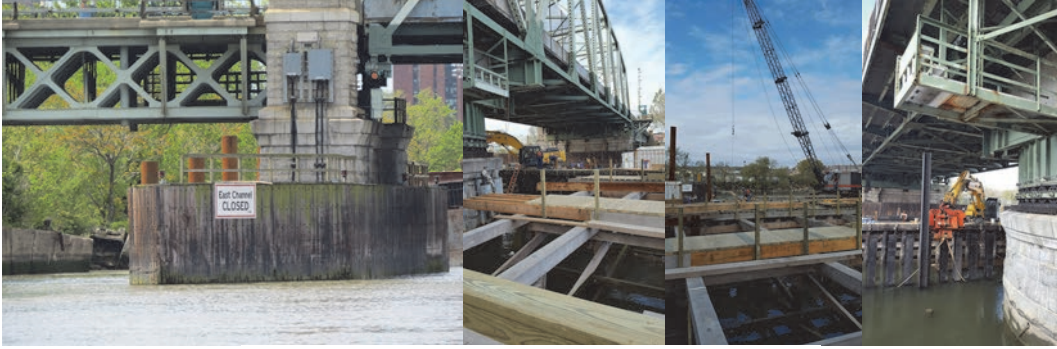
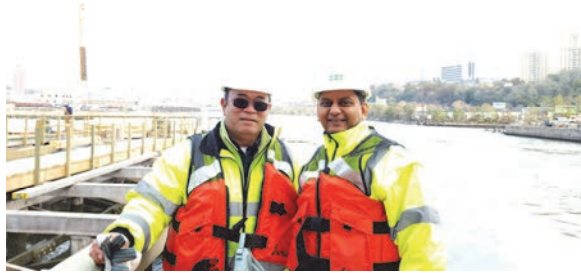
University Heights Bridge in May 2017: East Channel Closed Sign. Repairs in November 2017. Executive Director of Bridge Repair and Preventive Maintenance Roly Parroco and – Senior Director of When & Where /ERBPM Sunil Desai.

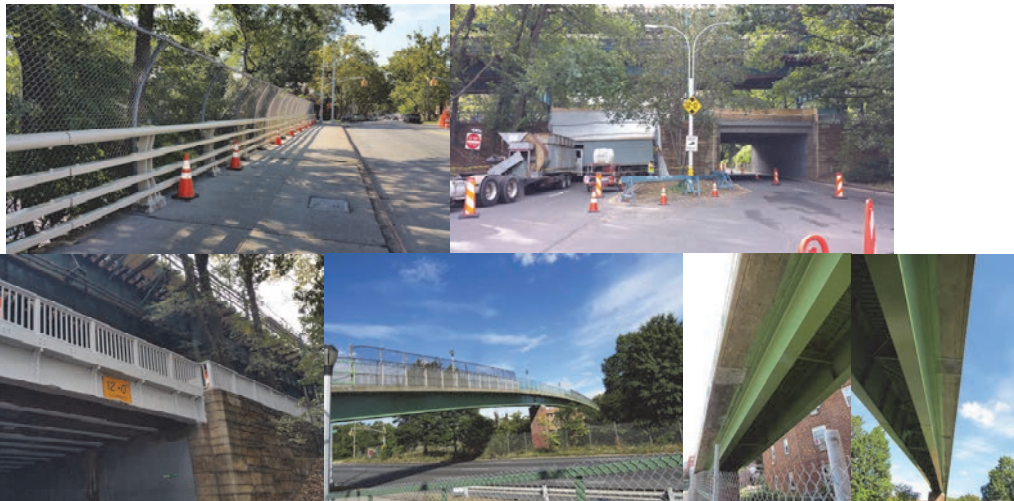
160th Street Bridge over Cross Island Parkway in August 2017. Roosevelt Avenue Bridge over Shea Road in September and November 2017. (Credit: Vadim Sokolovsky) Right Elevation of Whitelaw Pedestrian Bridge Over North and South Conduit Avenue. Underside of Spans 1-3.

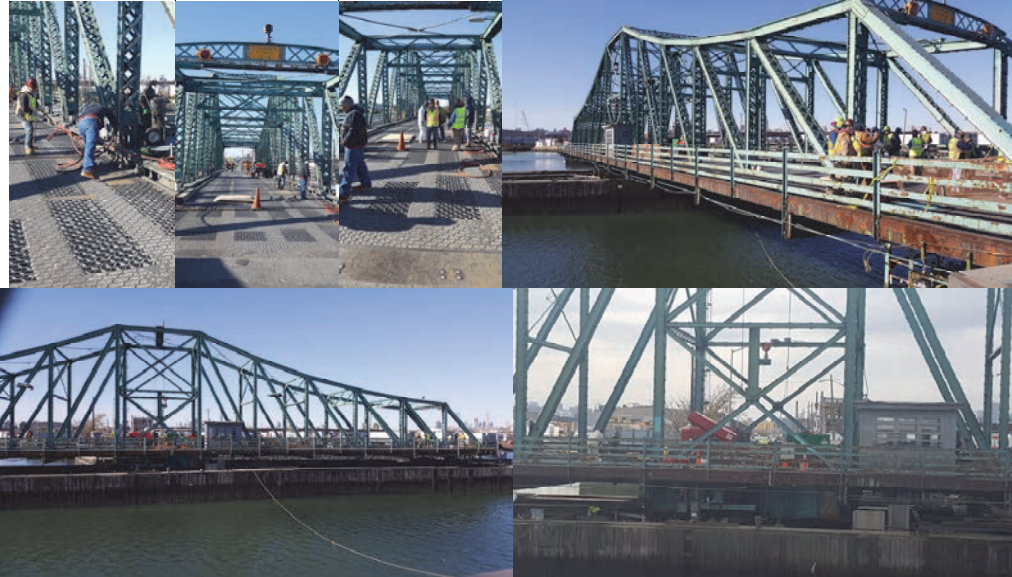
November 2017: Division Crews Addressed Multiple Red PIA Flags on the Grand Street Bridge. Work Included the Repair, Replacement, and Reinforcement of Stringers on Spans #1 and #2 as Well as Repairs to the Deck Grating and Roadway Plates. (Credit: Earlene Powell)

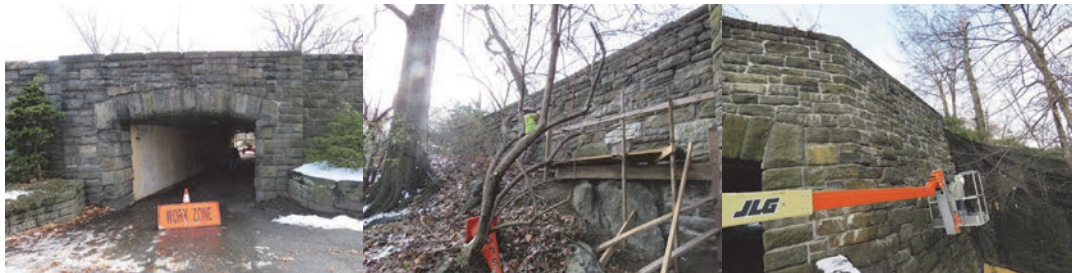
December 2017: Maintenance Workers Adding Mortar to the Joints on the Beginning and Ending Right Side Wing Walls of the Margaret Corbin Drive Bridge over Pedestrian Path Near the North Entrance.

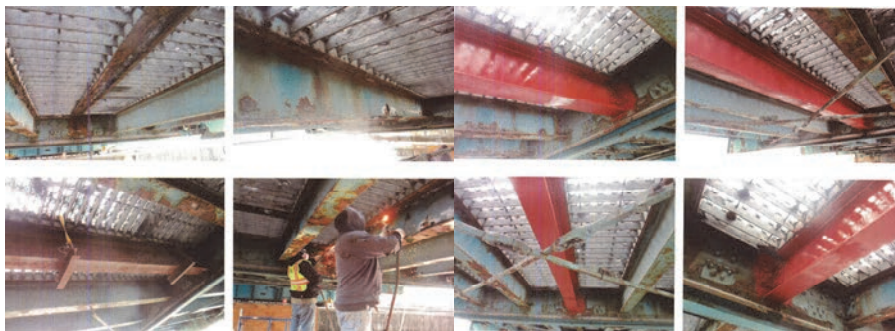
December 2016: Removing and Replacing a Severely Corroded Stringer Under Span 1 on the Grand Street Bridge over the Newtown Creek.

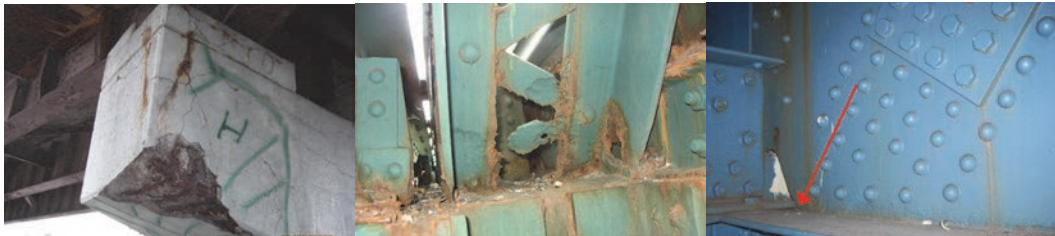
February 2008: Yellow Structural Flag Due to the Deteriorated Cap Beam. October 2008: Corrosion of Steel Secondary Member. November 2008: Crack in Steel Girder.

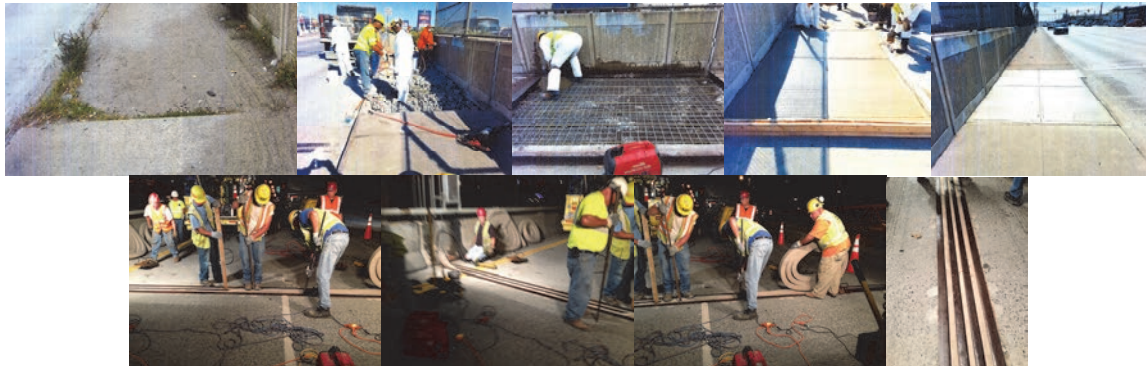
July 2013 Safety Flag: Ironworker and Mason Crews Repairing Missing Joint Seal Materials on the Brooklyn-Bound Williamsburg Bridge. The Joint Sealer Spaces Were Widened on Each Part of the Joint Utilizing the Shop-Made Jack Expansion Blocks, and Then Completely Cleaned With a Needle Gun to Prepare the Surface to be Rough Contacted With Epoxy Glue. After the Glue was Spread on the Sealer Space Surfaces, the Seal Strip was Installed and Tightened. (Credit: Hany Soliman) October 2017: Tripping Hazard on the Right Sidewalk of the Rockaway Boulevard Bridge over Hook Creek.

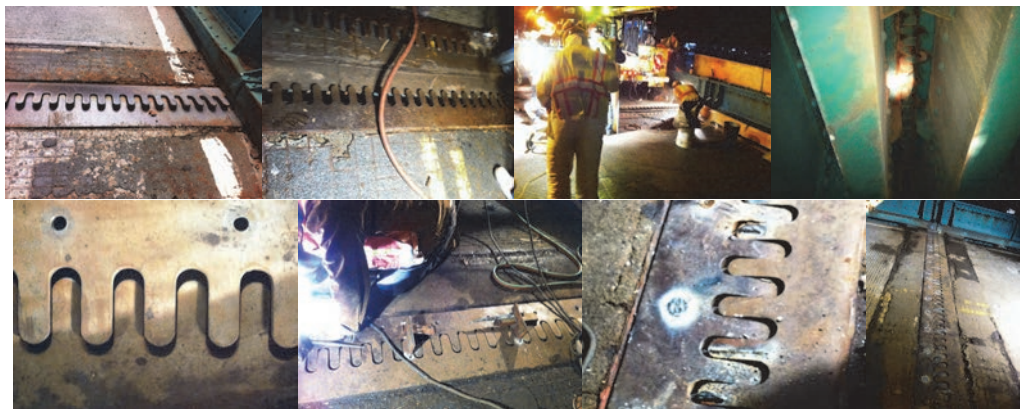
July 2013 PIA Safety Flag on the old City Island Bridge. The repairs, conducted after a record-breaking heat wave, involved opening the joint plates and installing plug welds, which helped correct the plates' position and recreated the proper gap to allow the bridge to expand and contract safely. Finger Joint Before the Repair. Open Finger Joint. Division Crews Repairing the Joints. View Beneath the Finger Joint. The Joint Plates are Placed to Check for the Proper Gap. Leveling the Plate Before Welding. Close-Up of a Plug Weld. After 17 Plug Welds, the Finger Joints Sit Flush on the Roadway.

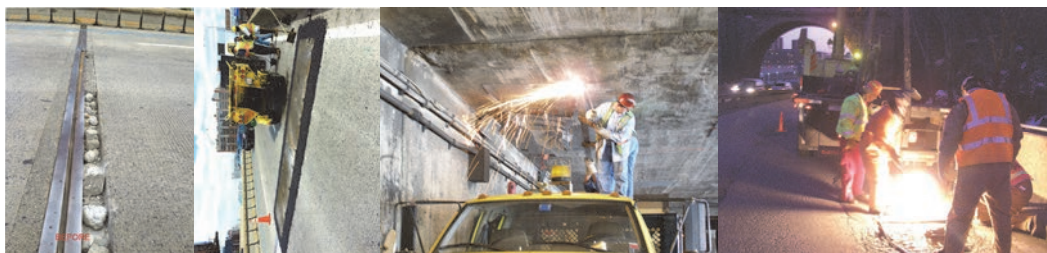
August 2014 PIA Safety Flag: Broken Joint Concrete Header And Steel Armor on the Long Island Expressway over Dutch Kills Creek. The Condition Was Made Safe By Installing Two Steel Plates. PIA Flag (Truck Wedged Under the FDR Drive at Span 41): Removing the Debris. (Credit: Victor Sandoval) PIA Flag Repair (Through Hole) on Harlem River Drive Ramp. (Credit: Bojdar Yanev)

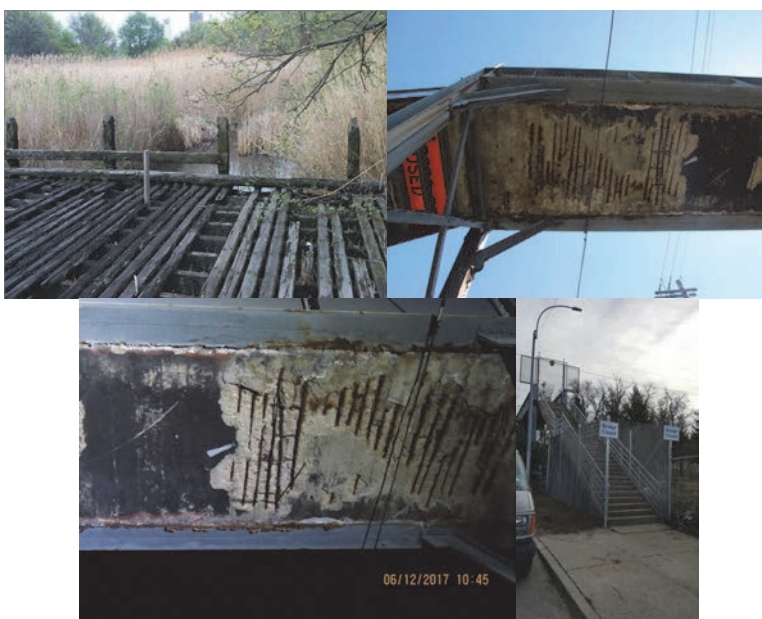
BIN	BOROUGH	LOCATION FEATURE-1	LOCATION FEATURE-2	LOCATION FEATURE-3	REMARKS
2248130	QUEENS	FLUSHING MEADOW PARK PEDESTRIAN	WILLOW LAKE	76 th ROAD	BRIDGE IS IN FLUSHING CORONA PARK, WHICH IS IN A REMOTE LOCATION AND WAS DAMAGED BY FIRE.
7703720	QUEENS	216 th STREET PEDESTRIAN	LIRR PORT WASHINGTON		WILL BE DEMOLISHED BY DDC in 2018.

Flushing Meadow Park Pedestrian Bridge – (Date Unknown). 216th Street Pedestrian Bridge in April 2016: Delaminated Concrete and Detached Exposed Rebar at Span 4 – Deck Underside. June 2017 – Close-up of Span 4. Bridge Closed Sign.

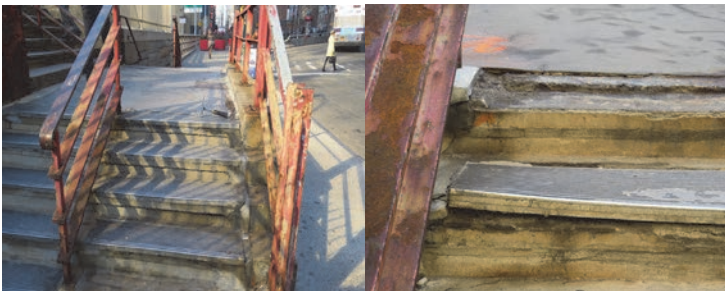
Morris Street Pedestrian Bridge in February 2017: Span #1, Near Beginning Abutment – First Step Tread Plate Missing and Second Tread Plate Broken.

B.I.N.	BORO	FEATURE CARRIED	FEATURE CROSSED	EXPLANATION
- Bridges deleted from the City’s Inventory:				
2268930	M	MORRIS STREET PEDESTRIAN BRIDGE	BROOKLYN-BATTERY TUNNEL PLAZA	TRANSFERRED TO AND DEMOLISHED BY TBTA

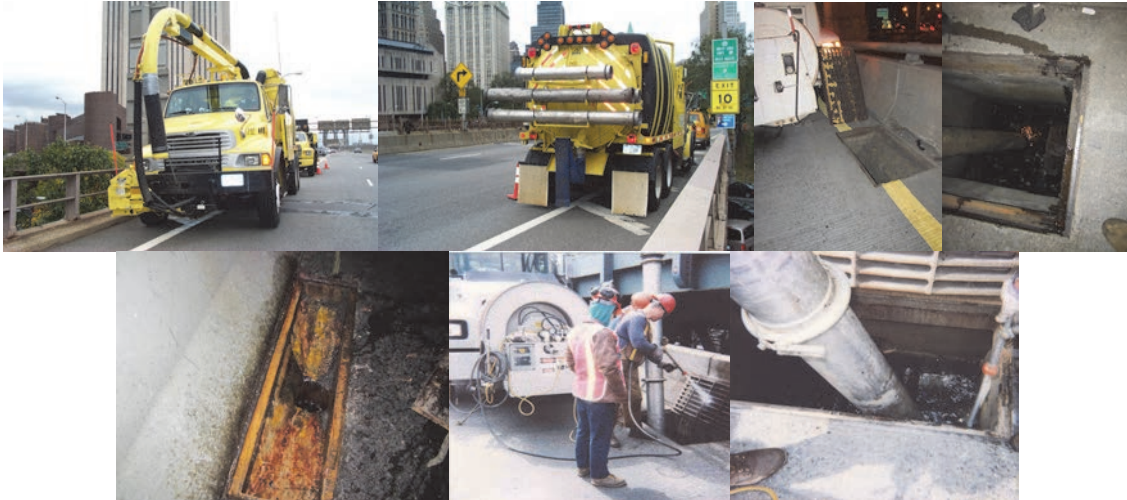
Cleaning of Drainage System Removal of debris, dirt and vegetation from drainage systems, including gutter gratings, gutters and leaders, scuppers, down spouts, clean-outs, and scupper piping systems. The cleaning of surface gratings and gutters requires hand tools, brooms and brushes. In some cases, a vacuum truck is used to clear the drain lines. Cleaning the scuppers and scupper piping systems requires specialized equipment.

Drain Truck on Brooklyn Bridge Ramp. (Credit: Peter Basich) Drain Cleaning on the Williamsburg Bridge in September 2011. (Credit: Shaikh Islam) Cleaning Catch Basins on the Manhattan Bridge.

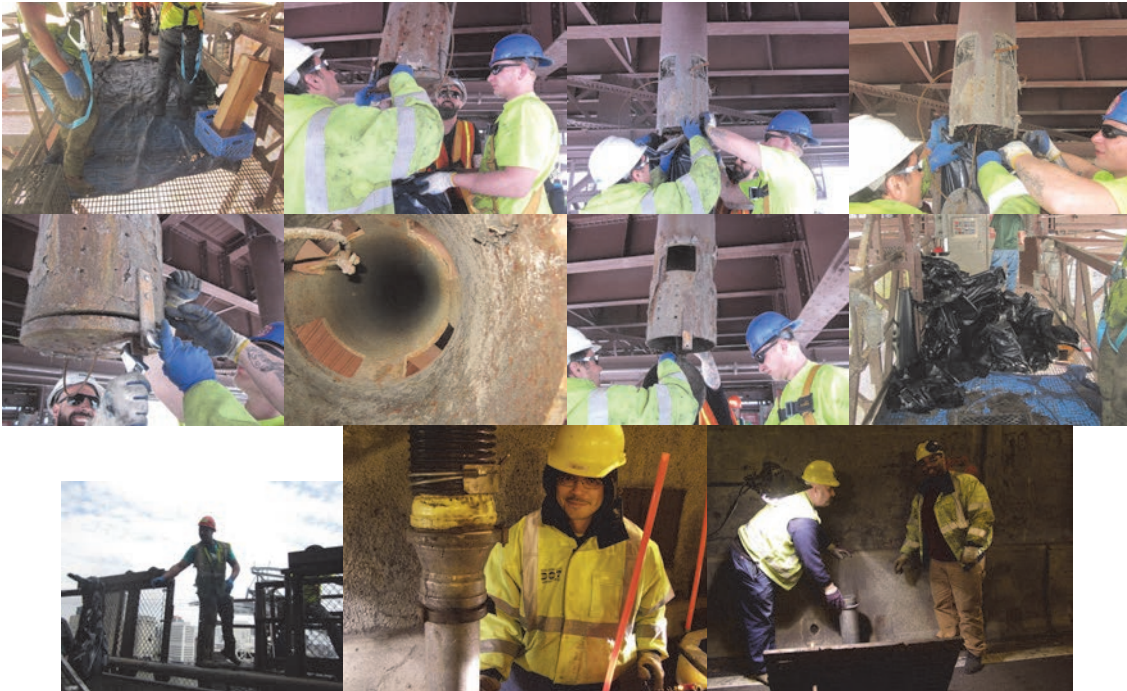
Preventive Maintenance Contractors on Traveler #3 South on the Ed Koch – Queensboro Bridge Conducting Drainage Cleaning. Drain Crew: Highway Repairer Anthony Irizarry, Supervisor Highway Repairer Michael Parise, and Assistant City Highway Repairer Giavonni Caballero. (Crew Credit: James Campbell)

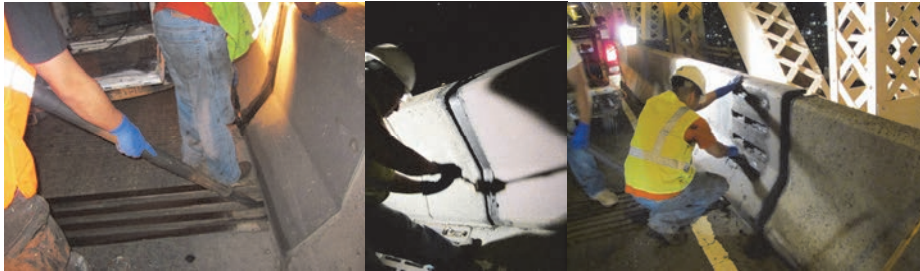
Expansion Joint Cleaning on the Williamsburg and Ed Koch - Queensboro Bridges in September 2011. (Credit: Shaikh Islam)

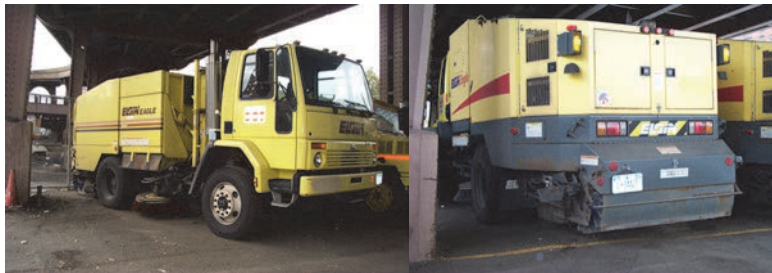
Sweeping Sweeping each bridge with a mechanical sweeper along each curb. Bulk debris is removed by hand in advance of the mechanical sweeper, which then removes smaller debris such as litter, rocks, and sand to prevent clogging of drainage systems and trapping of moisture against the curbs.

Mechanical Sweeper – Side and Rear Views. (Credit: Peter Basich)

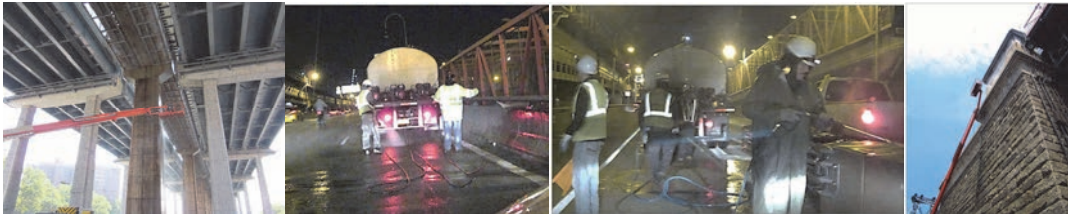
Washing of Decks and Salt Splash Zones Washing of decks, under-decks, substructures, and salt splash zones to remove remnants of de-icing salts; use of water jets to clean tight corners.

Washing the Williamsburg Bridge in July 2011 and May 2015.

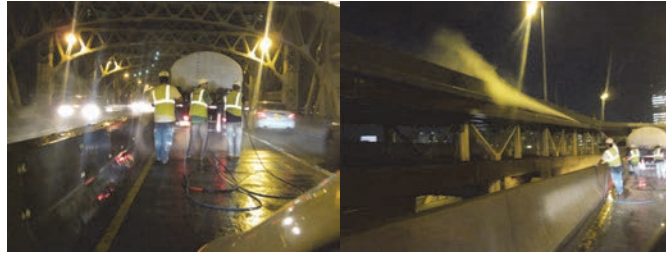
Washing the Ed Koch Queensboro Bridge in August 2011.

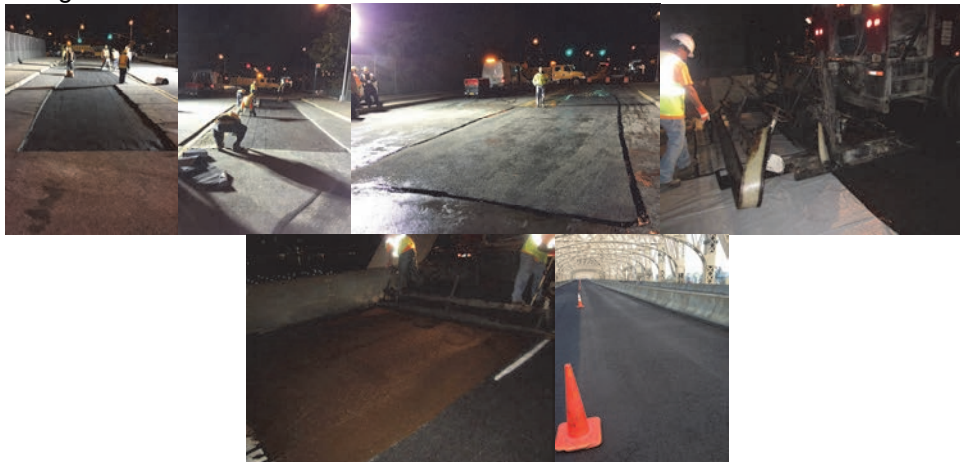
Replacement of Wearing Surfaces Removal of old wearing surface; preparation of exposed concrete slab or steel plate; installation of new wearing surface. The wearing surface is a minimum two-inch course of bituminous concrete. Also includes minor deck repair, cleaning and waterproofing of deck.

November 2014: Wearing Surface Repairs at 149th Street over the Cross Island Parkway. Applying the Waterproofing Membrane. The Finished Patch. (Credit: Steve Mezzacappa) Resurfacing the Deck of the Queens-Bound Upper Roadway of the Ed Koch - Queensboro Bridge in June 2014. (Credit: Sunil Desai)

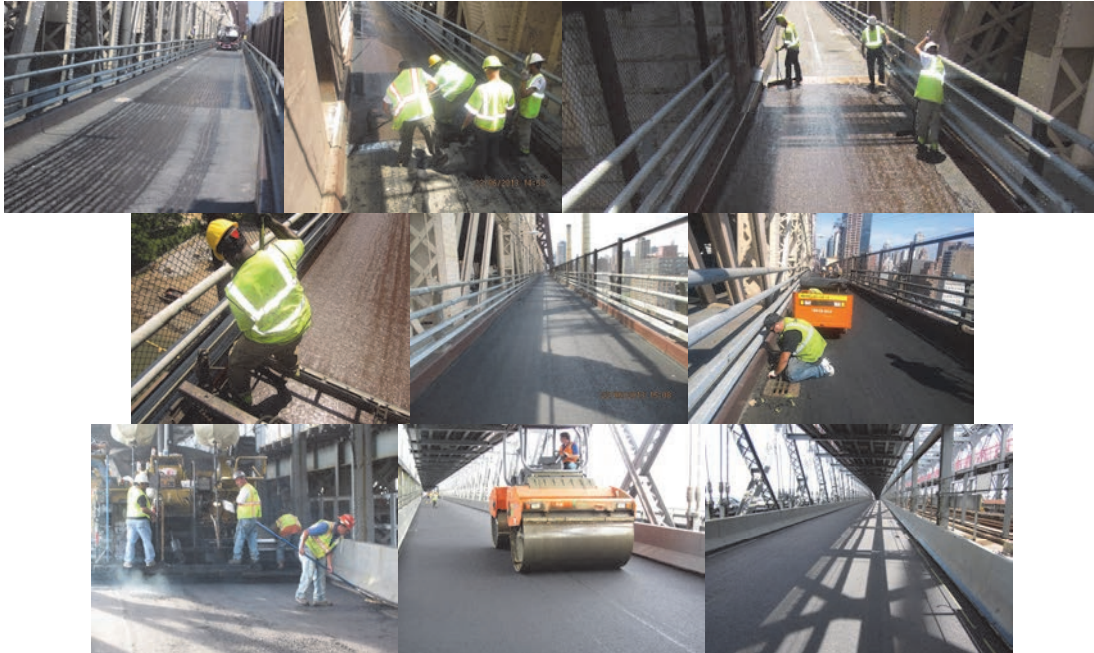
Repairing the Concrete Overlay on the South Upper Roadway of the Ed Koch – Queensboro Bridge in June 2013.
(Credit: Sunil Desai) Repaving the Williamsburg Bridge in 2011.

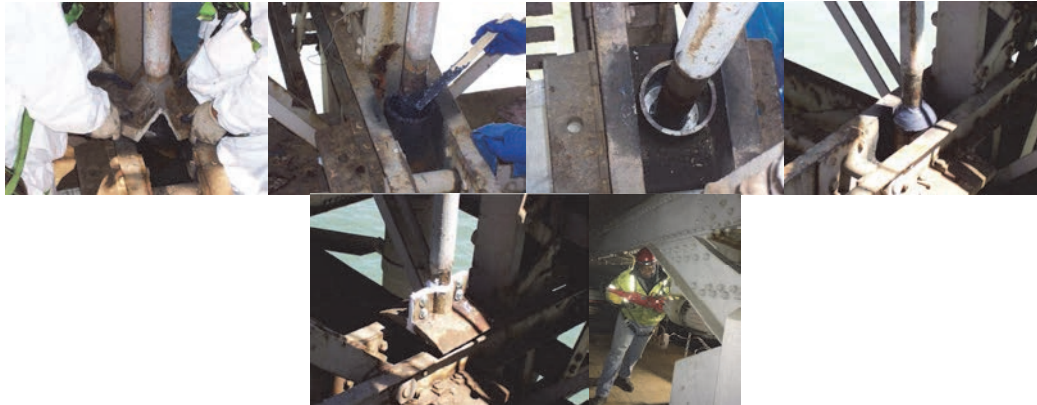
Maintenance of Mechanical Components Cleaning and lubrication of all movable parts for the four East River Bridges and the twenty-four movable bridges. In addition, specialized maintenance is performed on the bridge cables and eye-bars inside the anchorages, and on the solid rods on the suspended spans of the East River bridges, cleaning and lubrication of the travelers' mechanical components; cleaning of truss, sliding-surface, stringer, and roller bearings; cleaning and lubricating air and fire line valves. Cleaning and lubrication is required to keep components from corroding and becoming immobile. Allowing components to seize could cause operating failure and introduce unsafe structural stresses.

Cleaning and Lubricating the Solid Rods' Suspender Bearings on the Brooklyn Bridge. Oiler Rene Francis on the Madison Avenue Bridge During a Manual Opening of the End Lift Machinery. (Credit: Vera Ovetskaya)
