2017 NYC DOT

Bridges & Tunnels Annual Condition Report

NEW YORK CITY DEPARTMENT OF TRANSPORTATION DIVISION OF BRIDGES 2017 BRIDGES AND TUNNELS ANNUAL CONDITION REPORT

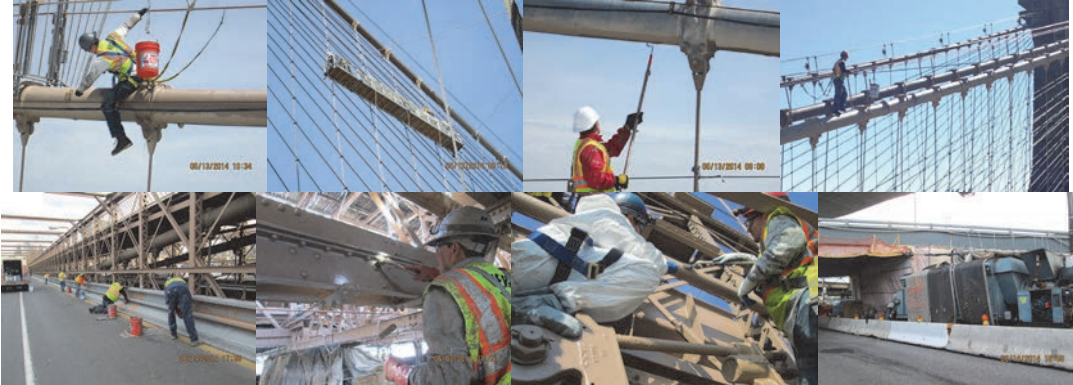
Equipment includes blasting machines, needle guns, spray pumps, compressors, dust collectors, filters, and ductwork.

Brooklyn Bridge Contract #6 in 2014 - Painting Main Cables and Suspension Ropes. Painting at Main Bridge – Safety Barrier and Touchup. Containment at Ramp A, Span 4.

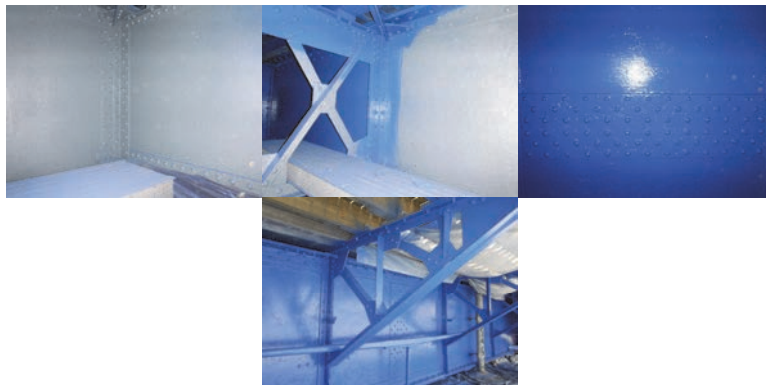
Movable Bridge Preventive Maintenance Contractor Removing Paint and Repainting on the Borden Avenue Bridge.

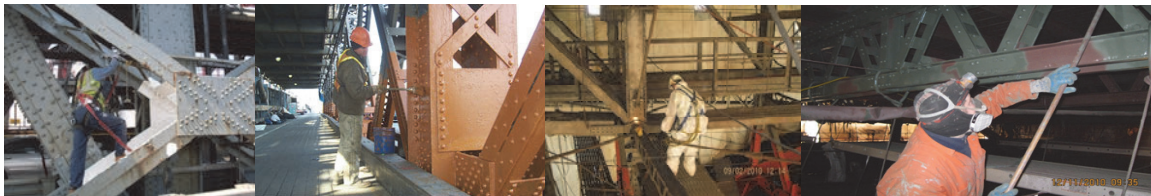
Salt Splash/Spot Painting This is a new process that combines salt splash with spot painting. It involves preparation of the area to be painted by power wash, using clean water or steam. Solvent cleaning is done in locations where oil and grease need to be removed from the steel surface. Areas to be power washed and painted are: the superstructure (up to six feet upwards from the deck), the underdeck steel (up to three feet from each side of the center line of the expansion joints), and the outside of the bridge's steel faces. In addition to these painted areas, we now perform localized surface preparation and painting of any deteriorated locations as mentioned in our spot painting definition above. After power washing, hand and power tools are used in areas that have started to show deterioration from accumulated de-icing agents. Power tool cleaning is performed in a Class 3P containment, and hand tool cleaning in a Class 4 containment. Combination hand/power tool cleaning is performed in a Class 3P containment. A spot primer coat and finish coat are then applied by brush or roller. Occasionally, when there is no danger of overspray, spray painting may be performed.

Williamsburg Bridge in June 2010: Application of Finish Coat at North Truss Diagonal. Salt Splash Painting on the Williamsburg Bridge. (Salt Splash Credit: Fouad Althaibani). Inspection of Blasting Surfaces Inside the Franklin Square Arch Containment in September 2010. Brooklyn Bridge Main Span Painting in December 2010.

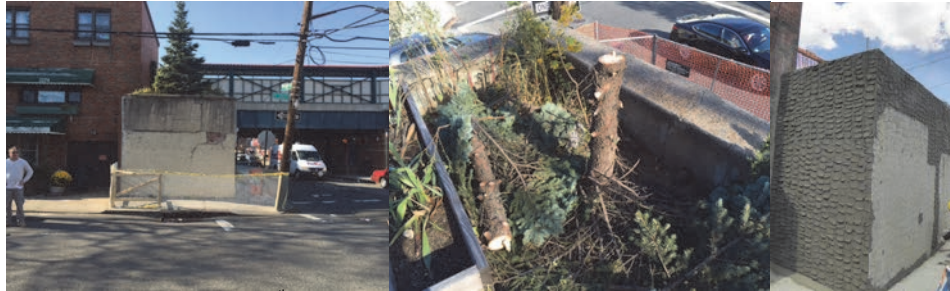
East 16th Street Retaining Wall – Before and After Repairs.

From the start, the lack of as-built drawings, or any substantial drawings, required research into other similar structures in the area to find clues relating to how the subjected wall was originally built. After determining the original wall was a concrete gravity-retaining wall, a work plan was executed in a methodical and deliberate fashion to ensure structural integrity. The damaged section of the wall was removed by hand, revealing a shear failure between the original concrete

wall and the masonry block addition, caused by a large amount of fill and plant growth placed on top of the original wall. The addition as well as the section of the original wall that had deteriorated was removed, as well as the fill behind it. An unstable brick veneer wall was removed, and a new section of concrete wall and cap was built, tying into the existing structure by grouting epoxy coated #5 reinforcing bar. Existing cracks were patched with epoxy and a stucco finish was reapplied. All of this work was completed without damaging the existing patio on private property. Fences were erected for public safety and the sidewalk was returned to service. The repair work began on April 24, and was completed by May 12, 2017.

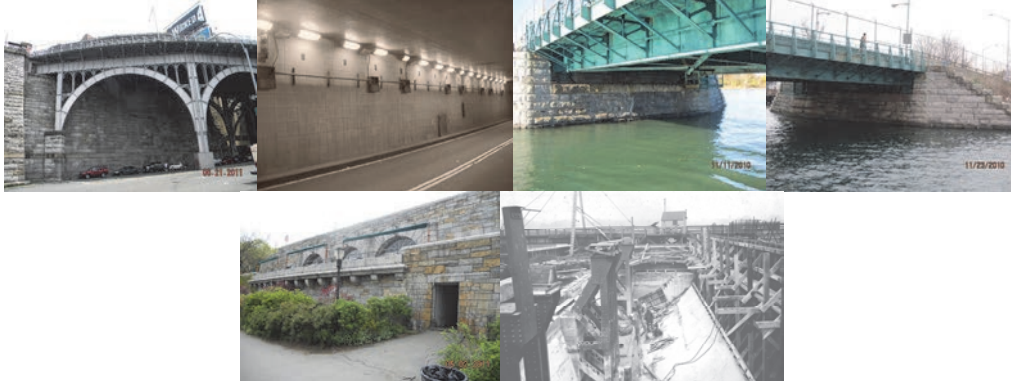
ABUTMENT - Walls of reinforced concrete or masonry. Abutments support a bridge's SUPERSTRUCTURE and APPROACHES, as well as retain the embankments that are positioned at the extreme ends of a multi-span bridge.

Riverside Drive Viaduct Abutment End. Battery Place Underpass Abutments. City Island Bridge Beginning and Ending Abutment. 79th Street Traffic Circle Abutment End. (Credit: NYSDOT) Constructing the Abutment of the Eastchester Bridge in 1921.

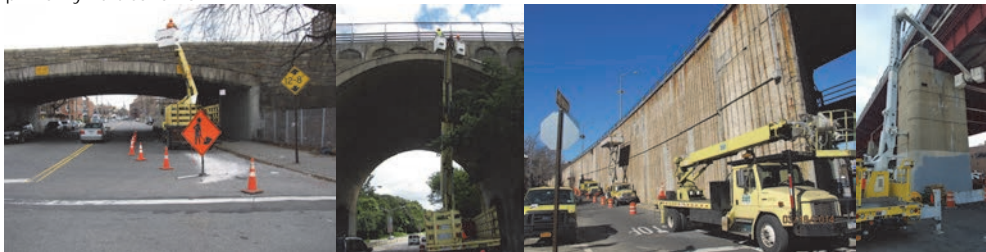
AERIAL LIFT - Any vehicle-mounted device used to elevate personnel, including: extendable boom platforms, aerial ladders, articulating (jointed) boom platforms, vertical towers, or any combination of these. Aerial lifts have replaced ladders and scaffolding on many job sites due to their mobility and flexibility. They may be made of metal, fiberglass-reinforced plastic, or other materials. They may be powered or manually operated, and are considered to be aerial lifts whether or not they can rotate around a primarily vertical axis.

Inspecting the Belt Parkway Bridge over 26th Avenue in December 2012. (Credit: Artemio Angeles) Nereid Avenue Bridge over Bronx River Parkway in June 2012 - Using a 60 Foot Boom With Outriggers. (Credit: Bojidar Yanev) Brooklyn-Queens Expressway (Eastbound) over Cadman Plaza/Brooklyn-Queens Expressway (Westbound). Pulaski Bridge in July 2017. (Credit: Mitul Patel)

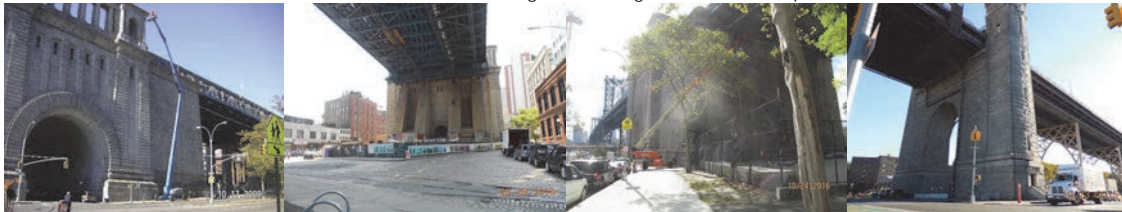
ANCHORAGE - A solid mass, usually comprised of concrete, that encases a grillage of heavy steel bars into which the ends of a SUSPENSION BRIDGE'S main CABLES are anchored. Anchorages are designed to resist the pull of the cables.

Inspecting the Exterior of the Manhattan Bridge Anchorage. Manhattan Bridge Brooklyn and Manhattan Anchorages. Ed Koch - Queensboro Bridge Queens Anchorage (Credit: NYSDOT)

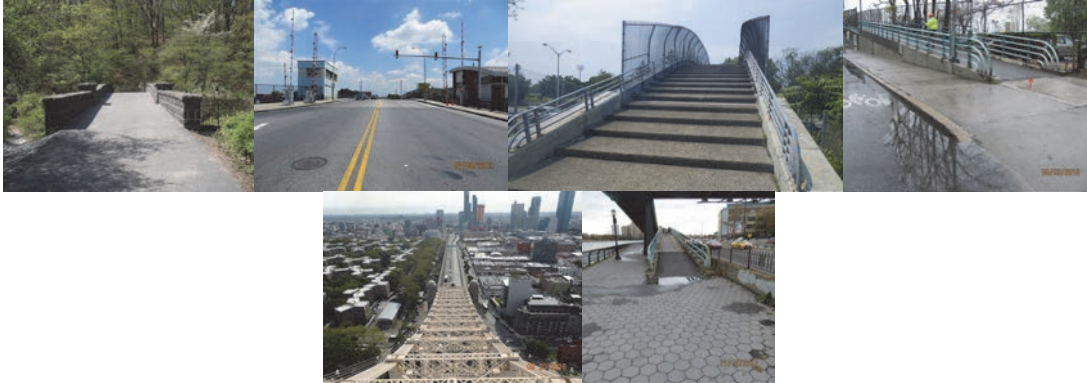
APPROACH - Roadway at each end of a bridge, beyond the ABUTMENT, providing access to the bridge.

End Approach to Bridge Over Dam at Clove Lake. Metropolitan Avenue Bridge Approach. (Metropolitan Credit: NYSDOT) Belt Parkway Bridge over 26th Avenue Approach. (Credit: Artemio Angeles) Begin Approach to Delancey Street Pedestrian Bridge Over FDR Drive. Ed Koch - Queensboro Bridge Approach. End Approach to East 120th Pedestrian Bridge Over FDR Drive. (QBB and East 120th Street Credit: NYSDOT)

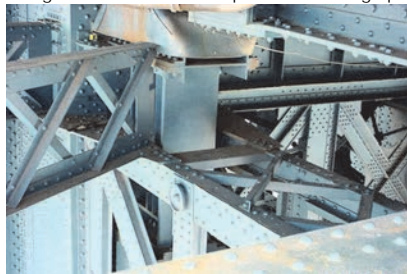
BEARINGS - Designed to transmit the load from the SUPERSTRUCTURE to the SUBSTRUCTURE. Divided into two types, expansion and fixed, bearings are needed to ensure that certain elements are not forced to take more load than that for which they were designed and that the bridge can move slightly under load and temperature changes as needed. Bearings that do not allow for horizontal movement of the superstructure are referred to as fixed bearings. Bearings that allow for horizontal movement of the superstructure are known as expansion bearings. Both fixed and expansion bearings permit rotation.

Truss Bearing on Manhattan Bridge. (Credit: NYSDOT)

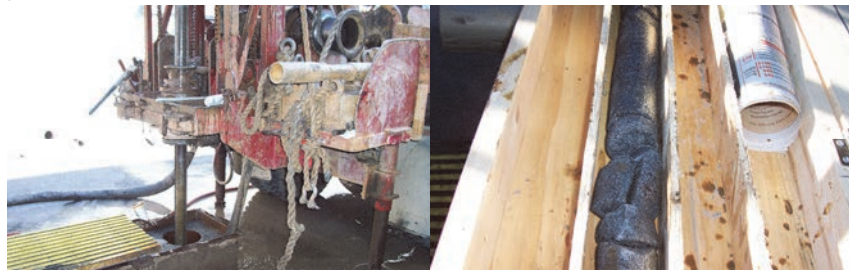
BORING - A soil exploration technique of drilling into the ground at various locations in an attempt to construct an accurate subsurface profile.

Conducting Soil Borings in 2008 as Part of the Seismic Retrofit Design of the Manhattan Bridge. Drilling to a Depth of Approximately 210 Feet to Obtain an 8-foot Long Hard Rock Sample. A 2 1/2 - Foot Long Hard Rock Sample Taken From a Depth of Between 202 and 204 1/2 Feet.

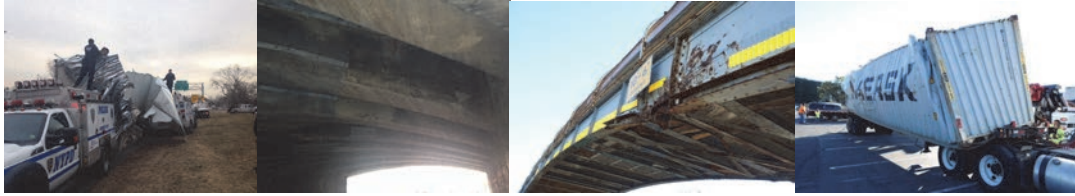
BRIDGE STRIKE - An incident in which a vehicle, its load or equipment collides with a bridge. A majority of these strikes occur on low-vertical clearance bridges over parkways or other local roadways prohibited to truck traffic.

Douglaston Parkway Bridge Strike in 2015: Police Observing the Truck Damage. Underside of Bridge Concrete Beams Only Exhibited Scratches. (Credit: Artemio Angeles) 17th Avenue Pedestrian Bridge Strike in 2015.

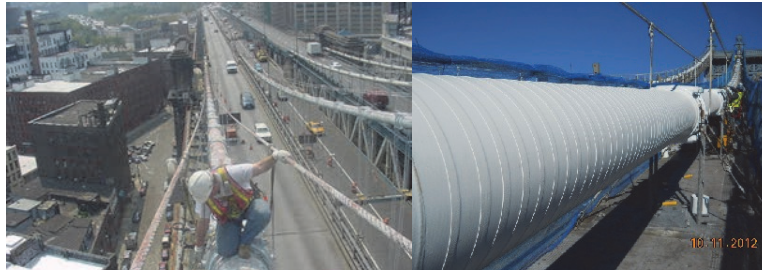
CABLE - A steel rope, composed of parallel or twisted wires, used to support the road deck of SUSPENSION BRIDGES or CABLE STAYED BRIDGES.

Inspector on Manhattan Bridge Cable. Cable B. (Credit: NYSDOT)

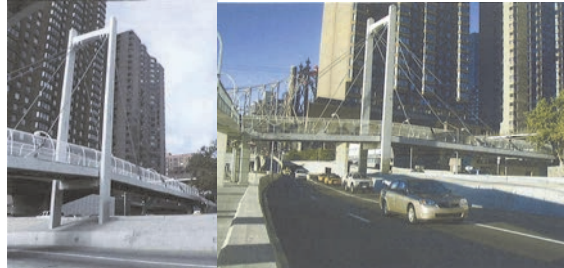
CABLE STAYED BRIDGES - Bridges in which the superstructure is directly supported by cables, or stays, passing over or attached to towers located at the main piers.

East 64th Street Pedestrian Bridge over FDR Drive.

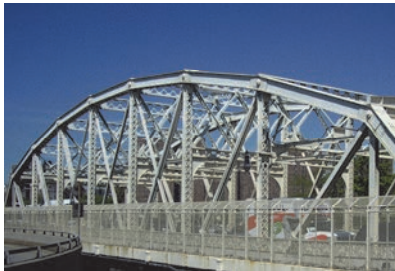
CAMELBACK TRUSS - A TRUSS having a curved top chord and straight bottom chord meeting at each end. There is a camelback truss on the Macombs Dam Bridge.

Macombs Dam Camelback Truss.

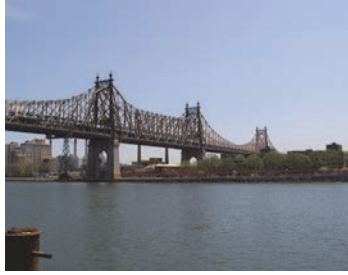
CANTILEVER BRIDGES - A cantilever is a BEAM that is supported only on one end. In a cantilever bridge, the tree branch-like beams project toward each other, forming a span of the bridge when connected in the center. Bridges of this type are economical to build because they require less material in construction and less condemnation of property is necessary for the narrow piers which are sufficient for support. Typically, no FALSEWORK is required during construction and the bridge does not exceed 1,800 feet in length. NYCDOT's *Ed Koch Queensboro Bridge* is a notable example of this type of structure.

Ed Koch Queensboro Bridge. (Credit: Russell Holcomb)

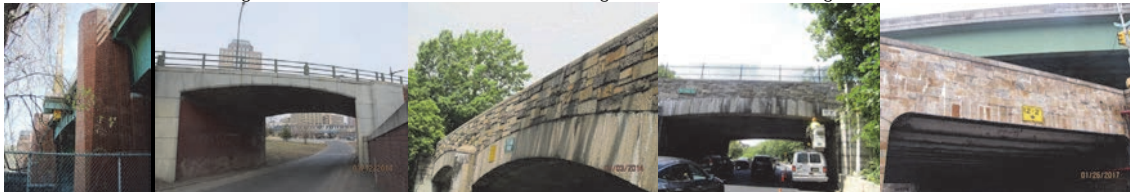
CLADDING - Non-load-bearing stone or brick veneer used as the facing material in exterior bridge wall construction.

Hutchinson River Parkway Bridge. Brooklyn-Queens Expressway Over Ramp to Brooklyn-Queens Expressway (Eastbound). Right Side Fascia on the Bronx Pelham Parkway Bridge. Inspecting the Cladding Stones of the Fascia of Span 1 on West 252nd Street Bridge Over Henry Hudson Parkway. Eliot Avenue Bridge Over Queens Boulevard.

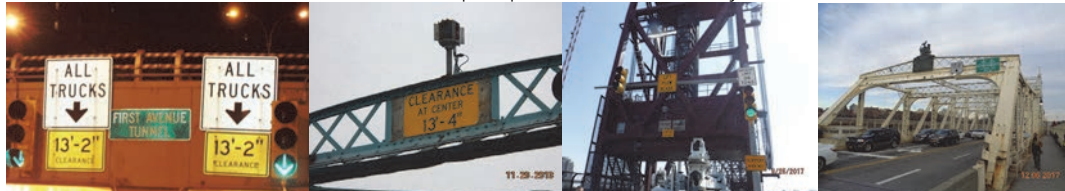
CLEARANCE - The unobstructed vertical and horizontal space provided between two objects.

United Nations – 1st Avenue Tunnel, Grand Street, Roosevelt Island, and Macombs Dam Bridge Vertical Clearance Posting. (Credit: NYSDOT)

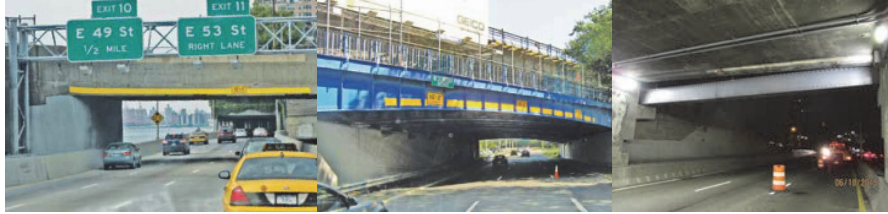
Retro-reflective Material Improves Visibility of These Low Vertical Clearance Bridges: East 60th Street Bridge Over FDR Drive and Westchester Avenue Bridge over Hutchinson River Parkway. Vertical Clearance Beam at Span 53, Southbound Roadway of the Promenade over the FDR Drive. (FDR Credit: NYSDOT)

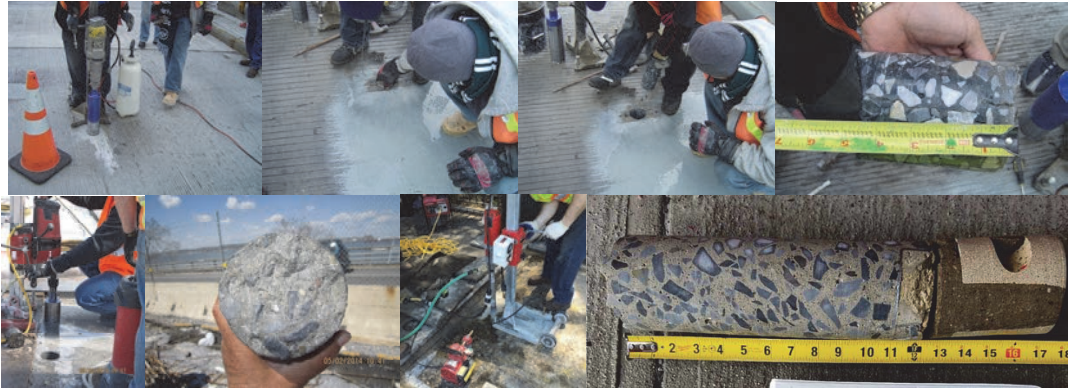
CORE - A cylindrical sample of concrete removed from a bridge component for the purpose of destructive testing.

Removing a Core From 252nd Street Bridge over Henry Hudson Parkway in January 2009. (Credit: Masroor Mahmood) Core Sampling on the Bay Ridge Avenue Bridge in 2014. Utilizing a Coring Machine to Obtain a Concrete Core for Testing in June 2016 from the Westbound BQE over Adams Street.

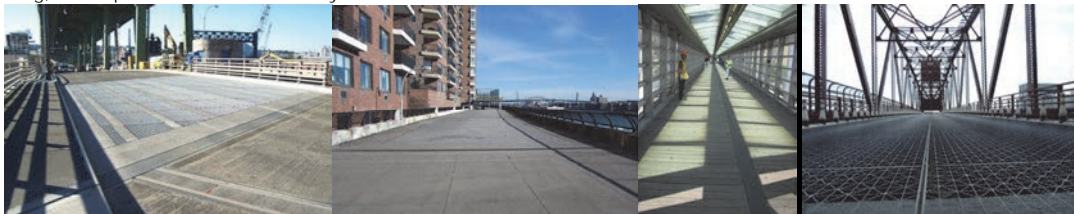
DECK - The supporting slab and wearing surface of a bridge. Since the deck is directly affected by traffic loads, it's most susceptible to traffic-related problems such as: traffic abrasion, corrosion effects of deicing chemicals, live load deflections and cracking, and impact loads that materially increase as the deck surface deteriorates.

Hamilton Avenue Bridge, East 81st to East 90th Street Promenade over FDR Drive, Chambers Street Pedestrian, and Roosevelt Island Bridge Decks. (Hamilton and FDR Drive Credit: NYSDOT)

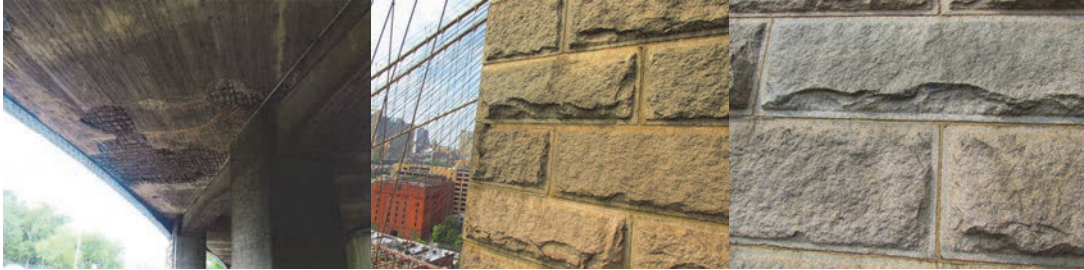
DELAMINATION - The subsurface separation of concrete or steel into layers. Delaminated areas give off a hollow "clacking" sound when tapped with a hammer or chain drag. Hammer-sounding of large areas generally proves to be extremely time consuming. More productive sounding methods are available when working with horizontal flat surfaces. Chain dragging accomplishes the same result as hammer-sounding. As the chain is dragged across a concrete surface, a distinctly different sound is heard when it crosses over a delaminated area. When a delaminated area completely separates from the member, the resulting depression is called a SPALL.

Hollow Sounding And Delaminated Concrete Areas With Exposed Rebars on the Sunrise Highway Bridge Westbound over Laurelton Parkway in 2014. Brooklyn Bridge Tower Stone Delamination in 2016.

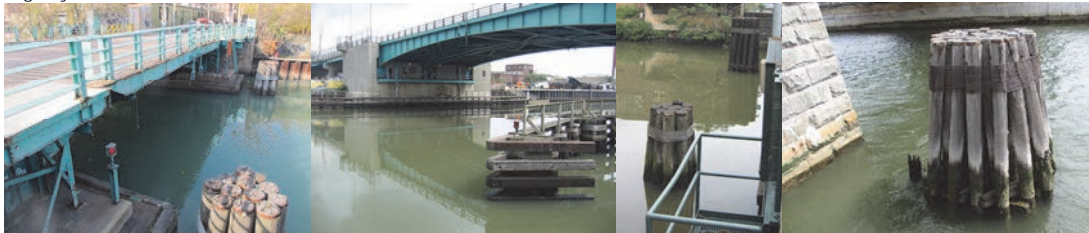
DOLPHIN - A group of PILES driven close together and placed to protect portions of a bridge or other structure exposed to possible damage by collision with marine traffic.

2014: Union Street Bridge Dolphins. Greenpoint Avenue Bridge Dolphin & Fender System. (Greenpoint Credit: Peter Basich) Hunters Point Avenue Bridge Dolphins. (Credit: Michele N. Vulcan) 145th Street Bridge Dolphin. (Credit: NYSDOT)

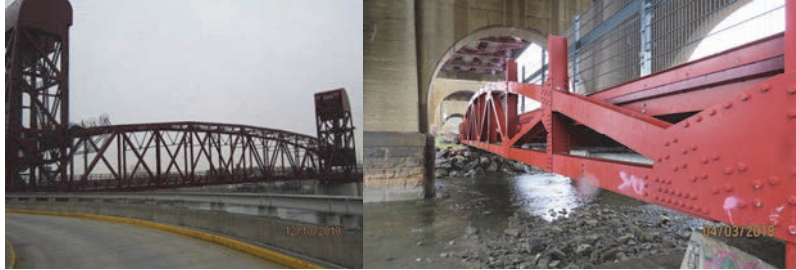
ELEVATION VIEW - A photograph or drawing of the side view of a structure.

Elevation View of Roosevelt Island Bridge. (Credit: NYSDOT) Right Elevation of Span 3 of the Randall's Island Connector Bridge over the Bronx Kill.

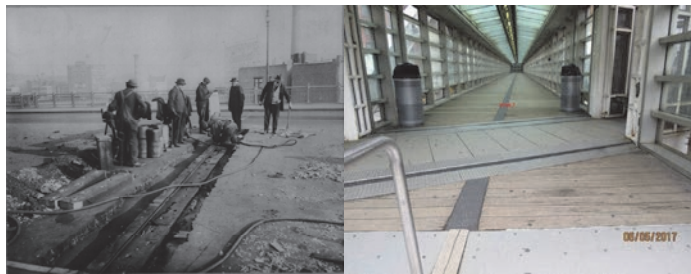
EXPANSION JOINTS - Located between bridge spans, expansion joints are located in the deck, directly above the BEARINGS. Expansion joints allow parts of the structure to expand independently and therefore relieve stresses that may otherwise cause damage.

Constructing an Expansion Joint on the Riverside Drive Viaduct in 1918. Joint for Span 7 on the Chambers Street Pedestrian Bridge in 2017.

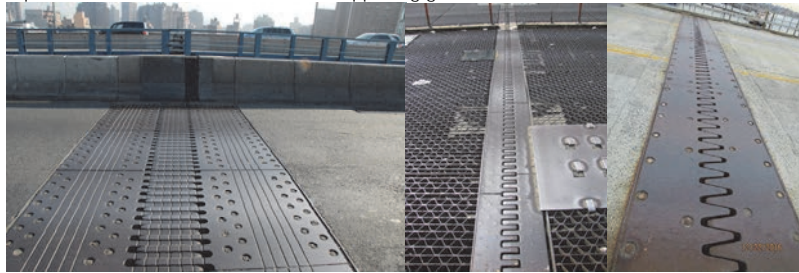
FINGER DAM - EXPANSION JOINT in which the opening is spanned by meshing steel fingers or teeth. Finger plate joints are made up of two loosely interlocking pieces of steel plates that cantilever out into the deck joint opening. The cantilevered portion of each plate is made up of rows of finger shaped protrusions that fit into the row of grooves in the opposing plate. The finger plates are anchored into the deck slab or directly attached to the underlying superstructure steel. Whenever the bridge spans undergo a movement, the finger plates move back and forth into the opposing grooves and accommodate this movement.

Manhattan Bridge Finger Dam. (Credit: Jagtar Khinda) Unionport Bridge Finger Dam at Span 9 in 2016. Riker's Island Finger Dam.

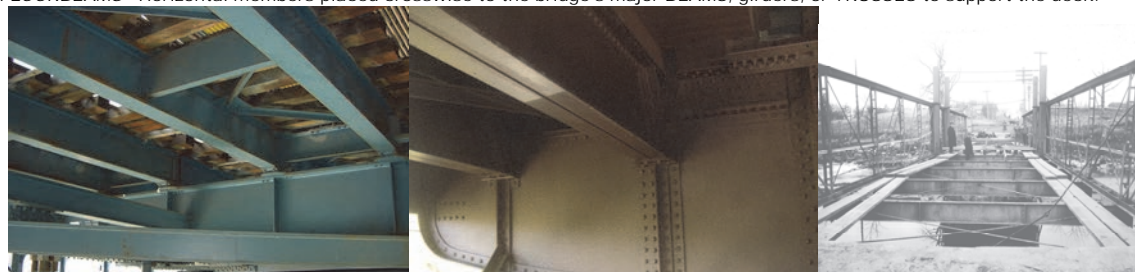
FLOORBEAMS - Horizontal members placed crosswise to the bridge's major BEAMS, girders, or TRUSSES to support the deck.

South Transit Floorbeams, Stringers, and Bracing Members on the Manhattan Bridge. Ed Koch Queensboro Bridge North Outer Roadway Floorbeam. (Credit: NYSDOT) Eastchester Bridge Floorbeams in 1914.

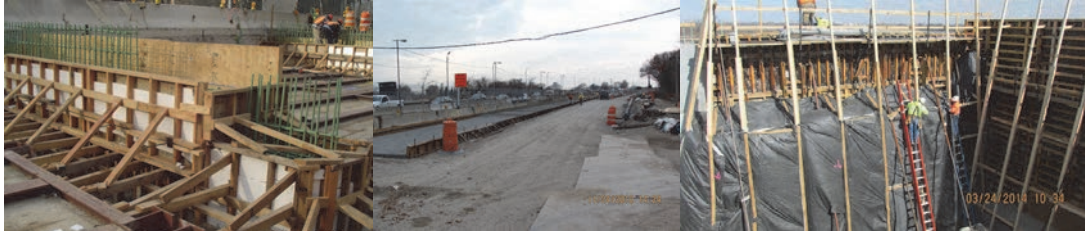
FORMS - The temporary molds that hold concrete in place while it is hardening; also known as form work.

West 252nd Street Bridge Formwork at the Pier and West Abutment in 2007. Formwork for the Westbound Roadway of the Rockaway Parkway Bridge in 2010. (Rockaway Bridge Credit: Eric Callender) Gerittsen Inlet Bridge in March 2014: Putting up Insulated Forms in Preparation for the Placement of Concrete at the West Abutment Wingwall. The Insulation Helps Protect the Concrete From the Elements and Fluctuating Temperatures During the Curing Period.

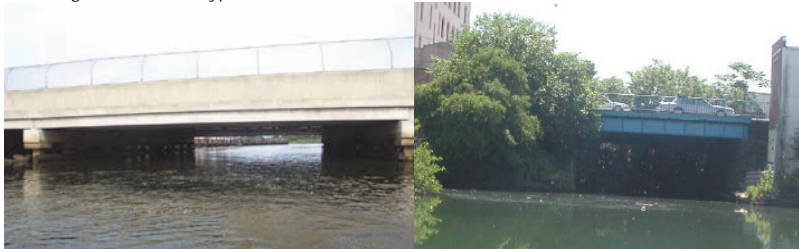
GIRDER SPAN BRIDGES - are primarily employed in bridging short distances, and may be classified as either simple or continuous. The steel girders carry the roadway and roadway load to end supports. The Midtown Highway, *Hook Creek*, Little Neck and *Brooklyn Third Avenue Bridges* are of this type.

Hook Creek Bridge and Brooklyn's Third Avenue Bridge. (Credit: NYSDOT)

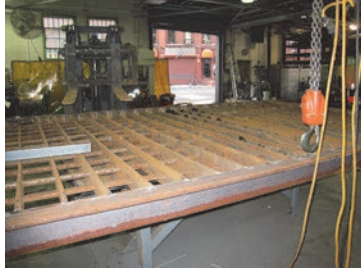
GRIZZLY - A coarse screen used to remove oversize pieces from **ASPHALT** or earth.

New Grizzly Under Fabrication for the Agency Hamilton Asphalt Plant. (Credit: Russell Holcomb)

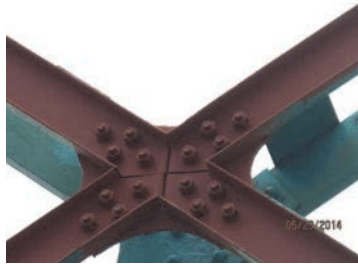
GUSSET PLATE - A metal plate connecting truss members.

Grand Street Bridge Span 1 Truss Diagonal Member Gusset Plate.

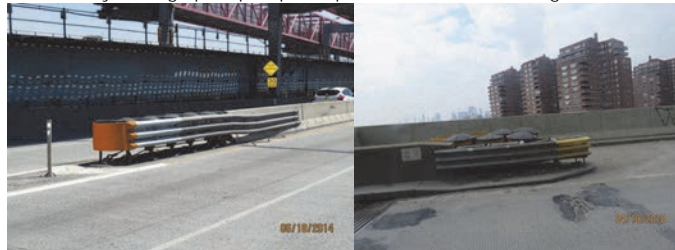
IMPACT ATTENUATORS also known as crash cushions, crash attenuators, or cowboy cushions are systems that mitigate the effects of errant vehicles that strike hazards, either by smoothly decelerating the vehicle to a stop when hit head-on, or by redirecting the errant vehicle. Periodic inspection of these devices is necessary to assure that attenuators function as intended throughout their useful life or that they undergo prompt repair/replacement if hit or damaged.

Williamsburg Bridge Impact Attenuators in 2014 and 2018.

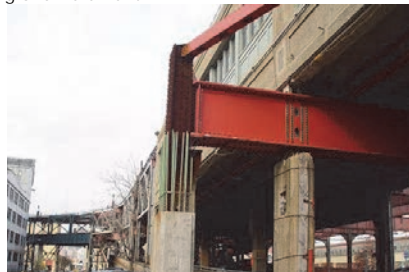
JACKING - The mechanical lifting or sliding of an element.

Ed Koch Queensboro Bridge Bent Column Ready for Jacking in 2005.

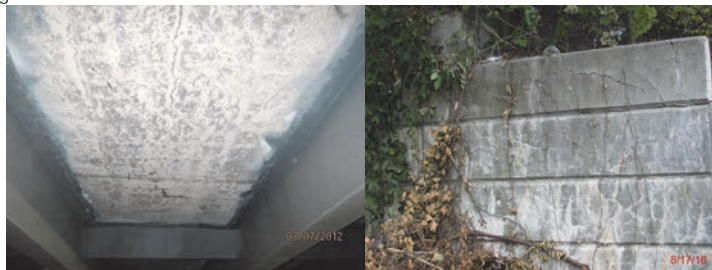
MAP CRACKING (CRAZE CRACKING) - Large pattern cracking can be caused by alkali-silica reaction within the concrete. Environmental conditions such as low humidity, high outside temperatures, direct sunlight, and wind can create high rates of evaporation from the surface layer of concrete. Resistance to shrinkage from the underlying concrete causes stress that is relieved by map cracking.

Union Street Bridge over Brooklyn-Queens Expressway in 2012 – Extensive Map Cracking With Efflorescence on the Underside of the Deck. (Credit: NYSDOT) Tompkins Avenue Bridge over B&O Railroad (Abandoned) in 2016 - Map Cracks With Efflorescence Near the End of the Wing Wall.

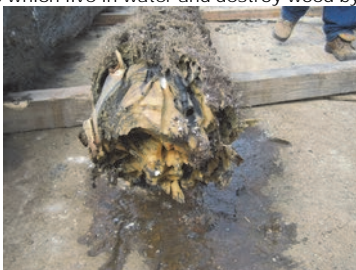
MARINE BORERS - Mollusks and crustaceans which live in water and destroy wood by digesting it.

During the Demolition of the North End of the Existing University Heights Bridge Fender, Marine Borers were Discovered in the Southern Yellow Pine Piles. The End of a Pile Segment Removed From the Fender - Based on the Size of the Holes, *Teredo Navalis* is the Likely Species.

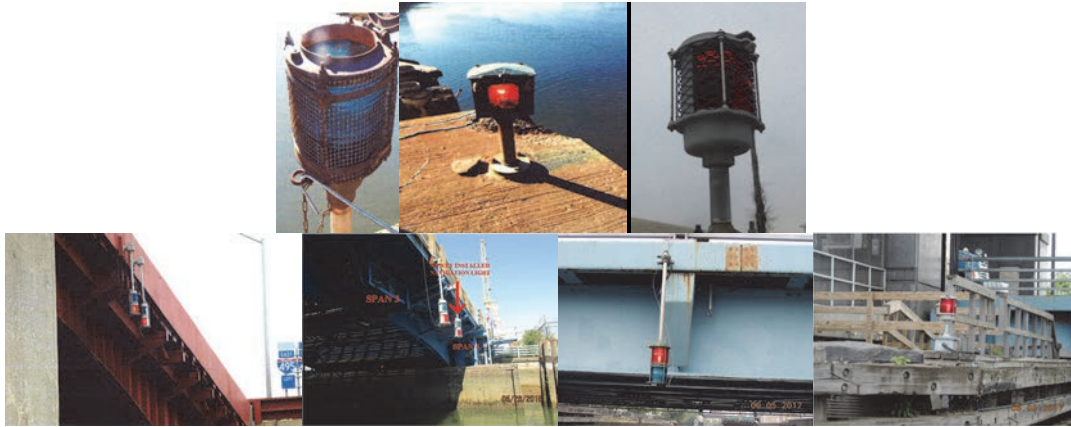
MARINE NAVIGATIONAL LIGHTING - The lights maintained on a bridge for the protection of marine navigation.

Northern Boulevard Bridge - Bridge and Pier Marine Navigational Lighting. Grand Street Bridge- Left Side Channel Light. Pulaski Bridge - Center Lights at Span #26. Third Street Bridge - Span #3. Ninth Street Span 2 Right Fascia and End Left Channel Embankment. (Credit Grand, Third, and Ninth Street: NYSDOT)

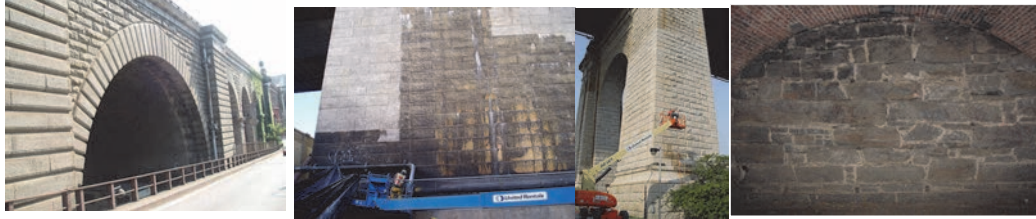
MASONRY - Construction materials made of concrete, brick, tile, or stone.

Brooklyn Bridge Cliff Street Arch Masonry. Cleaning the Masonry of the North Face of the Manhattan Bridge's Brooklyn Anchorage and of the North and East Faces of the Roosevelt Island Pier of the Ed Koch Queensboro Bridge. Masonry of the East Drive Bridge Over Eastwood Arch.

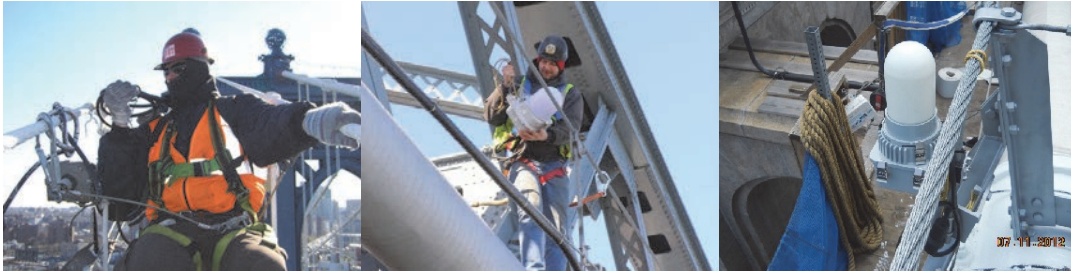
NECKLACE LIGHTS - The necklace lights are those lights on the main cables of bridges which, when illuminated at night, resemble a necklace.

Repairing a Manhattan Bridge Necklace Light. Bridge Repairer and Riveter Neil Dalton Installing a New Light on the Williamsburg Bridge in 2012. (Credit: Hany Soliman) Manhattan Bridge Side Necklace Light. (Credit: NYSDOT)

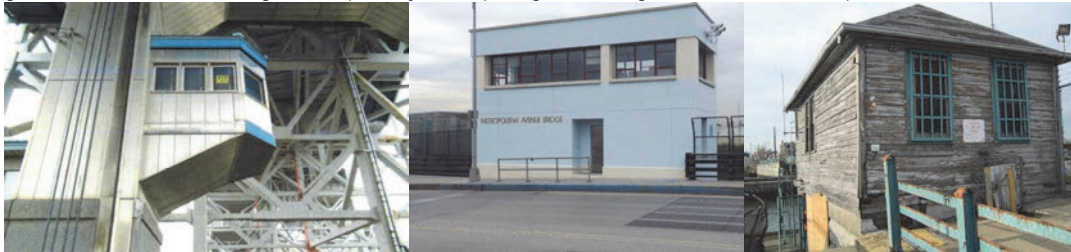
OPERATOR'S HOUSE - The building containing the power plant and operating machinery and devices required for the operator's (bridge tender's) work in executing the complete cycle of opening and closing a MOVABLE BRIDGE span.

Ninth Street Bridge over Gowanus Canal, Metropolitan Avenue Bridge over English Kills and Grand Street Bridge Operator Houses. (Metropolitan Avenue Credit: Sunil Desai)

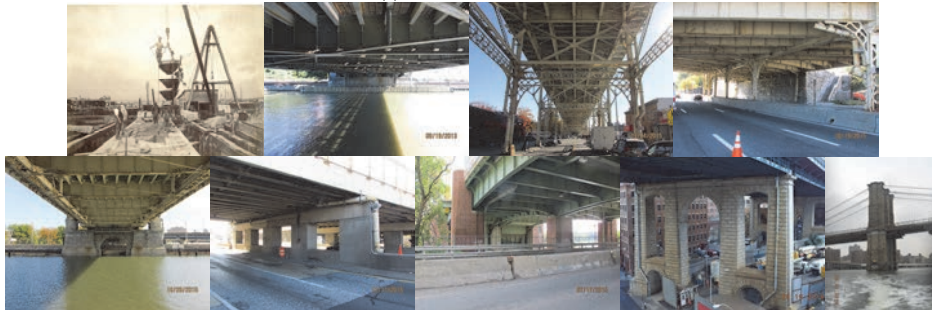
Madison Avenue Bridge Center Pier Under Construction in September 1909, Pier 2 of Broadway Bridge Piers 12, 33, 37, and 42 of Macombs Dam Bridge. (Credit: NYSDOT) Pier 1 (Looking East) of Hutchinson River Parkway Bridge over Hutchinson River. Pier 6 of Manhattan Bridge. Pier 39 of Brooklyn Bridge. (Manhattan and Brooklyn Bridge Credit: NYSDOT)

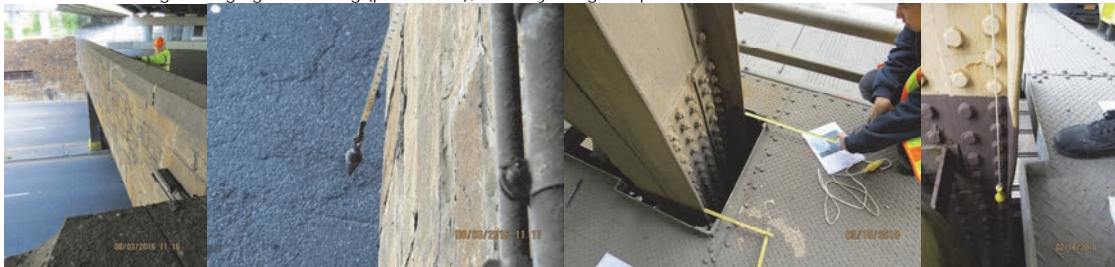
PLUMB BOB - A weight hanging on a string (plumb line), used by bridge inspectors to show the direction of the vertical distance.

Plumb Bob in Use at Elliot Avenue Bridge over Queens Boulevard in 2016, and the Lower Level of the Ed Koch - Queensboro Bridge in 2018.

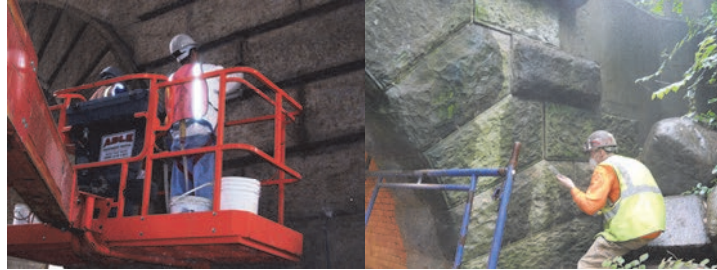
POINTING - The compacting of the mortar in the outermost portion of a joint and the troweling of its exposed surface to secure water tightness or desired architectural effect.

Pointing Joints on the East Face of the Brooklyn Anchorage of the Manhattan Bridge.
Pointing the Masonry on the East Drive Bridge (East Wood Arch).

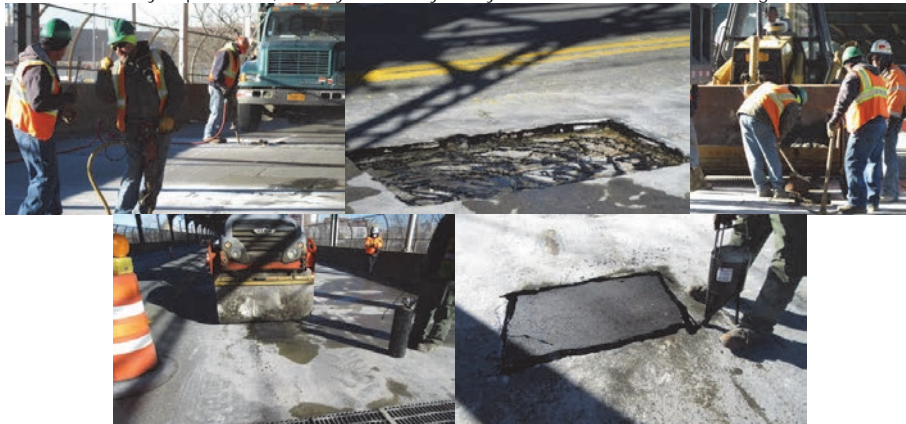
Repairing Potholes on the Roosevelt Avenue Bridge Deck Between Janet Place and 126th Street in January 2016. Each Perimeter is Sawcut. Filling in the Pothole With Asphalt. Paver Rolls Over the Pothole to Compact the Fill Material and Level the Surface. Finished Repair.

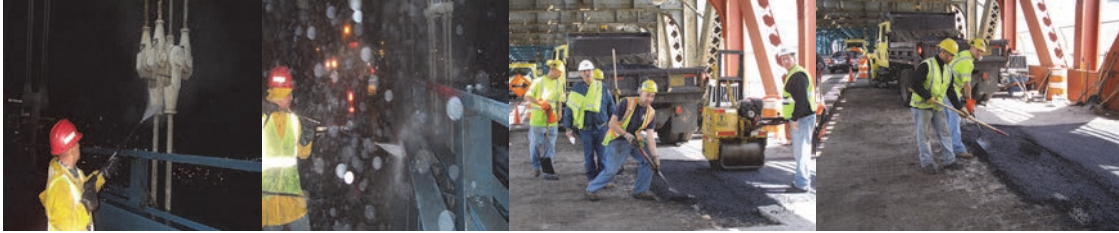
Power Washing the Corrosive Deicing Solvents Within the Range of the Roadway Splash Zone on The Manhattan Bridge in October 2007. Particular Attention is Directed to Cleaning the Gusset Plate. (Credit: Albert Hong) Performing Wear and Tear Resurfacing Work on the Roosevelt Avenue Bridges in April 2010: Assistant City Highway Repairer Victor Magagna, Supervisor Highway Repairer Joseph Palemine, Assistant City Highway Repairer Jonathan Adorno (Obscured), Assistant City Highway Repairer Anthony Montalbano, and Area Supervisor Highway Maintenance Edward Pedersen. Assistant City Highway Repairers Jonathan Adorno and Victor Magagna. (Credit: Joseph Flood)

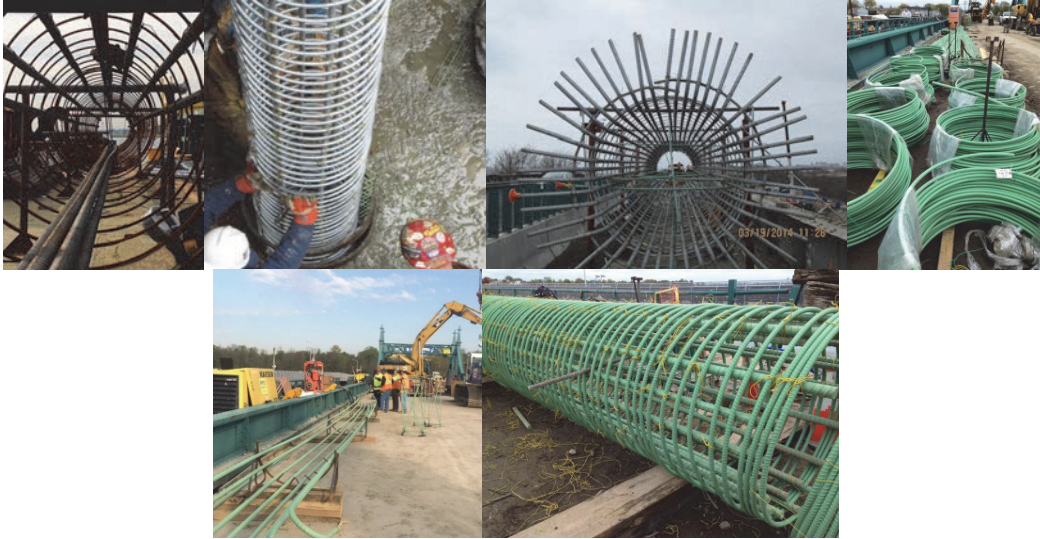
REBAR CAGES - Rebar cages are placed in large cast-in-place concrete columns (DRILLED SHAFTS), and are fabricated from steel reinforcing bars. The reinforcement will typically include concentric hoops (or spirals) along the length of the cage, which are tied to longitudinal bars perpendicular to the hoops.

City Island, Gerittsen Inlet, and Bay Ridge Avenue Bridge Rebar Cages. 2016: Rebar Cage Assembly for the City Island Bridge. May 2016: Each Drilled Shaft Requires a Custom-Built Rebar Cage. These Steel Structures Strengthen the Concrete That is Placed Within Each Shaft Casing. Steel Bars are Laid Out on a Template to Form the Shape of the Cage, and are Then Tied Together. Once completed, the cage is Lifted by Crane and Placed Within a Corresponding Drilled Shaft.

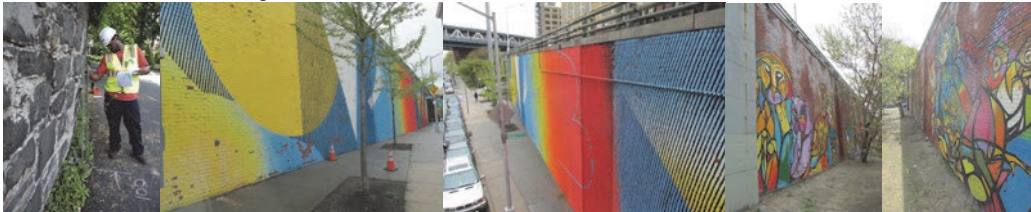
Inspecting a Bulge in a Retaining Wall Along Douglas Road in Staten Island in 2014. Brooklyn-Queens Expressway (BQE) Retaining Wall Between Washington and Adams Streets - Looking Northeast and Southwest. BQE Retaining Wall Between Adams and Pearl Streets - Looking Northeast and Southwest.

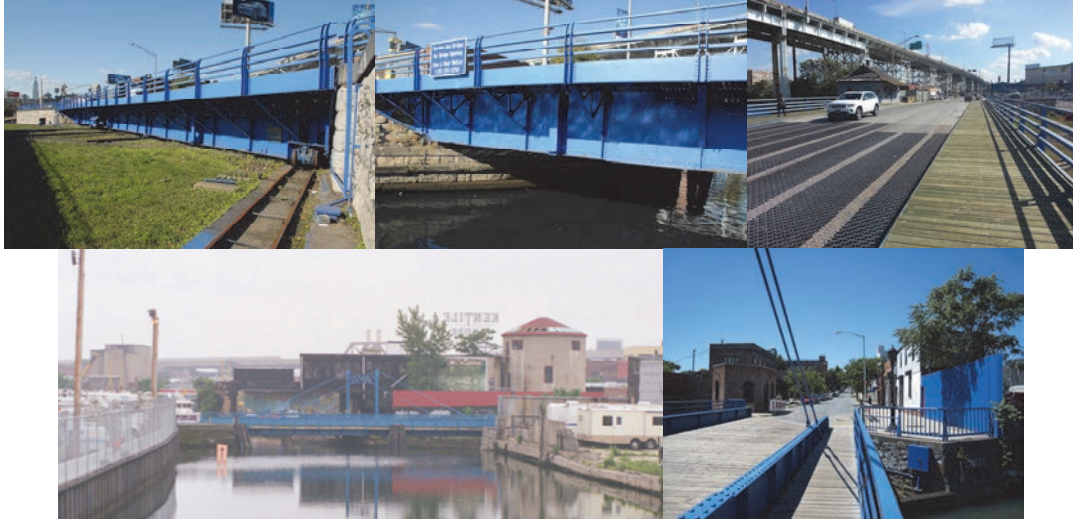
RETRACTILE BRIDGES - Retractable bridges are movable bridges that are mounted on tracks that are positioned to one side of a navigational channel. To open, the bridge is withdrawn or "retracted" to shore. Although fascinating to observe and efficient to operate, retractile bridges are considered obsolete because of the expansive land areas that must be condemned in order to accommodate their tracks. The New York City Department of Transportation currently possesses two retractile bridges - the *Borden Avenue* and *Carroll Street* bridges, rare examples of the bridge builders' art.

Borden Avenue Bridge. (1st and 2nd Credit: Peter Basich, 3rd: Vadim Sokolovsky Carroll Street Bridge. (1st Credit: NYSDOT, 2nd: Russell Holcomb)

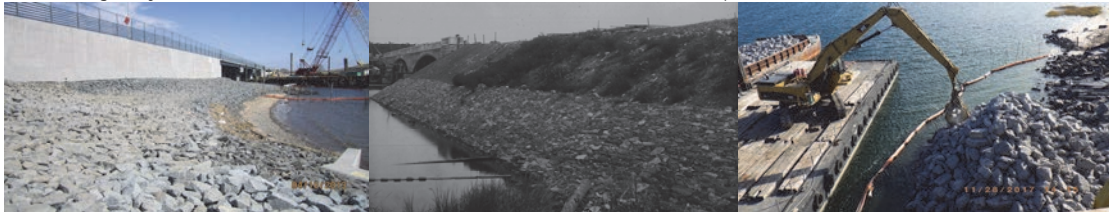
Riprap Installed in 2013 on South Side of Belt Parkway Bridge over Fresh Creek, Facing East. Riprap at the Southwest Side of the South Approach of the Shore Road Bridge over Hutchinson River in 1908. Barge-Mounted Crane Placing Riprap Stones on the South Slope of Gerritsen Inlet at the West Abutment in 2017.

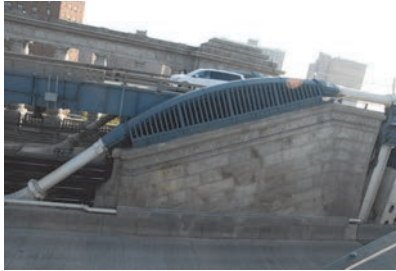
SADDLE - A special curved casting atop a SUSPENSION BRIDGE tower into which the cables are placed to avoid sharp bends in directional changes of the cable.

Manhattan Bridge Saddle. (Credit: Jagtar Khinda)

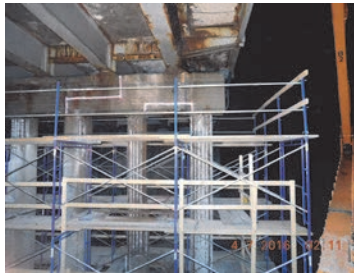
Mill Basin Bridge Scaffold Used During Pier Cap and Pier Column Repairs.

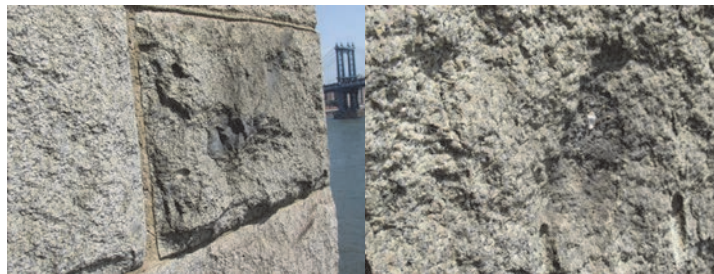
SCALING - Also known as surface breakdown, scaling is the gradual and continuing loss of concrete's surface mortar and aggregate over an area due to the chemical breakdown of the cement bond. Scaling is accelerated when the member is exposed to a harsh environment.

Brooklyn Bridge Tower Stone Scaling in 2016.

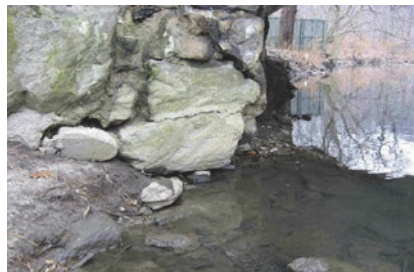
SCOUR - The washing away of stream bed material around or underneath the bridge abutments or piers that is caused by water channel flow.

Scour on Pier 2 End Face of Mosholu Parkway Bridge Over Bronx River in 2008. (Credit: NYSDOT)

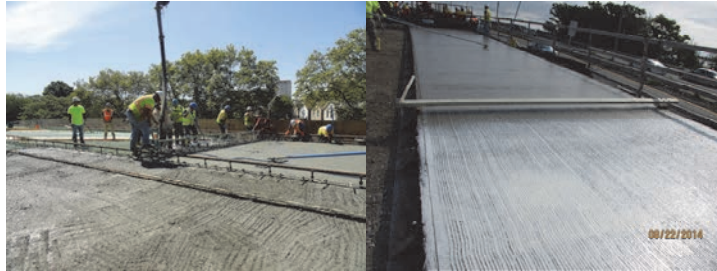
SCREED - A long section of metal or wood which is dragged across freshly placed concrete to both smooth the surface and consolidate the concrete.

Screed at East 8th Street Ramp in 2011, and at West Approach of Gerritsen Inlet Bridge in 2014.

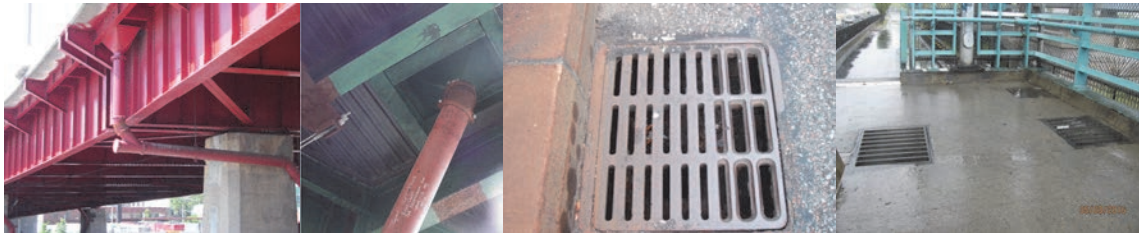
SCUPPER - An opening in the deck portion of a bridge to provide means for rain or other water accumulated upon the roadway surface to drain through it into the space beneath the structure.

Scuppers on the Pulaski, Madison Avenue, and Brooklyn Bridges. (Credit: NYSDOT) Delancey Street Pedestrian Bridge - Span 8.

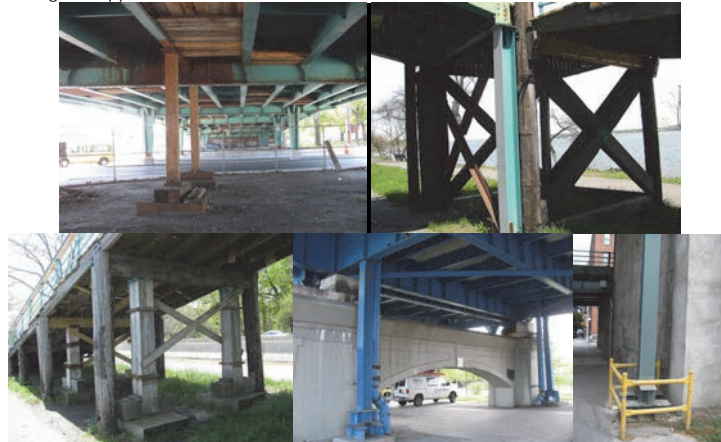
2014: Timber Shoring at Spans 7 and 8 of the Harlem River Drive over Ramp to and From Northbound Harlem River Drive. Steel Shoring of the Damaged Column at Pier 4 of the Crocheron Park Pedestrian Bridge. Timber Shoring at Piers 5 and 6. 2016: Steel Shoring at Span 5 of the East 174th Street Bridge over the Sheridan Expressway. Eastbound Brooklyn-Queens Expressway over Washington Street - Shoring on the Right Side of the End Abutment.

SHORING - Temporary bracing to support a structure.

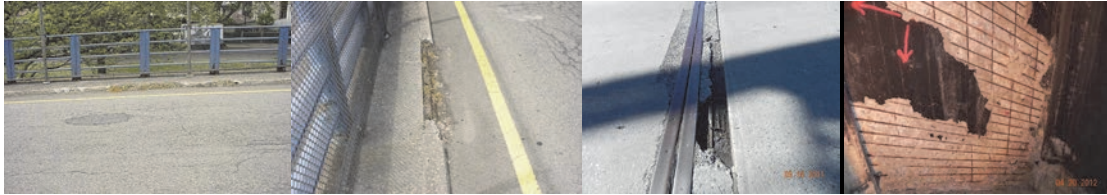
Spalled Section of Curb on the East 8th Street Bridge in 2006. (Credit: NYSDOT) Spalling With Exposed Rebar on the Beginning Abutment Joint Header of the Westchester Avenue Bridge over the Bronx River in 2011. Underdeck Spalling With Exposed Rebar on the Concourse Village Avenue Bridge over Metro North in 2012.

SPALLING - The flaking or breaking out of concrete parallel to the main surface, caused by a blow, or by the action of weather or pressure.

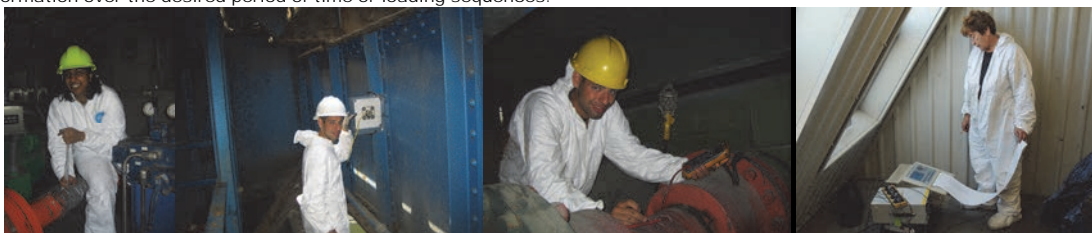
June 2012 - Metropolitan Avenue Bridge. Summer College Intern Nikita Gupta Unsealing the Wire for Strain Gauge Testing. July 2012 - Unionport Bridge. Summer College Intern Kevin Hillery Setting up Inclinator Calibration. August 2012 - Hunters Point Avenue Bridge. Kevin Hillery Checking Strain Gauge Connections With a Millimeter. (Credit: Vera Ovetskaya) August 2015: Assistant Mechanical Engineer Vera Ovetskaya Reviewing the Roosevelt Island Test Results.

STRAIN GAUGE TESTING - Small strips of material (imagine a small band-aid) are glued onto part of a structure to measure the stress in the material under load. Inside the small "band-aid" are tiny electrical wires. When a structure is under load it stretches (tension) or contracts (compression). When this happens, the resistance in the tiny wires in the strain gauge changes, resulting in a change in the wire's current. What is actually being measured are changes in the electrical current in the tiny wires. Knowing the physical properties of the structural member that the gauge is attached to, (such as steel), a calculation is can then be made to convert these changes in current to changes in stress. The readings are taken with special instruments that record the information over the desired period of time or loading sequences.

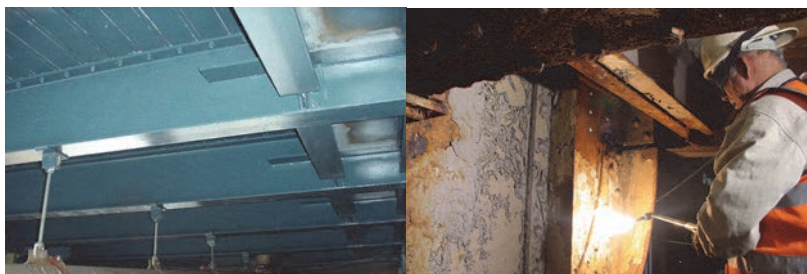
Stringers on the Manhattan Bridge. (Credit: NYSDOT) Bridge Repairer and Riveter Joseph Antony Repairing a Red-Flagged Stringer on the Bridge. (Credit: Hany Soliman)

STRINGER - A part of a bridge's SUPERSTRUCTURE, a stringer is essentially a BEAM parallel to the span used to support the road DECK.

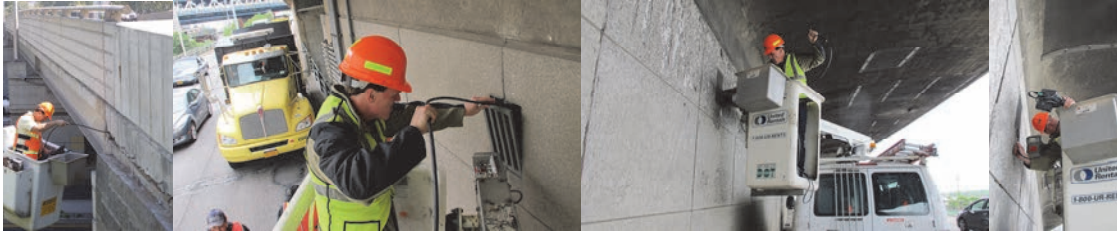
Director of Bridge Management Kevin McNulty Inspecting the Bridge Carrying the Belt Parkway over Ocean Parkway, Utilizing the Unit's Borescope. June 2015: Inspecting the Brooklyn-Queens Expressway Between Cadman Plaza and Atlantic Avenue.

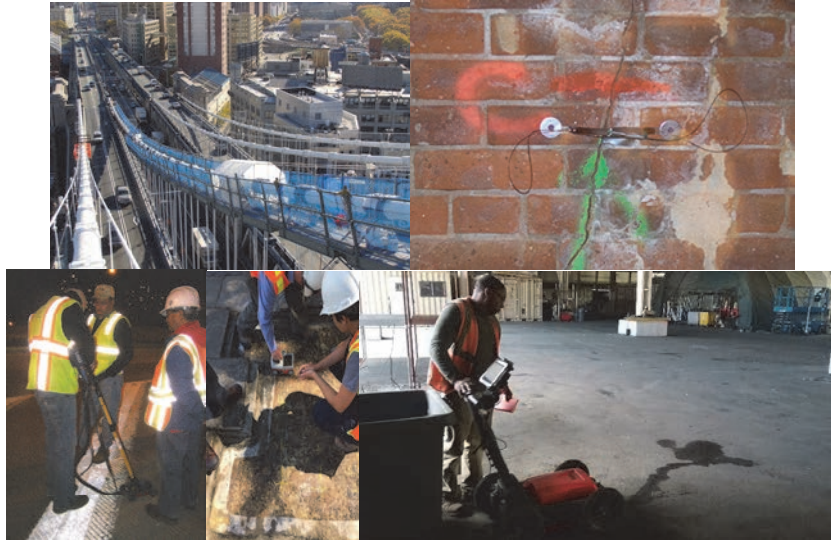
Experimental Corrosion Sensors Installed for a Test on Cable D of the Manhattan Bridge in 2011 (Left Corner). A Fiber Optic Sensor Monitoring a Crack in the Masonry of the Brooklyn Bridge's Manhattan Approach. A Ground Penetrating Radar Inspection of the Belt Parkway Bridge over Ocean Parkway. (Credit: Bojidar Yanev) 2016: Ground Penetrating Radar Utilized to Locate Rebars in the Brooklyn Heights Promenade Pavement. 2017: Ground Penetrating Radar Utilized to Detect Possible Subsurface Voids and Areas of Disturbed Soils That Could Cause Settlement in a Fenced, Paved Maintenance Storage Yard Located Under an Elevated Section of the FDR Drive Near its Intersection With the Avenue C Loop.

Corrosion Sensors: Corrosion sensors were developed for the first time under a FHWA contract specifically for New York City's suspension bridges.

Fiber Optic Sensors: Fiber optic sensors can measure very small displacements as well as strain gauges, but are more resilient and insensitive to temperature changes. The information is readily transmitted online and lends itself to real-time monitoring.

Ground Penetrating Radar: Ground penetrating radar uses the propagation and retraction of high frequency waves through materials such as concrete to detect the presence of voids. This nondestructive method uses electromagnetic radiation in the microwave band (UHF/VHF frequencies) of the radio spectrum and detects the reflected signals from subsurface structures.

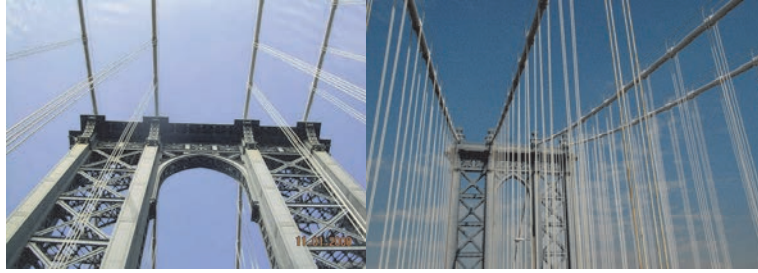
Manhattan Bridge Suspenders. (Credit: NYSDOT and Jagtar Khinda)

SUSPENDER - A wire rope or a short vertical rod that transmits forces from the roadway of a SUSPENSION BRIDGE to the supporting CABLES. The suspenders assist in supporting the bridge floor system and its superimposed loads by transferring loads to the main suspension members of the structure. They support other members against sagging, twisting, or other deformation due to its own weight.
