2017 NYC DOT

Bridges & Tunnels Annual Condition Report

NEW YORK CITY DEPARTMENT OF TRANSPORTATION DIVISION OF BRIDGES 2017 BRIDGES AND TUNNELS ANNUAL CONDITION REPORT

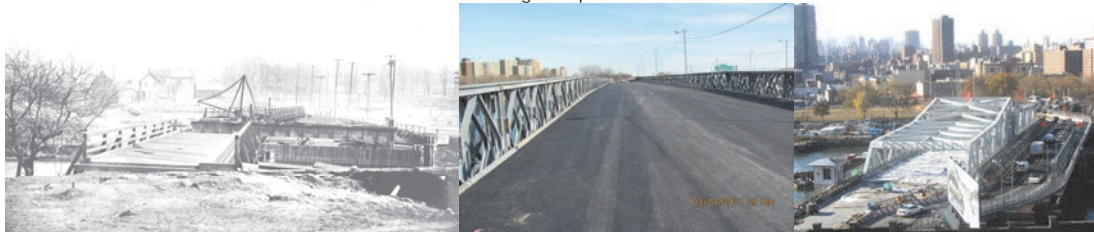
1911 Boston Road Bridge over Hutchinson River Temporary Bridge. 2011: Fresh Creek Temporary Bridge. 2004: Almost Completed New Third Avenue Span and Temporary Bridge. (Credit: Daniel Hom)

TEMPORARY BRIDGE - A pedestrian and/or vehicular bridge built to carry traffic around an active construction site in lieu of STAGE CONSTRUCTION. The structure is removed after the new bridge is open to traffic.

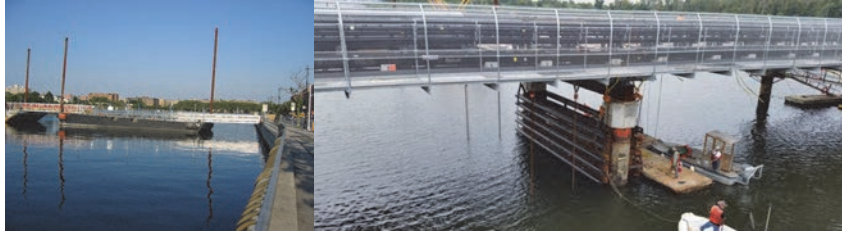
2005: Pontoon Bridge Used During the Emergency Reconstruction of the Ocean Avenue Pedestrian Bridge over Sheepshead Bay. (Credit: Russell Holcomb) 2015: City Island Temporary Bridge.

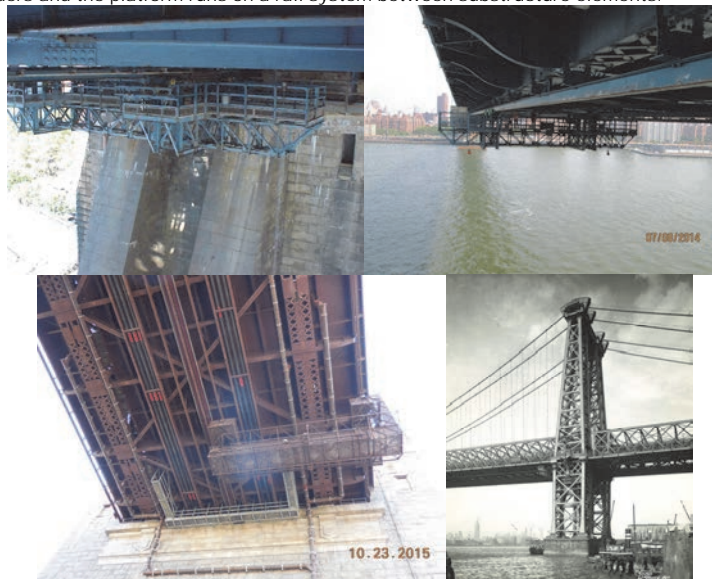
Manhattan Bridge and Ed Koch - Queensboro Bridge Travelers. (Credit: NYSDOT) Williamsburg Bridge in 1942: First Traveler in Place at the Brooklyn Tower. Second Traveler Shown on Scow Prior to Lifting.

TRAVELER MAINTENANCE - The maintenance of a traveler (movable underdeck platform) that runs under the East River Bridges so maintenance, inspections and repairs can be performed to the underside of the bridge. A traveler platform is typically perpendicular to the girders and the platform runs on a rail system between substructure elements.

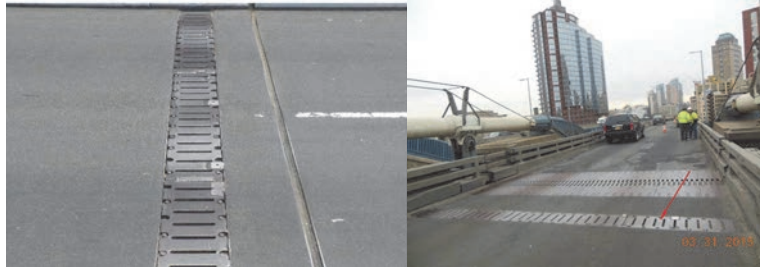
Manhattan Bridge Trench Drain.

TRENCH DRAIN - These drainage structures consist of a slotted opening with bars perpendicular to the opening. Trench drains (also known as slotted drains) function as weirs with flow entering from the side. They can be used to intercept sheet flow, collect gutter flow with or without curbs, modify existing systems to accommodate roadway widening or increased runoff, and reduce ponding depth and spread at grate inlets. The two types of trench drains in general use are the vertical riser type and the vane type.

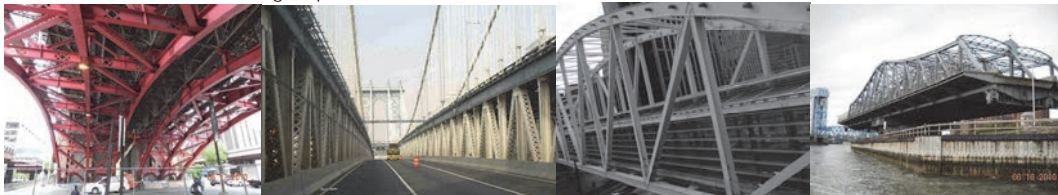
Brooklyn Bridge Franklin Square Truss. General view of Manhattan Bridge Trusses B and C From the Lower Roadway on the Main Span. (Credit: NYSDOT) Chambers Street Pedestrian Bridge Truss. Madison Avenue Bridge Truss Swinging. (Credit: NYSDOT)

TRUSS - A rigid framework built of interconnecting steel beams, creating a large "girder" to support the floor system and transfer loads to the substructure over a longer span.

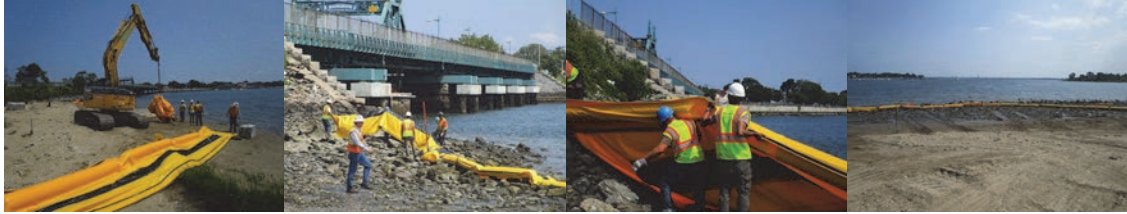
Installation of a Turbidity Curtain to Protect the Shore During Construction of the Temporary City Island Bridge in 2014.

TURBIDITY CURTAIN - A flexible, impermeable barrier used to trap sediment in water bodies. This curtain is generally weighted at the bottom to ensure that sediment does not travel under the curtain, which is supported at the top through a flotation system. Turbidity curtains prevent the migration of sediment from a work site in a water environment into the larger body of water. Also known as a turbidity barrier or silt curtain.

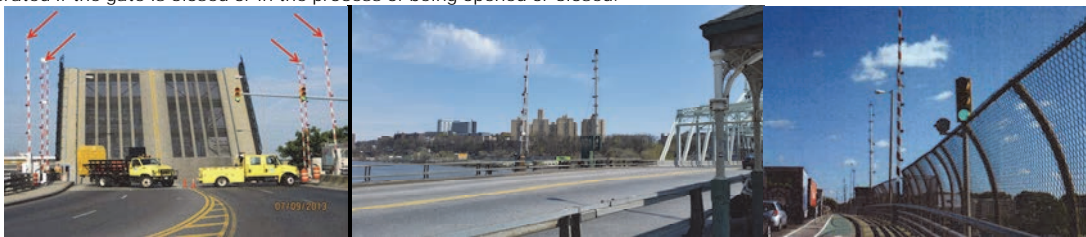
Metropolitan Avenue Bridge over English Kills Warning Gates. (Credit: NYSDOT) West 207th Street/West Fordham Road Bridge Warning Gate. Greenpoint Avenue Bridge over Newtown Creek Southwest Warning Gate.

WARNING GATE - Warning gates are installed at movable bridges to decrease the likelihood of vehicles and pedestrians passing the stop line and entering an area where potential hazards exist because of bridge operations. The gates are striped with 16-inch alternate vertical, fully reflectorized red and white stripes. Flashing red lights are included on the gate arm and they are only operated if the gate is closed or in the process of being opened or closed.

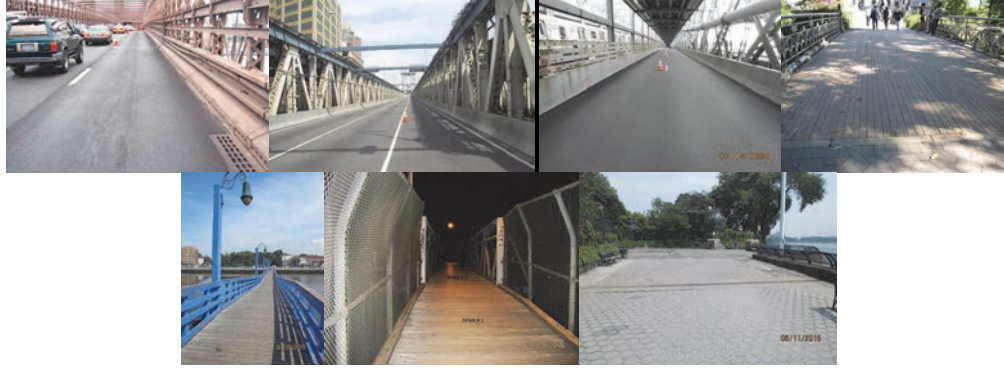
Brooklyn Bridge Wearing Surface. Manhattan Bridge Wearing Surface and Safety-Shaped Barriers. Williamsburg Bridge South Inner Roadway Wearing Surface. (Credit: NYSDOT) West 86th Street Pedestrian Bridge (Southwest Reservoir Bridge) Wooden Wearing Surface. Ocean Avenue Pedestrian Bridge over Sheepshead Bay. 60th Road Pedestrian Bridge over LIRR. Promenade over FDR Drive Span 43. (FDR Credit: NYSDOT)

WEARING SURFACE - The topmost layer of material applied on the DECK or roadway that receives the traffic loads; also known as wearing course. Wearing surfaces perform two functions in protecting the deck: they provide a seal and prevent water and deicing chemicals from penetrating into the deck slab, and they provide a smooth, skid-resistant surface for vehicular traffic, minimizing impact forces to the structure.

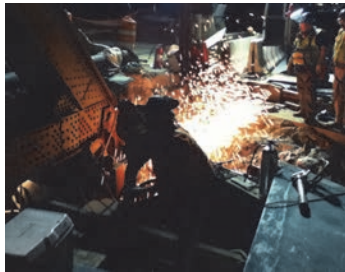
Welding Steel Packs for the Southbound Bruckner Expressway Bridge.

WELD - To fasten together metals by bonding with molten metal.

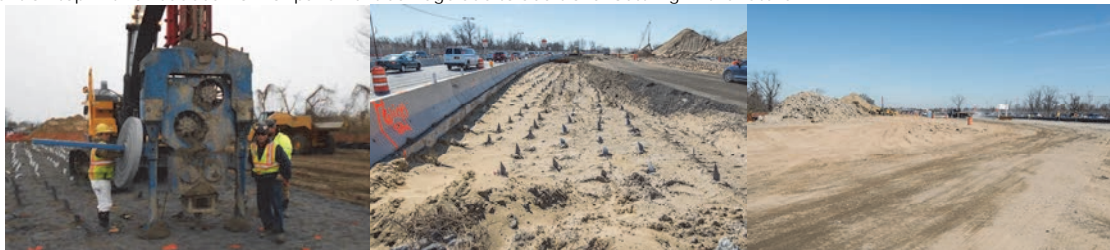
Northwest Quadrant Wick Drains for the New Mill Basin Bridge. Drains Backfilled.

WICK DRAINS - A mechanism used to accelerate the process in which water travels through the layers of soft soil, therefore allowing the soil to reach its full level of compaction (settling). Once full soil compaction is reached, the roadway surface can be built on top with a reduced risk for pavement damage due to additional settling in the future.

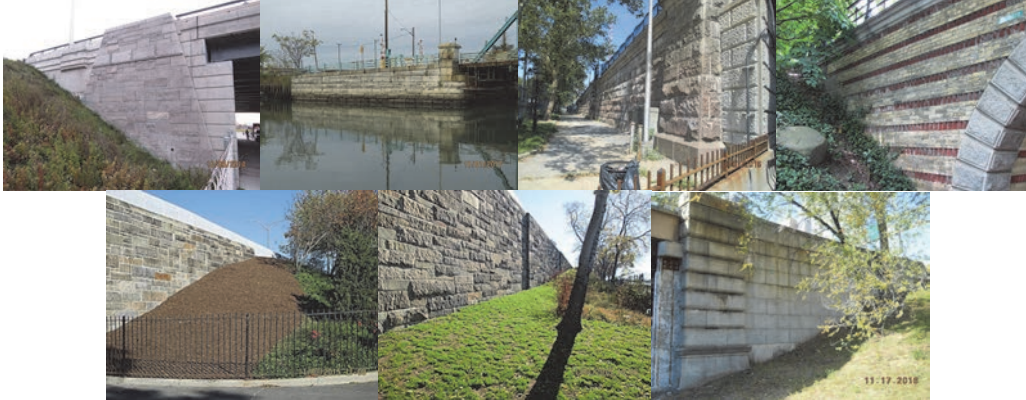
Belt Parkway over Rockaway Parkway, Grand Street, 145th Street, and Center Drive (Playmates Arch) Wingwalls. (First Four Credit: NYSDOT) Belt Parkway Over Bay Ridge Avenue Bridge Northwest and Southeast Wingwalls in 2015. Brooklyn Bridge North Wingwall in 2016. (Brooklyn Bridge Credit: NYSDOT)

WINGWALL - Walls of reinforced concrete or stone that prevent the soil behind the ABUTMENT from eroding away and leaving a void beneath the APPROACHES of the bridge. Wingwalls may extend over longer distances into retaining walls. Wingwalls are extensions of ABUTMENT STEMS, not supporting direct loads from the SUPERSTRUCTURE.

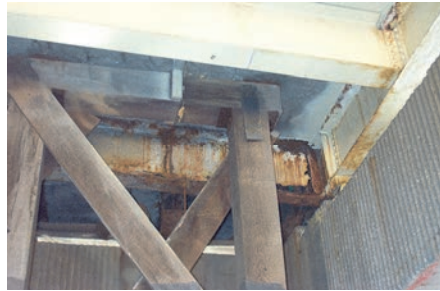
Timber Shoring Supporting a Failing Steel Beam – a Potential Winter Hazard.
(Credit: Bojidar Yanev)

WINTER INSPECTION - Inspection of a site known to have a greater hazard potential during winter. This may be due to low ambient temperatures, accidental or deliberately set fires.

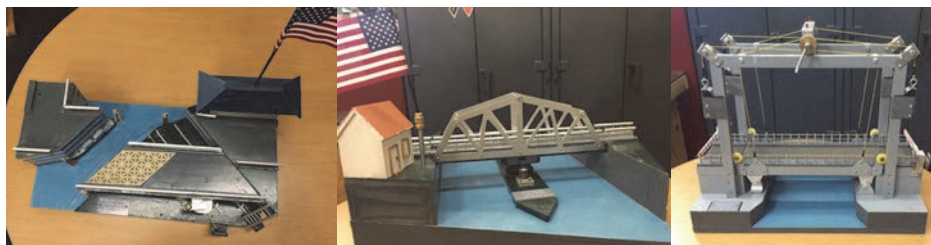
Working Models of Rolling Lift Bascule, Retractable, Swing, and Vertical Lift Bridges created by Machinist Mark Blokh in 2016.
(Credit: Vera Ovetskaya)

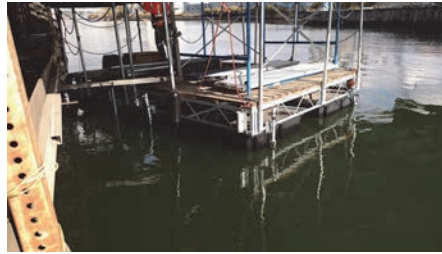
Inspector Utilizing a Motorized Platform Boat With Scaffolding to Access Most of the Underside of the Grand Street Bridge over Newtown Creek in November 2017. (Credit: NYS DOT)
