CITYWIDE CONGESTED CORRIDORS PROJECT

Flatbush Avenue

From Ocean Avenue to Nostrand Avenue

FINAL REPORT

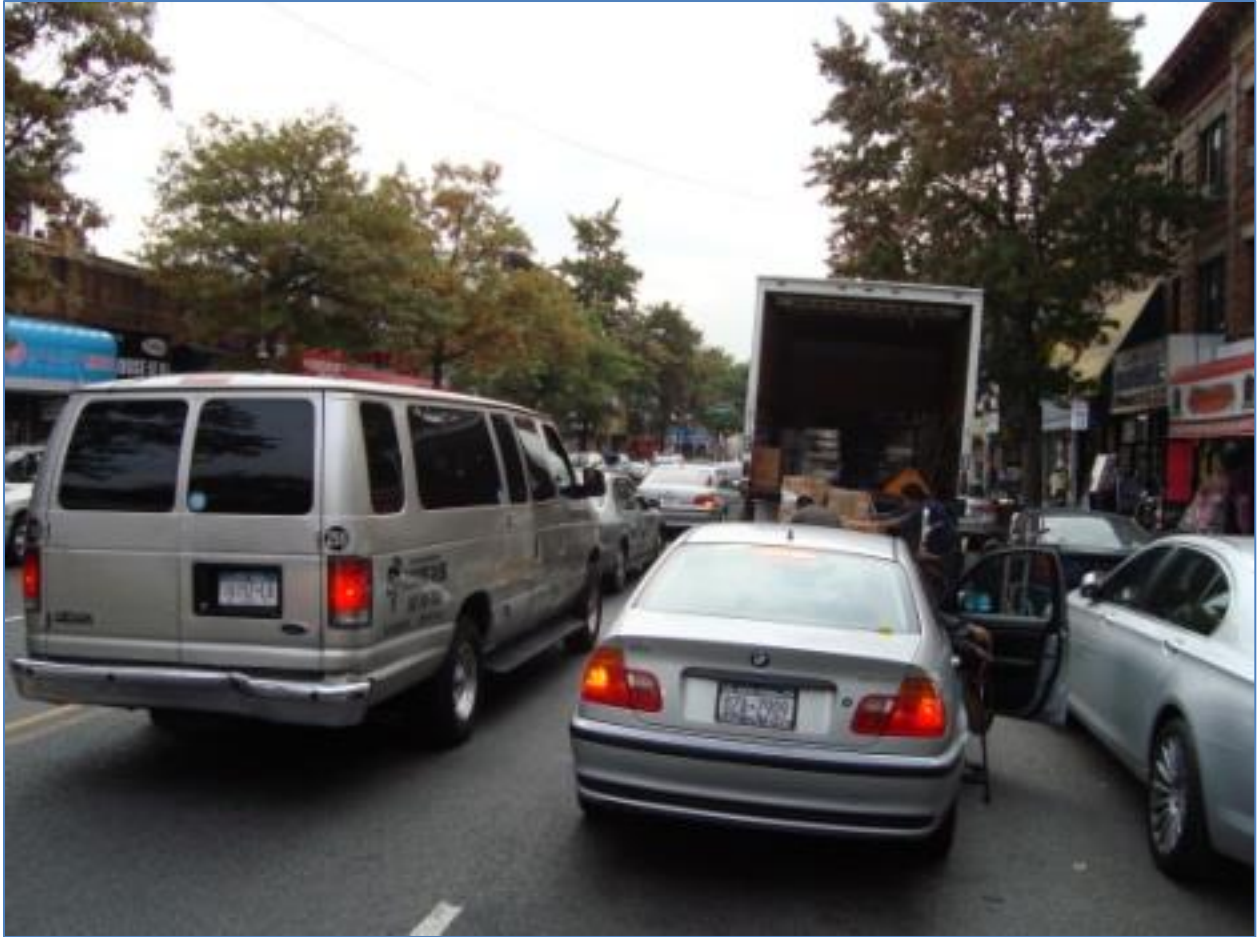
Photograph 1: Double parked vehicles blocking the right travel lane.

The photographs below highlight the operational inadequacies that existed on the corridor and illustrate how Flatbush Avenue operated like a one lane roadway even though it was marked as two lanes.

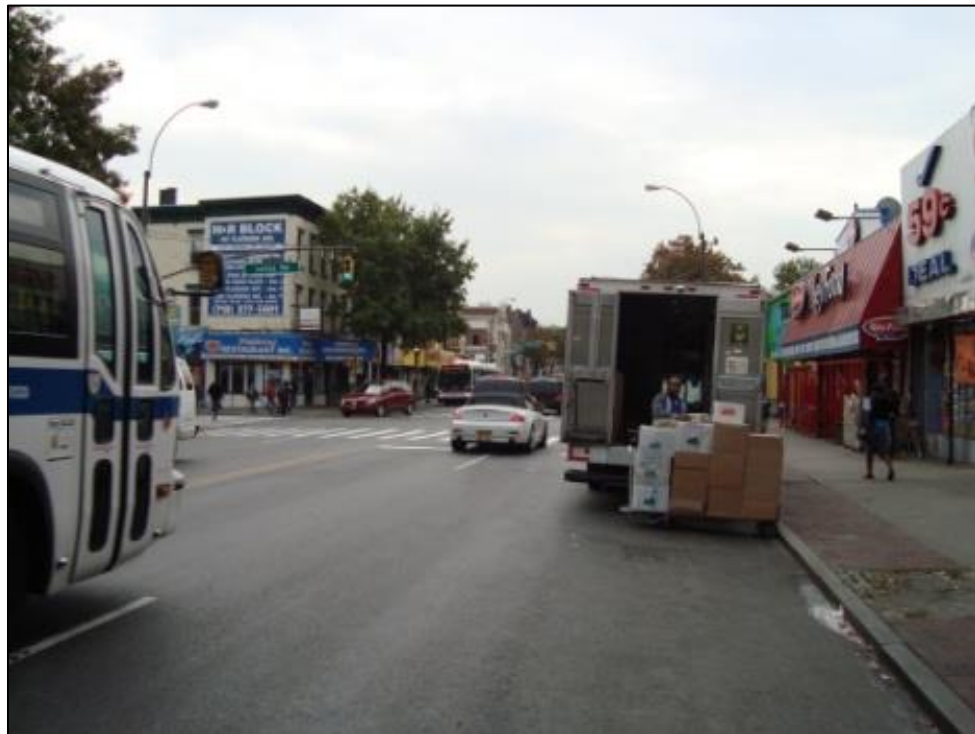
Photograph 3: Trucks legally loading and unloading in parking lane blocked the right travel lane, even when pulled all the way to the curb.

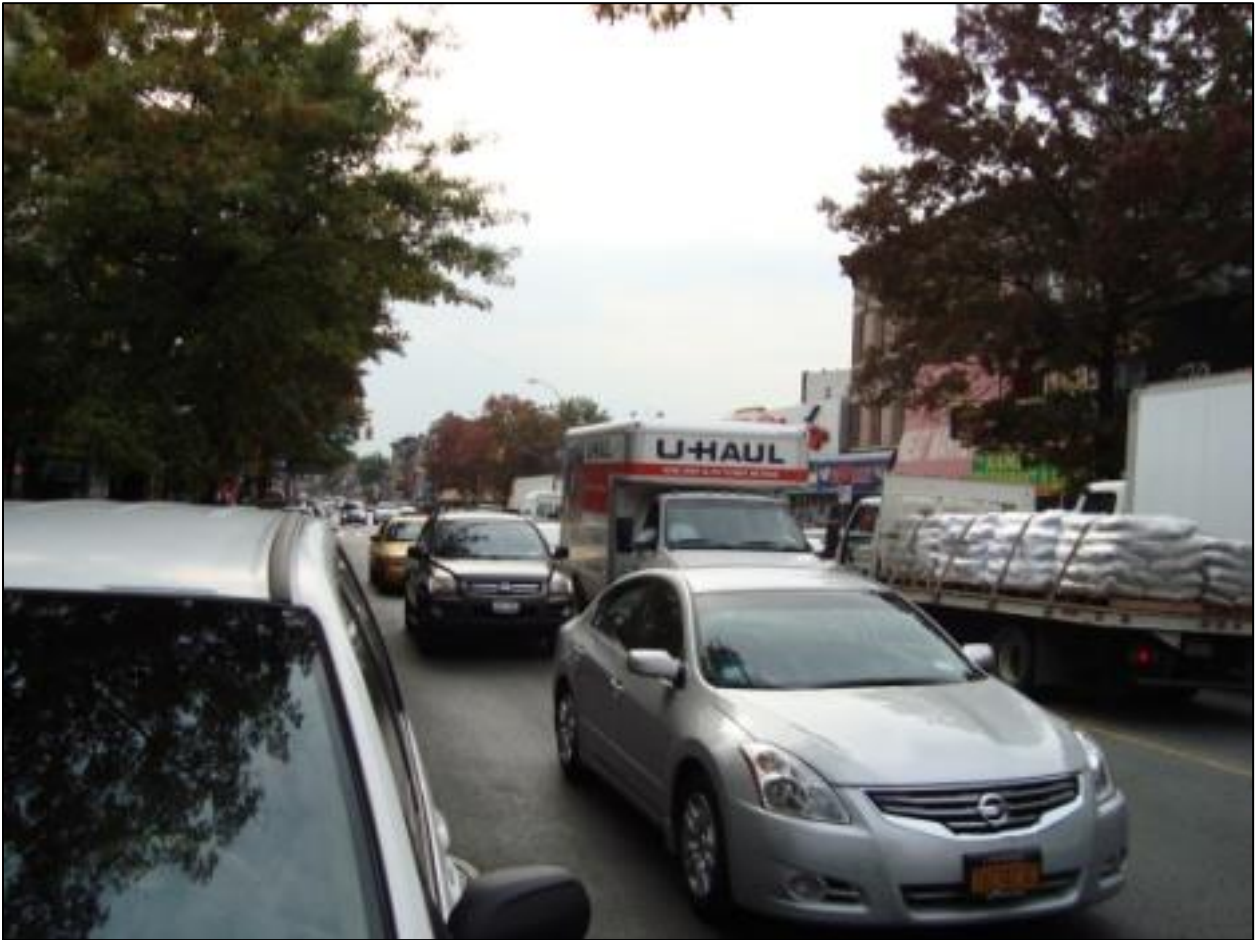
Photograph 4: The narrow lanes made for a tight squeeze when operating as two lanes even when trucks were not parked.

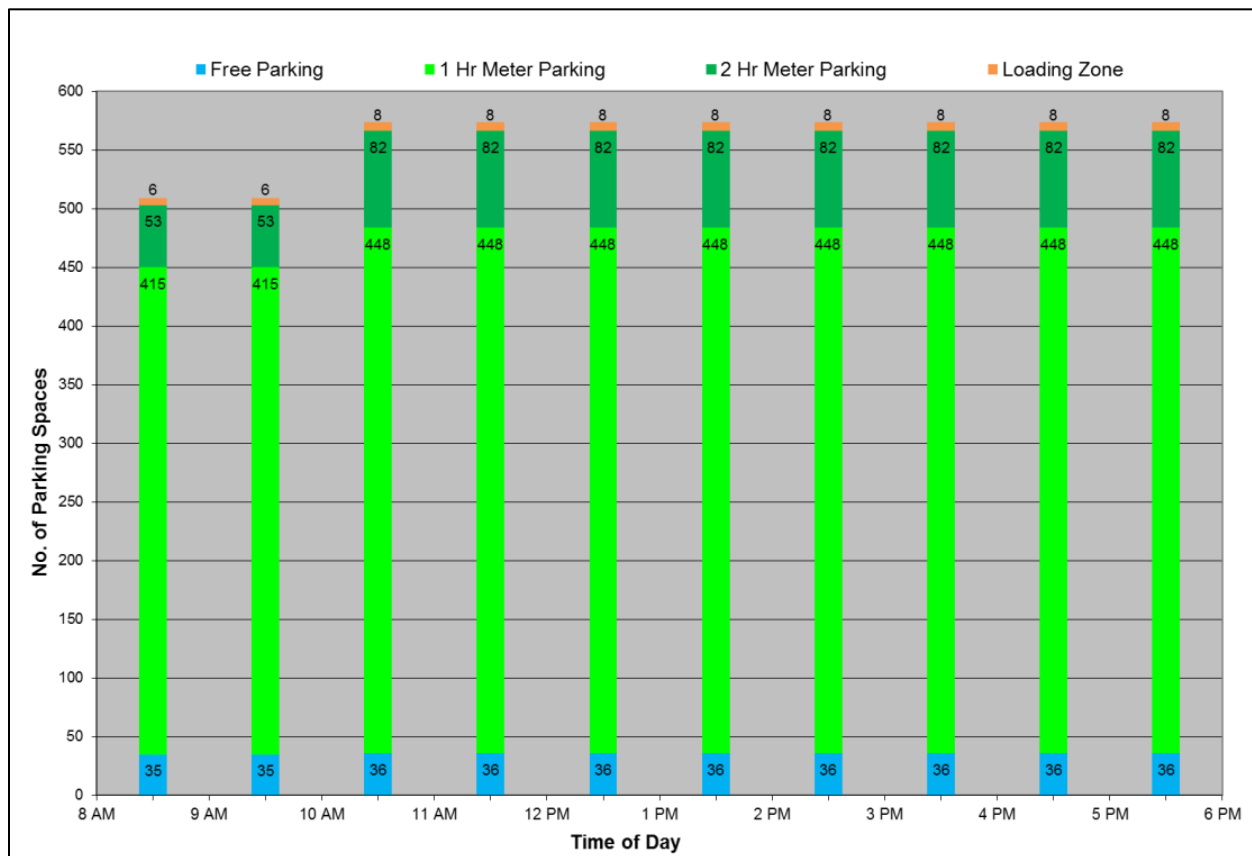
Figure 10 below breaks down the types of on-street parking spots available on weekdays from 8AM to 6PM. From 10 AM to 6 PM, there were a total of approximately 574 parking spots along the project corridor, of which 448 were one-hour metered parking, 82 were two-hour metered parking, 36 were free and approximately eight (depending on truck size) were designated for trucks loading or unloading. During the morning hours from 8 AM to 10 AM, there were a total of 509 parking spots, of which 415 were one-hour metered parking, 53 were two-hour metered parking, 35 were free and 6 were for trucks loading or unloading. These lower numbers were due to weekday morning "No Parking 7-10 AM Mon-Fri" regulations that existed on the east curb north of Caton Avenue.

Figure 10: Legal Parking Space Capacity during Weekdays

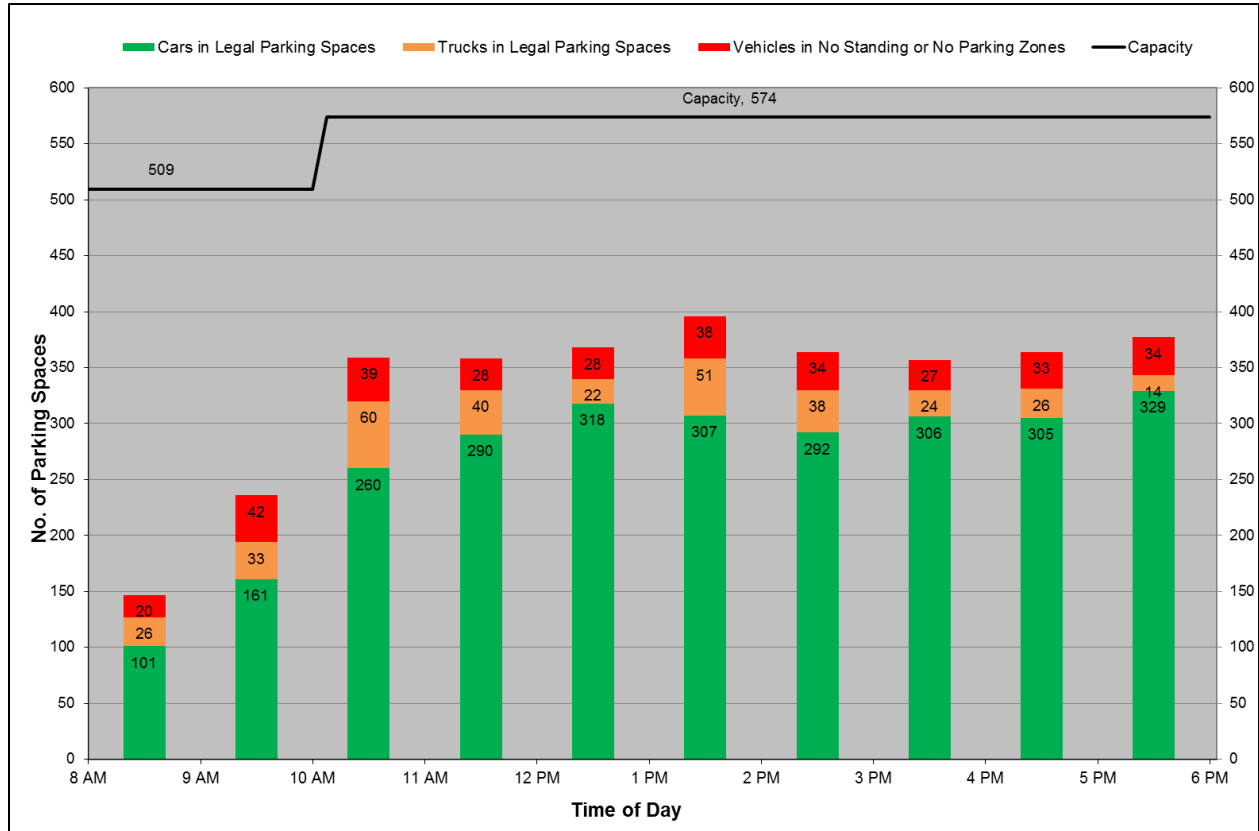
Figure 11 summarizes the occupancy rate by hour. The different colors depict the number of legally parked cars, legally parked trucks and illegally parked vehicles. This figure illustrates, and observations have confirmed, that even though capacity was underutilized, motorists still parked illegally, including double parking. This is important because it indicates that the presence of double parking does not reflect a lack of capacity, but rather parking behavior. Double parking was commonly observed when there were legal spaces on the next block, and sometimes on the same block.

Figure 11: Parking Occupancy during a Typical Weekday

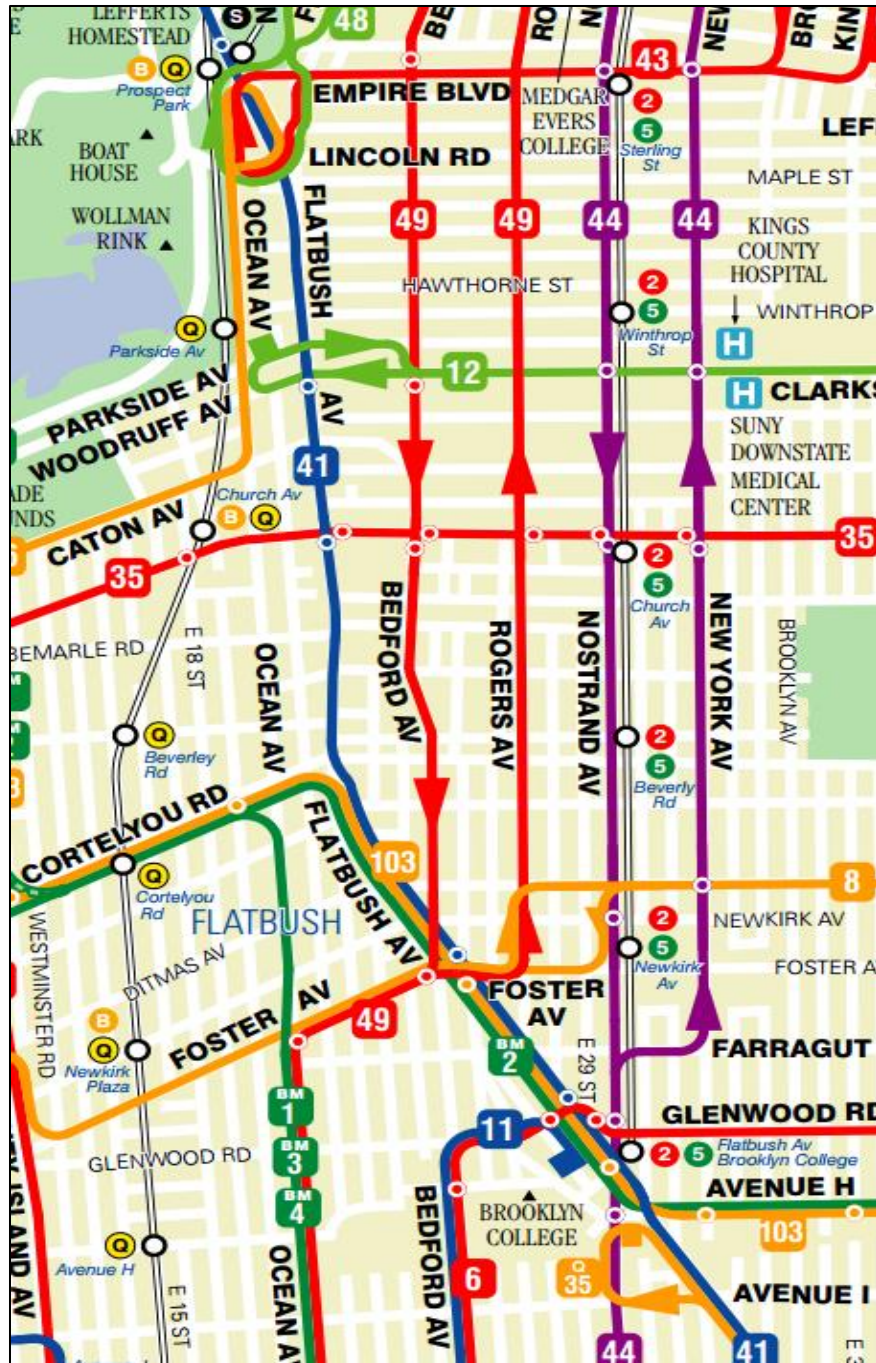
Figure 16: MTA/NYC Transit Map

The study area is served by MTA/NYC transit buses and subways. The service is presented in Figure 16.

The B41 bus operates between Downtown Brooklyn and Mill Basin, running the entire length of Flatbush Avenue with 15 stops in each direction within the study area. The average weekday

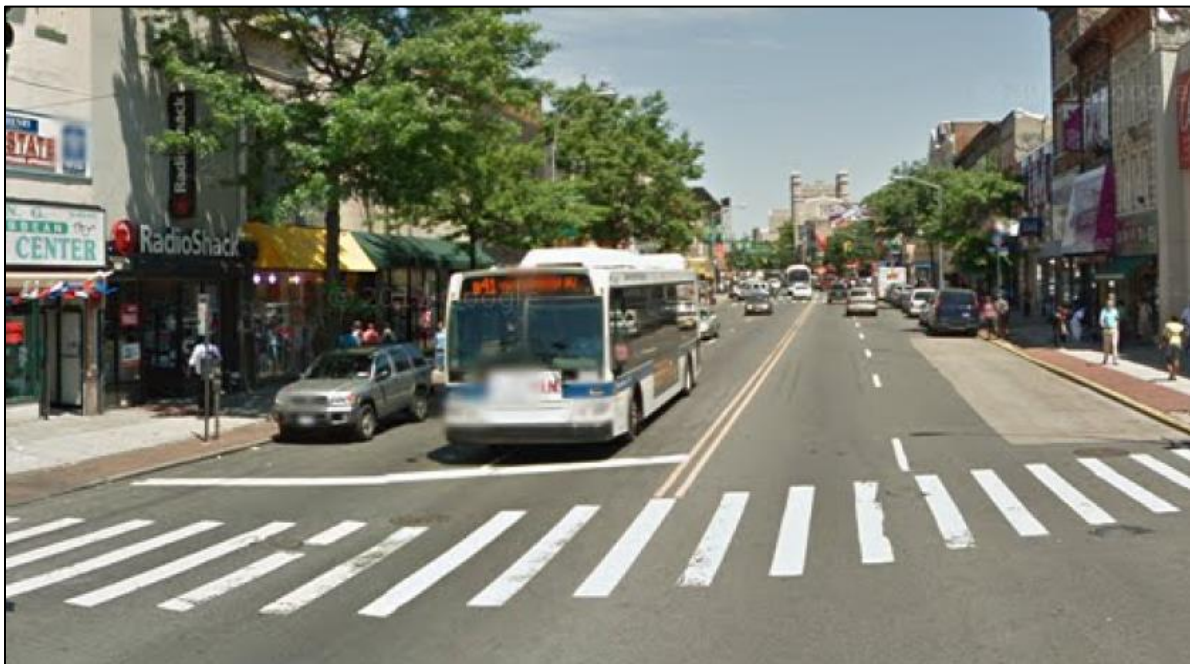
The B-41 bus was often observed to blocking the right travel lane when at a bus stop, due to insufficient curbside width. The narrow travel lanes also made it a very tight squeeze for a passenger vehicle to be traveling adjacent to a traveling bus, as indicated in the photograph below that shows the bus taking up both lanes.

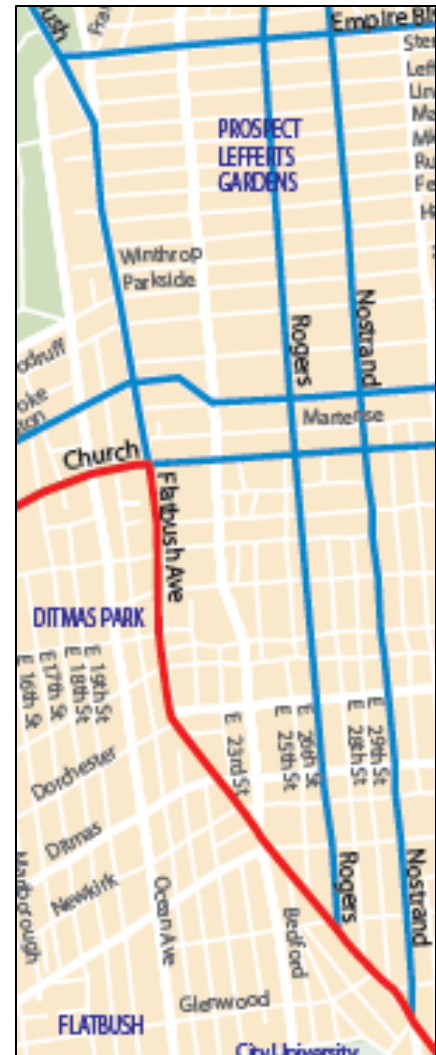
Figure 17: Truck Route Map

The truck routes in the study area are illustrated in Figure 17. Flatbush Avenue is designated as a local truck route between the Manhattan Bridge and Church Avenue, and a through truck route from Church Avenue to the Marine Parkway Bridge. The west leg of Church Avenue is a through truck route. The local truck routes that cross Flatbush Avenue are Empire Boulevard, Caton Avenue, the east leg of Church Avenue, Rogers Avenue and Nostrand Avenue north of Flatbush Avenue.

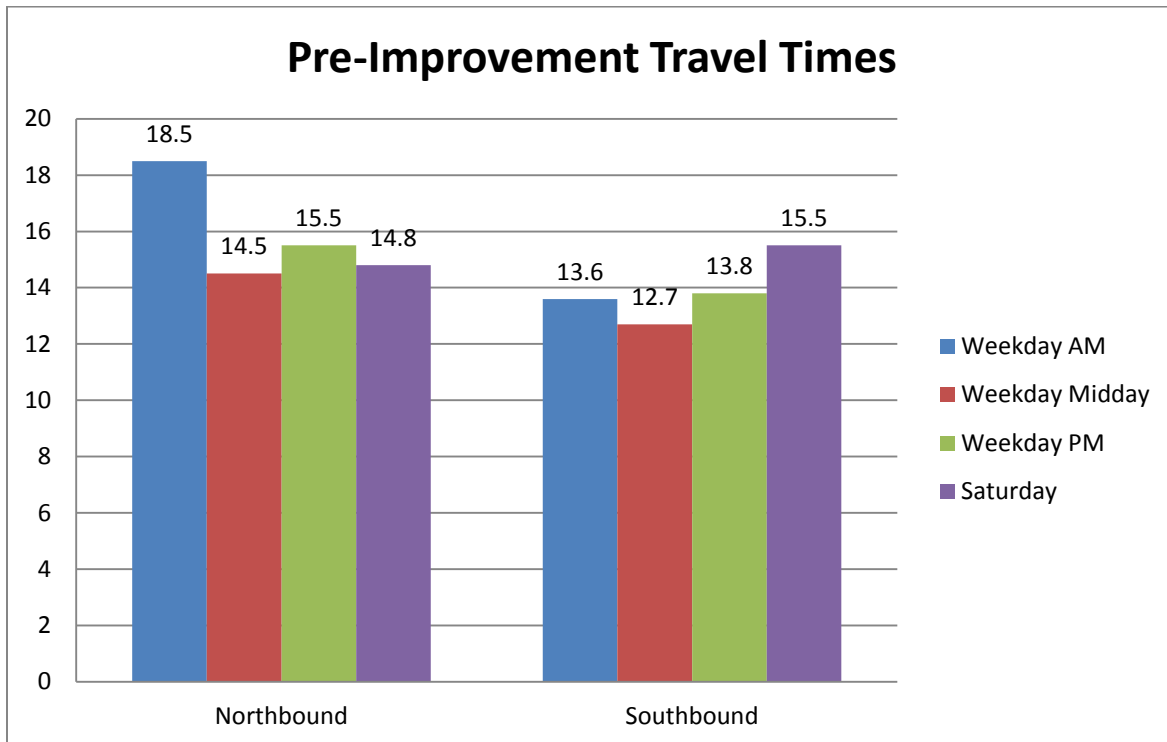
The first step of this process required creating a baseline condition that closely reflects the pre-improvement conditions. Figure 18 presents the results, which was calibrated to match the results of the travel time runs. As expected, the longest peak hour travel time for the northbound direction from the southernmost intersection (Nostrand Avenue) to the northernmost intersection (Empire Boulevard/Ocean Avenue) was during the weekday AM peak period at 18.5 minutes. The longest peak period travel time for the southbound direction was during the Saturday peak period at 15.5 minutes, followed by the weekday PM peak period at 13.8 minutes. Midday travel times were the shortest in both directions.

Figure 18: Pre-Improvement Travel Times on Flatbush Ave between Empire Blvd and Nostrand Ave

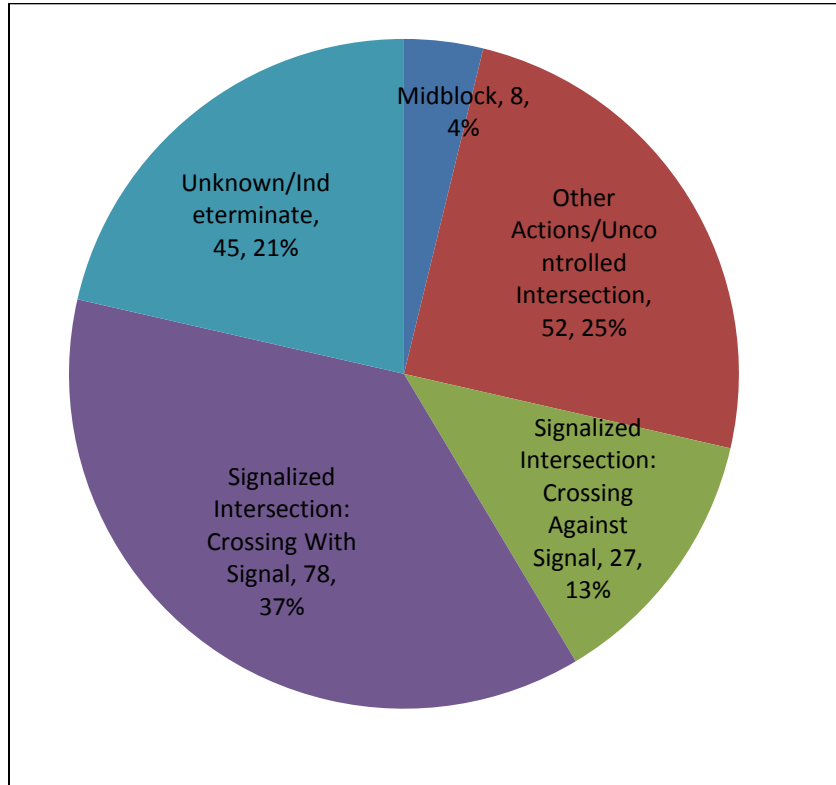
Figure 25 presents a corridor-wide breakdown of crashes involving pedestrians by action. It illustrates that at intersections, pedestrian crashes occurred almost three times as much when the pedestrians were crossing with the signal as when they were crossing against the signal. Further investigation needs to be performed at the time of the crash, like determining crosswalk location, pedestrian action, vehicle action and contributing factors, in order to understand why pedestrian crashes are occurring with this frequency.

Figure 25: Pedestrian Crashes by Action

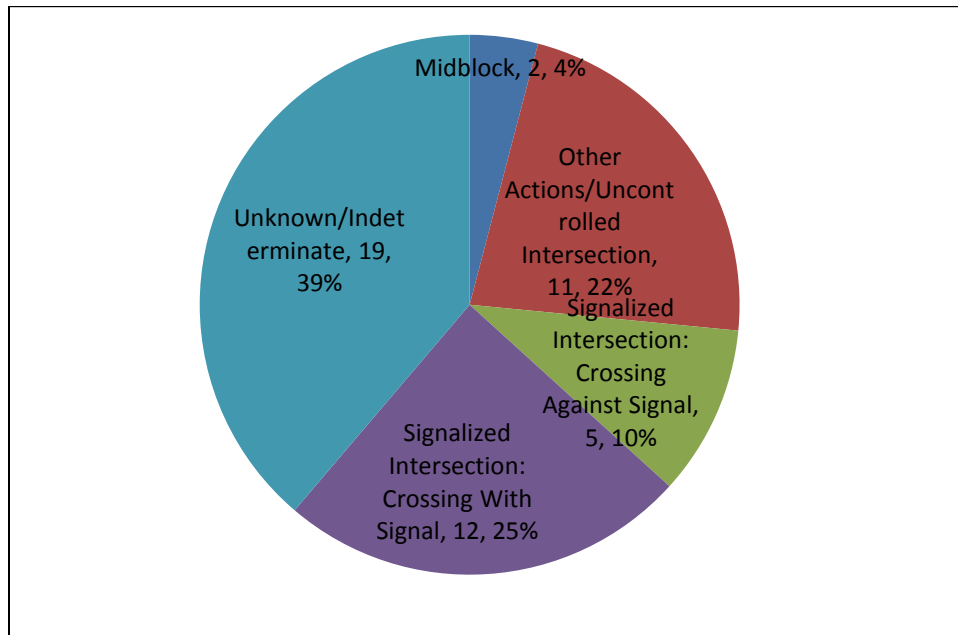
Figure 26 presents a breakdown of bicycle crashes by action. Out of 49 bicycle crashes, 2 (4%) occurred at midblock segments, one between Martense Street and Church Avenue and one between Tilden Avenue and Duryea Place. At intersections, crashes involving bicyclists crossing with the signal occurred 2.5 times more than crossing against the signal.

Figure 26: Bicycle Crashes by Action

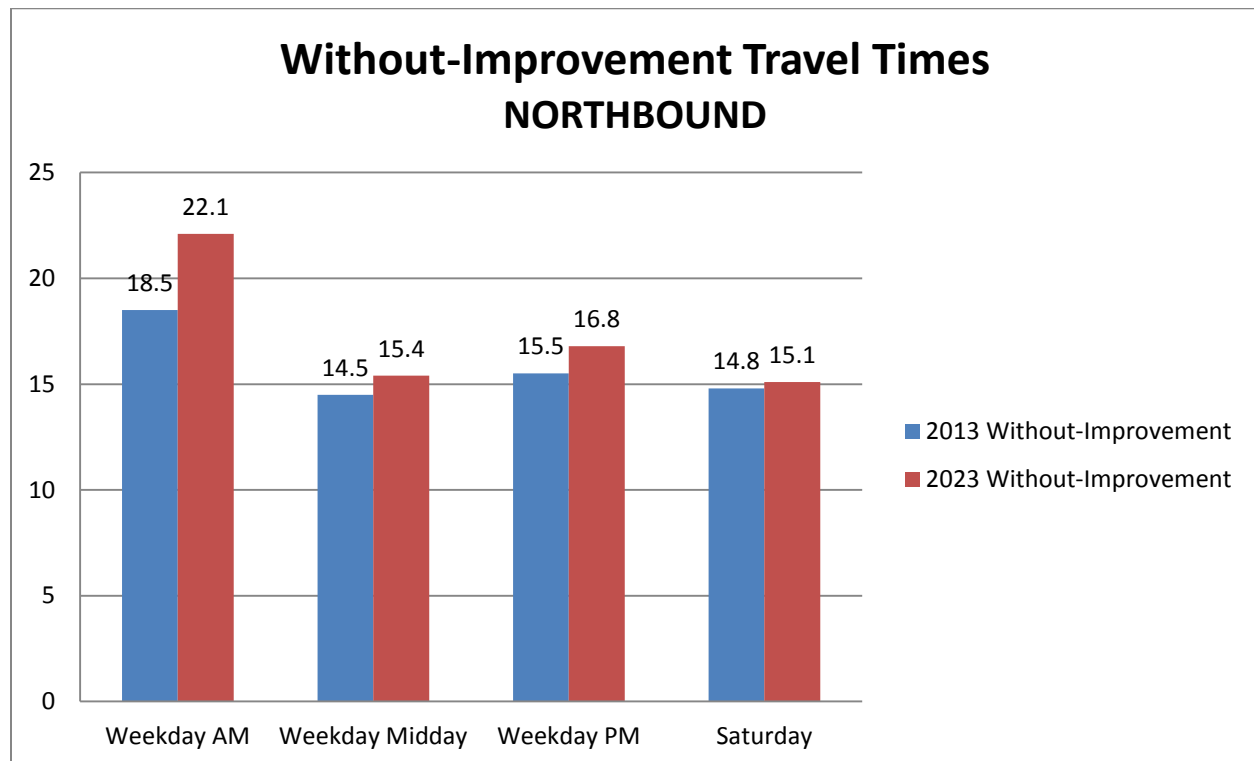
If no improvement measures were implemented, by the year 2023 travel times would increase for all periods due to additional traffic volumes present on the network. Figure 27 compares the travel times of pre-improvement 2013 to future 2023 without improvements for both northbound and southbound directions and shows that the northbound AM period would suffer from the most increase in delays if no improvements were implemented.

Figure 27: 2013 and 2023 Without-Improvement Travel Times for Northbound Direction

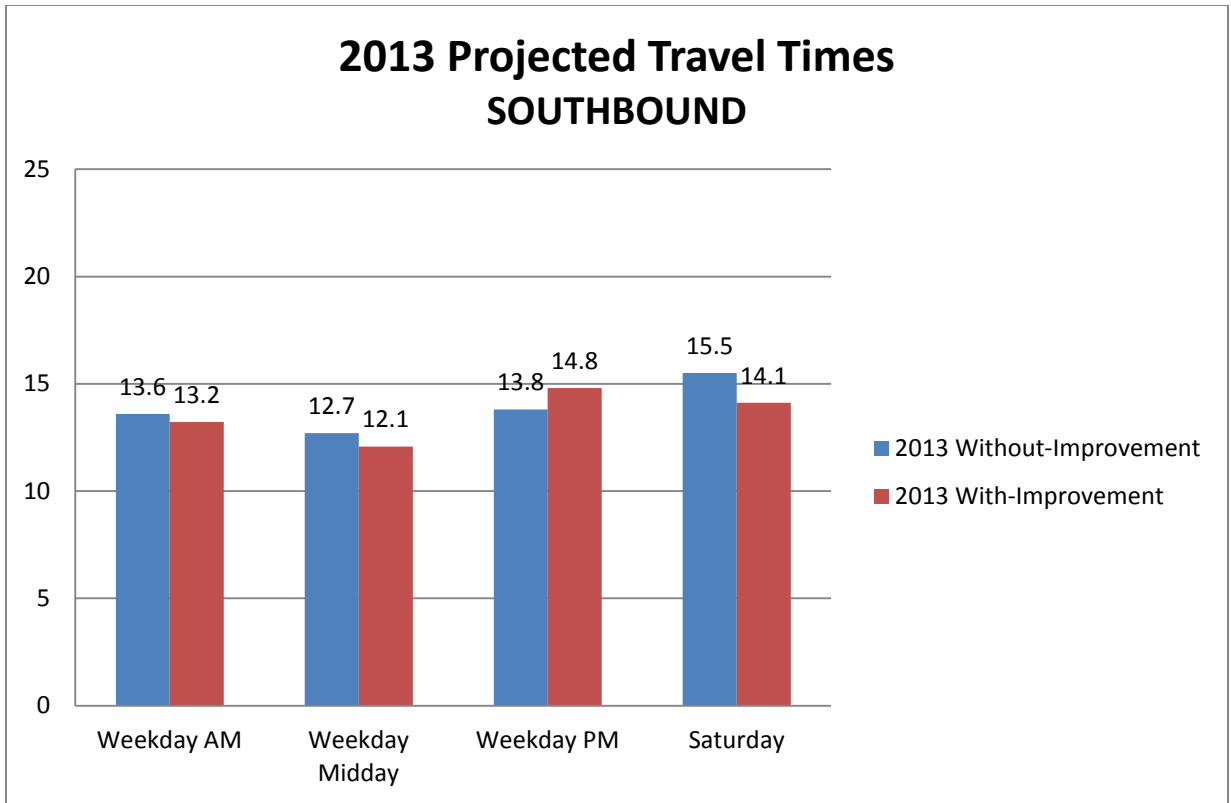
The projections for southbound travel times are shown in Figure 36. Modest improvements in travel times were projected for all but the weekday PM peak hour, where a slight increase in travel time is projected. As mentioned previously, it was decided not to provide a second travel lane in the southbound direction during the weekday PM peak period, as was done for the northbound direction during the weekday AM peak period, because on-street parking and loading was more heavily utilized and it could adversely affect merchants. The late afternoon and early evening hours are more often frequented by shoppers. If future traffic conditions deteriorate as a result of future development, implementing “No Standing 4-7 PM Mon-Fri” is a possible remedy.

Figure 36: 2013 Projected Travel Times for Southbound Direction

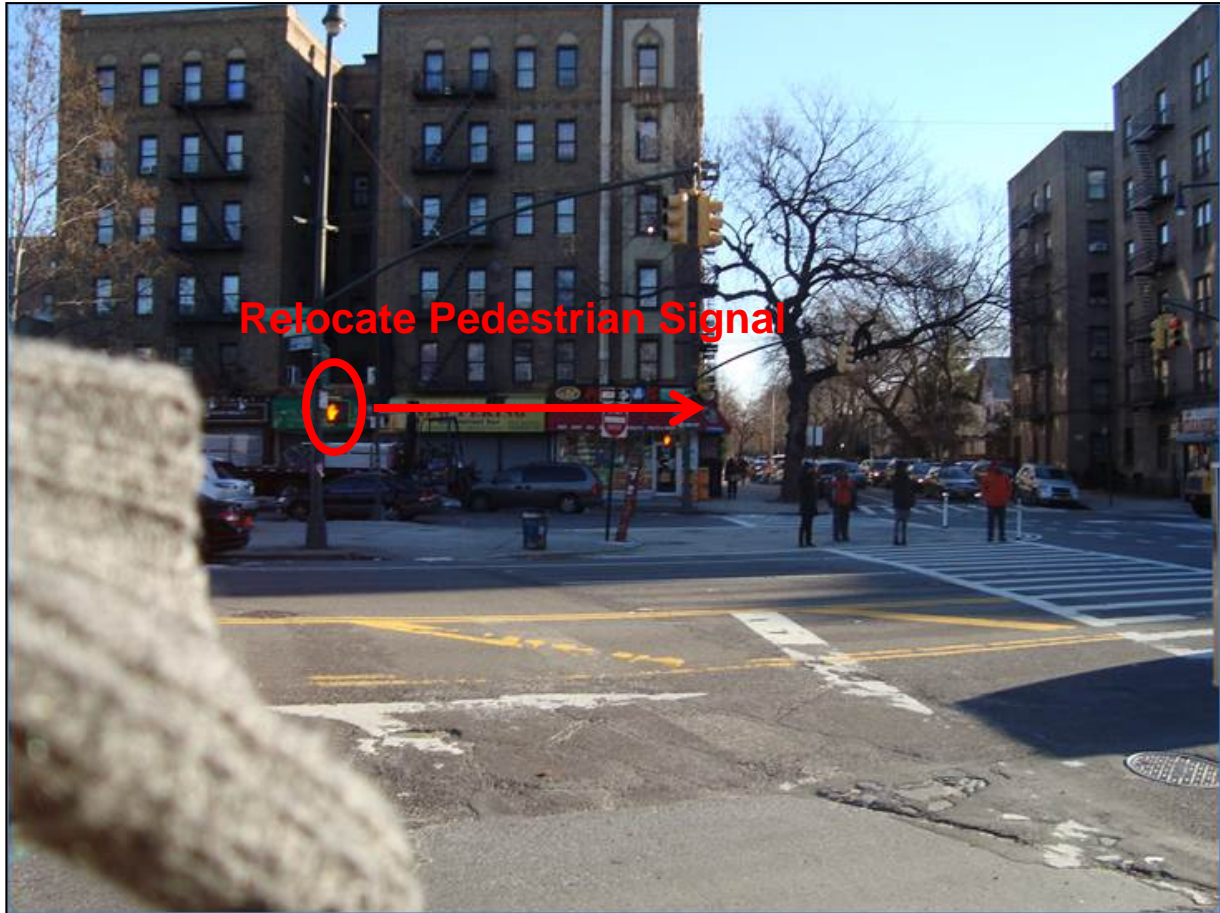
Section 3.3.2 describes improvements for the 5-legged intersection of Flatbush Avenue, Lincoln Road and Washington Avenue that were implemented in 2013. Supplementary improvements for this location are being considered. The first item would be to make permanent with concrete the wedge-shaped sidewalk corner extension on the north side of the intersection between Flatbush Avenue and Washington Avenue, as shown in Figure 45. The feasibility of such construction has been recently investigated, and it was determined that, because of the presence of a catch basin, making this temporary improvement permanent with concrete will require a capital project. Implementation is expected to be completed in 2018.

Photo 5: Looking East from West Side of Flatbush Avenue at Lincoln Road.
