NEW YORK CITY DEPARTMENT OF TRANSPORTATION
Office of School Safety Engineering

School Safety Engineering Project

FINAL REPORT: Collegiate School, Manhattan

NOVEMBER 17, 2006

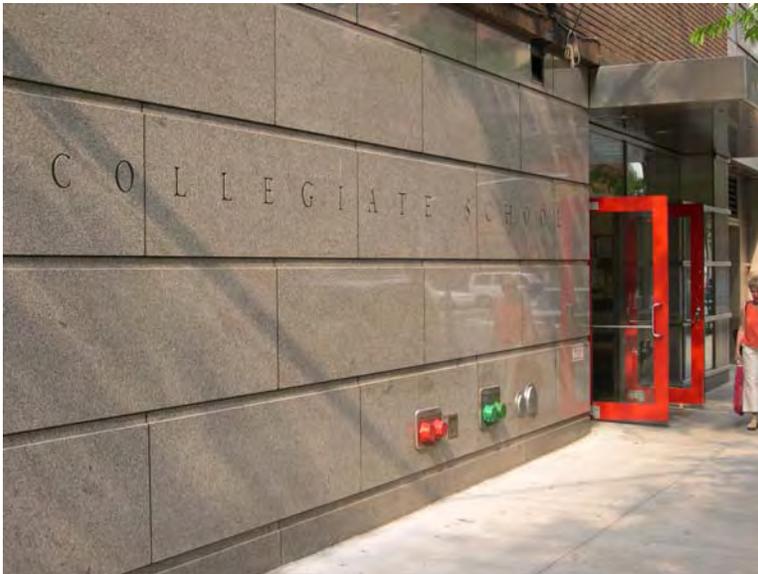
Located at 260 West 78th Street in Manhattan, Collegiate School is located on the south side of West 78th Street between Broadway and West End Avenue (see Figure 1). The school's main entrance is on West 78th Street. There is also a secondary entrance with a distinctive metal gate (painted red) facing West End Avenue.

Figure 1: Collegiate School main entrance on West 78th Street

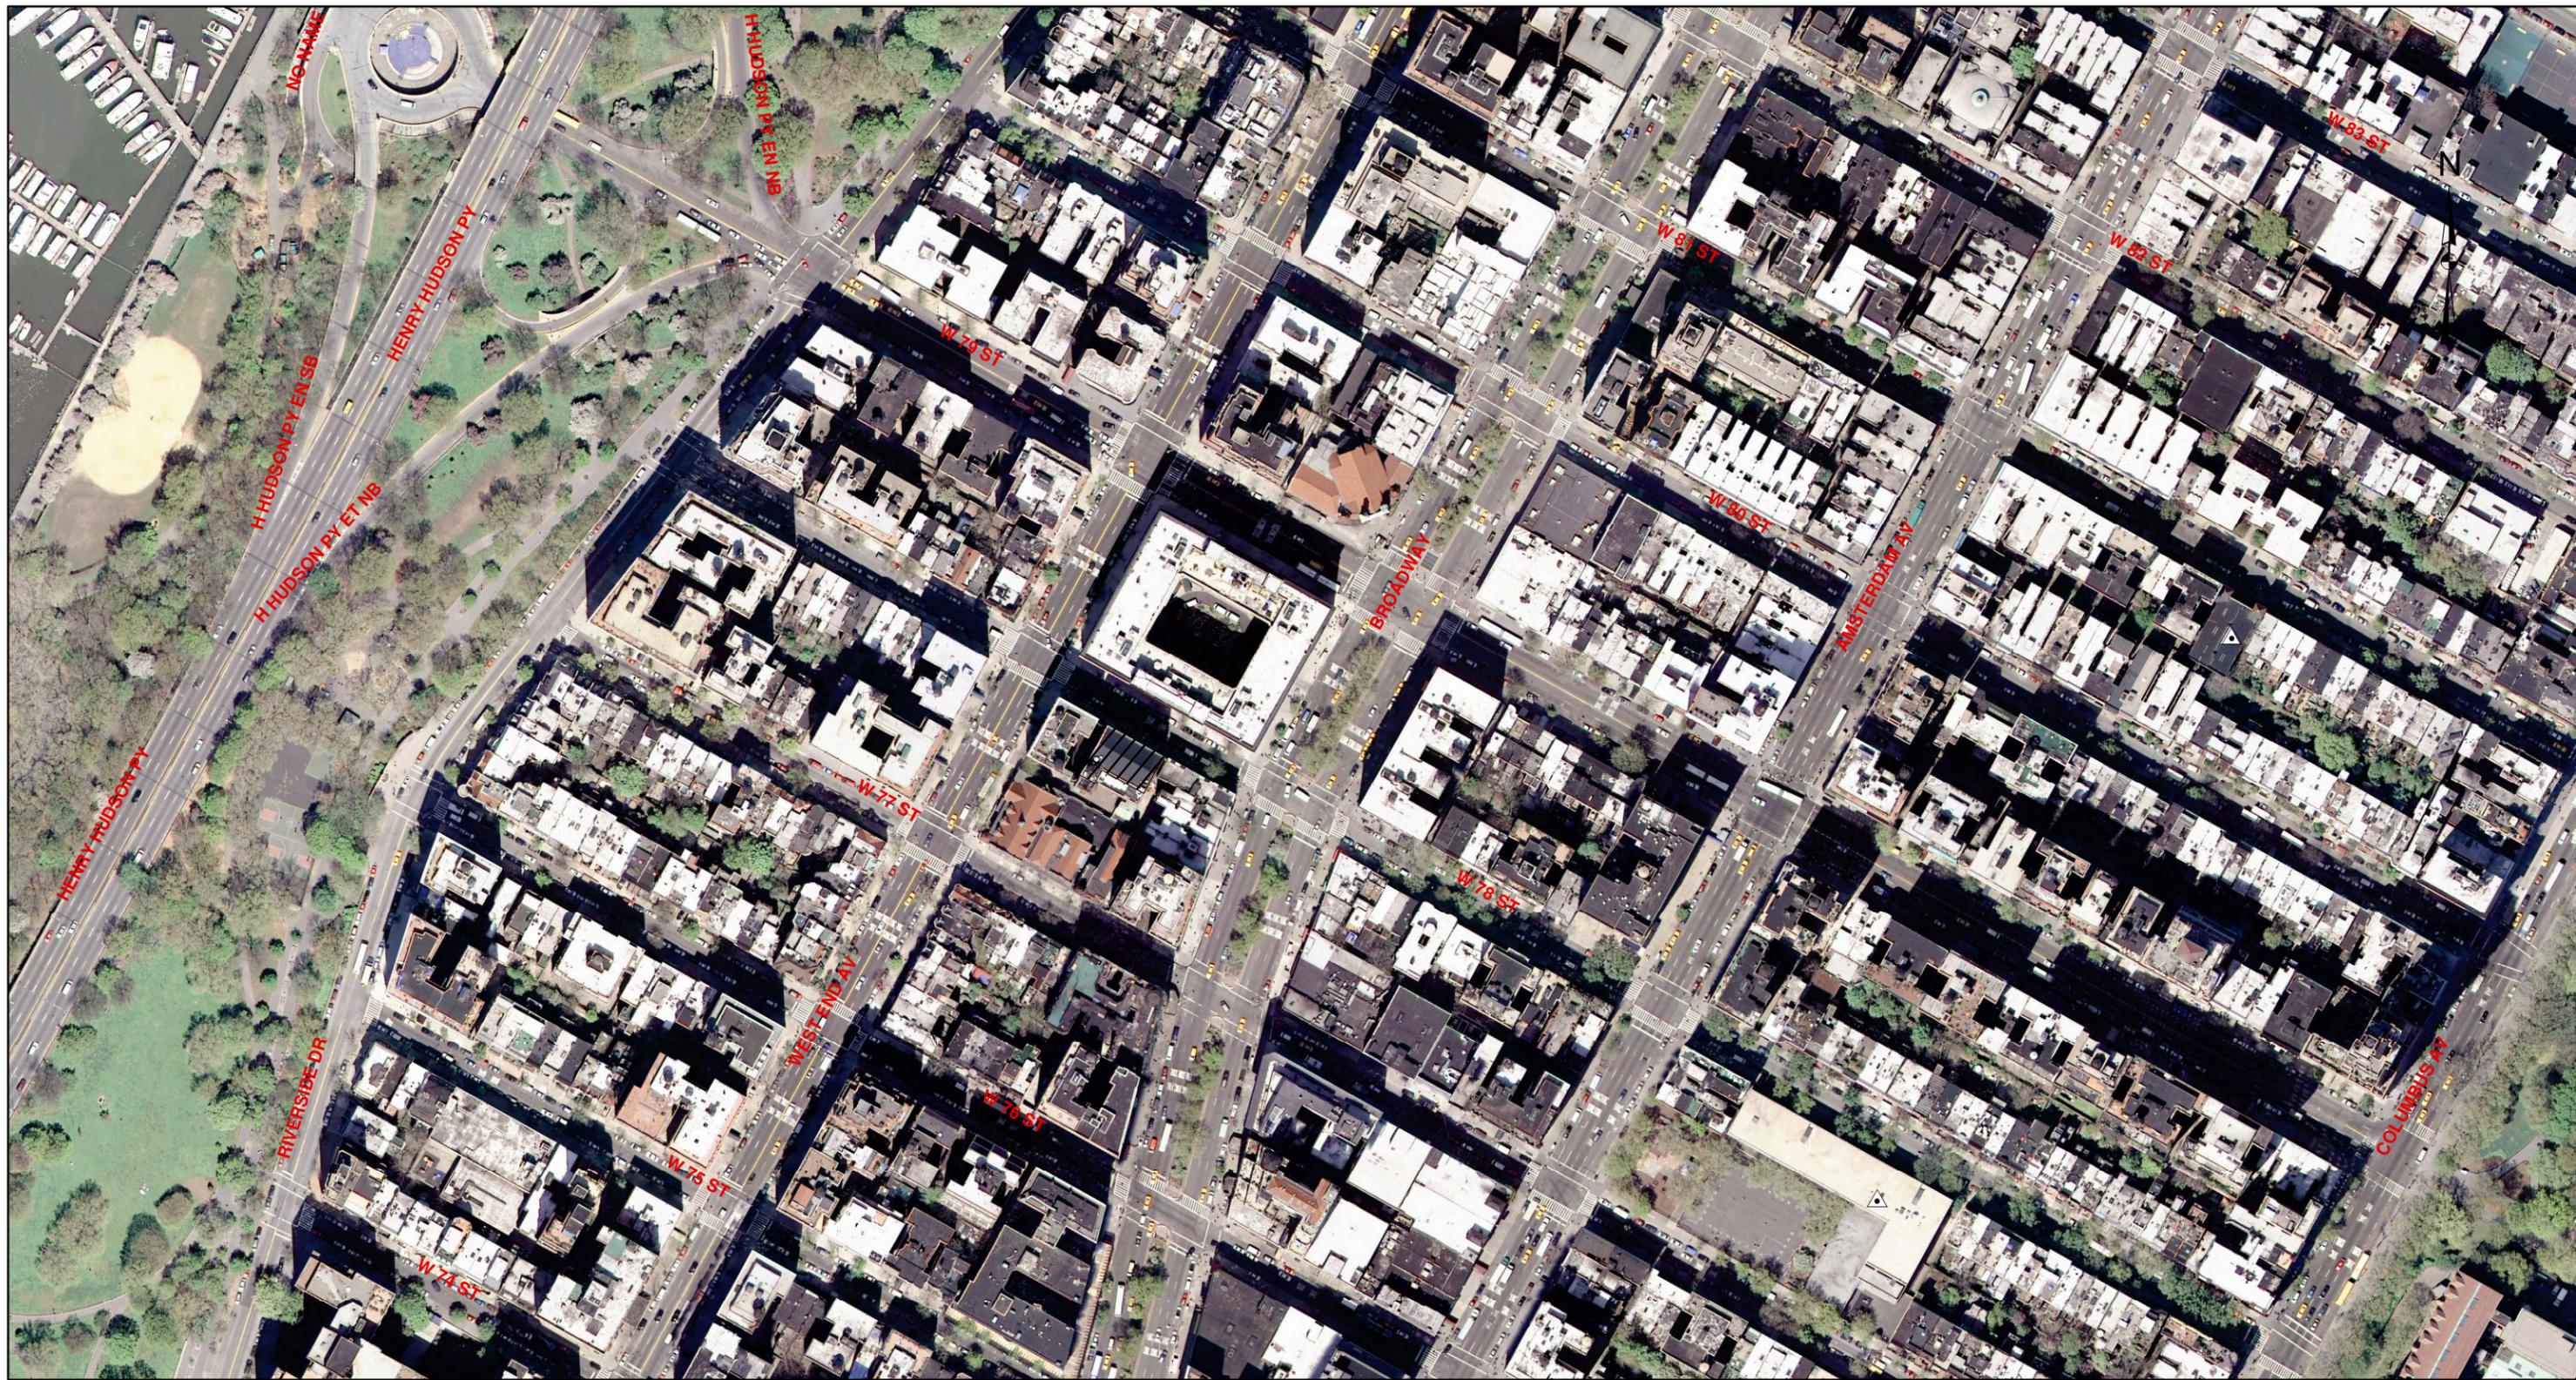
EXHIBIT 1
COLLEGIATE SCHOOL
MANHATTAN

AERIAL PHOTOGRAPH

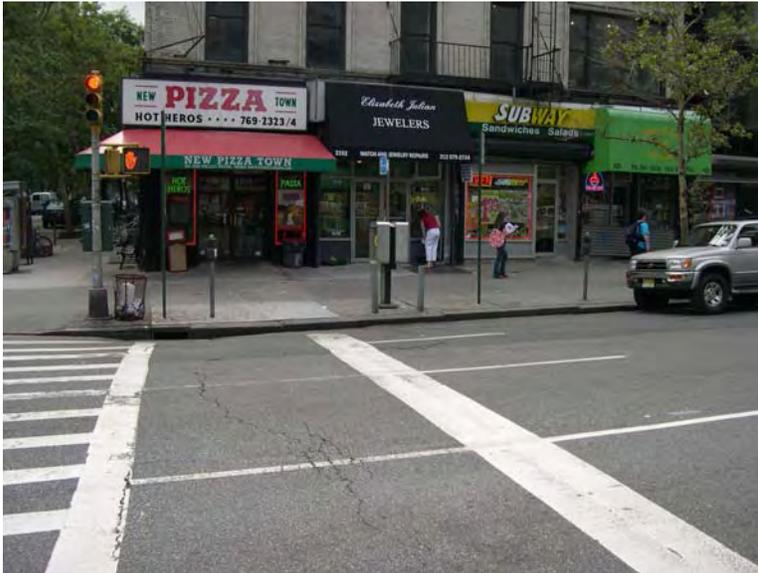
The commercial district along Broadway is located half a block east of Collegiate School (see Figure 2). There are several bus routes operating in the vicinity of the school: M7, M11 and M79. In addition, a subway station for the 1 line is located one block north of the school at the corner of Broadway and West 79th Street.

Figure 2 – Broadway in the vicinity of Collegiate School

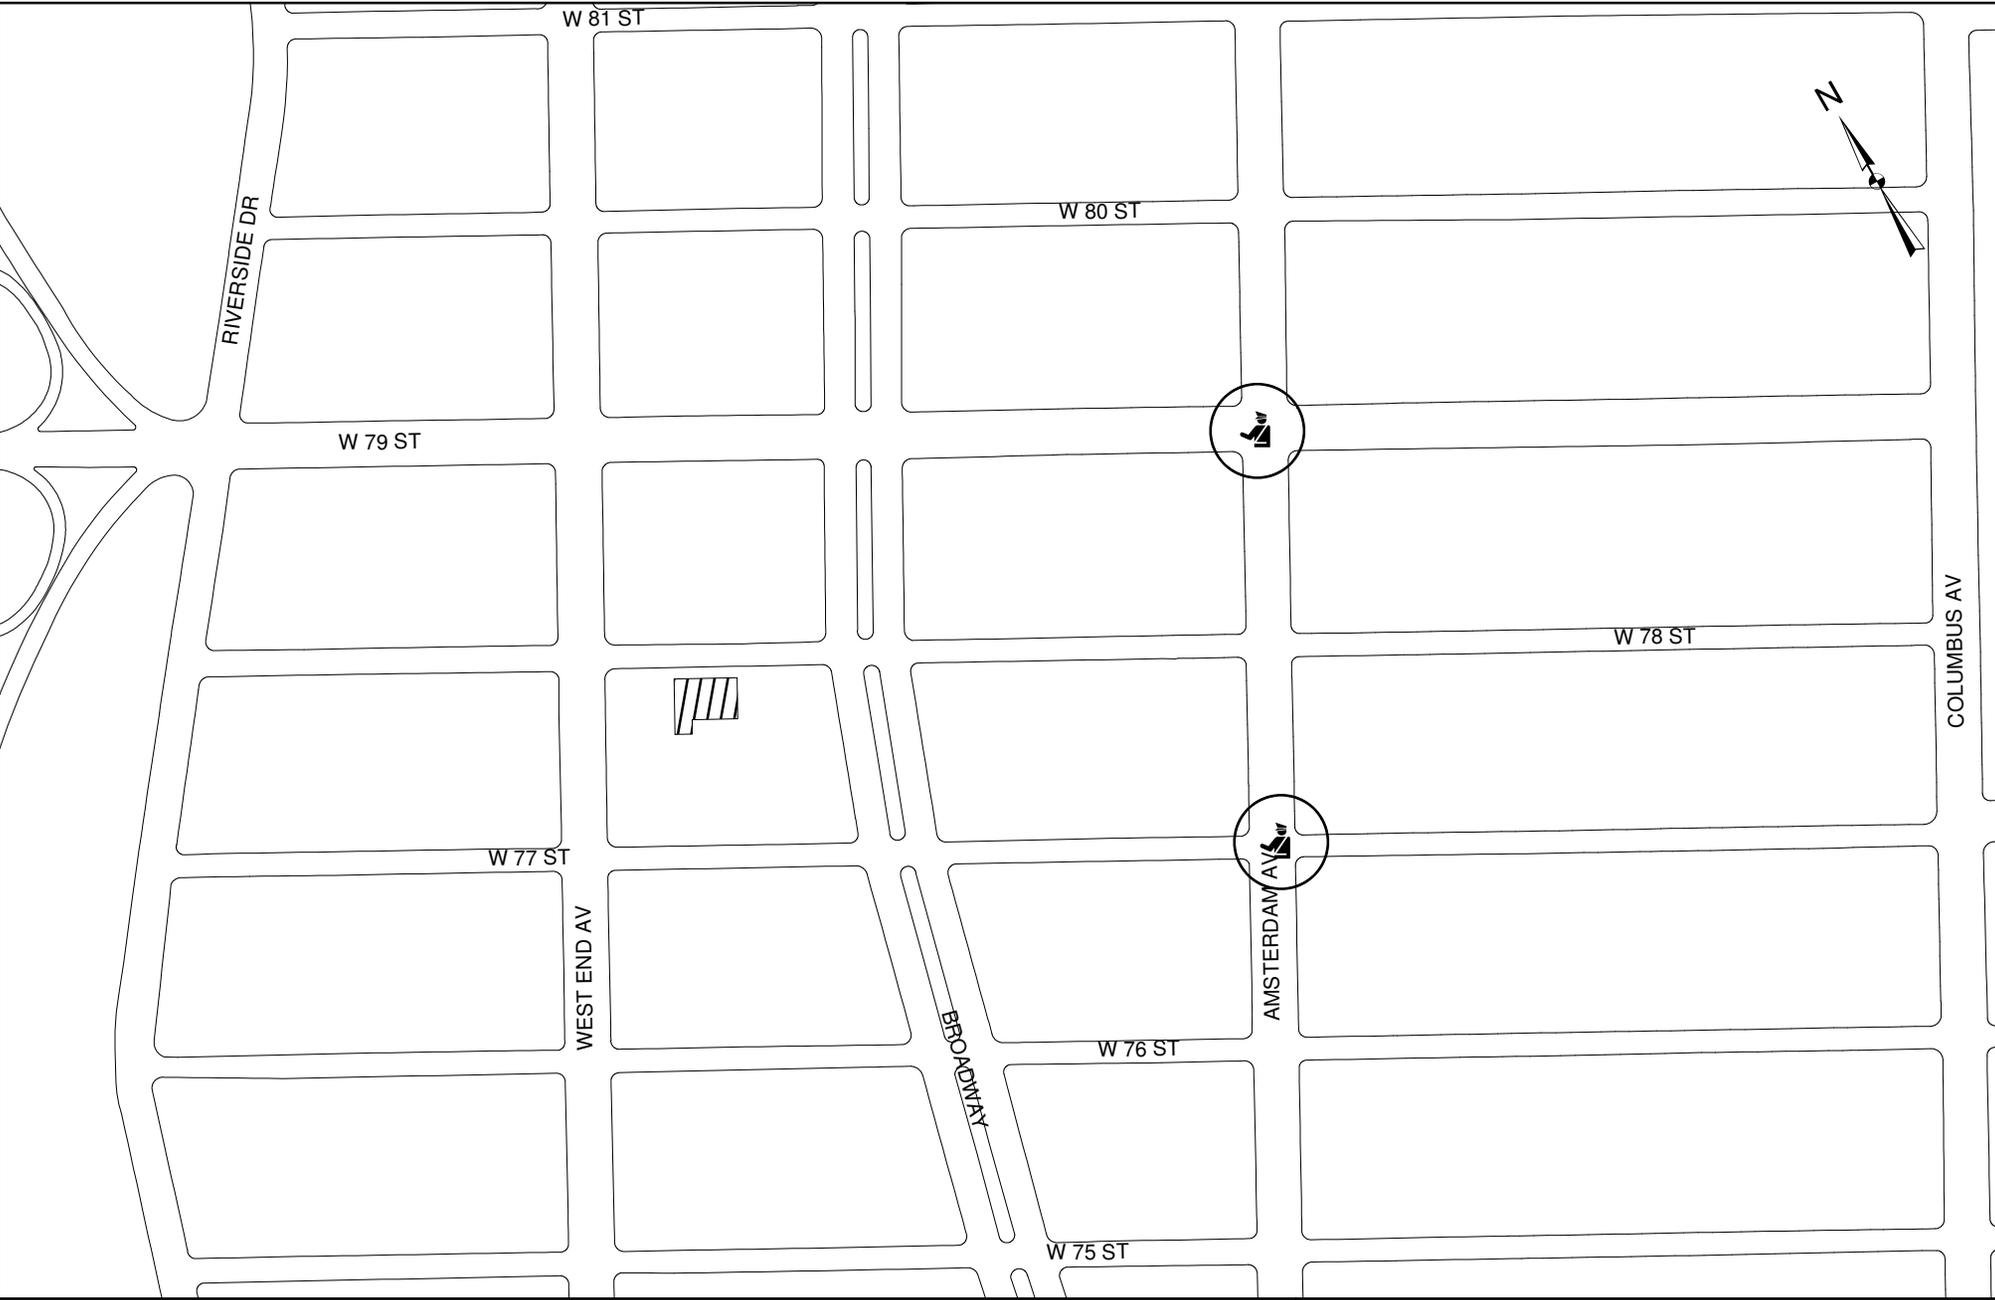
EXHIBIT 3
COLLEGIATE SCHOOL
MANHATTAN
CROSSING GUARDS

CROSSING GUARD ASSIGNED TO ANOTHER SCHOOL

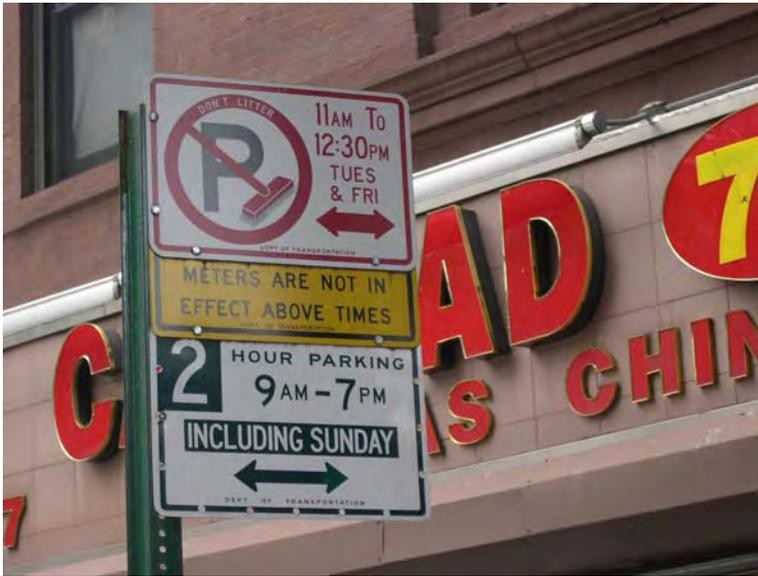
“NO PARKING 7AM – 4 PM SCHOOL DAYS” parking regulations are posted in front of the school on the south side of West 78th Street. “2-HOUR PARKING 9:00 AM - 7:00 PM INCLUDING SUNDAY” regulations are posted on both sides of West 78th Street (see Figure 3).

Figure 3 – Parking regulations on West 78th Street, east of Collegiate School

Existing “NO PARKING 7:00 AM - 4:00 PM, SCHOOL DAYS” parking regulations on West 78th Street should be upgraded to “NO STANDING 7:00 AM -4:00 PM, SCHOOL days” for a length of 60 feet in front of the school's main entrance. (This is a typical requirement for all NYC schools in order to provide for emergency access to and from the school.)

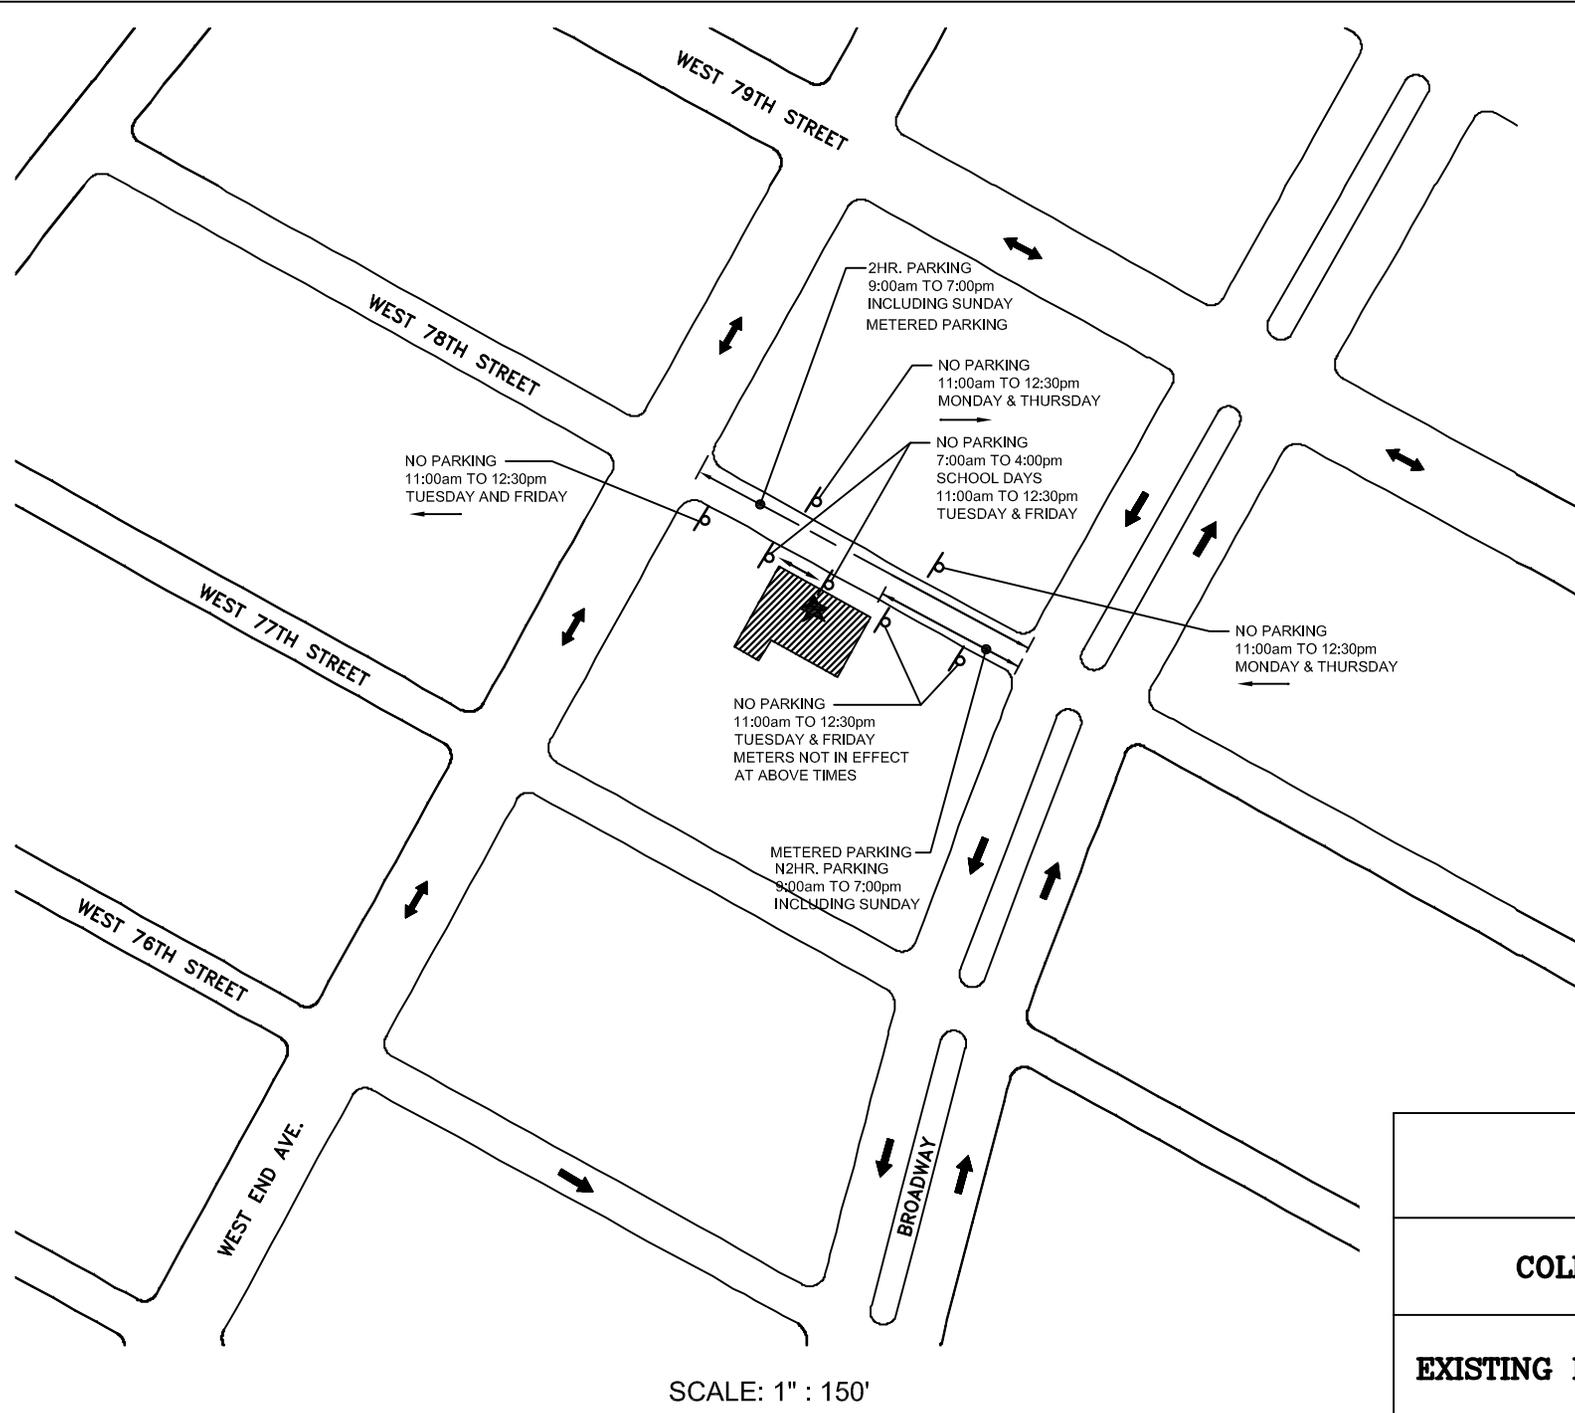
EXHIBIT 4

Alternate side street parking regulations are in effect 11:00 am – 12:30 pm on the roadways surrounding the school. See Exhibit 4 for parking regulations.

EXISTING PARKING REGULATIONS

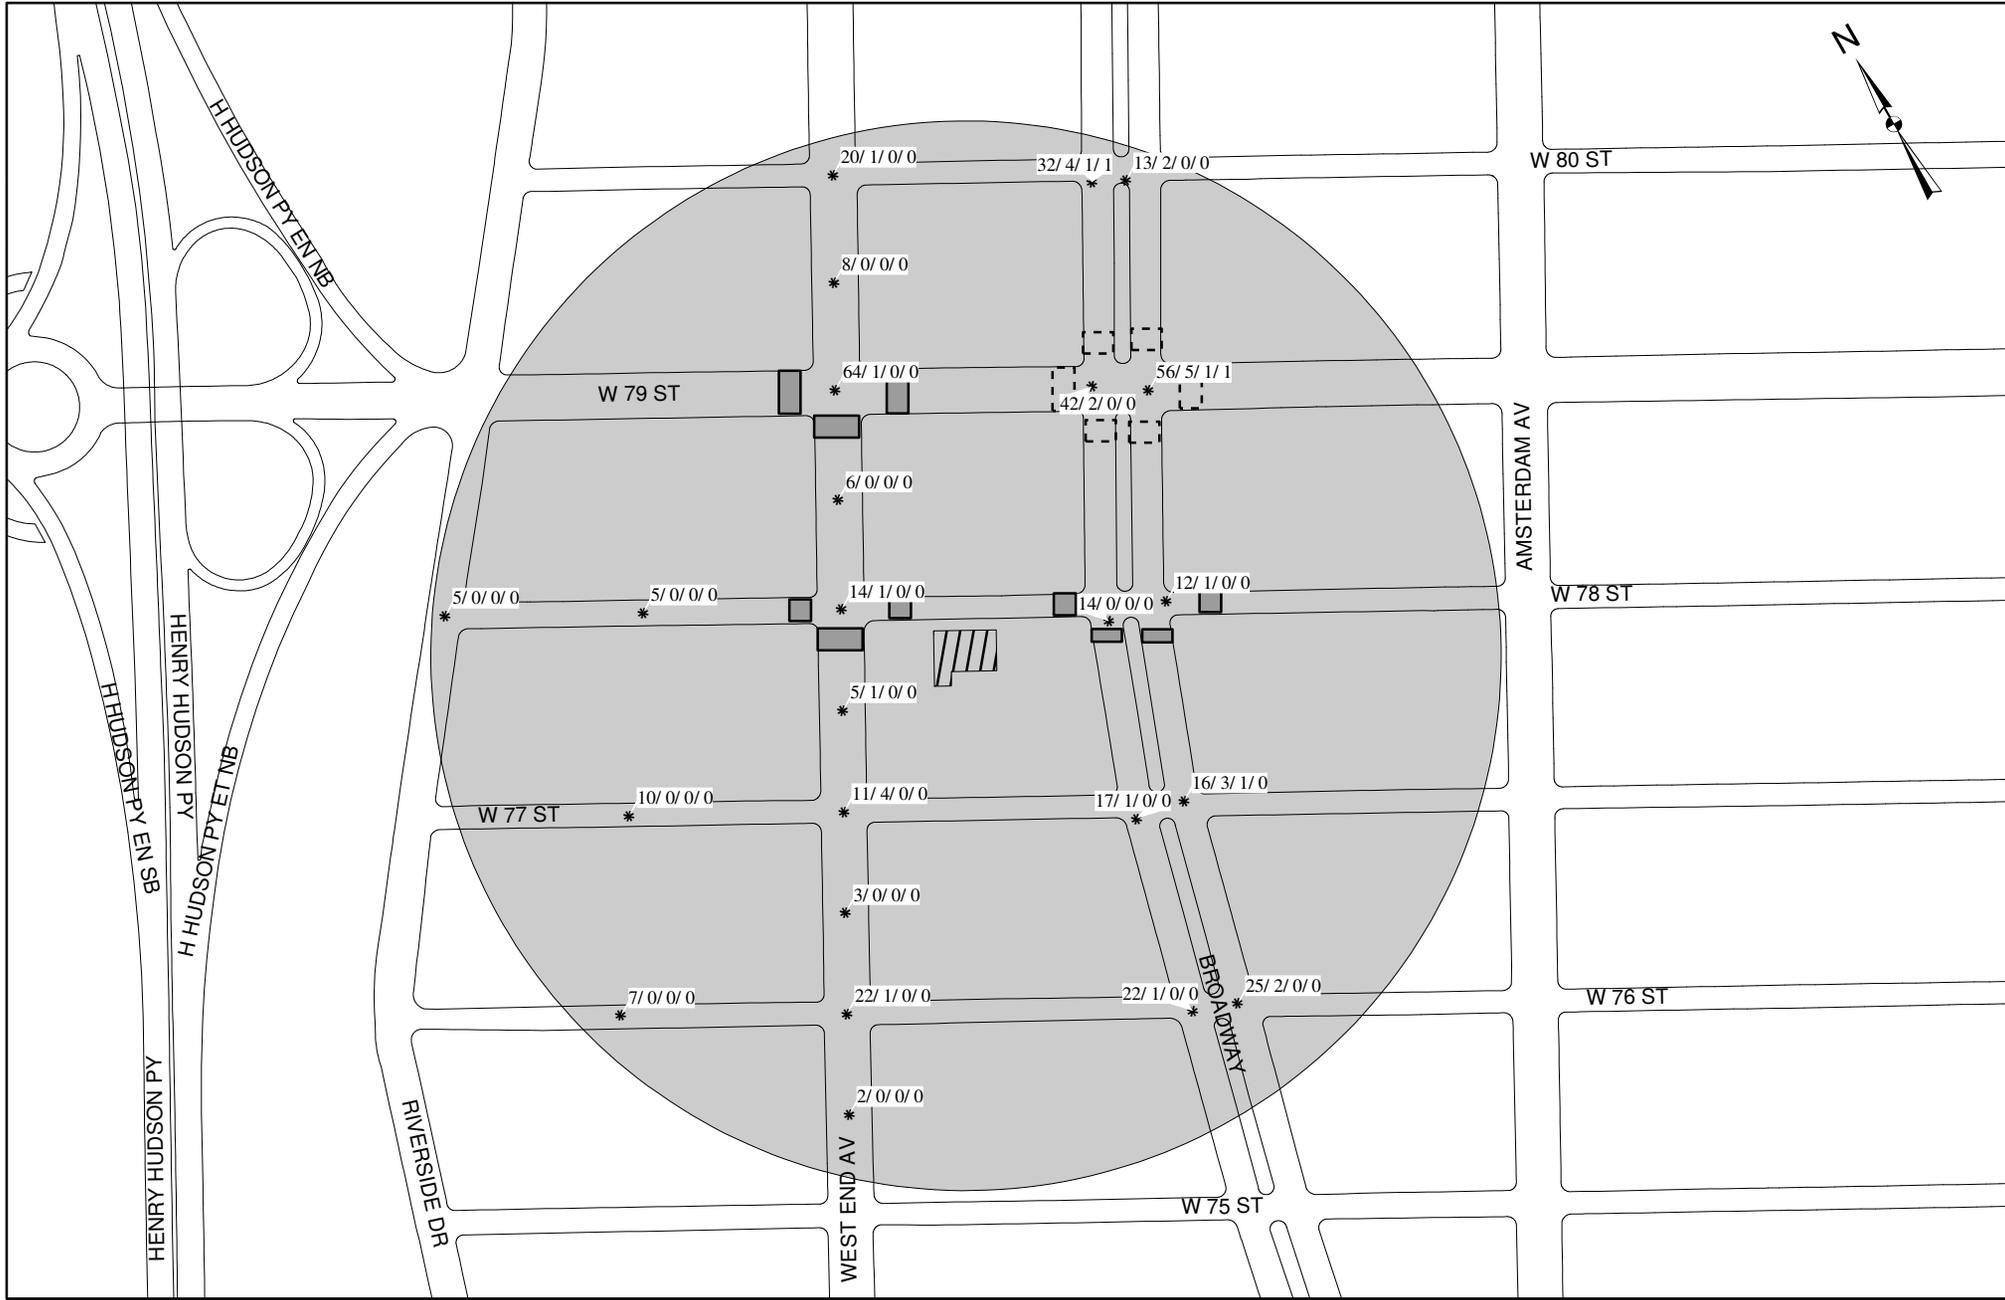
EXHIBIT 5
COLLEGIATE SCHOOL
MANHATTAN
ACCIDENT SUMMARY
THREE YEAR PERIOD
(1998-2000)

Exhibit 5 and Table 1 show a summary of accidents, as obtained from the New York State Department of Motor Vehicles (DMV), in the vicinity of Collegiate School for the three-year period from January 1, 1998 through December 31, 2000. The DMV data provides some detail relating to the circumstances and cause of the accident. Table 2 is a summary of more recent accident data obtained from the NYC Police Department (NYPD). Though current through 2004, the NYPD data does not provide the same level of detail as the DMV data.

ACCIDENT LOCATION *
SCHOOL CROSSWALK ASSIGNED TO COLLEGIATE SCHOOL
SCHOOL CROSSWALK ASSIGNED TO ANOTHER SCHOOL
CROSSWALK

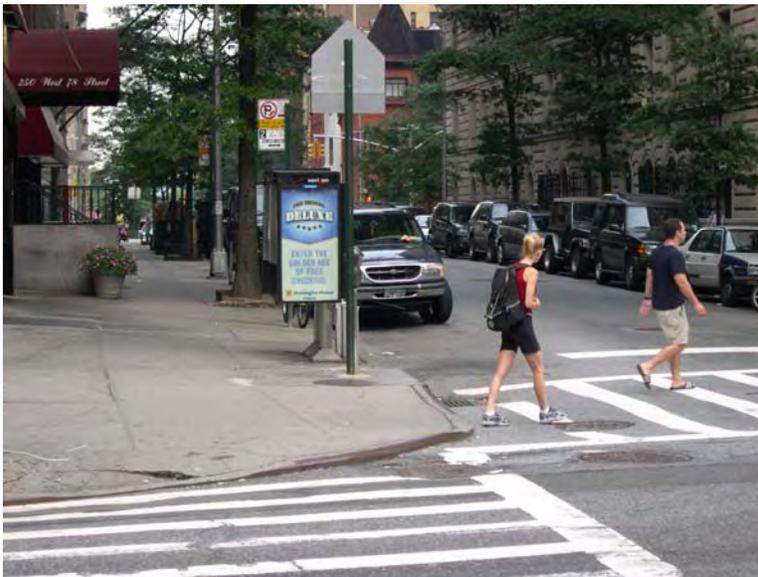
West 78th Street is a 30-foot wide, one-way eastbound street, with one travel lane and parking on both sides (see Figure 5). Broadway is a 100-foot wide, two-way roadway with three moving lanes in each direction and parking on both sides of the street (see Figure 6). A 20-foot wide median separates the northbound and the southbound traffic. Broadway and West 78th Street is a signalized intersection with school crosswalks on the south, east and west legs.

Figure 5: West 78th Street looking west from Broadway

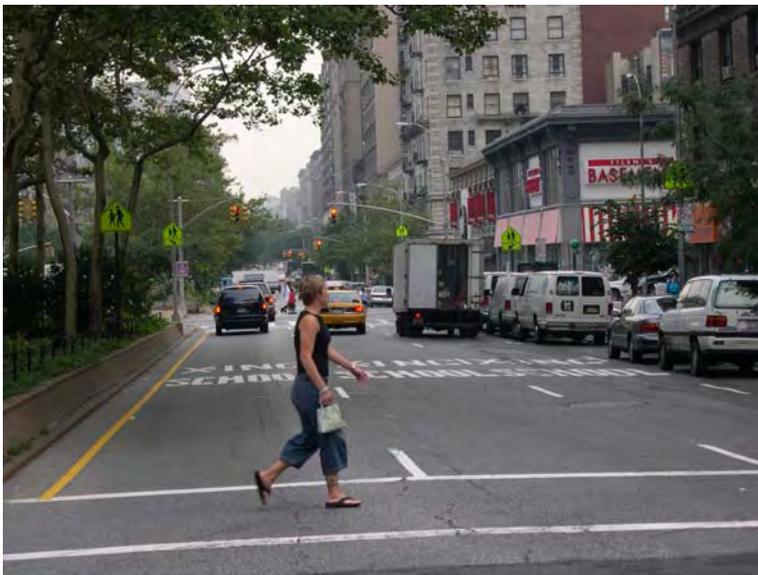
Figure 6: Looking north on Broadway from West 78th Street

Review of the existing signal timing indicates that the pedestrian phase does not provide adequate time for pedestrians to cross Broadway from curb-to-curb in one cycle at a walking rate of three feet per second plus three seconds reaction time. A pedestrian is expected to wait at the center median between signal cycles. It is common practice to utilize the median as a refuge for pedestrians to wait between signal cycles

There were 26 accidents at this intersection during the 1998-2000 study period. One accident involved a pedestrian, which was not school-related. The accident was attributed to a driver backing up his vehicle unsafely.

The safety of pedestrians at the wide intersections of Broadway at West 78th Street, West 79th Street and West 80th Street is a major concern. Installation of a pedestrian information sign adjacent to each school crosswalk that explains the signal phases is recommended. The pedestrian should be informed to wait at the median between signal cycles.

- Broadway and West 78th Street
- Broadway and West 79th Street

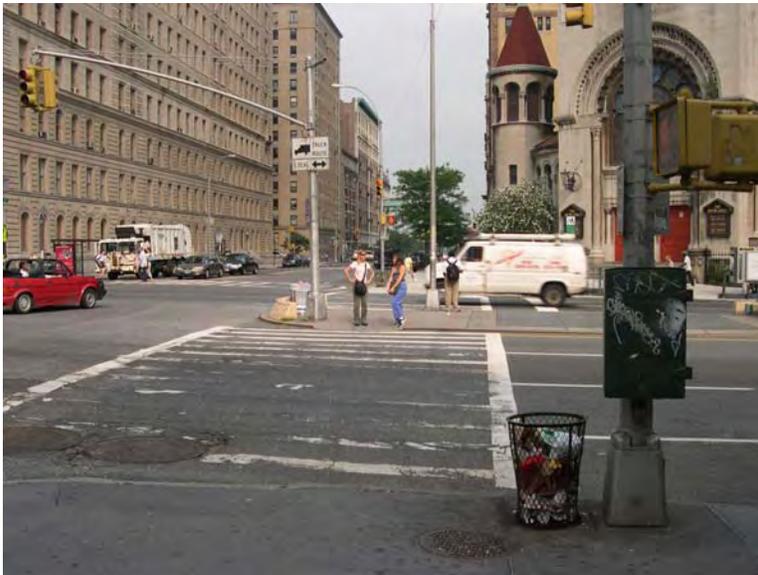
Broadway and West 79th Street is a signalized intersection. West 79th Street is a 60-foot wide, two-way roadway with two travel lanes in each direction and parking on both sides of the street (Figures 7 and 8). West 79th Street provides access to Henry Hudson Parkway and carries significant traffic volumes through the area. There are school crosswalks on all four legs of the intersection. The northeast and northwest quadrants do not have standard pedestrian ramps.

Figure 7: Looking west at West 79th Street and Broadway

Review of the existing signal timing indicates that the pedestrian phase does not provide adequate time for pedestrians to cross Broadway from curb-to-curb in one cycle at a walking rate of three feet per second plus three seconds reaction time. A pedestrian is expected to wait in the center median between signal cycles. It is common practice to utilize the median as a refuge for pedestrians to wait between signal cycles

There were 98 accidents at this intersection during the 1998-2000 study period. Seven accidents involved pedestrians, one of which was fatal. A 79-year-old pedestrian was struck and killed. This fatal accident was a combination of pedestrian error and the driver traveling at an unsafe speed.

There was one school-related pedestrian accident. An 11-year-old student was struck while crossing with the signal. It was cited as driver error. Two pedestrians were struck while crossing against the signal. One pedestrian was struck while getting out of a vehicle. Another accident was due to the driver's failure to yield to a pedestrian while he making a left turn. There was no further detail for the last accident.

- Broadway and West 79th Street – northeast and northwest corners

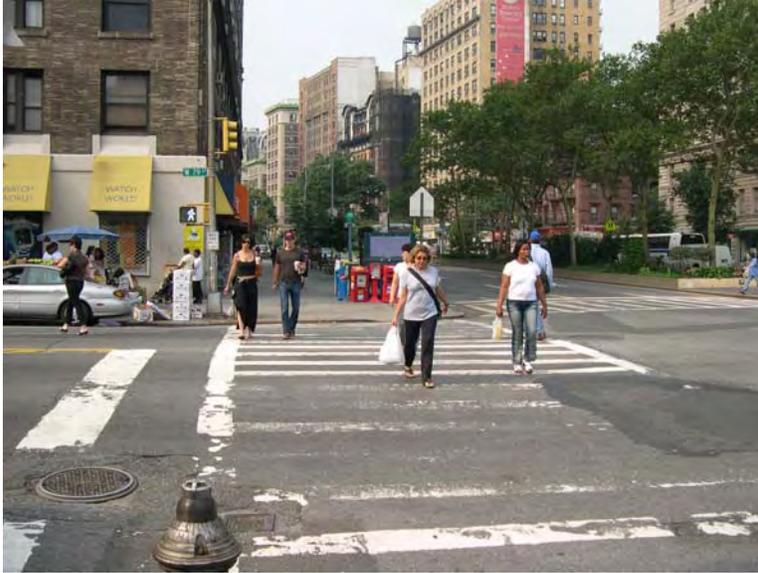
Figure 8: Looking south on the east side of Broadway across West 79th Street

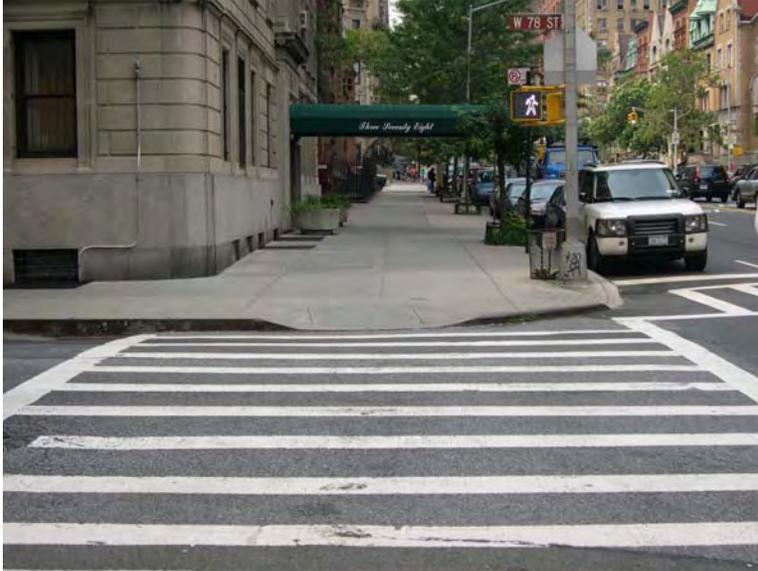
West End Avenue and West 78th Street is a signalized intersection. West End Avenue is a 60-foot wide, two-way roadway with two travel lanes and parking on both sides (see Figure 9). There are school crosswalks on the south, east and west legs of the intersection (see Figures 9 and 10).

Figure 9: Looking south on the east side of West End Avenue across West 78th Street

There were 14 accidents at this intersection during the 1998-2000 study period. One accident involved a pedestrian, which was not school-related. A pedestrian was struck while emerging from between parked vehicles.

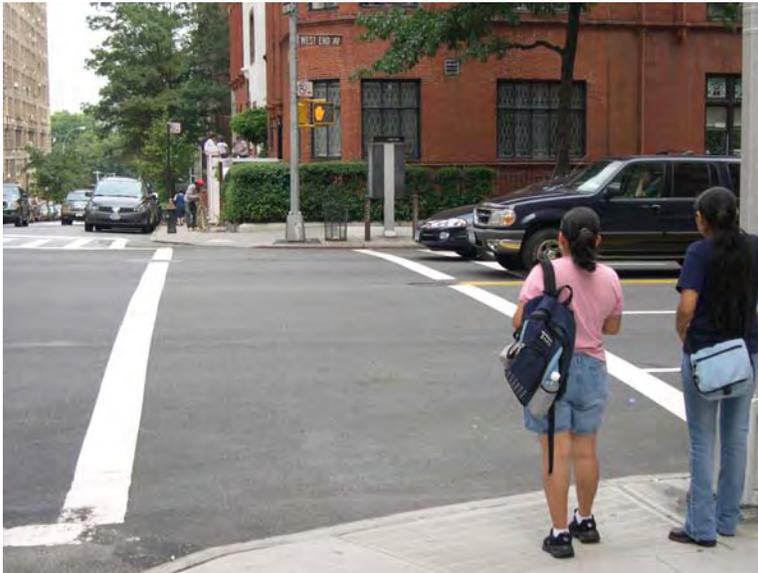
Figure 10: Looking west on the north side of West 78th Street across West End Avenue

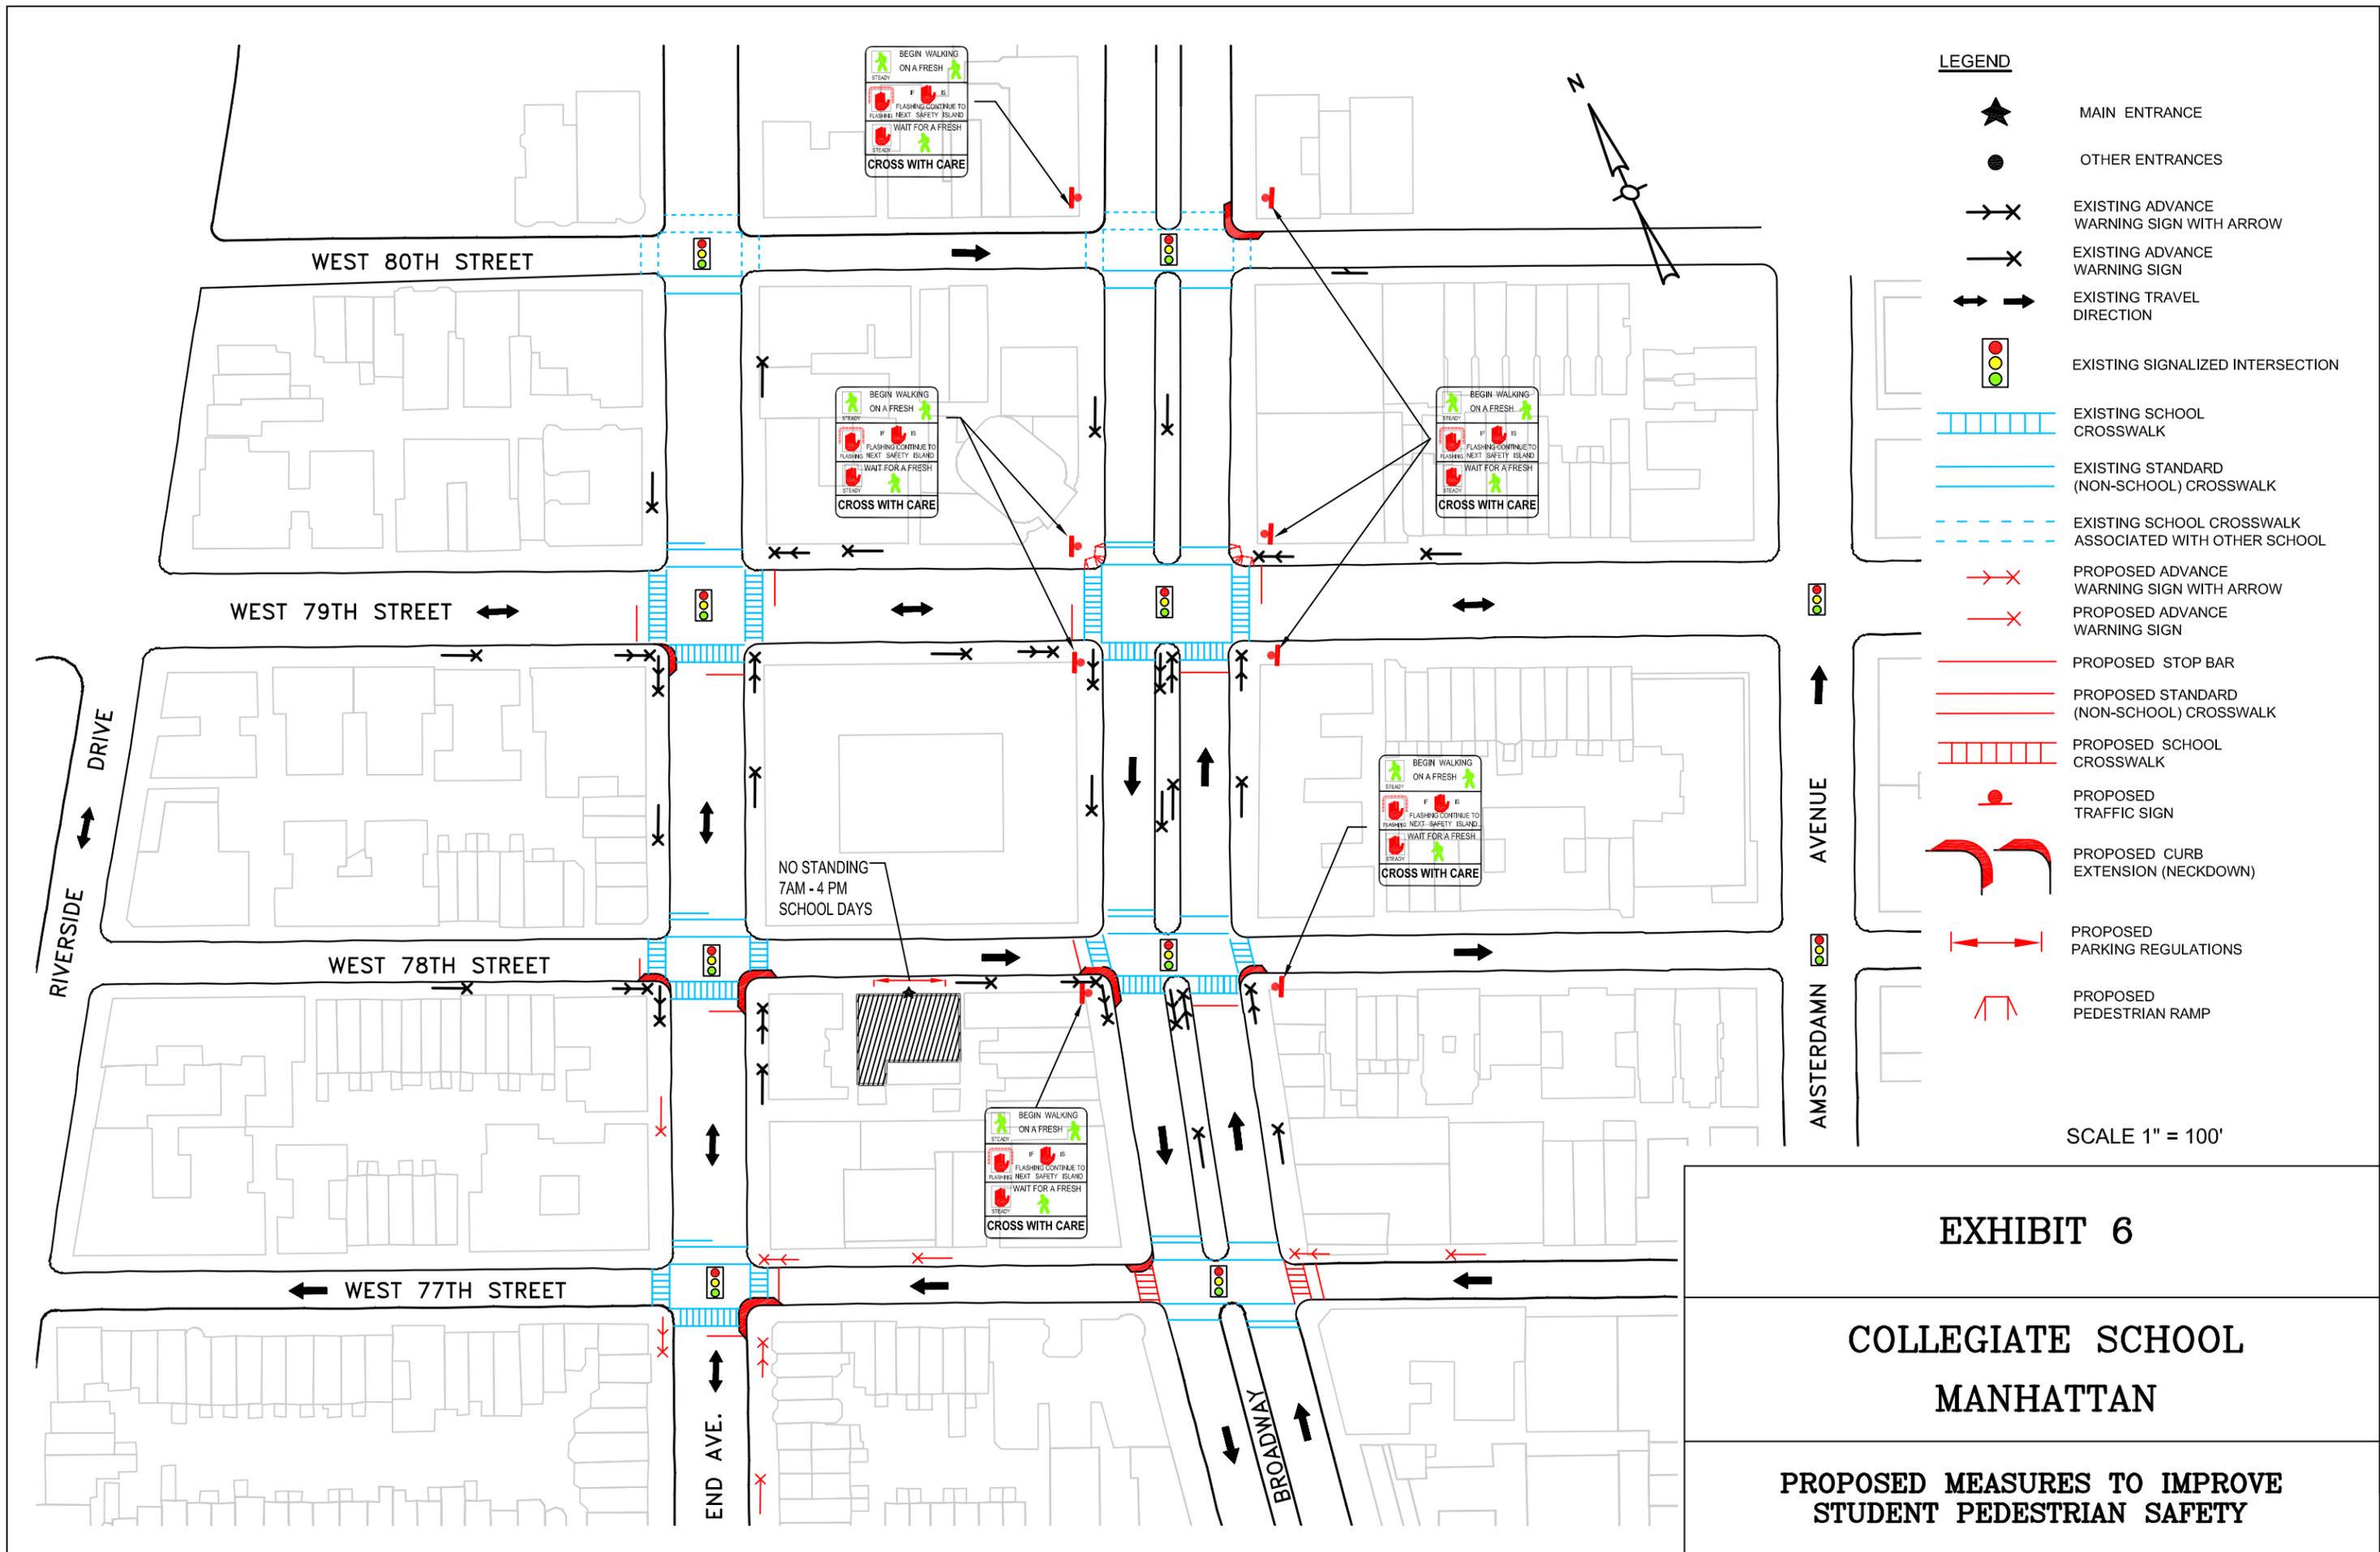
Curb extensions should be considered at the corners as shown in Exhibit 6.

The purpose of the curb extensions is to shorten the crossing distance for pedestrians, and to reduce speeds of vehicles approaching and turning at these heavily utilized school crosswalks (or intersections). These curb extensions would not eliminate or reduce the width of any moving lanes.

- Broadway and West 78th Street – southwest, southeast corners
- Broadway and West 77th Street – northwest corner
- Broadway and West 80th Street – northeast corner
- West End Avenue and West 78th Street – southeast, southwest corner
- West End Avenue and West 77th Street – southeast corner
- West End Avenue and West 79th Street – southwest corner
