**New York City Department of Transportation
Office of School Safety Engineering**

School Safety Engineering Project

FINAL REPORT: P.S. 153, Adam Clayton Powell School Manhattan

**Prepared by
The RBA Group/Urbitran Associates**

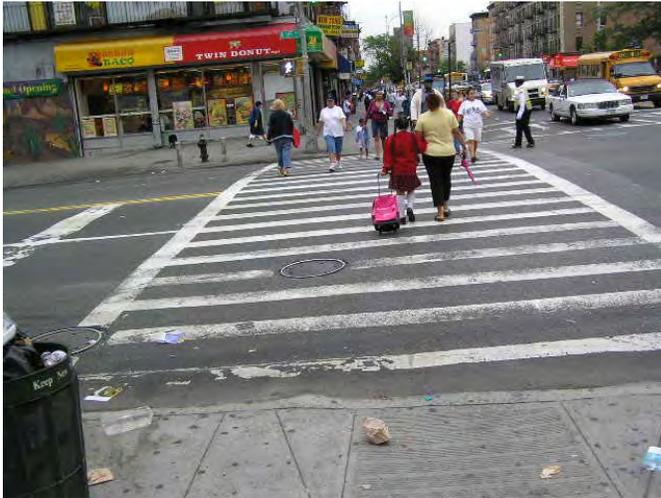
According to field observations, there are three crossing guards assigned to P.S. 153. They are stationed at the following locations:

- Amsterdam Avenue at West 145th Street
- Amsterdam Avenue at West 146th Street
- Amsterdam Avenue at West 147th Street

Figure 2- Crossing guard at Amsterdam Avenue and West 145th Street

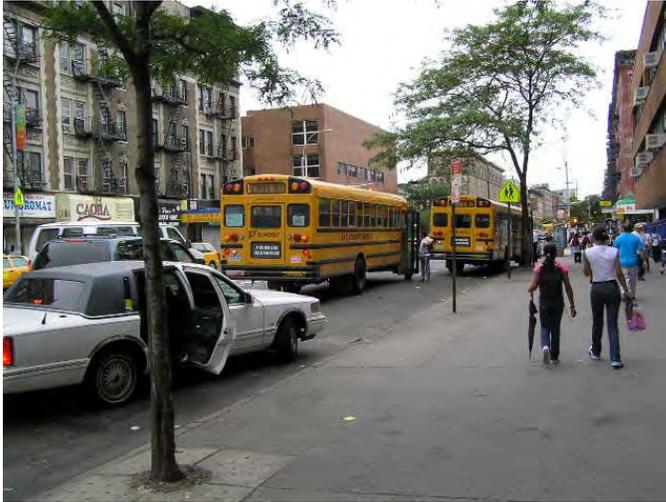
According to the school principal, five school buses are assigned to P.S. 153. School buses pick up and drop off students on Amsterdam Avenue or West 147th Street. All bused students enter the school through the entrances on West 146th or West 147th Street, depending on their grades.

Figure 3: School buses on Amsterdam Avenue in front of P.S. 153

Currently, school buses unload P.S. 153 students through right hand side doors. The school entrance is on the left side of the buses that drop off and pick up students on West 146th Street and West 147th Street. The Department of Education bus fleet includes buses with left hand side doors. Therefore, it is recommended that buses with left hand side doors be used to transport students to and from P.S. 153.

This measure in conjunction with “NO STANDING 7 AM - 4 PM” in front of the school’s entrance on West 146th Street and West 147th Street, would allow students to load and unload from the bus, at the curbside, directly in front of the school.

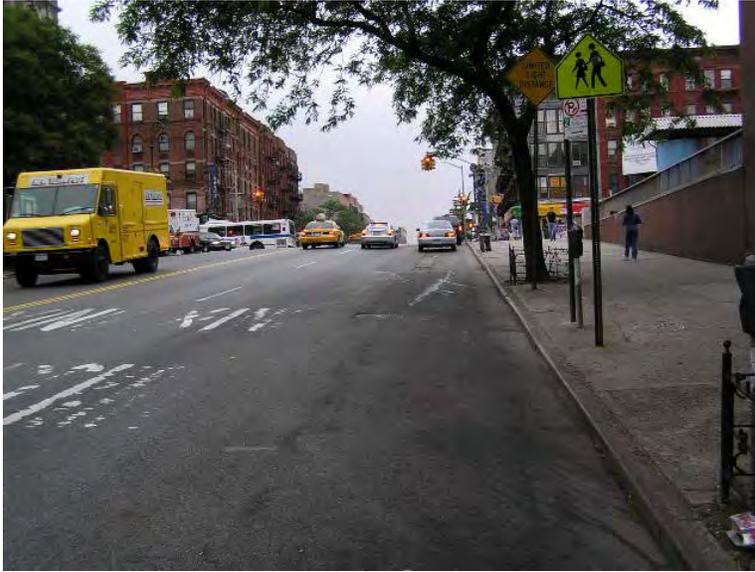
The Traffic Safety Plan, Exhibit 3, shows existing crosswalk pavement markings. It is noted that a citywide signage program is currently underway to upgrade school signage to current Federal Manual of Uniform Traffic Control (MUTCD) standards of fluorescent yellow-green signs accompanied by downward pointing arrows. Signs scheduled to be installed under this program are shown as “existing” on Exhibit 8.

Figure 4: Advance warning signs on West 145th Street, west of Broadway (looking east)

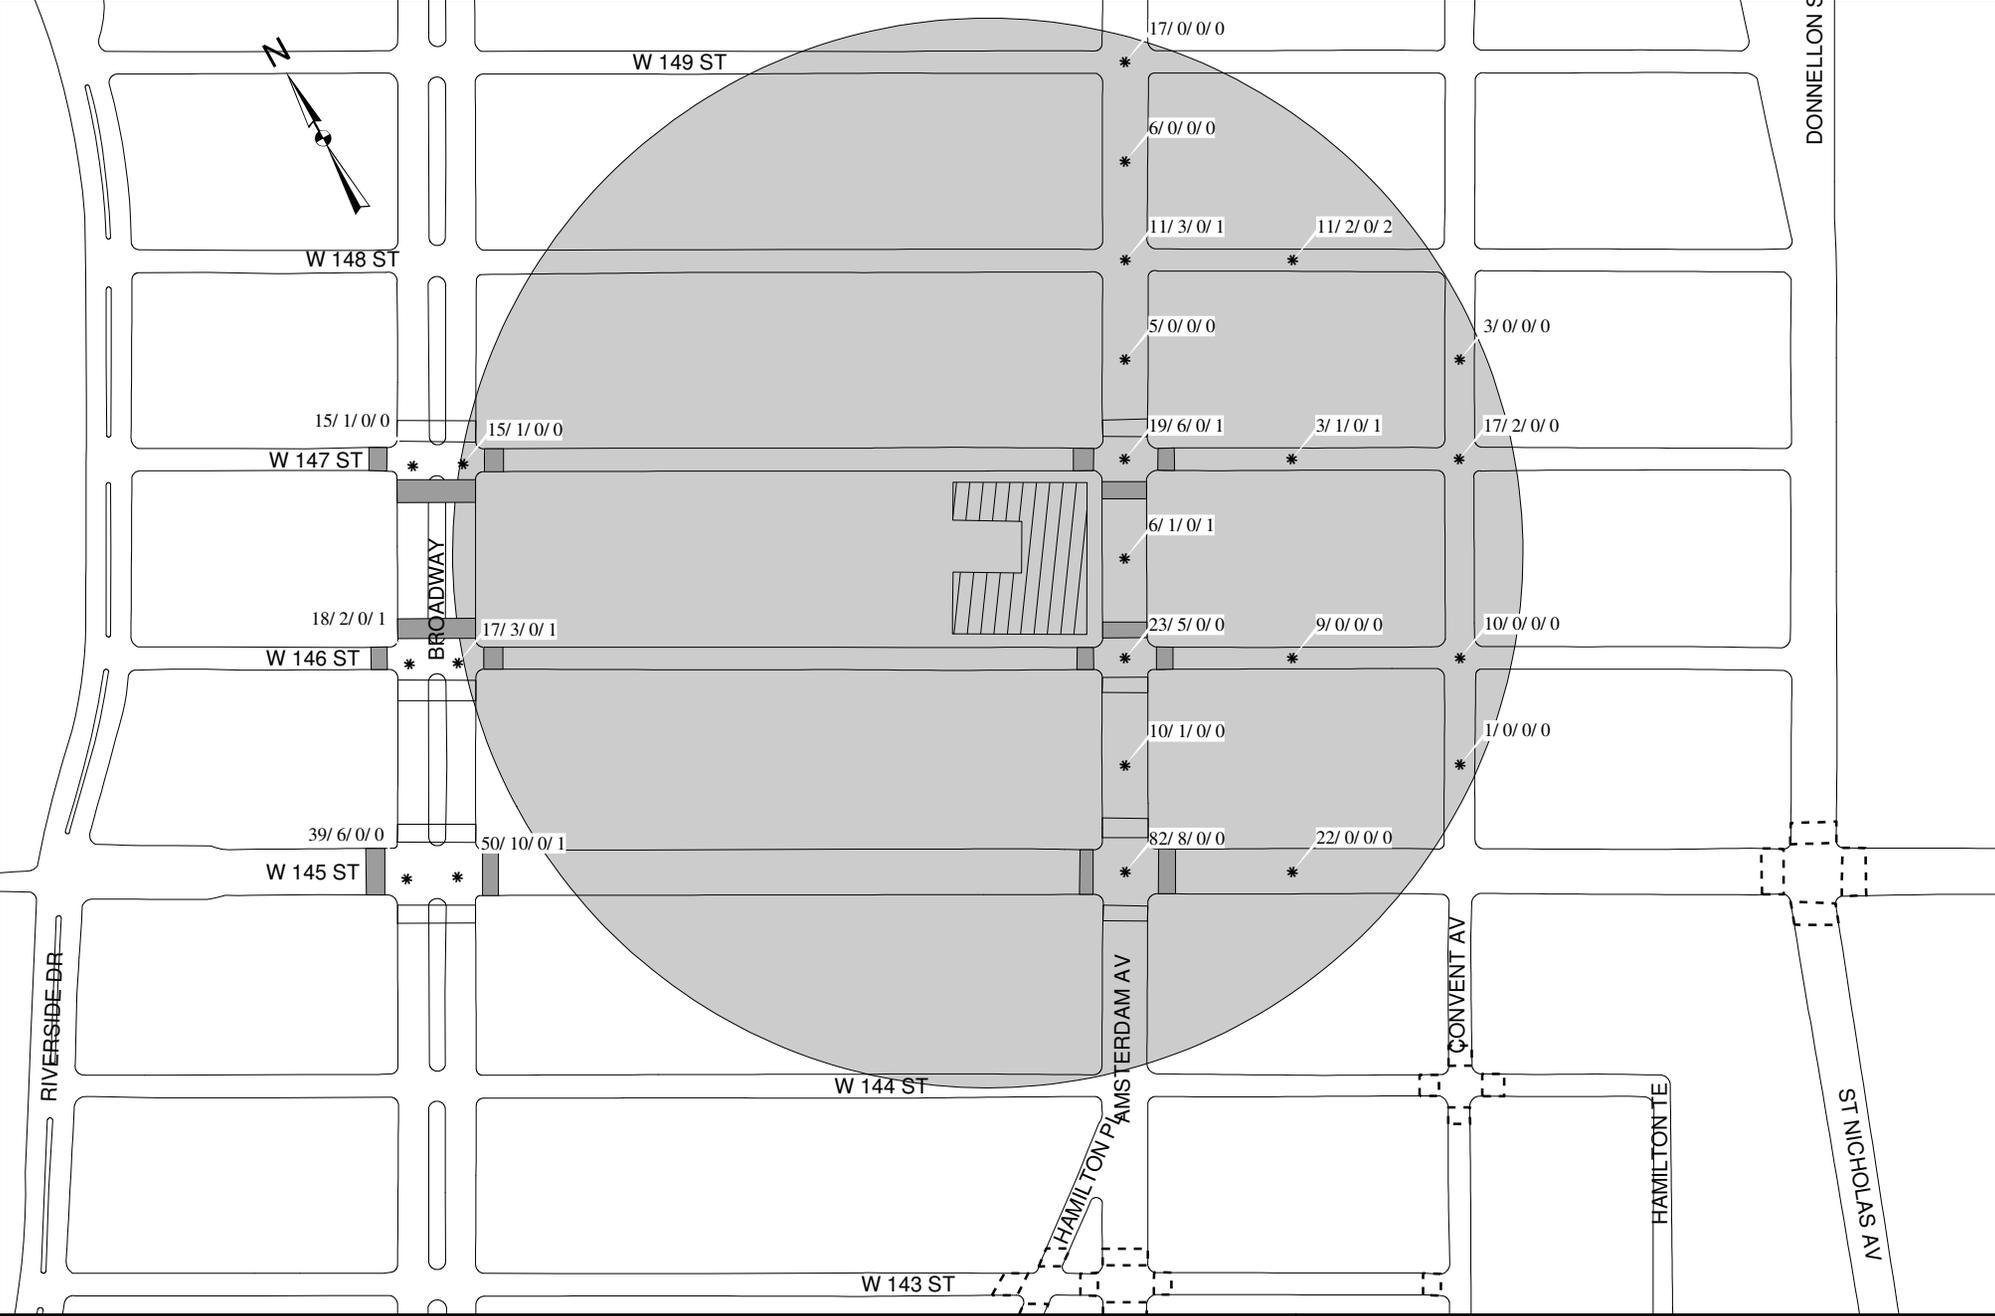
EXHIBIT 6
P.S. 153, MANHATTAN
ADAM CLAYTON POWELL SCHOOL

Exhibit 6 and Table 2 show a summary of accidents, as obtained from the New York State Department of Motor Vehicles (DMV), in the vicinity of P.S. 153 for the three-year period from January 1, 1998 through December 31, 2000. The DMV data provides some detail relating to the circumstances and cause of the accidents. Table 3 is a summary of more recent accident data obtained from the NYC Police Department (NYPD). Though current through 2004, the NYPD data do not provide the same level of detail as the DMV data.

ACCIDENT SUMMARY
THREE YEAR PERIOD
(1998-2000)

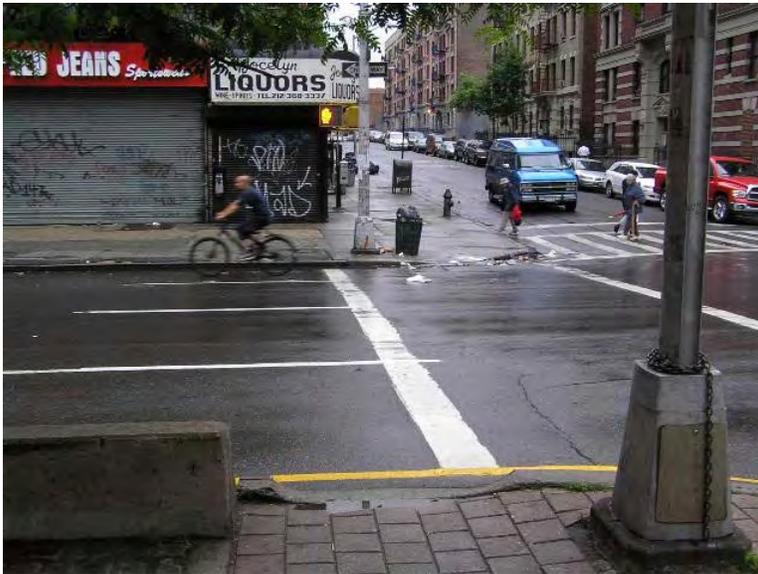
Broadway is a 100-foot wide, two-way divided roadway with three moving lanes in each direction and parking along the outer curb of the roadway. A 20-foot wide median separates the northbound and southbound traffic (Figure 5). West 147th Street is a 30-foot wide, one-way westbound roadway with one moving lane and parking on both sides. The intersection is controlled by a two-phase signal. School crosswalks are in place on the west, south and east legs. The north median does not have standard pedestrian ramps due to utility conflicts (Figure 5).

Figure 5: Broadway at West 147th Street, looking east

Review of existing signal timing indicates that the pedestrian phase does not provide adequate time for pedestrians to cross Broadway from curb-to-curb in one cycle at a walking rate of three feet per second plus three seconds reaction time. A pedestrian is expected to wait at the center median between signal cycles. It is common practice to utilize the median as a refuge for pedestrians to wait between signal cycles (see Table 5).

- Broadway and West 145th Street – north median, northeast and northwest corners
- Broadway and West 146th Street – north and south medians
- Broadway and West 147th Street – southwest corner and north median
- Amsterdam Avenue and West 145th Street – northeast corner

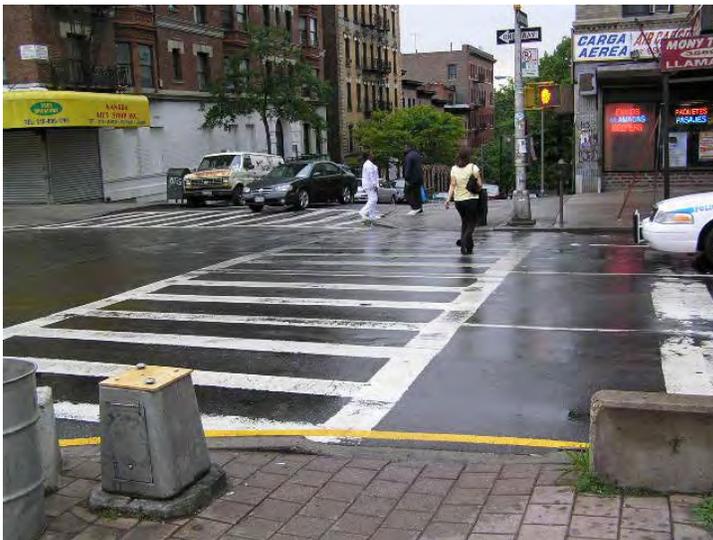
West 146th Street is a 30-foot wide, one-way eastbound roadway with one moving lane and parking on both sides. The intersection is controlled by a two-phase signal. School crosswalks are in place on the north, west, and east legs. The north and south medians do not have standard pedestrian ramps due to utility conflicts (Figure 6).

Thirty-five accidents occurred at this intersection during the 1998-2000 study period. Five accidents involved pedestrians two of which were school related. A six-year-old student was struck while emerging from parked vehicles. A 12-year-old student was struck due to the driver's failure to yield. The third pedestrian was struck when crossing against the signal. Two other accidents were attributed to drivers' unsafe speeds.

Figure 6: Broadway at West 146th Street, looking west from the north leg center median (substandard pedestrian ramp)

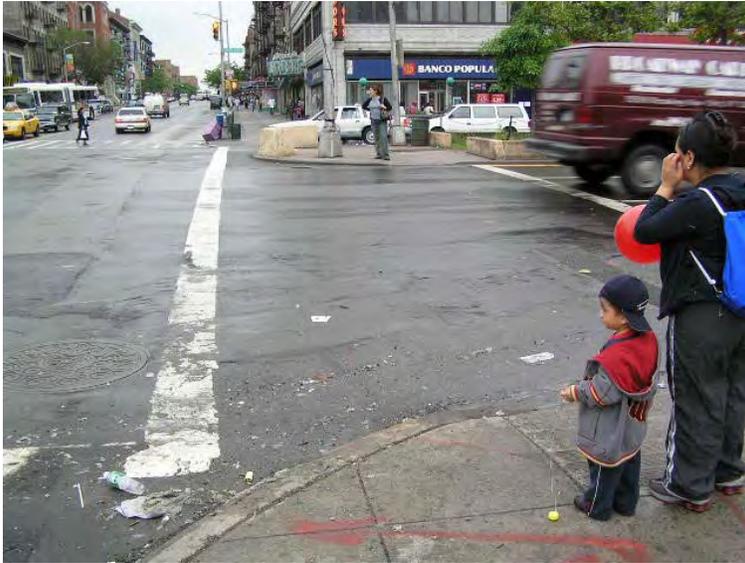
West 145th Street is a 60-foot wide, two-way roadway with two moving lanes in each direction and parking on both sides. The intersection is controlled by a two-phase signal. School crosswalks are in place on the west and east legs. The northeast, northwest corner and the north raised median do not have standard pedestrian ramps.

Figure 7: Broadway at West 145th Street, looking east from southwest corner

Eighty-nine accidents occurred at this intersection during the 1998-2000 study period. Sixteen accidents involved pedestrians, one of which was school related. Four pedestrians, including a 10-year-old student, were struck while crossing against the signal. Eleven pedestrian accidents occurred due to drivers' failure to yield when making turns. There were no details for the last accident.

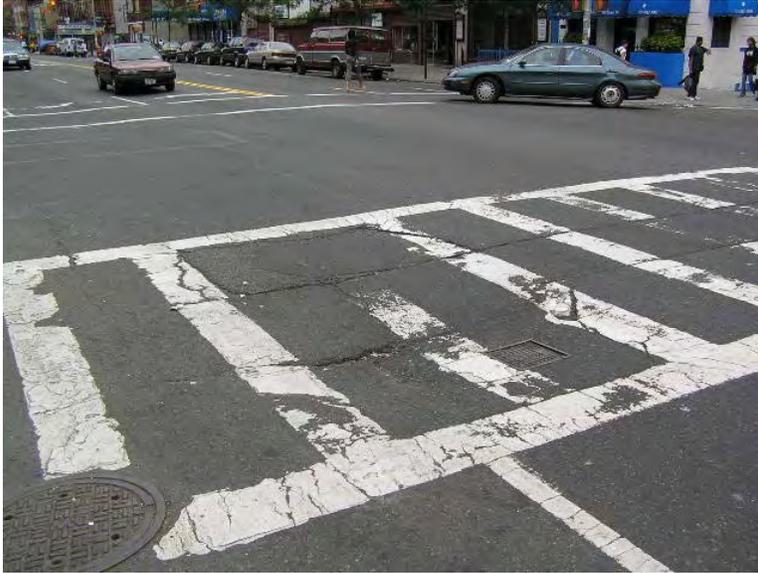
Amsterdam Avenue is a 60-foot wide, two-way roadway with two moving lanes in each direction and parking on both sides. The intersection of West 147th Street and Amsterdam Avenue is controlled by a two-phase signal. School crosswalks are in place on the south, east and west legs.

Nineteen accidents occurred at this location during the 1998-2000 study period. Six accidents involved pedestrians, one of which was school related. According to the accident data, a nine-year-old student was struck while emerging from parked vehicles. Three accidents occurred due to drivers' failure to yield. Two other pedestrians were struck while crossing against the signal.

The school principal noted that students have difficulties crossing Amsterdam Avenue. Traffic and pedestrian counts were conducted at this intersection to determine if a Lead Pedestrian Interval (LPI) was warranted. It was determined that the existing volumes do not warrant an LPI at this time (Exhibit 7).

Figure 7: Amsterdam Avenue at West 147th Street (south crosswalk)

- Amsterdam Avenue and West 146th Street
- Amsterdam Avenue and West 147th Street
- Broadway and West 146th Street
- Broadway and West 147th Street

Curb extensions should be installed at the corners as shown in Exhibit 8.

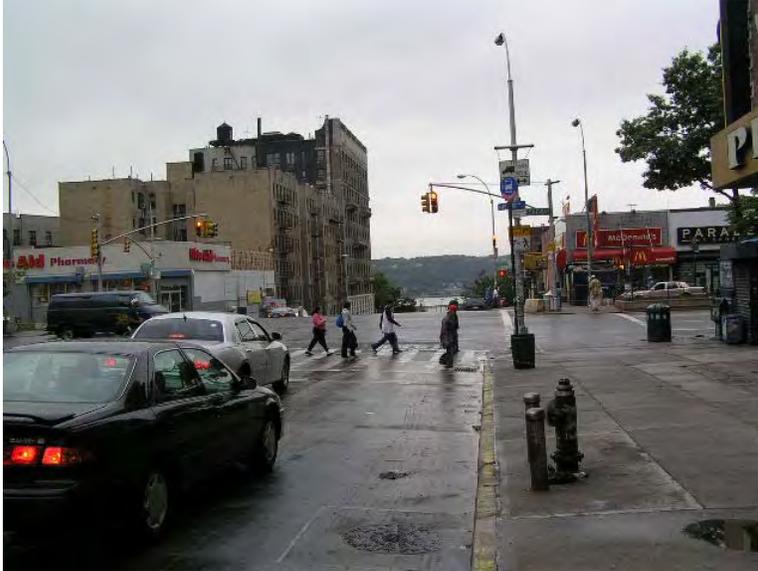
The intersection of West 145th Street and Amsterdam Avenue is controlled by a two-phased signal. School crosswalks are in place on the east and west legs.

Eighty-two accidents occurred at this intersection during the 1998-2000 study period, including eight non-school related pedestrian accidents. Four pedestrians were struck due to drivers' failure to yield or unsafe speed. Two pedestrians were struck while crossing against the signal. There were no details for the last two accidents.

Figure 8: Amsterdam Avenue at West 145th Street, looking east

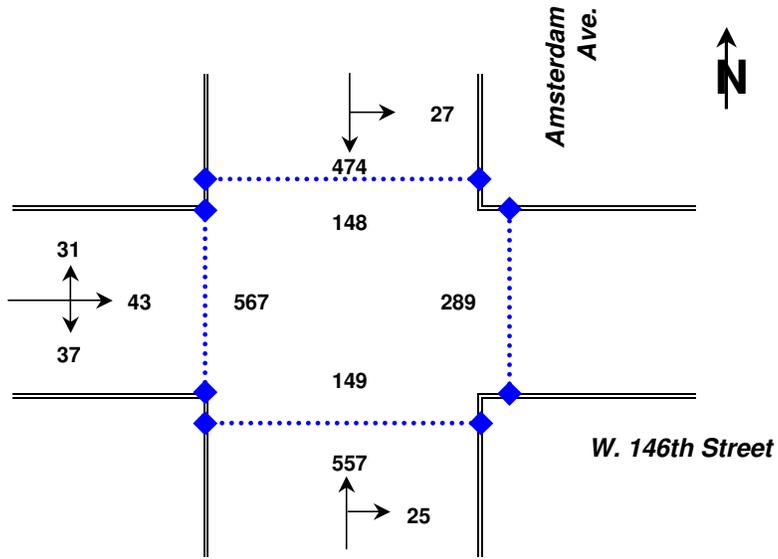
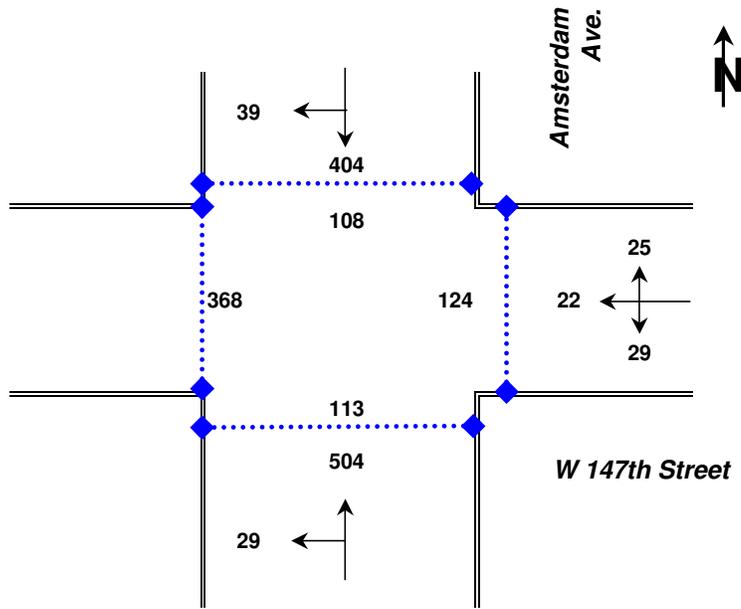
EXHIBIT 7
P.S. 153, MANHATTAN ADAM CLAYTON POWEL SCHOOL
TRAFFIC COUNTS

The school principal noted that students have difficulties crossing Amsterdam Avenue. Traffic and pedestrian counts were conducted at this intersection to determine if a Lead Pedestrian Interval (LPI) was warranted. It was determined that the existing volumes do not warrant an LPI at this time (Exhibit 7).

One Hour Traffic Count Volumes
(2:30 PM - 3:30 AM October 31, 2005)

Intersection of Amsterdam Avenue and West 146th Street

Intersection of Amsterdam Avenue and West 147th Street

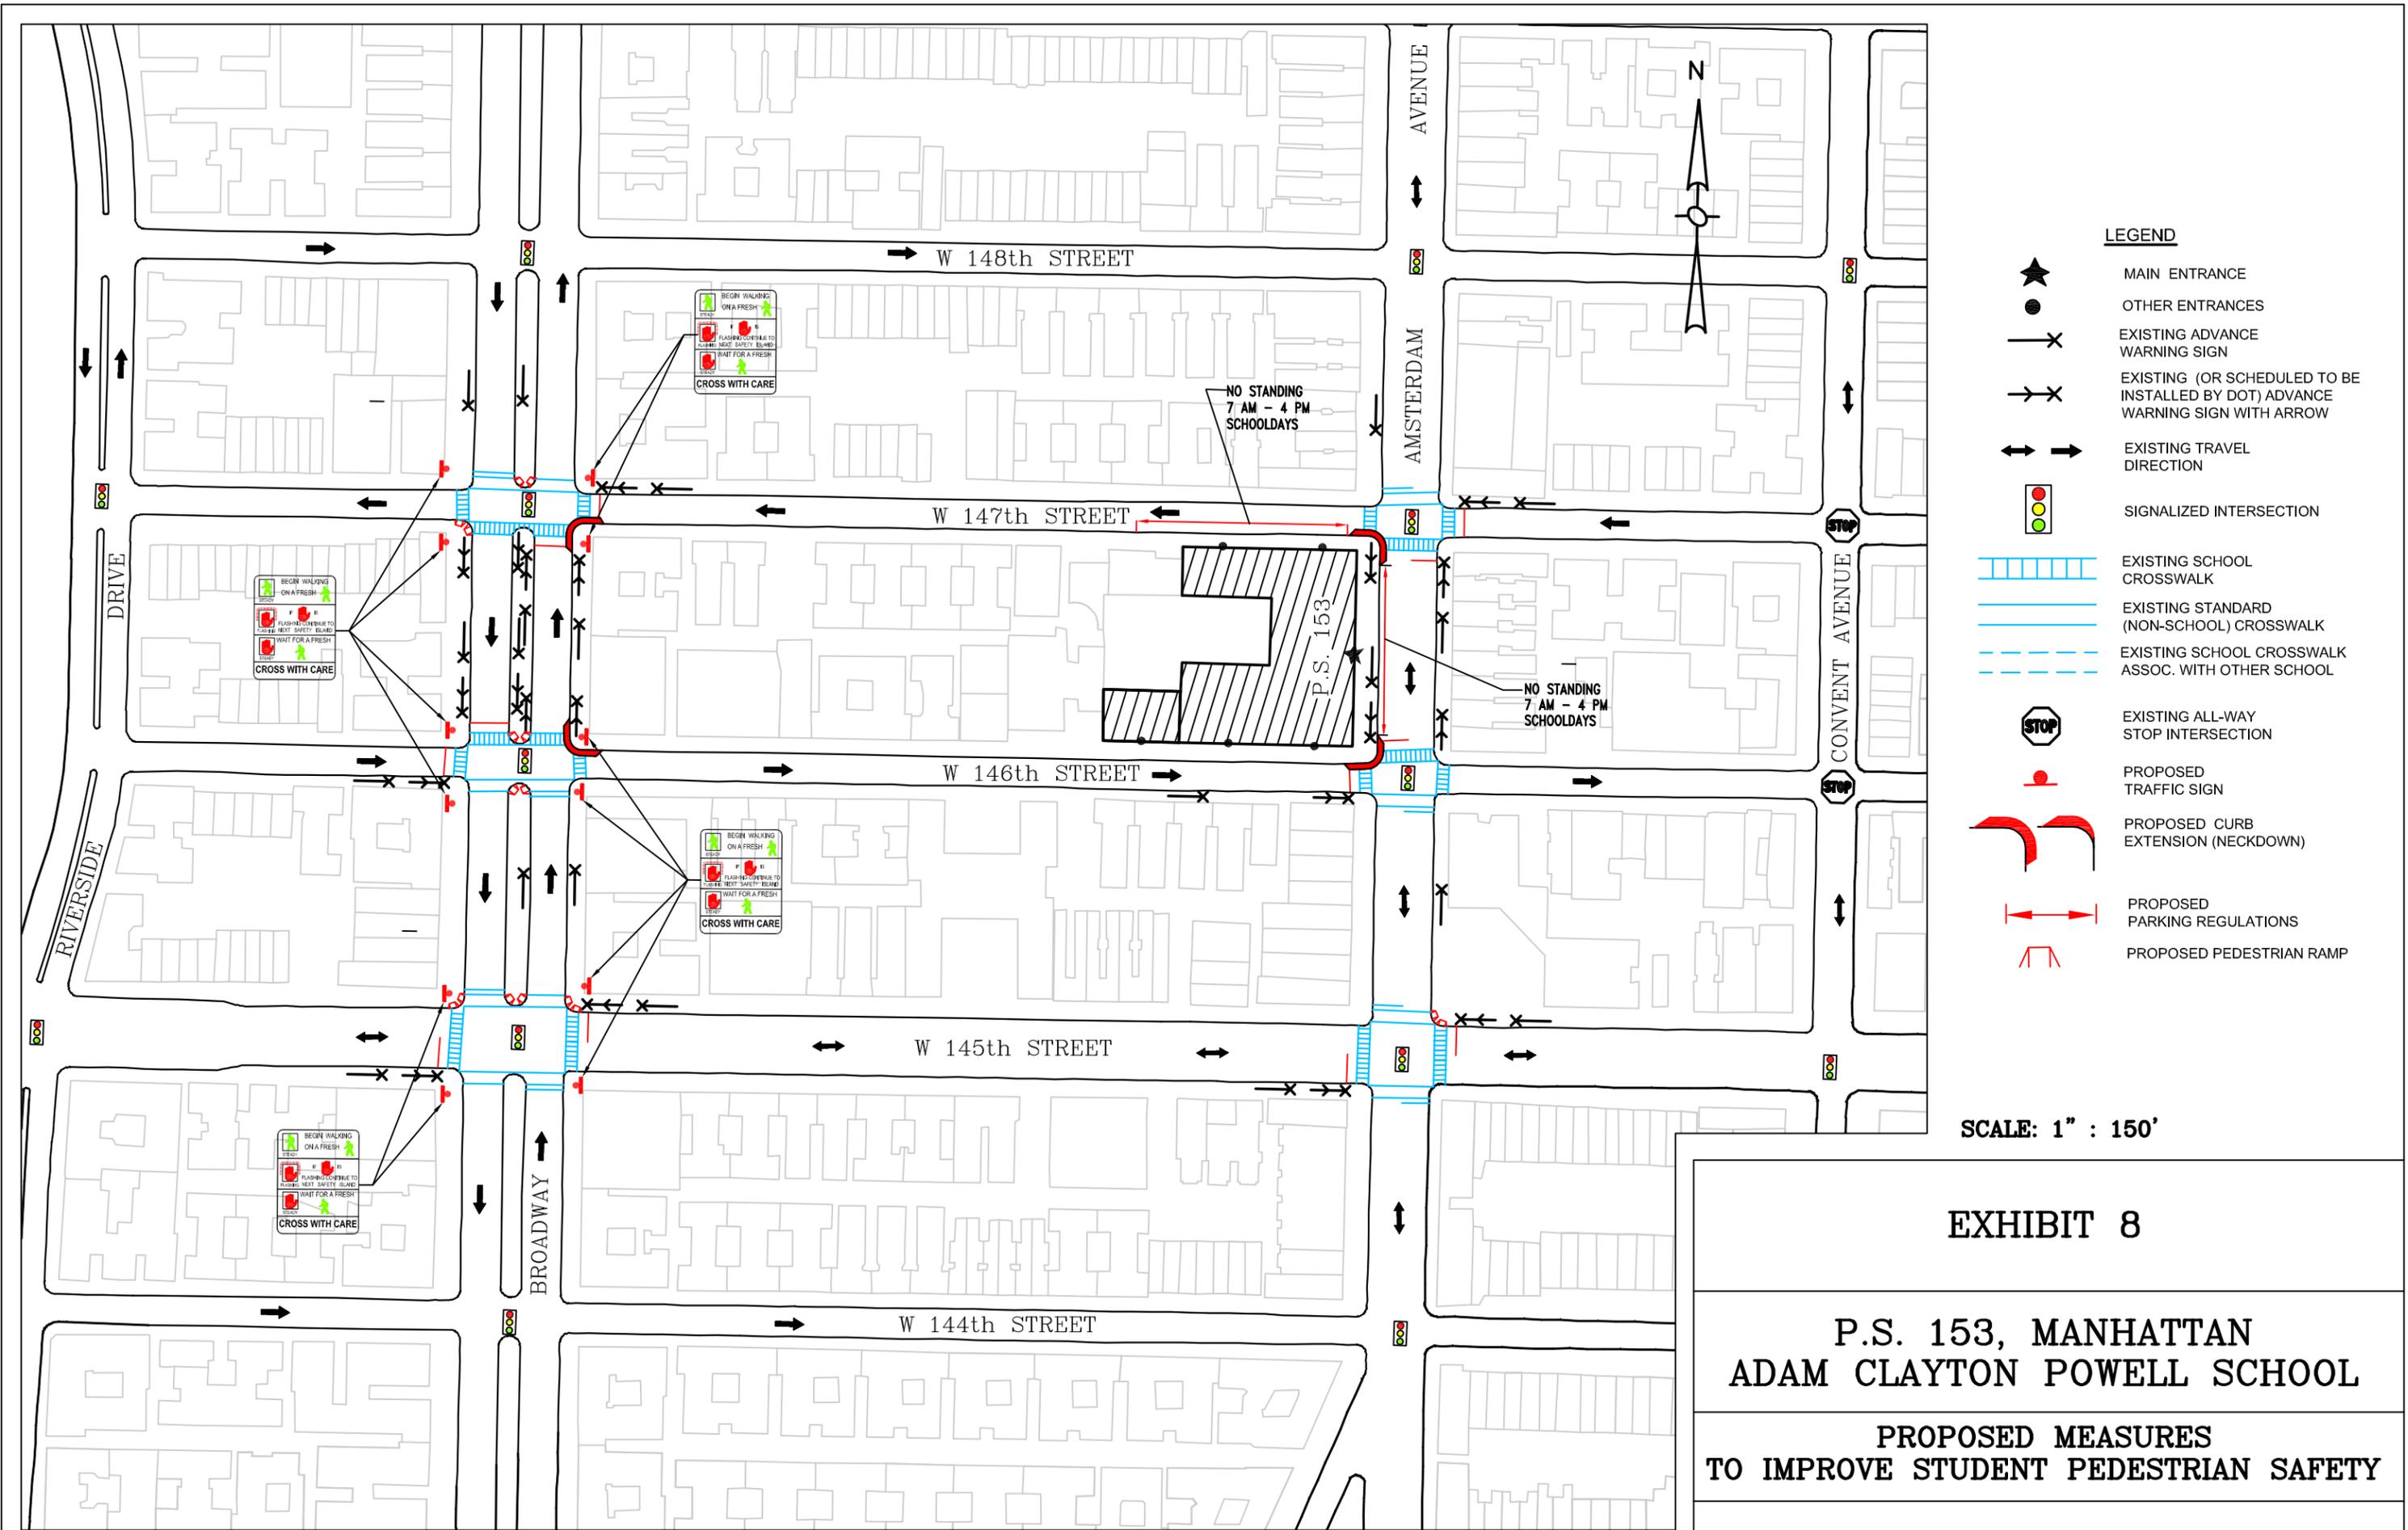
The roadways and sidewalks in the vicinity of the school were generally observed to be in good condition. Several pedestrian ramps are misaligned or in poor condition. The locations where pedestrian ramps need to be replaced are shown on Exhibit 8 and discussed in Section 4.2.

Due to existing utility pole conflicts, the following pedestrian ramps are considered complex. Consideration should be given to the installation of pedestrian ramps per NYCDOT standards at these locations.
