**New York City Department of Transportation  
Office of School Safety Engineering**

**School Safety Engineering Project**

**FINAL REPORT: IS 77, Queens**

**Prepared by  
The RBA Group and URBITRAN Associates Inc.**

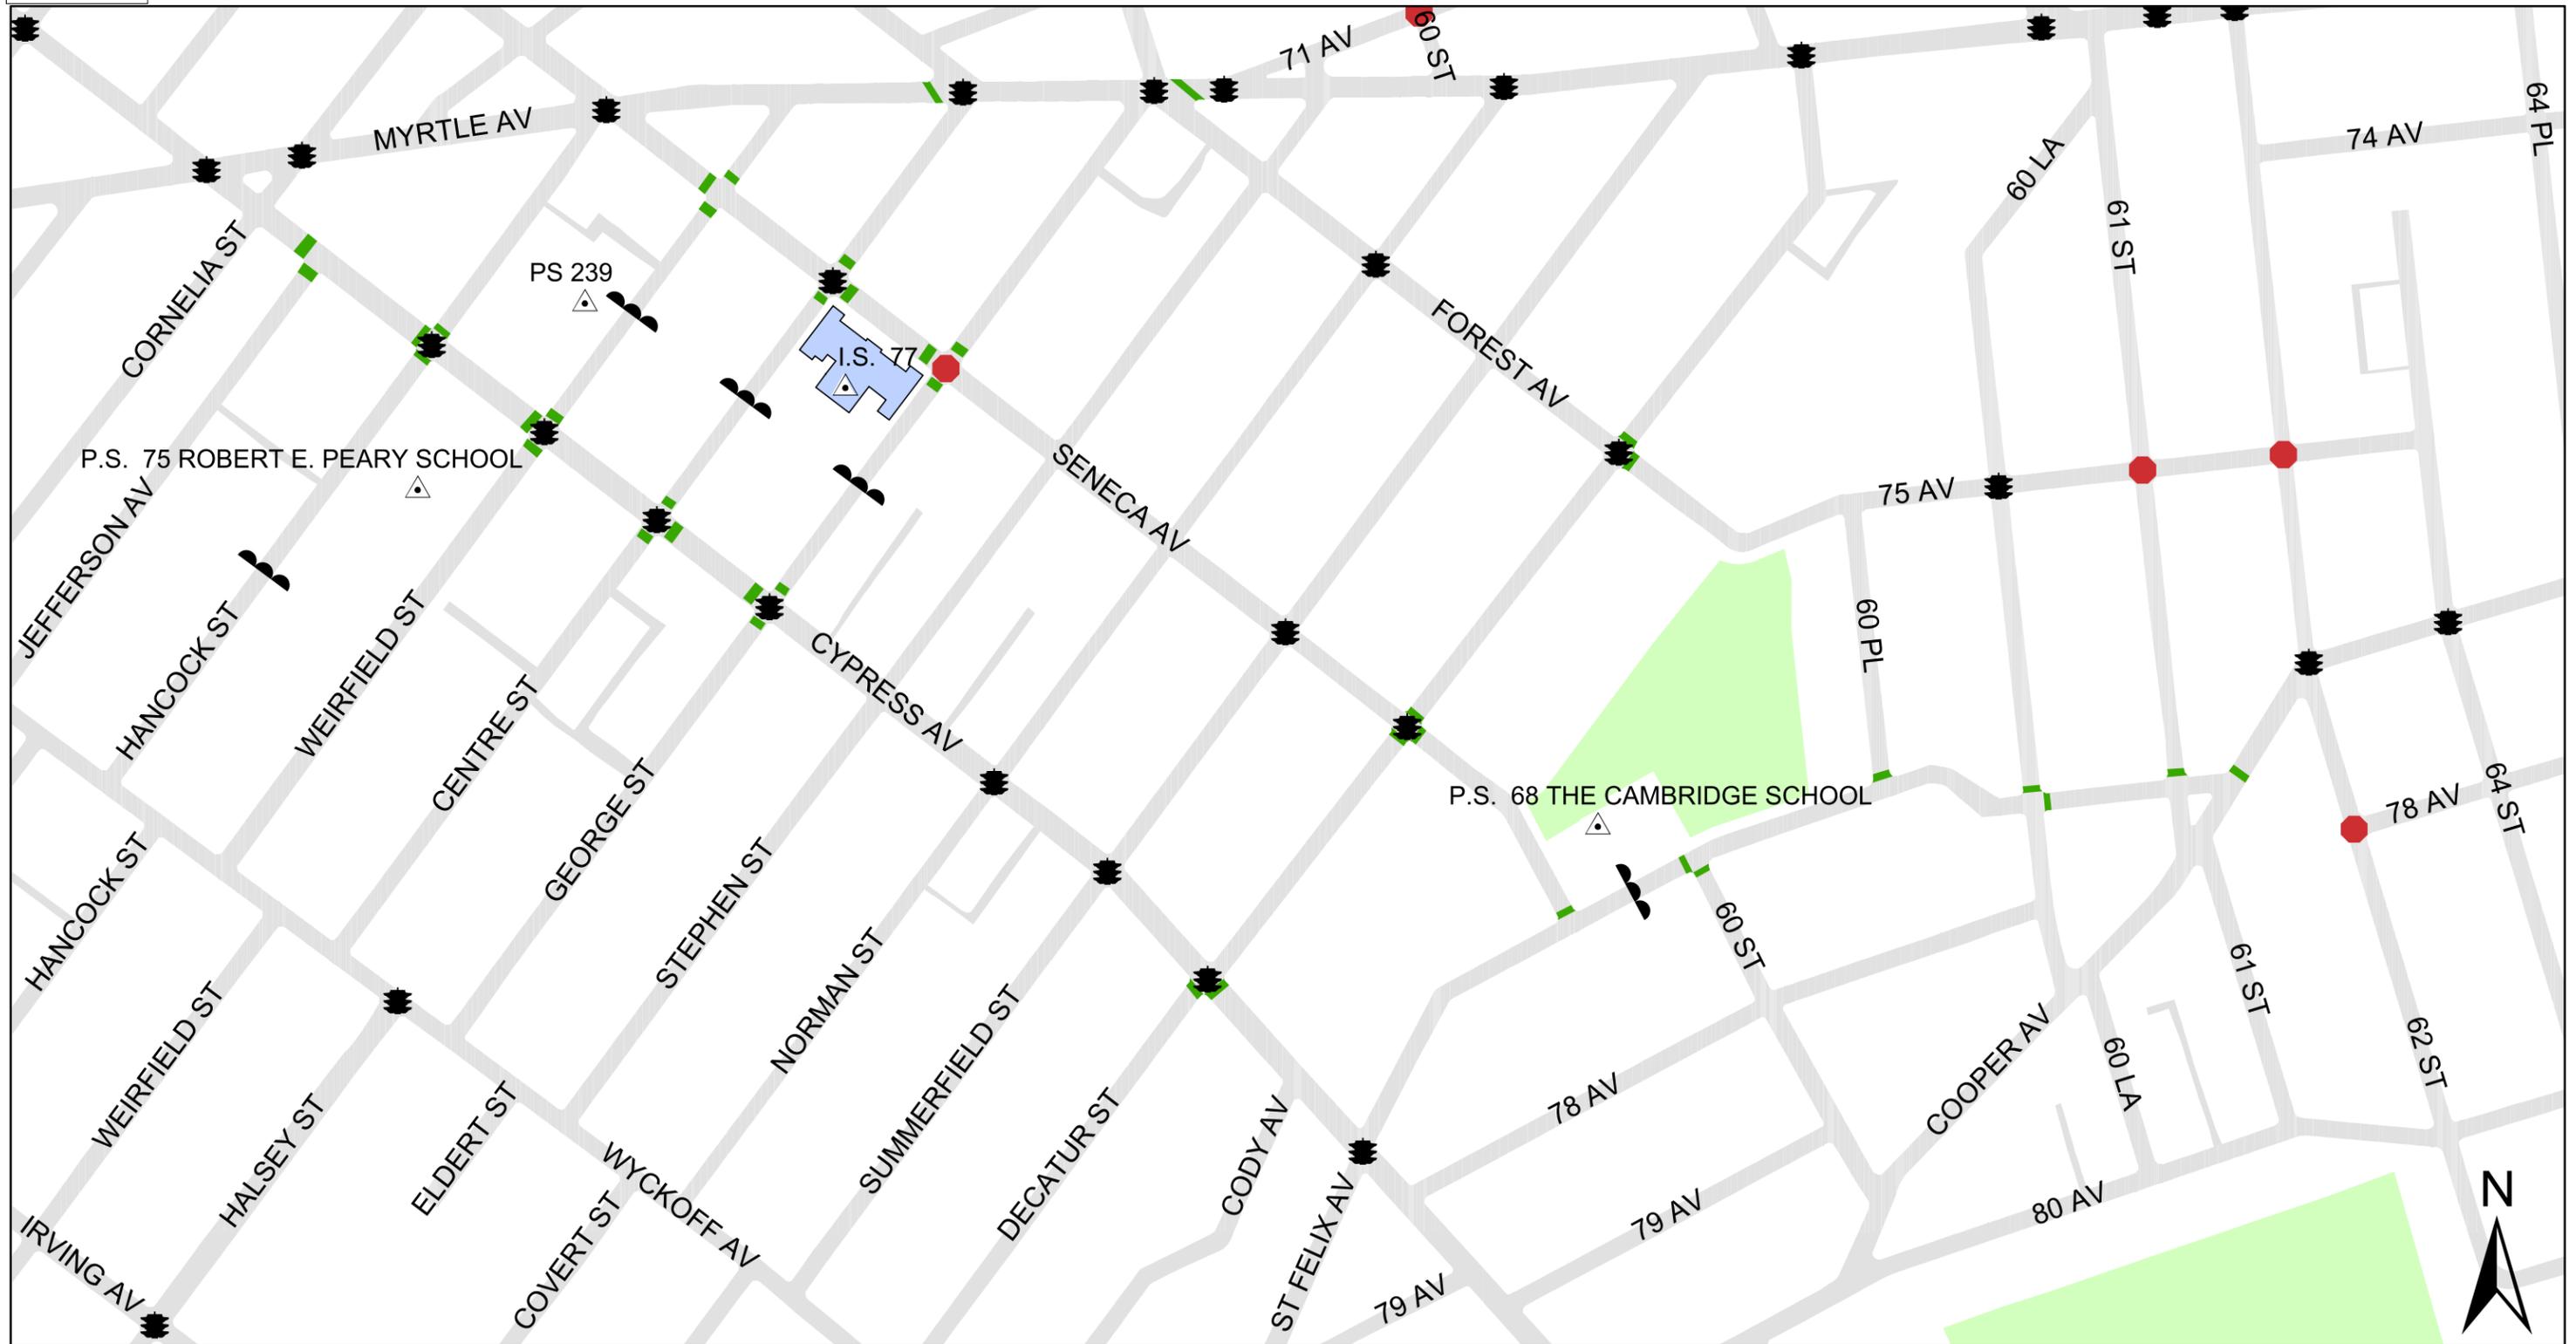
**EXHIBIT 3**

The School Traffic Safety Map was established to help provide the maximum degree of safety for children going to and from school - by indicating the location of speed reducers, school crosswalks and some traffic control devices. (While virtually all intersections in NYC benefit from traffic control devices - such as stop signs, traffic signals, yield signs, and all way stop signs - this map shows only traffic signals and all way stop signs.) The school crosswalks that are shown are ladder striped and make the crosswalk more visible to drivers and help make the intersection safer. These crosswalks are where school children are recommended to cross.

Exhibit 3, at the end of Section 2, shows the existing school signs, signals, and pavement markings around I.S. 77. It should be noted that a citywide signage program is currently underway to upgrade school signage to current Federal Manual on Uniform Traffic Control Devices (MUTCD) standards of fluorescent yellow-green accompanied by downward pointing arrows. This will make the school crossing warning signs more visible to motorists. Signs scheduled to be installed under this program are shown as “existing” in Exhibit 6.

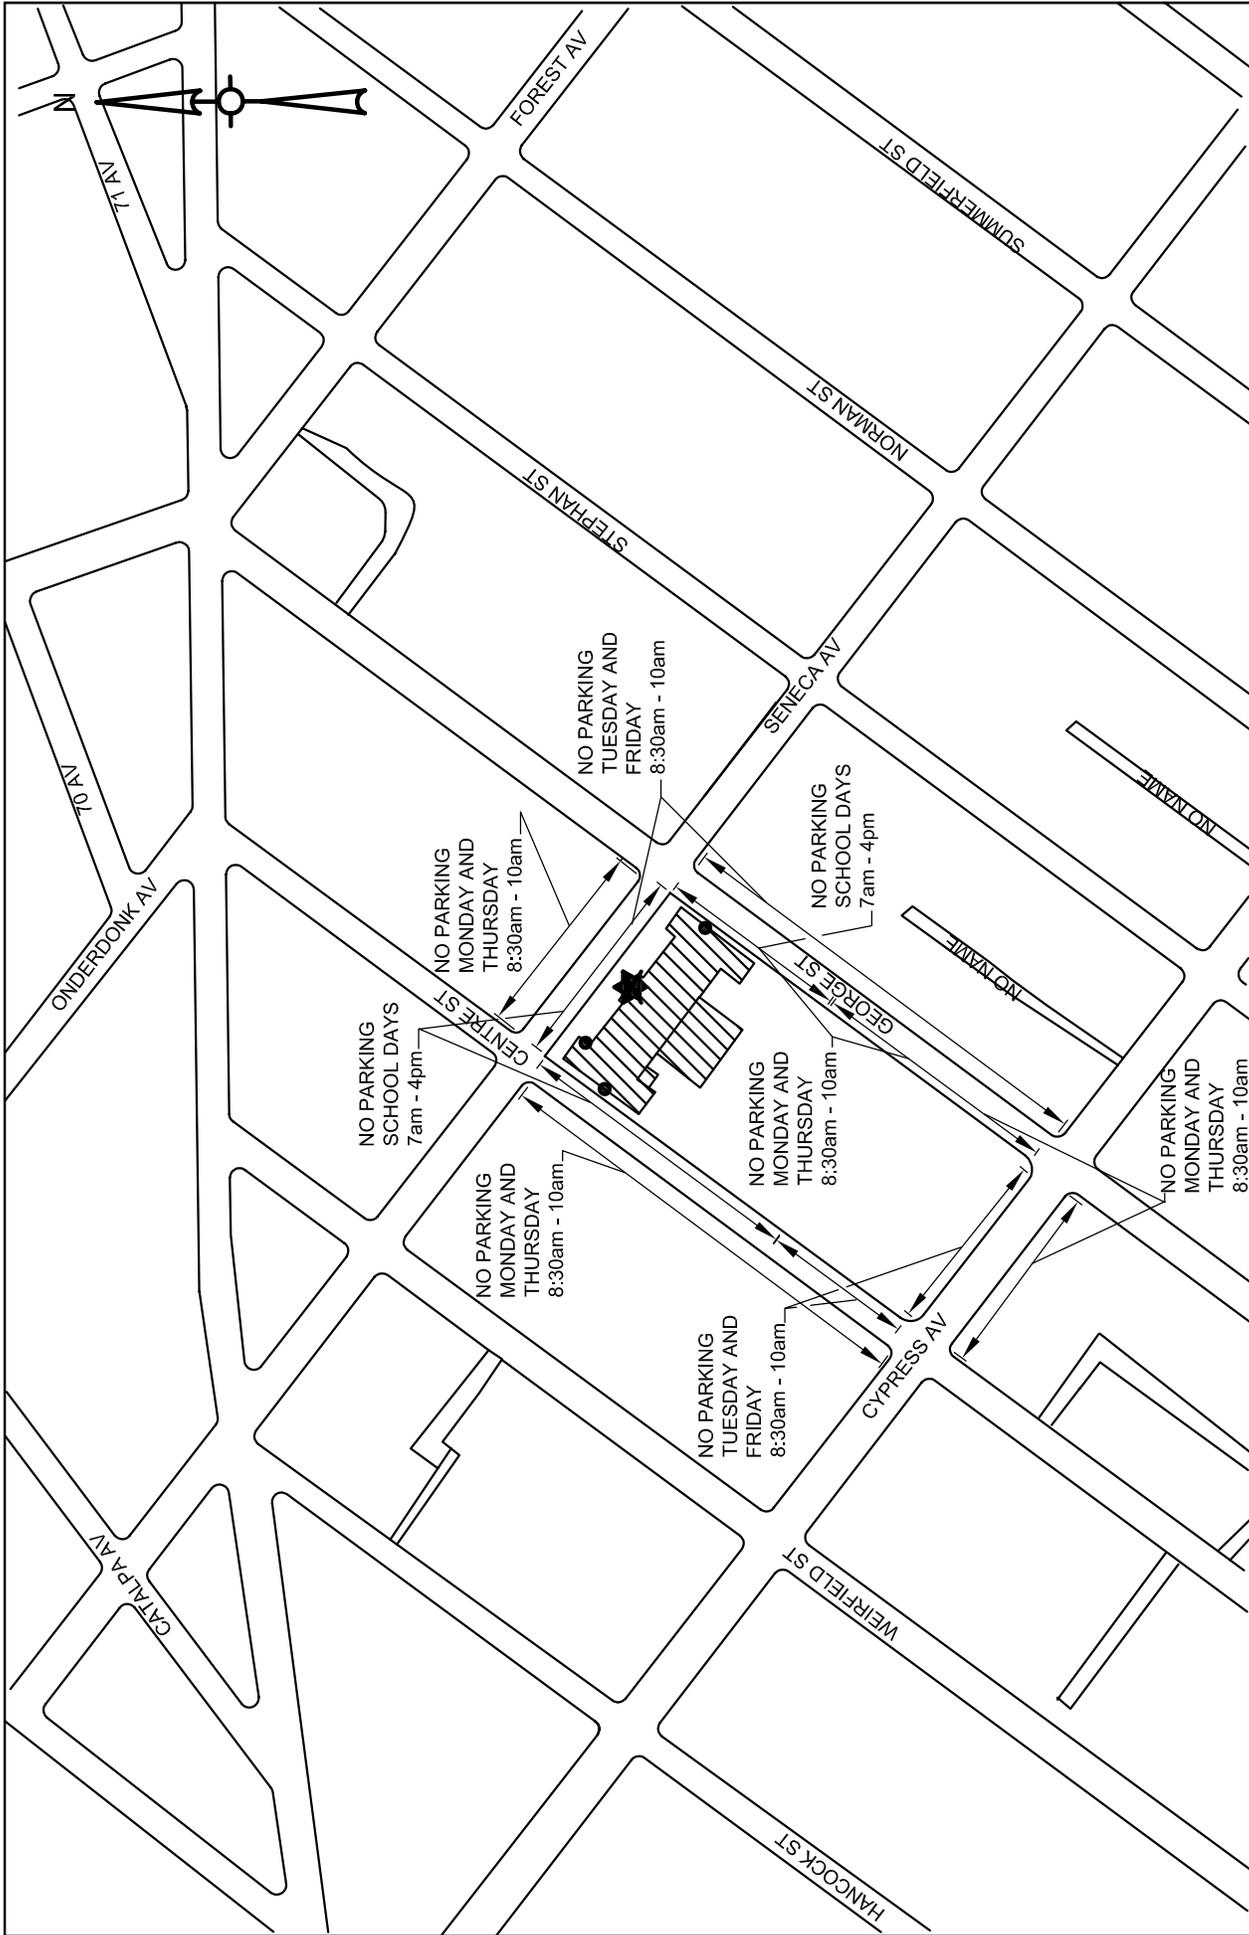
EXHIBIT 4  
I.S. 77 QUEENS

Parking regulations around the school block are shown in Exhibit 4 at the end of this section.

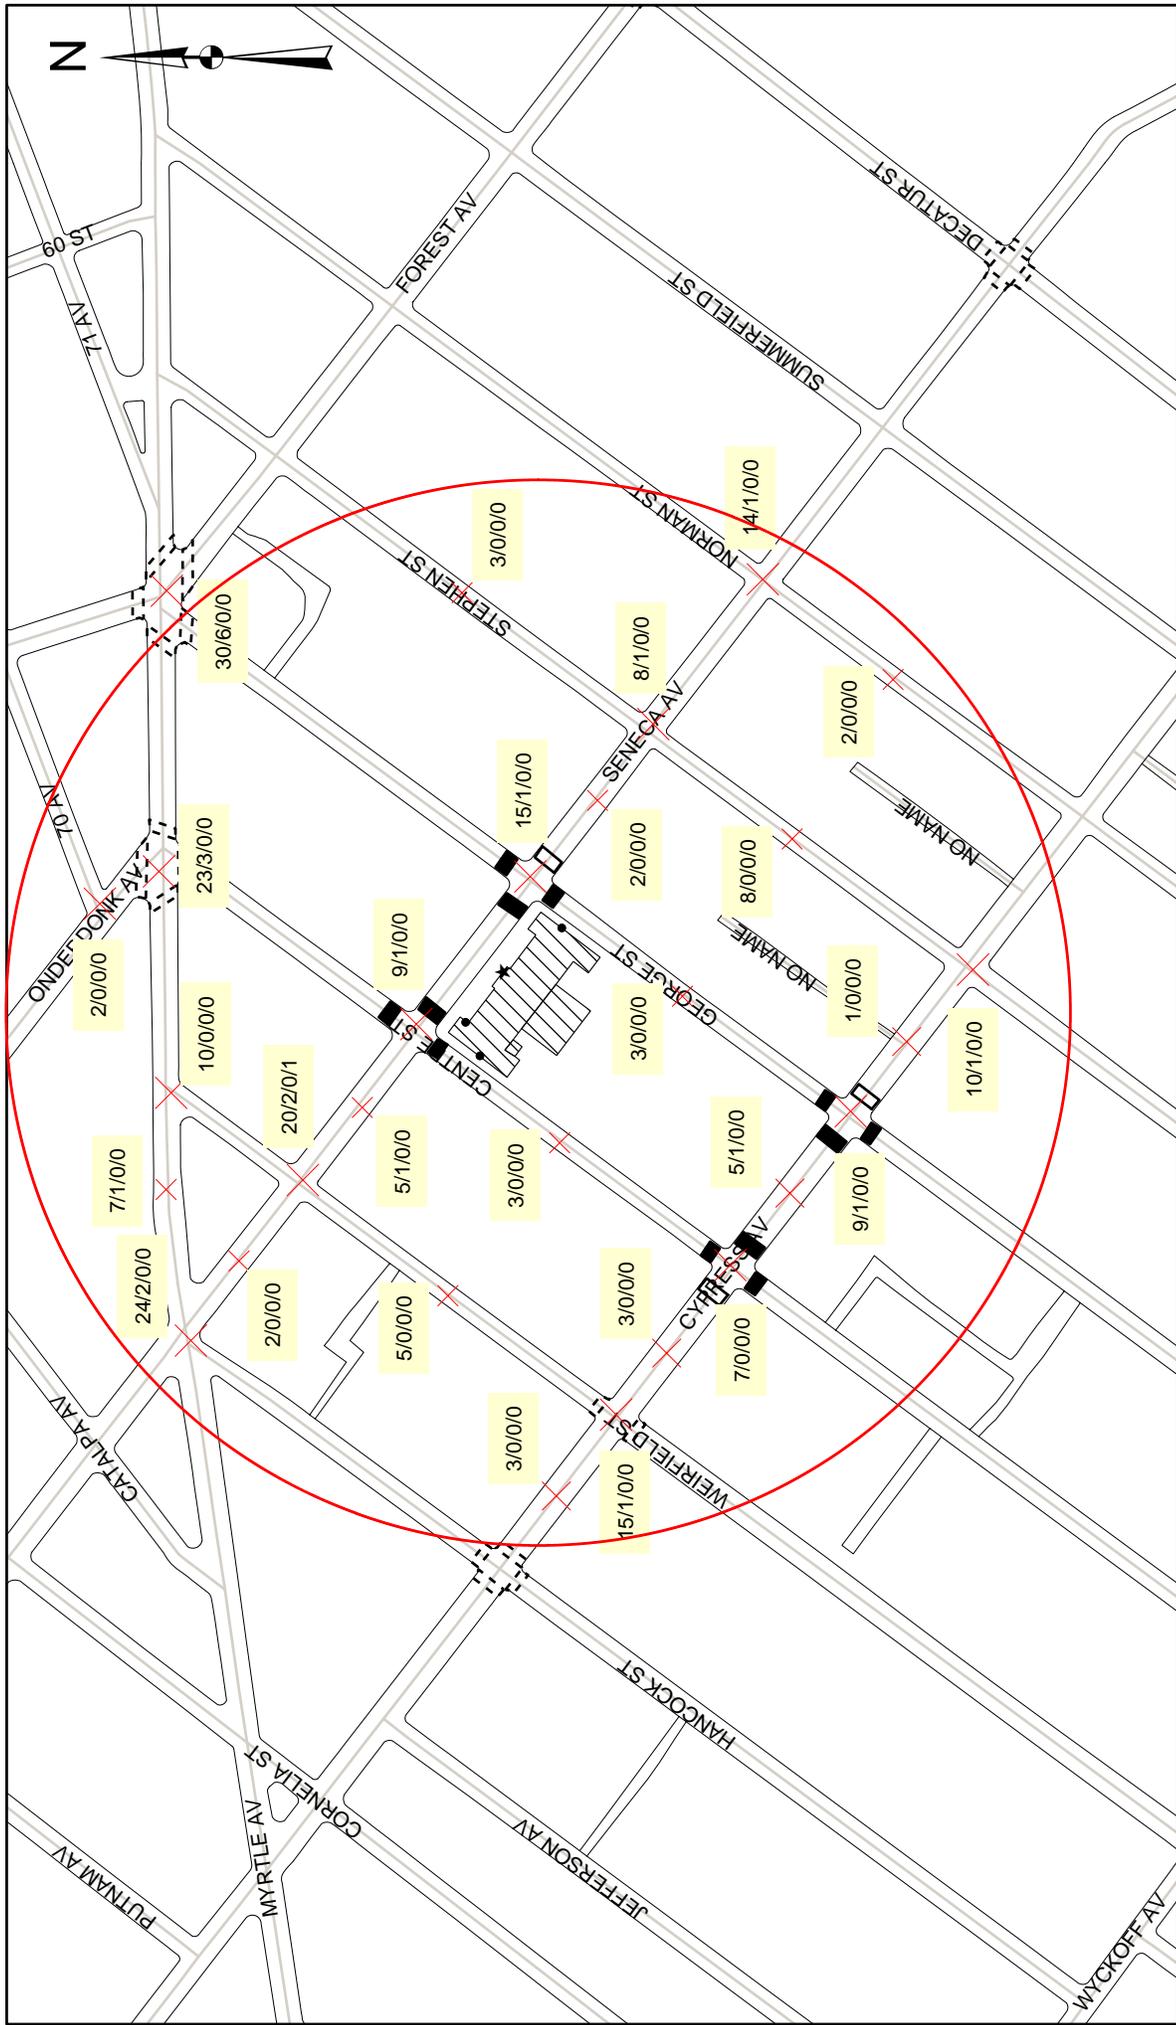
**EXHIBIT 5**  
**I.S. 77 QUEENS**  
**ACCIDENT SUMMARY (1998-2000)**

Exhibit 5 and Table 2 show a summary of accidents, as obtained from the New York State Department of Motor Vehicles (DMV), in the vicinity of I.S. 77 for a three-year period from January 1, 1998 through December 31, 2000. The DMV data provides some detail relating to the circumstances and cause of an accident. Table 3 is a summary of more recent accident data obtained from the NYC Police Department (NYPD). Though current through 2004, the NYPD data does not provide the same level of detail as the DMV data.

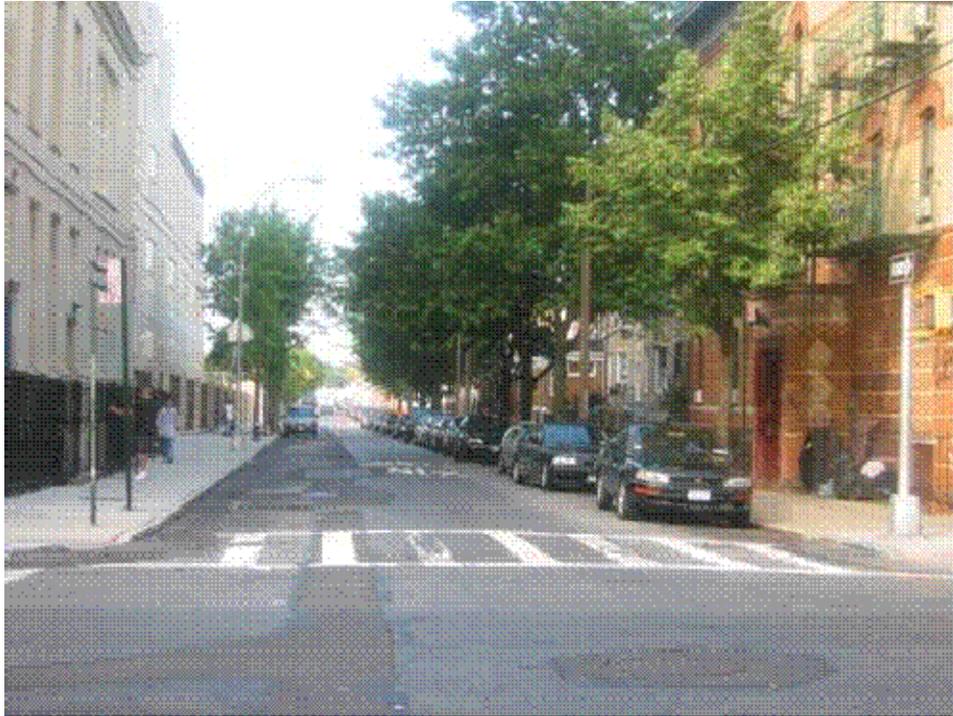
This is a four-leg signalized intersection with school crosswalks located across the north and south legs of Centre Street and the east leg of Seneca Avenue. A pedestrian crosswalk is located across the west leg of Seneca Avenue. Seneca Avenue is a two-way street with one travel lane and a parking lane on each side of the roadway. Centre Street is a one-way northbound street with one travel lane and parking on both sides of the roadway (see Figures 4 and 5).

*Figure 4: Looking south on Centre Street across Seneca Avenue, school is on the left*

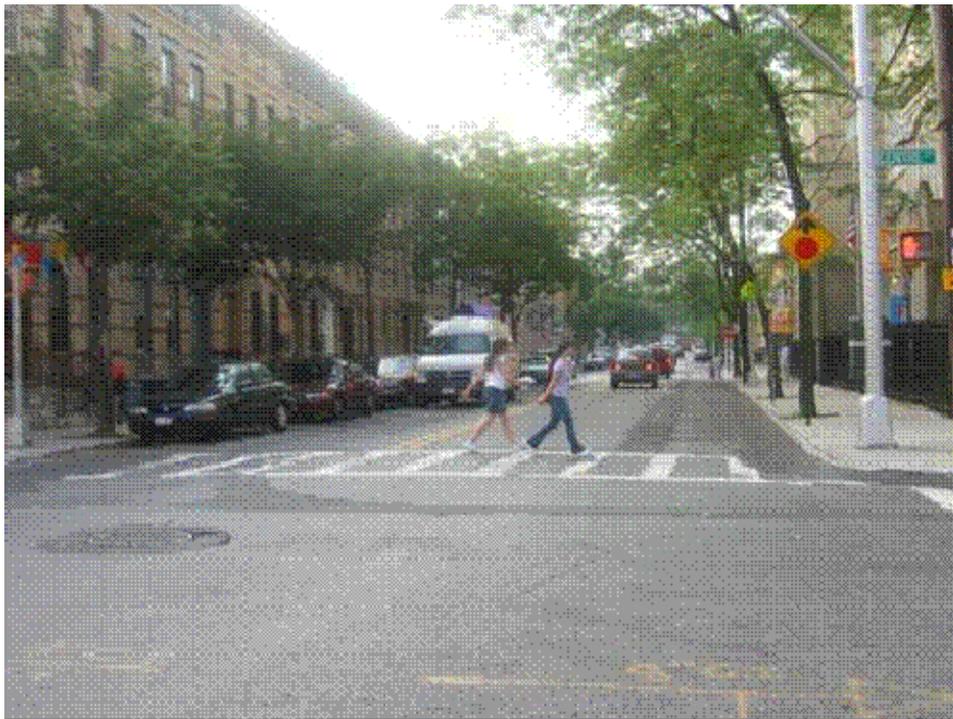
*Figure 5: Looking east on Seneca Avenue across Centre Street, the front of the school is on the right*

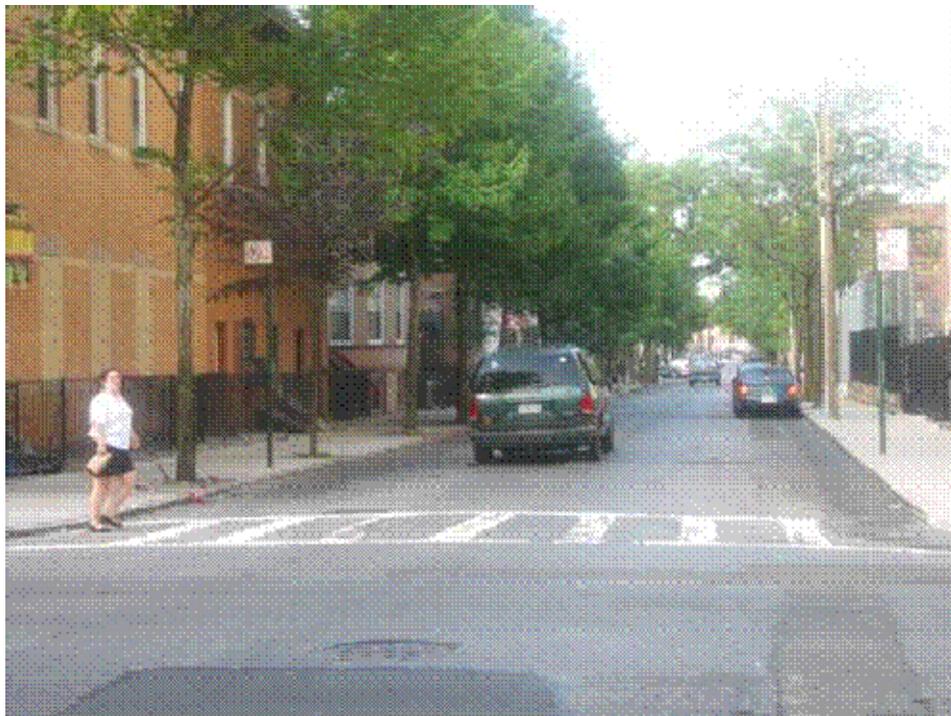
A pedestrian crosswalk is located across the east leg of Seneca Avenue. Seneca Avenue is a two-way street with one travel lane and a parking lane on each side of the roadway. George Street is a one-way southbound street with one travel lane and parking on both sides of the roadway (see Figures 6 and 7).

*Figure 6: Looking south on George Street across Seneca Avenue, school is off to the right*

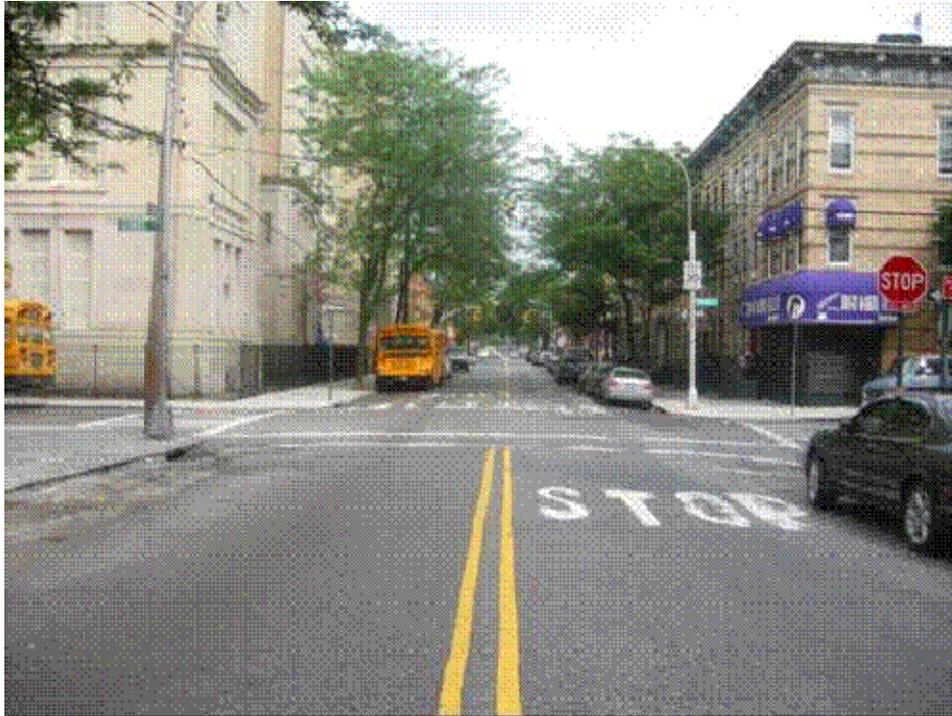
*Figure 7: Looking west on Seneca Avenue toward George Street, school is to the left*

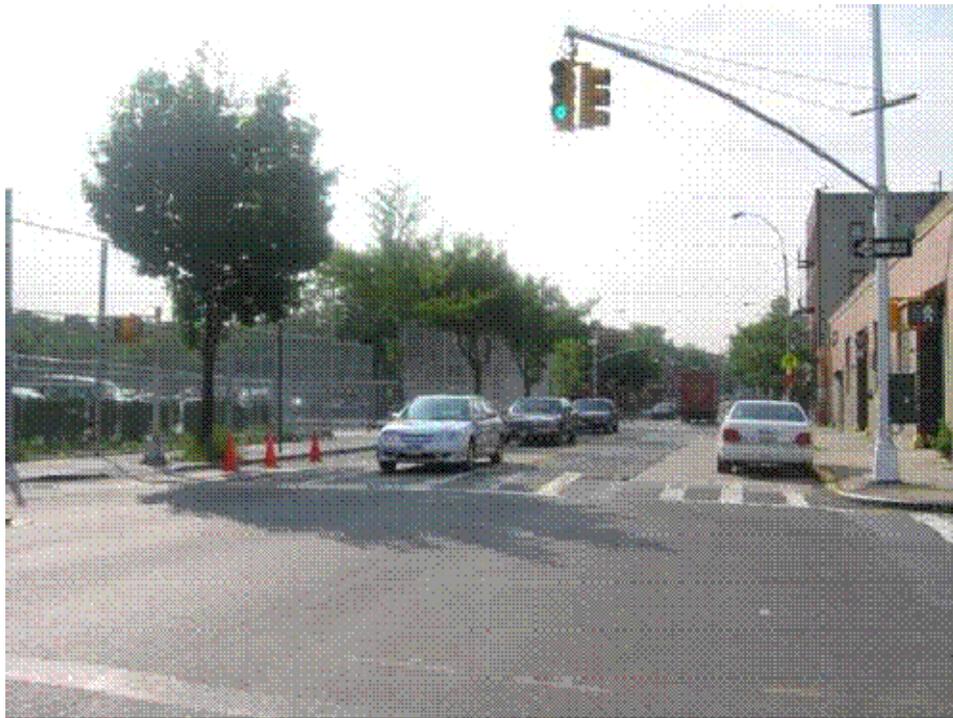
*Figure 8: Looking east on Cypress Avenue across Centre Street, schoolyard is to the left*

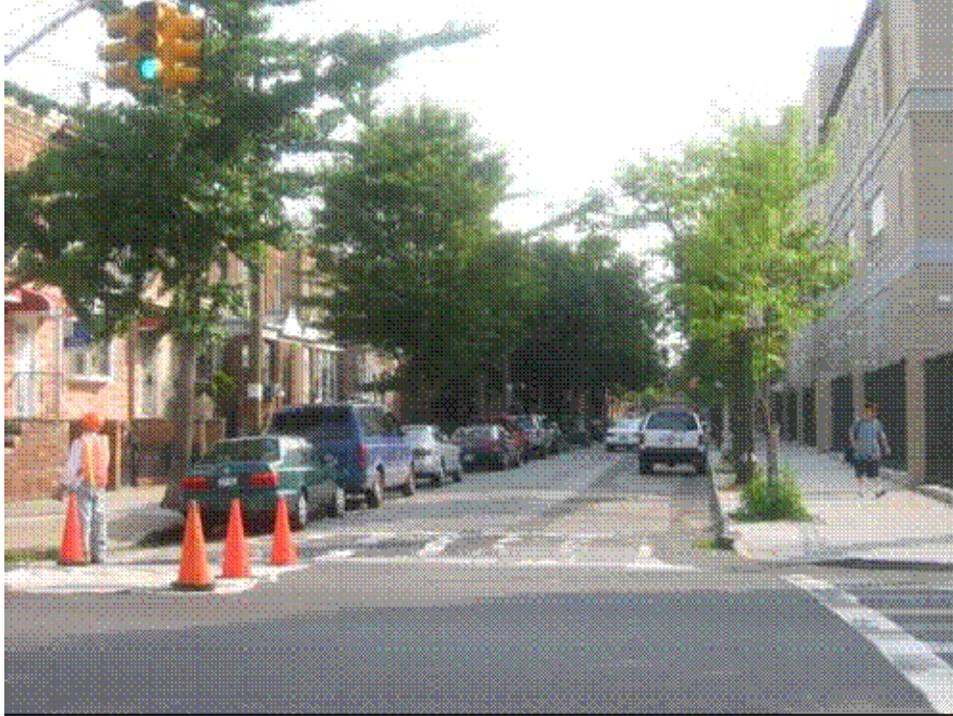
*Figure 9: Looking north on Centre Street across Cypress Avenue, school is on the right*

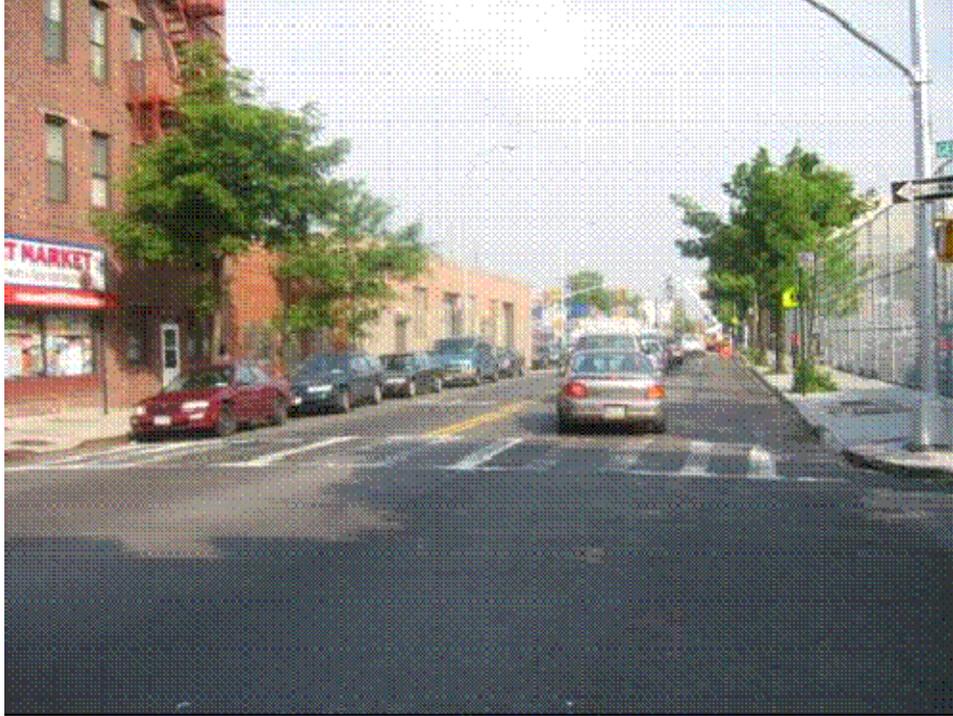
*Figure 10: Looking west on Cypress Avenue across George Street intersection*

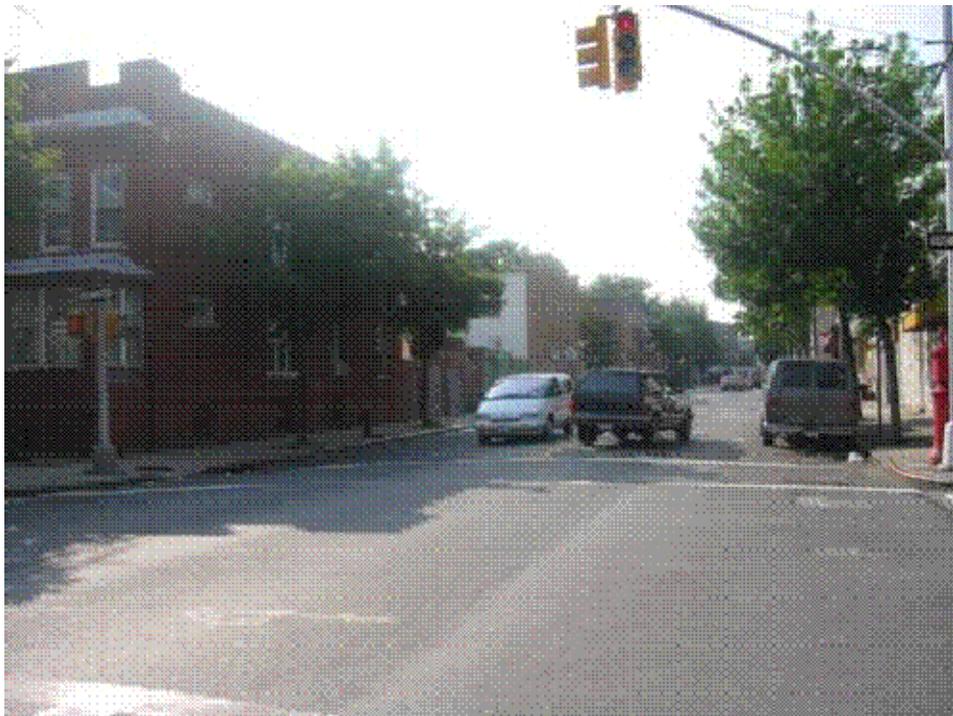
*Figure 11: Looking east along Cypress Avenue across George Street*

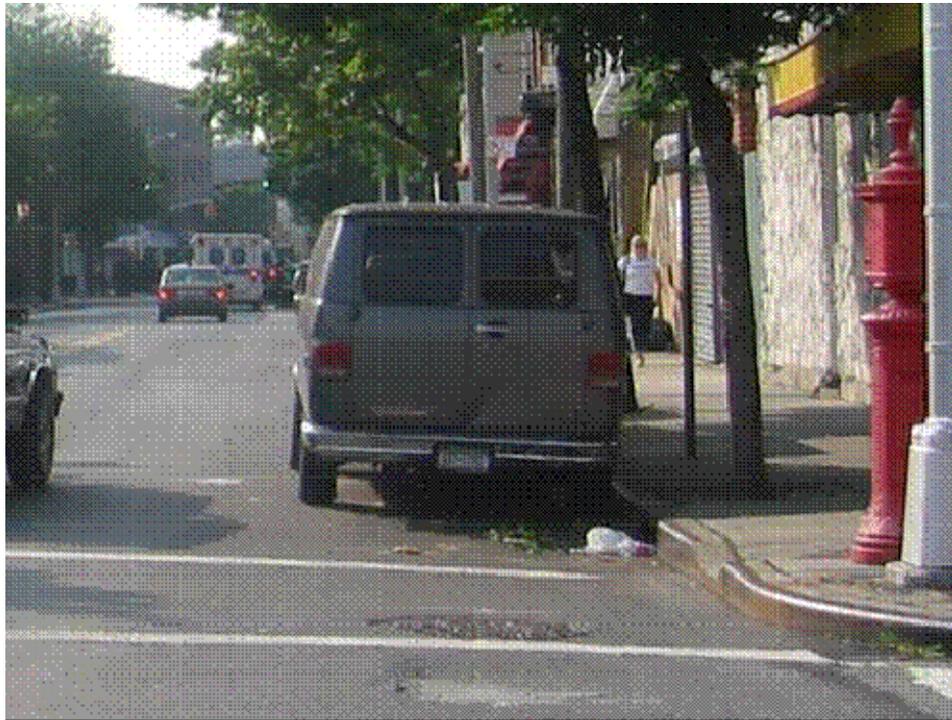
There are also some obstructions to the crosswalk paths in the sidewalk/pedestrian ramp area on the southeast corner of Cypress Avenue and George Street. One is a traffic signal pole and the other is a fire call box, both of which are in the path of the crosswalk located across the east leg of Cypress Avenue (see Figure 12).

*Figure 12: Looking east on Cypress Avenue at pedestrian ramp on southeast corner with lip at curb (Also note fire call box and traffic signal pole in path of pedestrian crosswalk located across east leg of Cypress Avenue)*

- Reconstruct the pedestrian ramps on the southeast corner to make them standard in size and to eliminate the lip at the curb, and provide a smooth transition from the pavement to the ramp, on the south side of Cypress Avenue and the east side of George Street.
- Modify the pedestrian ramps on the southwest corner to eliminate the lip at the curb, and provide a smooth transition from the pavement to the ramp, on the south side of Cypress Avenue and the west side of George Street.
- Reconstruct the pedestrian ramps on the northeast corner to make them standard in size and to eliminate the small lip at the curb, providing a smooth transition from the pavement to the ramp, on the north side of Cypress Avenue and the east side of George Street.

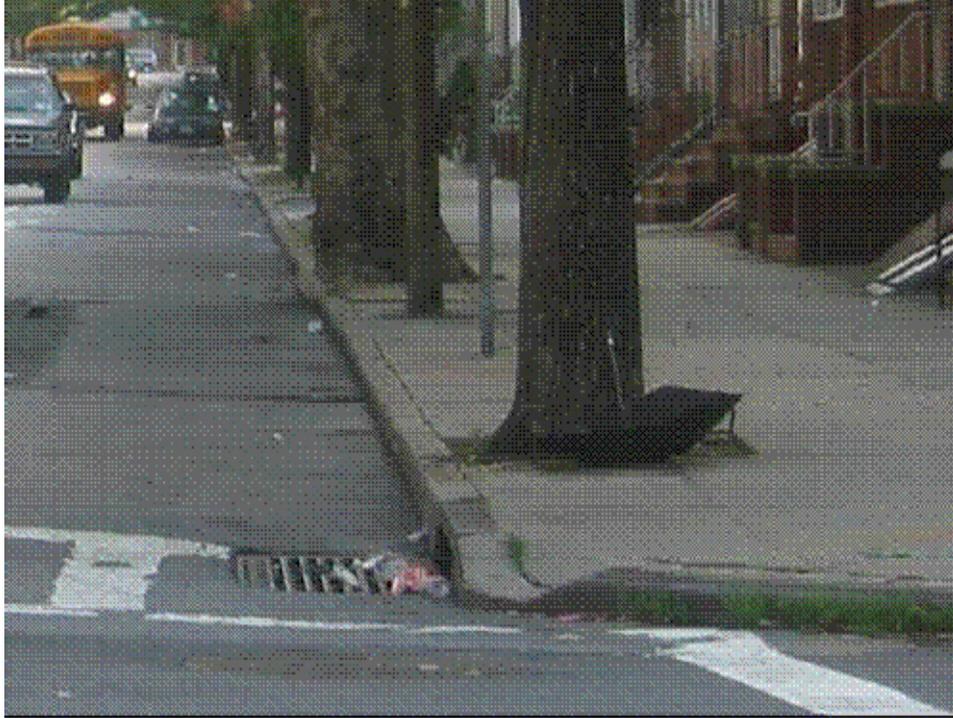
There is a drainage inlet on the northeast corner, which is in the path of the school crosswalk located across the north leg of George Street (see Figure 13).

*Figure 13: Looking north on east side of George Street, north of Cypress Avenue, at drainage inlet in path of crosswalk located across north leg of George Street*

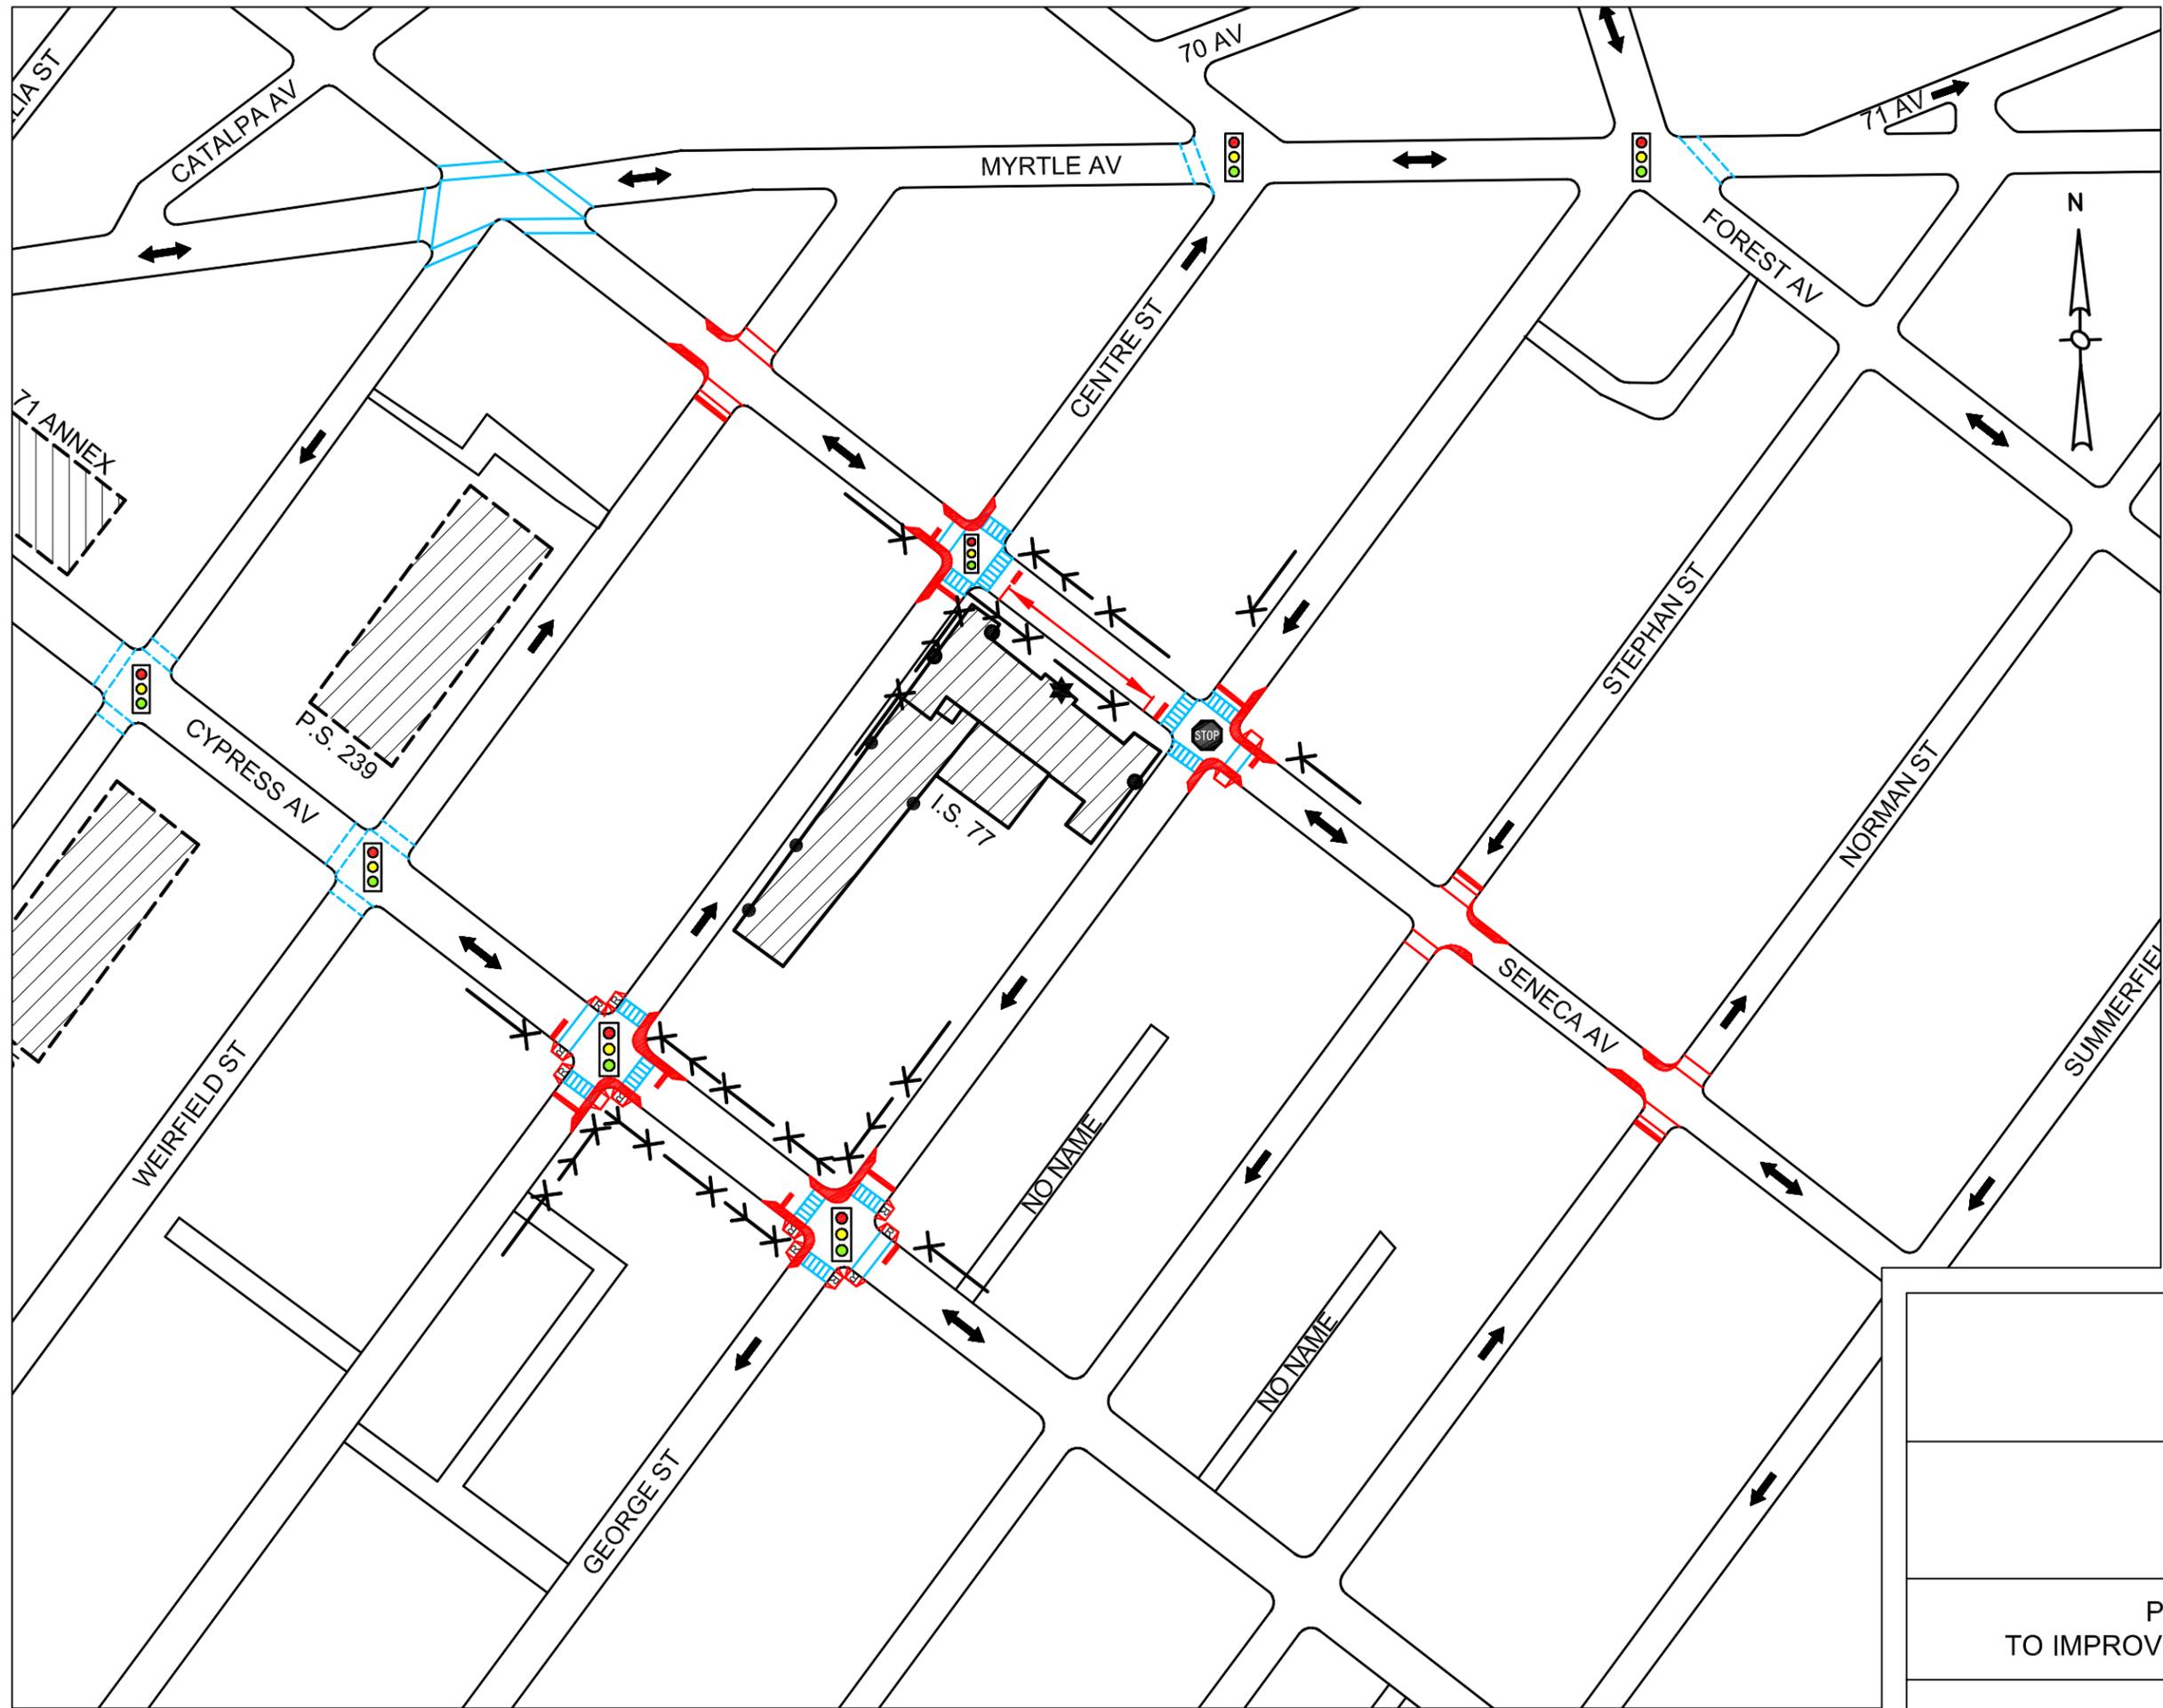
PROPOSED MEASURES  
TO IMPROVE SCHOOL PEDESTRIAN SAFETY

This section describes the proposed measures to improve school pedestrian safety around I.S. 77. The proposed recommendations are divided into short-term and long-term measures. Short-term measures are those that potentially can be performed in-house. Long-term measures involve capital improvements. Each of the short- and long-term measures recommended for I.S. 77 is discussed as follows, and is shown in more detail in Exhibit 6 at the end of this section.

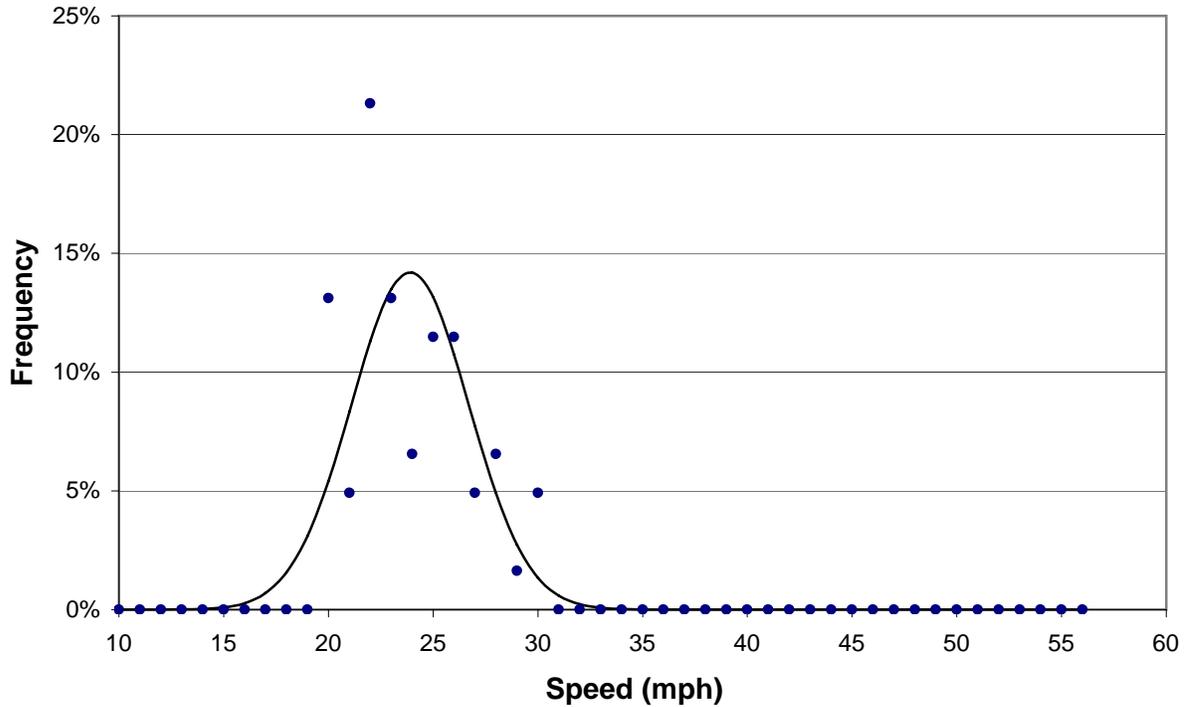
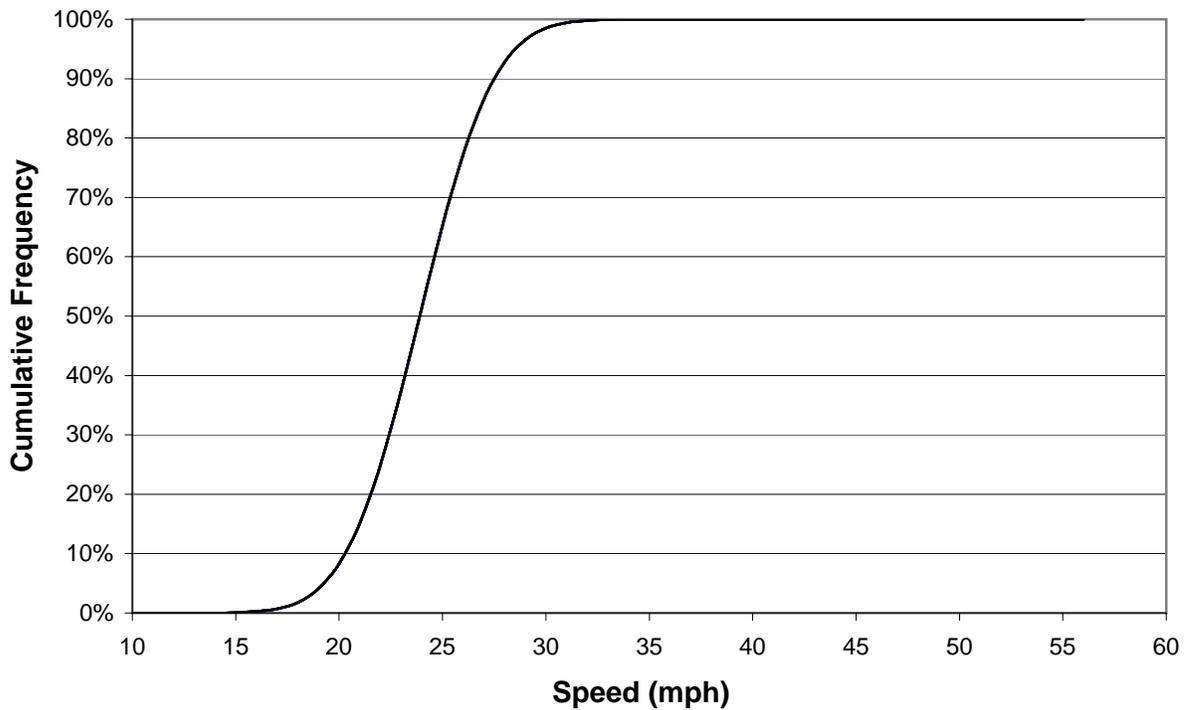
Median Speed = 23.9 mph  
15th Percentile Speed = 21.0 mph  
85th Percentile Speed = 26.8 mph

The 85<sup>th</sup> percentile speed for northbound vehicles on Centre Street between Cypress Avenue and Seneca Avenue was found to be 27 mph.
