**New York City Department of Transportation  
Office of School Safety Engineering**

**School Safety Engineering Project**

**FINAL REPORT: IS 77, Queens**

**Prepared by  
The RBA Group and URBITRAN Associates Inc.**

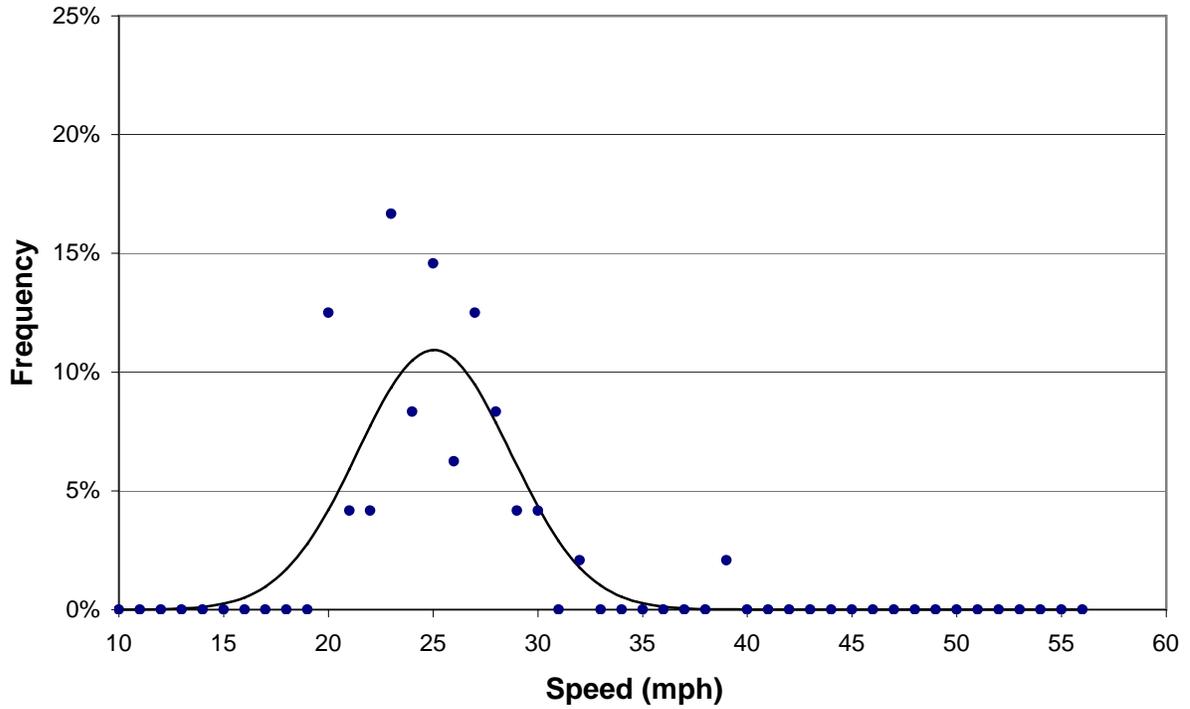
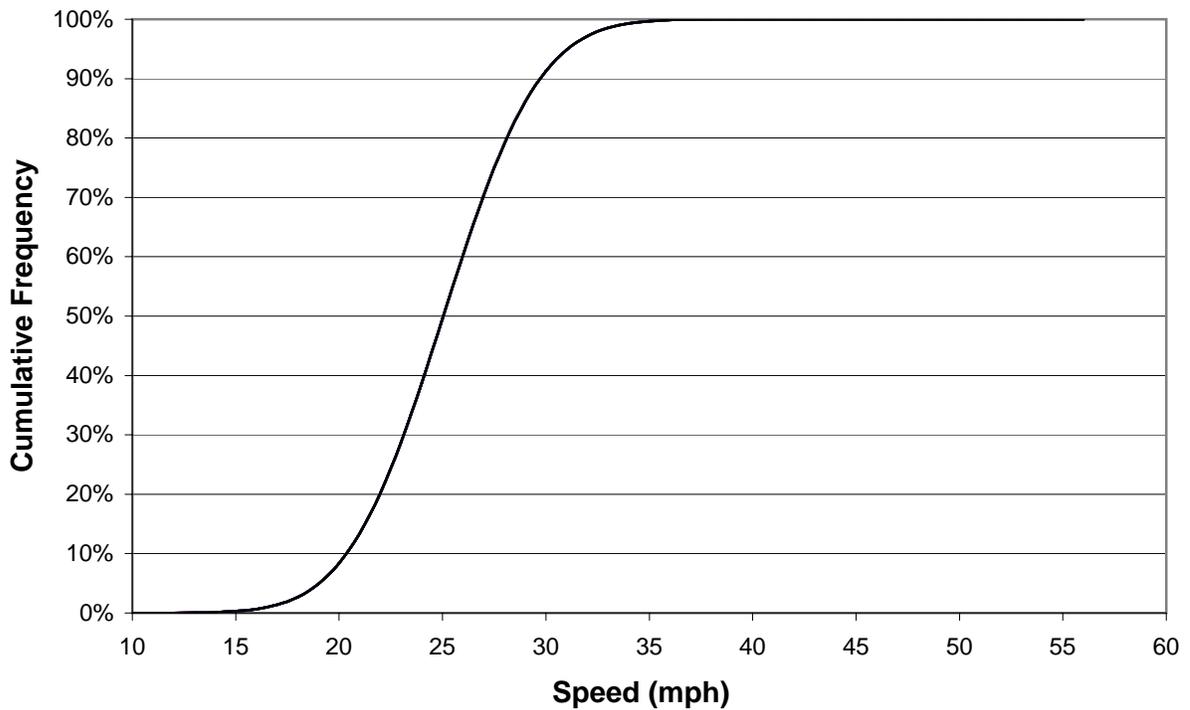
Median Speed = 25.0 mph  
 15th Percentile Speed = 21.3 mph  
 85th Percentile Speed = 28.8 mph

The eastbound vehicles on Seneca Avenue between Centre Street and George Street were found to be traveling with an 85<sup>th</sup> percentile speed of 29 mph. The westbound vehicles on Seneca Avenue between Centre Street and George Street were found to be traveling with an 85<sup>th</sup> percentile speed of 27 mph.

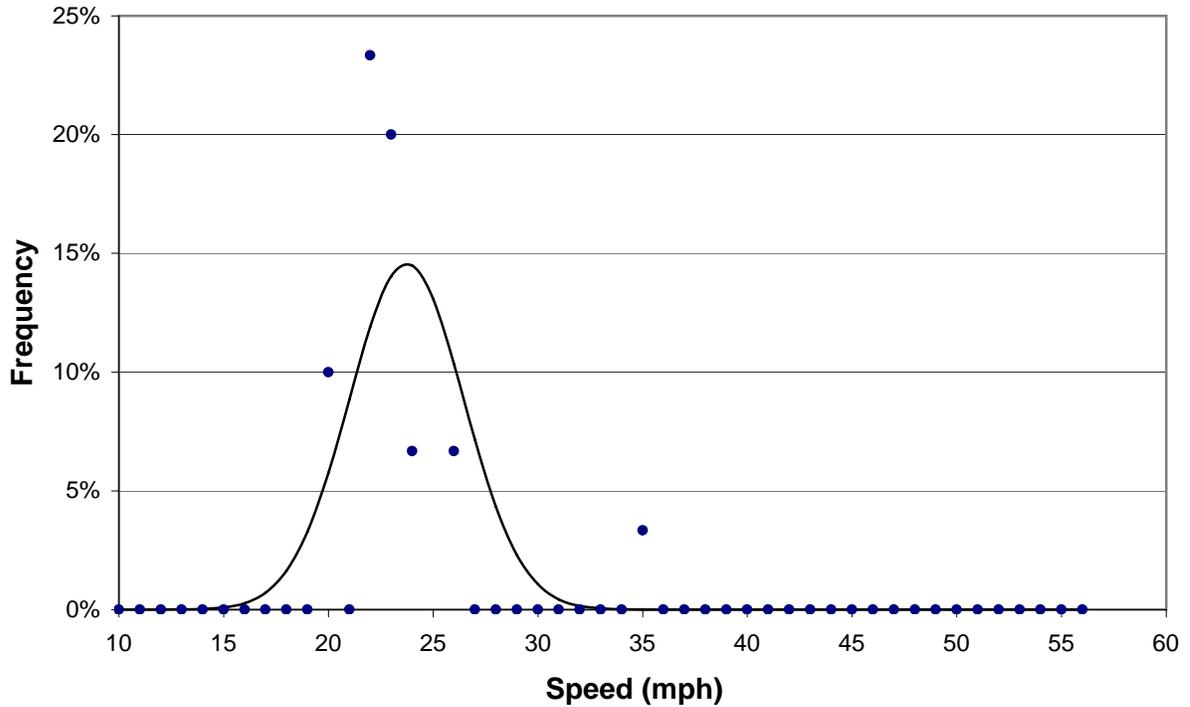
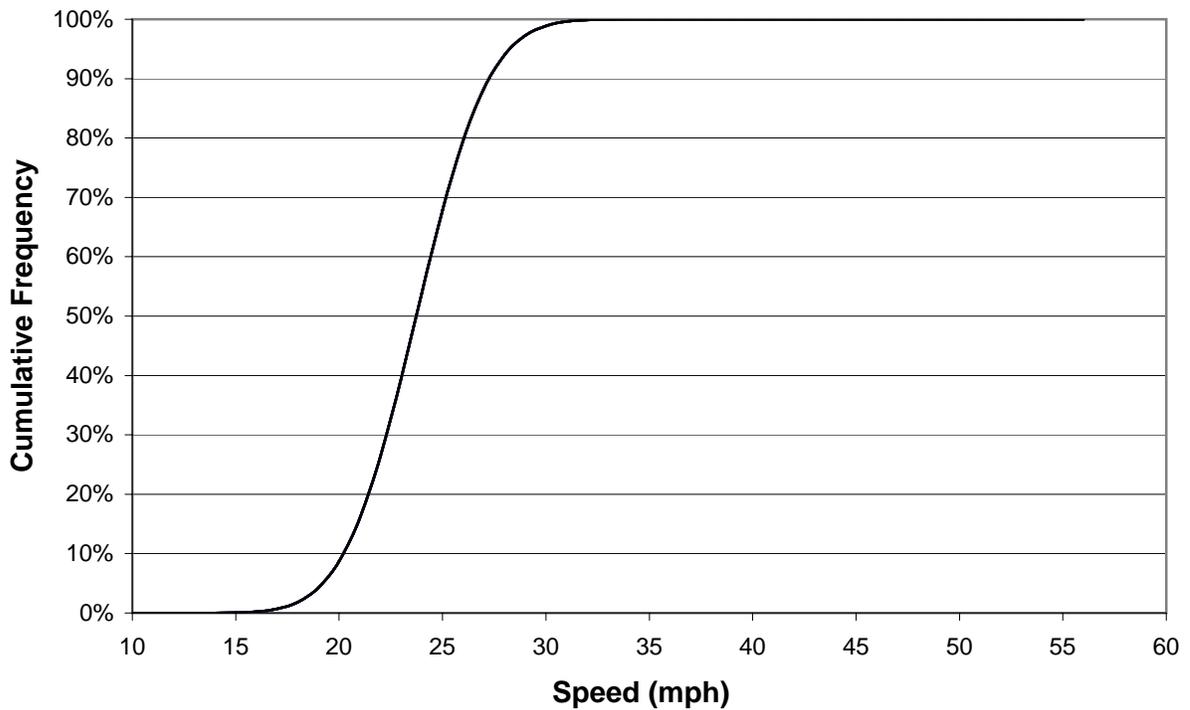
Median Speed = 23.7 mph  
15th Percentile Speed = 20.9 mph  
85th Percentile Speed = 26.6 mph
