**New York City Department of Transportation
Office of School Safety Engineering**

FINAL REPORT: P.S. 50 (Talfourd Lawn Elementary School), Queens

**Prepared by
The RBA Group and URBITRAN Associates Inc.**

October 13, 2006

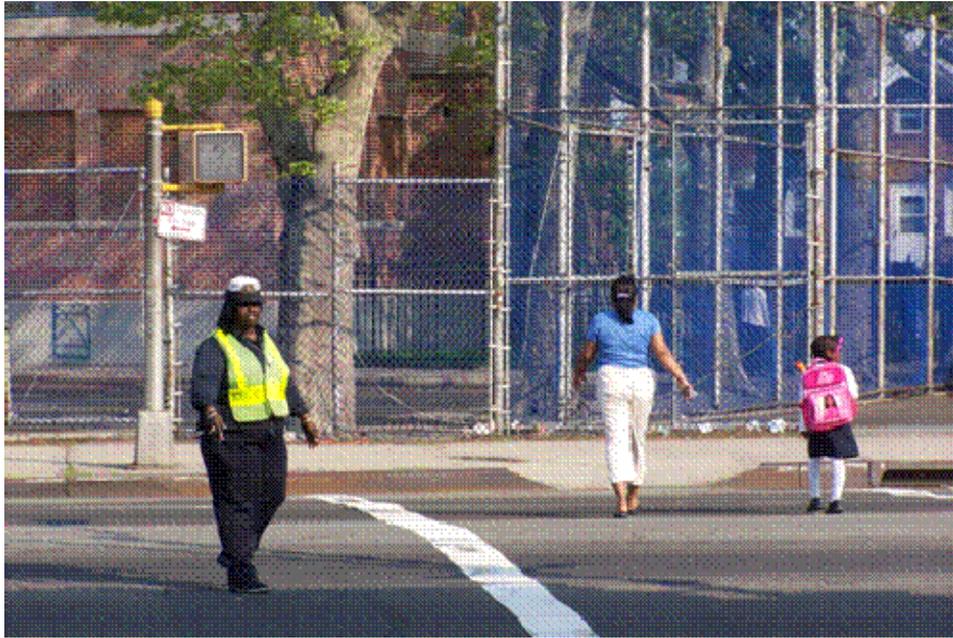
Figure 3: Looking north across Liberty Avenue at the signalized intersection with Liverpool Street (school crossing guard on duty)

As shown in Figure 3, a crossing guard is assigned to the signalized intersection of Liberty Avenue and Liverpool Street on school days. There is also a crossing guard assigned to the signalized intersection of 101st Avenue and Liverpool Street. Exhibit 4 shows the location of both crossing guards.

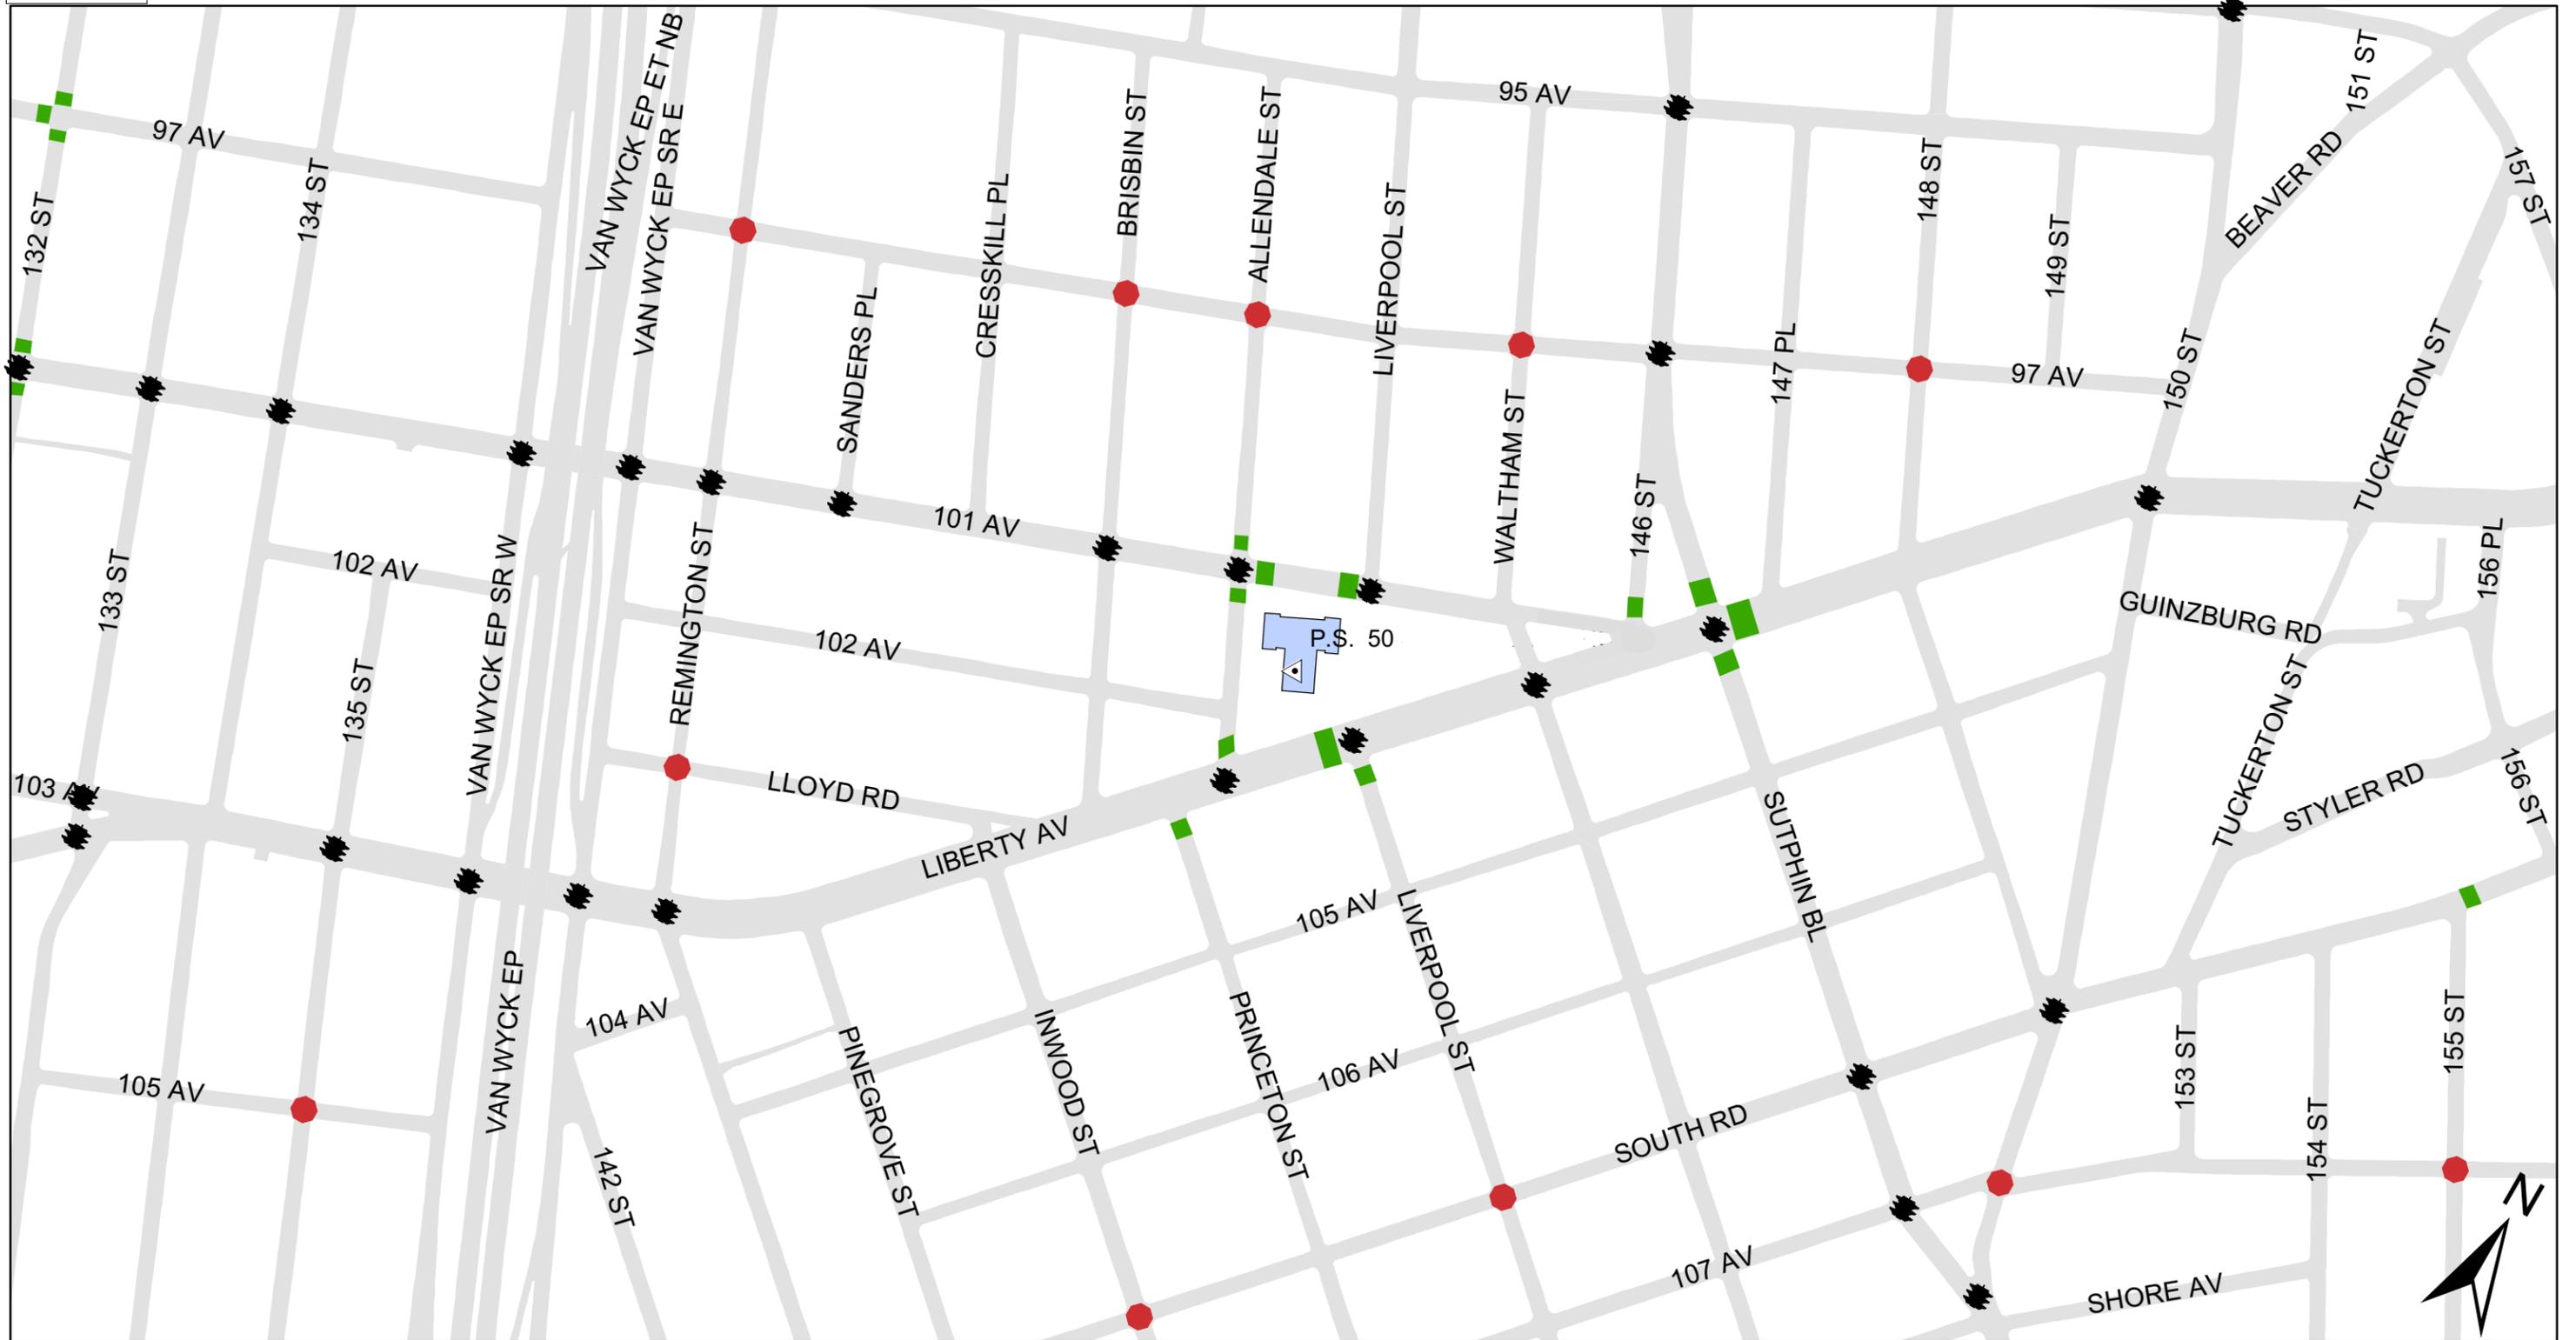
EXHIBIT 3

The School Traffic Safety Map was established to help provide the maximum degree of safety for children going to and from school - by indicating the location of speed reducers, school crosswalks and some traffic control devices. (While virtually all intersections in NYC benefit from traffic control devices - such as stop signs, traffic signals, yield signs, and all way stop signs - this map shows only traffic signals and all way stop signs.) The school crosswalks that are shown are ladder striped and make the crosswalk more visible to drivers and help make the intersection safer. These crosswalks are where school children are recommended to cross.

Exhibit 3 shows the existing signals, school crosswalks, and speed reducers in the vicinity of P.S. 50. It should be noted that a citywide signage program is currently underway to upgrade school signage to current Federal Manual on Uniform Traffic Control Devices (MUTCD) standards of fluorescent yellow-green signs accompanied by downward pointing arrows. Signs scheduled to be installed under this program are shown as "existing" in Exhibit 8.

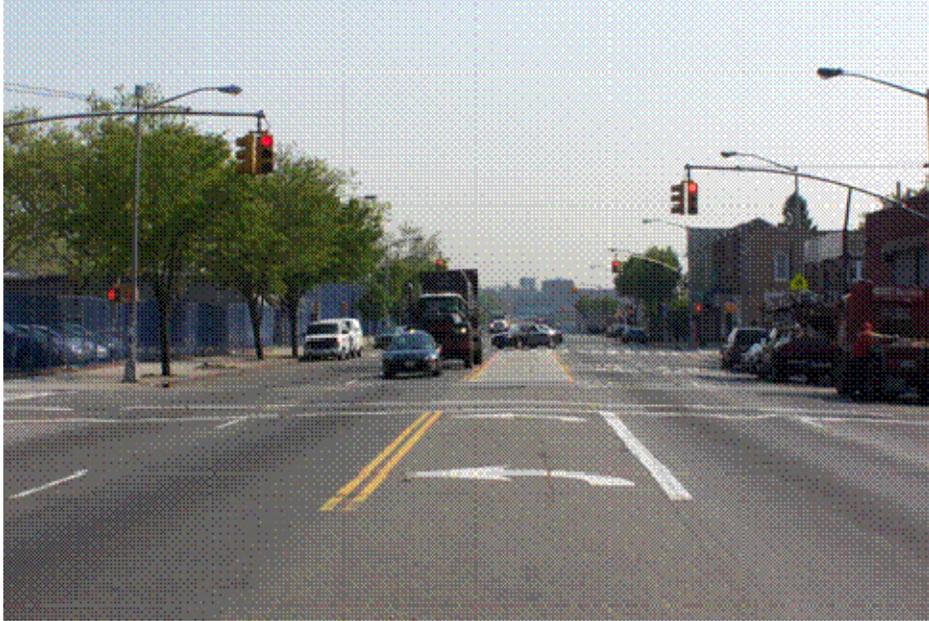
Figure 4: Looking northeast on Liberty Avenue to the intersection with Allendale Street

This is a signalized "T"-intersection with a school crosswalk located across the northwest leg of Allendale Street, and pedestrian crosswalks located across both legs of Liberty Avenue. Liberty Avenue is a two-way street on a northeast-southwest alignment, with two travel lanes and one on-street parking lane on each side of the roadway, plus a ten foot painted center median with exclusive left-turn lanes at selected intersections. Allendale Street is a two-way street on a northwest-southeast alignment with one travel lane and one on-street parking lane on each side of the roadway. There is an exclusive left-turn lane on Liberty Avenue at its intersection with Allendale Street (see Figures 4 and 5).

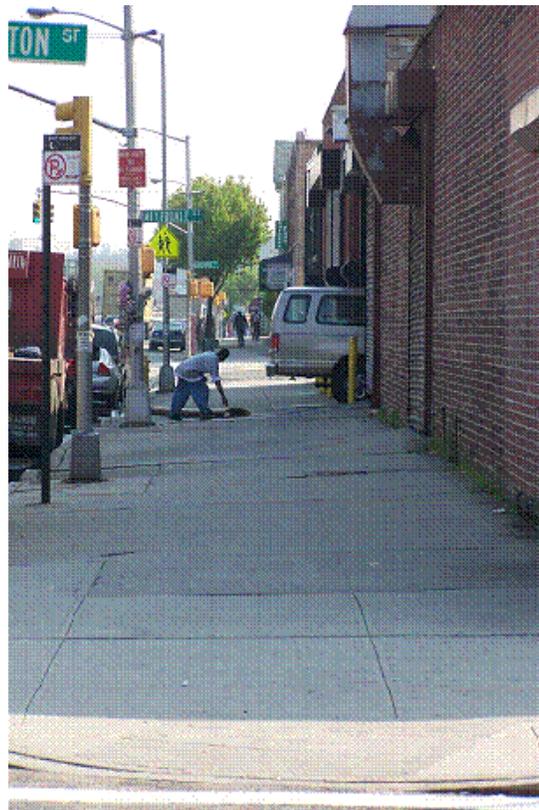
Figure 5: Looking northeast at the sidewalk on the south side of Liberty Avenue, between Princeton Street and Liverpool Street

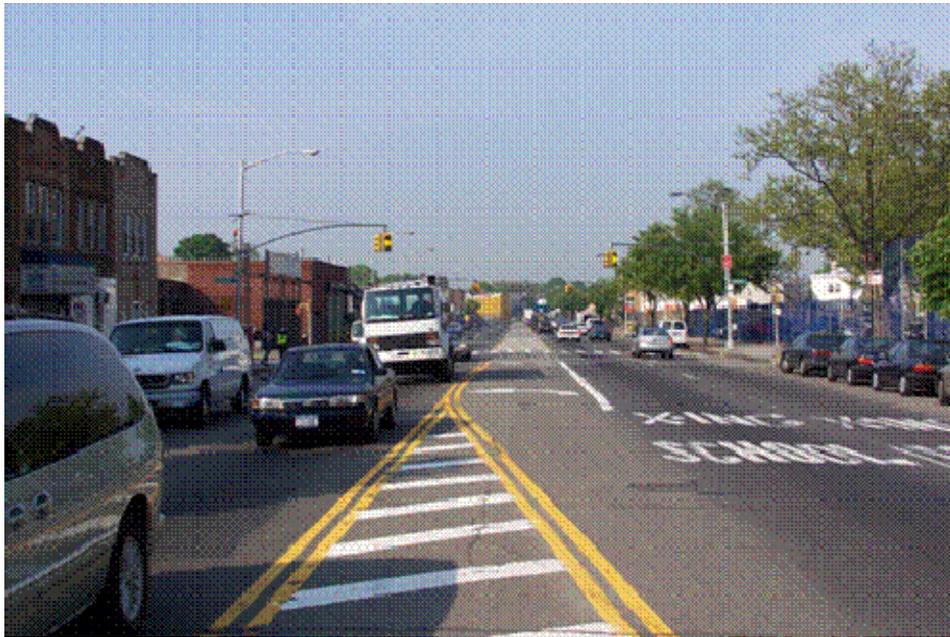
Figure 6: Looking southwest on Liberty Avenue to the intersection with Liverpool Street

This is a signalized “T”-intersection with school crosswalks located across the southwest leg of Liberty Avenue and the southeast leg of Liverpool Street, and a pedestrian crosswalk located across the northeast leg of Liberty Avenue. Liberty Avenue is a two-way street on a northeast-southwest alignment, with two travel lanes and one on-street parking lane on each side of the roadway, plus a ten-foot painted center median with exclusive left-turn lanes at selected intersections. Liverpool Street is a two-way street on a northwest-southeast alignment with one travel lane and one on-street parking lane on each side of the roadway. Liverpool Street is discontinuous through the school property (between Liberty Avenue and 101st Avenue), but continues north of 101st Avenue. There is an exclusive left-turn lane on Liberty Avenue at its intersection with Liverpool Street (see Figures 6 and 7).

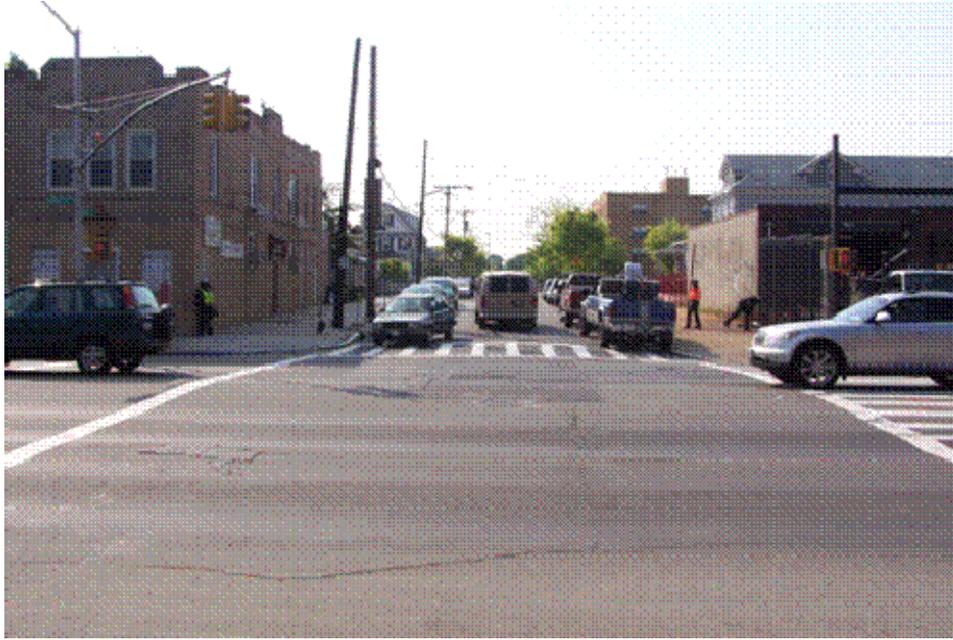
Figure 7: Looking southeast on Liverpool Street from across the intersection with Liberty Avenue

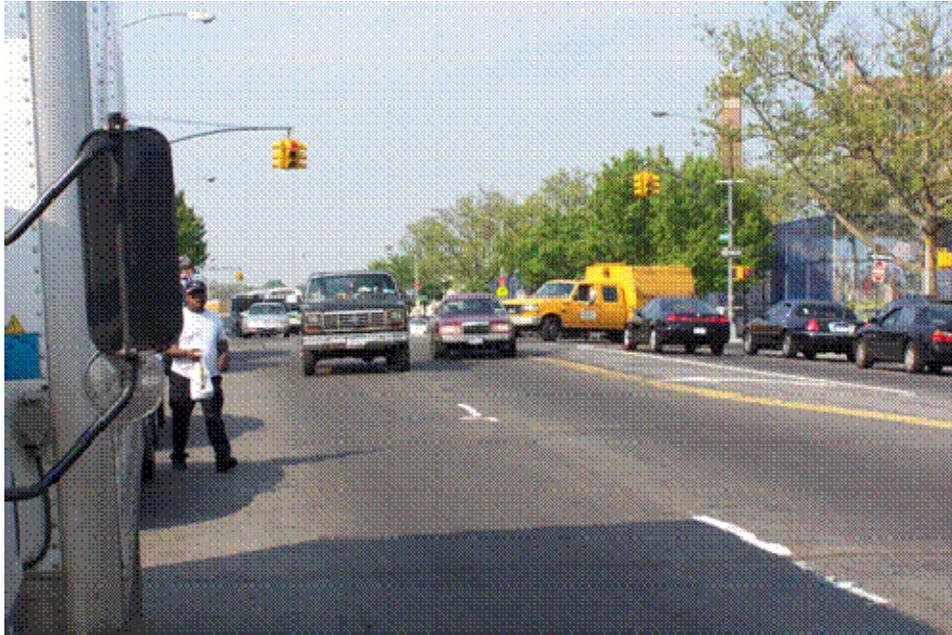
Figure 8: Looking southwest on Liberty Avenue to the intersection with Waltham Street

Between Liberty Avenue and 101st Avenue, Waltham Street is a one-way southbound street with two travel lanes. Although on-street parking is not prohibited along this segment of Waltham Street, motorists typically do not park here due to the relatively short block length between 101st Avenue and Liberty Avenue. There is one exclusive left-turn lane on Liberty Avenue for southwest-bound traffic on Liberty Avenue to turn onto southeast-bound Waltham Street (see Figure 8).

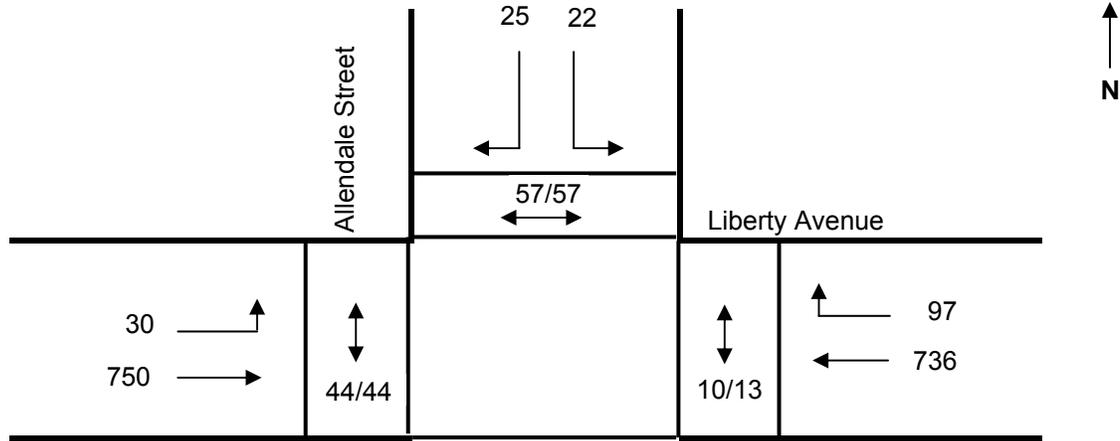
EXHIBIT 7A
P.S. 50 QUEENS
TALFOURD LAWN ELEMENTARY SCHOOL
TRAFFIC AND PEDESTRIAN COUNTS

One Hour Traffic Volumes
Friday, September 30th, 2005 7:30 am - 8:30 am

Intersection of Liberty Avenue and Allendale Street

To assess vehicle and pedestrian volumes on Liberty Avenue in the vicinity of P.S. 50, vehicle turning movement and pedestrian crossing counts were conducted at the intersection from 7:30 to 9:00 am on Friday, September 30, 2005. The results of these counts during the weekday morning peak hour (7:30 to 8:30 am) are shown in Tables 4 and 5, and in Exhibit 7A at the end of this section.

As shown in Table 5, the pedestrian crossing count identified a total of 88 pedestrians (including 44 adults and 44 students) utilizing the pedestrian crosswalk located across the southwest leg of Liberty Avenue, and a total of 23 pedestrians (including 10 adults and 13 students) utilizing the pedestrian crosswalk located across the northeast leg of Liberty Avenue. This represents a total of 111 pedestrians (including 54 adults and 57 students) crossing Liberty Avenue at Allendale Street during the weekday morning peak hour (7:30 to 8:30 am).

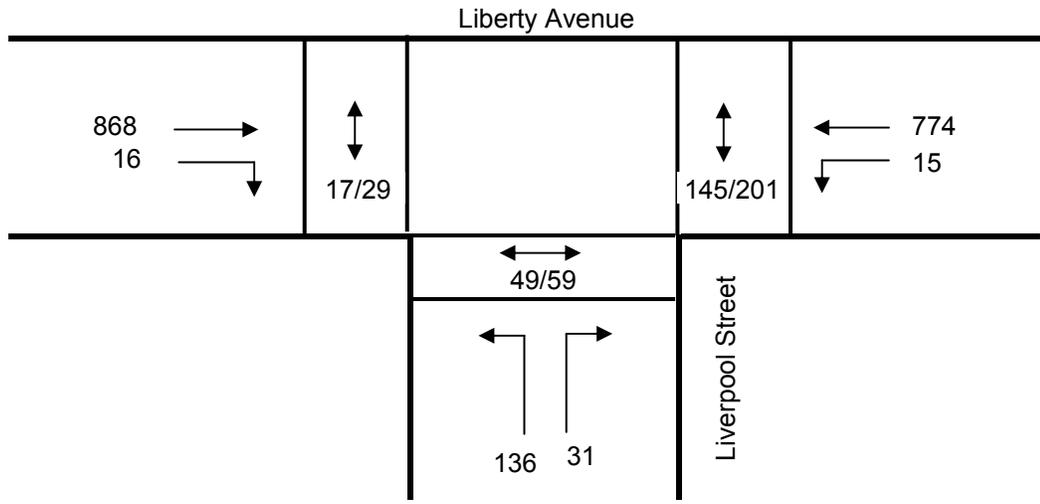
EXHIBIT 7B
P.S. 50
TALFOURD LAWN ELEMENTARY SCHOOL
TRAFFIC AND PEDESTRIAN COUNTS

One Hour Traffic Volumes
Wednesday, September 25th, 2005 7:30am - 8:30am

Intersection of Liberty Avenue and Liverpool Street

The available time for a student pedestrian to cross Liberty Avenue (assuming a child pedestrian walking rate of three feet/second, plus three seconds reaction time) was found to be insufficient at this intersection. To determine the effect that a change in traffic signal timing would have on traffic flow at this intersection, and to assess vehicle and pedestrian volumes on Liberty Avenue in the vicinity of P.S. 50, vehicle turning movement and pedestrian crossing counts were conducted at the intersection from 7:30 to 9:00 am on Monday, September 26, 2005. The results of these counts during the weekday morning peak hour (7:30 to 8:30 am) are shown in Tables 6 and 7, and in Exhibit 7B at the end of this section.

As shown in Table 7, the pedestrian crossing count identified a total of 46 pedestrians (including 17 adults and 29 students) utilizing the school crosswalk located across the southwest leg of Liberty Avenue, and a total of 346 pedestrians (including 145 adults and 201 students) utilizing the pedestrian crosswalk located across the northeast leg of Liberty Avenue. This represents a total of 392 pedestrians (including 162 adults and 230 students) crossing Liberty Avenue at Liverpool Street during the weekday morning peak hour (7:30 to 8:30 am).

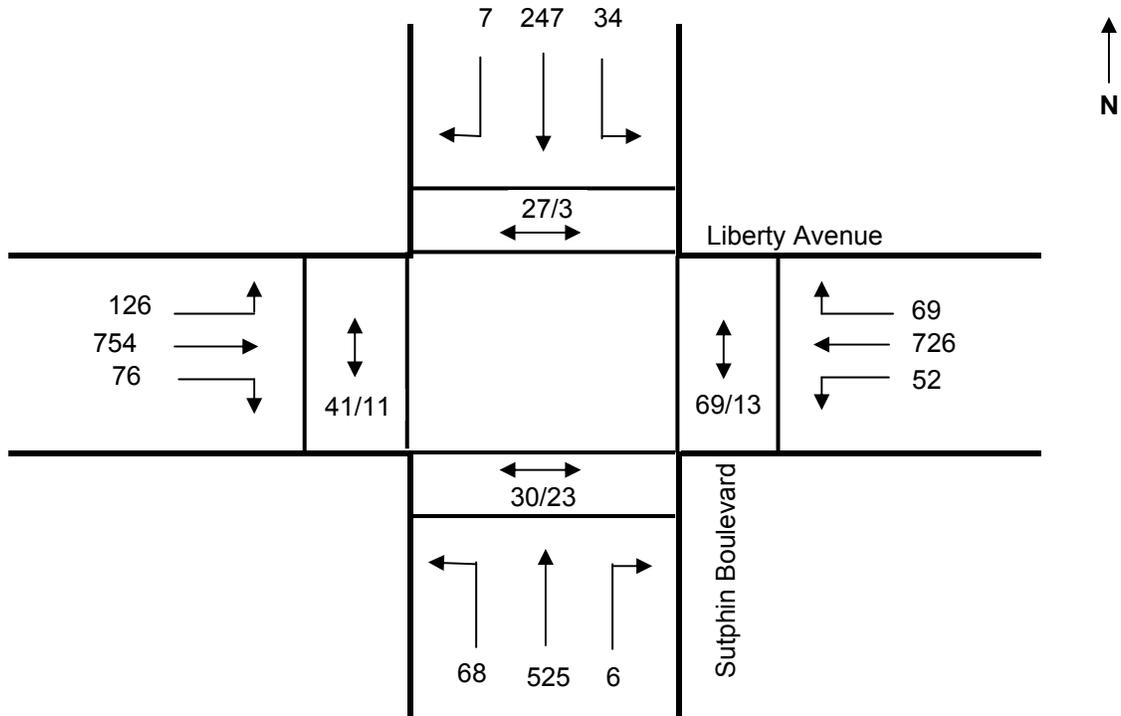
One Hour Traffic Volumes
Friday, June 17th, 2005 7:30 am - 8:30 am

Intersection of Liberty Avenue and Sutphin Blvd

To assess vehicle and pedestrian volumes on Liberty Avenue in the vicinity of P.S. 50, vehicle turning movement and pedestrian crossing counts were conducted at the intersection of Liberty Avenue and Sutphin Boulevard between 7:30 and 9:00 am on Friday, June 17, 2005. The results of these counts during the weekday morning peak hour (7:30 to 8:30 am) are shown in Tables 8 and 9 and in Exhibit 7C at the end of this section.

The pedestrian crossing count determined that there were a total of 52 pedestrians (including 41 adults and 11 students) utilizing the pedestrian crosswalk located across the southwest leg of Liberty Avenue, and a total of 82 pedestrians (including 69 adults and 13 students) utilizing the school crosswalk located across the east leg of Liberty Avenue.

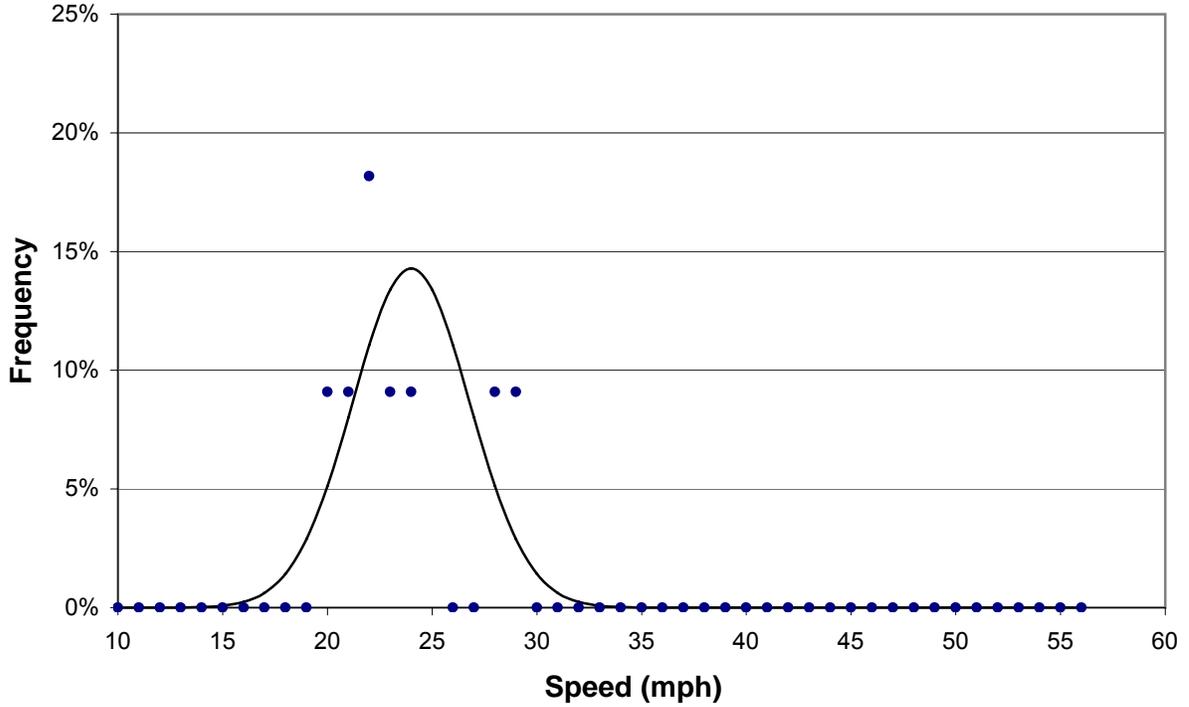
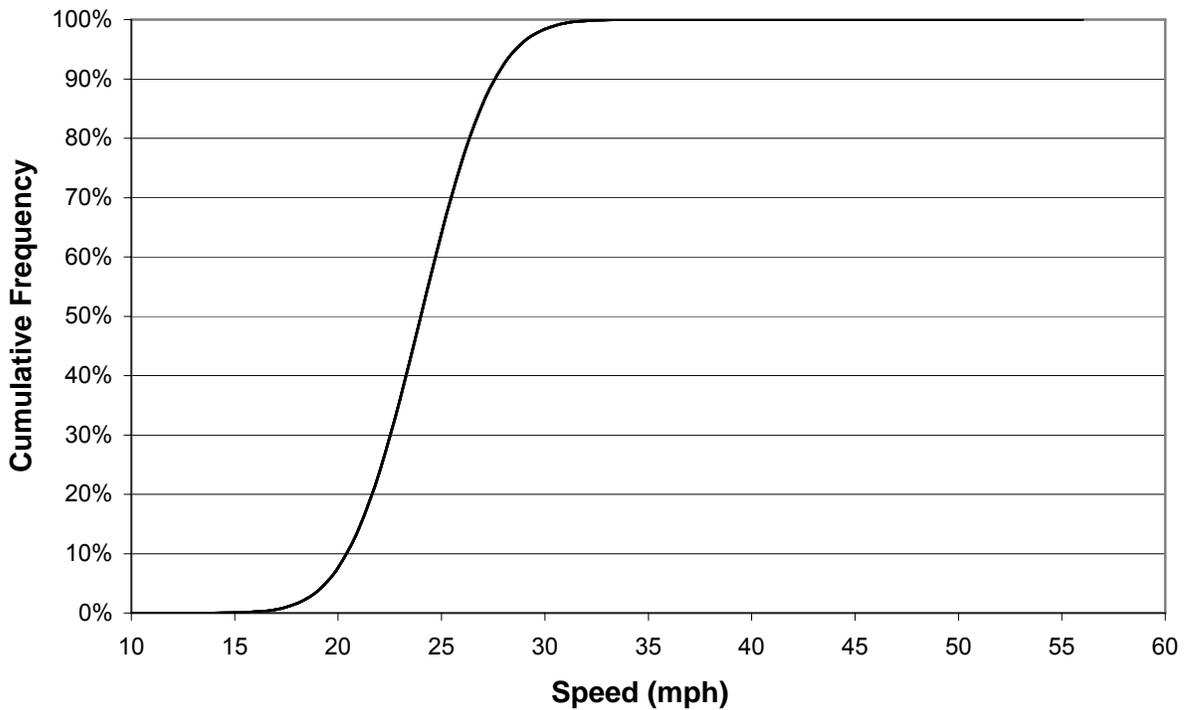
Mean Speed = 24.0 mph
Standard Deviation = 2.8 mph
Margin of Error (95% Confidence) = ± 1.7 mph

Median Speed = 24.0 mph
15th Percentile Speed = 21.1 mph
85th Percentile Speed = 26.9 mph

The results of the spot speed survey revealed that northwest-bound vehicles on Allendale Street between 101st Avenue and Liberty Avenue were traveling at an 85th percentile speed of 27 mph, and that southeast-bound vehicles on this same section were traveling at an 85th percentile speed of 28 mph. Because these 85th percentile speeds do not exceed the 30 mph threshold, no traffic calming measures are recommended.

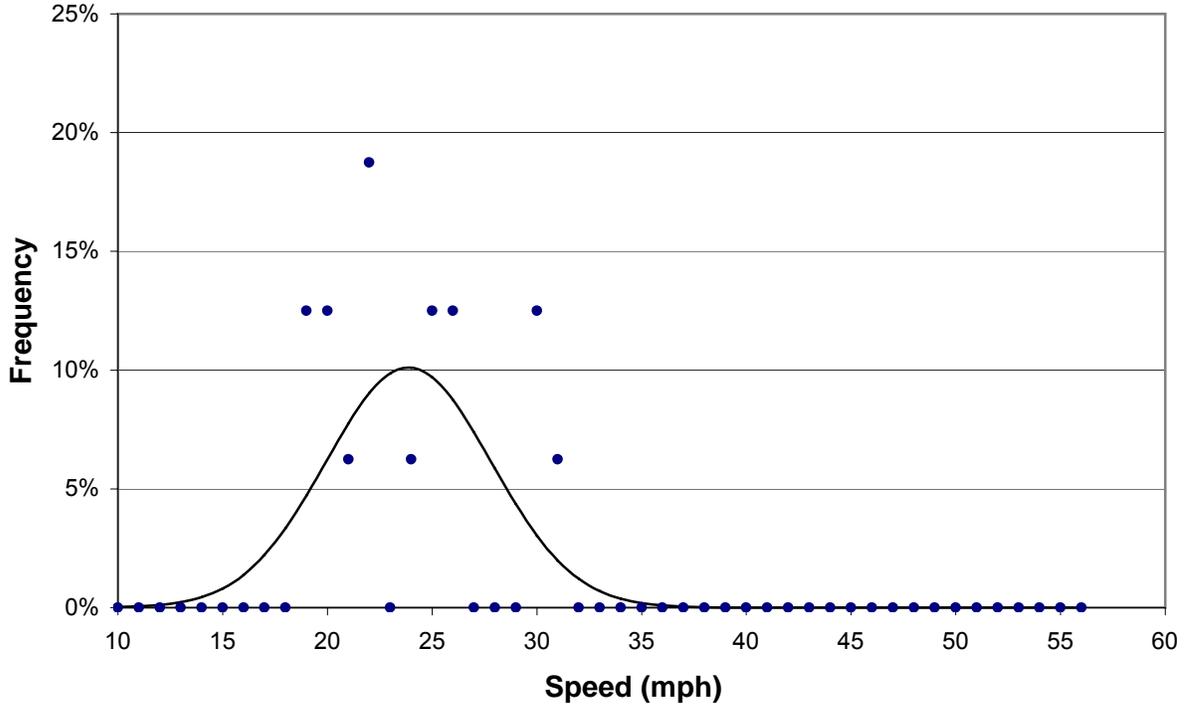
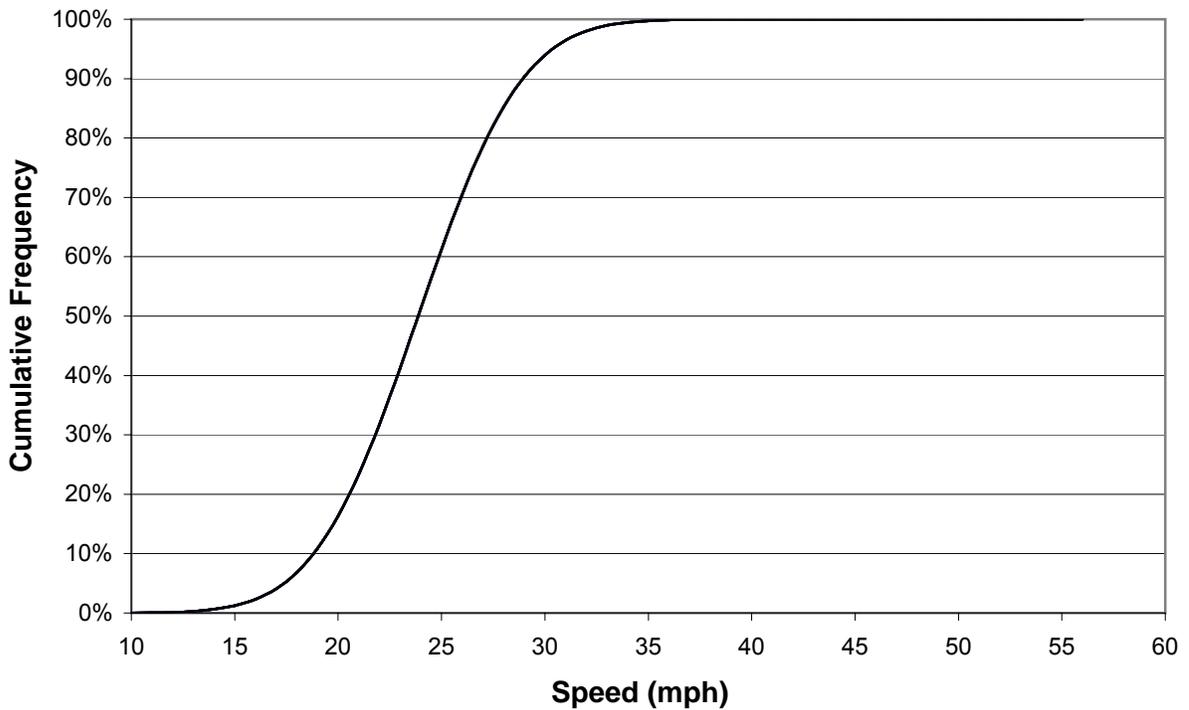
Date: **October 11, 2005** Time: **1:15- 2:15 pm**
 Location: **Allendale Street between 101 Avenue & Liberty Avenue**
 Surveyor: **Richard Calvache & Hugo Salinas**

Mean Speed = 23.9 mph
Standard Deviation = 3.9 mph
Margin of Error (95% Confidence) = ± 1.9 mph

Median Speed = 23.9 mph
15th Percentile Speed = 19.8 mph
85th Percentile Speed = 28.0 mph
