**School Safety Engineering Project**

**FINAL REPORT: I.S. 27 (Anning S. Prall School), Staten Island**

**Prepared by  
The RBA Group/Urbitran Associates**

**February 15, 2006**

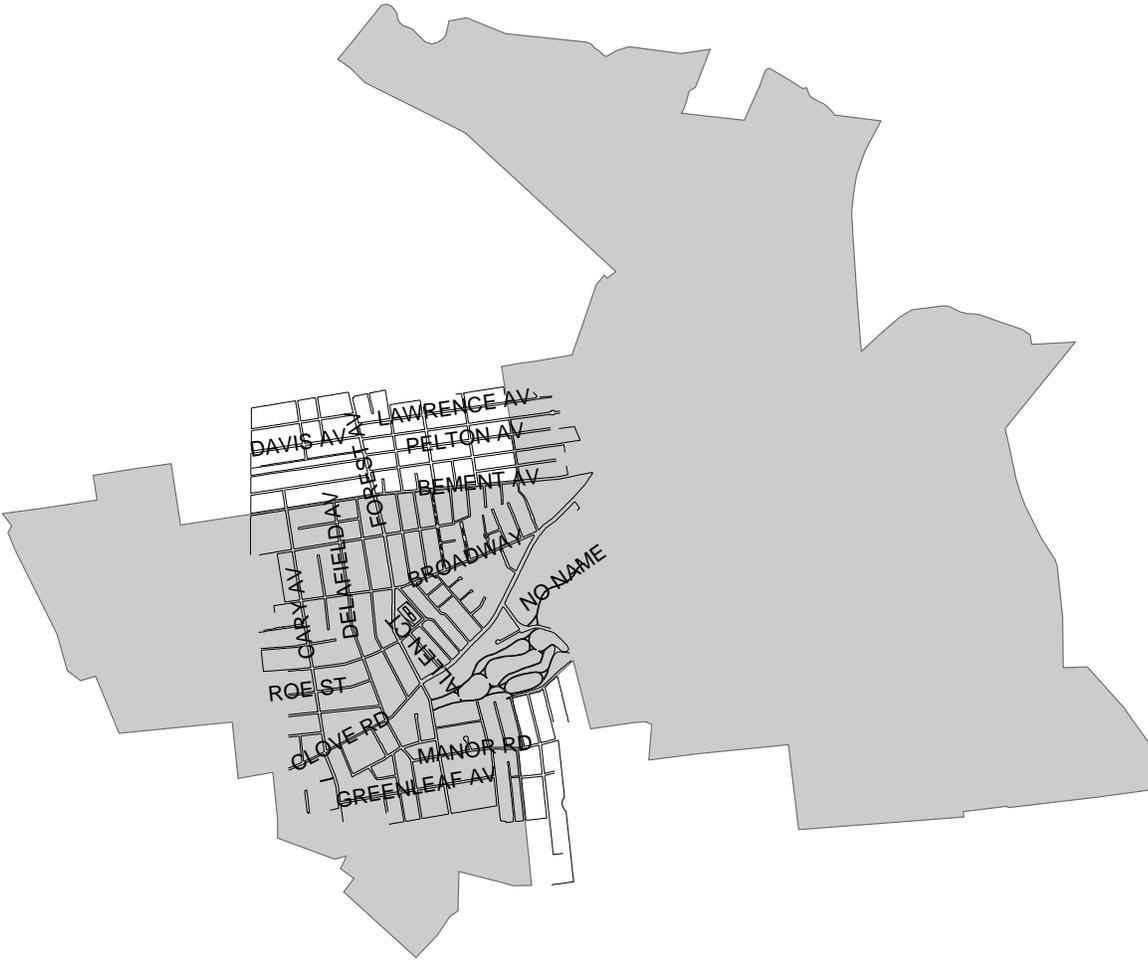
**EXHIBIT 2**

The school's catchment area as defined as the Department of Education is shown in Exhibit 2 at the end of this section. Based upon information gathered from the school principal, the catchment area shown in Exhibit 2 is correct for I.S. 27.

**I.S. 27 STATEN ISLAND  
ANNING S. PRALL SCHOOL  
CATCHMENT AREA**

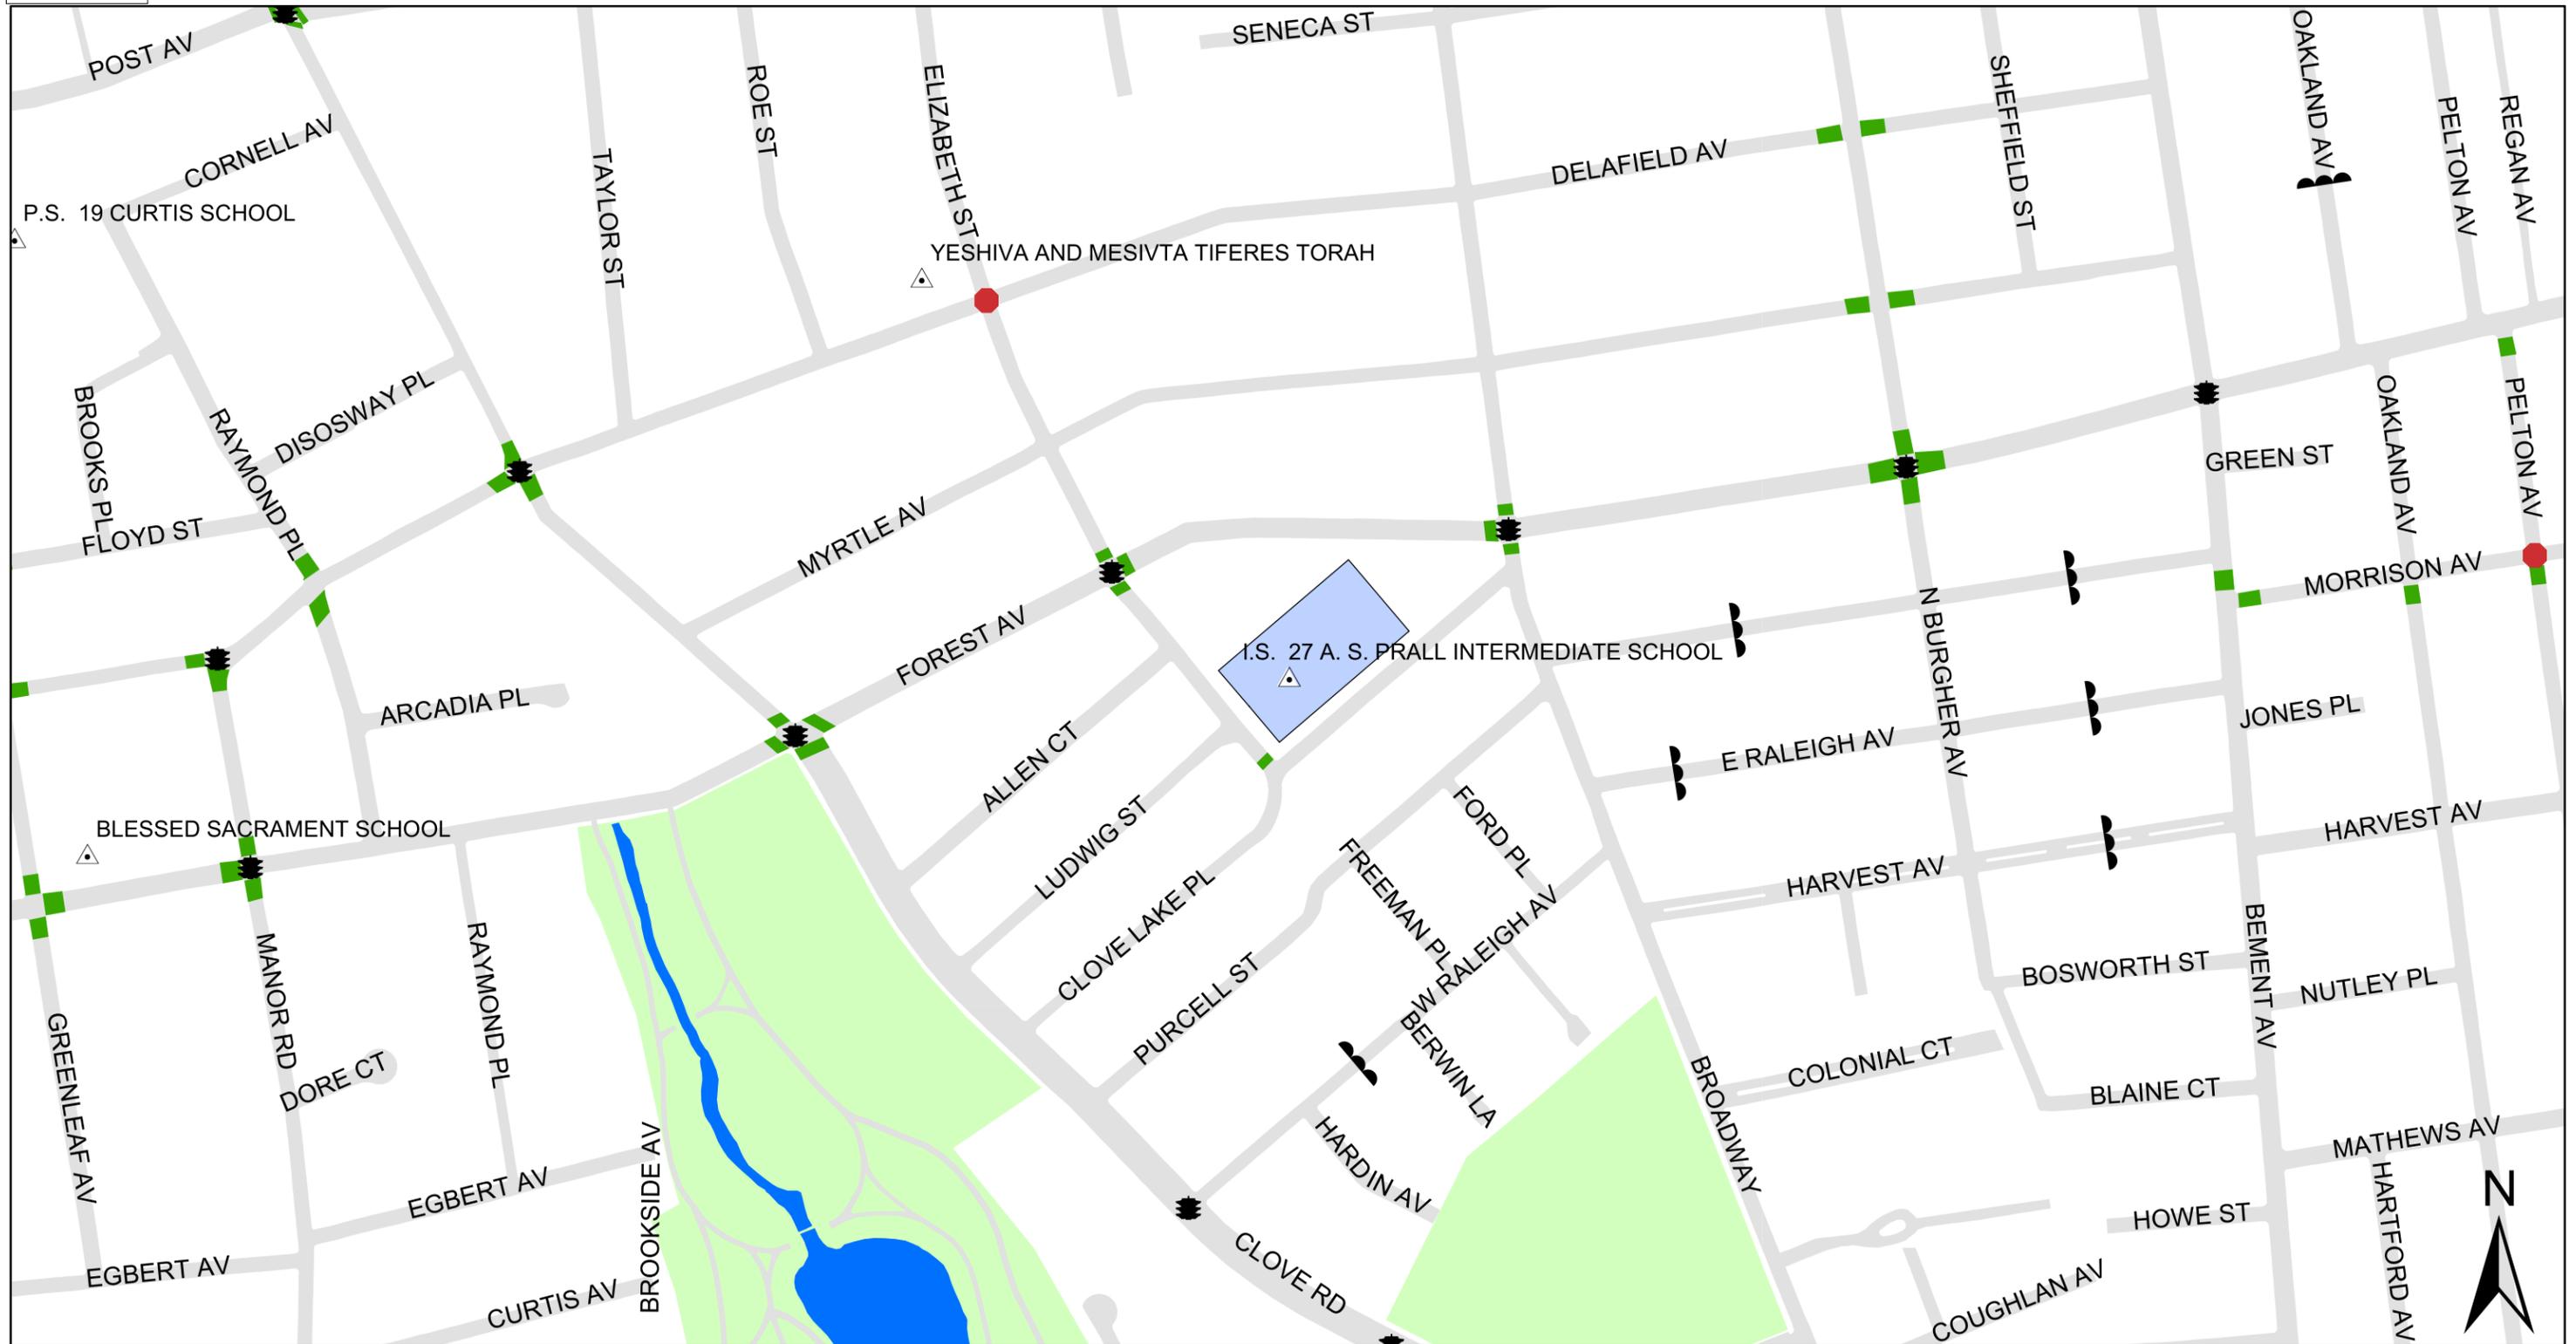
**EXHIBIT 3**

The School Traffic Safety Map was established to help provide the maximum degree of safety for children going to and from school - by indicating the location of speed reducers, school crosswalks and some traffic control devices. (While virtually all intersections in NYC benefit from traffic control devices - such as stop signs, traffic signals, yield signs, and all way stop signs - this map shows only traffic signals and all way stop signs.) The school crosswalks that are shown are ladder striped and make the crosswalk more visible to drivers and help make the intersection safer. These crosswalks are where school children are recommended to cross.

Exhibit 3, at the end of Section 2, shows the existing signs, signals, and pavement markings assigned to I.S. 27. It should be noted that a citywide signage program is currently underway to upgrade school signage to the current edition of the Federal Manual of Uniform Traffic Control Devices (MUTCD) standards of fluorescent yellow-green accompanied by downward pointing arrows. Signs scheduled to be installed under this program are shown as “existing” in Exhibit 7.

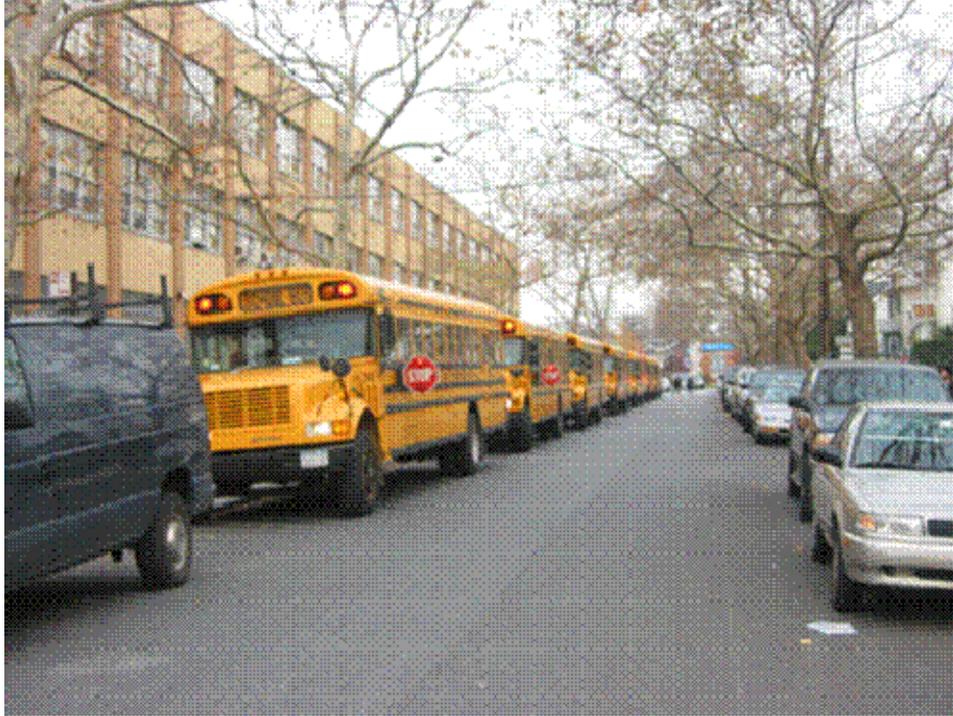
*Figure 2: School buses parked along north side of Clove Lake Pl. in front of school (school is on left)*

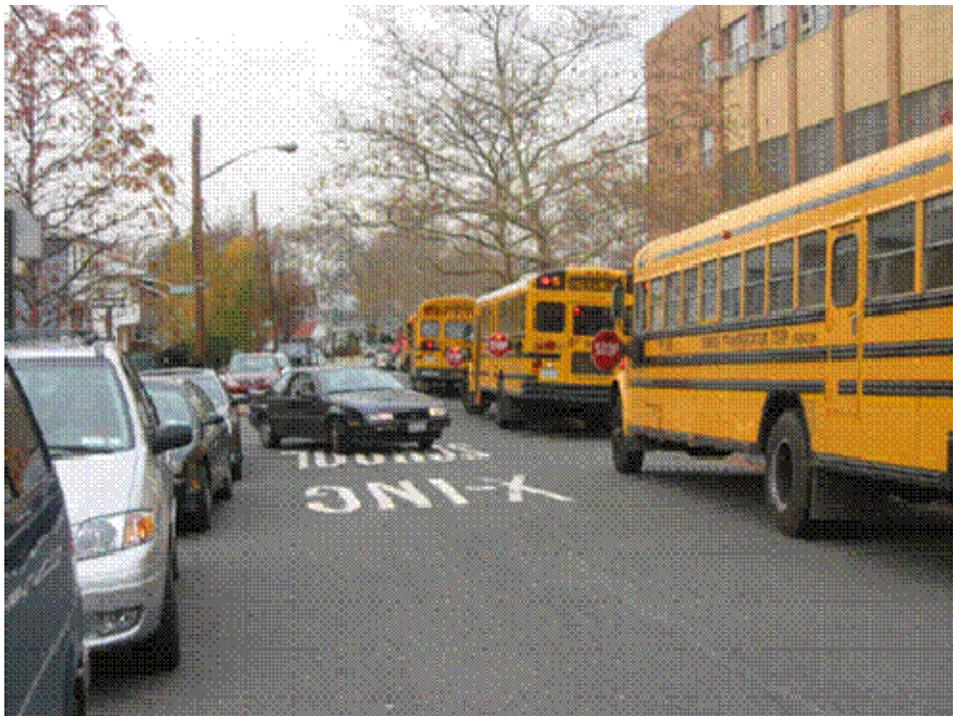
*Figure 3: School buses parked along Elizabeth Street on west side of school (school is on right)*

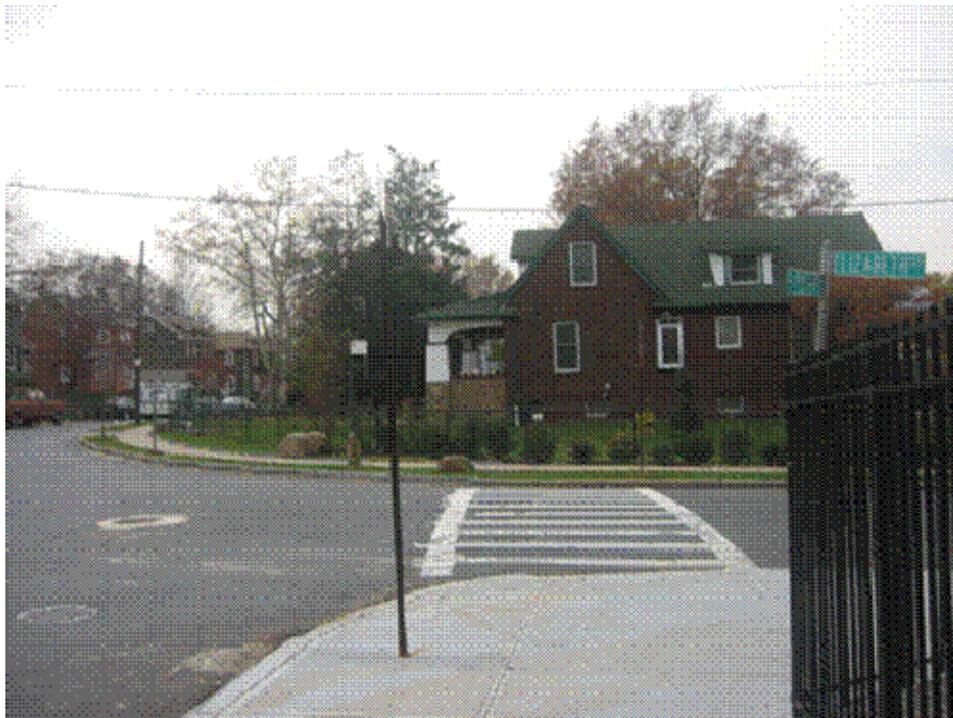
This is an unsignalized "T" intersection with a stop-controlled school crosswalk located across the north leg of Elizabeth Street (see Figure 4). Clove Lake Place is a one-way street in the westbound direction from Broadway to Clove Road. Clove Lake Place has one travel lane and parking lanes on both sides of the roadway. Elizabeth Street is a two-way street with one moving lane and a parking lane on each side of the roadway.

Figure 4: Looking west along Clove Lake Place at school crosswalk on north leg of Elizabeth Street

- There is no pedestrian ramp on the west side of Elizabeth Street at its intersection with Clove Lake Place. (see Figure 4).
- On the northwest corner of the Forest Avenue and Broadway intersection, there is a misaligned pedestrian ramp and a utility pole (see Figures 7). The utility pole obstructs the crosswalk on the west leg of Forest Avenue.

- The crosswalk across the west leg of Forest Avenue at its intersection with Broadway is partially obstructed at both the north and south ends of the crosswalk by two utility poles. The pole on the south side is situated near the western edge of the crosswalk, but within the crosswalk extension. The pole on the north side is situated approximately in the center of the crosswalk extension. Consideration should be given to conducting a study to determine how the areas leading to and from the crosswalk could be cleared of the two utility poles, by either relocating the utility poles or realigning the crosswalks and the associated pedestrian ramps.
- Install a pedestrian ramp on the west side of Elizabeth Street at its intersection with Clove Lake Place.

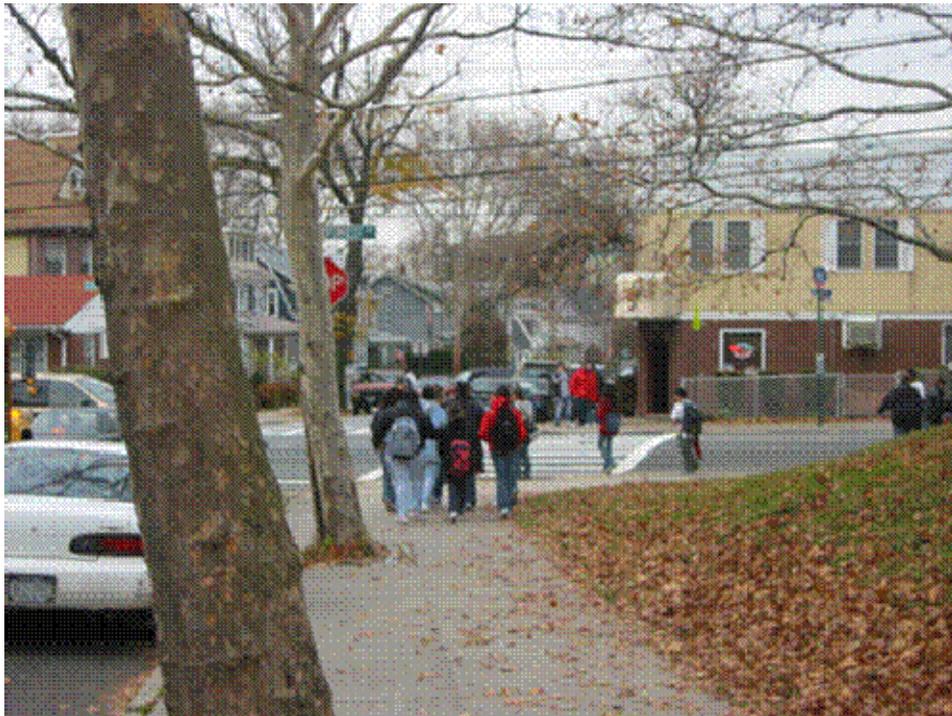
This is an unsignalized four-legged intersection with school crosswalks located across the north, east, and south legs (see Figure 5). Forest Avenue is a two-way street with one travel lane and a parking lane on each side of the roadway. Elizabeth Street is also a two-way street with one moving lane and a parking lane on each side of the roadway.

The school has requested the installation of a traffic signal for the intersection of Forest Avenue and Elizabeth Street. It was reported by the school principal that significant number of students utilizes this intersection, which school officials provide some assistance during arrival and dismissal.

*Figure 5: Looking north along Elizabeth Street at school crosswalk on east leg of Forest Avenue*

➤ Consider Curb Extension at the intersection of Forest Avenue and Elizabeth Street

- A speed reducer (speed hump) is not feasible on Forest Avenue as Forest Avenue is not only a major roadway; but also a truck, snow emergency, and bus route. It is therefore recommended to provide curb extensions at the northeast and northwest corners of Forest Avenue at its intersection with Elizabeth Street, as shown in Exhibit 7. There is a bus stop on the south side of Forest Avenue just west of the intersection which precludes construction of curb extensions at the south corners. However, it is also recommended to provide a white solid line on Forest Avenue between Clove Road and Broadway to separate the travel and parking lanes on both sides of the street.

- In addition to a curb extension, it is recommended to assign a crossing guard at this location.

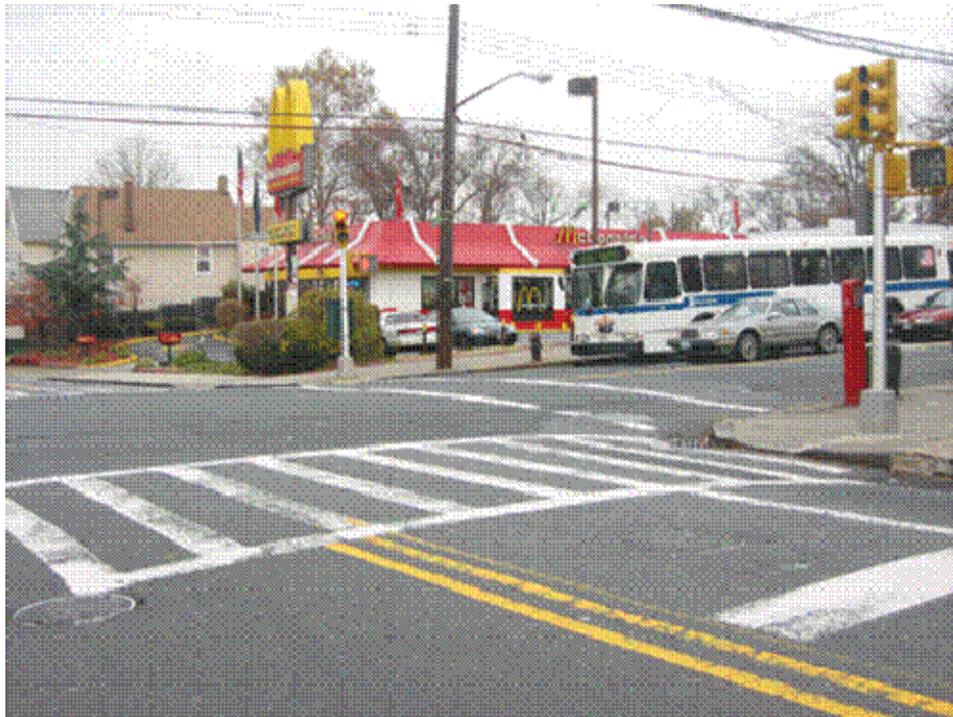
This is a signalized four-legged intersection with school crosswalks located across the west, north, and south legs (see Figure 6). Forest Avenue is a two-way street with one moving lane and a parking lane on each side of the roadway. Broadway is also a two-way street with one travel lane and a parking lane on each side of the roadway.

*Figure 6: Looking northwest at McDonald's Restaurant, located at the intersection of Forest Avenue and Broadway*

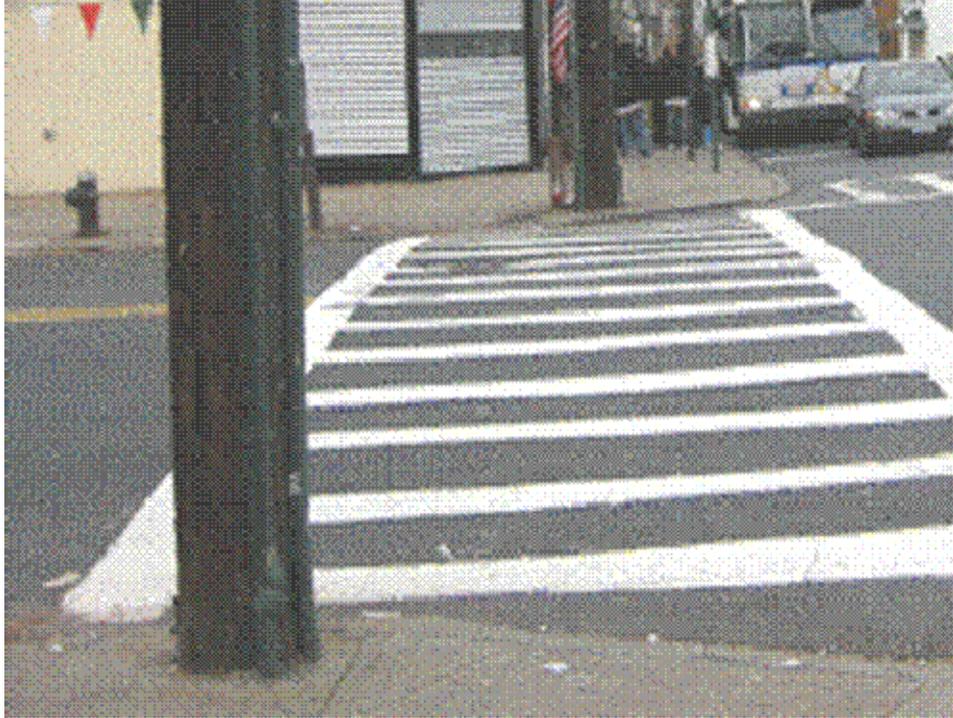
*Figure 7: Looking north at unaligned pedestrian ramp and obstructing utility pole on west leg of Forest Avenue crosswalk at its intersection with Broadway*

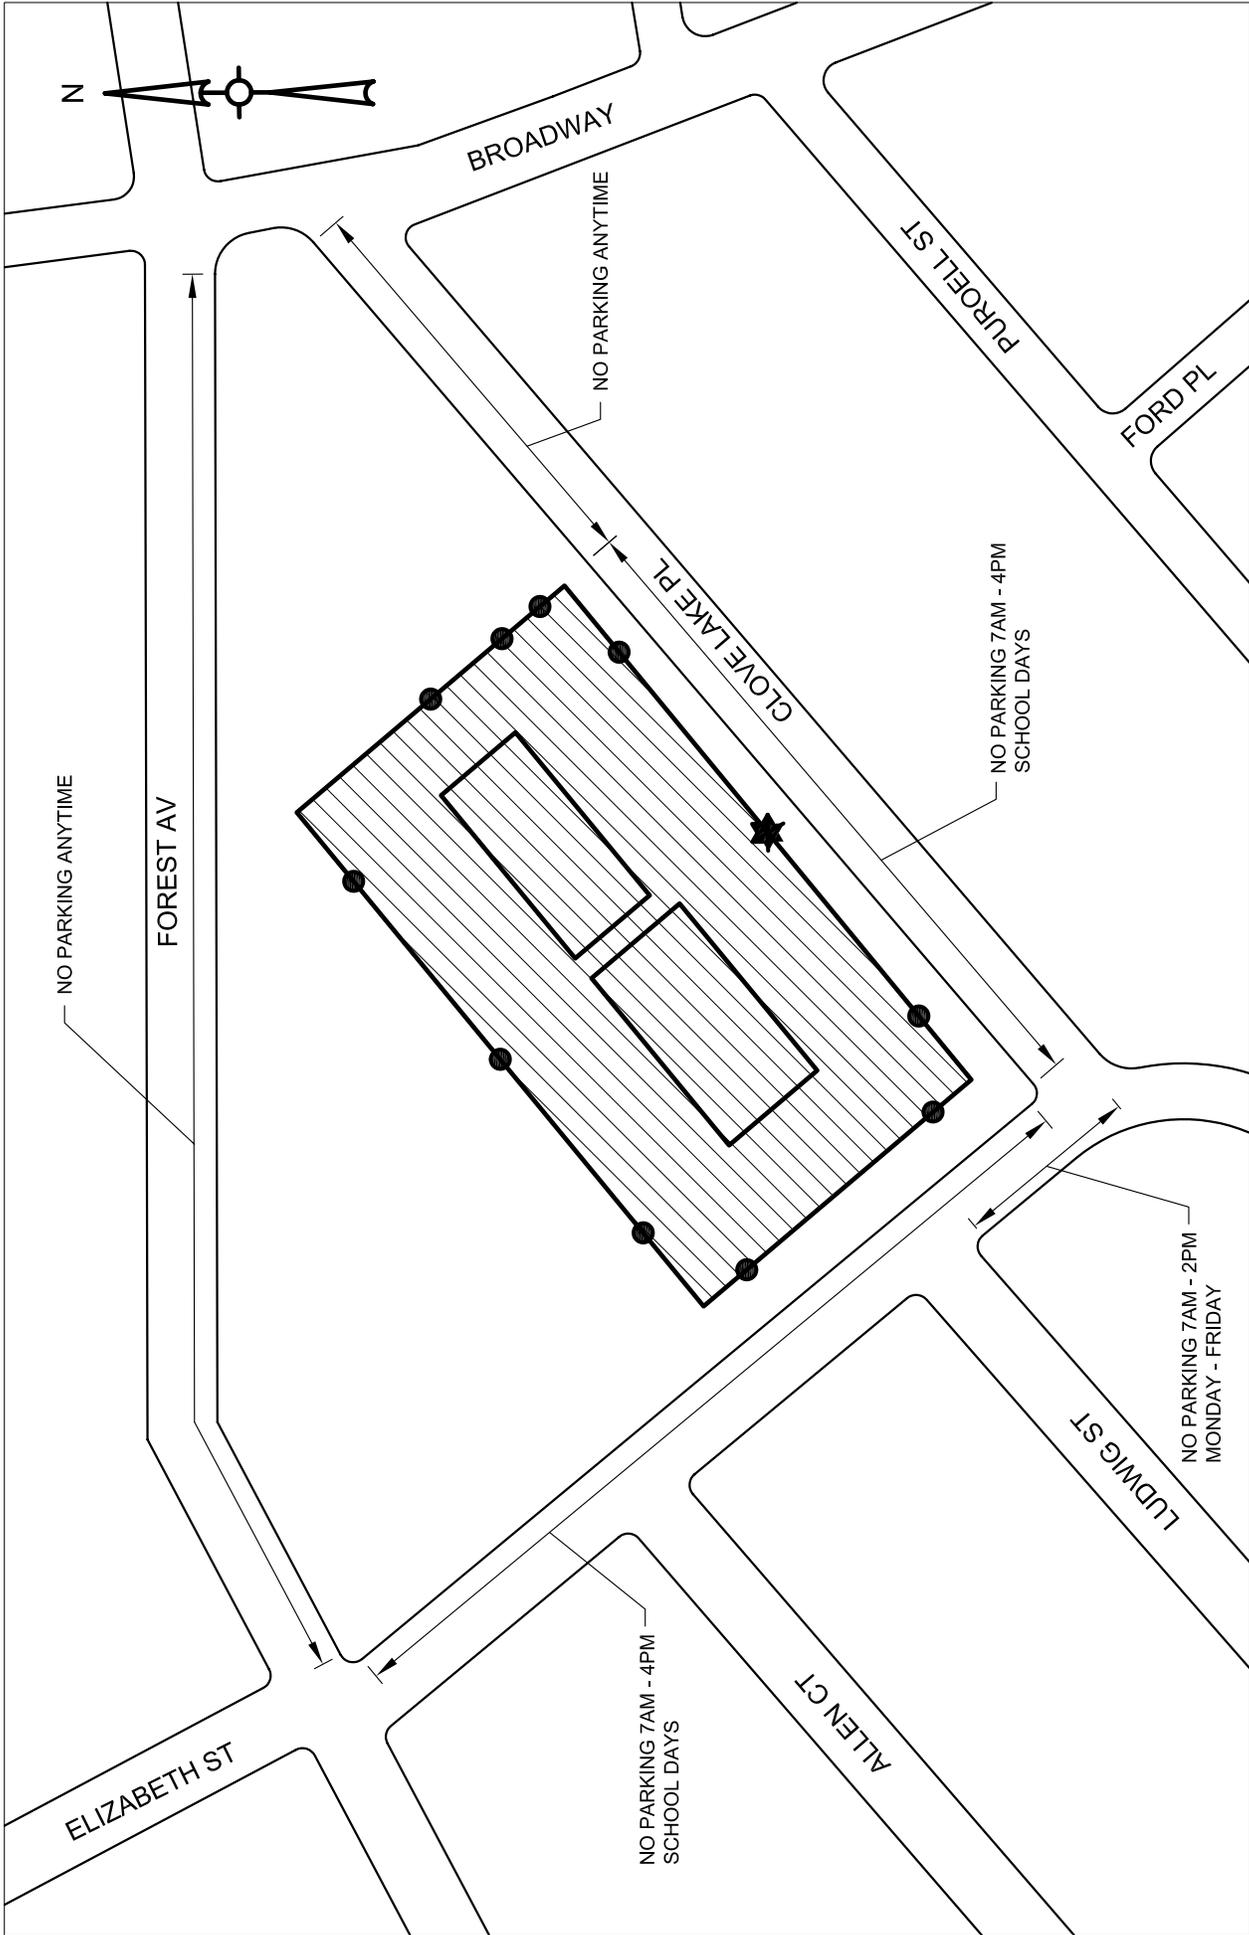
EXHIBIT 4

Parking regulations around the school block are shown in Exhibit 4 at the end of this section.

EXISTING PARKING REGULATIONS

Replace the existing “No Parking 7 AM – 4 PM School Days” signs with “No Standing 7AM – 4PM School Days” signs on north side of Clove Lake Place in front of the school.

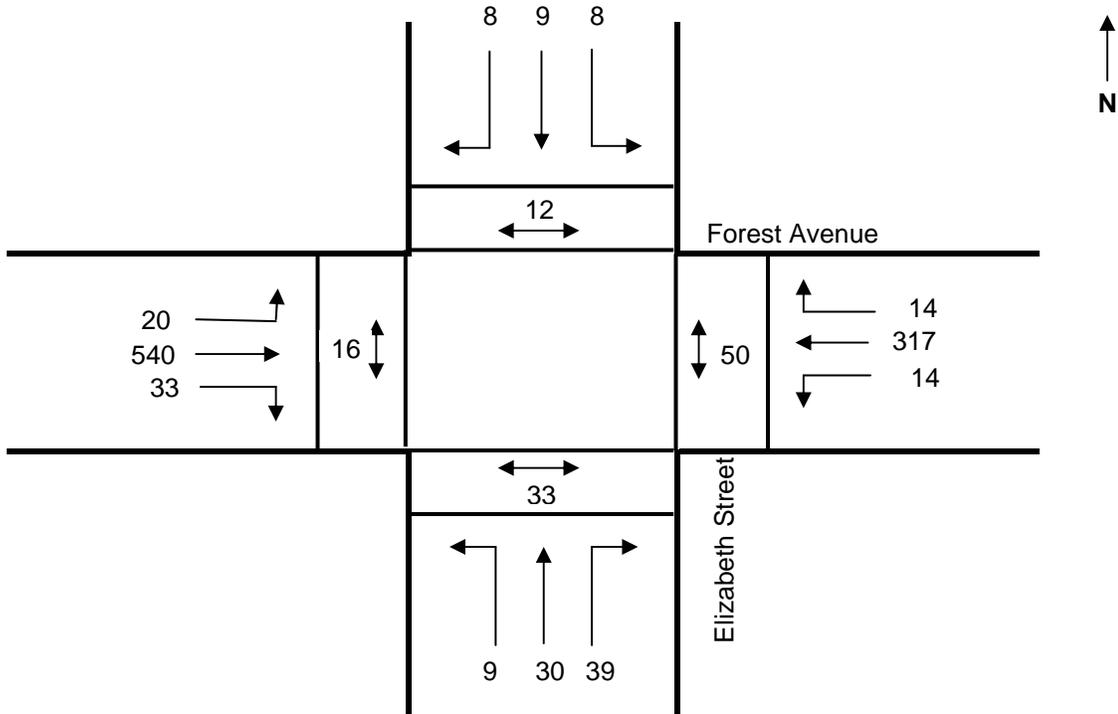
<b>EXHIBIT 6</b>
<b>I.S. 27 ANNING S. PRALL SCHOOL</b>
<b>TRAFFIC AND PEDESTRIAN COUNTS</b>

In order to better determine the available options for this intersection, a traffic count was conducted on Wednesday, May 11, 2005 from 7:15 am - 8:15 am. The results of this count are shown in Tables 4 and 5 and in Exhibit 6 at the end of this section.

**One Hour Traffic Volumes**  
**Wednesday, May 11th, 2005 7:15am - 8:15am**

***Intersection of Forest Avenue and Elizabeth Street***

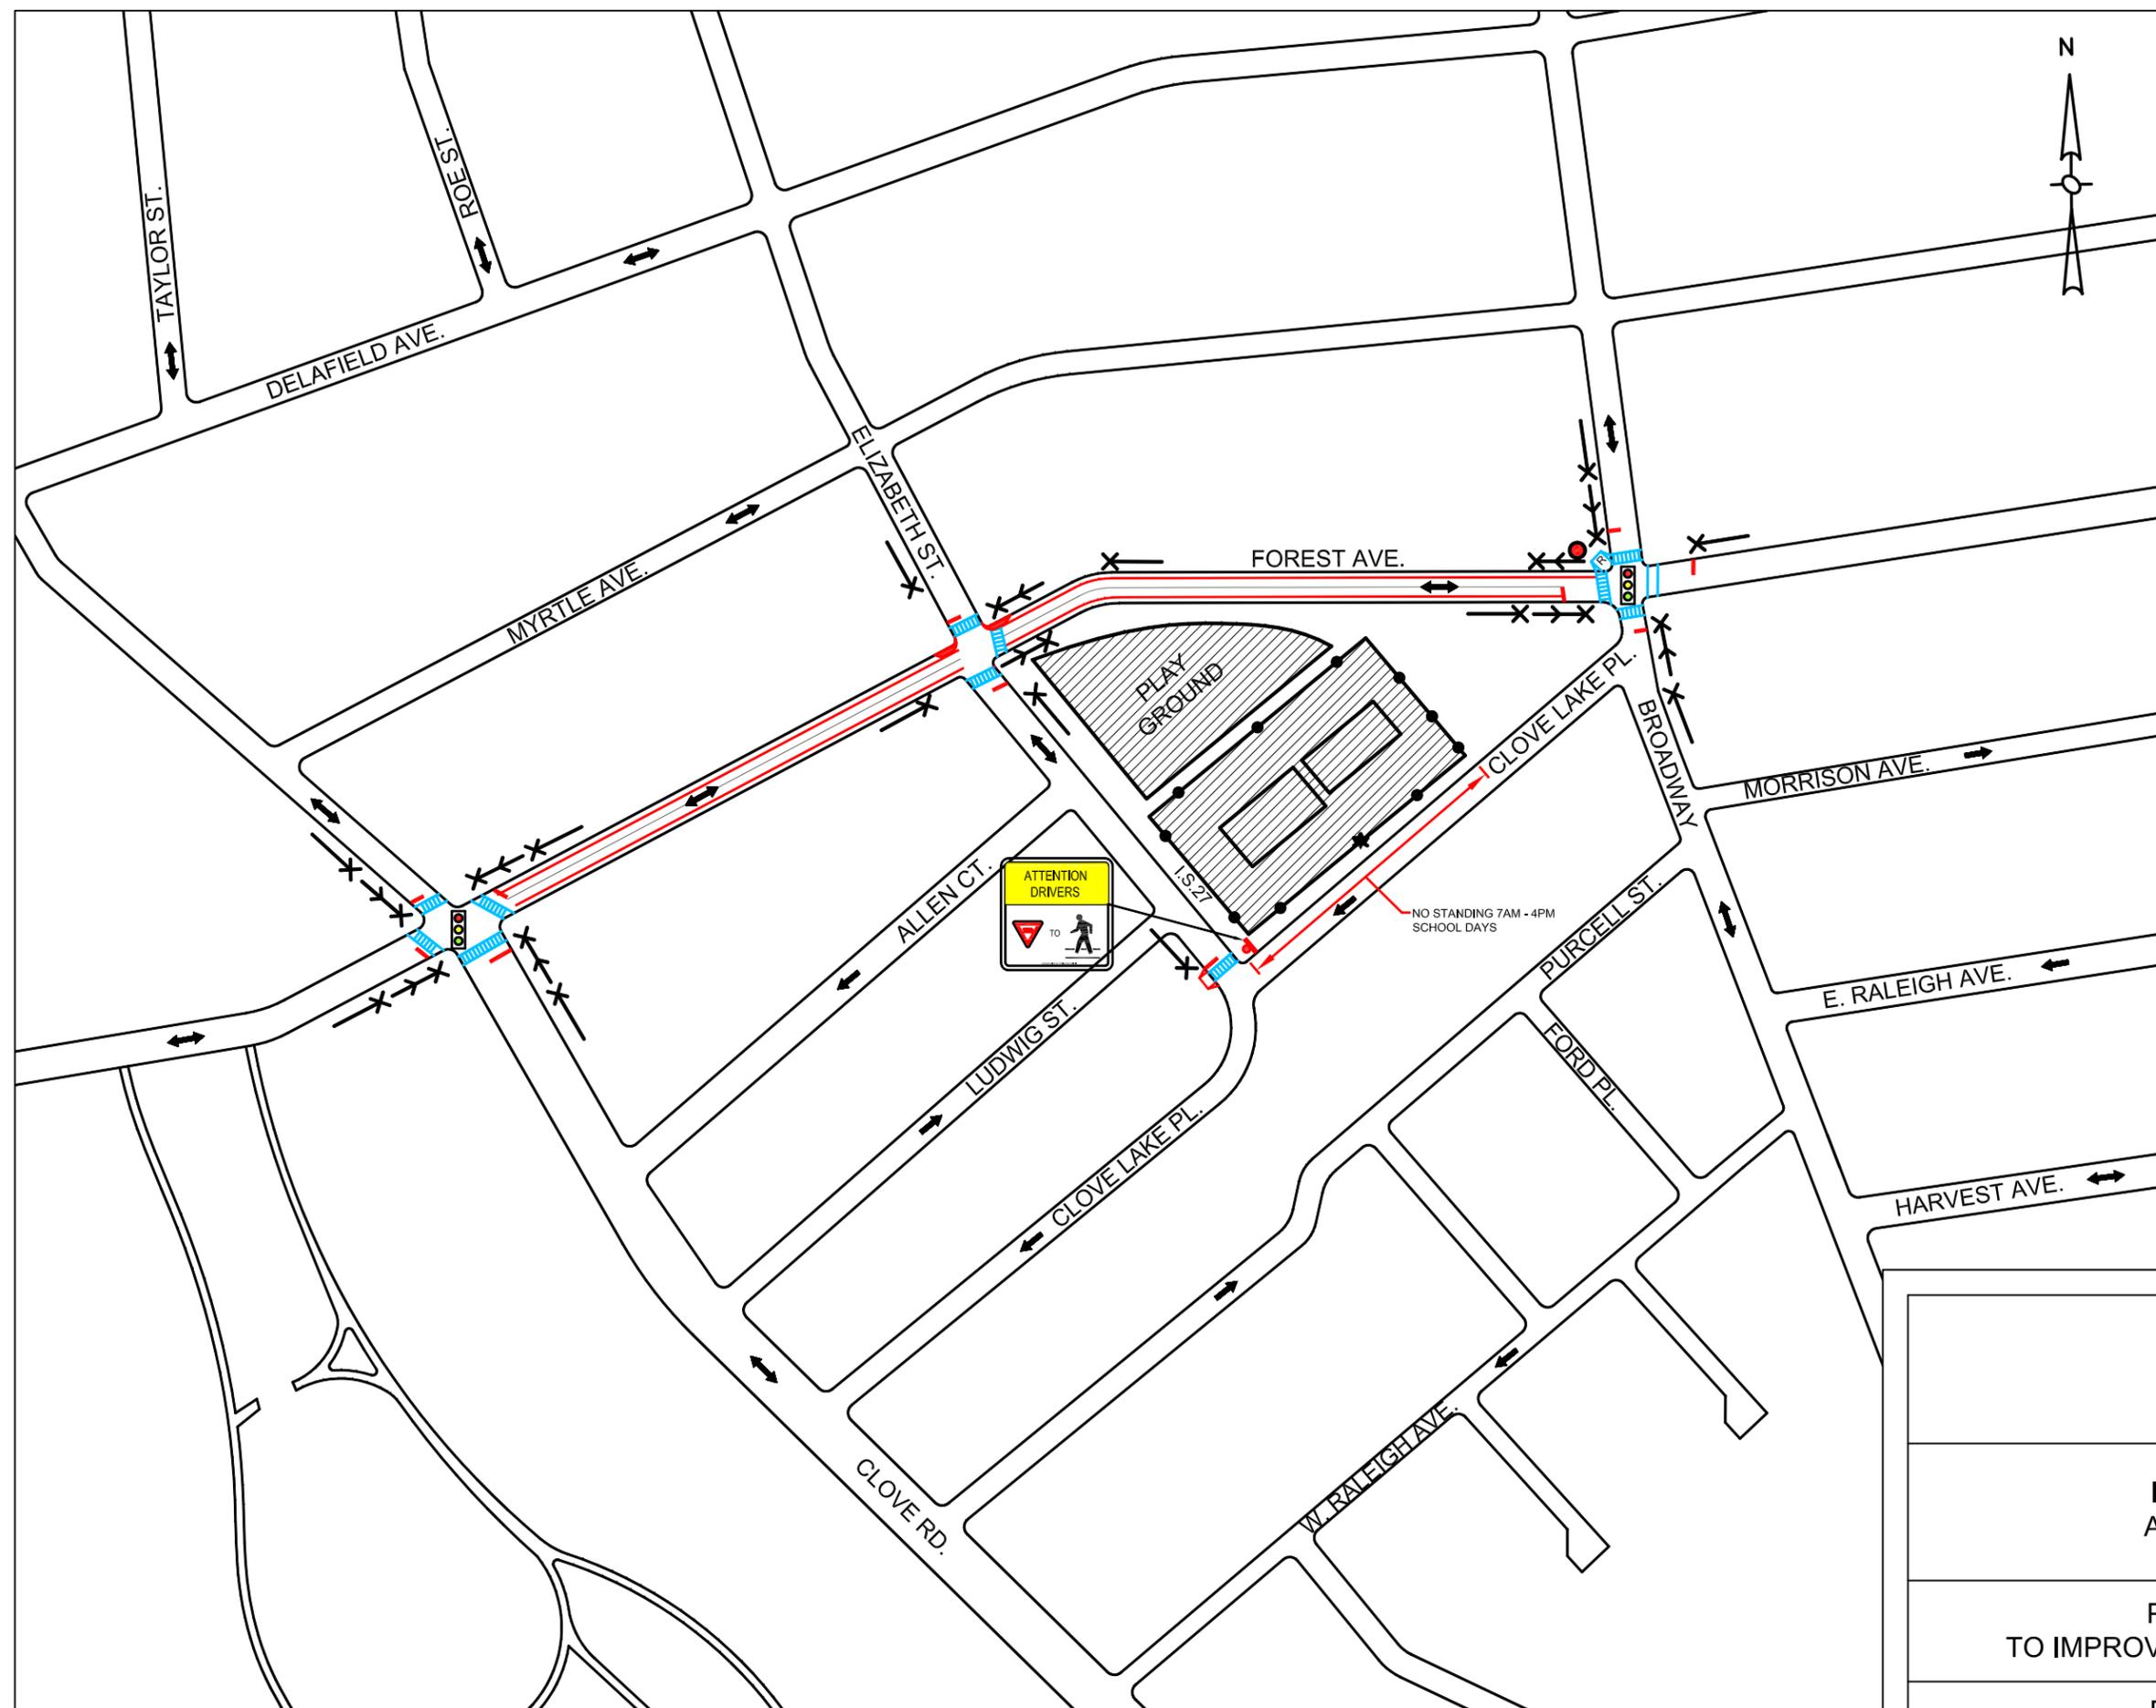
This section describes the proposed measures to improve school pedestrian safety around I.S. 27. The proposed recommendations are divided into short-term and long-term measures. Short-term measures are those that potentially can be performed in-house. Long-term measures involve capital improvements. Each of the short- and long-term measures recommended for I.S. 27 is discussed as follows, and is shown in more detail in Exhibit 7 at the end of this section.

➤ Install “No Standing 7AM – 4PM School Days” signs

Ten feet (10’) advanced stop bars before school crosswalks are recommended on the following approaches of signalized intersections surrounding I.S. 27:

- Northbound approach of Clove Road at its intersection with Forest Avenue
- Westbound approach of Forest Avenue at its intersection with Clove Road
- Northbound approach of Elizabeth Street at its intersection with Forest Avenue
- Westbound approach of Forest Avenue at its intersection with Elizabeth Street

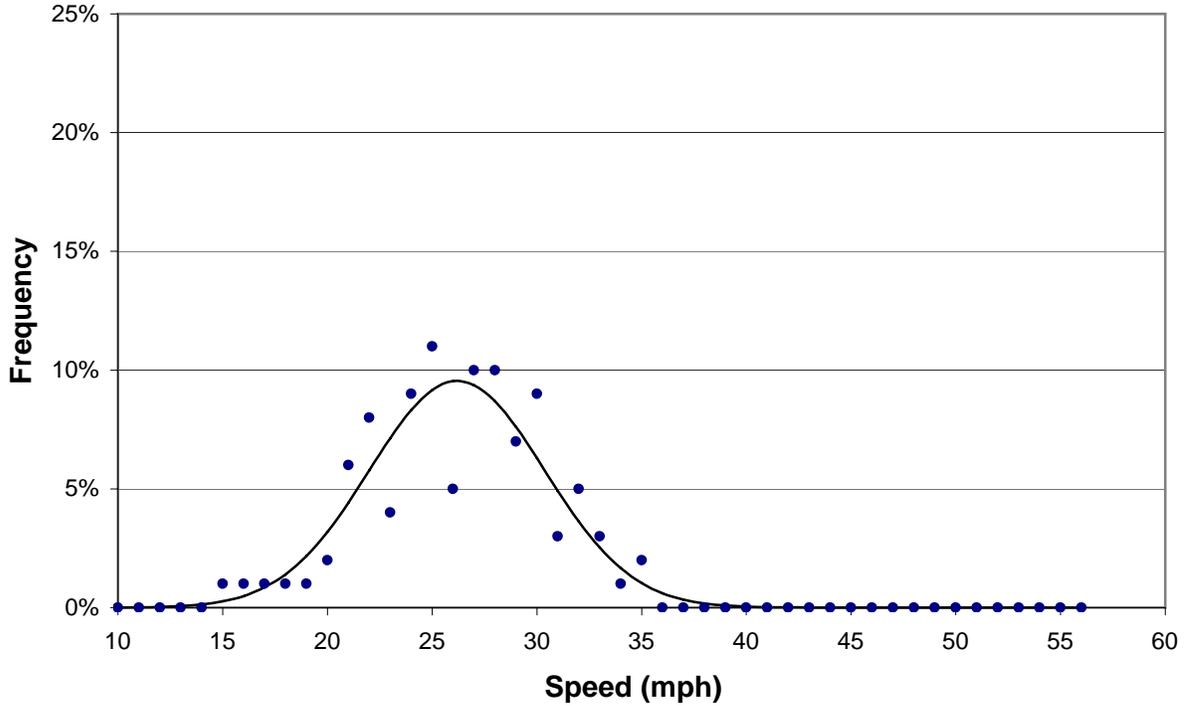
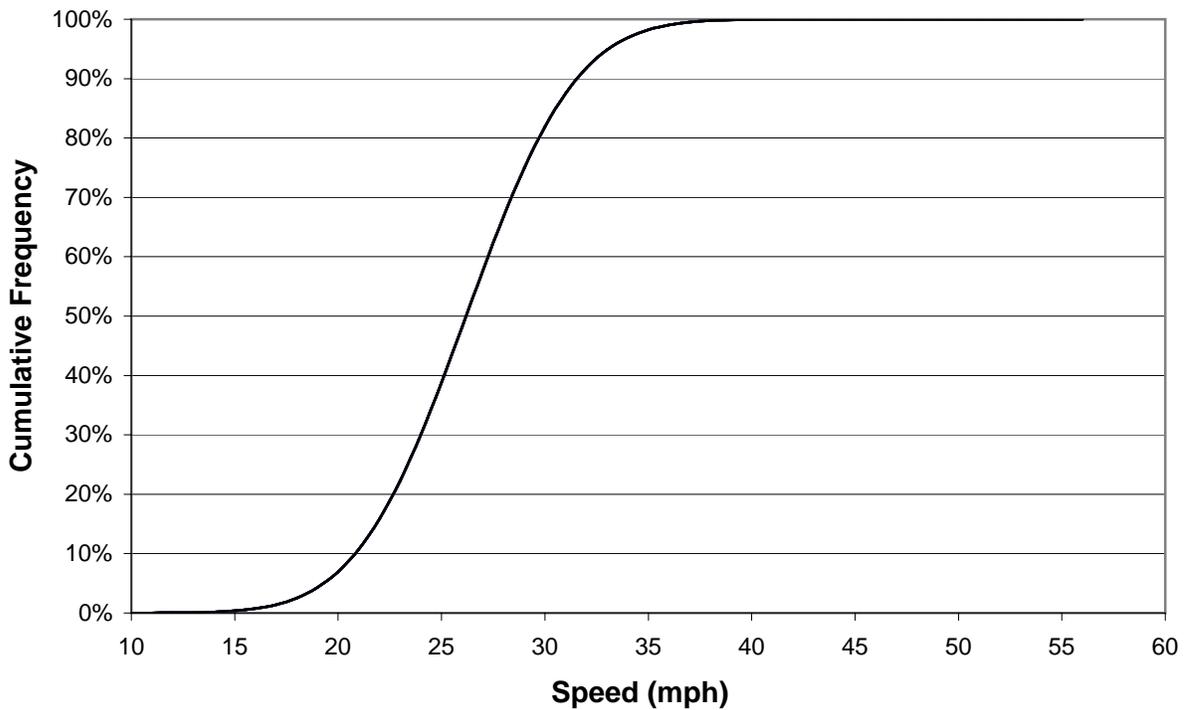
Mean Speed = 26.2 mph  
Standard Deviation = 4.2 mph  
Margin of Error (95% Confidence) =  $\pm 0.8$  mph

Median Speed = 26.2 mph  
15th Percentile Speed = 21.9 mph  
85th Percentile Speed = 30.5 mph
