Remedial Action Plan

**NICHOLAS AVENUE ESTATES
RICHMOND TERRACE AND NICHOLAS AVENUE
BLOCK 1116, LOTS 60 TO 89, 91 TO 100,
102 TO 104, 106 TO 108, AND 113 TO 155
(FORMER BLOCK 1116, LOTS 40, 75, AND
105 & BLOCK 1121, LOT 101)
STATEN ISLAND, RICHMOND COUNTY, NEW YORK
OER PROJECT NO.: 13RHAZ041R**

NICHOLAS AVENUE REZONING

APRIL 2013

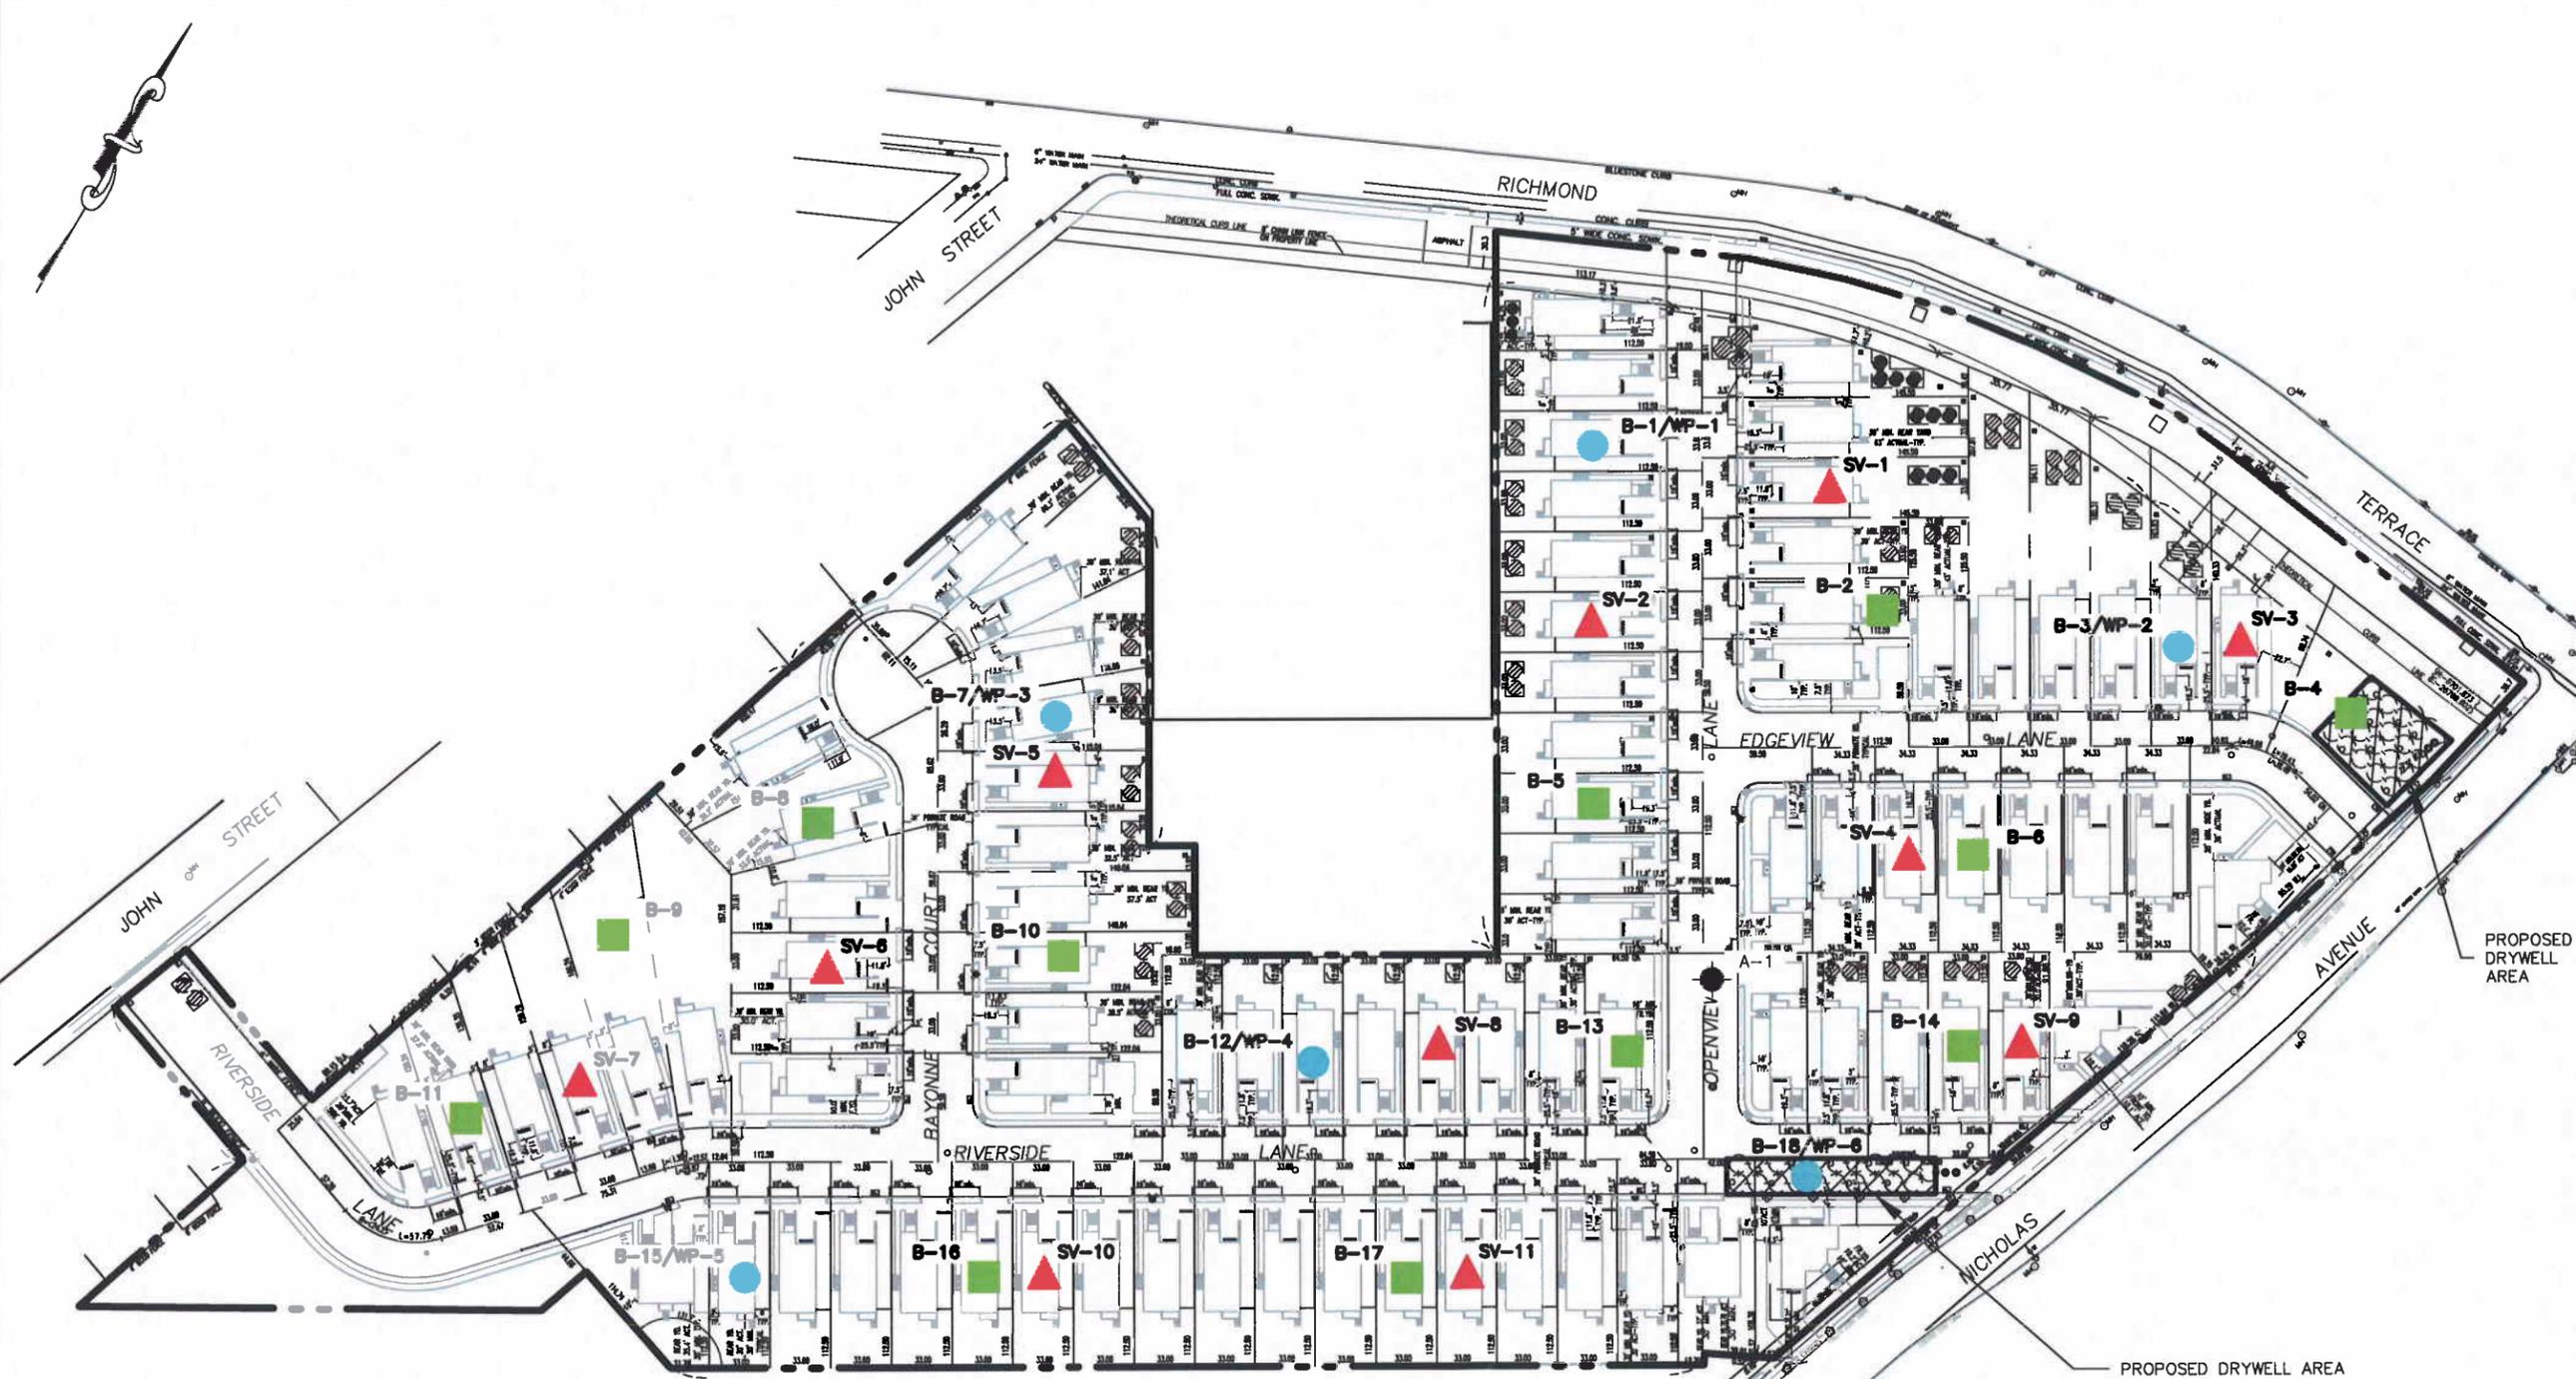
SAMPLING SUMMARY

- **SOIL (12)**
0' - 2' fbgs
5' - 7' fbgs - Foundations
10' - 12' fbgs - B-4 (Drywell)
- **COMBINED SOIL & GROUNDWATER (6)**
0' - 2' fbgs
5' - 7' fbgs - Foundations
10' - 12' fbgs - B-18 (Drywell)
- ▲ **SOIL VAPOR (11)**
Probe set at 5' - 7' fbgs

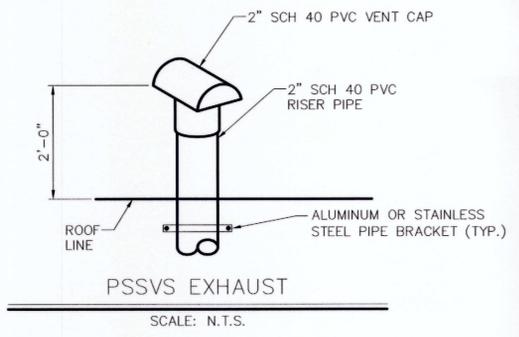
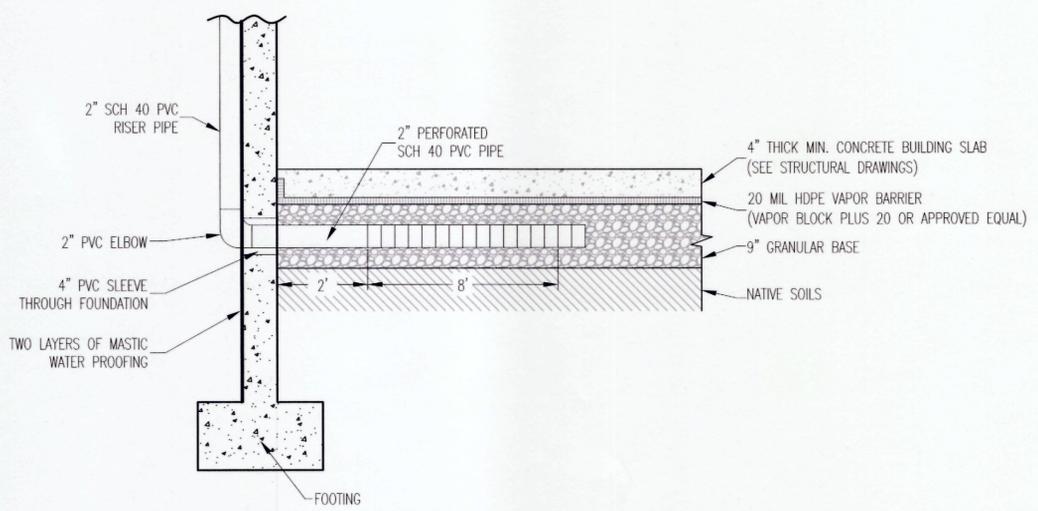
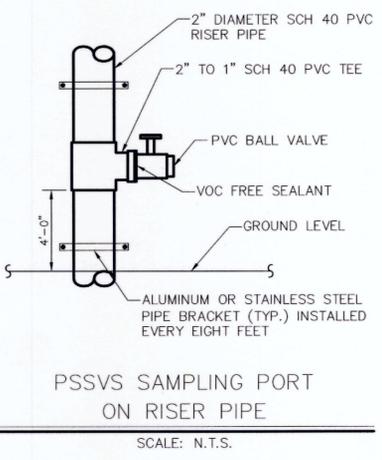
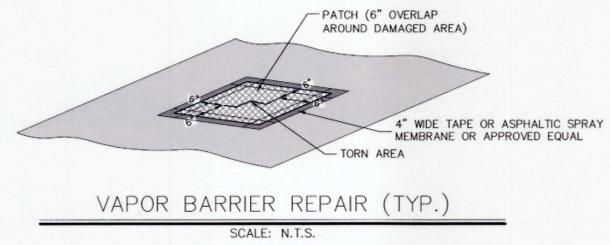
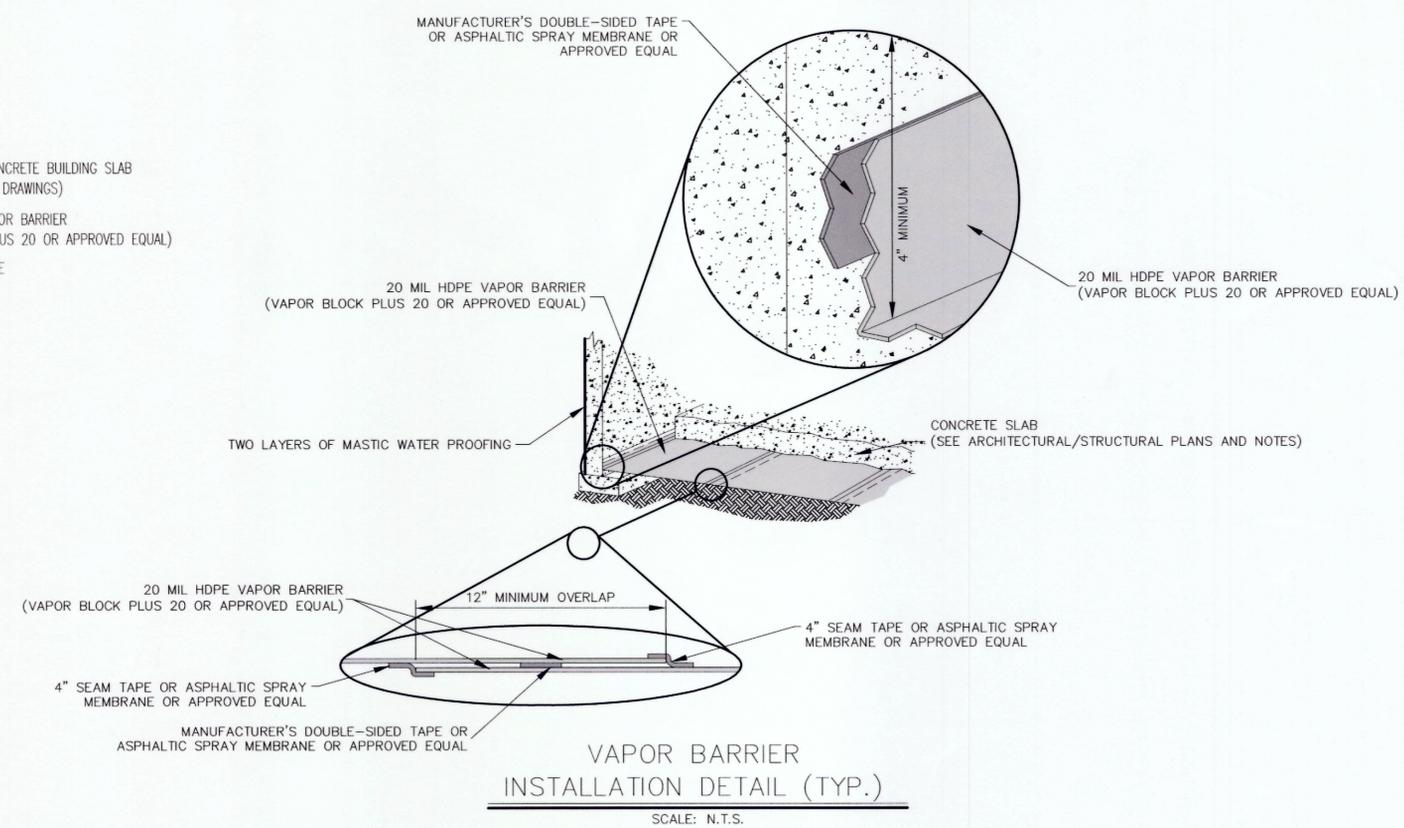
FIGURE 5
Vapor Barrier Details

- NOTES:**
1. THIS PLAN IS FOR USE IN SIZING AND GENERAL LAYOUT OF SUBSLAB VENTING SYSTEM ONLY. ANY STRUCTURAL ELEMENTS SHOWN ARE FOR GENERAL ILLUSTRATION ONLY. REFER TO STRUCTURAL DRAWINGS AND/OR CONTACT THE STRUCTURAL ENGINEER OF RECORD REGARDING ANY STRUCTURAL COMPONENTS.

2. ALL PVC CONNECTIONS SHALL BE SLIP FITTINGS OR FASTENED WITH STAINLESS STEEL SCREWS. NO GLUE SHALL BE UTILIZED AT ANY PVC CONNECTIONS.
 3. THE PVC PIPING SHALL BE PLACED IN THE GRANULAR BASE BENEATH THE CONCRETE FLOOR SLAB. DO NOT SUPPORT THE PIPING FROM THE CONCRETE FLOOR SLAB.

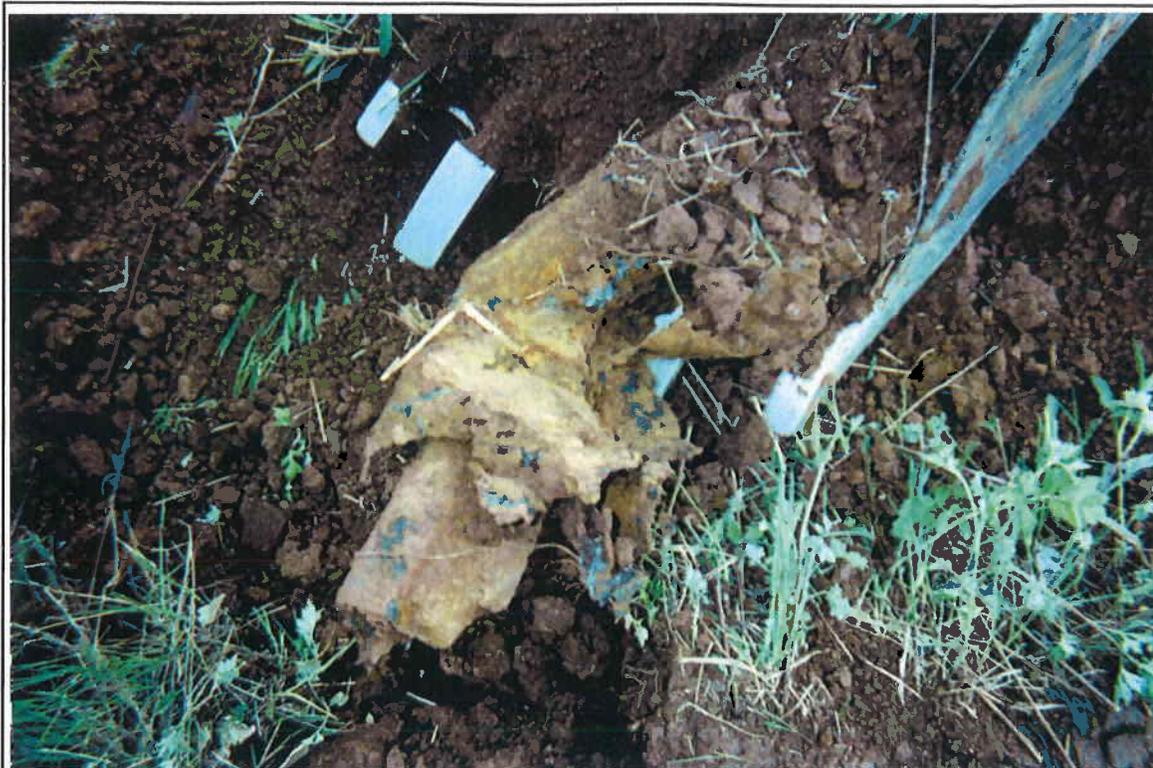
PHOTO #4

VIEW OF GPR/EM
SURVEY AREA. VIEW
TO THE WEST.

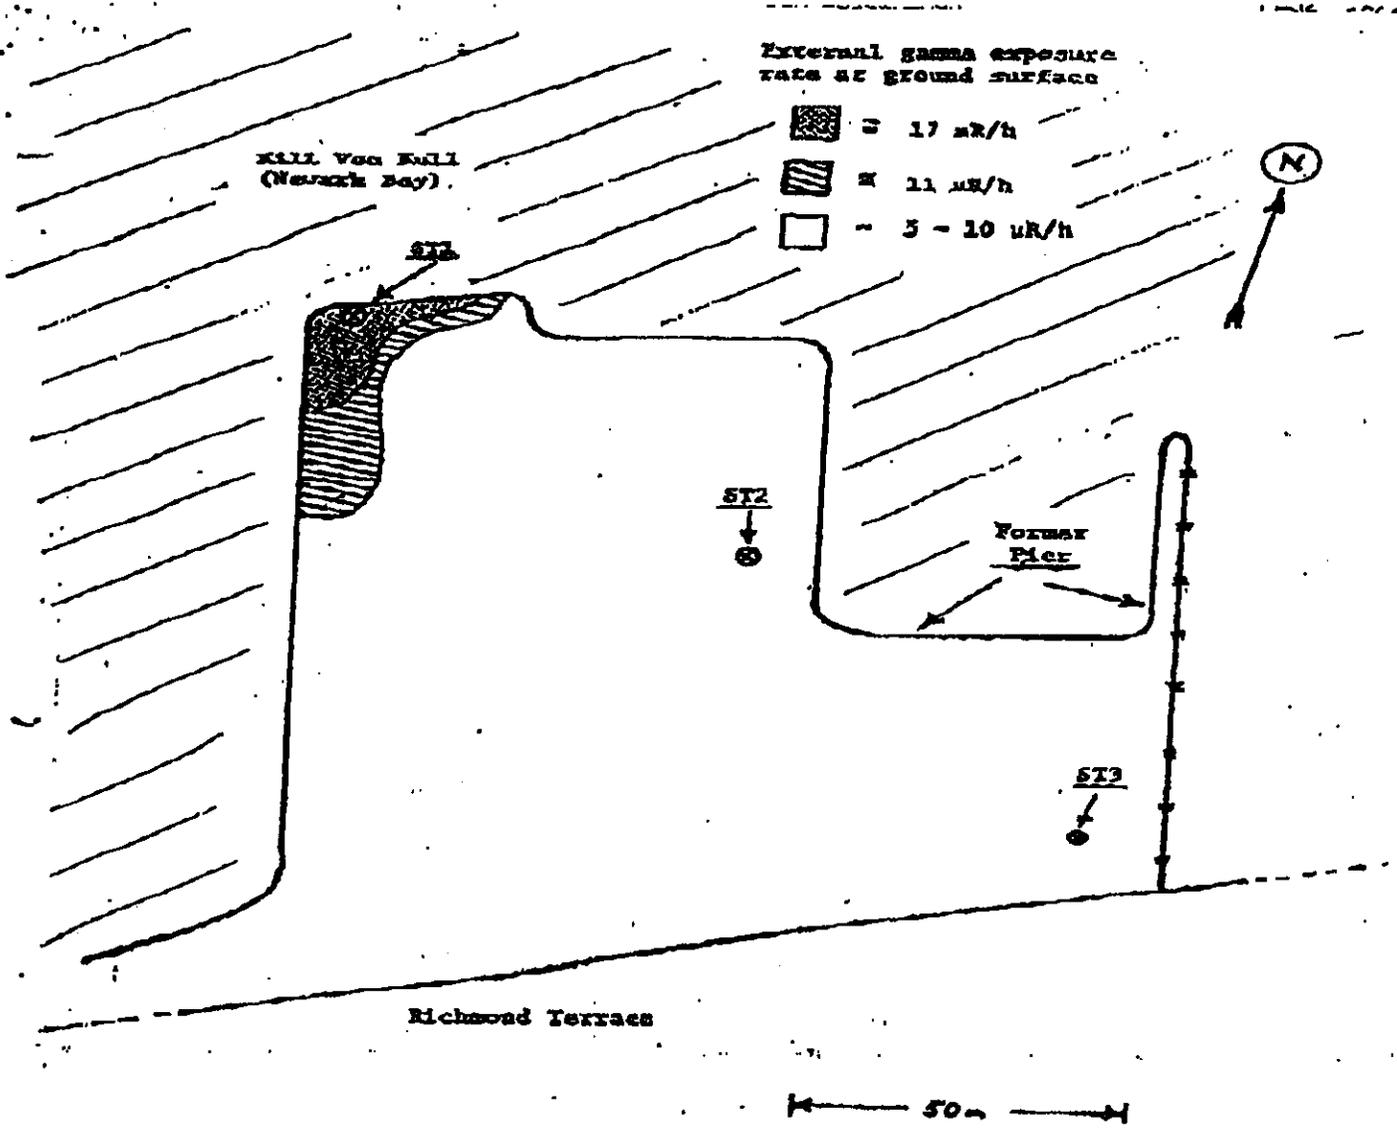
Figure 5. External gamma exposure rates observed at ground surface on Parcel 1 and location of three surface soil samples.

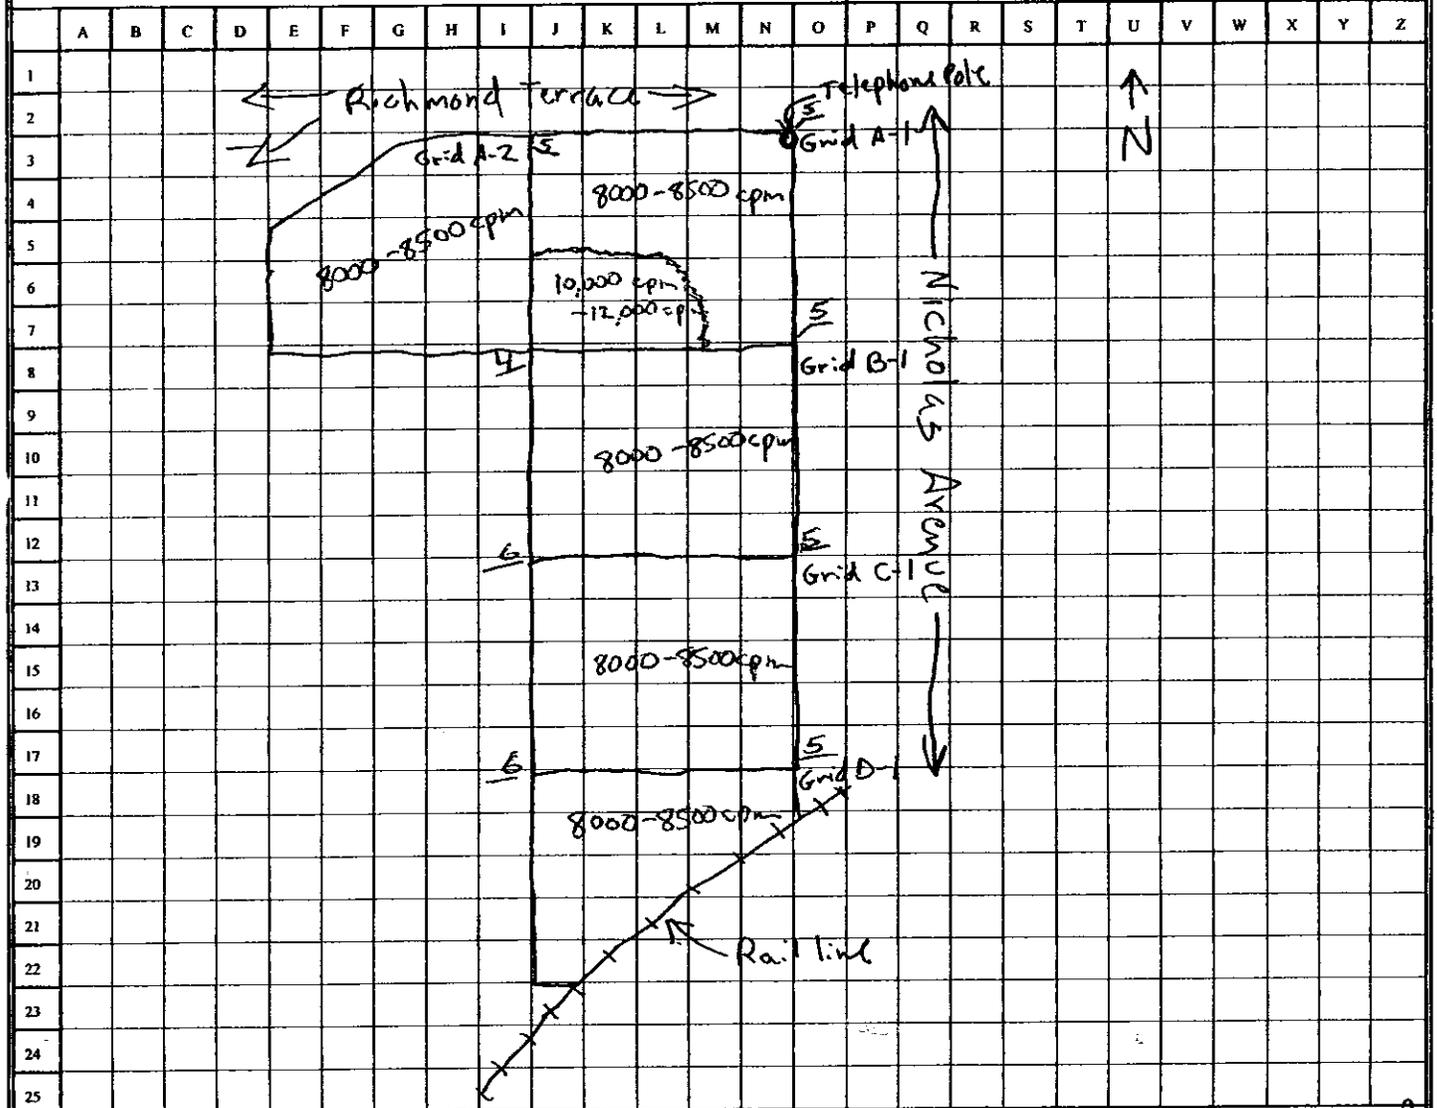
Notes: Conducted a walkover survey using Ludlum Model 2241/44-10 probe, covered 100% of the grid areas shown, moving the probe in a serpentine pattern ~ 1/2" from soil surface. All areas were indistinguishable from bkgd. w/ exception of the area shown. Dose rate measurements were taken at grid nodes with Bicon MicroRem, shown as # (in units of urem/hr) held @ waist height.

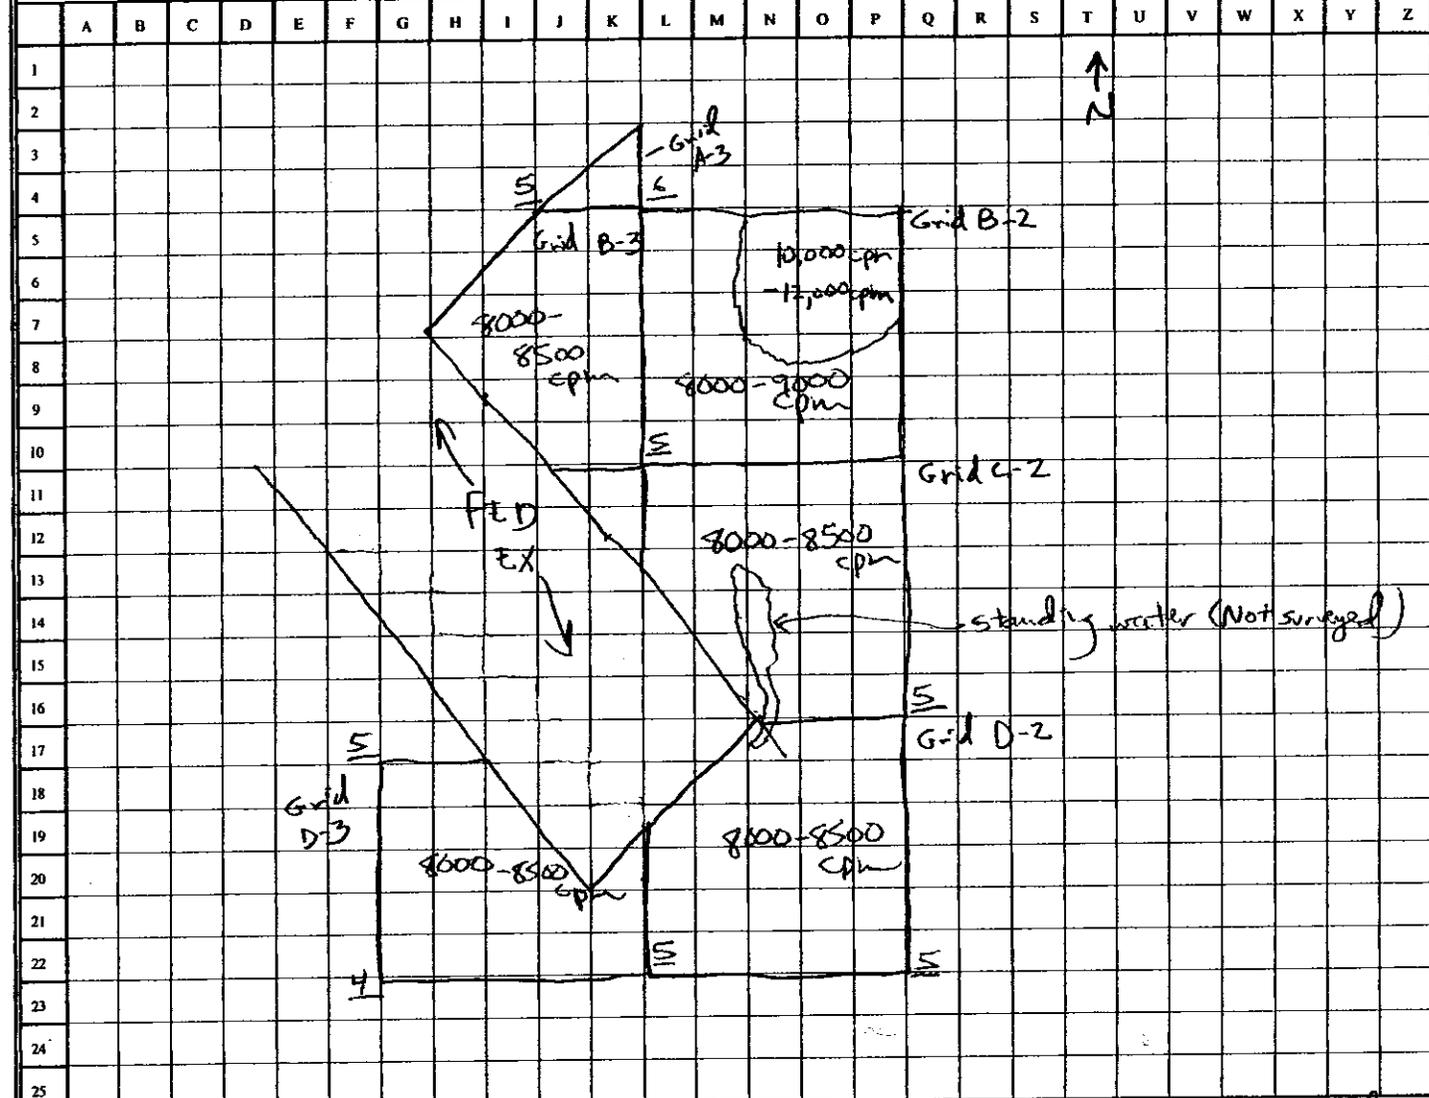
Notes: Conducted a walkover survey using Ludlum Model 2241/44-10 probe, covered 100% of the grid areas shown, moving the probe in a serpentine pattern $\approx 1/2''$ from the soil surface. All areas were indistinguishable from bkgd with the exception of the area shown. Dose Rate Measurements were taken at grid nodes with Bicon Microrem, shown as # (in units of $\mu\text{rem/hr}$) held @ waist height

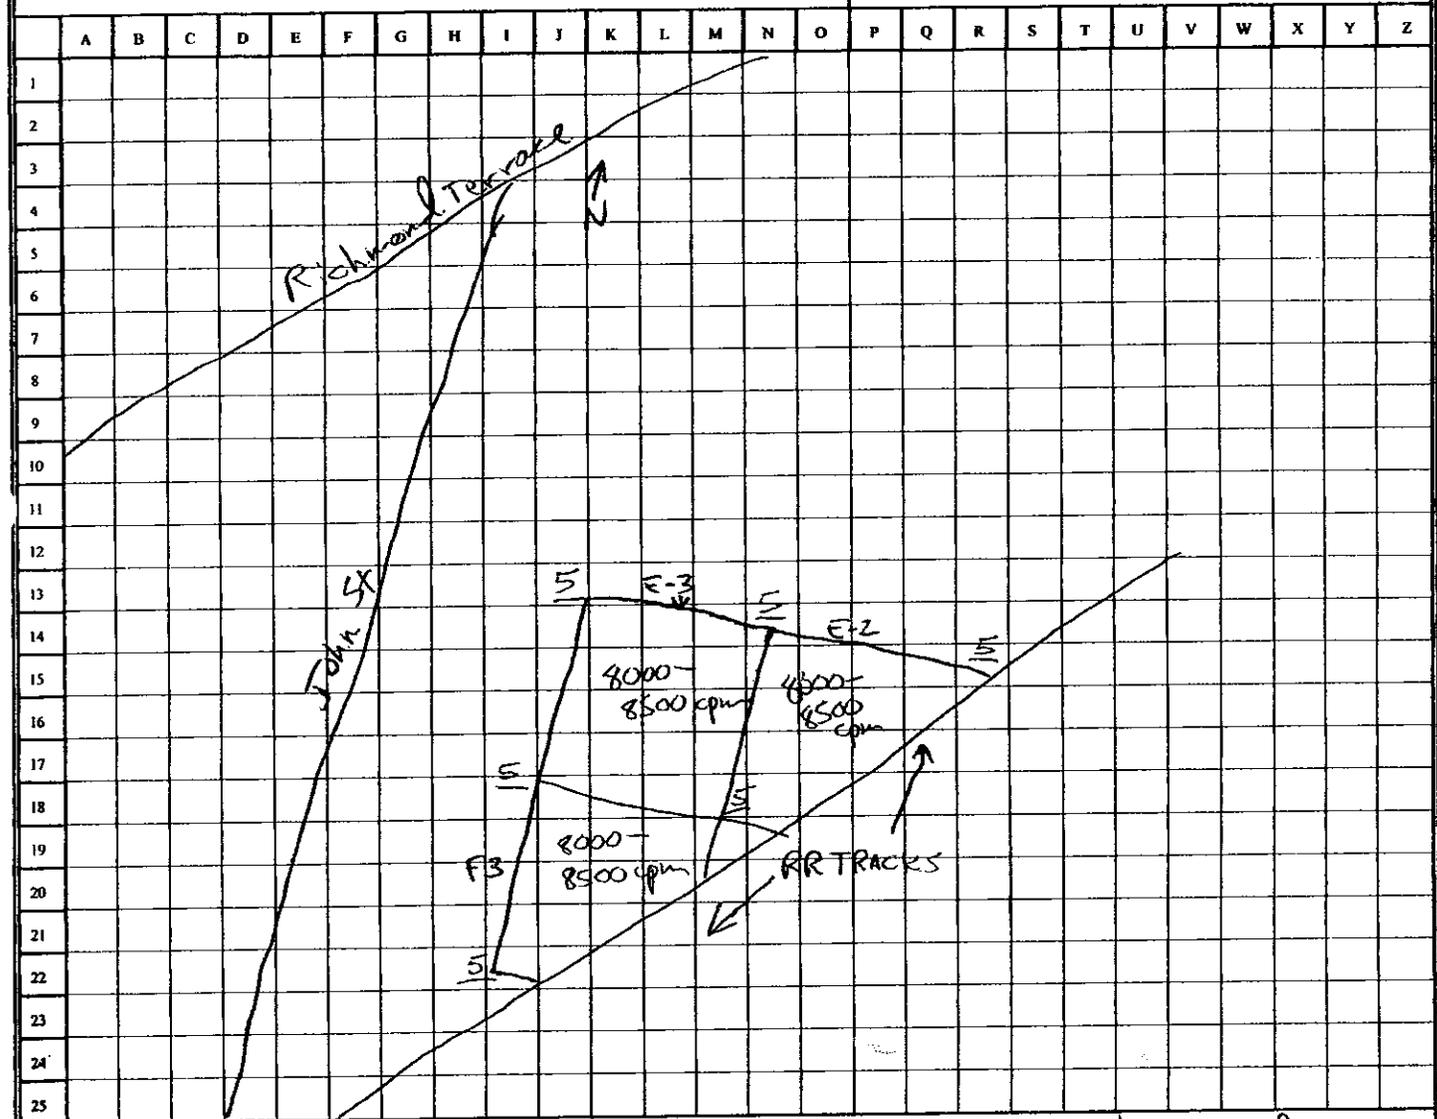
Notes: Conducted a walkover survey using Ludlum Model 2241/44-10 probe, covered 100% of the grid areas shown, moving the probe in a serpentine pattern $\approx 1/2'$ from soil surface. All areas were indistinguishable from background. Dose rate measurements were taken at grid nodes with Bicon MicroRem held at waist height, shown as # (in units of $\mu\text{rem}/\text{hr}$).
