102-14 / 102-16 LIBERTY AVENUE

QUEENS, NEW YORK

Remedial Action Report

NYC VCP Project Number 14CVCP234Q
OER Project Number 14EH-N350Q

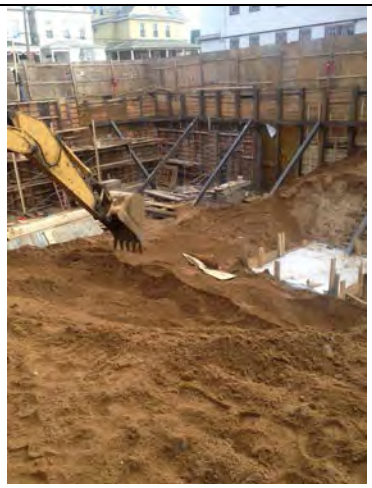
Photo 1 – Removing soil from grid 2 shoring wall.	
Photo 2 – New footing for rakers..	
Photo 3 – Moving soil from grid 2 into soil pile.

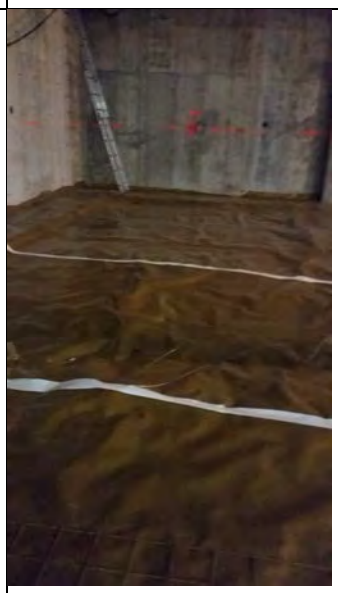
Photo 3 – Vapor barrier attaching to existing slab.

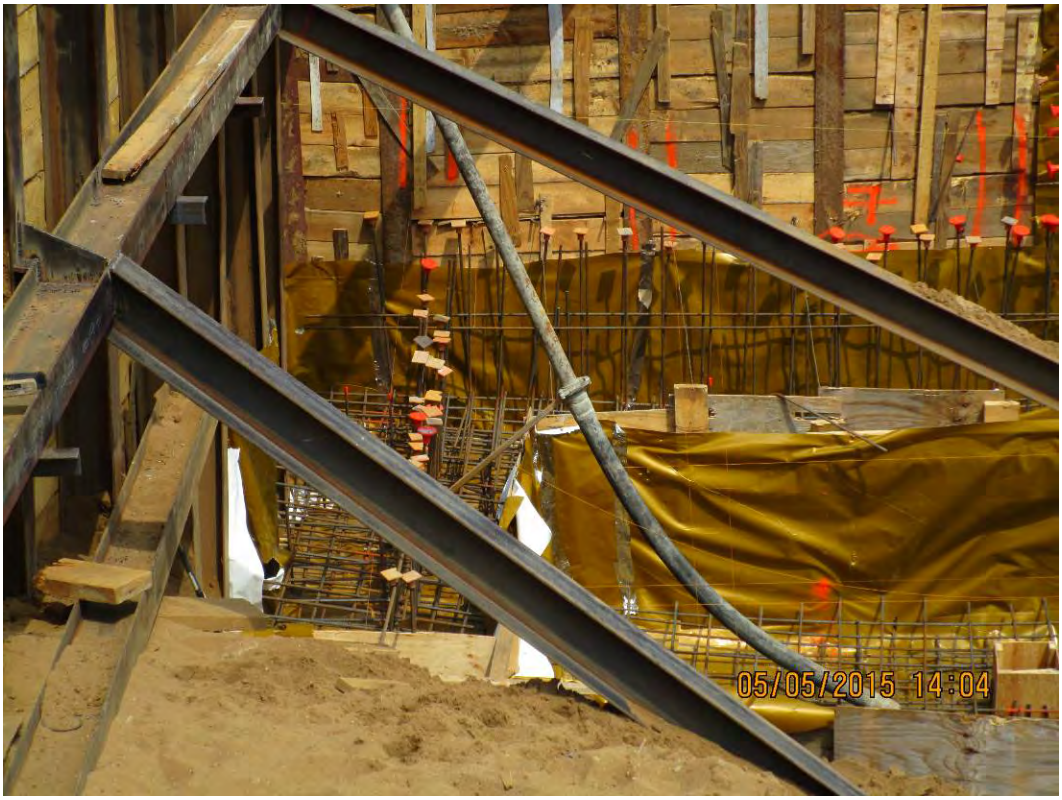
Photo 12 – View of the vapor barrier in the elevator pit prior to concrete pouring.

Photo 13 – Close up view of a taped seem in the elevator pit.

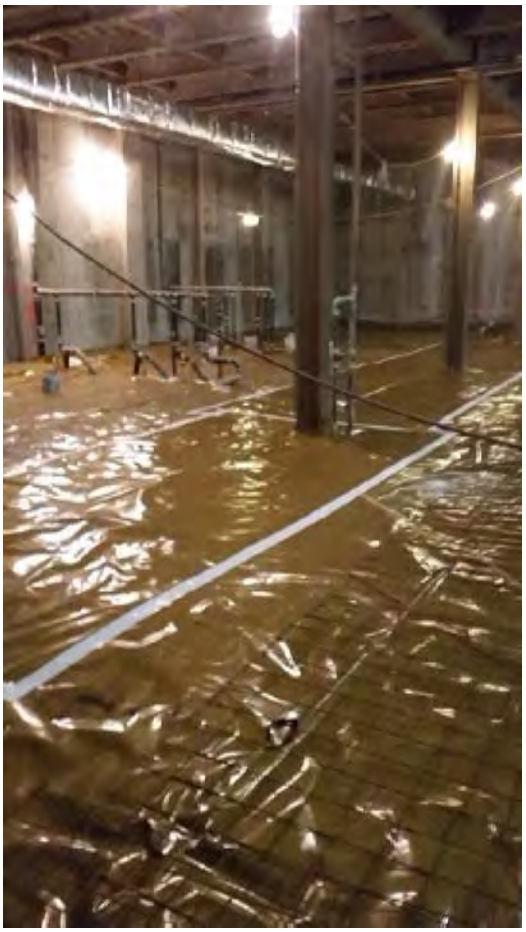
Photo 20 – View of vapor barrier below rebar. Seems are tape with appropriate 4" tape.
