Cannonsville Dam Public Outreach Meetings

Deputy Commissioner Paul V. Rush, P.E.
Bureau of Water Supply

Deposit, NY
July 23, 2015

Cannonsville Dam

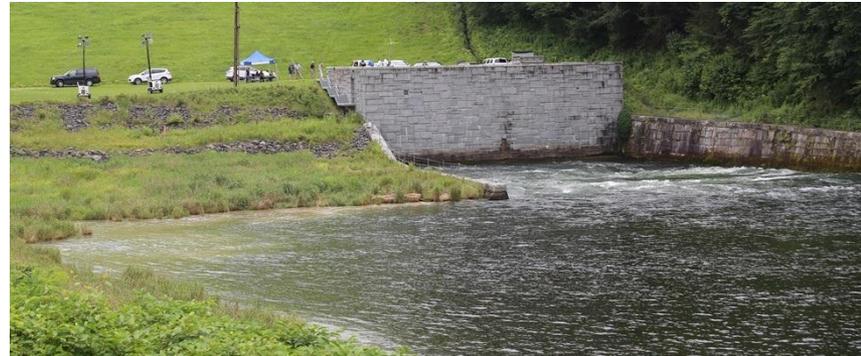
- Site monitoring
 - 24/7 physical monitoring presence
 - Enhanced piezometer data collection/analysis by consultant experts
 - Turbidity monitoring, water sample analysis and comparison to boring samples
 - Piezometer and turbidity alarms
 - Engineer daily inspections
 - Frequent DEP Police patrols
 - Downstream flow monitoring
 - Turbid discharge plume photographic monitoring
- Review of historical information
- Stockpiling materials and equipment for emergency on-call repairs
- Consultations with FERC, DEC Dam Safety and construction contractors for repair plans
- Lowering Reservoir – maximized drinking water diversions and river releases
- Public awareness, EAP reviews, Updates with State and County OEMs

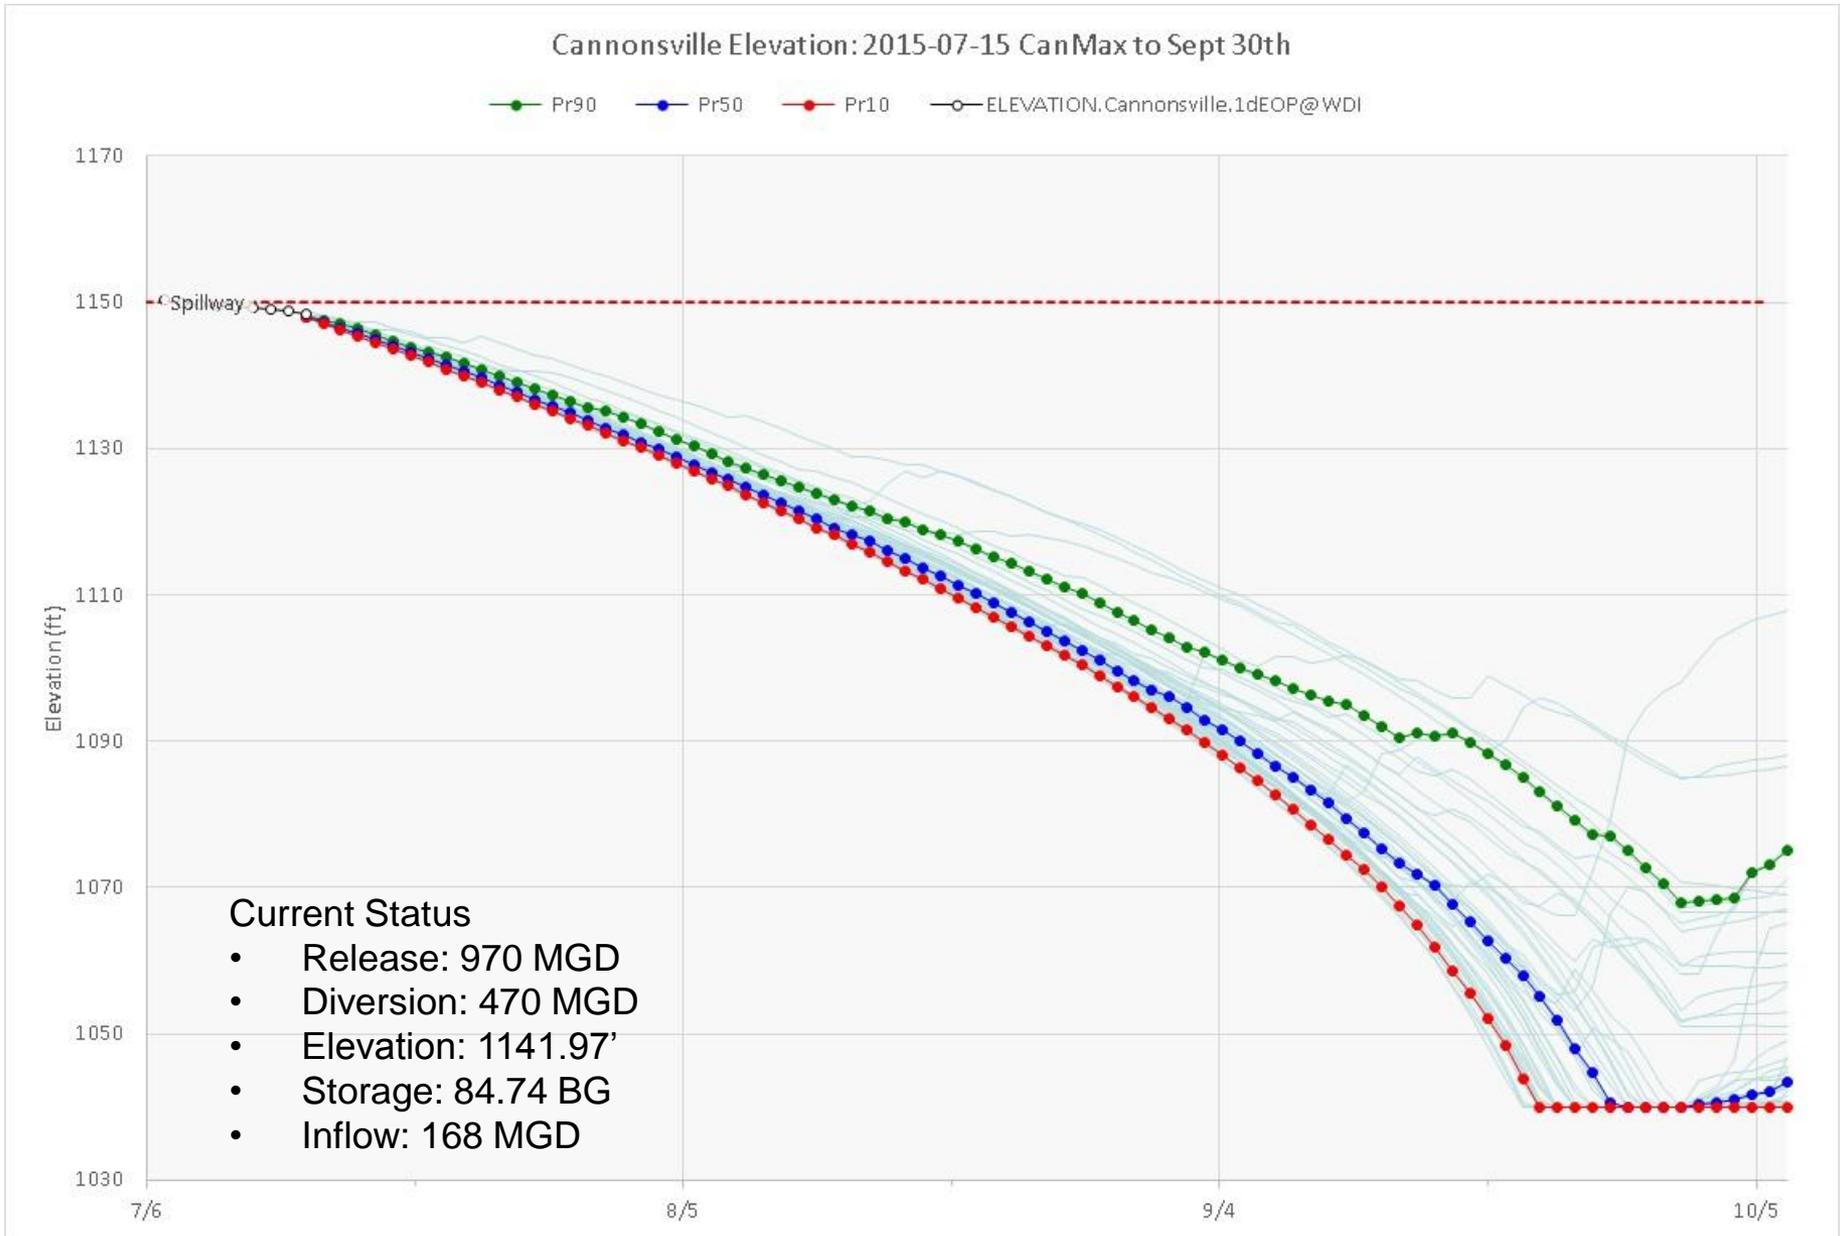
Projected Cannonsville Elevation

- Timeline
 - Moretrench able to perform all contemplated work
 - Mobilization scheduled for Tuesday July 21, 2015
 - Work scheduled to begin Thursday, July 23, 2015
 - Preliminary timeline for completion – September 2015
- Impacts
 - Higher flows in West Branch (FFMP L1A – 1500 cfs)
 - Lower elevation in Reservoir
 - Increased turbidity of release as reservoir elevation decreases

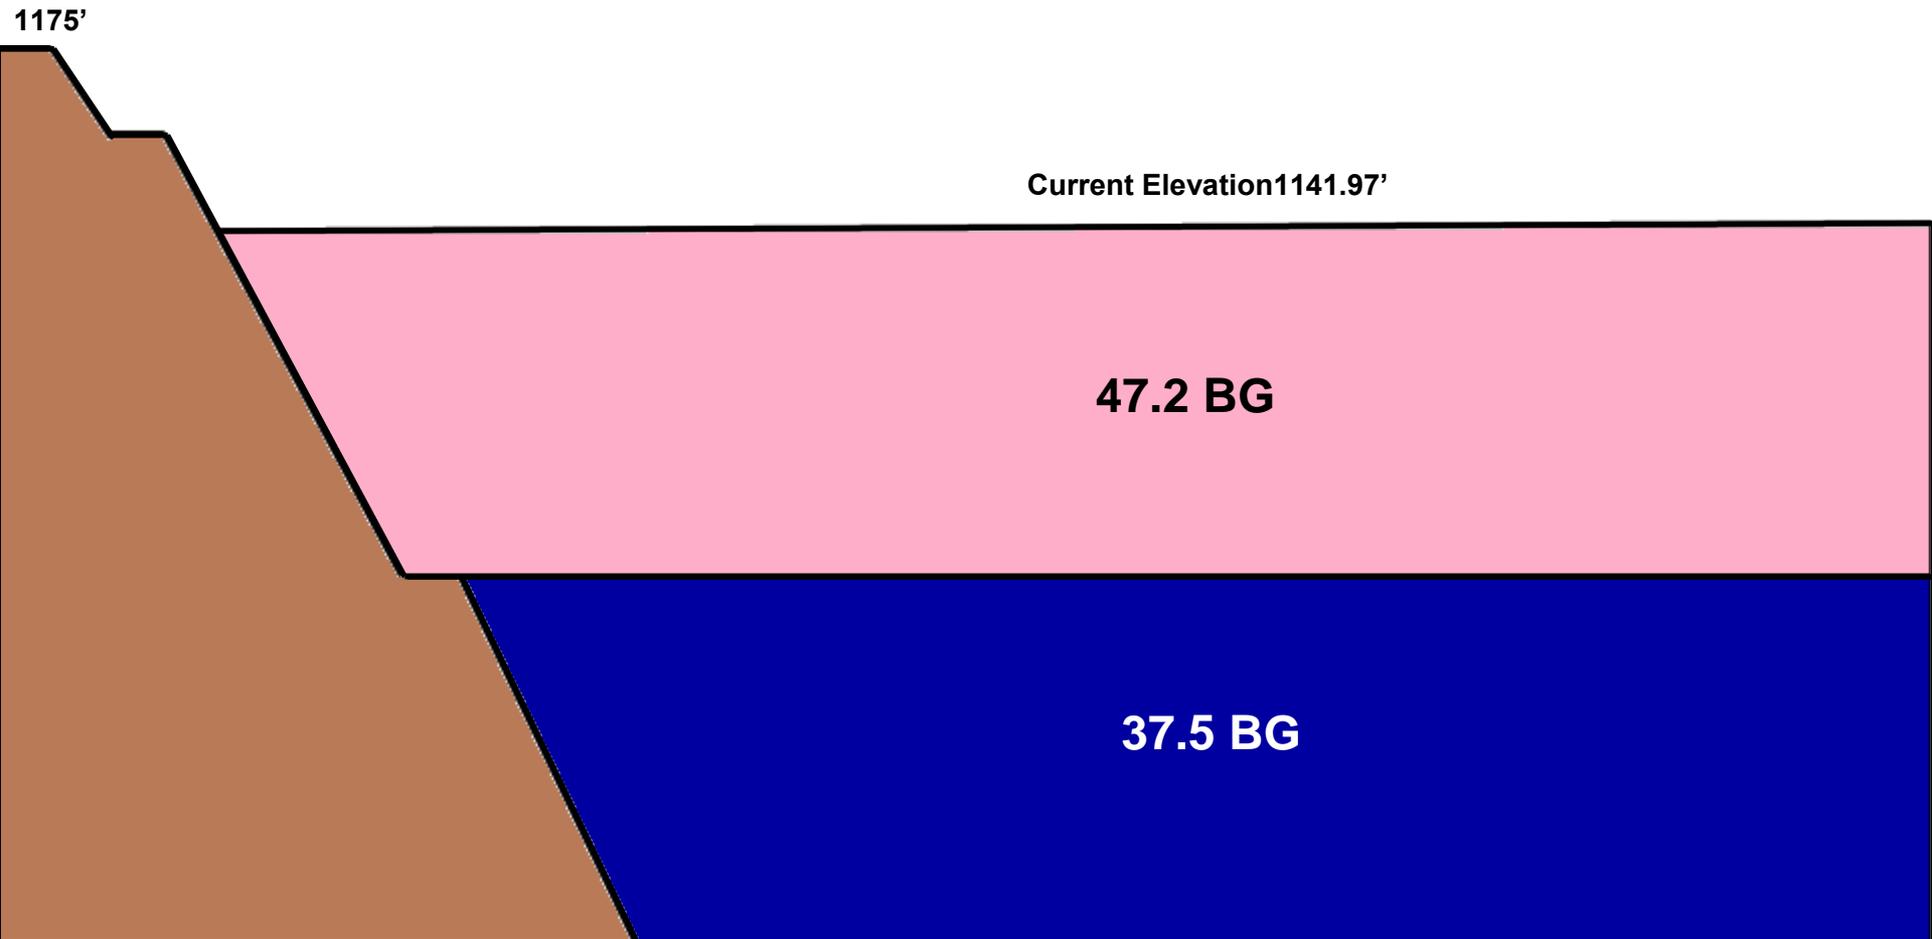
Temperature Profile

Cold water pool at present rate will be depleted by August 17, 2015
