**New York City Department of Transportation  
Office of School Safety Engineering**

**School Safety Engineering Project**

**FINAL REPORT: P.S. 279 (Captain Manuel Rivera Jr. School), Bronx**

**August 9, 2006**

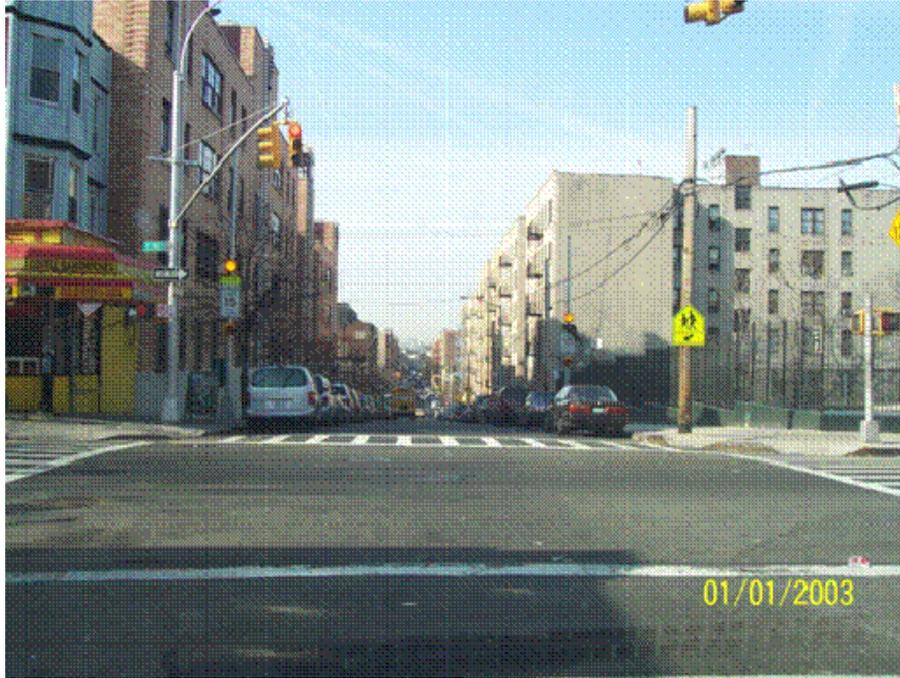
*Figure 5: Looking south along Walton Avenue across East 181<sup>st</sup> Street (school is on east side of street)*

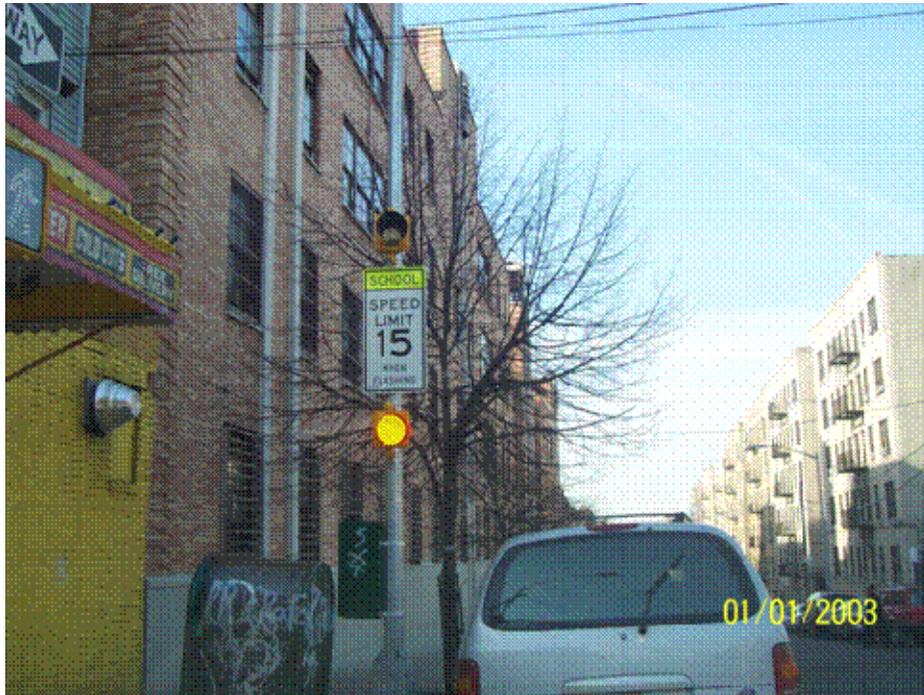
*Figure 6: 15 mph Speed limit sign along Walton Avenue*

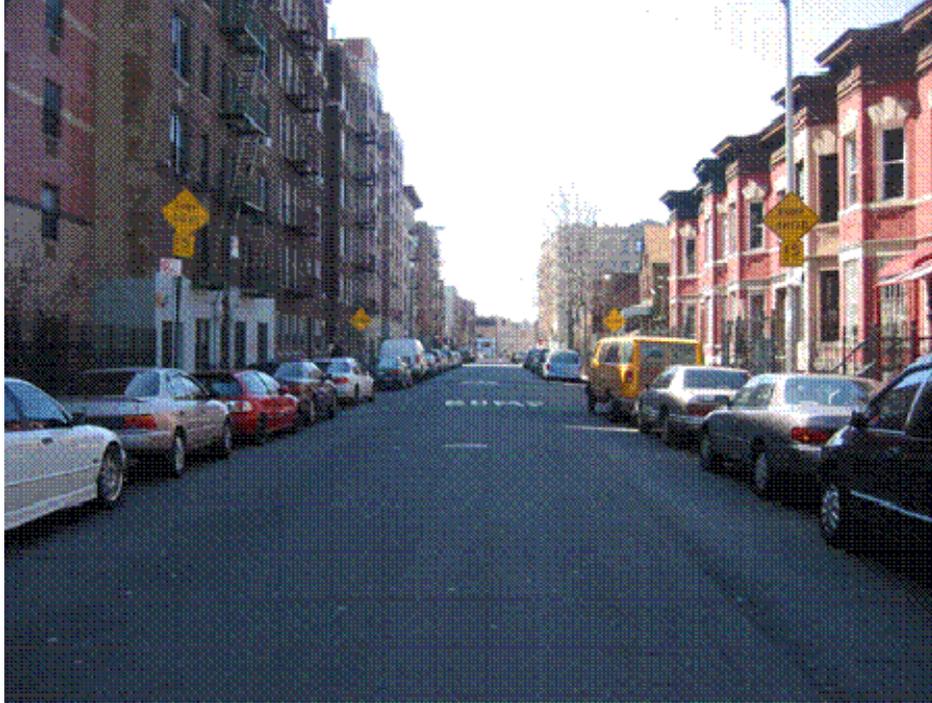
DOT also found that the existing speed reducer on Walton Avenue was installed to correct specifications

*Figure 7: Looking south along Walton Avenue at a speed reducer*

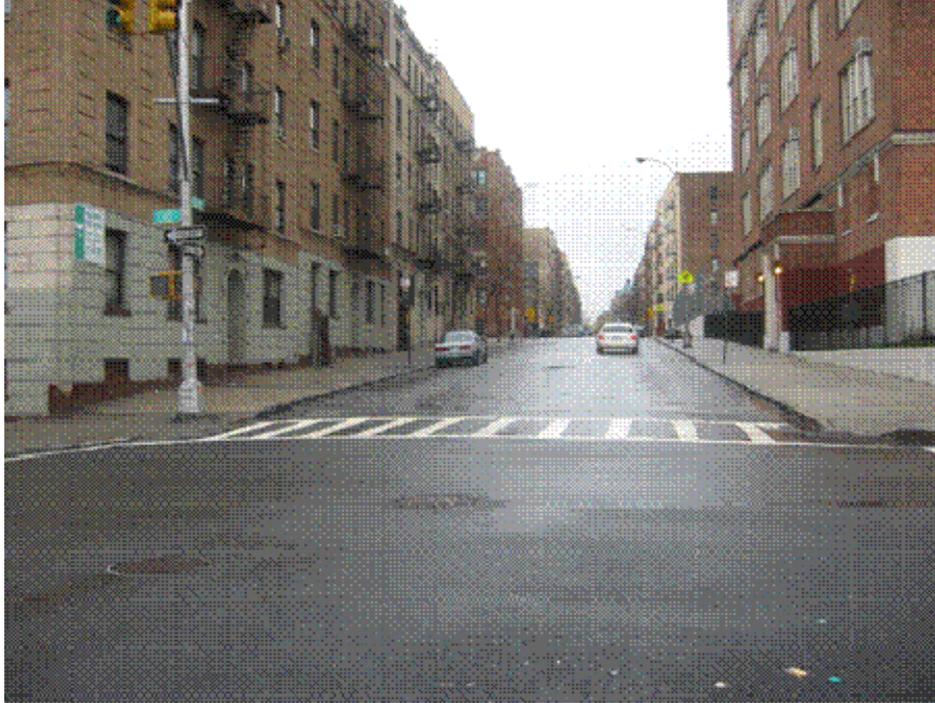
This intersection has been the site of three accidents between 1998 and 2000; none were pedestrian accidents. There were no pedestrian fatalities during this four-year period.

*Figure 8: Looking north along Morris Avenue across East 181<sup>st</sup> Street*

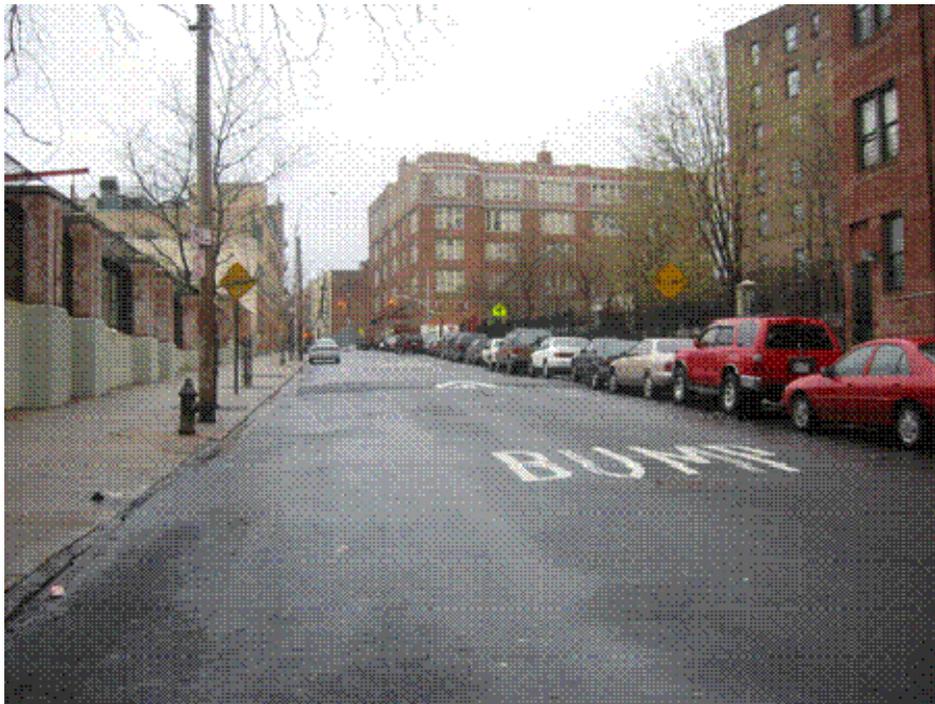
East 181<sup>st</sup> Street is a one-way, westbound street with one travel lane and parking on both sides of the roadway. Morris Avenue is a one-way, northbound street with one travel lane and parking on both sides of the roadway. According to school representatives, a speed reducer installed on Morris Avenue between East Burnside Avenue and East 181<sup>st</sup> Street alleviated a speeding problem.

*Figure 9: Looking north at a speed reducer on Morris Avenue (back of school is on the left)*

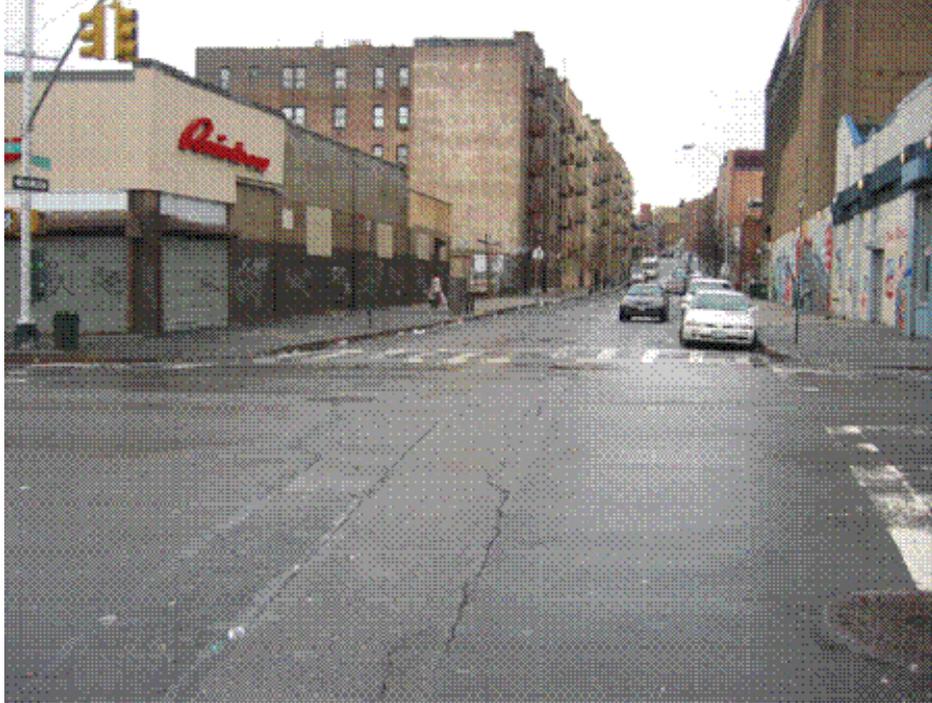
This intersection has been the site of 22 accidents between 1998 and 2000; four of which were pedestrian accidents. None of the accidents were school-related.

*Figure 11: Looking north along Walton Avenue across East Burnside Avenue*

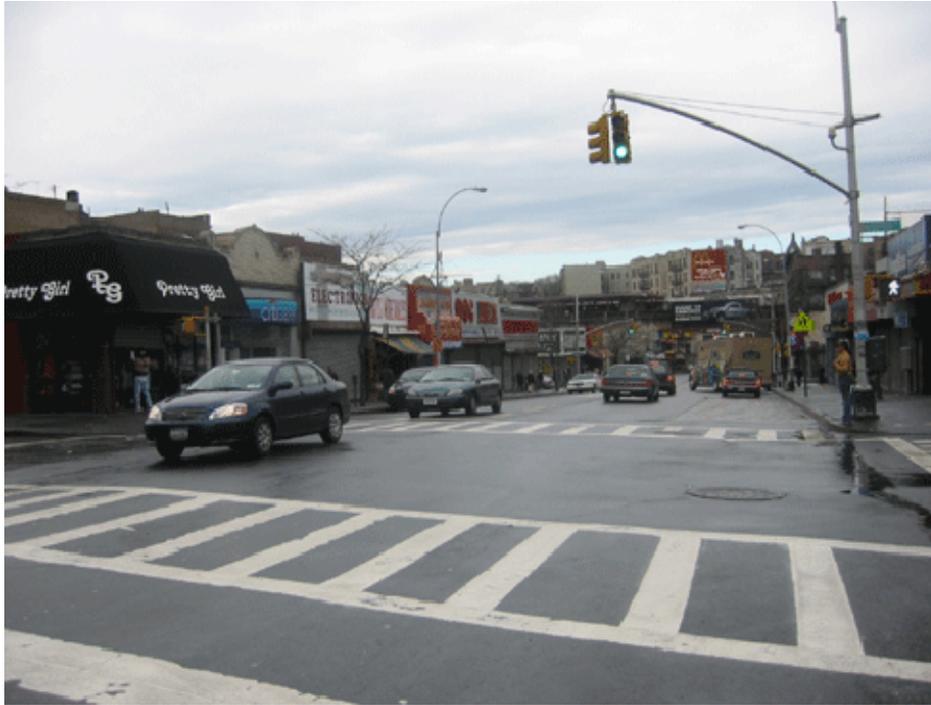
This intersection has been the site of 31 accidents between 1998 and 2000; one of the accidents was a pedestrian accident which was not a school-related accident. There were no pedestrian fatalities reported during the same three-year period.

*Figure 12: Looking west along East Burnside Avenue across Morris Avenue*

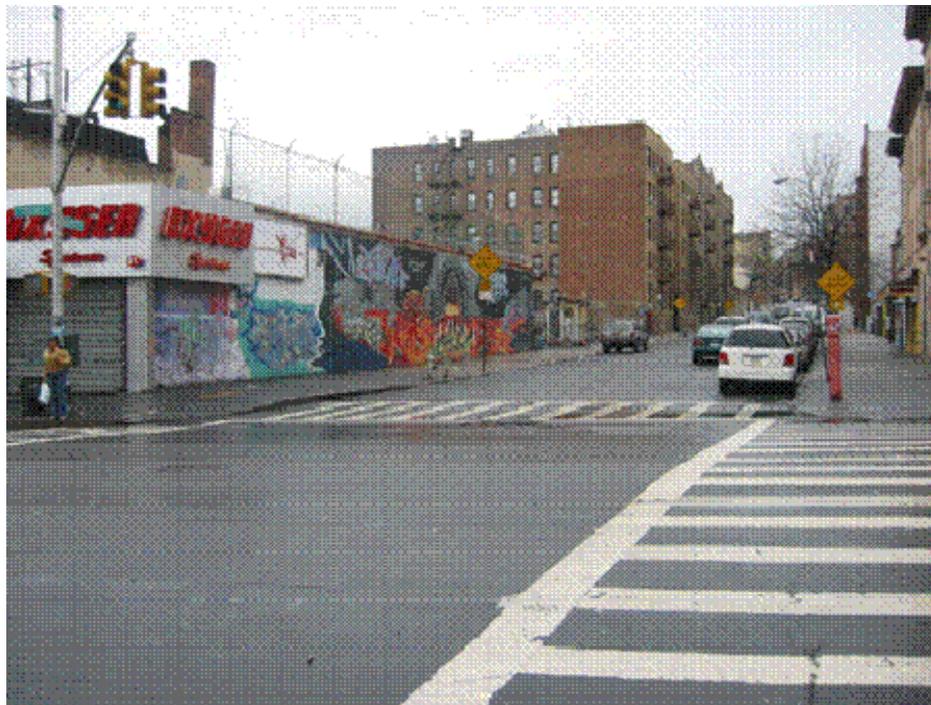
*Figure 13: Looking north along Morris Avenue across East Burnside Avenue*
