**New York City Department of Transportation  
Office of School Safety Engineering**

**School Safety Engineering Project**

**FINAL REPORT: ST. LUKE, Bronx**

**June 9, 2006**

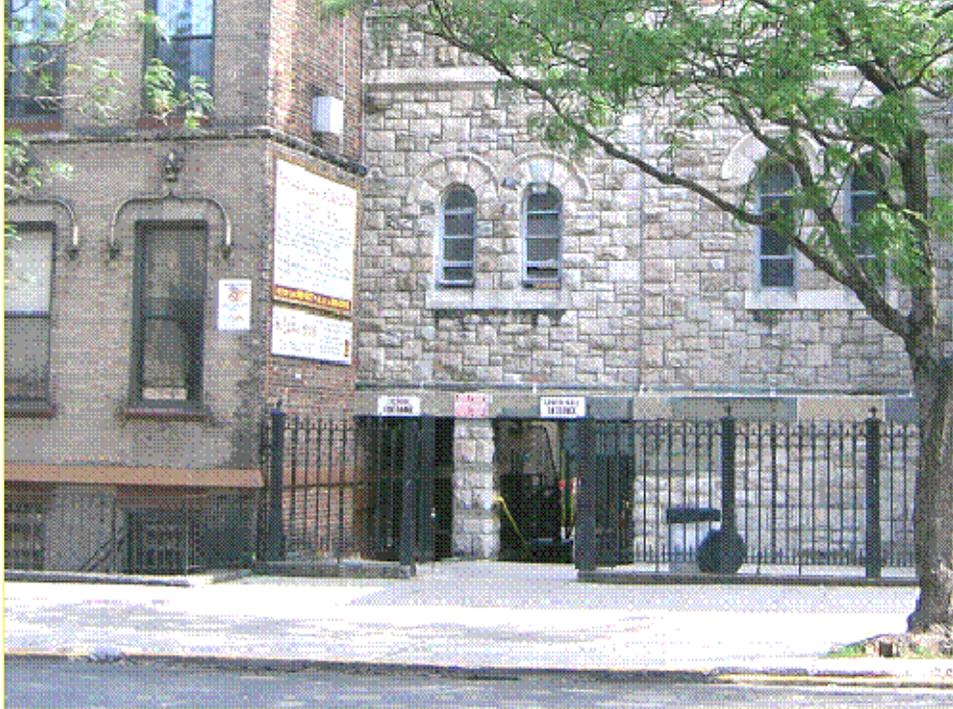
Figure 1: Looking north across East 138<sup>th</sup> Street at alternate entrance of Saint Luke School

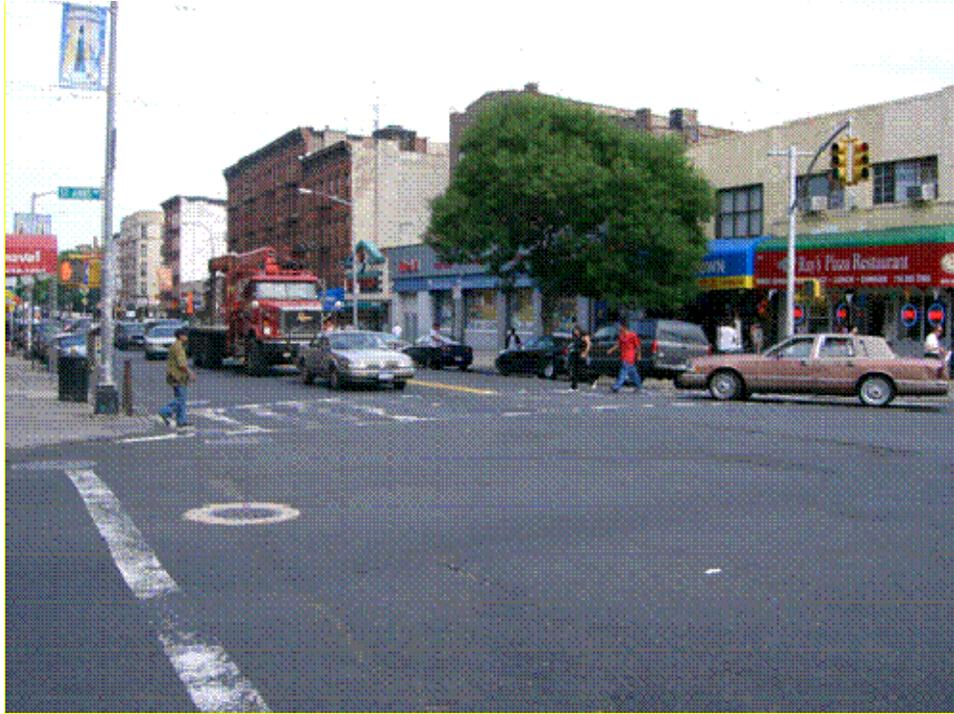
*Figure 2: Looking northwest across St. Ann's Avenue & East 138<sup>th</sup> Street intersection at pizzeria and other stores*

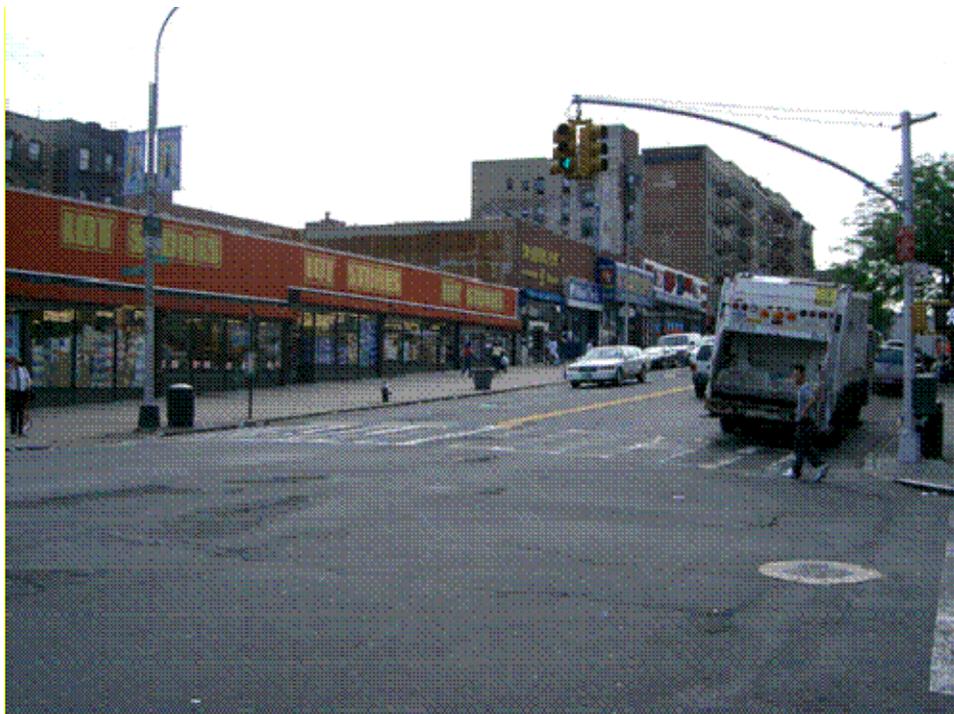
*Figure 3: Looking northeast across St. Ann's Avenue at various stores along north side of East 138<sup>th</sup> Street*

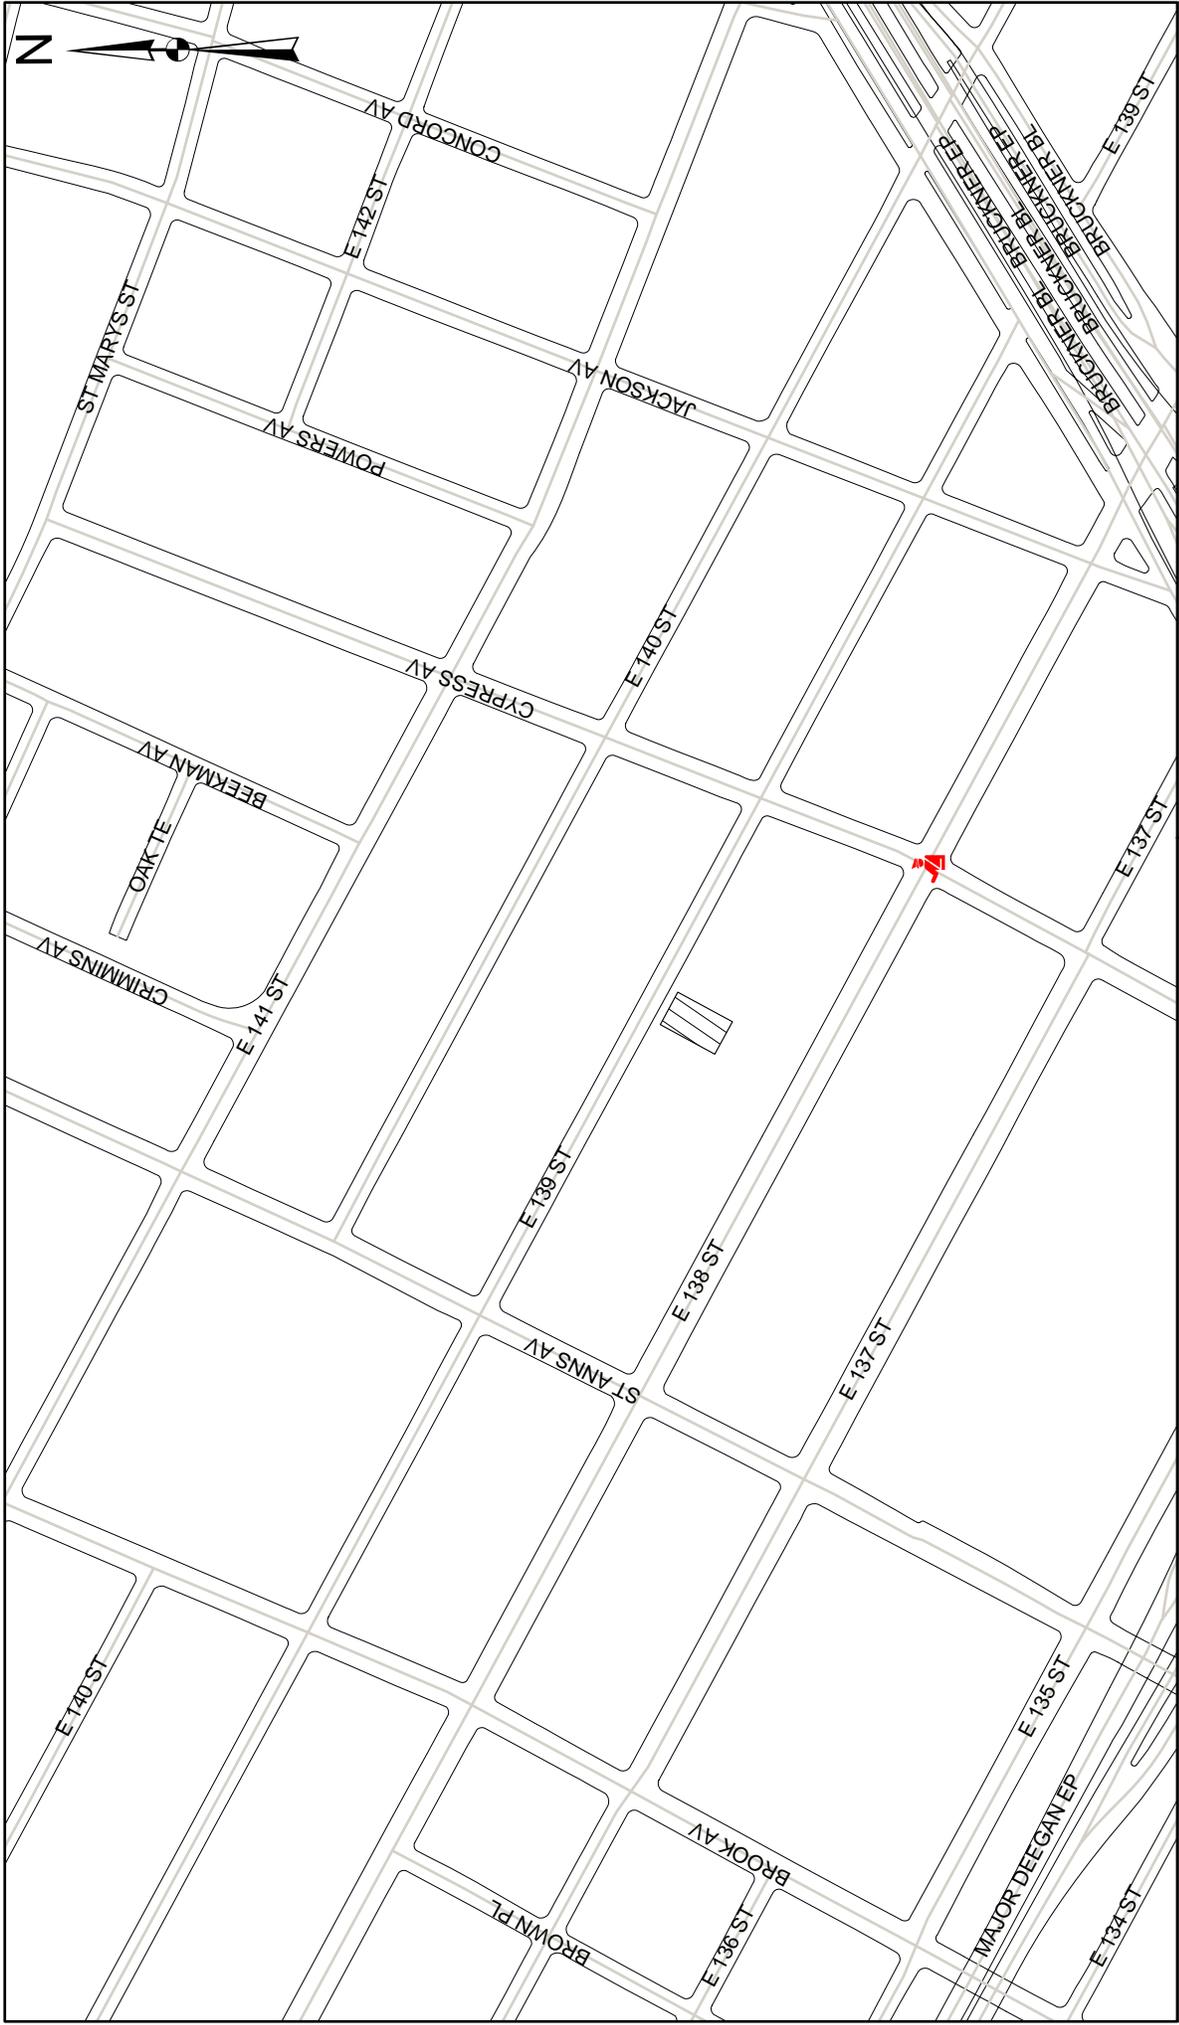
**EXHIBIT 3**

According to the school representatives, a school crossing guard is assigned to the intersection of 138<sup>th</sup> Street & Cypress Avenue.
