LENOX HILL HOSPITAL - CENTER FOR COMPREHENSIVE CARE

Landmarks Preservation Commission Submission

June 9, 2011

**SUBJECT: Façade and Roof Investigation:
Photo Report
Maritime Building
37th Avenue**

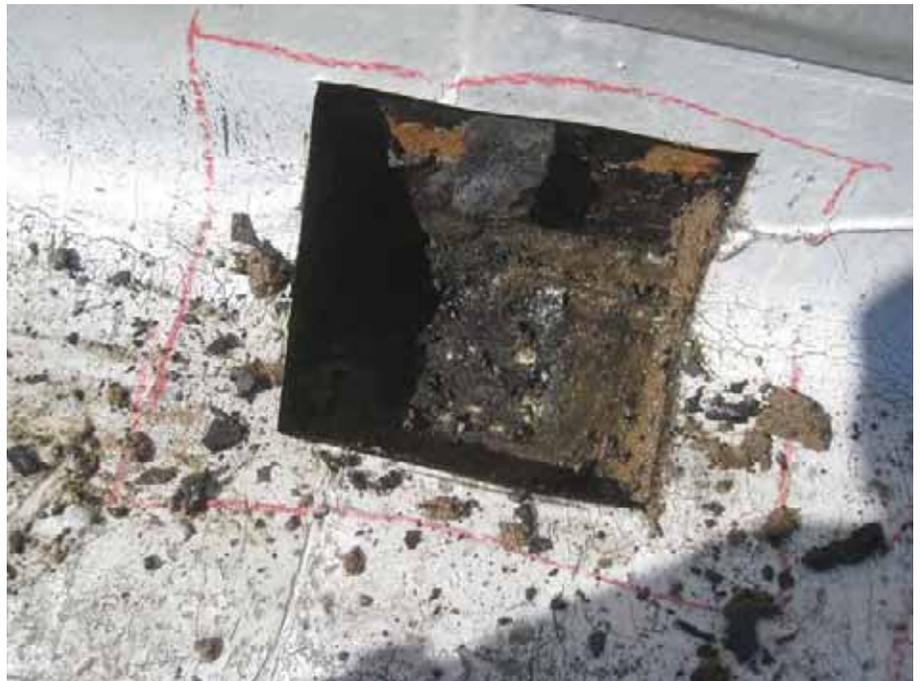
Photograph # 45:

Typical base flashing probe, exposed the embedded steel clips that support the façade panels along the perimeter of the roof.

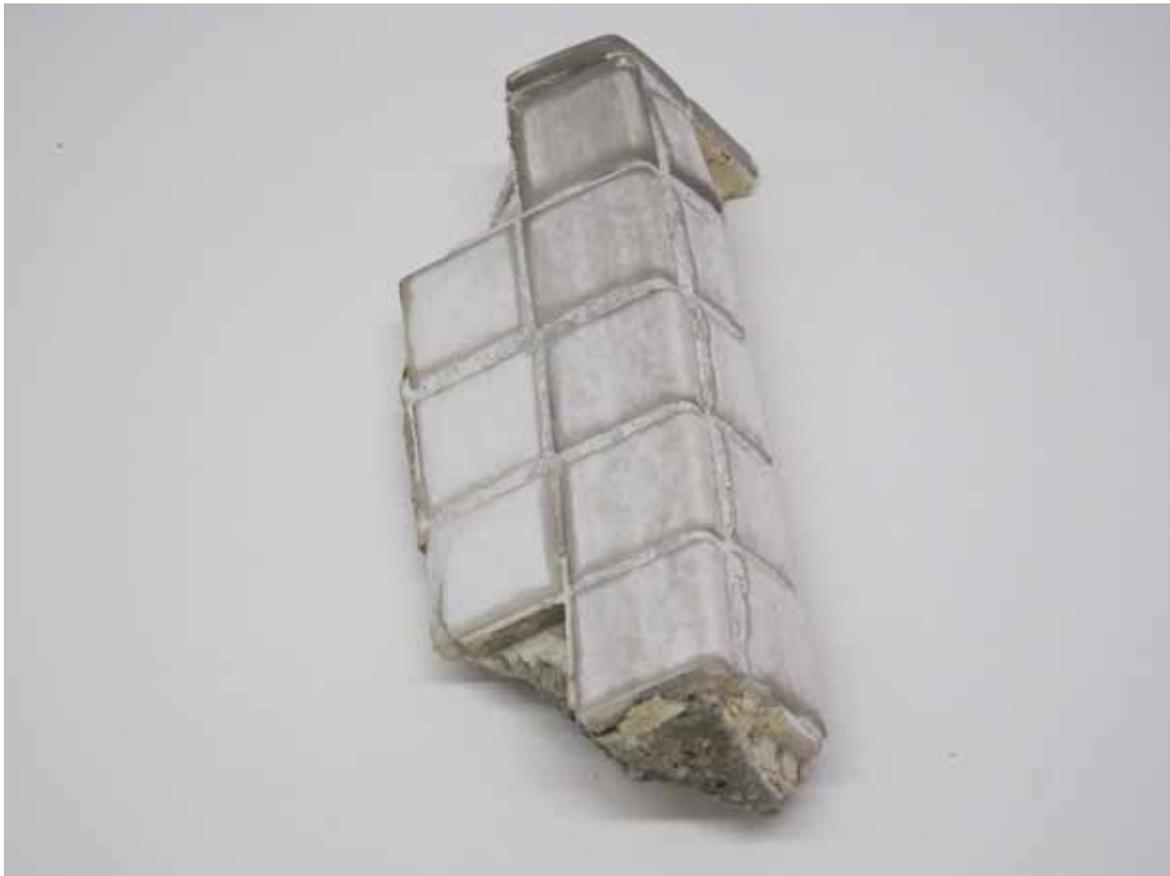
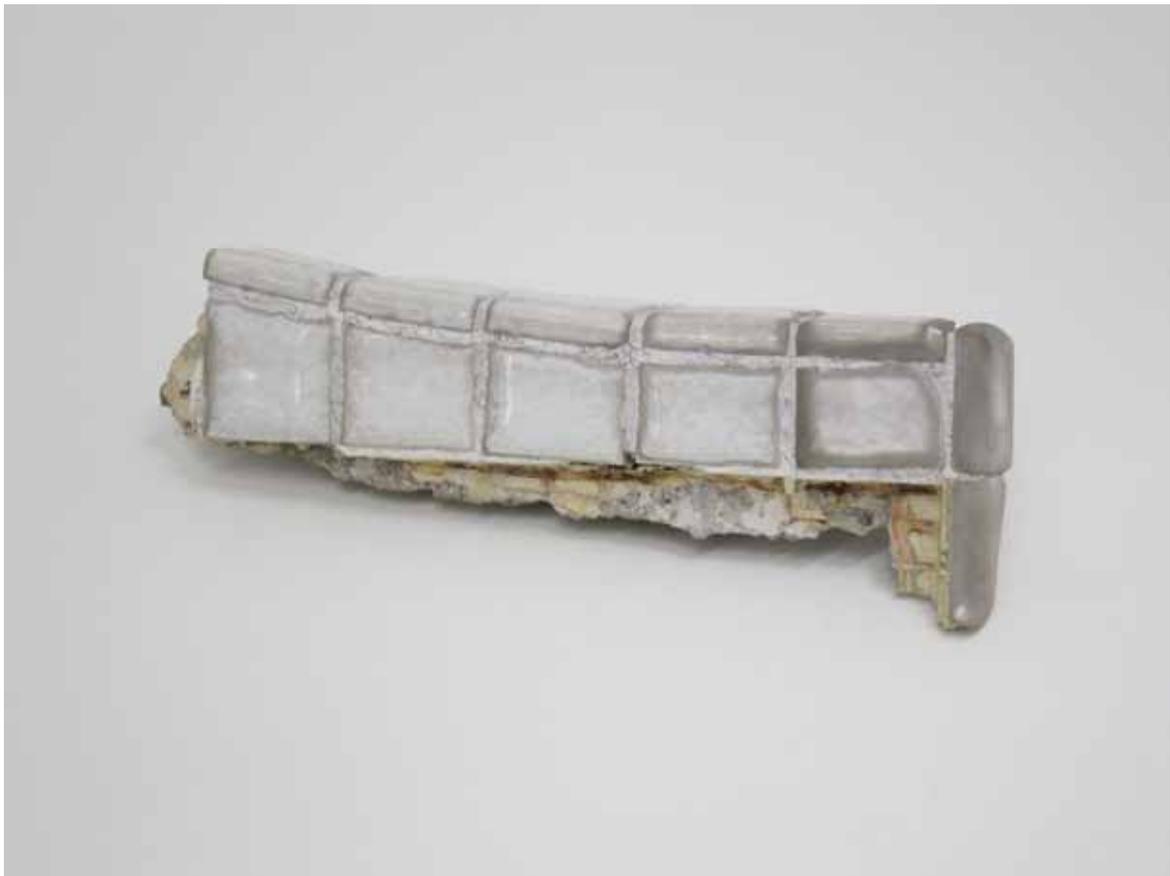
EXISTING CERAMIC TILE FACADE FINISH
