MANHATTAN

EAST 20TH STREET/ FIRST AVENUE

Description

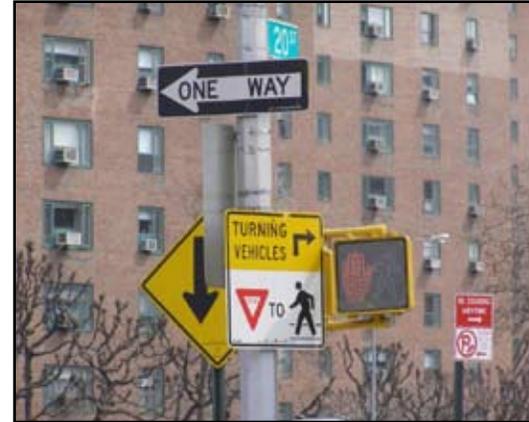
This Green Street was constructed where the service road along the eastern side First Avenue formally existed. By closing off the service area to vehicles, pedestrians have more space to walk and encounter less vehicle conflicts as they walk along First Avenue.

The entrance to the service road on the east side of First Avenue was closed, normalizing the intersection and eliminating a portion of the service road. This reduced the distance required to cross First Avenue on the north side and allowed the Department to realign the crosswalk and shorten the crossing distance of East 20th Street on the east side. Vehicles are still able to access the service road at the existing opening in the median south of East 21st Street. As part of this closure and in conjunction with the Department of Parks and Recreation, a Greenstreet was installed between East 20th and East 21st Streets, providing an amenity to the community.

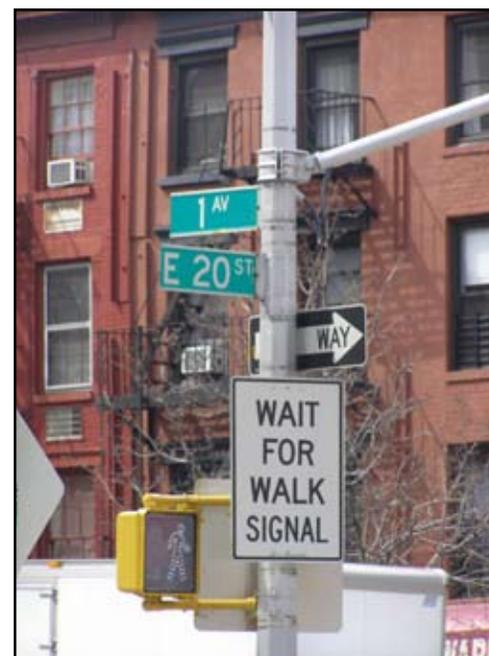
The LPI on East 20th Street gives pedestrians more time to cross the street without vehicle conflict.

The traffic signals at East 20th Street and First Avenue were also modified to provide additional crossing time for pedestrians. The existing Leading Pedestrian Interval (LPI) across First Avenue (which allows pedestrians begin crossing First Avenue prior to the vehicles on East 20th Street receiving a green indication) was increased to 18 seconds from 11 seconds. While the realignment of the east crosswalk resulted in the removal of the right arrow signals for northbound First Avenue, an eight second LPI was installed to supply the additional crossing time for pedestrians. Americans with Disability Act (ADA) compliant wheelchair ramps were also stalled at this intersection during reconstruction.

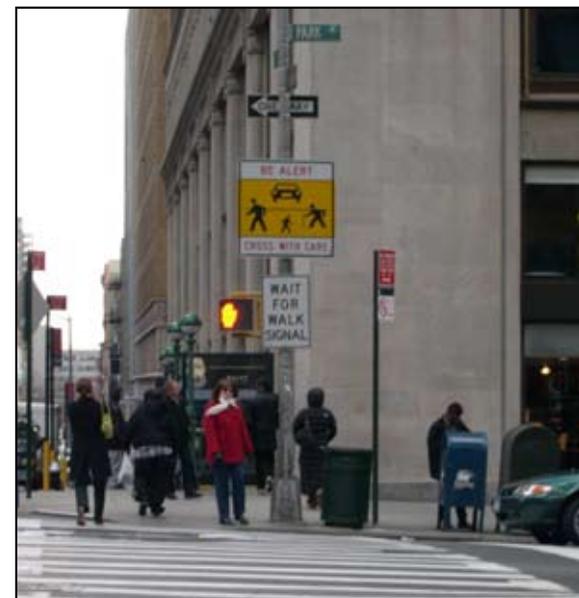
Oversized signage advised pedestrians to cross with care and wait for the walk signal

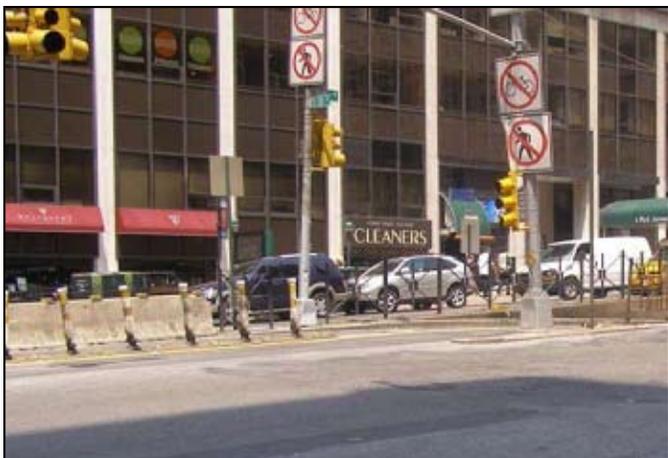
Pedestrian signage, iron pedestrian fences and other roadway improvements discourage pedestrians from crossing at this location and provide for safer vehicular movements

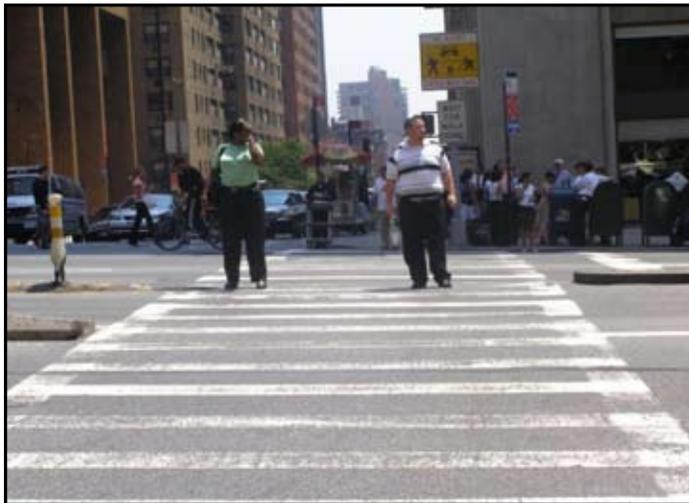
BEFORE conditions at E 33rd Street: Pedestrian stuck in middle of roadway with no safety area (facing east).

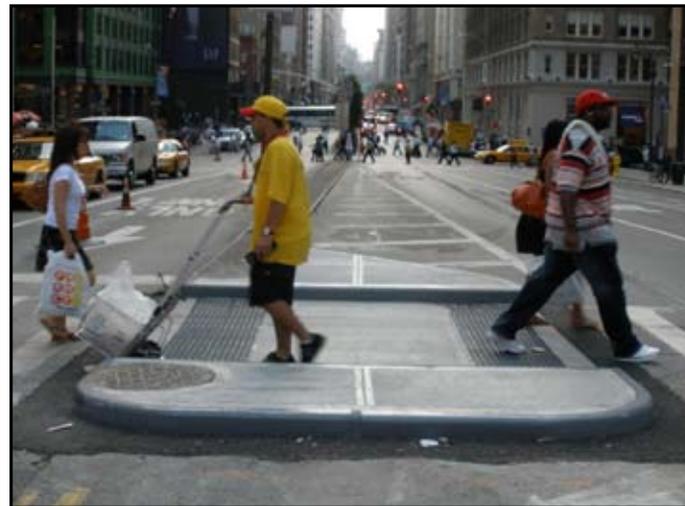
AFTER conditions at E 33rd Street: Pedestrians have refuge island between north and southbound traffic (facing south).

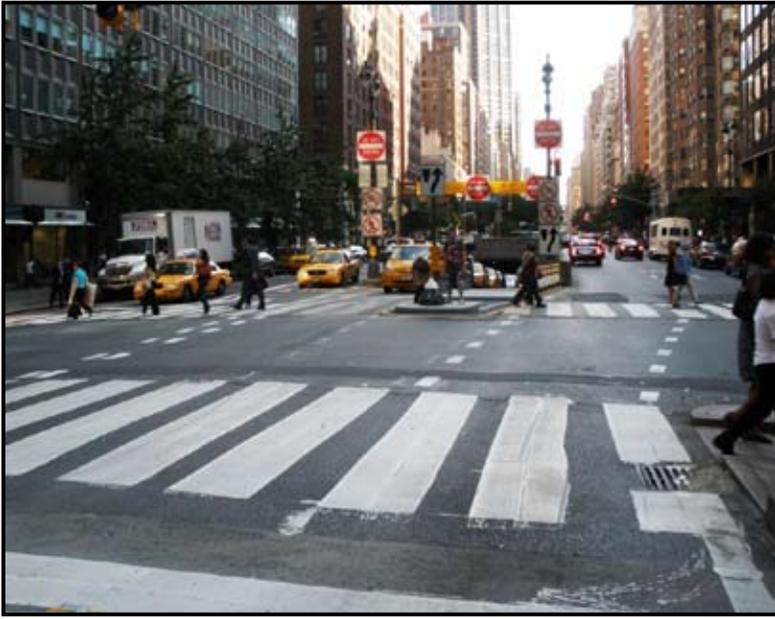
AFTER: Park Avenue tunnel at E. 40th Street (facing south) with one-way northbound tunnel traffic pattern. Southbound traffic is directed onto local streets. The newly constructed pedestrian island provides a safe refuge for the numerous pedestrians crossing the street.

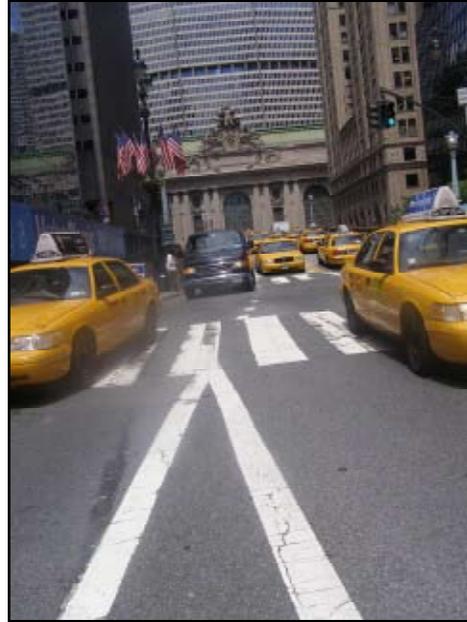
BEFORE conditions: Vehicles traveling southbound on the Viaduct approaching the tunnel at East 40th Street.

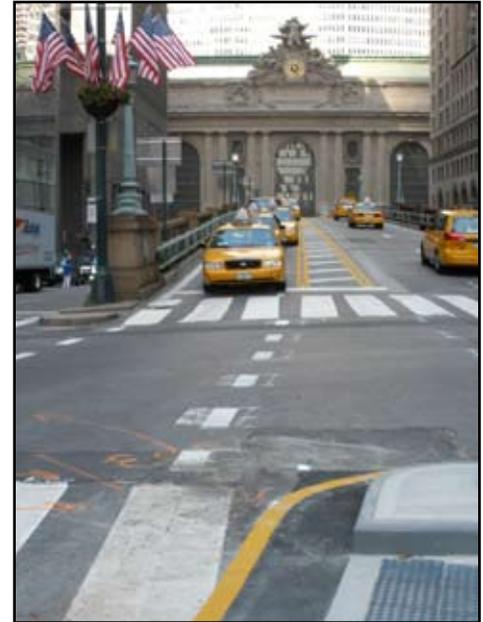
AFTER conditions: New traffic patterns force all southbound vehicles on the Viaduct to use local lanes at East 40th Street.

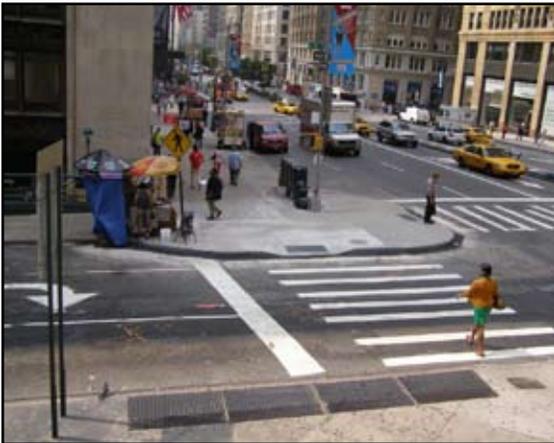
A neckdown was constructed on the SE corner of Park Avenue and East 33rd Street. The sidewalk extension shortened the crossing distance for pedestrians and aligned the intersection with the northeast curb line.

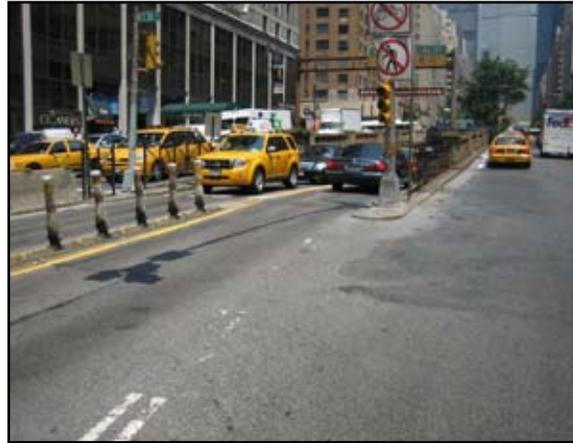
BEFORE conditions: NB and SB vehicles could use the tunnel, creating hazardous conditions for pedestrians at E. 33rd Street.

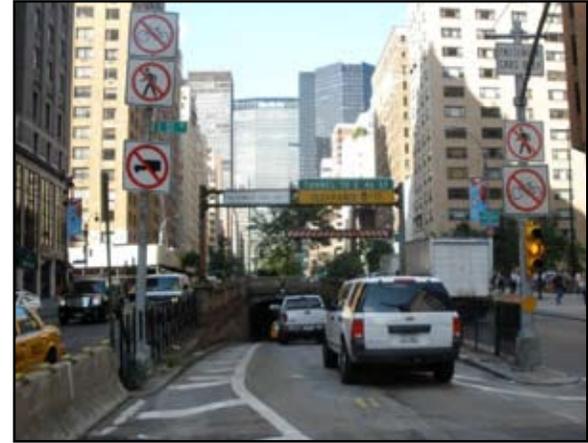
AFTER conditions: Only NB vehicles can enter the tunnel at E. 33rd Street, eliminating the SB conflict for pedestrians at this location.

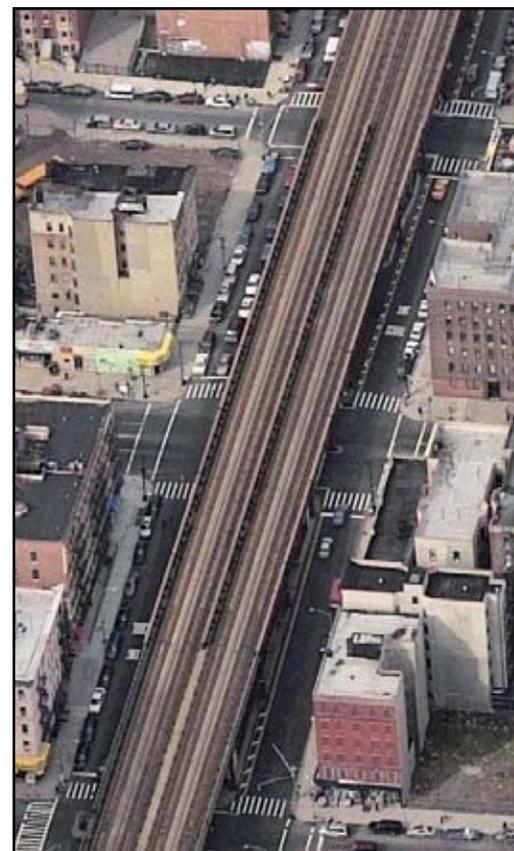
Aerial view of the Park Avenue corridor with improved markings and buffer zone

- Installed a three-foot wide thermoplastic ‘buffer’ (flush channelization) using pavement marking between East 101st and East 132nd Streets. The buffer is intended to realign the single travel lane away from the pedestrian refuge area in the center of Park Avenue’s north and south roadways. The buffer markings improve the line of sight between motorist and pedestrian as well as cause motorists to reduce speed by creating the appearance of a narrowed roadway.
- Installed “Wait for Walk Signal” pavement messages to advise pedestrians to wait for a fresh walk signal between East 101st and East 111th Streets where the stone walls of the viaduct severely limit visibility for both pedestrians and motorists.

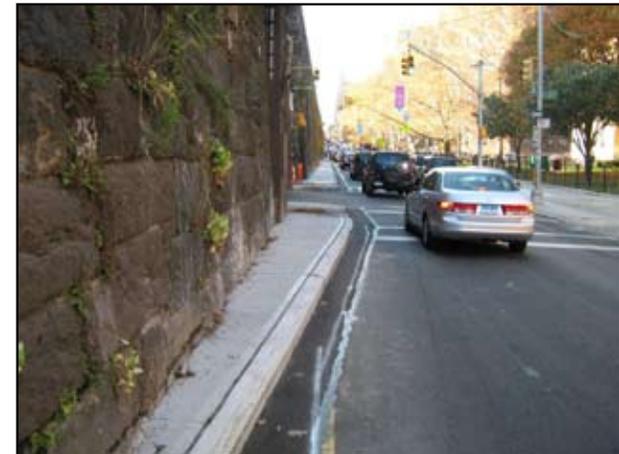
New sidewalk on southbound Park Avenue at East 105th Street

- **As part of DOT’s Phase I of capital construction at Priority Schools, construction of a new sidewalk on Park Avenue between 104th and 105th Streets was completed. The new sidewalk provides a raised protected area for pedestrians to stand when exiting from the underpass of the elevated structure that runs along Park Avenue. Other safety measures implemented near PS 72 include neckdowns on Lexington Avenue at 104th and 105th Streets. The new sidewalk and neckdowns were recommended by DOT’s Priority School Report for PS 72 published in 2006.**

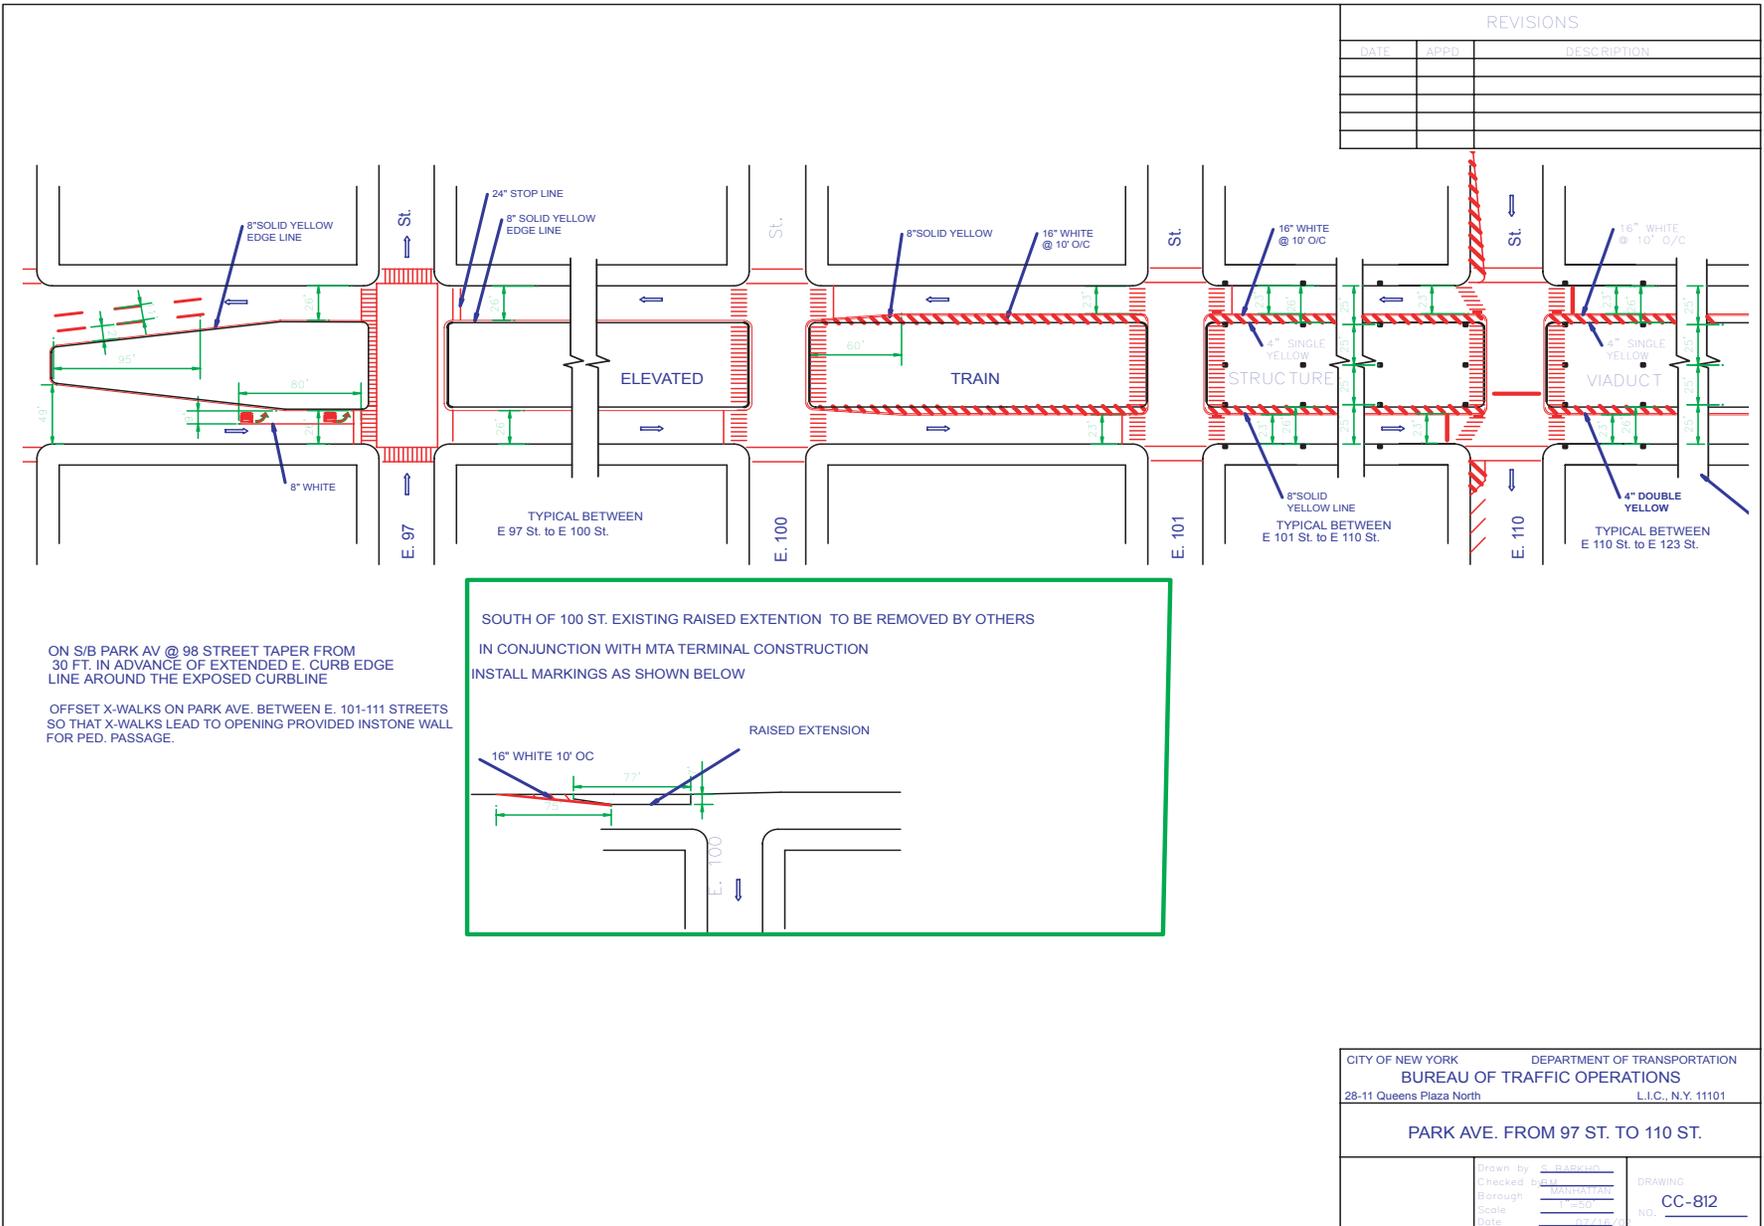
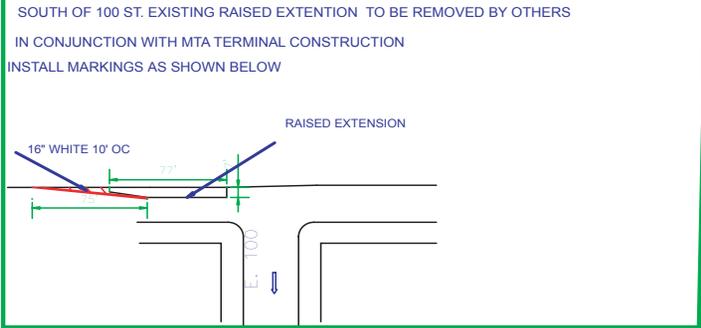
ON S/B PARK AV @ 98 STREET TAPER FROM 30 FT. IN ADVANCE OF EXTENDED E. CURB EDGE LINE AROUND THE EXPOSED CURBLINE

OFFSET X-WALKS ON PARK AVE. BETWEEN E. 101-111 STREETS SO THAT X-WALKS LEAD TO OPENING PROVIDED IN STONE WALL FOR PED. PASSAGE.

In conjunction with a DDC Engineering Resurfacing project between East 96th and East 132nd Streets, the following improvements were implemented in September 2002:

- Installed 20-foot jersey barriers at the north and south ends of each block in advance of the crosswalks between East 127th and East 132nd Streets to prevent motorists from traveling beneath the elevated structure. Some of these barriers have been removed as space beneath the tracks has been leased for parking purposes.

- Installed edge lines between East 97th and East 100th Streets south of the new bus terminal.
- Installed “No Standing 7-10AM Mon-Fri” regulations on the west curb (southbound) from East 132nd Street to East 130th Street to provide a second travel lane during the morning peak period.

- Removed signal faces (for northbound and southbound traffic) within the area beneath the elevated structure north of East 127th Street.
- Upgraded crosswalk markings to high visibility at all signalized intersections.

- Installed advance pedestrian crossing warning signs in the section of the stone viaduct between East 101st and East 111th Streets.

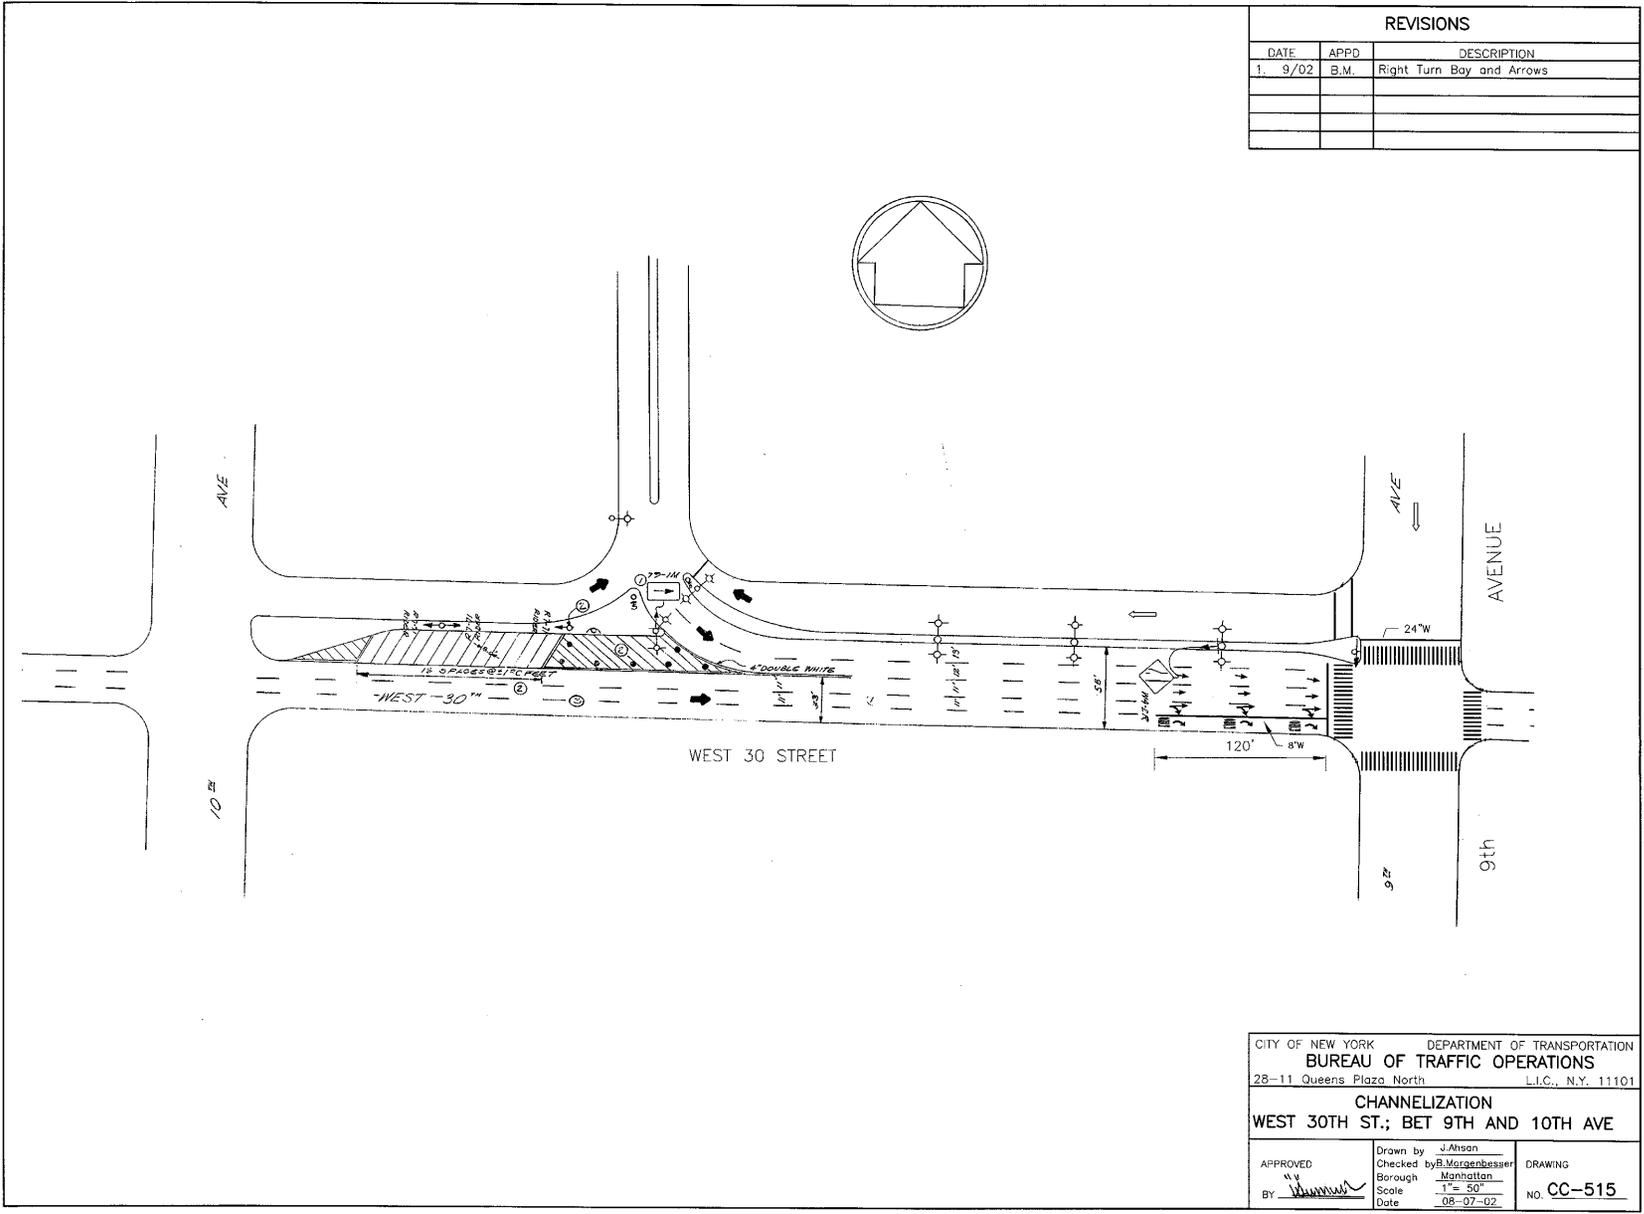
CHANNELIZATION
WEST 30TH ST.; BET 9TH AND 10TH AVE

REVISIONS		
DATE	APPD	DESCRIPTION
1. 9/02	B.M.	Right Turn Bay and Arrows

- Old pedestrian crossing signs were repositioned for improved visibility in September 2002.
- “Yield to Pedestrian” signs were installed on the southeast and southwest corners in September 2002.
- Lane assignment markings were installed in November 2002 to improve vehicular movements and decrease conflicts.
- All crosswalks were upgraded to high visibility to improve pedestrian safety in November 2002.
- A Leading Pedestrian Interval (LPI) was installed on the south leg of the intersection in December 2002.
- Two new pedestrian signals for the westerly crossing of West 30th Street were installed and signal timing modifications were completed in December 2002.
- **A new protected bike lane was installed on 9th Avenue south of 31st street that narrows the street and provides a refuge island to promote safer pedestrian crossing.**

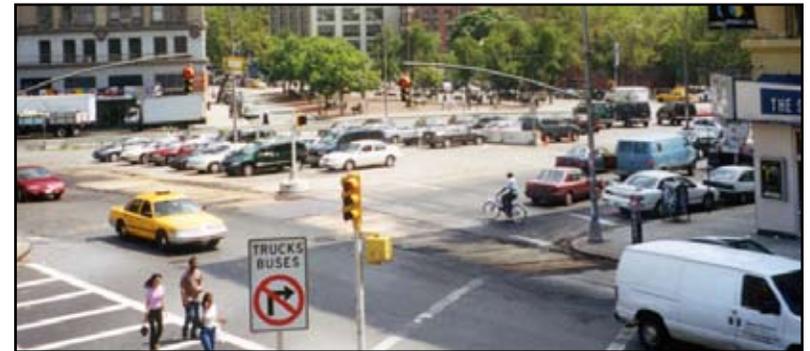
In its original configuration, the triangle was used as a temporary parking lot and did not provide adequate pedestrian space

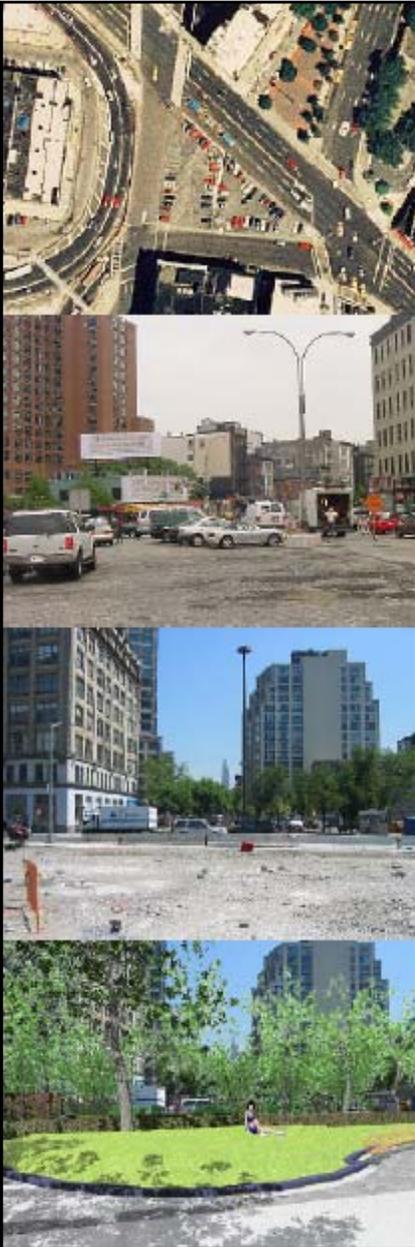
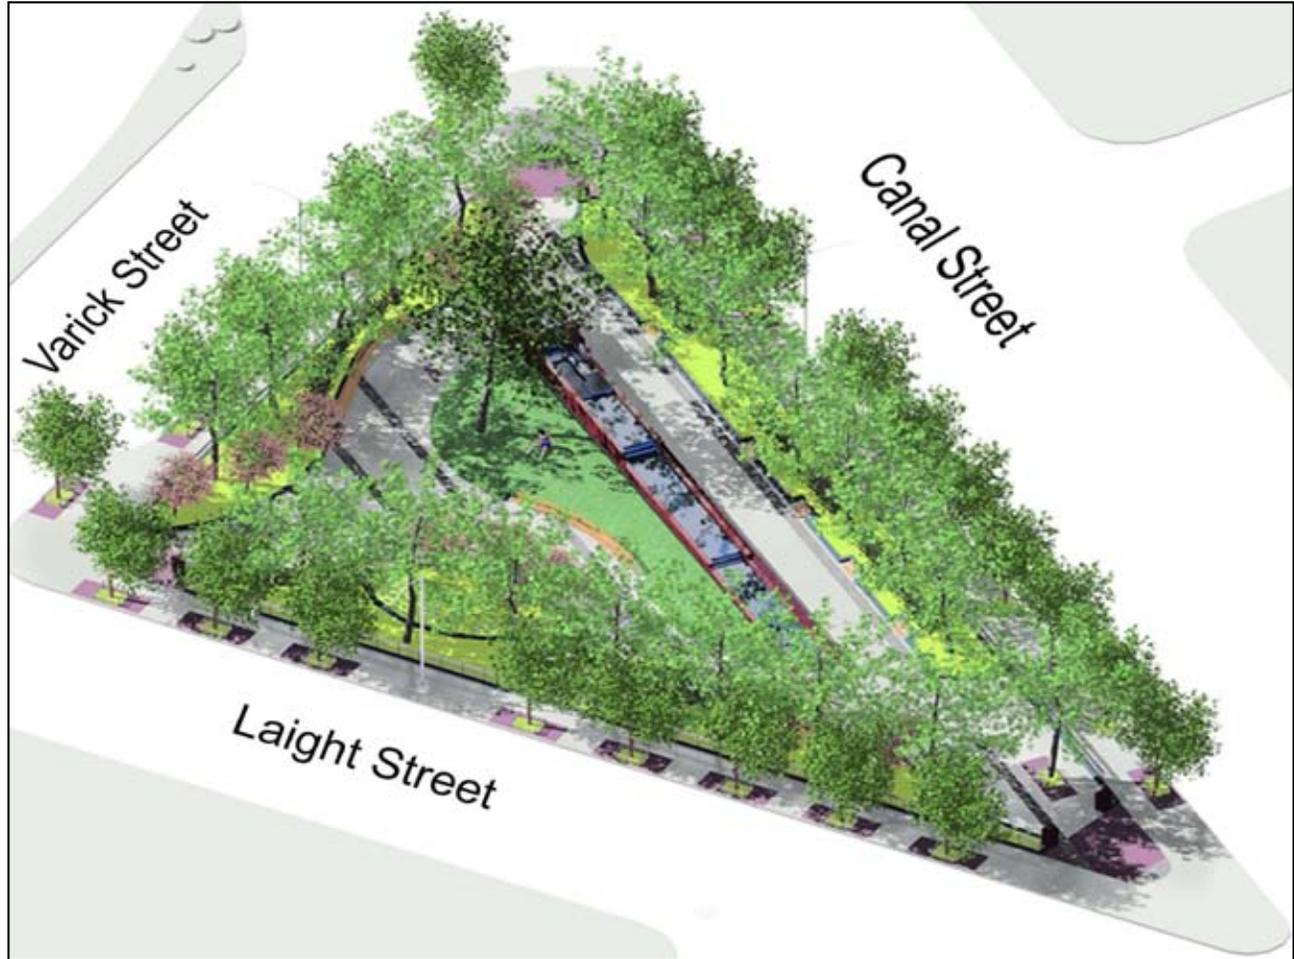
Parks Department plans for the Triangle. They began work in the Summer of 2008.

The improvements and redesigned park are shown on the following two pages.

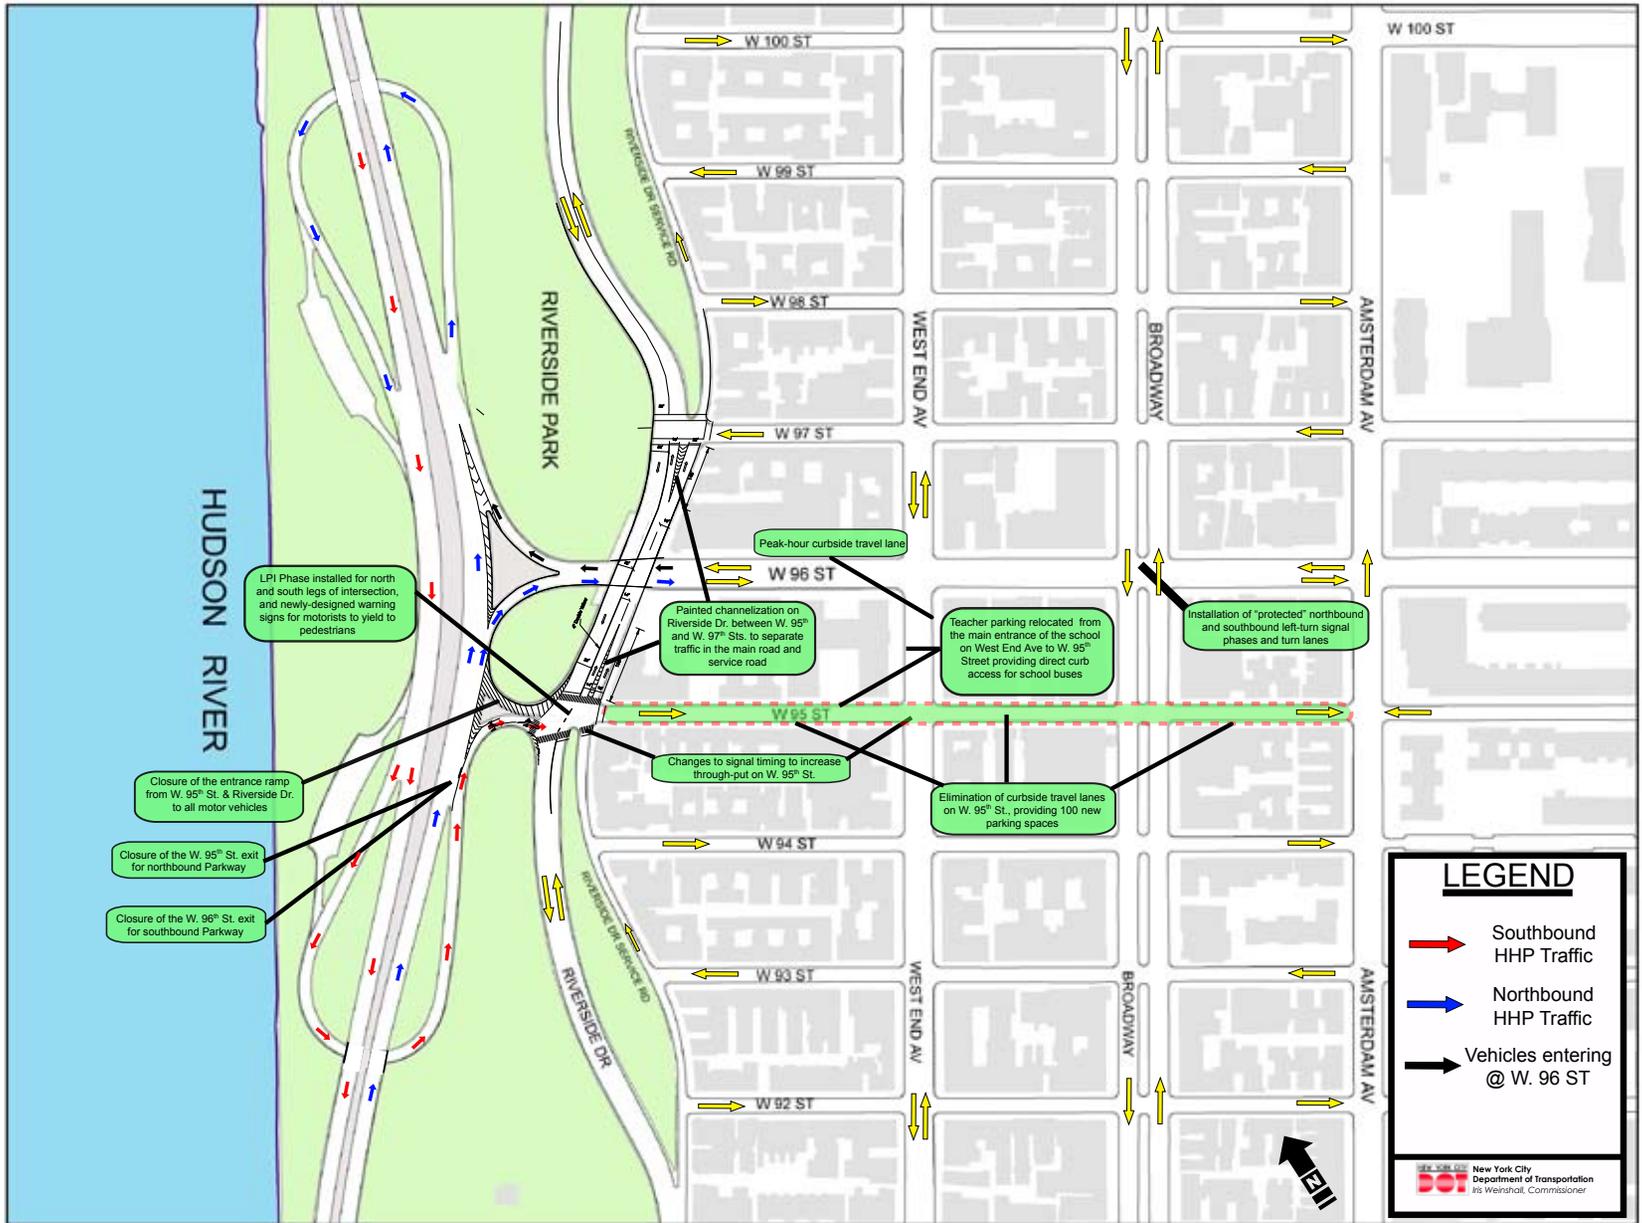
While the operation of the Henry Hudson Parkway interchange was the central component of this initiative, the safety improvements and changes in regulations on the interchange's supporting intersections provide for a substantial improvement in pedestrian and vehicular safety throughout the area. Although each component is detailed in the following pages, the illustration on the following page summarizes the overall improvements.

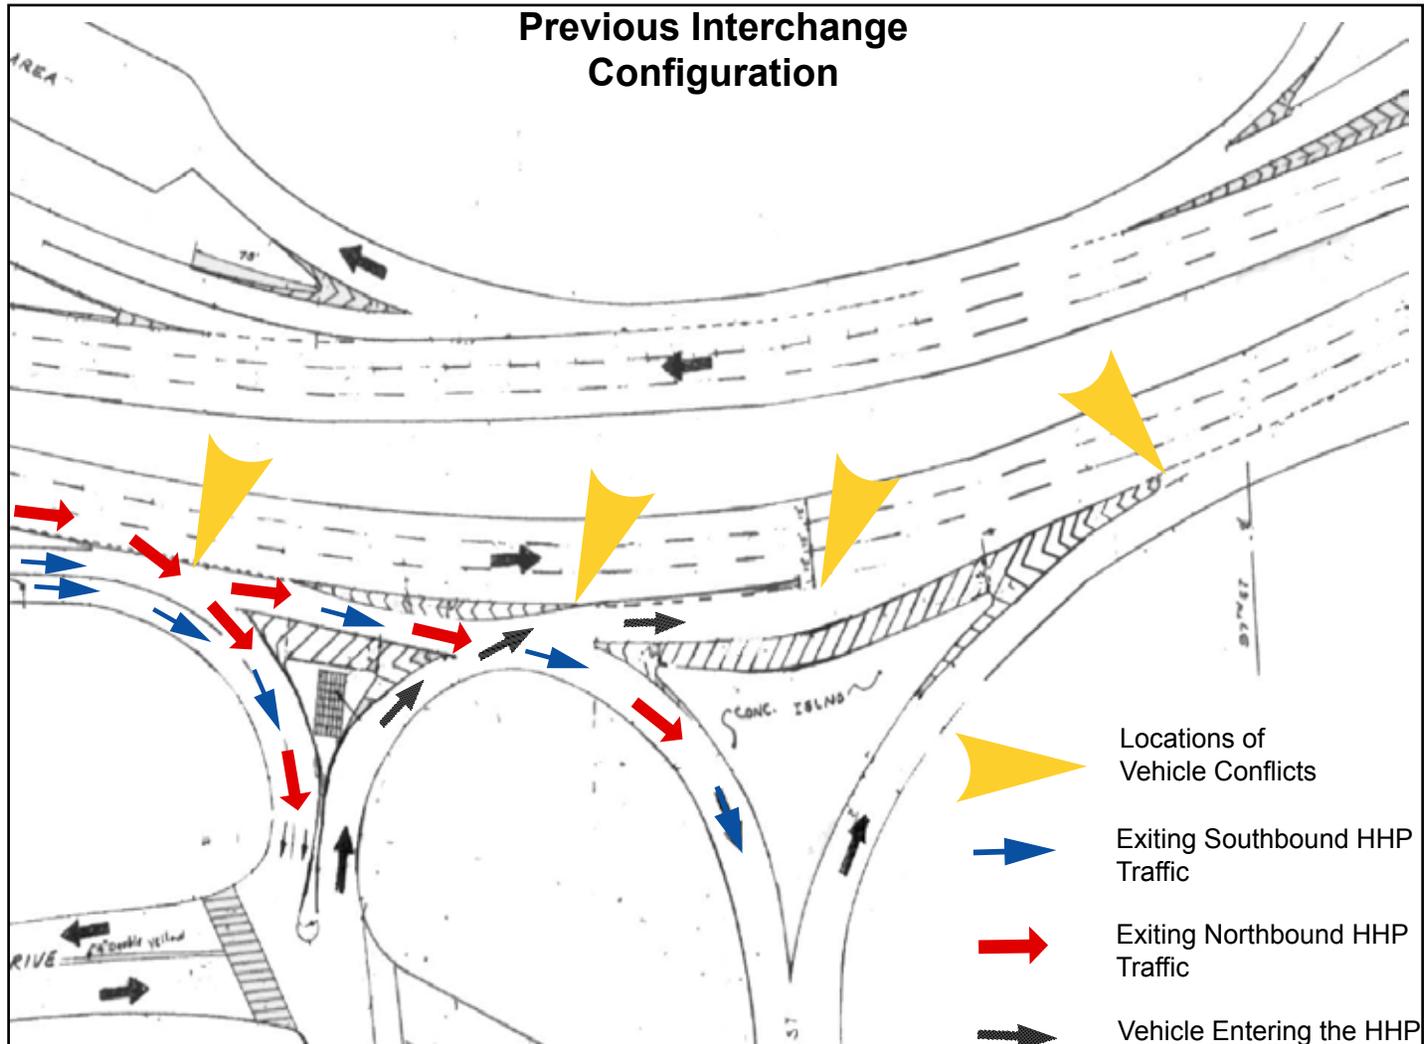
The original configuration of the interchange, as well as conflict points is illustrated graphically below:

The interchange had provided two pairs of closely spaced entrance and exit ramps, all with substandard conditions for weaving, accelerating/decelerating and queuing. This design required all vehicles exiting the Parkway from both the northbound and southbound directions to utilize a single ramp. From this ramp, they had the option to exit at either West 95th or West 96th Street. Additionally, the exit ramp also served as the entrance ramp for vehicles entering the northbound parkway from West 95th Street. The substandard weaving section created chronic vehicle conflicts resulting in frequent overtaking and rear-end crashes. Vehicle merges were made more difficult by the large speed differential in traffic entering and exiting the Parkway. Furthermore, the interchange created undesirable demands on nearby local streets that served the access and egress needs of the Parkway.

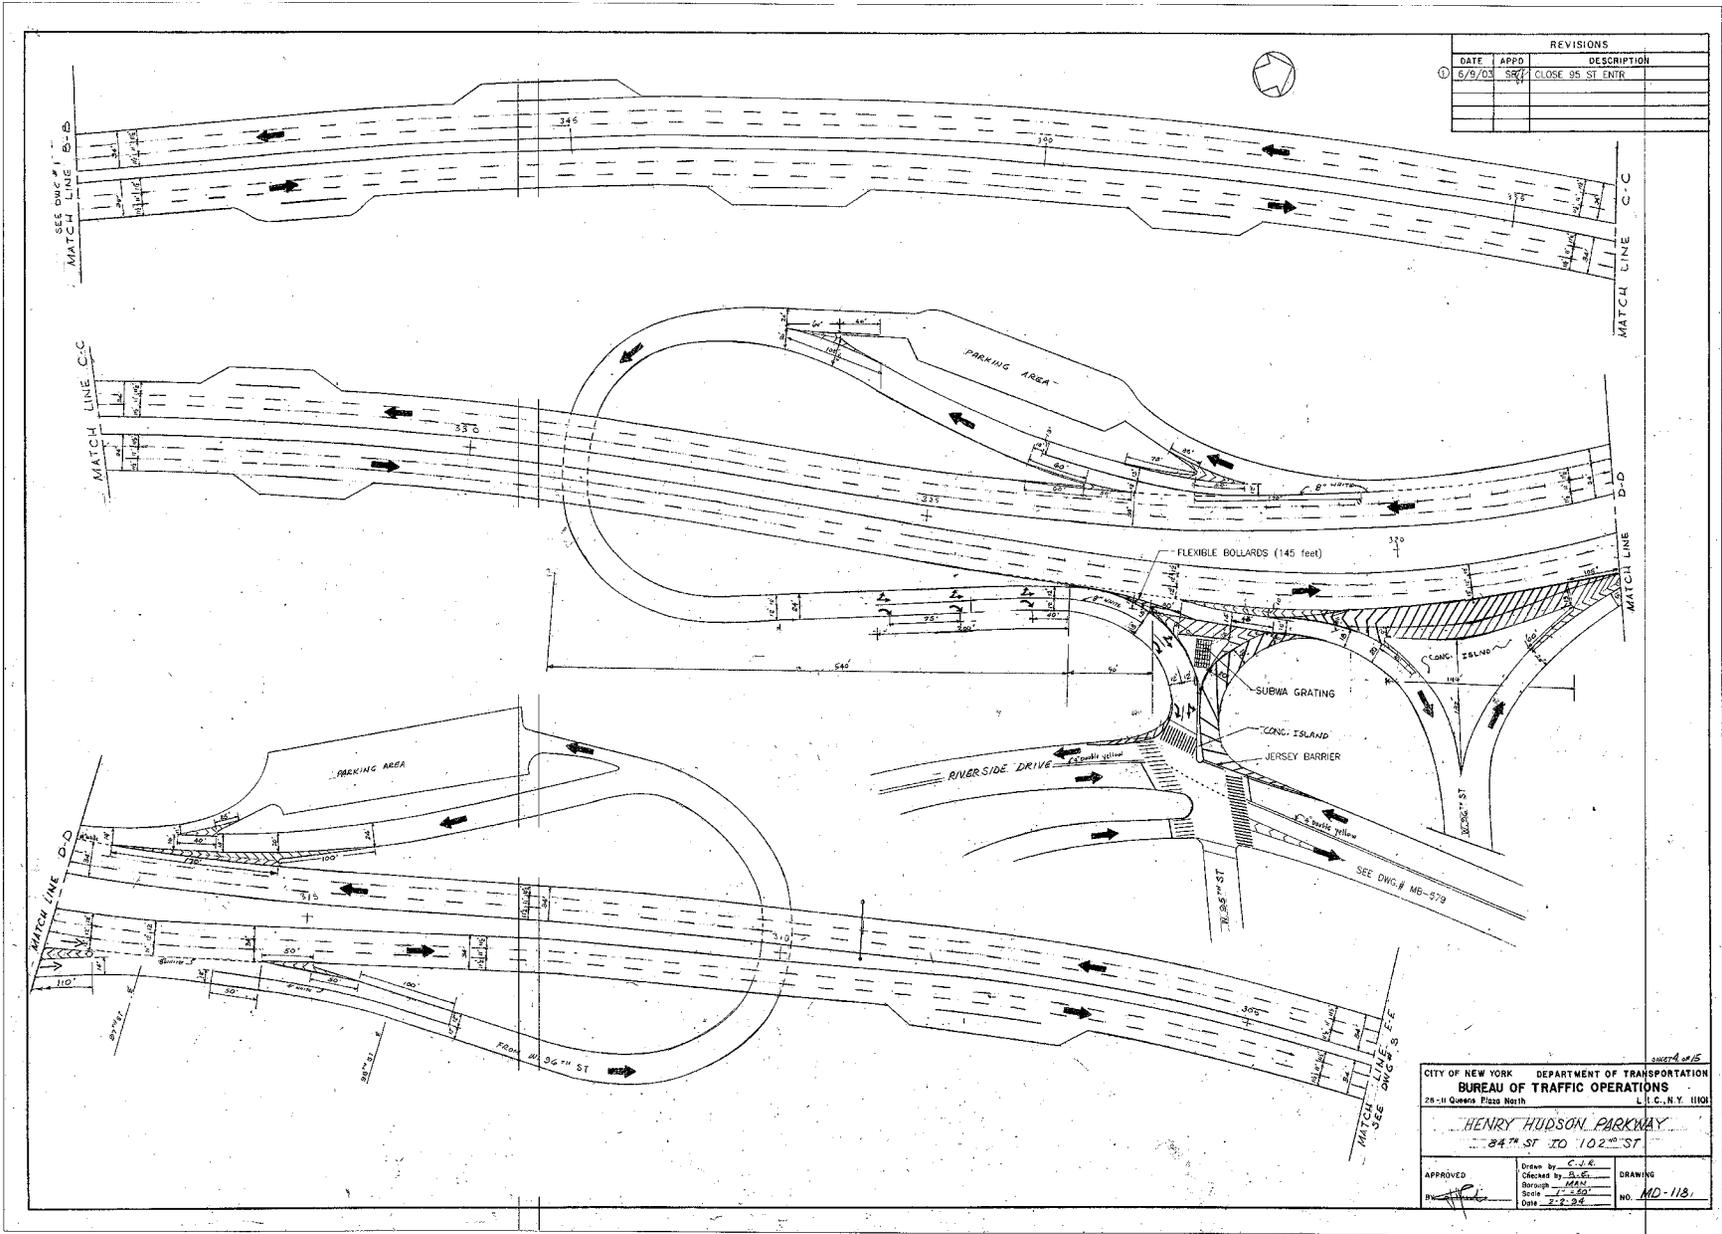
HENRY HUDSON PARKWAY
 84TH ST TO 102ND ST

REVISIONS		
DATE	APPD	DESCRIPTION
6/9/03	SS	CLOSE 95 ST ENTR

APPROVED	Drawn by <u>C.J.R.</u>	DRAWING
	Checked by <u>B.E.</u>	NO. <u>MD-118</u>
	Scale <u>1"=20'</u>	
	Date <u>2-2-04</u>

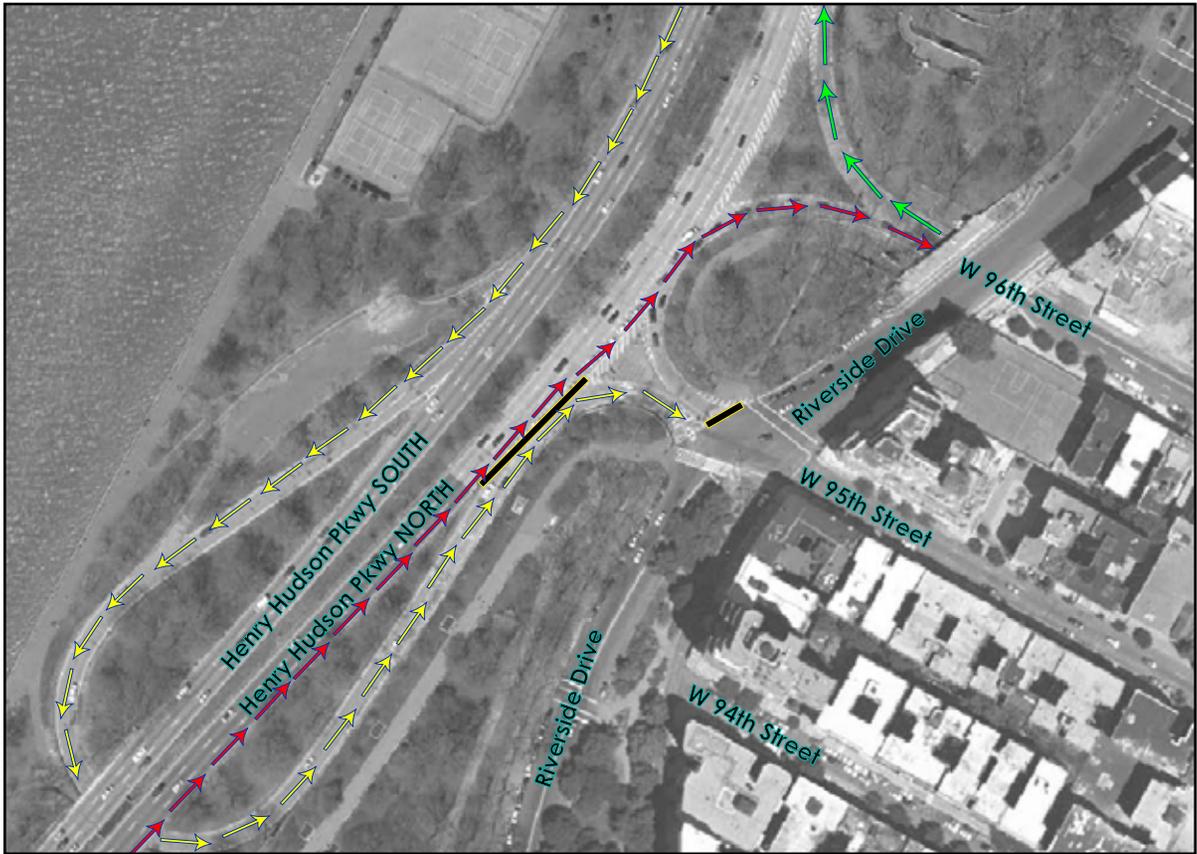
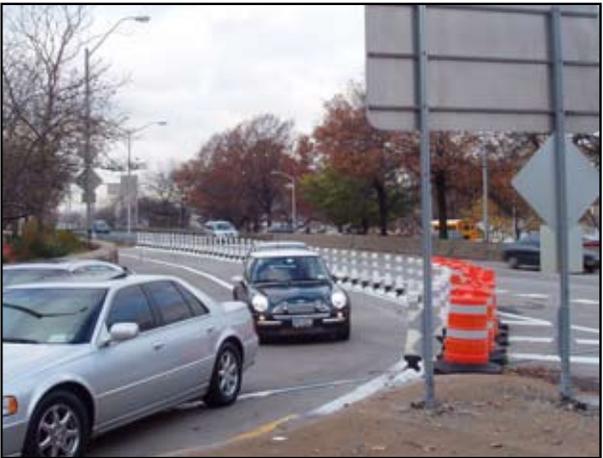
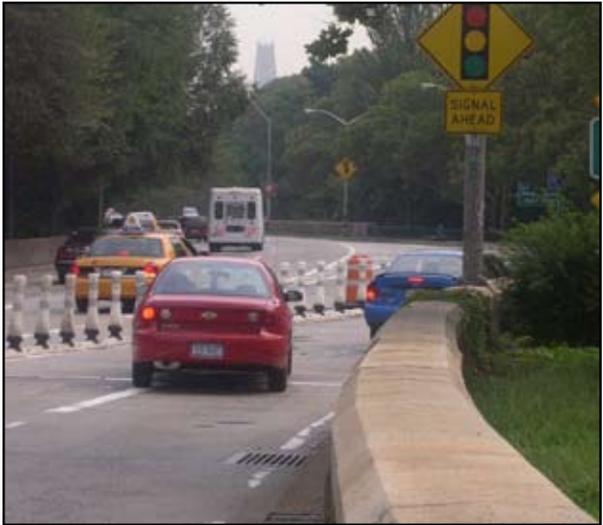
Clockwise from above: The operation of the Henry Hudson Parkway/ West 95th/96th Street Interchange under the new configuration. Flexible delineators, traffic barrels and improved markings for southbound vehicles exiting at West 95th Street. Advanced signage advises motorists of approaching signal. Oversized gantry mounted signage advises motorists of approaching exit ramp.

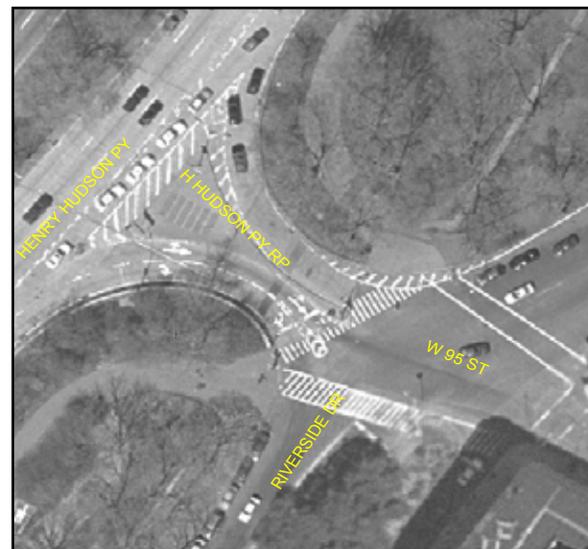
Original configuration of Intersection

The intersection of West 95th Street and Riverside Drive was a signalized four-way intersection with an entrance and exit ramp to the Henry Hudson Parkway along its western leg. Due to the curvature of the exit ramps from the northbound Henry Hudson Parkway, motorists had little time to react to pedestrians crossing the southwest side of the intersection. Motorists entering the northbound Henry Hudson Parkway, especially those turning from southbound Riverside Drive had limited visibility of pedestrians crossing on the northwest side of the intersection. Additionally, there was insufficient refuge area for pedestrians crossing between the exit and exit ramps.

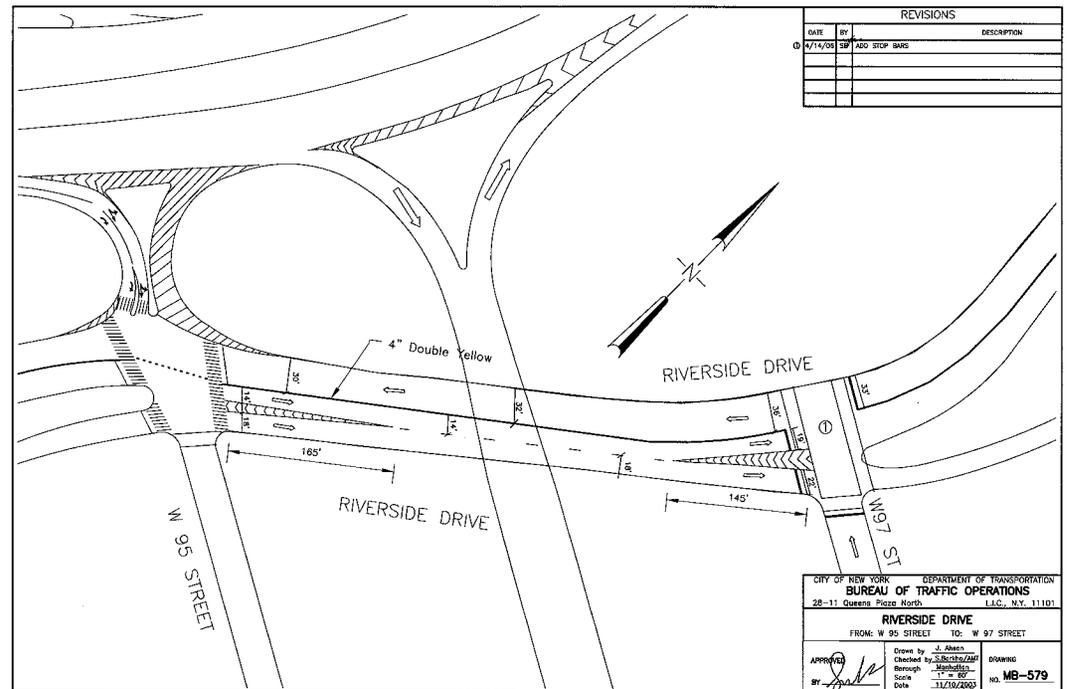
Details of new roadway markings and channelization on Riverside Drive

- As part of the overall changes in the operation of the Henry Hudson Parkway interchange, the Department closed the entrance ramp from West 95th Street and Riverside Drive to reduce conflicts on the Parkway. This closure was implemented through the use of signage and barriers.
- In an effort to better channelize traffic and organize weaving movement between the main roadway and service road of Riverside Drive, the Department installed additional roadway markings between West 95th and West 97th Streets. The improvement is illustrated below.

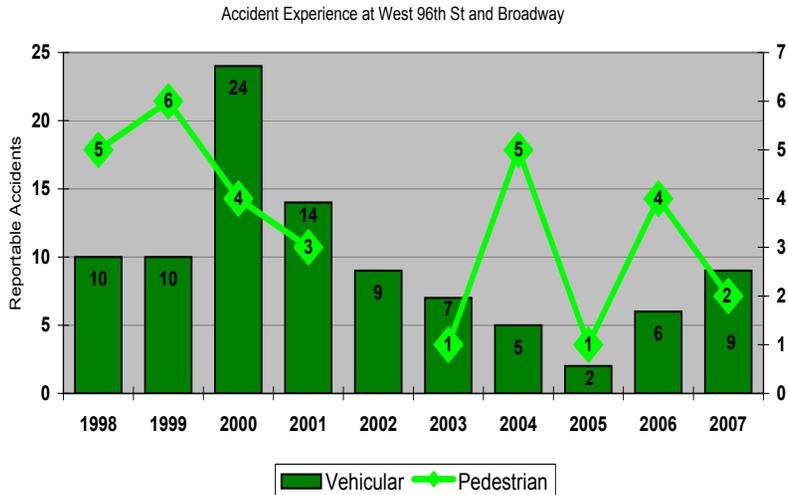
In both 1998 and 1999, pedestrian crashes accounted for approximately 30% of total reportable crashes. While vehicular crashes increased significantly in 2000, pedestrian crashes, as a percentage of all reportable crashes, declined to less than 15%. Starting in 2001, vehicular crashes began a downward

trend from a high of 24 in 2000 to a low of 2 in 2005 but then went back up to six and nine in 2006 and 2007, respectively. Pedestrian crashes steadily declined from 1999 to 2003 but had odd increases in 2004 and 2006. As with the other improvements implemented throughout this corridor, the treatments at this location are part of an overall plan for improving traffic and safety throughout the area.
