PHASE IA ARCHEOLOGICAL LITERATURE REVIEW AND SENSITIVITY ASSESSMENT

**West of Hudson Hydroelectric Project: Cannonsville, Downsville, and Neversink
Dams**

FERC Project No. 13287

Hartgen Archeological Associates, Inc.

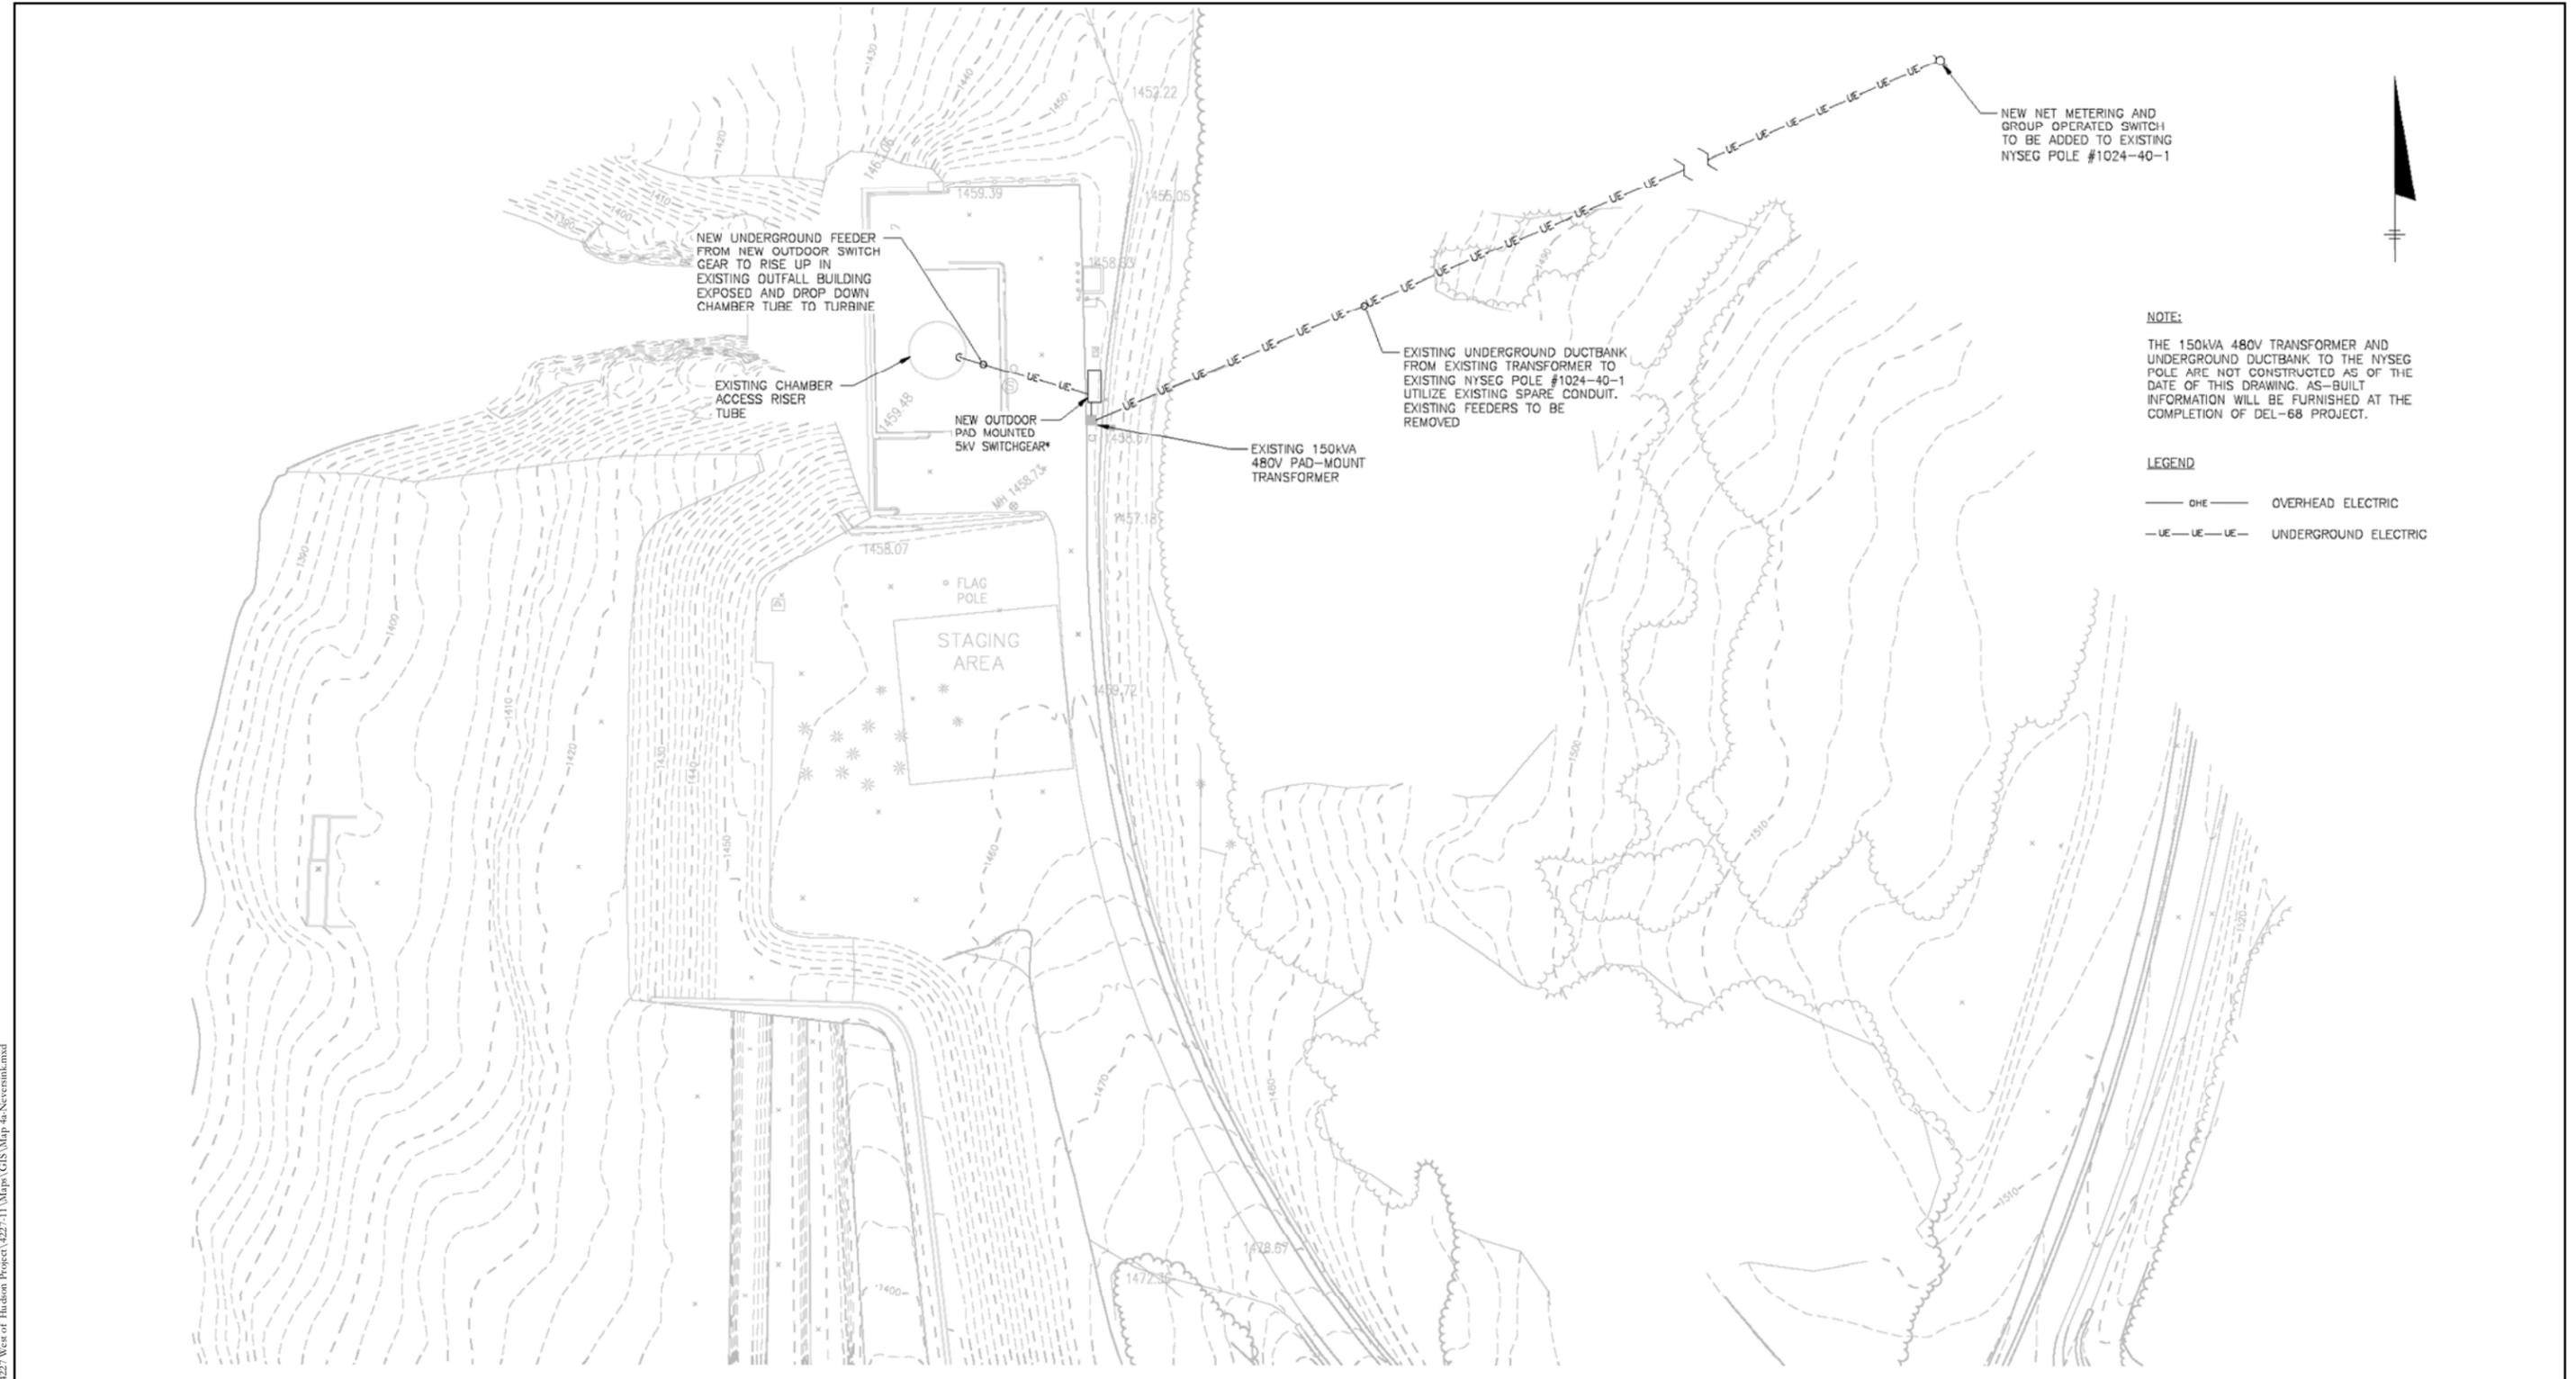
Map 4a

Conceptual Plan of Neversink
(DEP and O'Brien & Gere)

All three of the proposed developments of the Project are located within the existing reservoir systems for New York City (DEP 2009). Each is located within or immediately adjacent to the dams associated with each reservoir. At Neversink, the hydroelectric turbine will replace valves located between the intake structure for the East Delaware Tunnel and the inclined portal tunnel that provides a minimum flow for the Neversink River. Plans also include a small substation along the east elevation of the intake structure and a staging area just south of the intake structure (Map 4a). As will be discussed, the area proposed to be impacted by the Project at Neversink has been previously disturbed by the construction of the dam and its appurtenances.

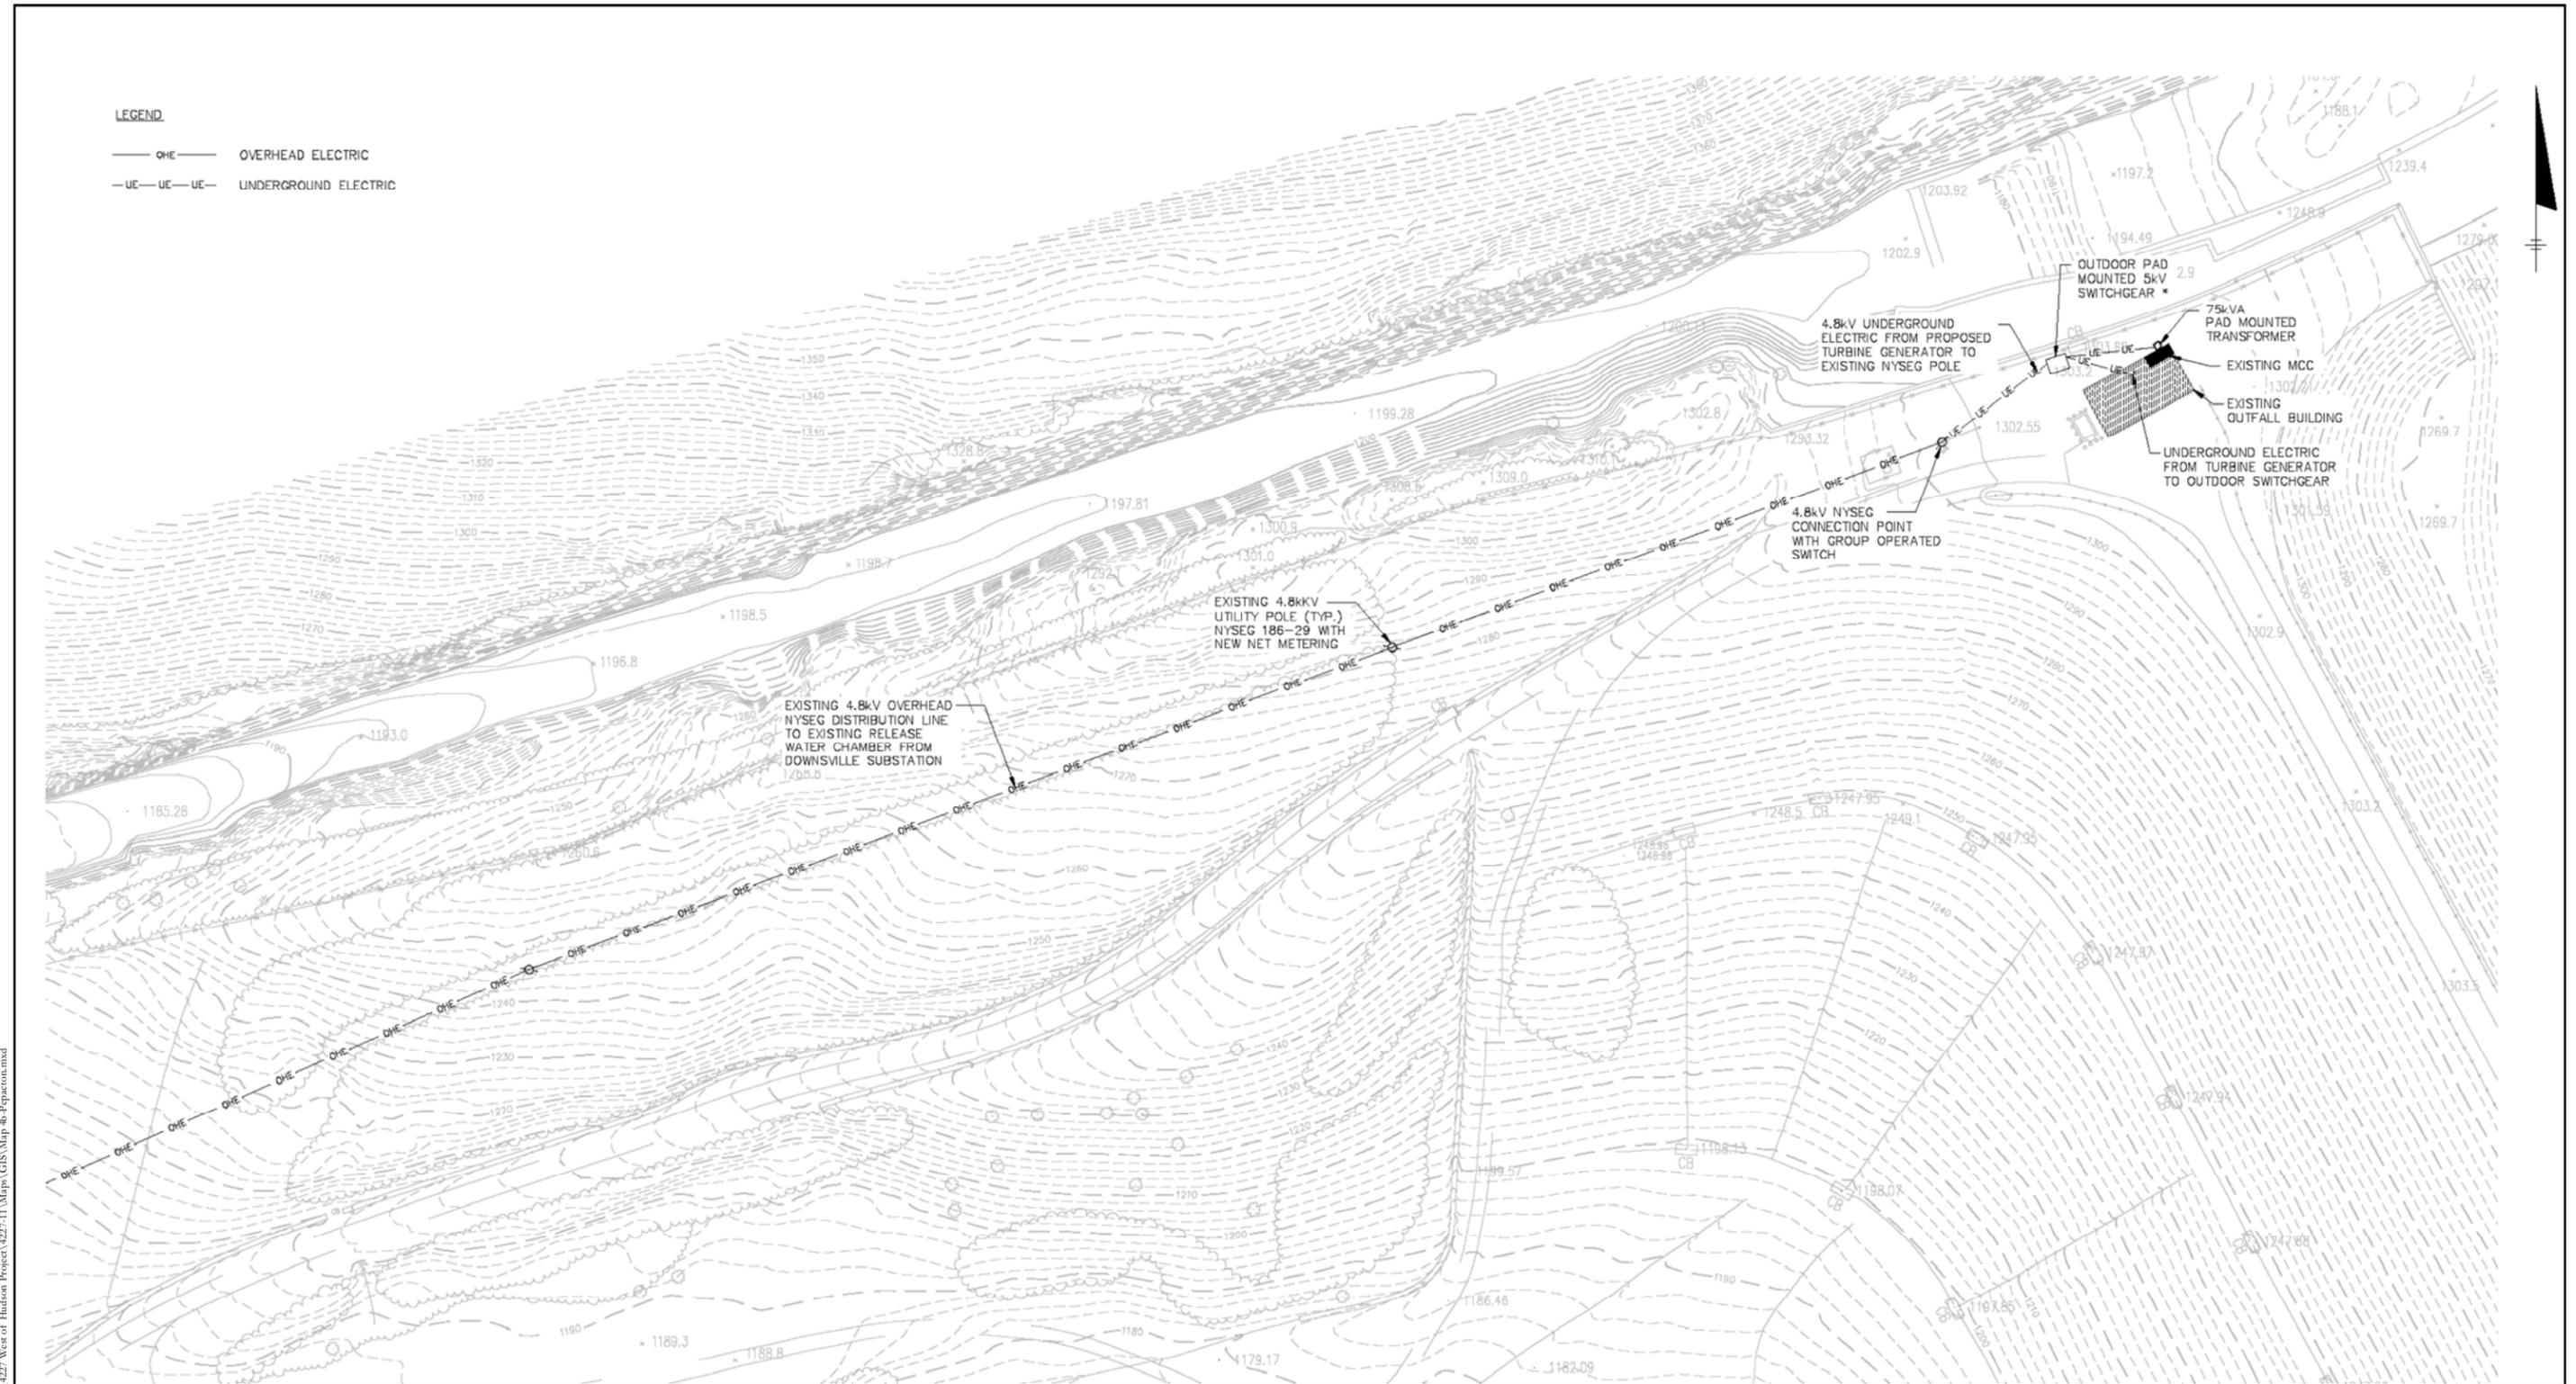
Map 4b

Conceptual Plan of Pepacton
 (DEP and O'Brien & Gere)

The Project will also include a hydroelectric turbine at the Downsville dam of the Pepacton Reservoir. The turbine will be located within the existing release water chamber at the spillway (Map 4b). One turbine will replace one of the existing valves in the release water chamber, the other valve will remain to control water when the turbine is off-line and for a bypass system. The valves are located in two, 5.5-foot diameter supply tunnels, that are 90 feet in length and connect to the inclined portal tunnel where water is discharged (DEP 2009).

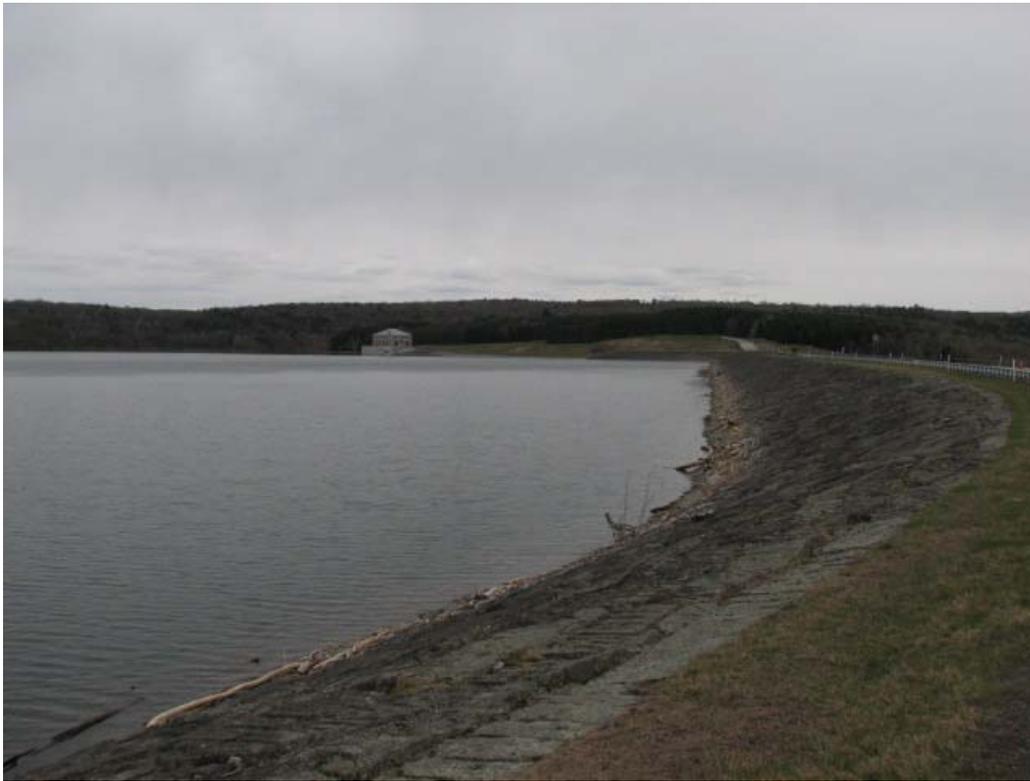
Photograph 1. The Neversink dam as viewed on the upstream portion towards the east. In the distance the intake structure can be seen, the Project proposes to replace one of the valves with a hydroelectric turbine.

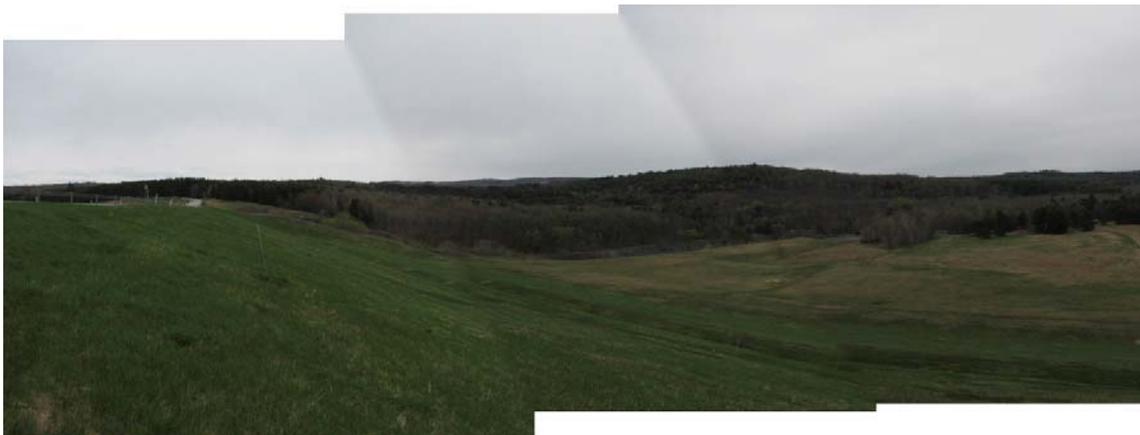
Photograph 2. View east of the downstream portion of the earthen dam at Neversink. The dam was constructed in 1953.

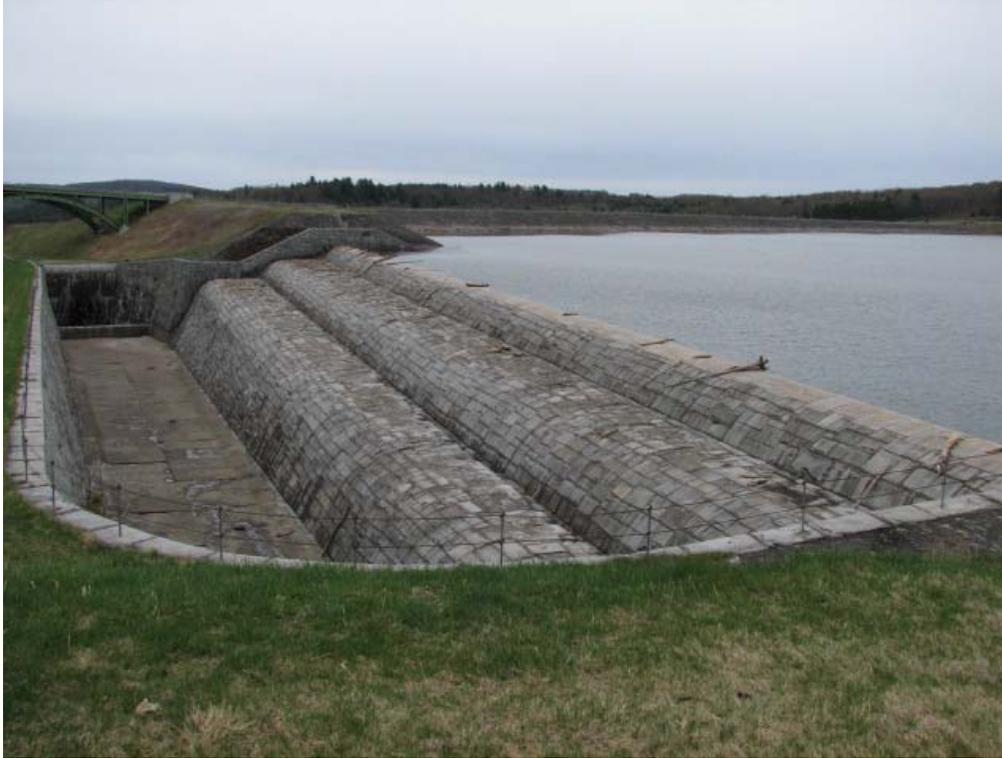
Photograph 3. The waste weir or spillway at the Neversink dam as viewed from the northeast. The weir is composed of three large steps faced in granite to minimize the effects of scouring. The water is diverted to an inclined tunnel at the west end of the weir, just beyond view.

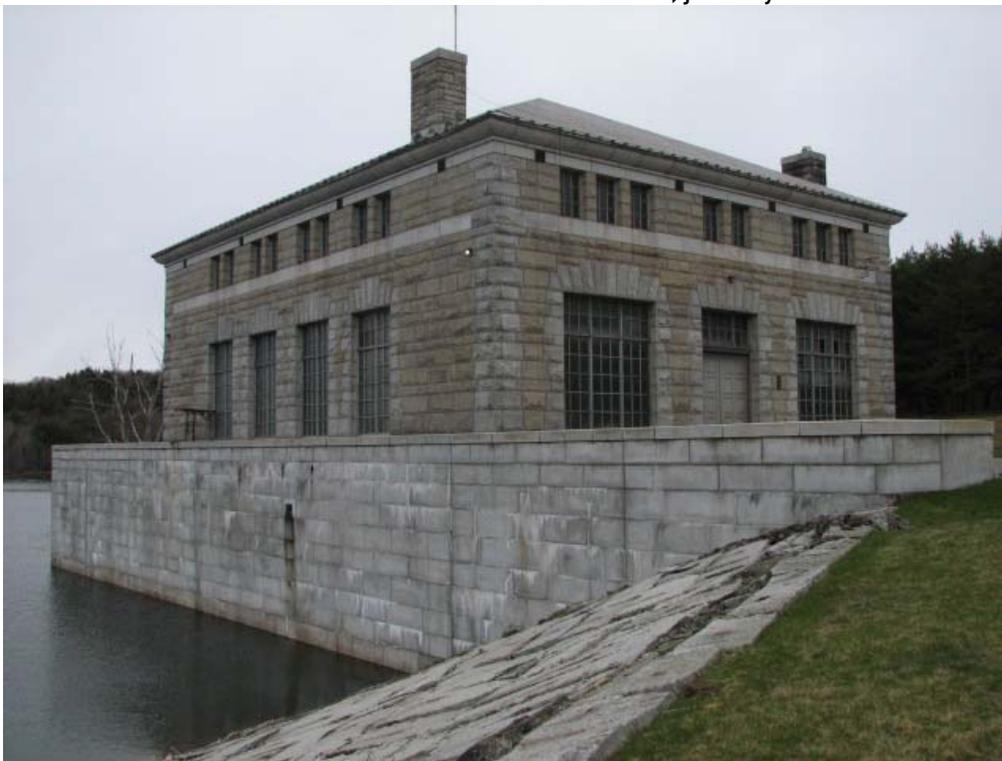
Photograph 4. The intake structure at the Neversink dam and tunnel. The structure regulates water flow through the Neversink Tunnel and a minimum flow to the Neversink River through the former diversion tunnel. The Project proposes to replace one of the existing valves with a hydroelectric turbine.

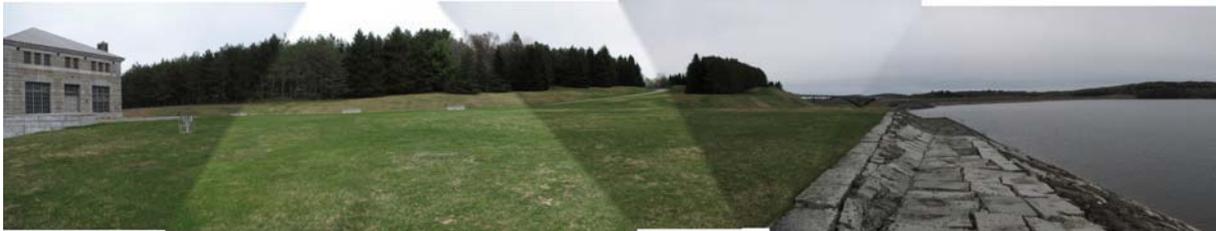
Photograph 6. The Project proposes to replace an existing valve at the structure with a hydroelectric turbine. The valve releases water into an inclined tunnel located below the lawn in the foreground. The tunnel empties into the spillway channel and to an outlet into the Neversink River. A staging area is likely to be located south (to the right) of the intake structure.

The proposed turbine will be installed in the release water tunnel between the intake chamber and the waste weir and outlet channel (Photo 6). The turbine will replace the existing valve that regulates the water through the release tunnel. Since the turbine will be installed in an existing facility, ground disturbing activities

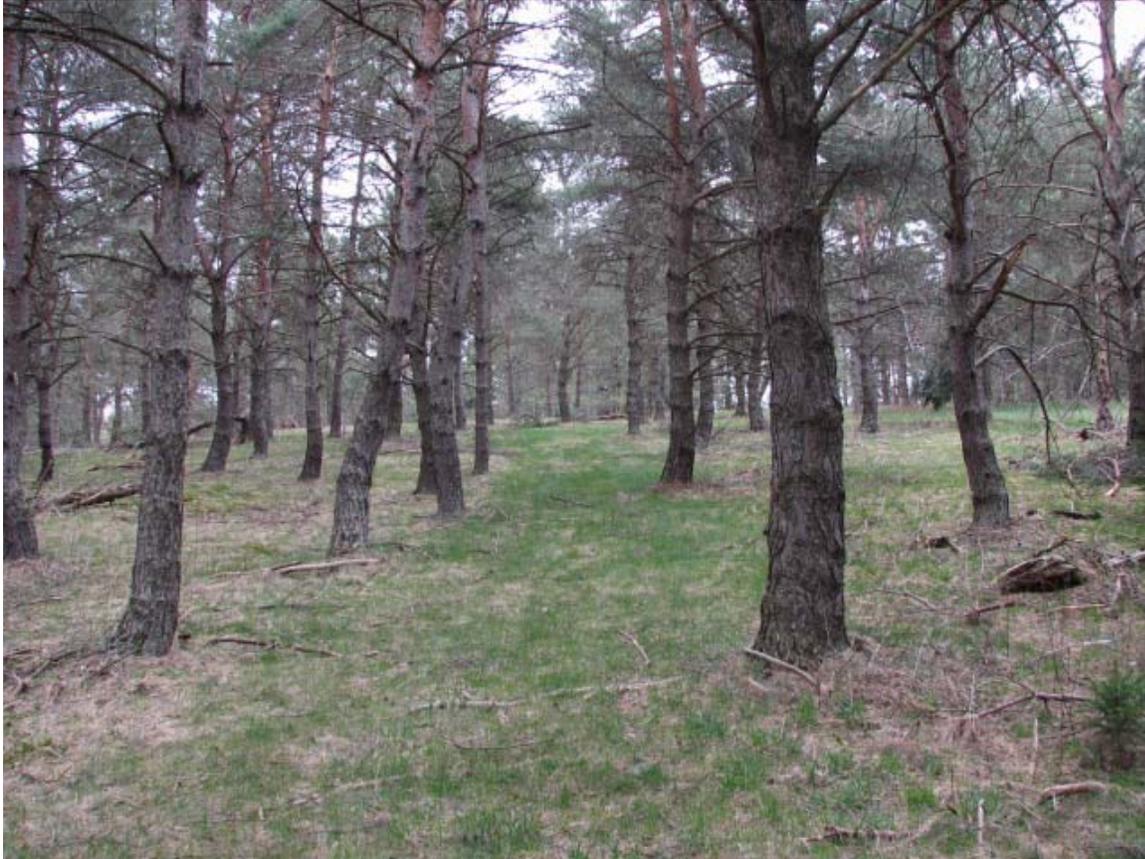
Photograph 7. The current plans for the Project include a distribution line that will utilize an existing underground ductbank located along this steep bank to NY 55 (in the background).

According to the construction documents and related photographs, this area has been heavily disturbed from the construction of the dam and nearby Neversink Tunnel. Early construction documents indicate that grading occurred at least to the 1,500 foot elevation level, or about half of the distance from the intake structure to NY 55. During the site visit, a lack of trees older than 50 years in age along the slope was noted, indicating that the entire hill side was cleared of vegetation and perhaps graded as part of the dam building efforts in the early 1950s (Photo 7).

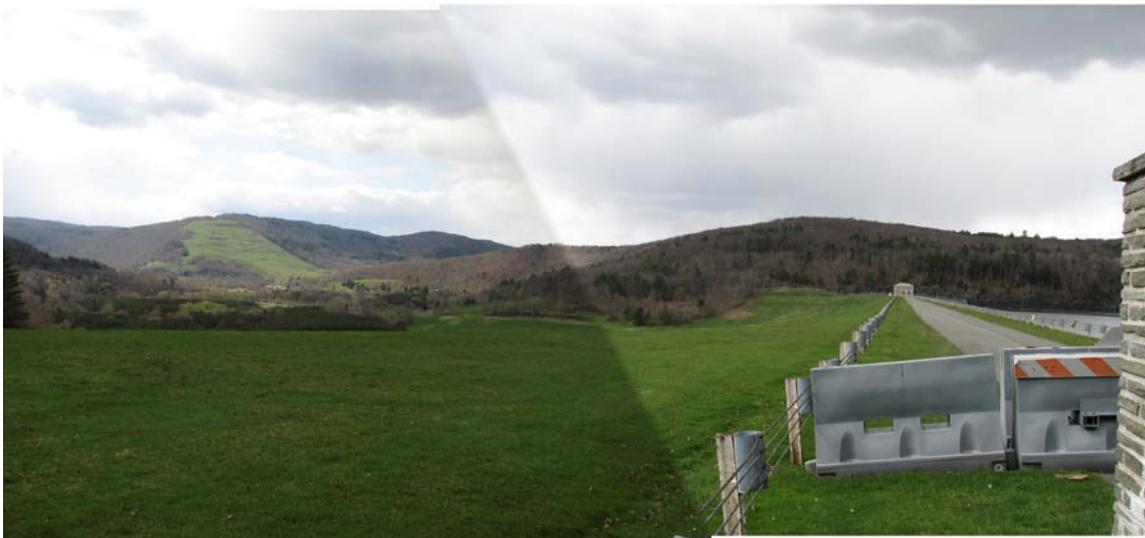
Photograph 8. View north of the downstream portion of the earthen dam at Downsville created for the Pepacton Reservoir. The proposed turbine will be installed in the valve control structure at the north end of the dam, seen at a distance in the photograph.

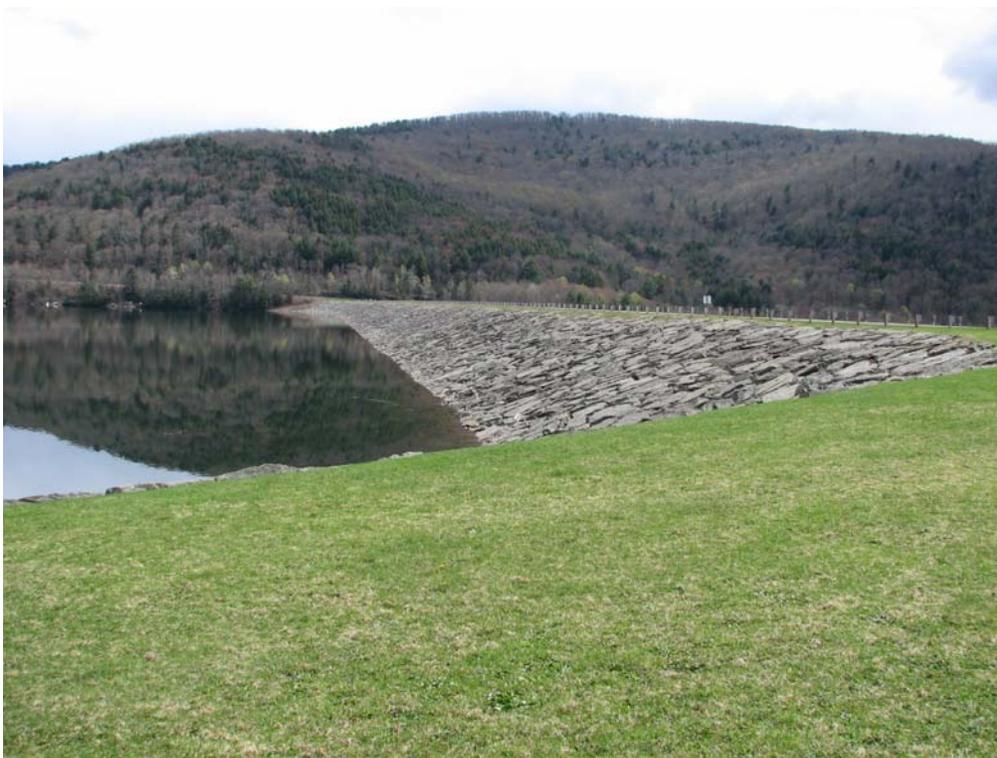
Photograph 9. Upstream portion of the Downsville dam as viewed to the southwest. Stone rip-rap lines the interior section of the earthen dam. The proposed project area is just out of view to the right.

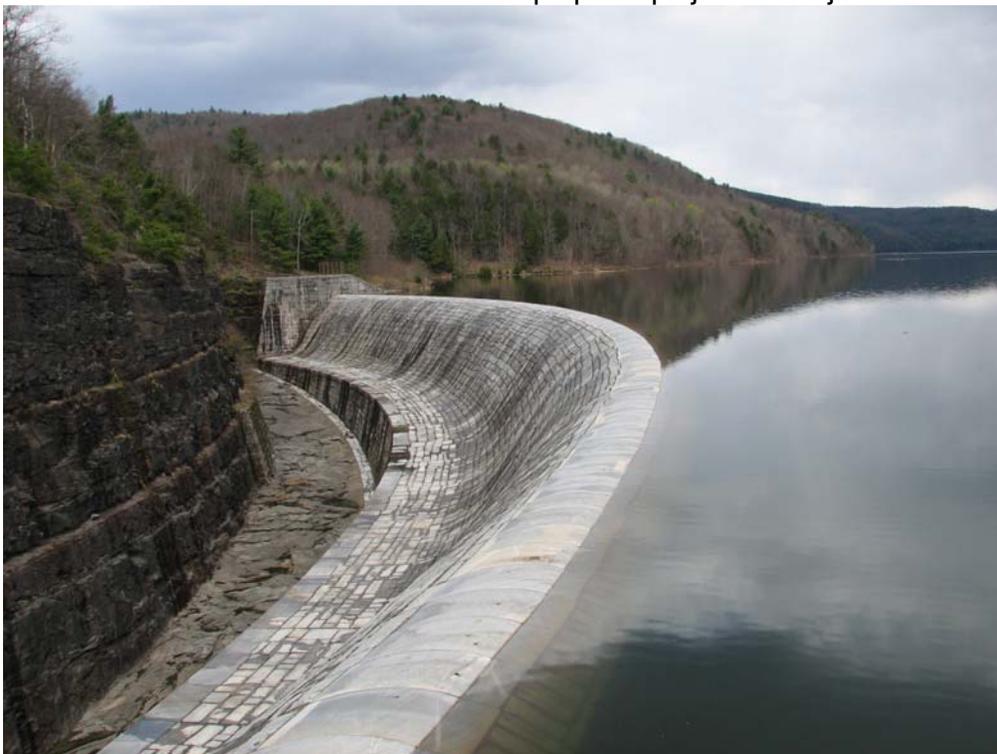
Photograph 10. View east of the waste weir of the Downsville dam. The ogee crest of the weir is faced with granite. A waste channel to the left is excavated out of bedrock.

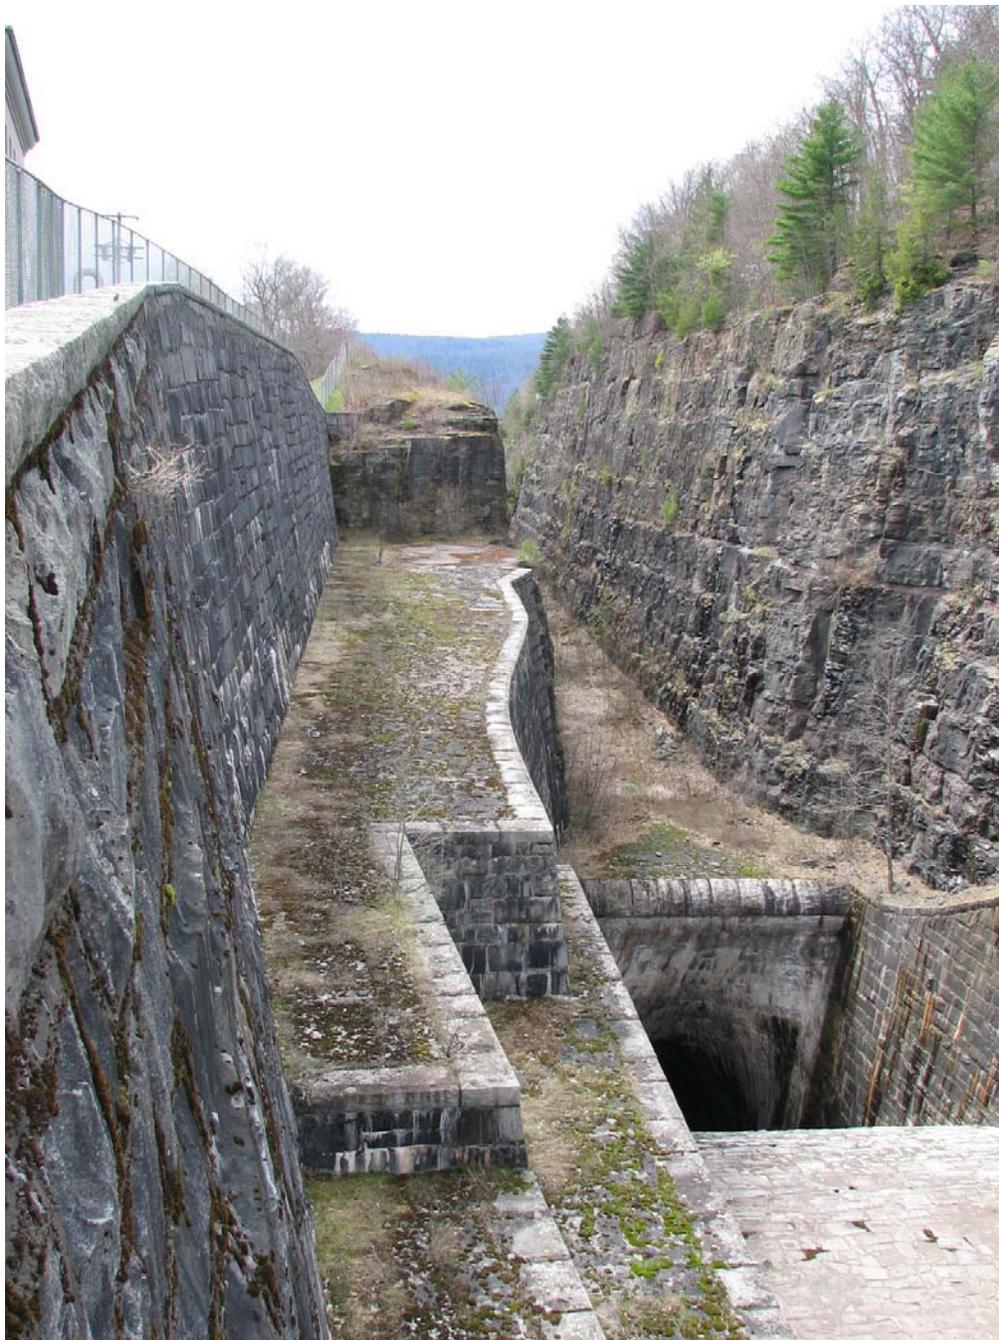
Photograph 11. View west of the spillway channel of the Downsville dam. Below is the inclined tunnel lined in concrete that was once part of the diversion tunnel. The valve structure regulates a minimum flow of water from the reservoir and is located just out of view to the left. Water released from the valve structure enters the inclined tunnel below. Above the inclined tunnel is a secondary spillway channel for overflow at peak discharges. The Project proposes to replace the valve with a turbine.

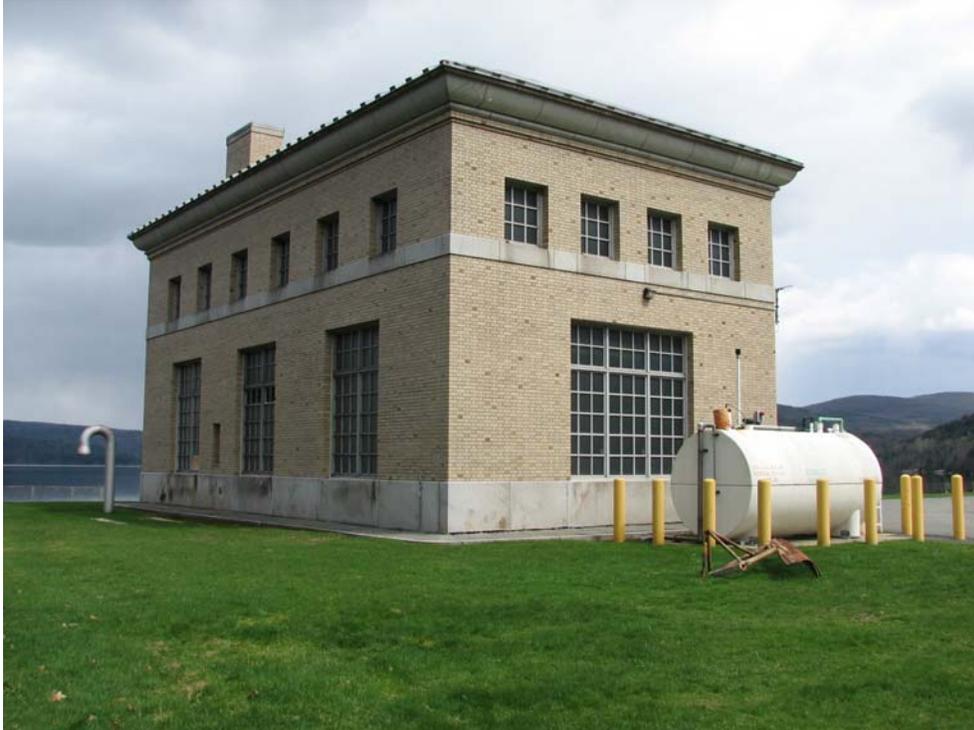
Photograph 12. The valve structure at the north abutment of the Downsville dam. The two-story brick and masonry building houses two valves that regulate minimum flow from the reservoir. The Project proposes to replace one of the valves with a turbine. A switchyard will be built in the immediate vicinity.

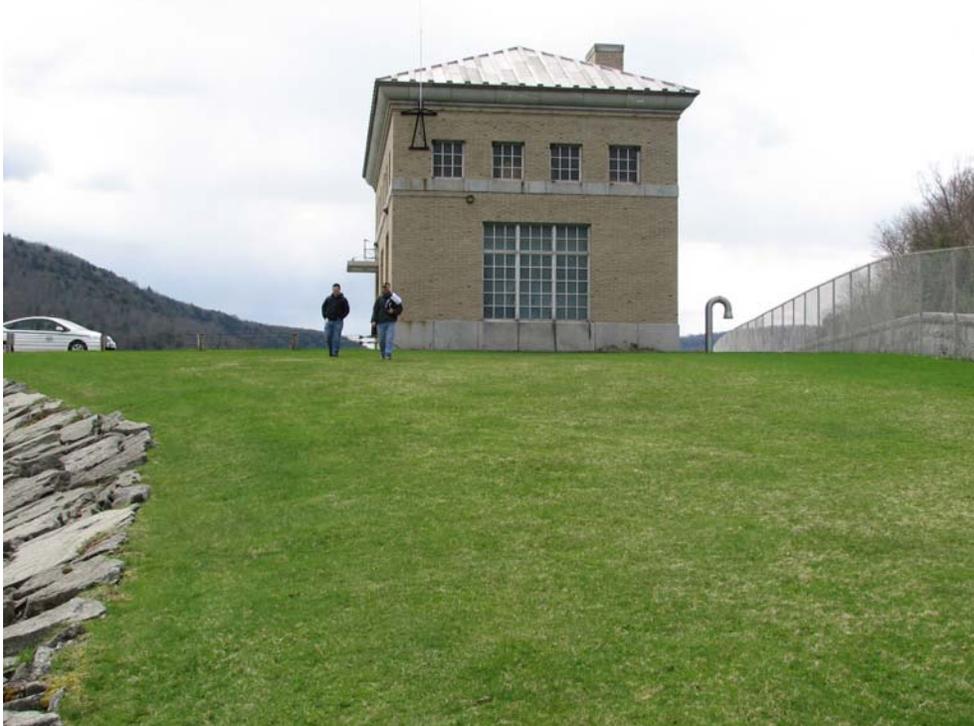
Photograph 13. View west of the valve structure at Downsville dam, the rip-rap of the dam is to the left and to the right beyond the chain-link fence is the spillway channel.

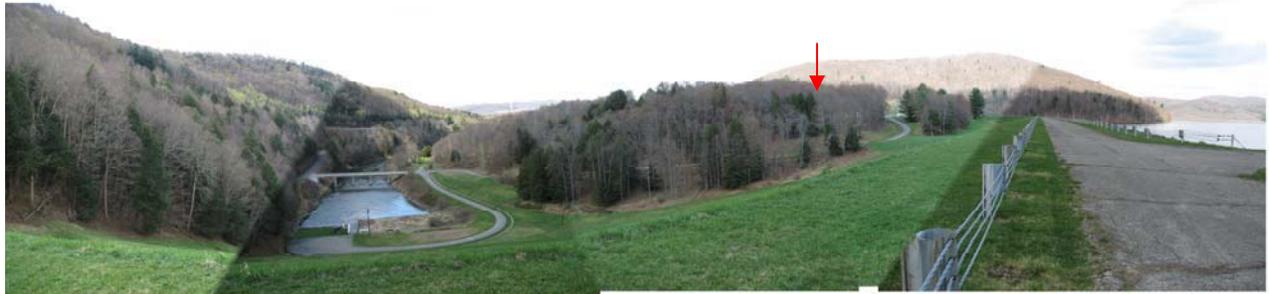
Photograph 14. A view of the downstream side of the Cannonsville dam. To the right is an access road at the top of the dam. To the lower left is the release chamber below the dam. The proposed powerhouse will be sited next to the existing release chamber. A small cluster of outbuildings are located in the distance, as indicated by the arrow.

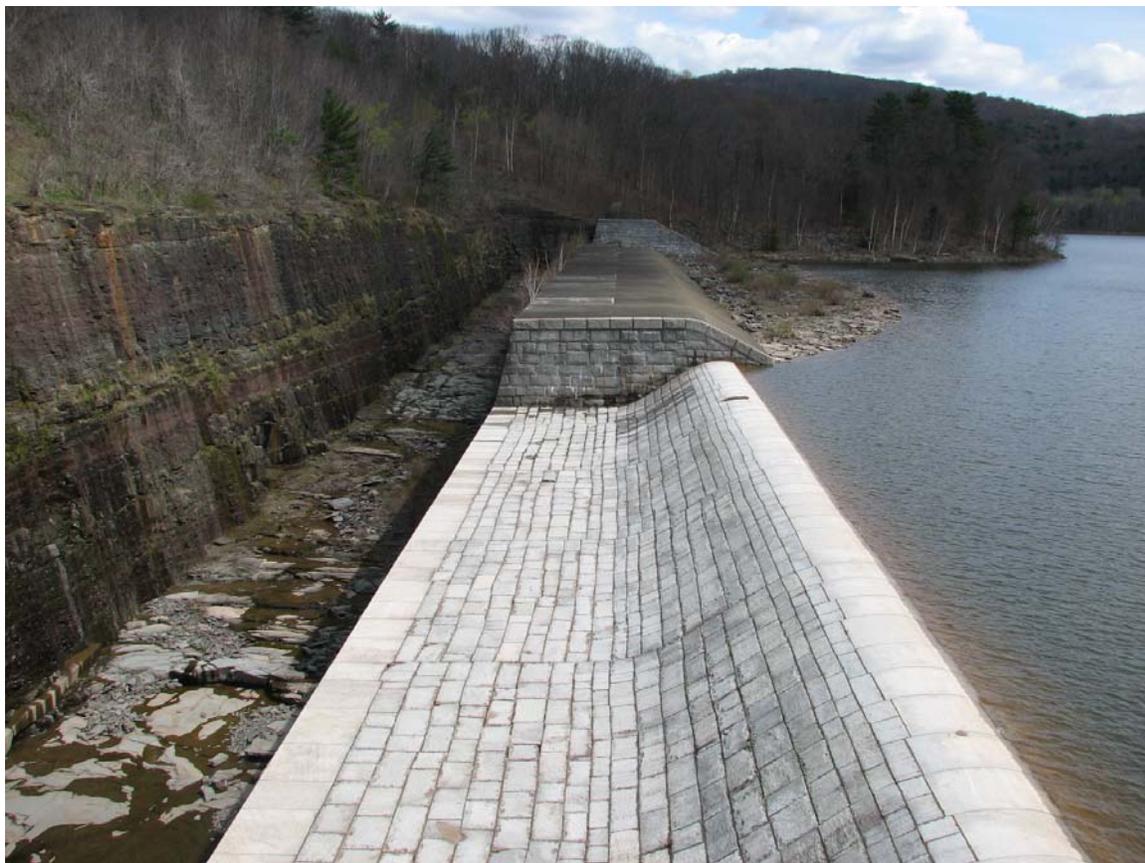
Photograph 15. The doubled-crested waste weir at Cannonsville dam and its associated spillway. The ogee-shaped weir is faced in granite. The spillway channel is cut through bedrock.

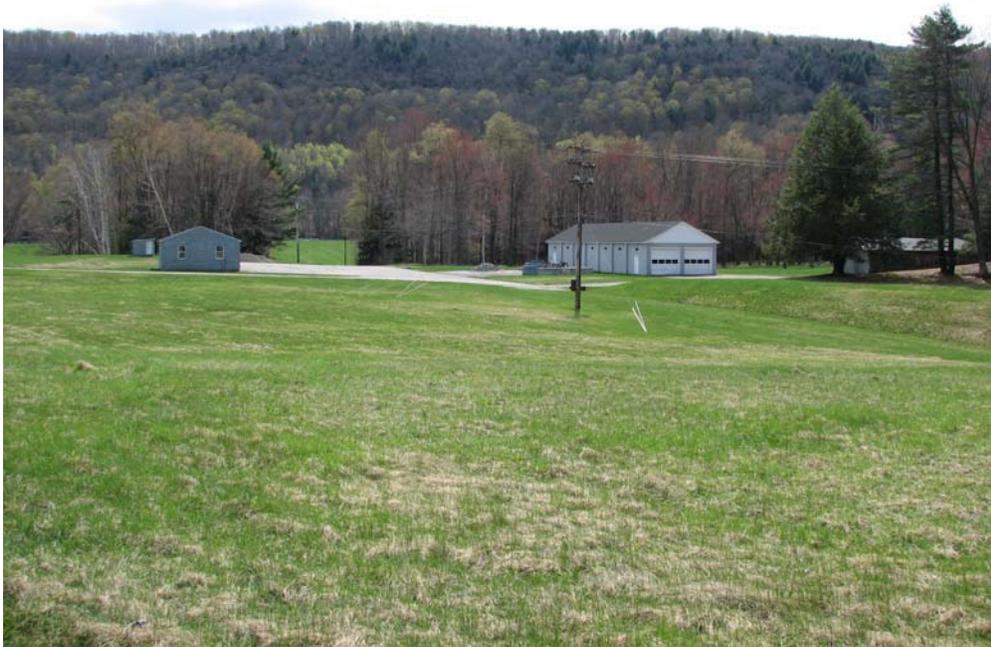
Photograph 16. A small cluster of maintenance buildings remain along the top of the Cannonsville dam. Several other structures, including the Engineer's office and laboratory, were moved and/or demolished over the years, view west. A switchyard or substation will be sited just behind the garage.

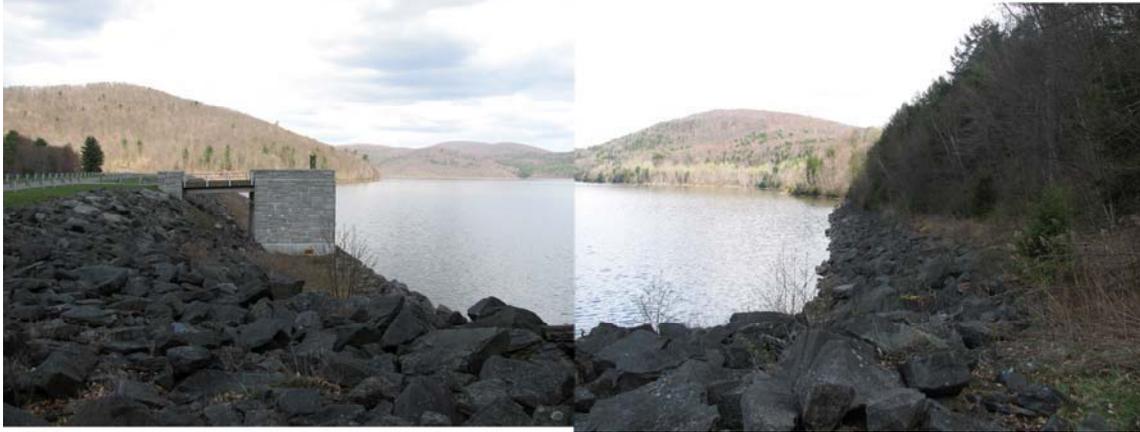
Photograph 18. The intake structure along the reservoir at the Cannonsville dam, viewed to the southeast. The upstream portion of the dam is lined with stone rip-rap.

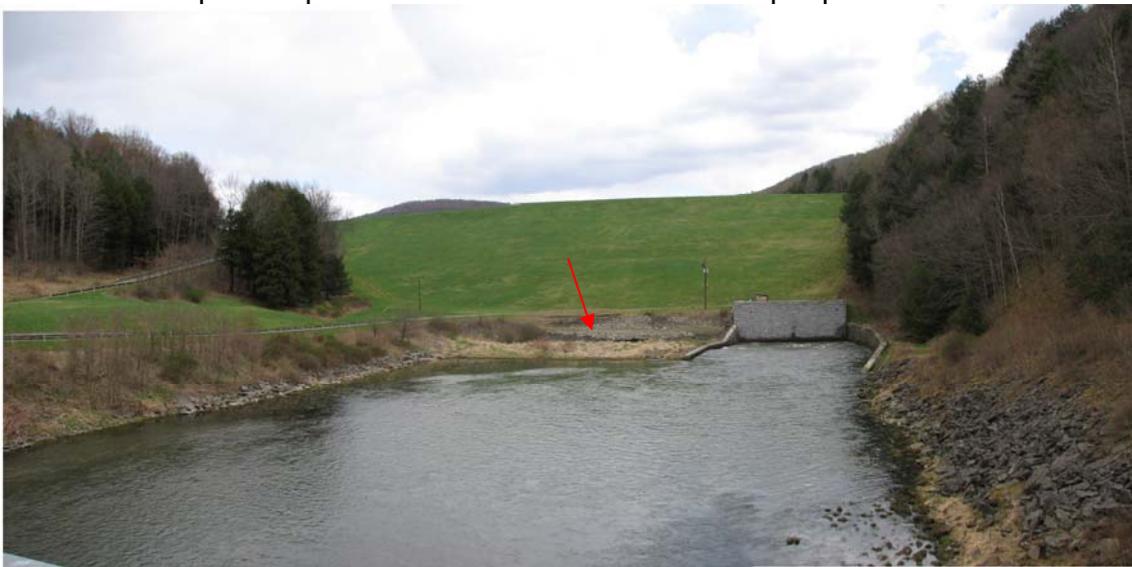
Photograph 19. The release chamber is located at the western abutment of the Cannonsville dam. The proposed powerhouse will be located to the east of the chamber, as indicated by the arrow. The distribution lines will extend up the dam face to the maintenance facility.

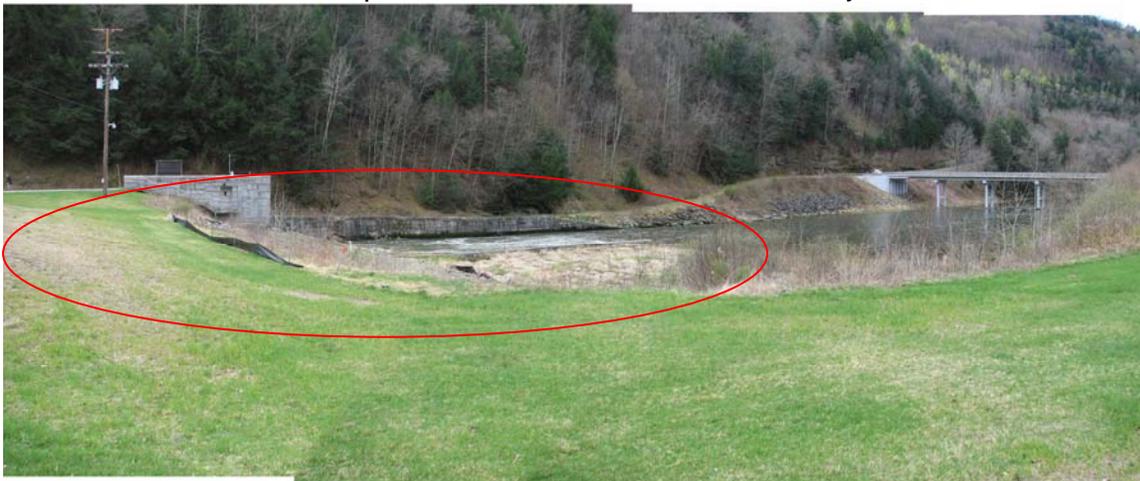
Photograph 20. A view west of the proposed location of the powerhouse at Cannonsville dam. The powerhouse will be situated in the area (see oval) previously disturbed by the construction of the dam and the deep stilling pool at the end of the release chamber.
