PHASE IA ARCHEOLOGICAL LITERATURE REVIEW AND SENSITIVITY ASSESSMENT

**West of Hudson Hydroelectric Project: Cannonsville, Downsville, and Neversink
Dams**

FERC Project No. 13287

Hartgen Archeological Associates, Inc.

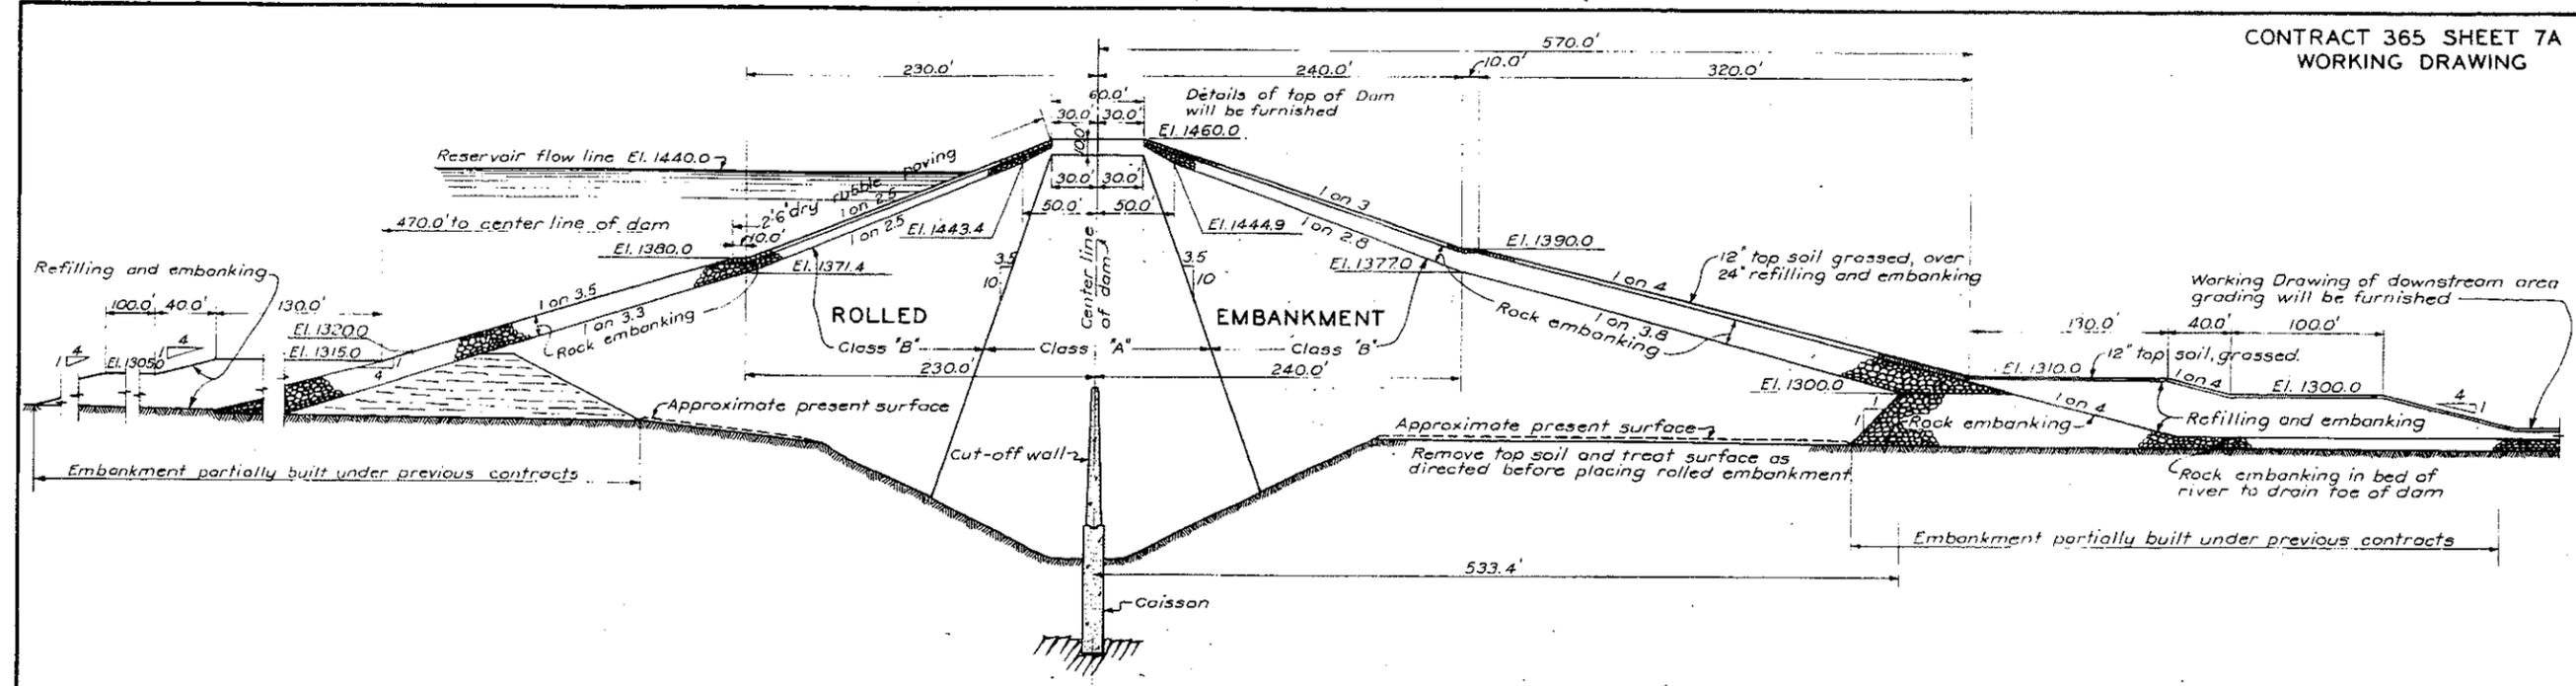
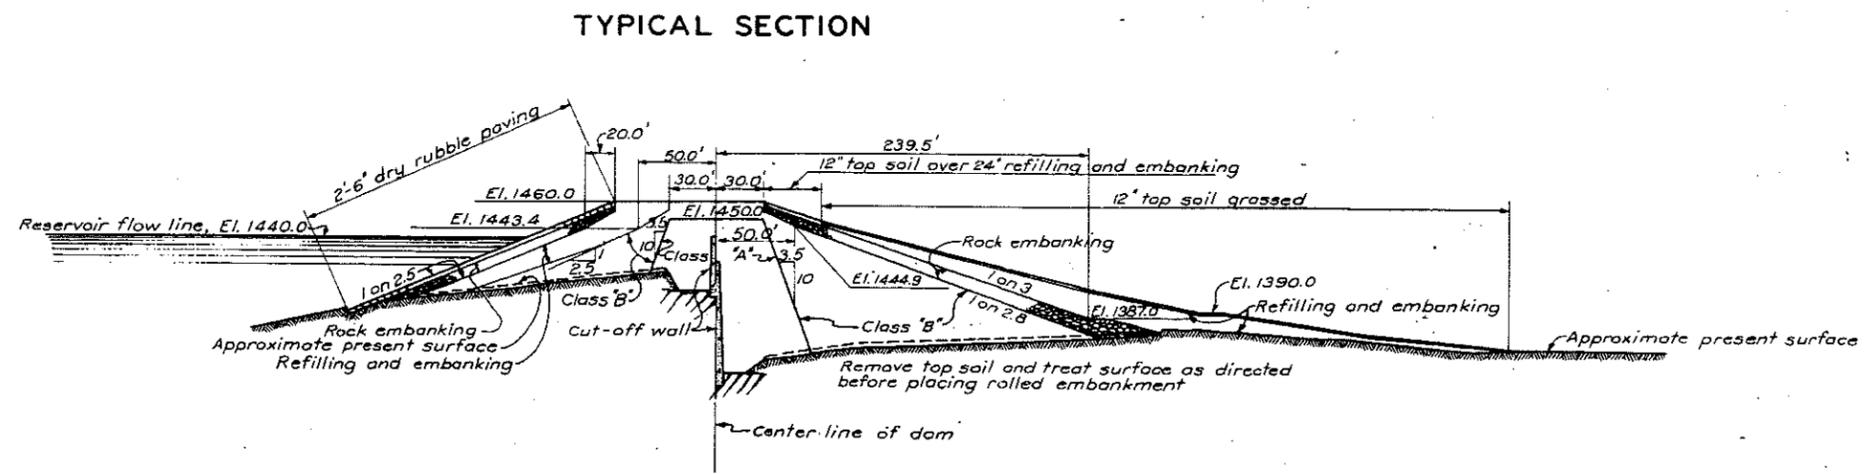
City of New York
BOARD OF WATER SUPPLY
NEVERSINK DAM
SECTIONS
MARCH 18, 1949

Dimensions given for finished surface do not apply at ends of dam.
For plan showing surface grading at ends of dam and location of Sections A-A, B-B and C-C, see Sheet 5A, Acc. 641B7.
For downstream slope drainage, see Sheet 7B, Acc. 641B8.

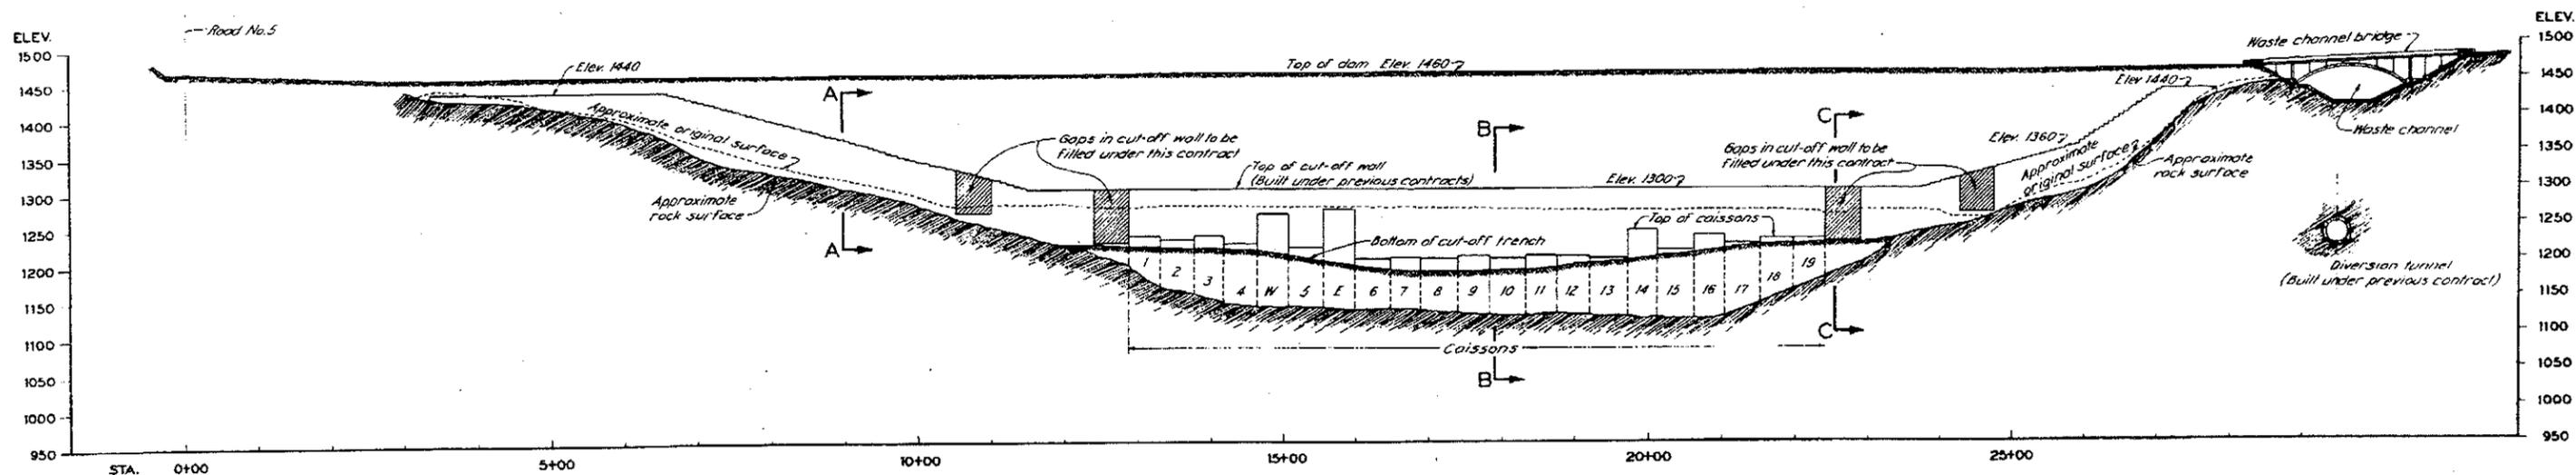
City of New York
BOARD OF WATER SUPPLY
NEVERSINK DAM
PROFILE
100 0 100 200 FT.
JANUARY 2, 1948

PROFILE OF DAM ON CENTER LINE
(Looking upstream)

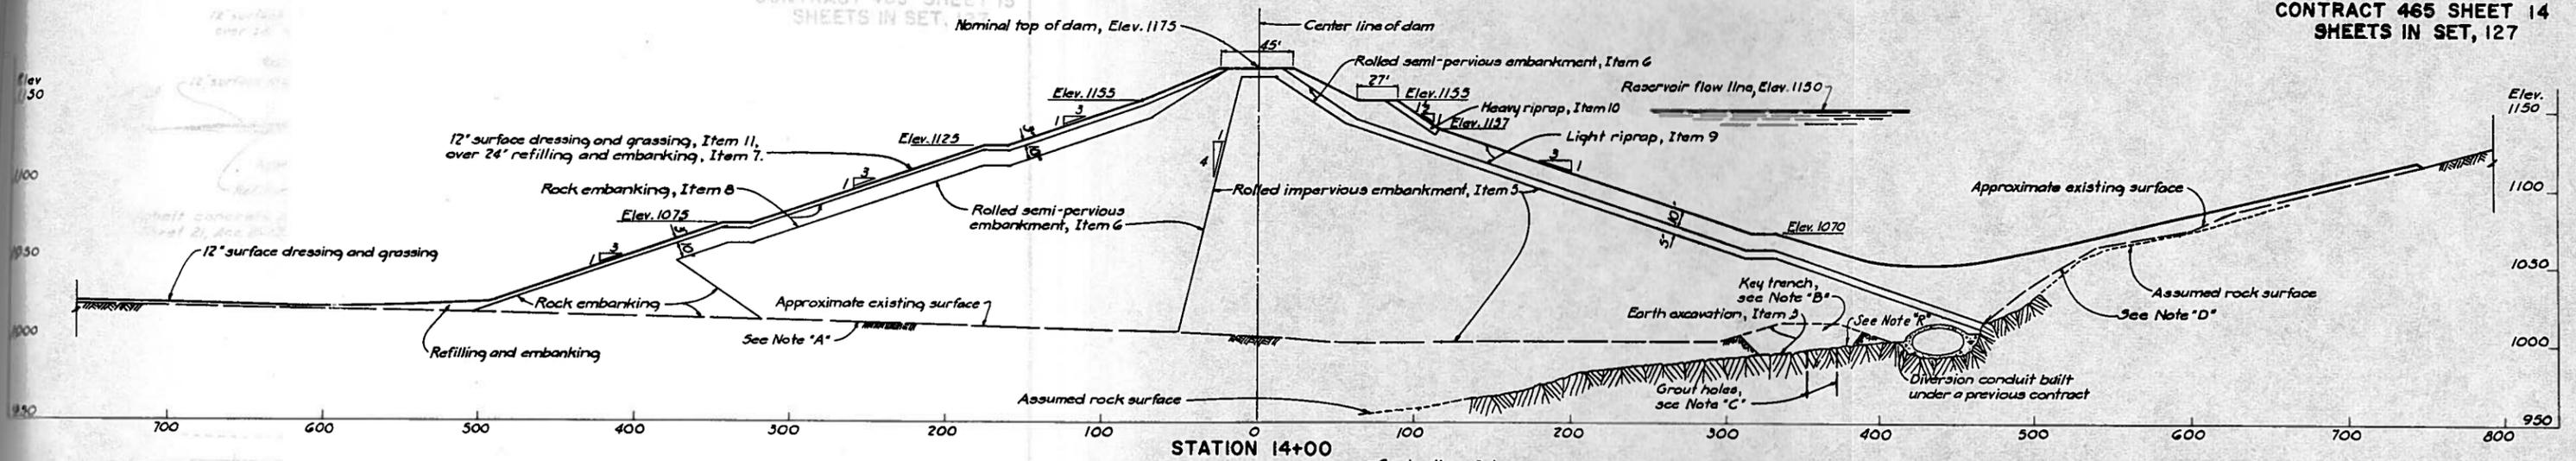
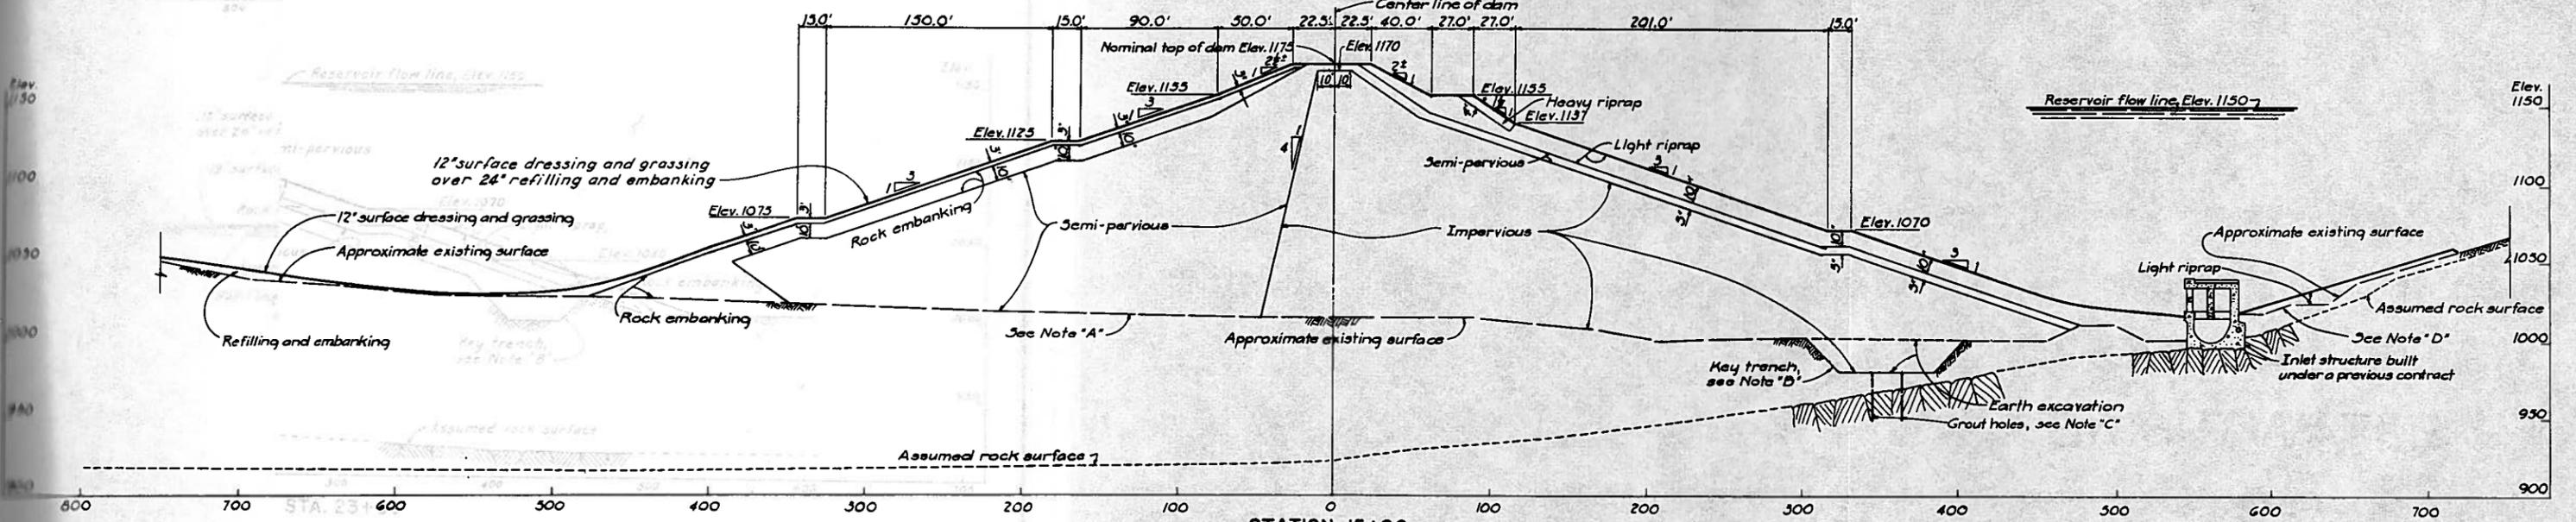
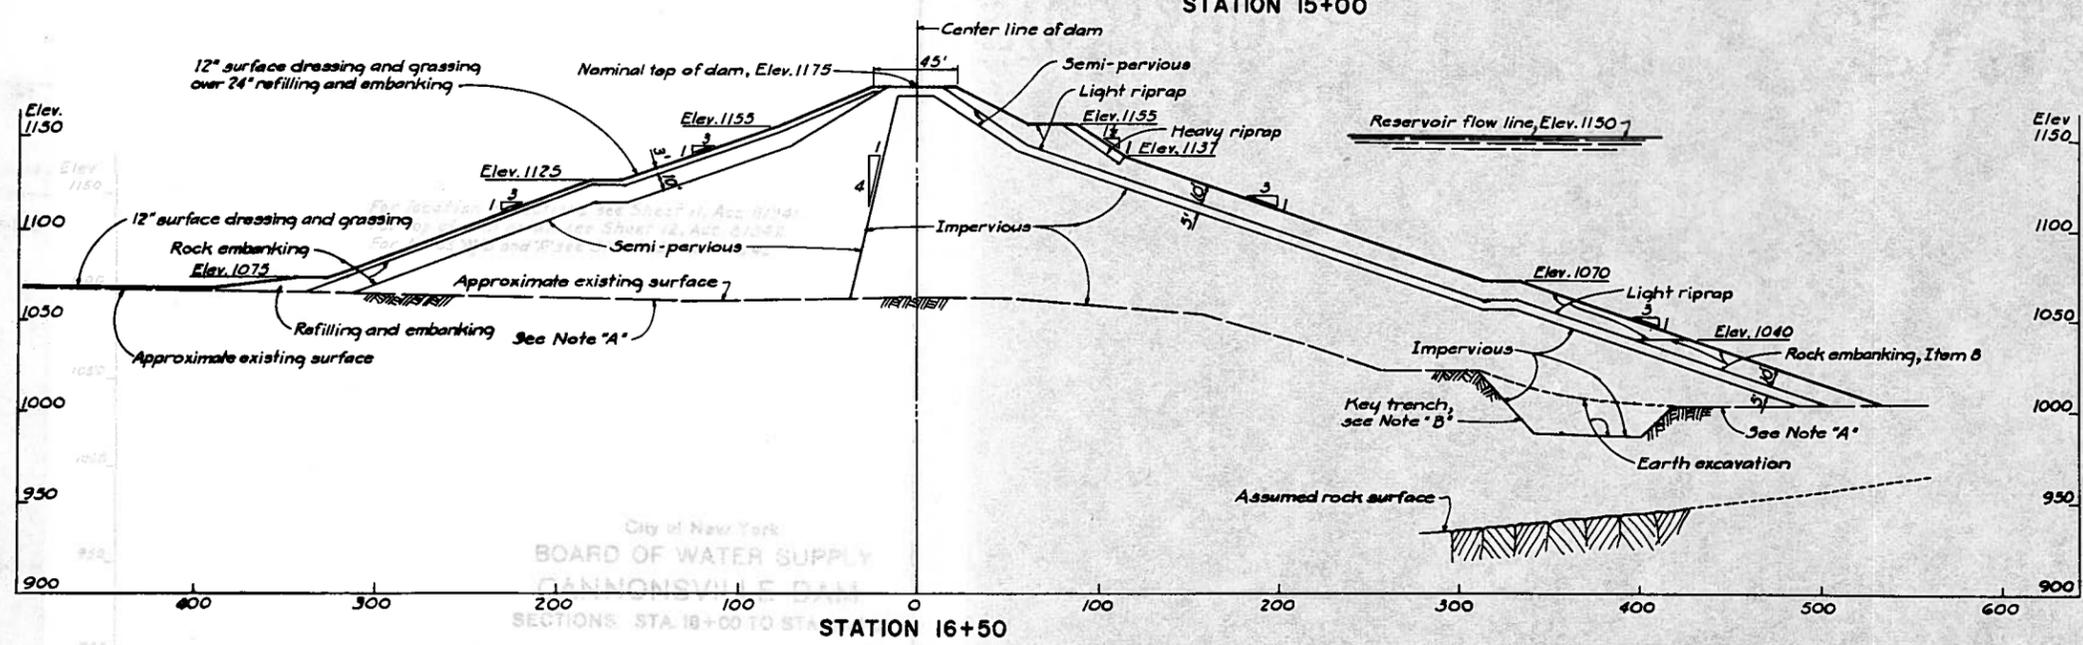
City of New York
BOARD OF WATER SUPPLY
CANNONVILLE DAM
SECTIONS STA. 14+00 TO STA. 16+50

For location of sections see Sheet 11, Acc. 81341.
For top of dam detail see Sheet 12, Acc. 81342.
For Notes "A", "B", "C", "D" and "R" see Sheet 13, Acc. 81343.
